Visual Property Inspection Report

**9 King Street
Raymond Terrace, NSW 2324**

February 9, 2026

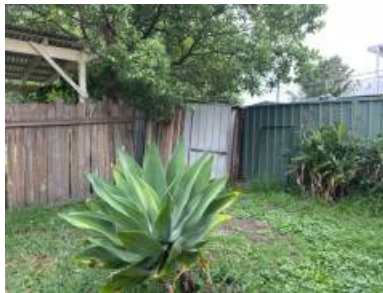
The fences are mainly constructed from timber and metal. The fences are generally in fair condition but some repairs or maintenance are required. Wet rot decay and defects were noted to the wooden fencing. Repairs and or replacement of damaged timber will be required.

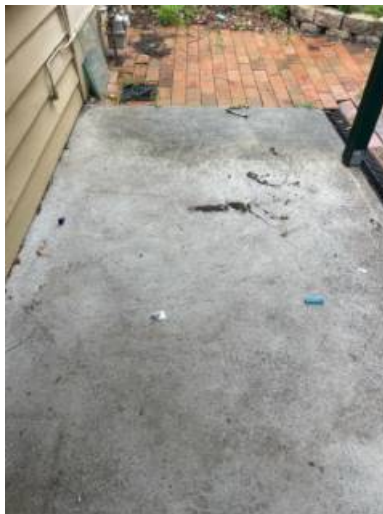
The paths/paved areas are in fair condition. The paths/paved areas have some visible cracking and damaged areas may require repair and or replacement.

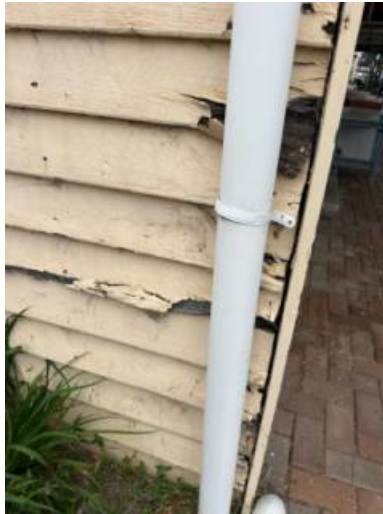
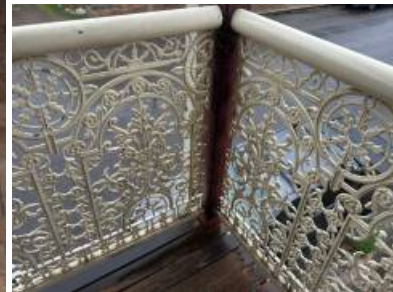
The external wall timbers show signs of age and weathering. Maintenance and or repairs will be required. Moderate wet rot decay is present to external walls. Recommend decayed timbers be replaced. Cladding is damaged and will require repairs and maintenance. External cladding is in contact with or close to soil areas. This practice is conducive to timber pest attack and we recommend modifications be made to prevent contact with soil.

Gap around AC unit should be filled. Bottom weatherboard is missing from western elevation. Minor repairs required to decking. Handrails require further fixings as are loose in areas.

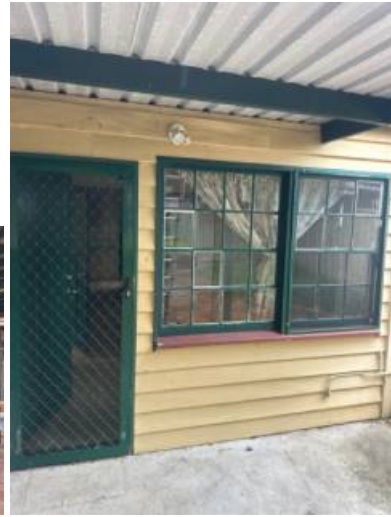
The condition of the exterior of the windows is generally fair. Insect screen/s have not been provided to all openings and should be installed. Some glazing beads to windows have deteriorated and require repair/replacement.

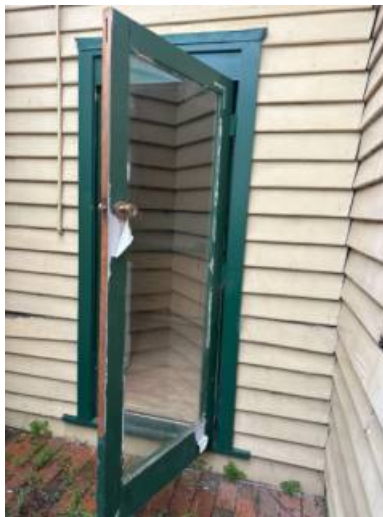
The condition of the exterior of the doors is generally fair. Some doors bind and adjustments are required to ensure correct operation. Insect screen door/s have not been provided and should be installed.

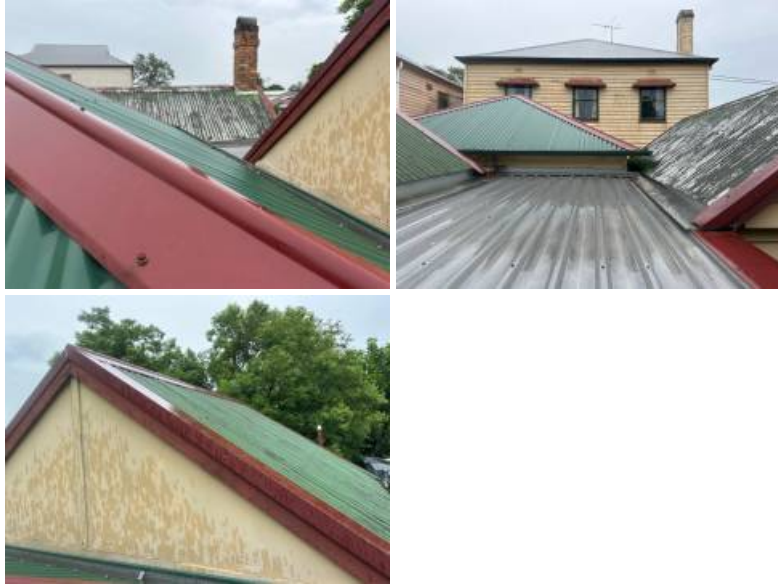
The overall condition of the roof coverings is fair. Paint to roofing has deteriorated.

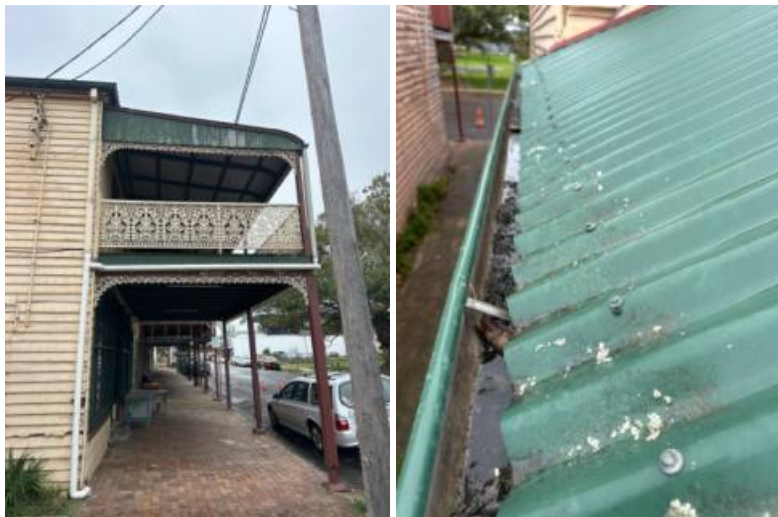
Appear to be in serviceable condition. Downpipes are damaged or rusting and should be repaired or replaced as necessary. Leaves and debris are present in gutters and the guttering should be cleared. Painting to downpipes require completion.

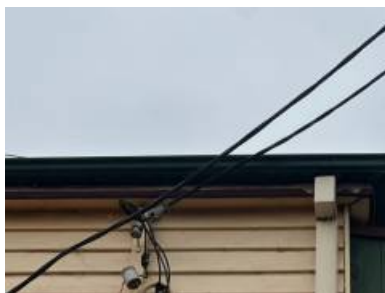
The eaves appear to be lined with fibre cement sheeting. Although we are not qualified in the detection of asbestos material, this item appears to contain asbestos. Asbestos material should not be disturbed or damaged and should only be removed or altered by a licensed asbestos removal contractor. Asbestos is hazardous to health and should be sealed to prevent exposure. Recommend an analysis by a qualified removal expert be conducted of these materials to confirm the amount and importance of the asbestos present, and the cost to seal or remove. The overall condition of the eaves lining is fair.

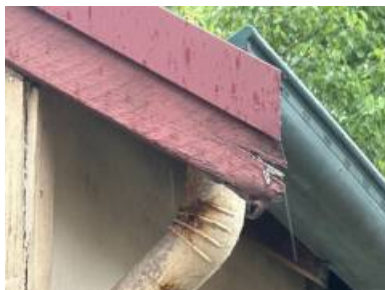
The overall condition of the fascias/bargeboards is fair. Moderate wet rot decay is present to some sections of the timber fascias/bargeboards. Maintenance and or replacement of damaged timber will be required.

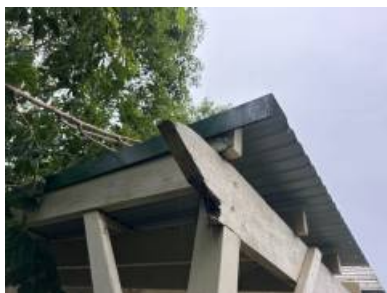
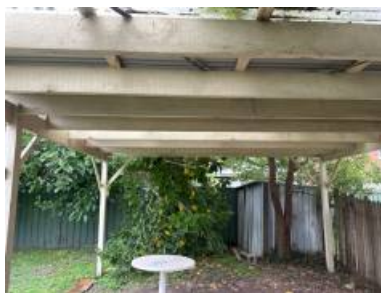
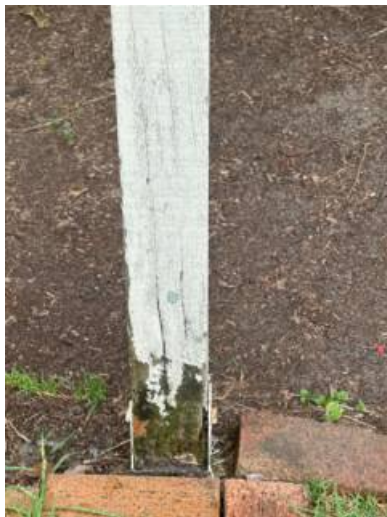
The structure is generally in fair condition. Some repairs required. Wet rot is present to some parts of the structure. No gutters/downpipes have been installed.

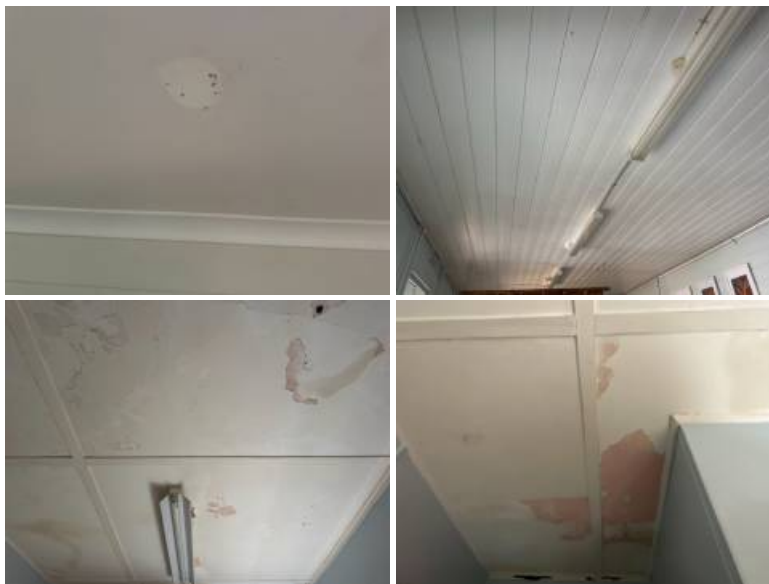
Ceiling Condition: The condition of the ceilings is generally fair. Older ceiling fabrics as viewed in this building, unless carefully maintained, are often sagging, cracked and have often been painted and or patched with poor results. These types of ceilings can have hidden flaws such as poor adhesion and or delamination affecting the long term safety and rigidity due to continued maintenance and repair. It is likely that replacement of some or all of these ceiling linings may be required. Asbestos may be present to some ceilings.

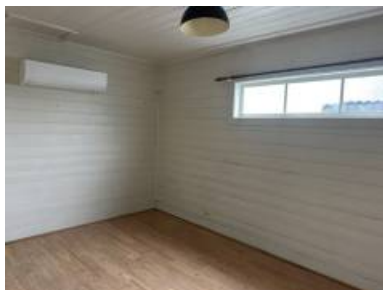
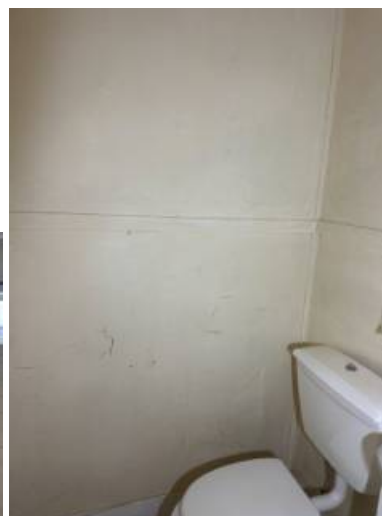
The condition of the walls is generally fair. Older wall fabrics as viewed in this building, unless carefully maintained, are often loose, cracked and have often been painted and or patched with poor results. These types of wall linings can have hidden flaws such as poor adhesion, dampness and or delamination affecting the long term safety and rigidity due to continued maintenance and repair. It is likely that replacement of some or all of these wall linings may be required.

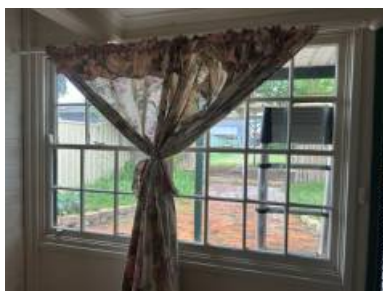
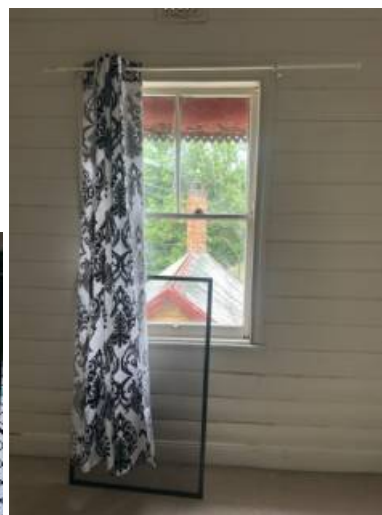
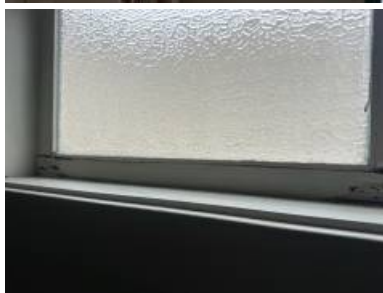
The condition of the windows is generally fair. Sash/s are sticking or fixed in the closed position and will require easing or repair to be operational. The windows show signs of age and weathering. Periodical maintenance will be required. The condition of the window hardware is generally fair. Some repairs or maintenance will be required. Insect screens require minor repairs/maintenance. Wet rot is present to some window frames.

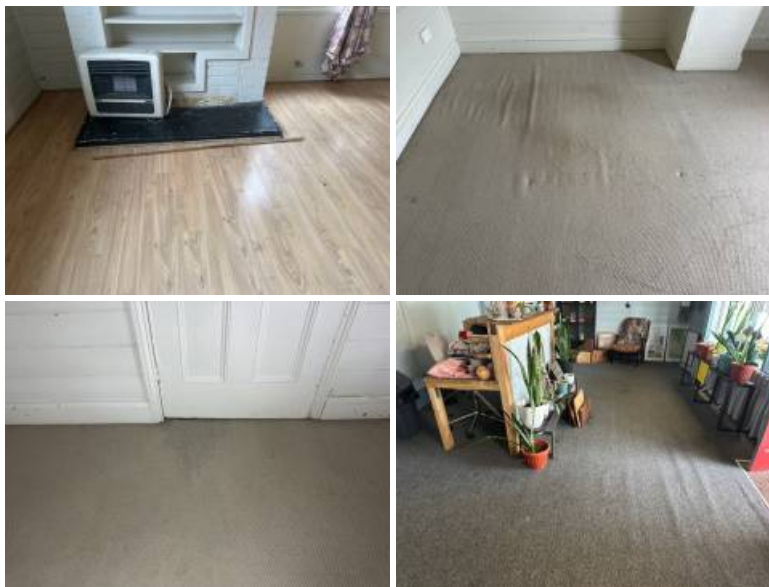
Flooring is uneven and squeaking flooring was noted. These areas should be leveled and secured to prevent movement. Trims to flooring are loose in areas.

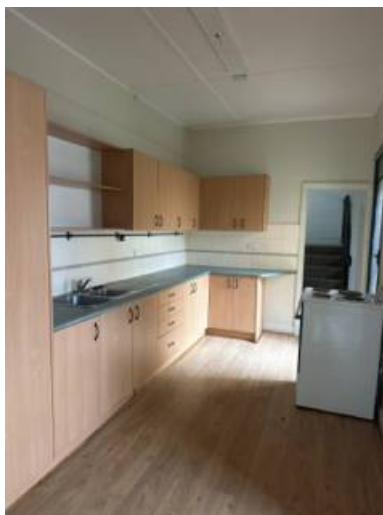
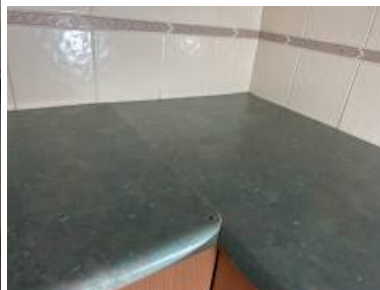
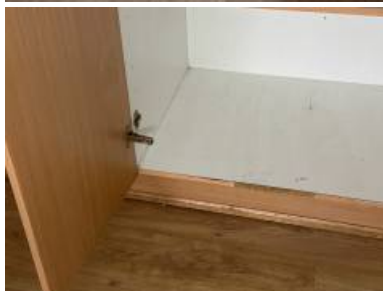
The condition of the fixtures is generally fair. Benchtop is blemished. A range hood has not been fitted. Wear and tear is noted to cabinets and some maintenance or repairs will be required.

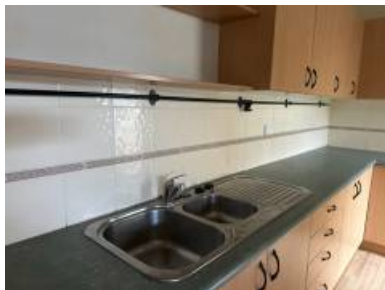
The condition of the tiles is generally fair. Movement and or settlement cracking to the junctions around fixtures should be filled with a flexible sealant to provide an acceptable

finish and prevent water penetration.

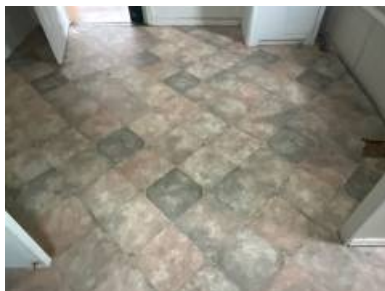
Tiles are not present to wet areas. Recommend tiles be installed to prevent water penetration. Recommend that the gap around tap spindles (behind the handle/tap fitting flanges) in the shower/bath areas be sealed with a flexible sealant to prevent water entering the wall area.

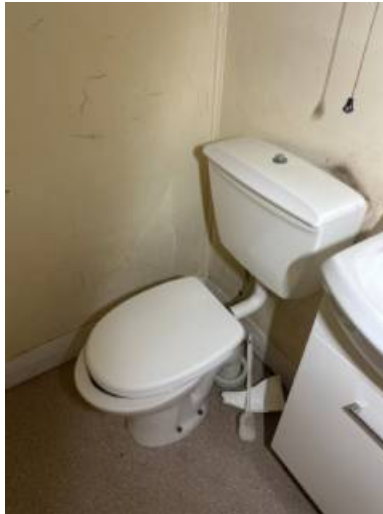
The toilet appears to be in working order. Toilet seat is loose and requires adjustment.

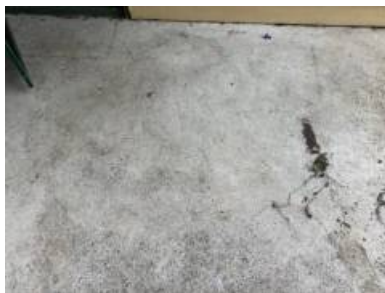
Crack Type: Differential movement cracking Located: Pathways Width: 0.5mm Length: 1.5M.

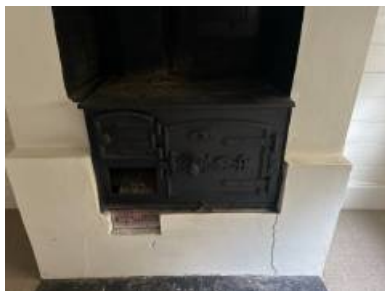
Crack Type: Vertical cracking Differential movement cracking Located: Width: 0.5mm Length: 500mm Fireplace.

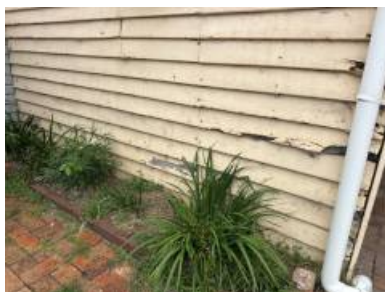
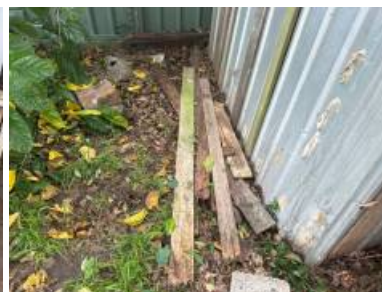
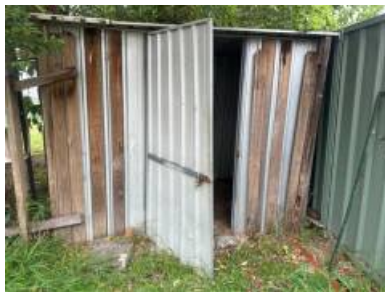
External cladding is in contact with soil. This can allow concealed termite entry and we recommend modifications be made so that soil is not in contact with cladding. Stored timbers should be removed. Some external timbers are in contact with soil. These should be modified so that timber to soil contact does not occur.

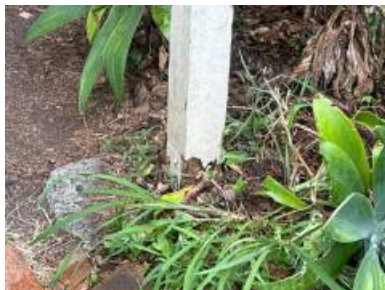
The following timbers are in contact with soil. Timber to soil contact can allow concealed termite entry and we recommend modifications be made.
