## VISUAL BUILDING & PEST INSPECTION REPORT

Complies with Australian Standard 4349.1 & 4349.6

**30 Blaxland Street, Frenchs Forest**

30.9.25

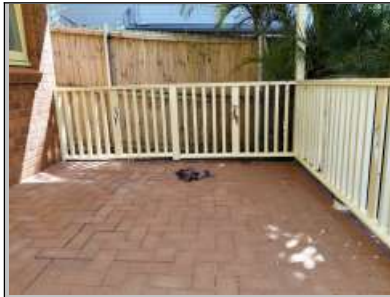
Rear elevation.

Constructed from concrete or masonry. The condition of the structure is generally acceptable.

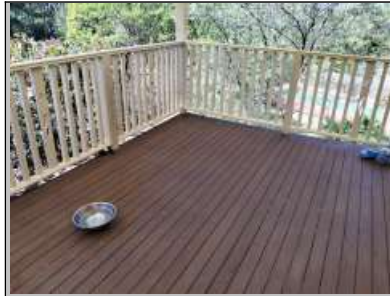
Rear elevation.

Where an external structure is constructed from timber or has significant timber components, and exposed to the elements, a suitably qualified engineer should inspect the structure to determine if it is structurally sound. We cannot determine or advise what weight the structure can hold. The general condition of this structure is fair.

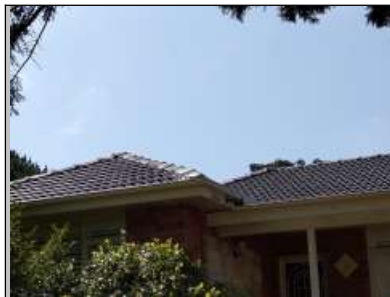
The roof is of pitched construction.

The roofing materials were viewed from a distance only. It should be noted that when roofing cannot be inspected in detail, other associated aspects of the roofing are also often not inspected in detail.

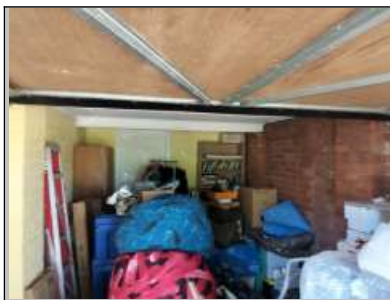
Garage.

Under the main building.

The structure is generally in good condition

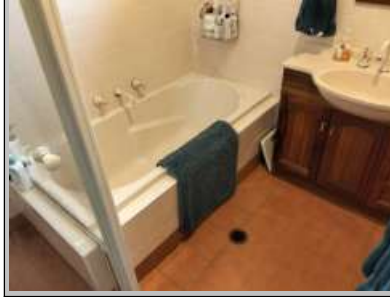
Adjacent to hall.

The shower recess was tested and there was no visible water penetration to surrounding areas. IMPORTANT NOTE: This test may not reveal water leaks until the shower is put into constant use and surrounding areas monitored over a period of time. Silicone sealant has been applied to the interface of the floor and walls in the shower recess in an apparent attempt to prevent water penetration to surrounding areas. This method of repair can only be considered to be temporary. Further waterproofing may be necessary.

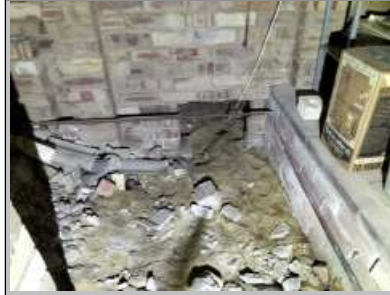
Some areas of the building are a concrete slab on ground construction and to these areas there is no accessible void for inspection. The entry point is too small to allow body access and accordingly no report on this area is submitted. Inspection was restricted in or below the following locations and or areas: Rumpus room.

Damage and or defects may be present and not detected in areas where inspection was limited, obstructed or access was not gained. If restrictions are noted we STRONGLY recommend that access be gained to all inaccessible areas.

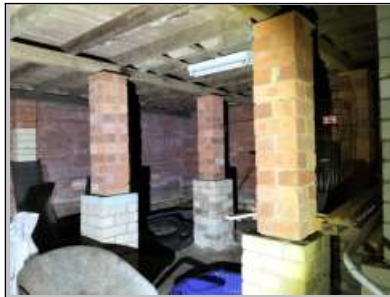
The building is constructed on a combination of strip footings and piers. The footings appear to be generally sound.

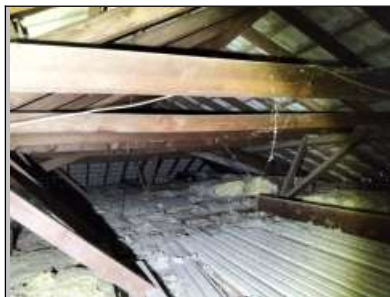
Insulation is present in the roof cavity. This restricted inspection to some roofing timbers. Removal of insulation is not within the scope of a standard visual inspection report, however as in accordance with "industry best standard" the inspector will lift insulation in 3 areas in roof void.

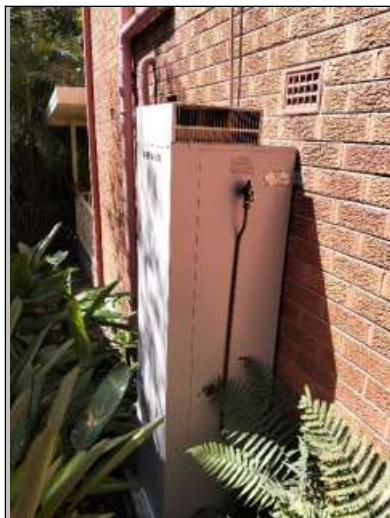
Gas hot water system: Mains pressure: Located externally: The hot water system appears to be in working condition. No specific tests other than running the hot water tap were carried out. No determination has been made as to the suitability or adequacy of the hot water system in relation to capacity or otherwise.

**Important Note:** It would be prudent to have all services (visible and non-visible) including electrical wiring, plumbing and drainage etc checked by appropriately qualified contractors.

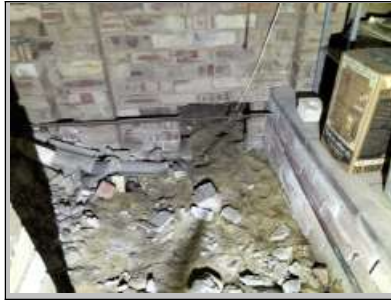
Some areas of the building are a concrete slab on ground construction and to these areas there is no accessible void for inspection. The entry point is too small to allow body access and accordingly no report on this area is submitted. Inspection was restricted in or below the following locations and or areas: Rumpus room.

Active termites or other timber damaging pests may be present and not detected in areas where inspection was limited, obstructed or access was not gained. We STRONGLY recommend that access be gained to all inaccessible areas. See Section 2.0 - Reasonable Access

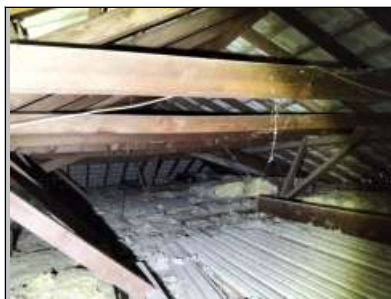
Insulation is present in the roof cavity. This restricted inspection to some roofing timbers. Removal of insulation is not within the scope of a standard visual inspection report, however as in accordance with "industry best standard" the inspector will lift insulation in 3 areas in roof void.

A comment is not made where access was unable to be gained. Active termites or other timber damaging pests may be present and not detected in areas where inspection was limited, obstructed or access was not gained. Timbers above the areas nominated were not accessed and not able to be inspected. Recommend access be gained to allow a full inspection of inaccessible areas.
