PRE-PURCHASE PEST INSPECTION REPORT

Property Address:
56 Drift Street, The Ponds NSW 2769

Inspection Report Ref:
AI5136

30/03/2023.

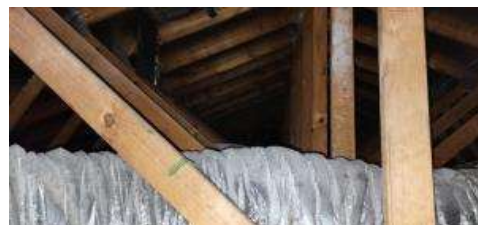
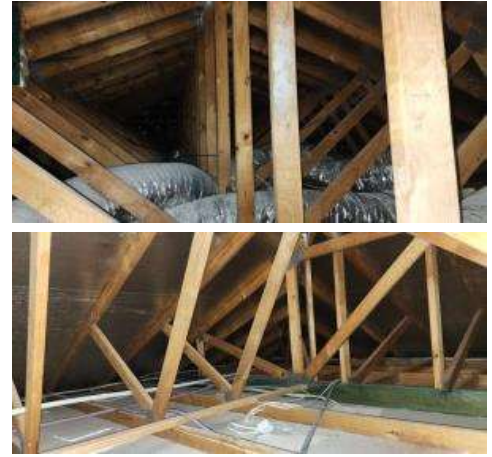
Sarking paper covered tile battens restricting inspection.

Ducting associated with air-conditioning or heating restricted inspection.

We were able to inspect the roof timbers above the garage and in the adjacent area over the main roof however, an additional access point should be cut at the other end of the building to facilitate further access and a more complete inspection to be carried out.

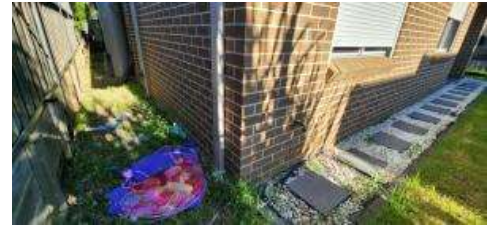
Inspection of the concrete floor slab edge was restricted. In our experience, termites most commonly enter over the slab edge and therefore we recommend modifications be made to expose the slab edge, see Section 4.0 - Concrete Slab Homes (part or full). A very high proportion of termite entry occurs over the slab edge. Covering the slab edge makes concealed entry for termites very easy and nearly impossible to visually detect. The following items restricted access to the edge of the slab: **Soil: Paths: Pavers: Hot water service: Air-conditioning unit: Stored goods: Gravel: Building materials: The method of construction:**

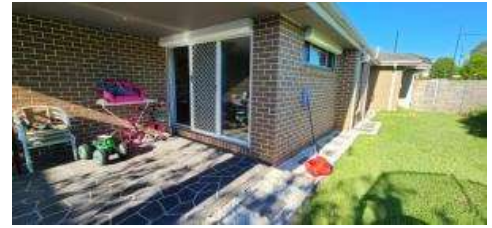
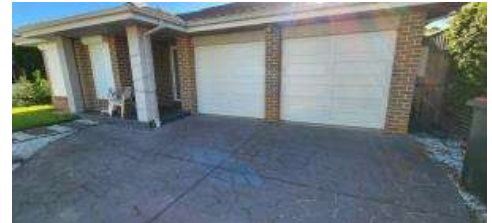
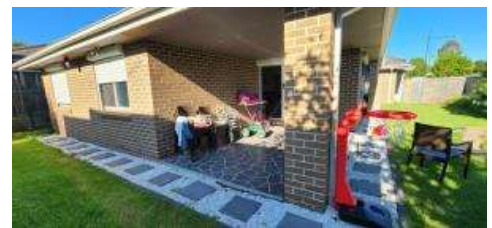
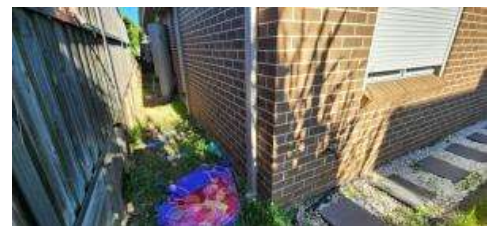
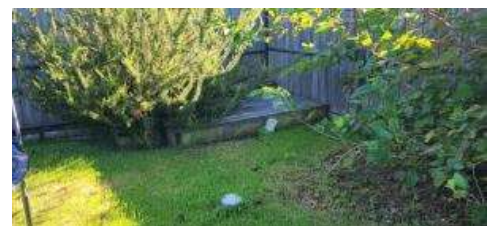
The level of some external paths, paved areas or soil is either higher than, or at a similar level, as that of the internal floors. This situation could allow concealed termite entry. We strongly recommend the lowering of these to below the internal floor level to reduce the risk of concealed termite entry.

The air-conditioning condenser discharges adjacent to the external walls. We recommend modification so that water is discharged over a drain. Air conditioning units which release water alongside or near to building walls should be piped to a drain (if not possible then several meters away from the building) as the resulting wet area is highly conducive to termites.

The hot water system overflow is discharging moisture adjacent to the structure. Hot water units that release water alongside or near to building walls should be piped to a drain (if not possible then several meters away from the building) as the resulting wet area is highly conducive to termites.

Loose timbers are present and in contact with the external soil. Timbers such as these are highly attractive to subterranean termite attack and should be removed.

Untreated landscaping timbers should be removed or replaced with a treated timber or non timber alternative. If replaced with timber, ensure appropriate durability rating for external use.

Some external timbers are in contact with soil. These should be modified so that timber to soil contact does not occur.

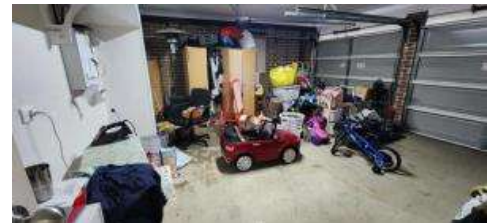
Stored items restricted inspection to the interior of the garage.

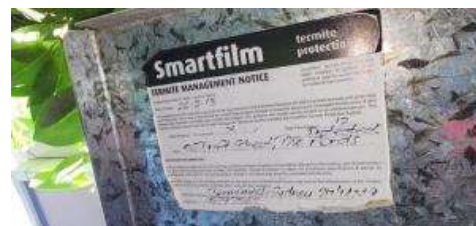
A notice indicates that the property may have been treated during construction in respect to protection against subterranean termite attack. We strongly recommend any prospective purchaser attempt to verify this information and obtain copies of all relevant documentation.
