**PRE-PURCHASE**  
**PROPERTY**  
**INSPECTION**  
**BUILDING REPORT**

Visual Pre-Purchase Building Inspection Report.

**24 JAMES RUSE CLOSE WINDSOR**

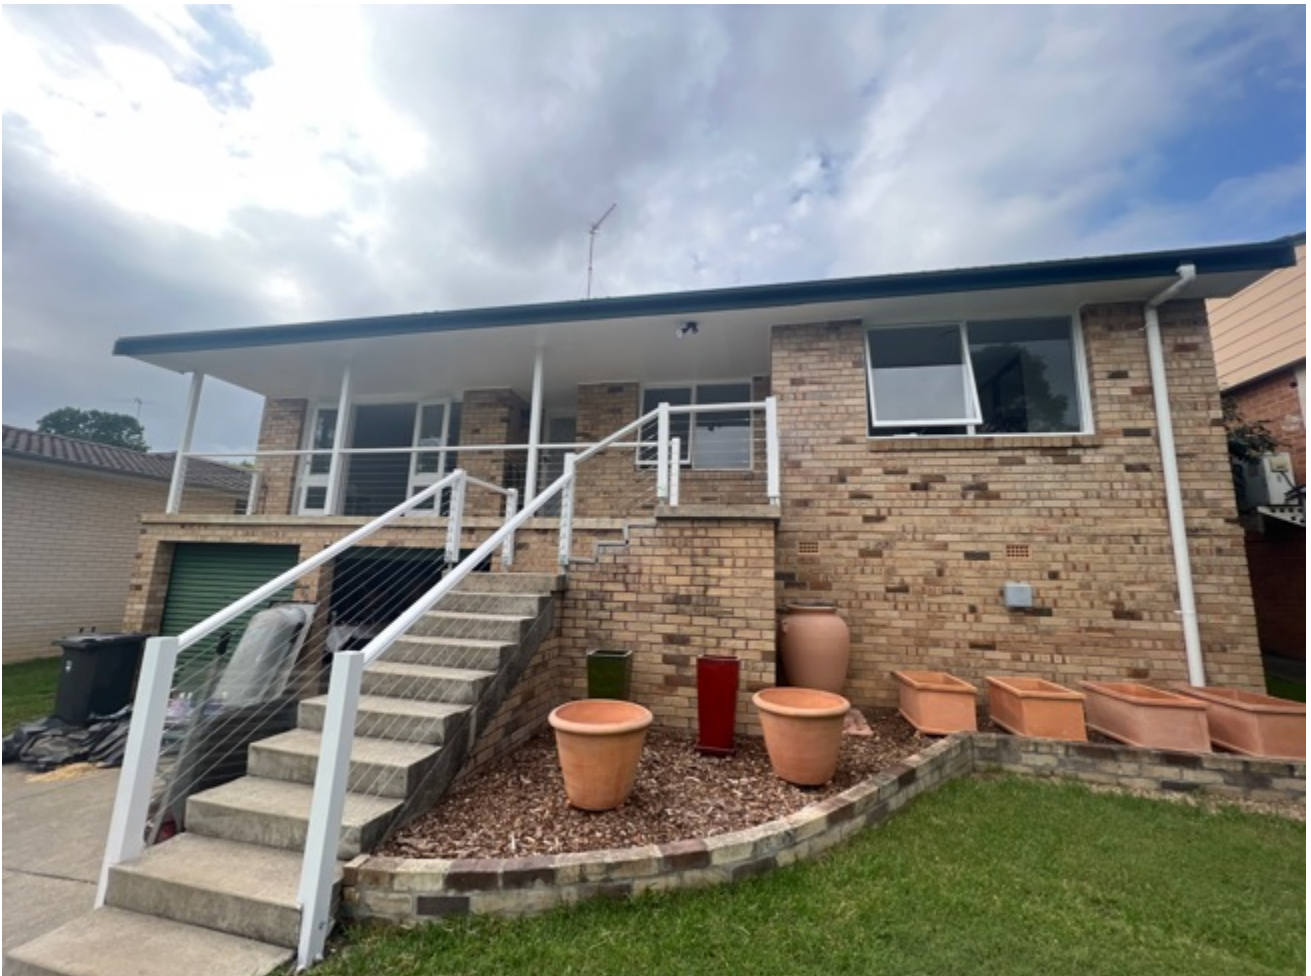
The exterior of the house is in satisfactory condition displaying no major structural issues.

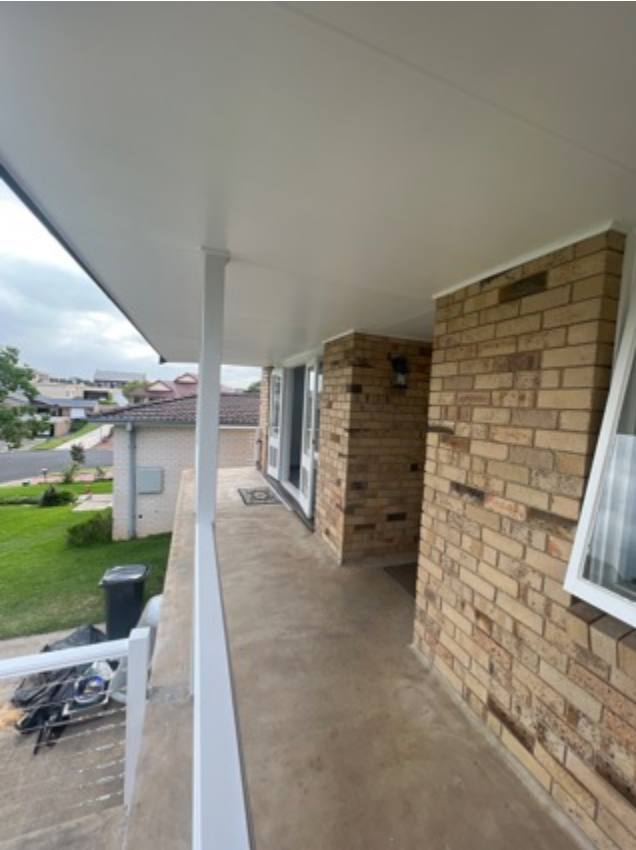
External surfaces have sufficient paint coverage, recently completed (example soffits.)

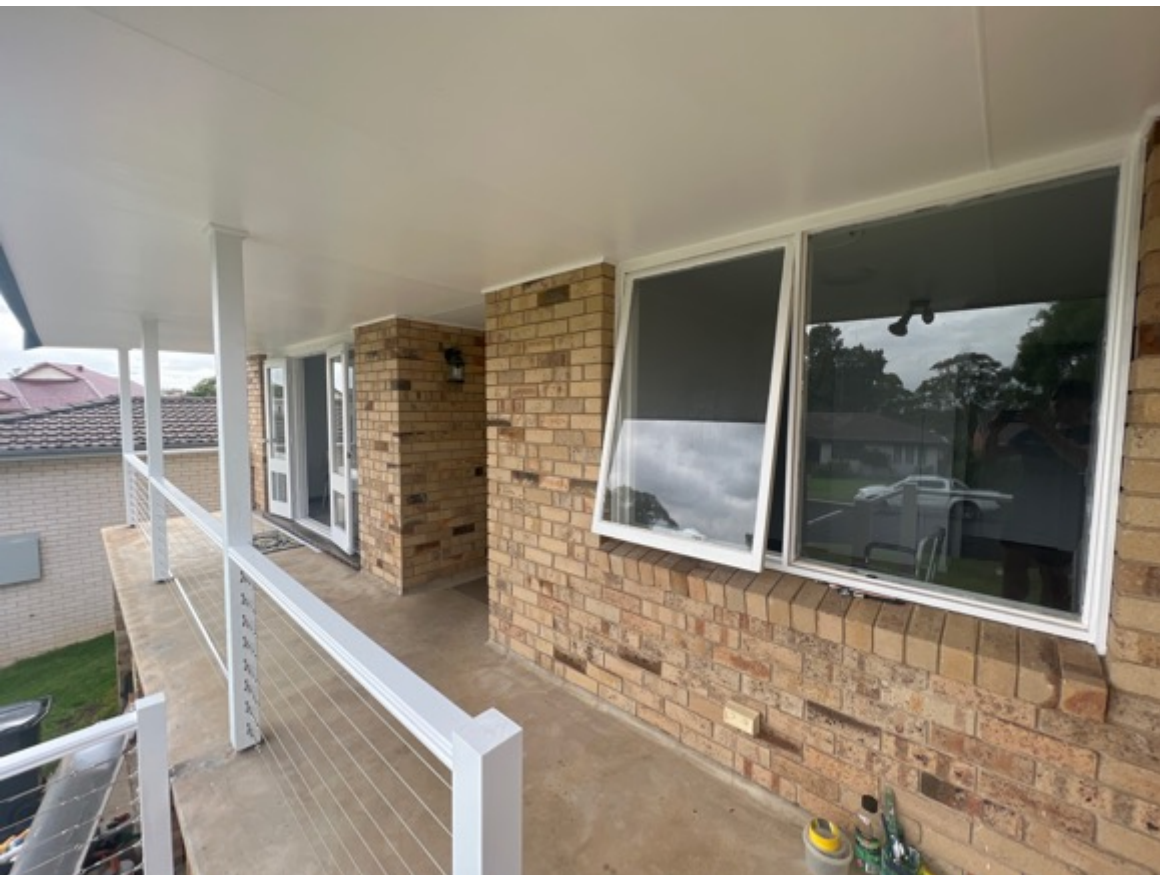
External windows and doors present in satisfactory condition for the age.

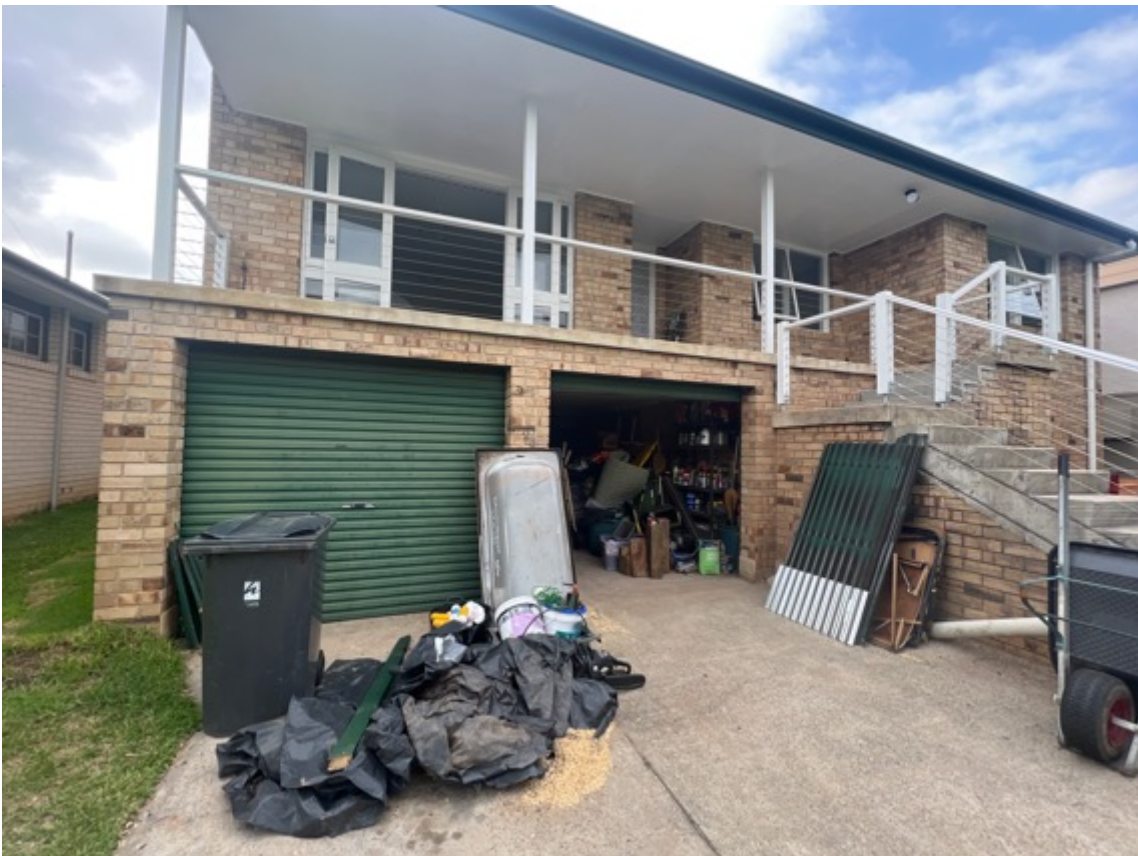
External roller doors tested, function as intended.

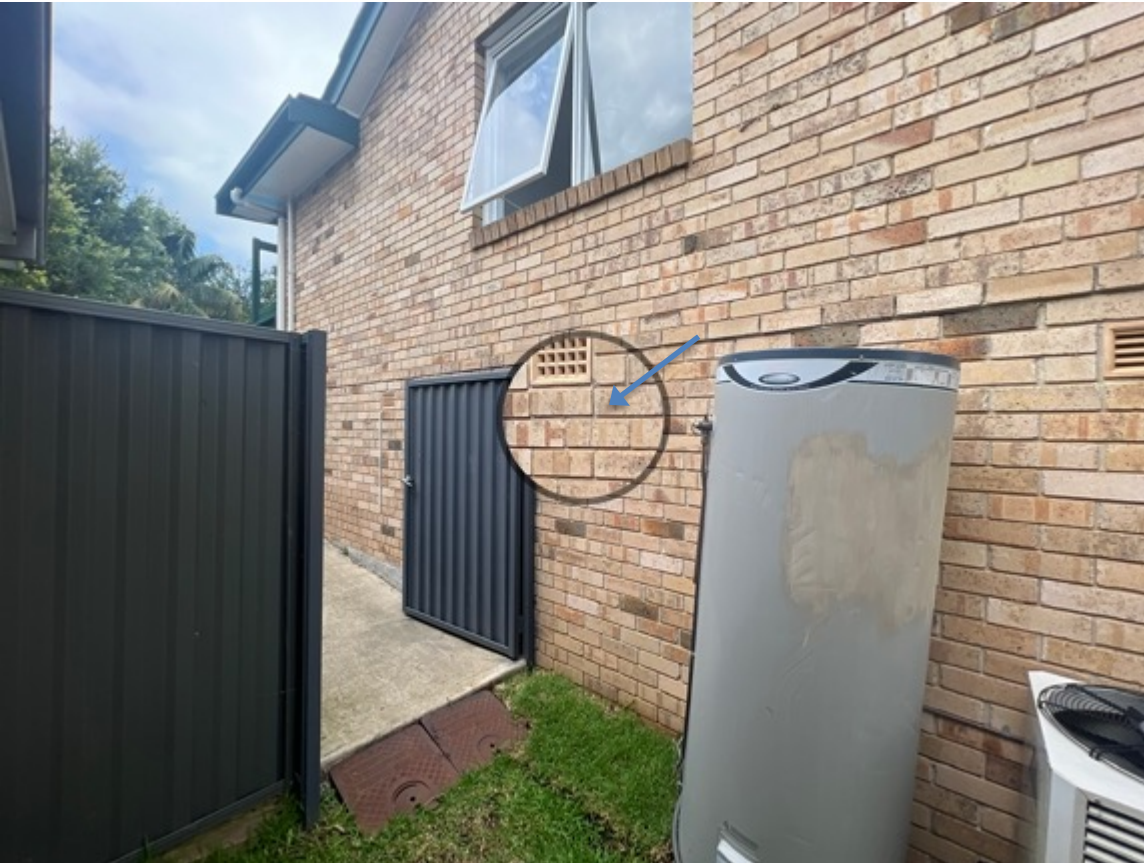
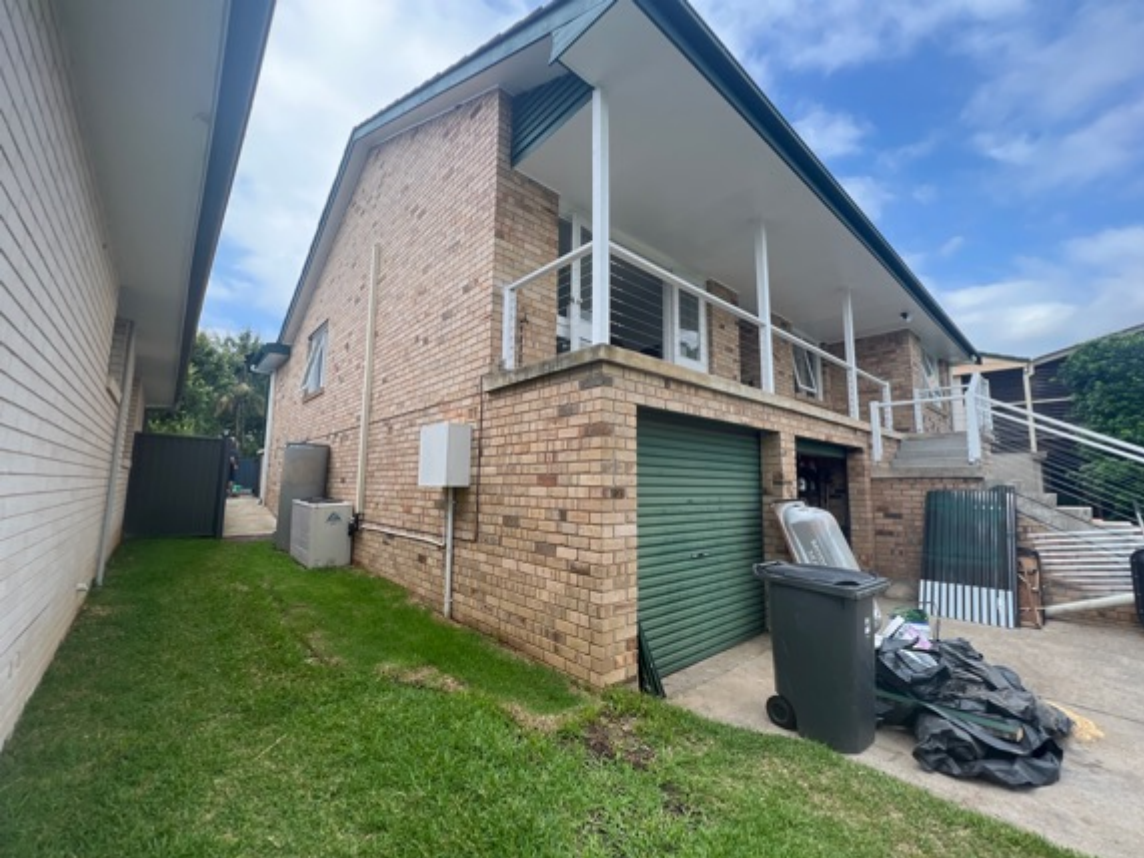
Location shot.

External brickwork has some category one cracking on the left elevation near the side access gate.

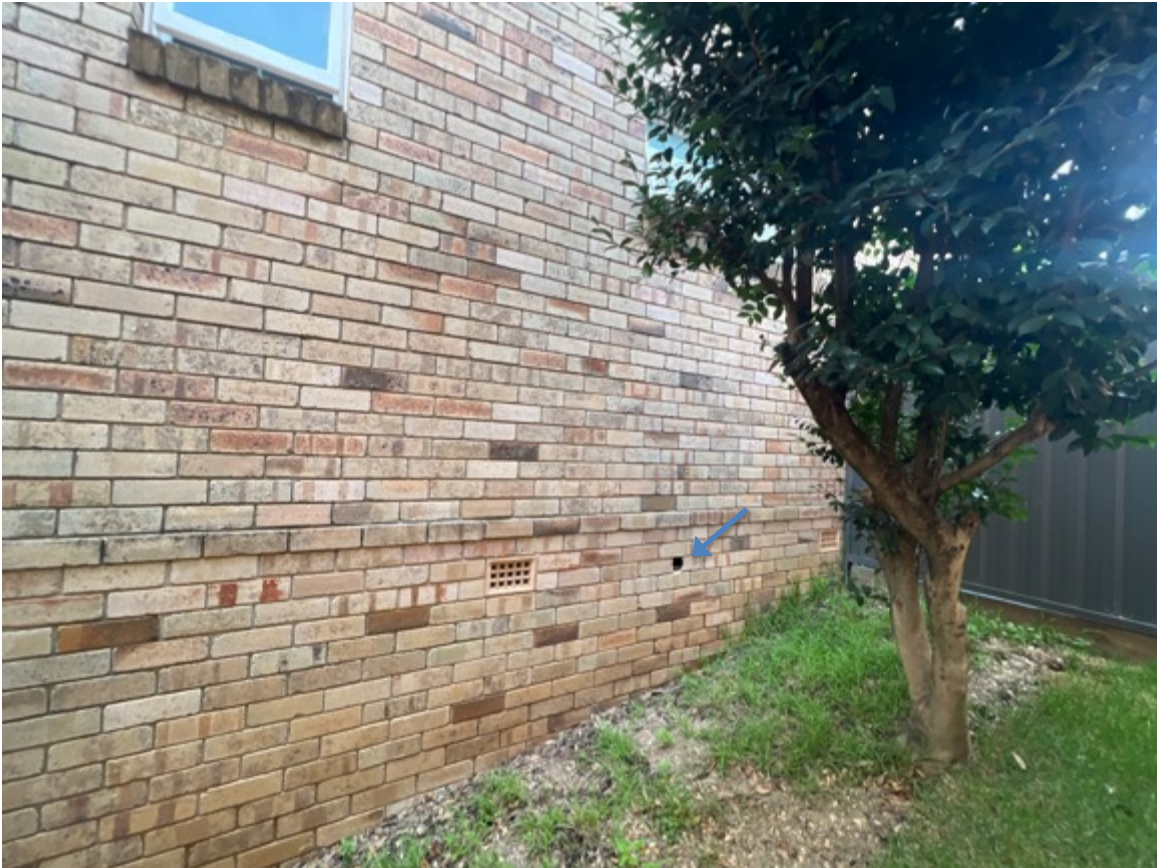
One right side elevation brick has a hole here.

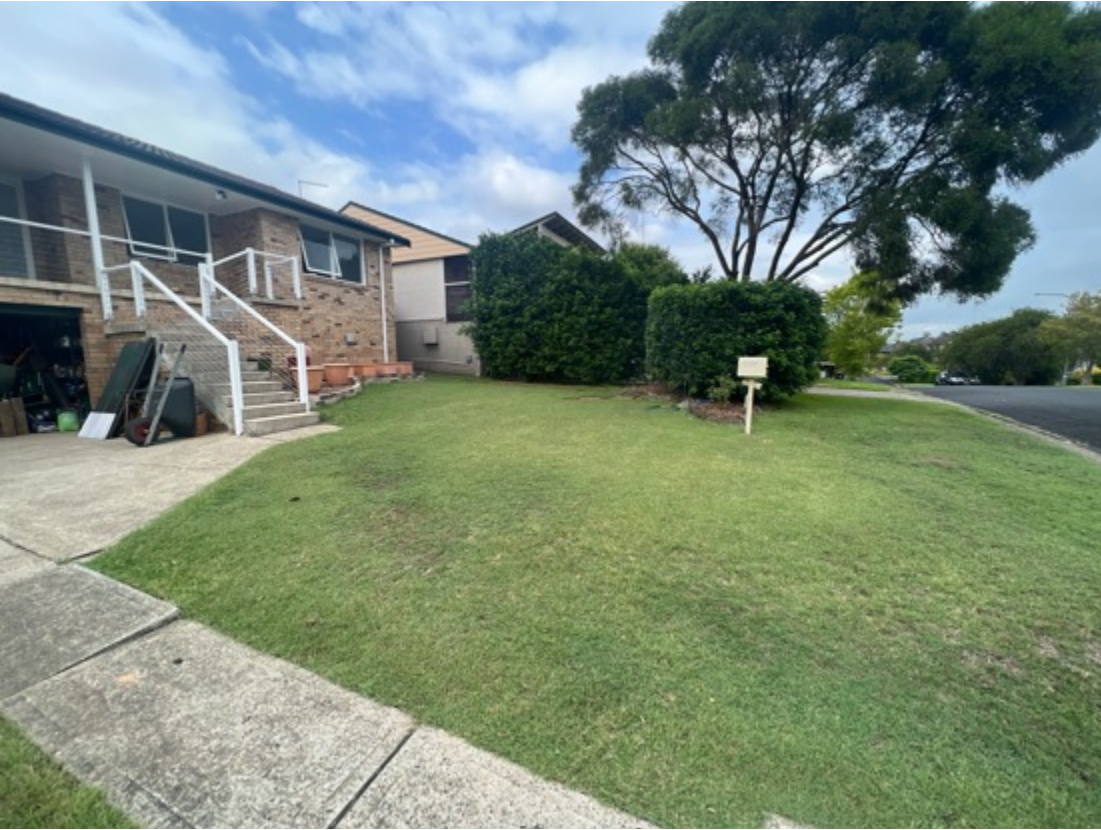
Site drainage / land overflow appears to function adequately with no signs of water laying at the time of inspection.

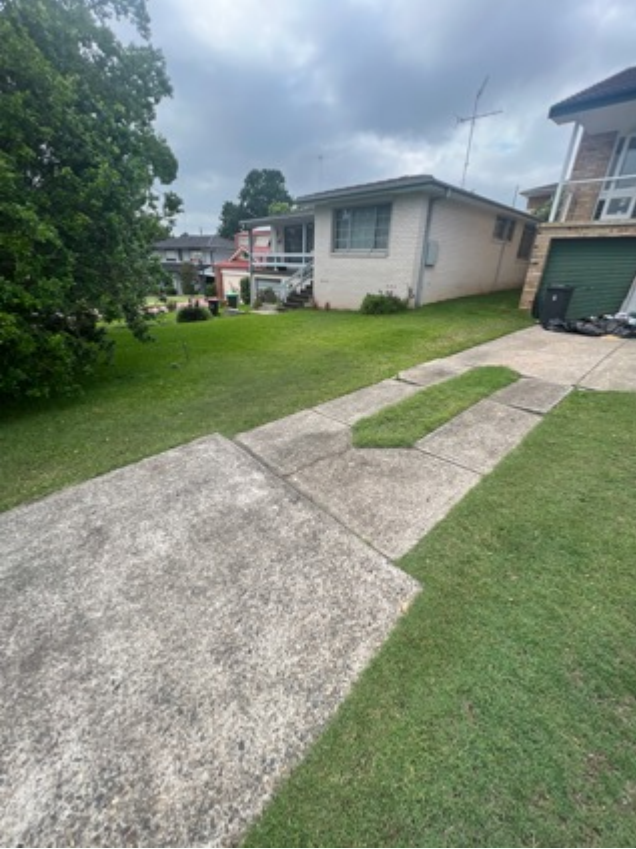
Sections of external concrete is lipped and cracked - other areas are in serviceable condition.

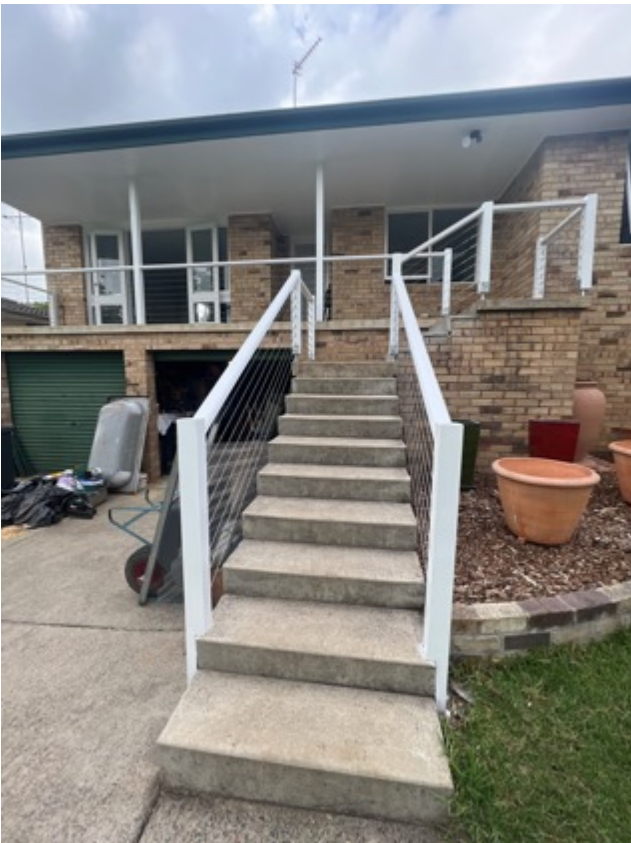
External railings and the rear pergola checked are structurally sound.

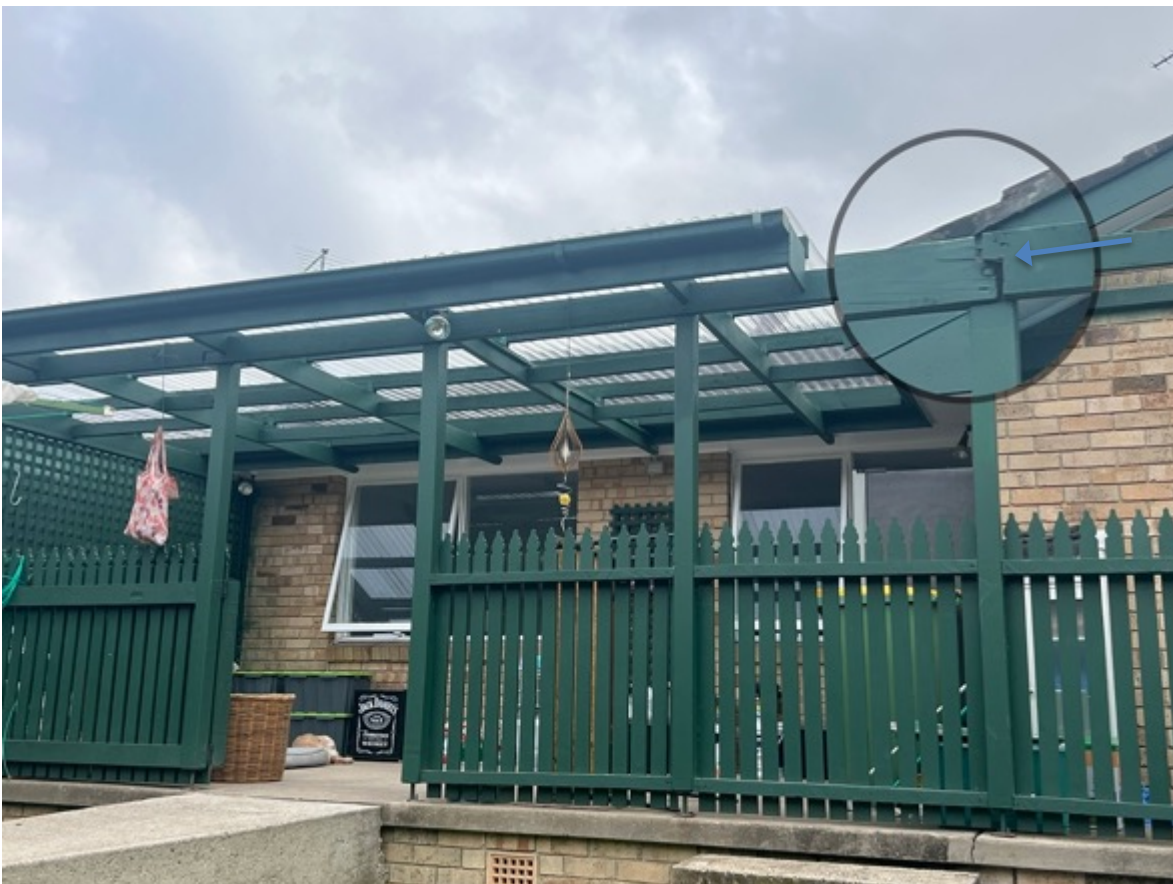
Sections of external timber is weathered - typical for the age.

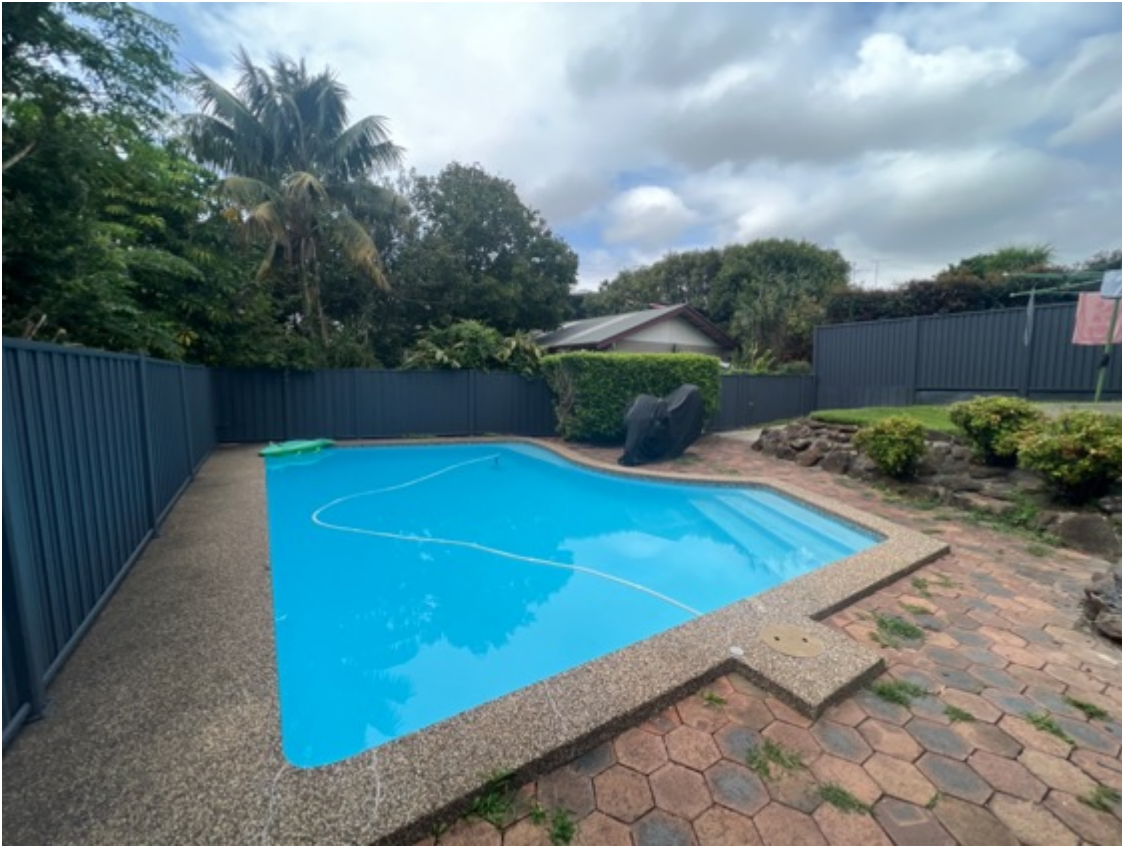
The pool area presents in satisfactory condition.

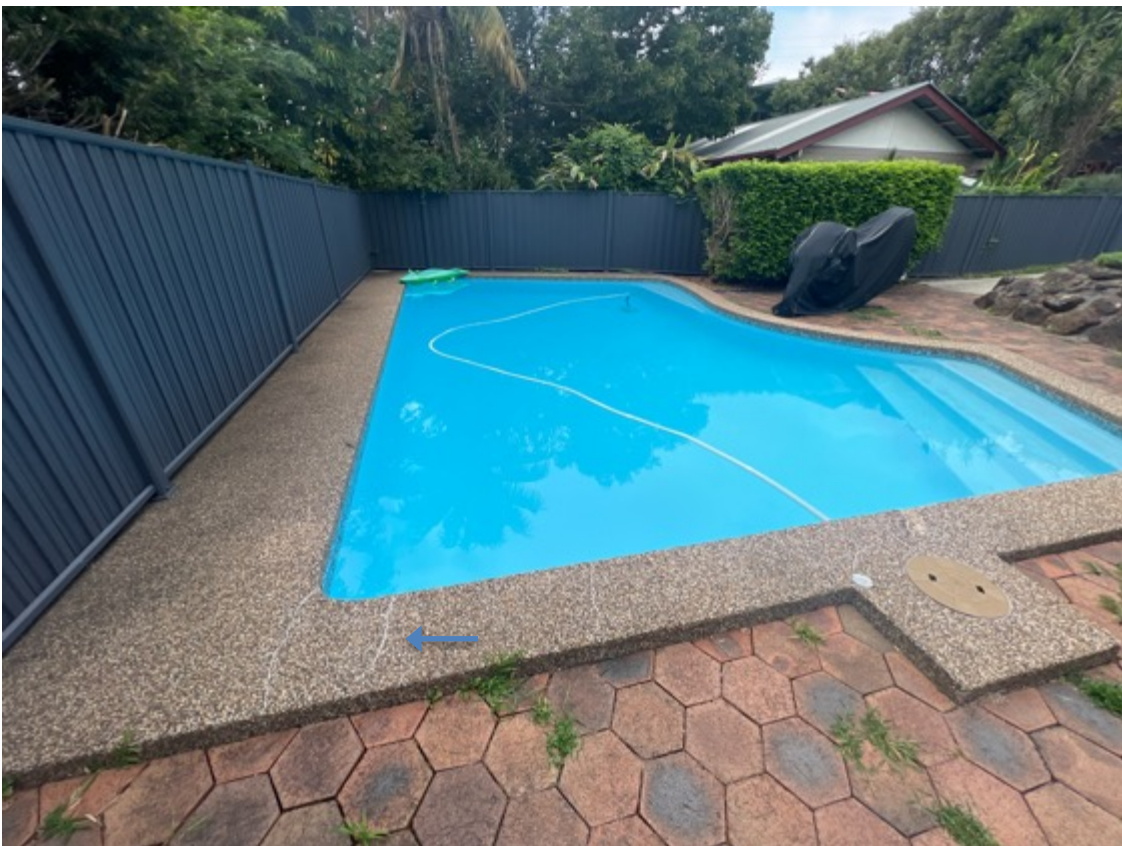
Minor sections of pebblecrete are cracked.

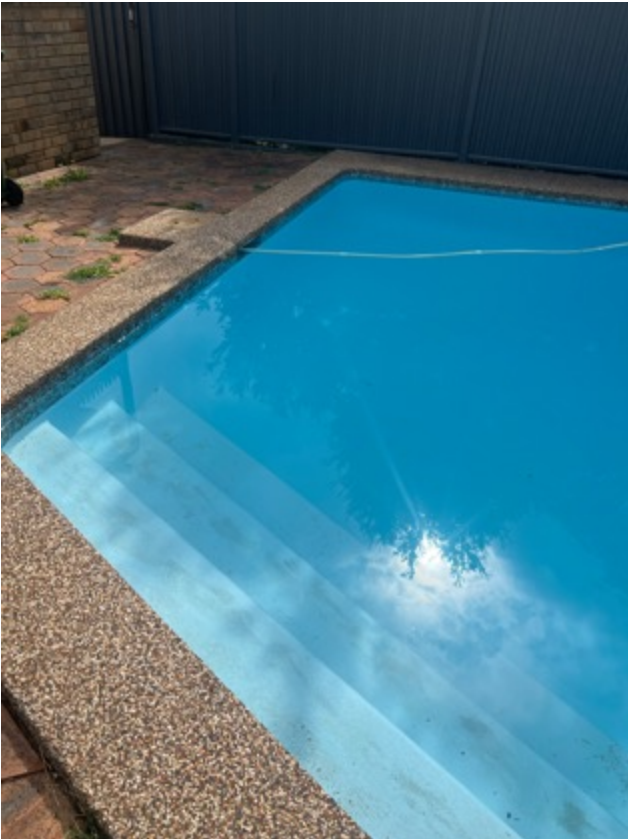
External pavers are in serviceable condition, minor sections are undulating. Minor sections of the pool interior are worn.

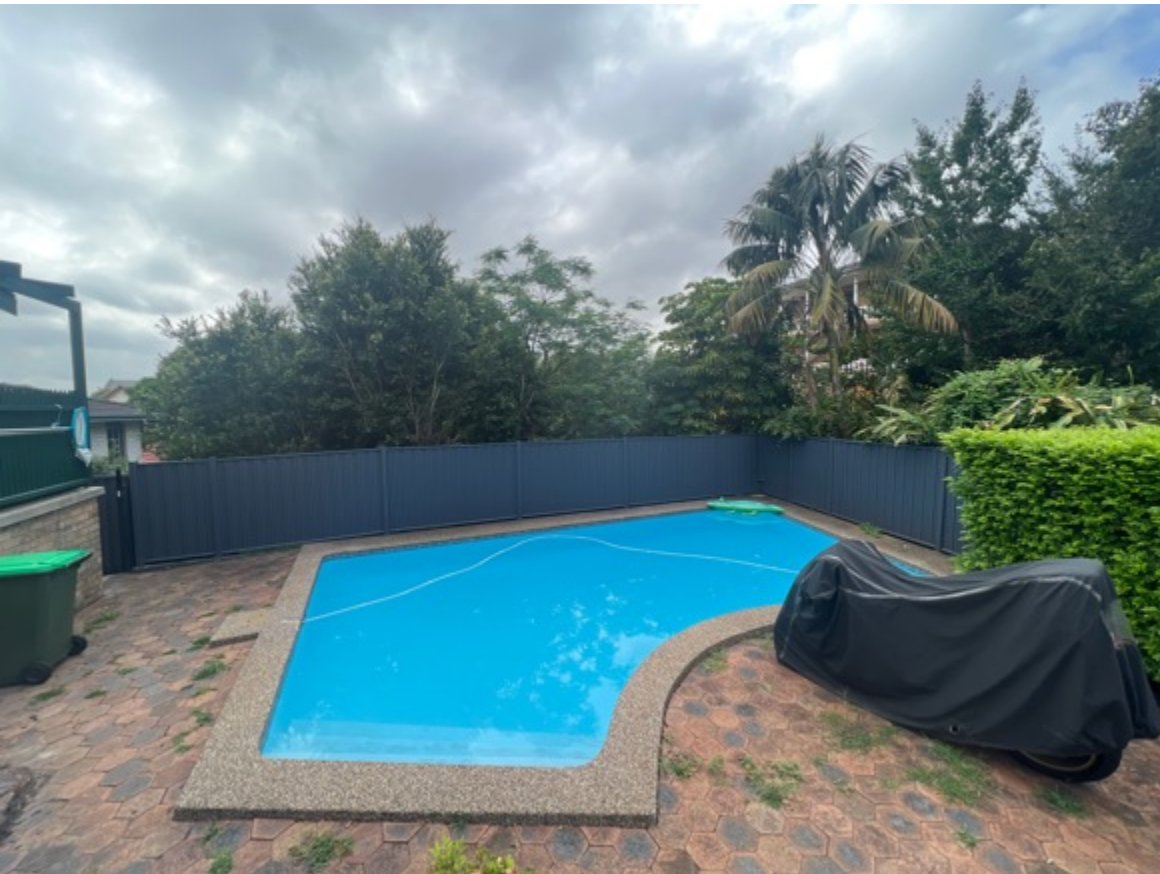
Site fences are in serviceable condition.

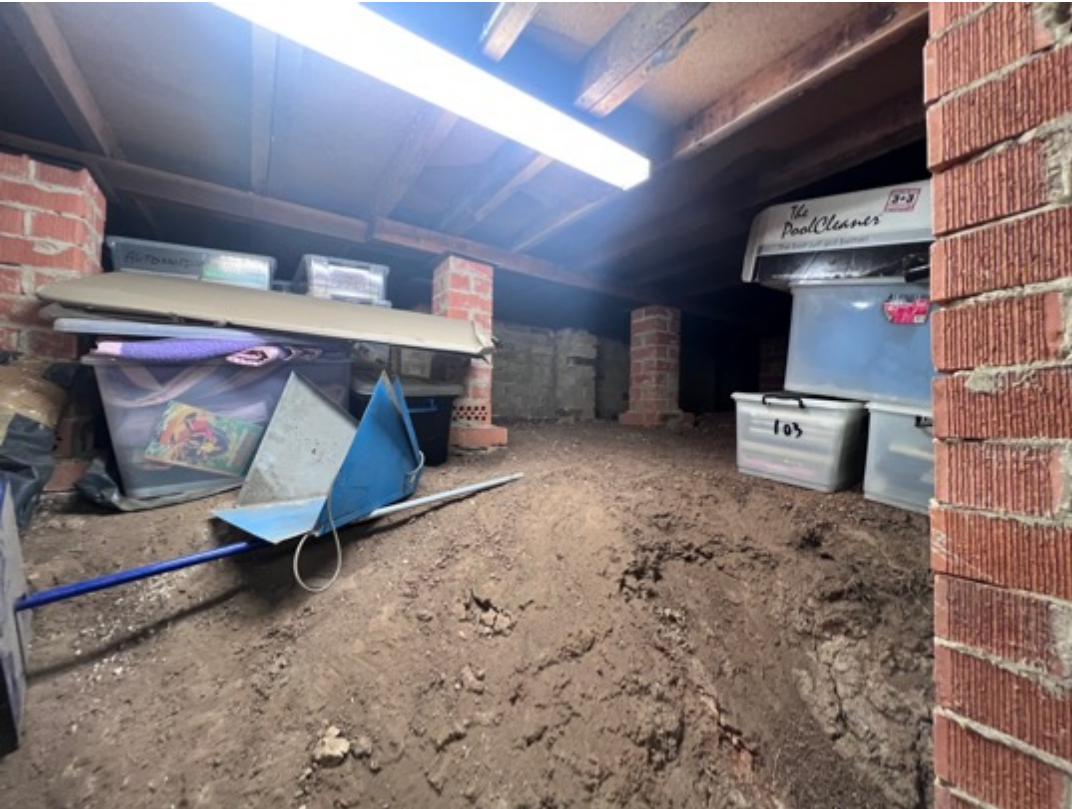
The subfloor area was dry at the time of inspection.

Maintain regular pest control by means of baits, sprays and monitoring to prevent pest attack within the subfloor area.

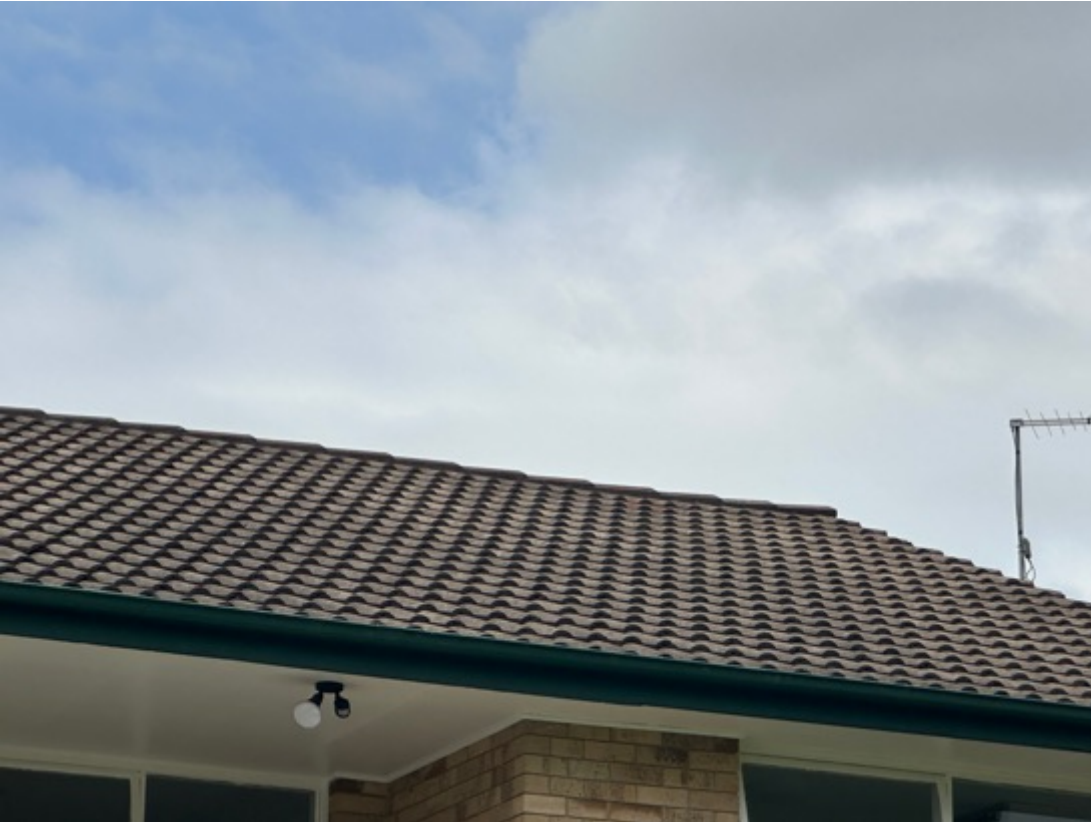
The roof exterior is in satisfactory condition for the age.

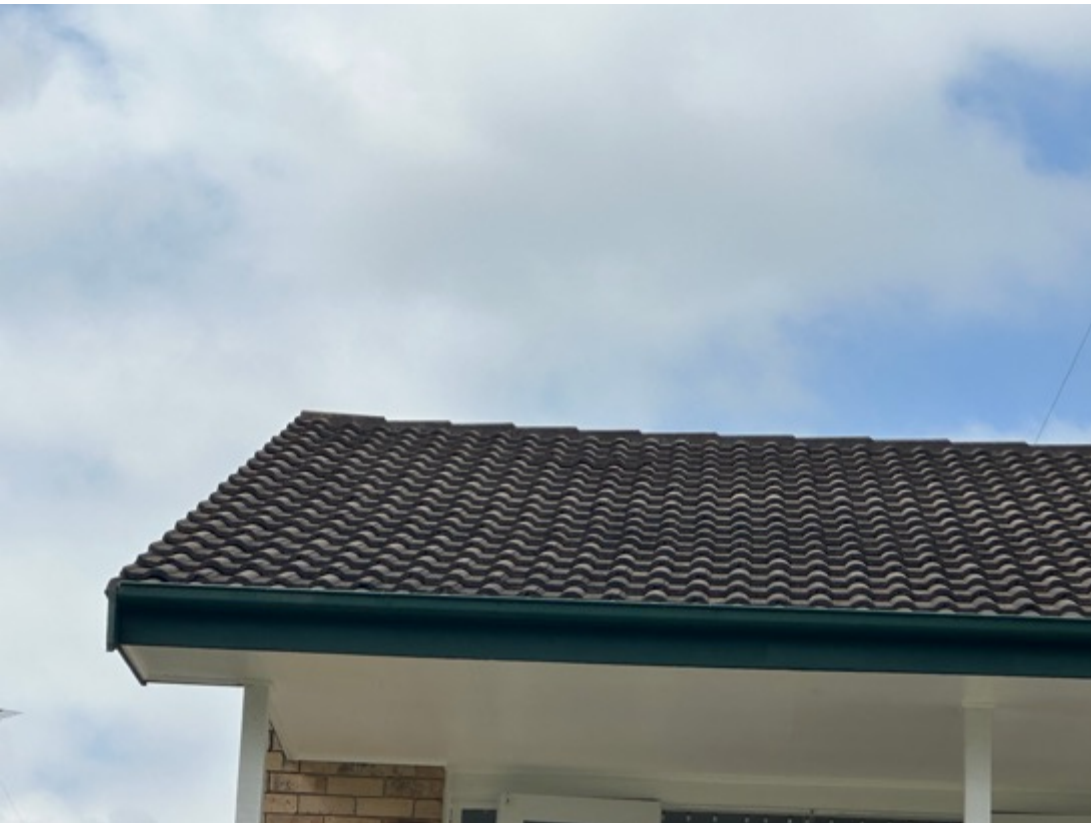
Pointing checked is intact.

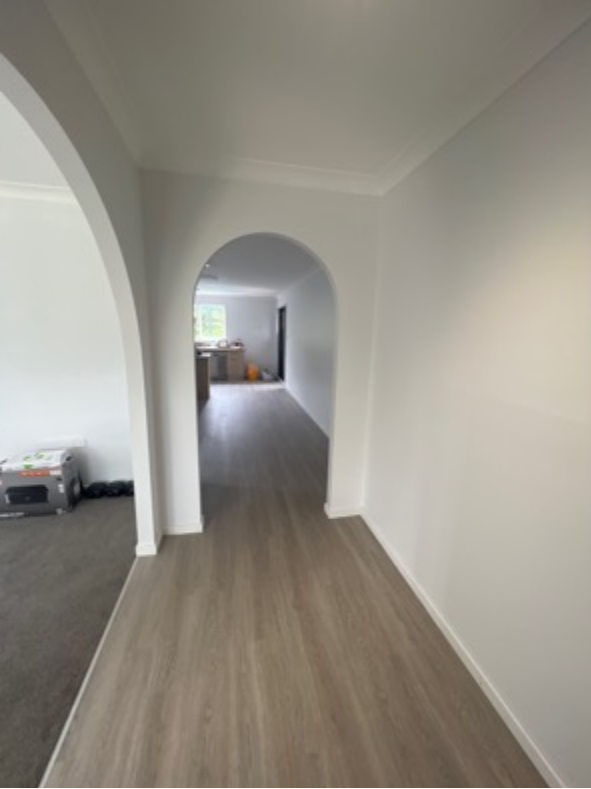
The interior of the house is in satisfactory condition, maintained to a high level for the age.

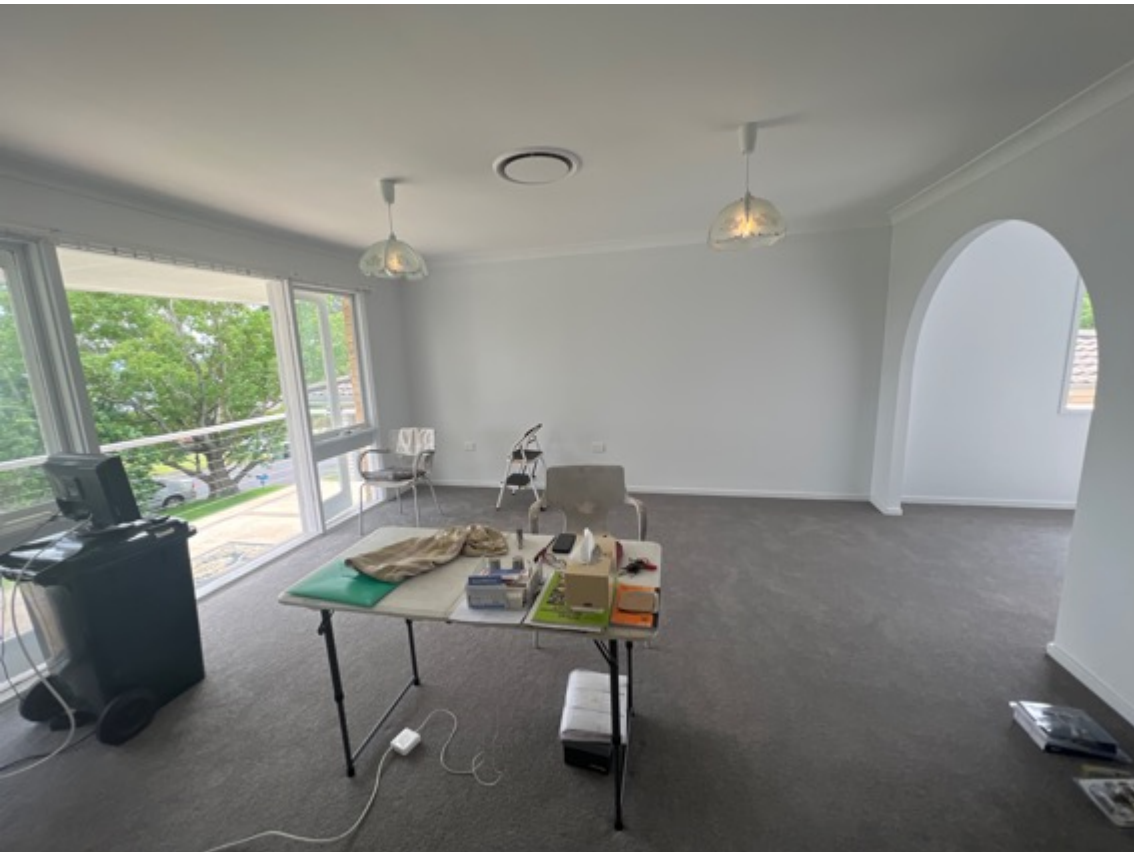
Internal living / dining rooms present in satisfactory condition for the age.

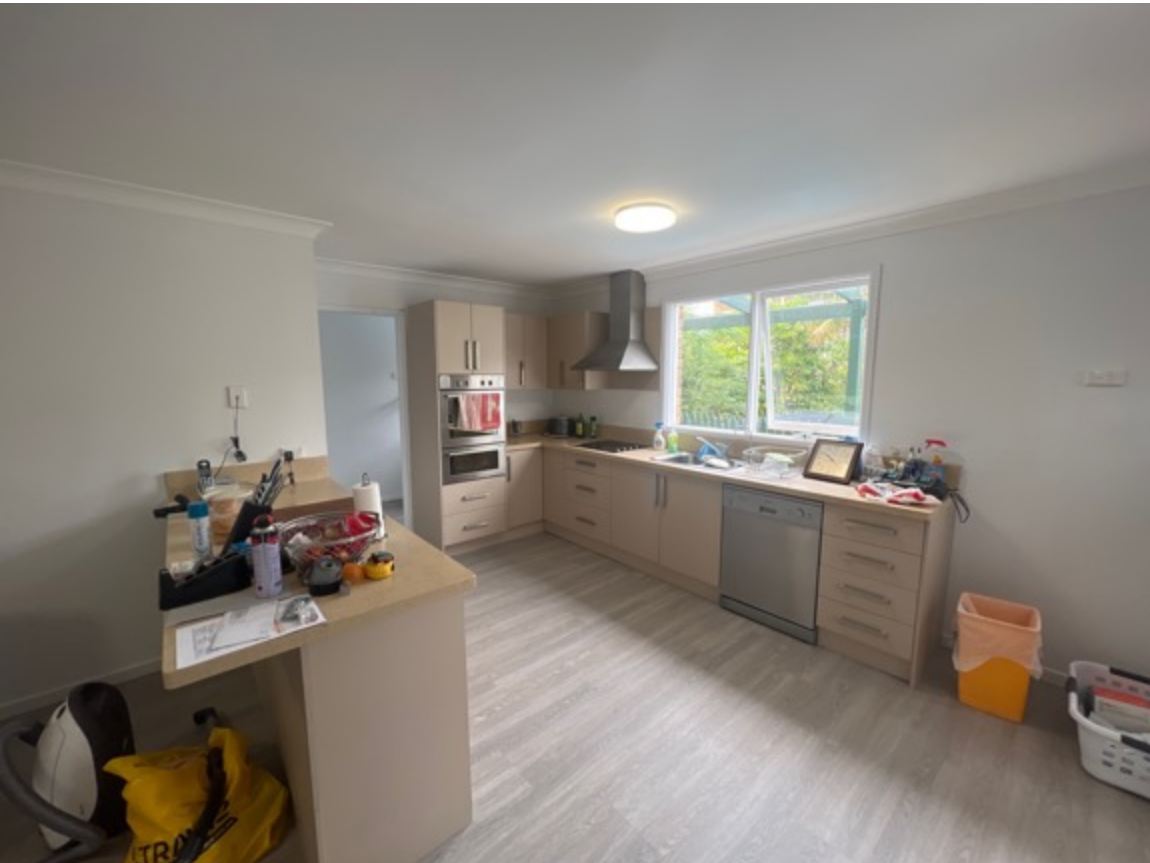
The kitchen presents in satisfactory condition for the age.

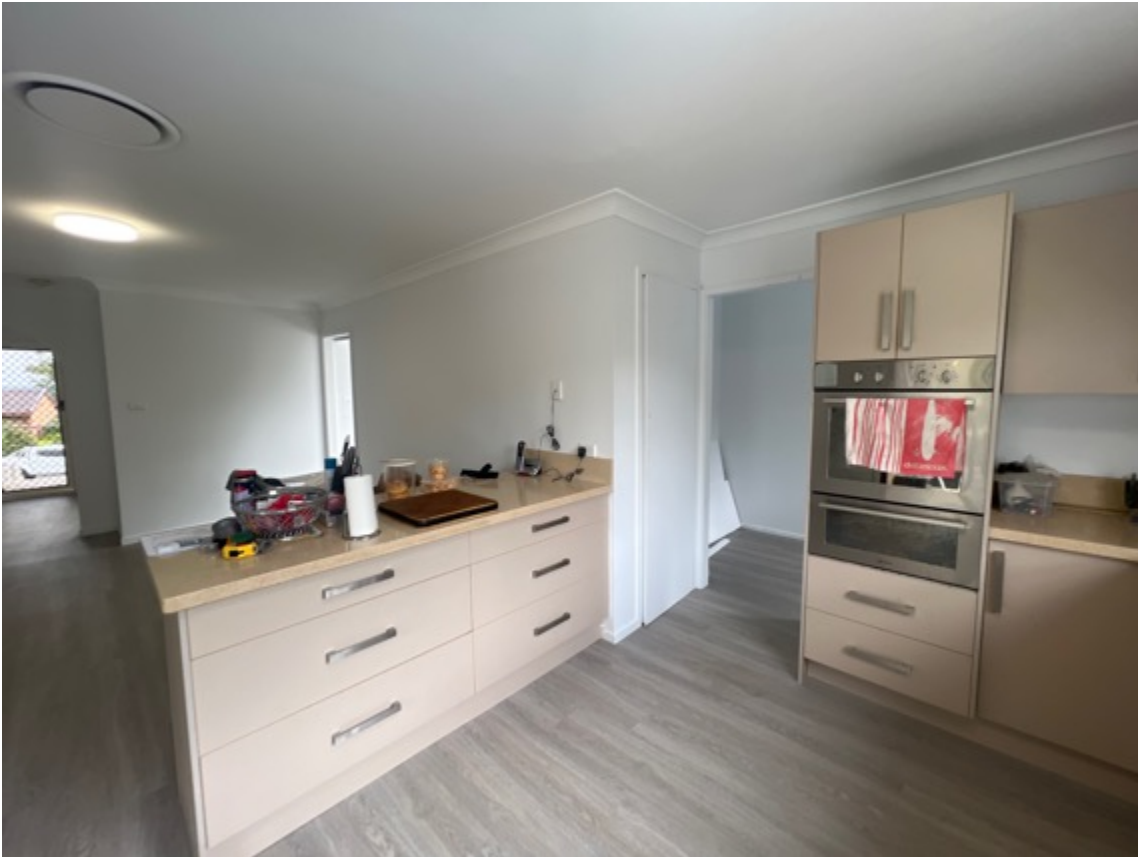
Cupboards and draws tested, function as intended (minor sections display low level wear, typical for the age.)

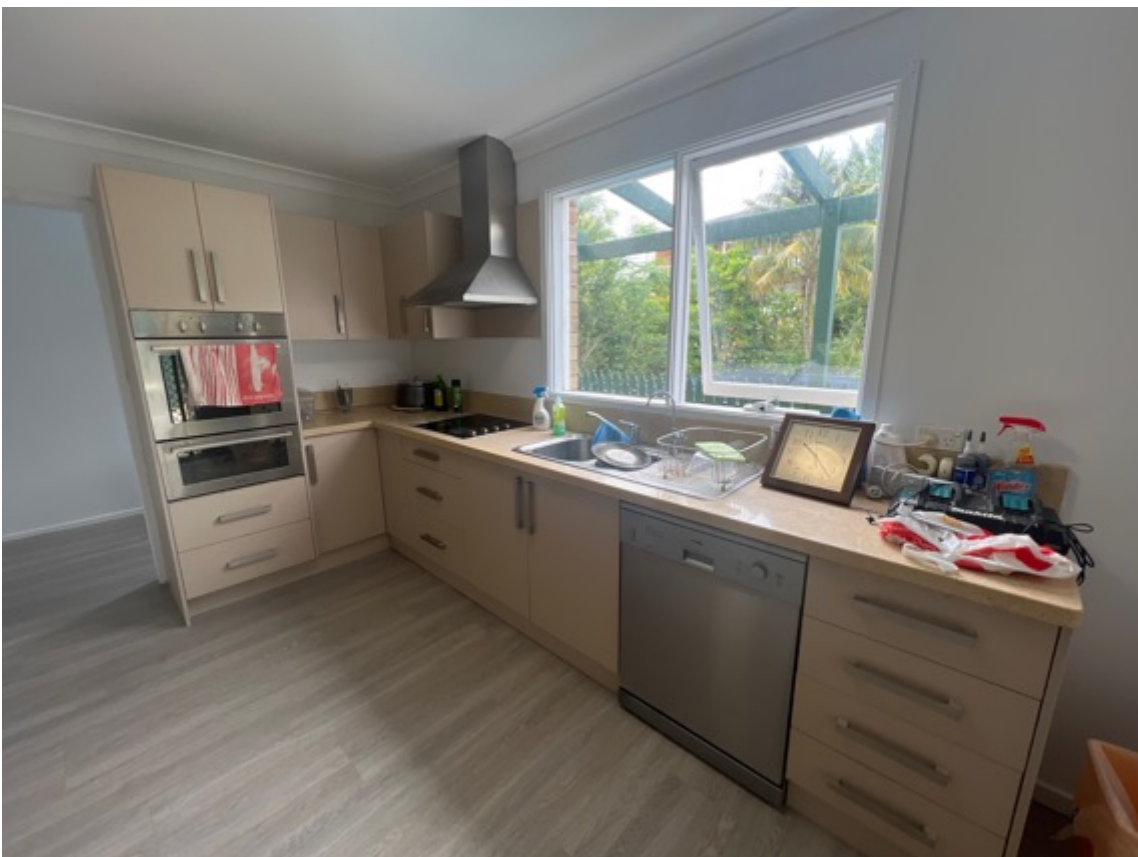
Water pressure tested, is sufficient.

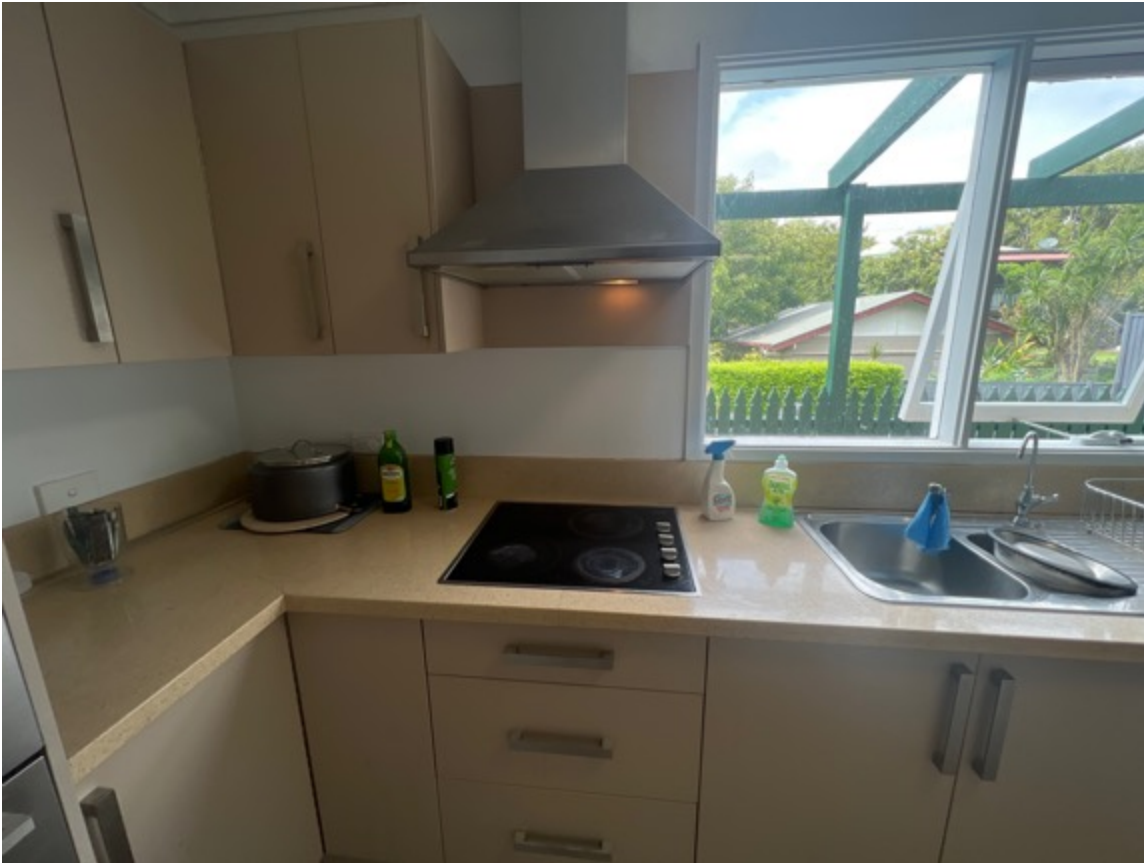
The cooktop displays typical wear. The left side range hood light doesn't function, right side light functioned issue free at the time of inspection.

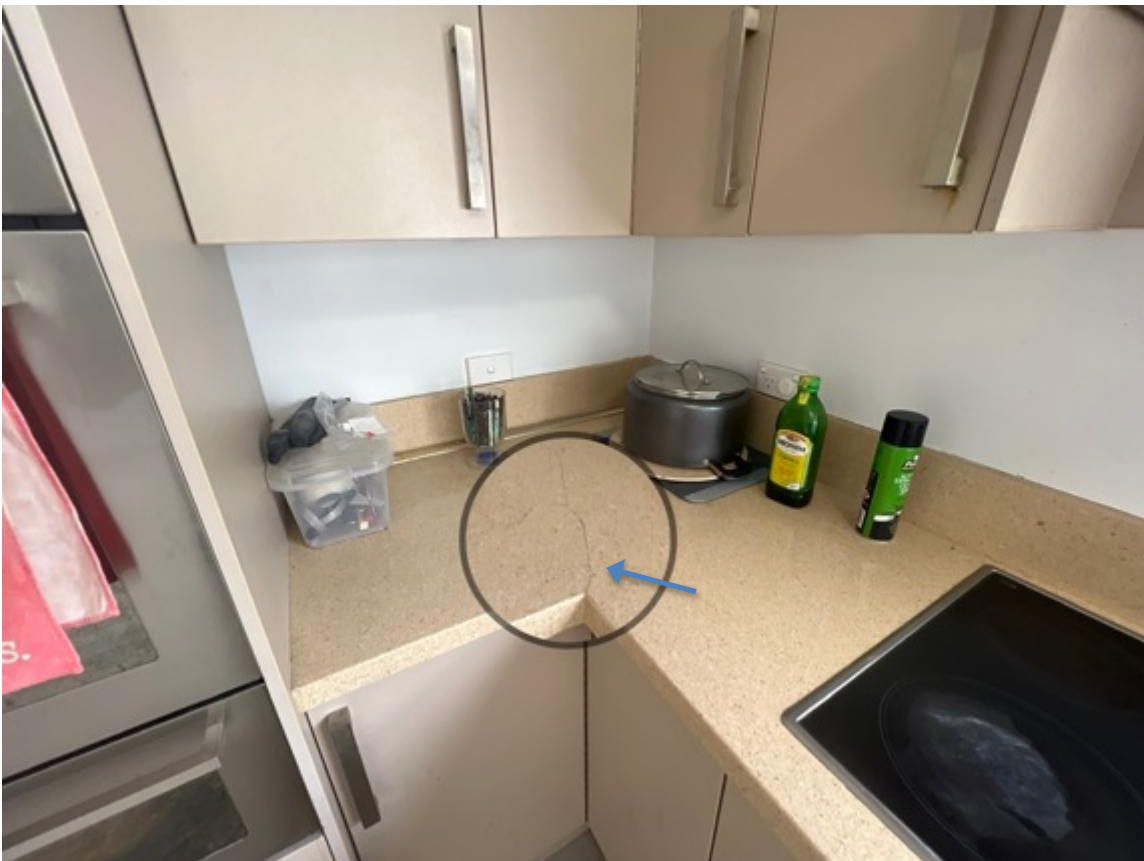
The kitchen bench is cracked here.

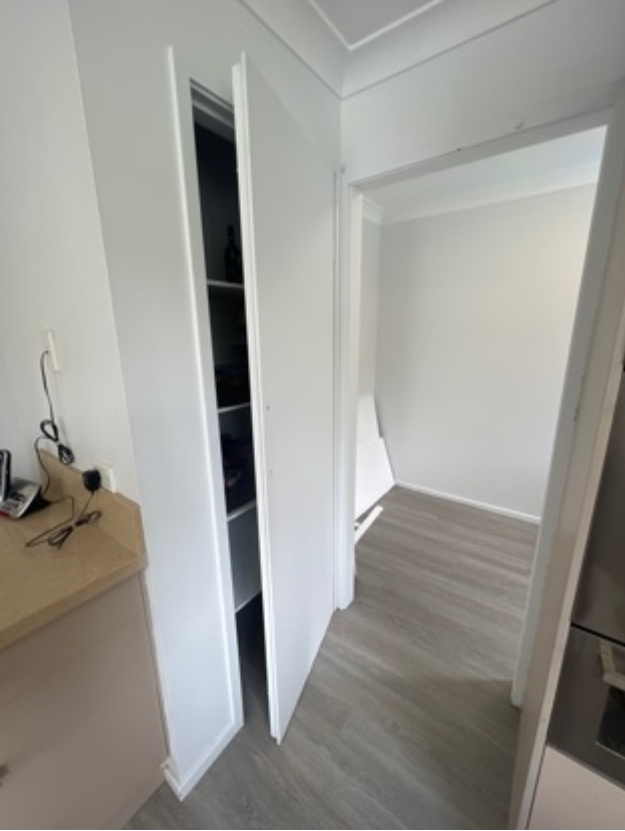
The linen cupboard requires door hardware.
