**PRE-PURCHASE**  
**PROPERTY**  
**INSPECTION**  
**BUILDING REPORT**

Visual Pre-Purchase Building Inspection Report.

**24 JAMES RUSE CLOSE WINDSOR**

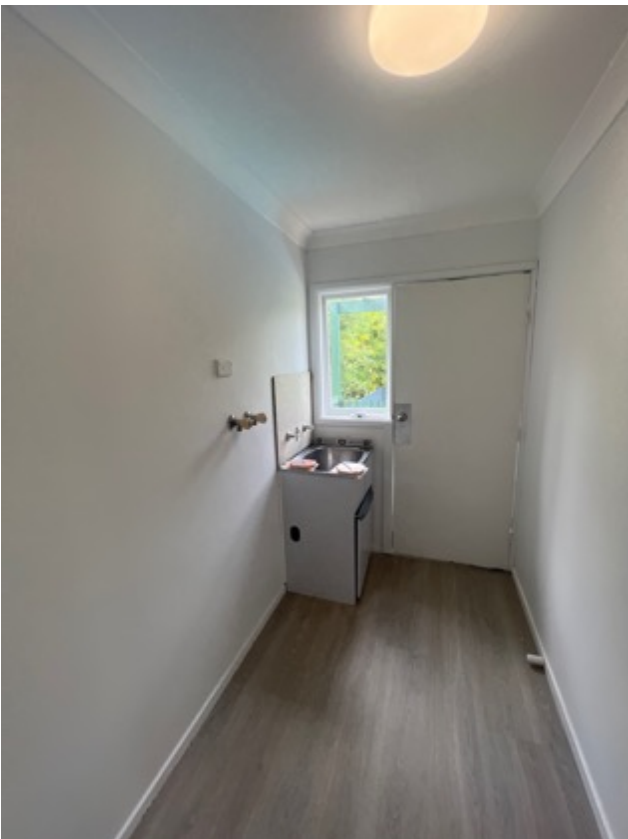
The laundry is in serviceable condition.

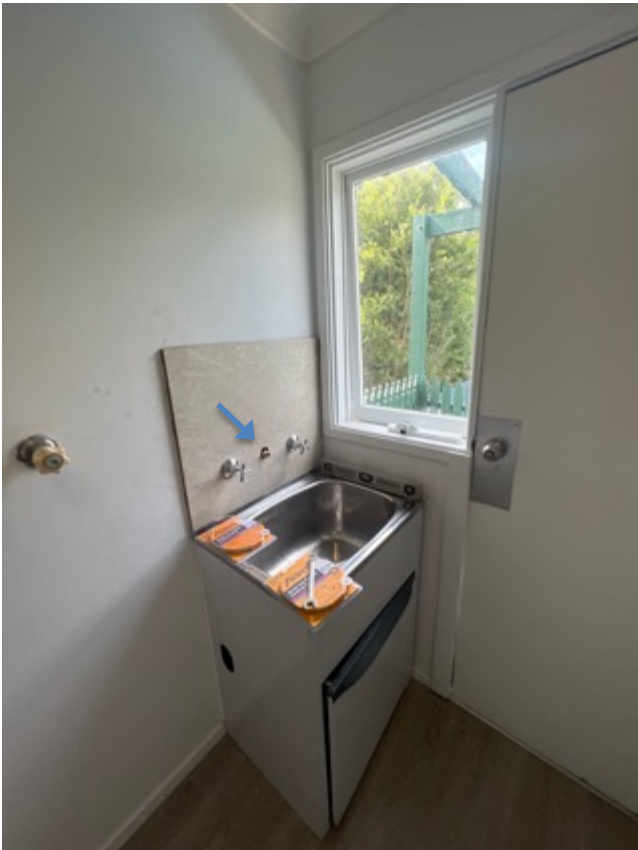
Water services tested, function as intended - the laundry tub tap is missing.

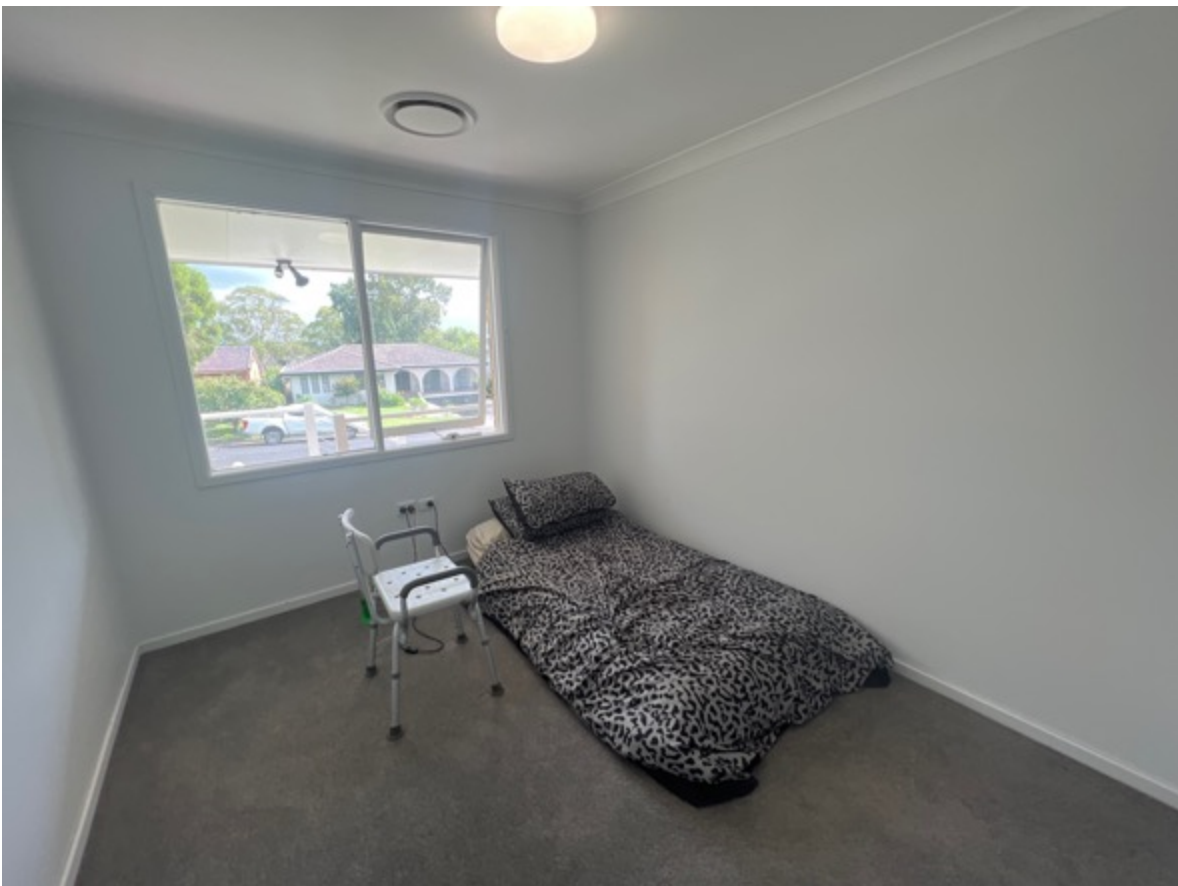
Internal bedrooms present in satisfactory condition for the age.

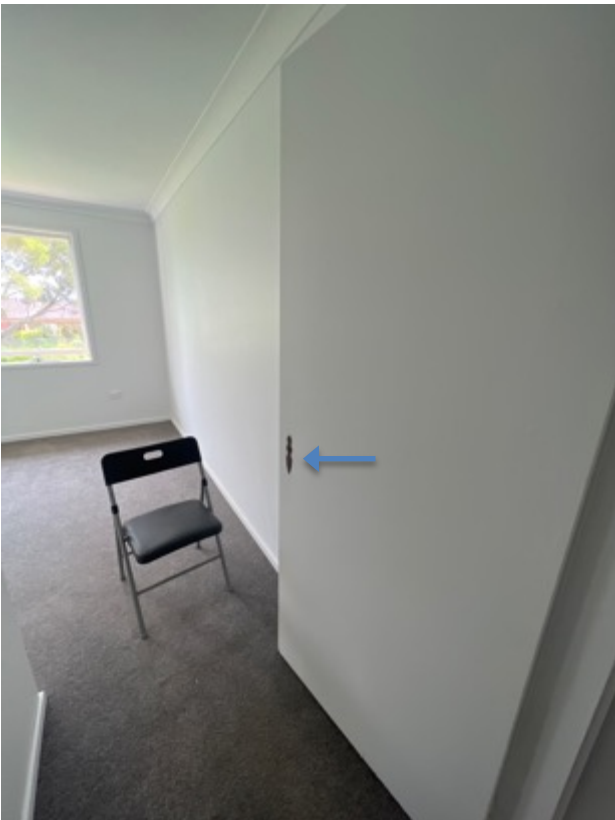
The main bedroom door hardware is missing.

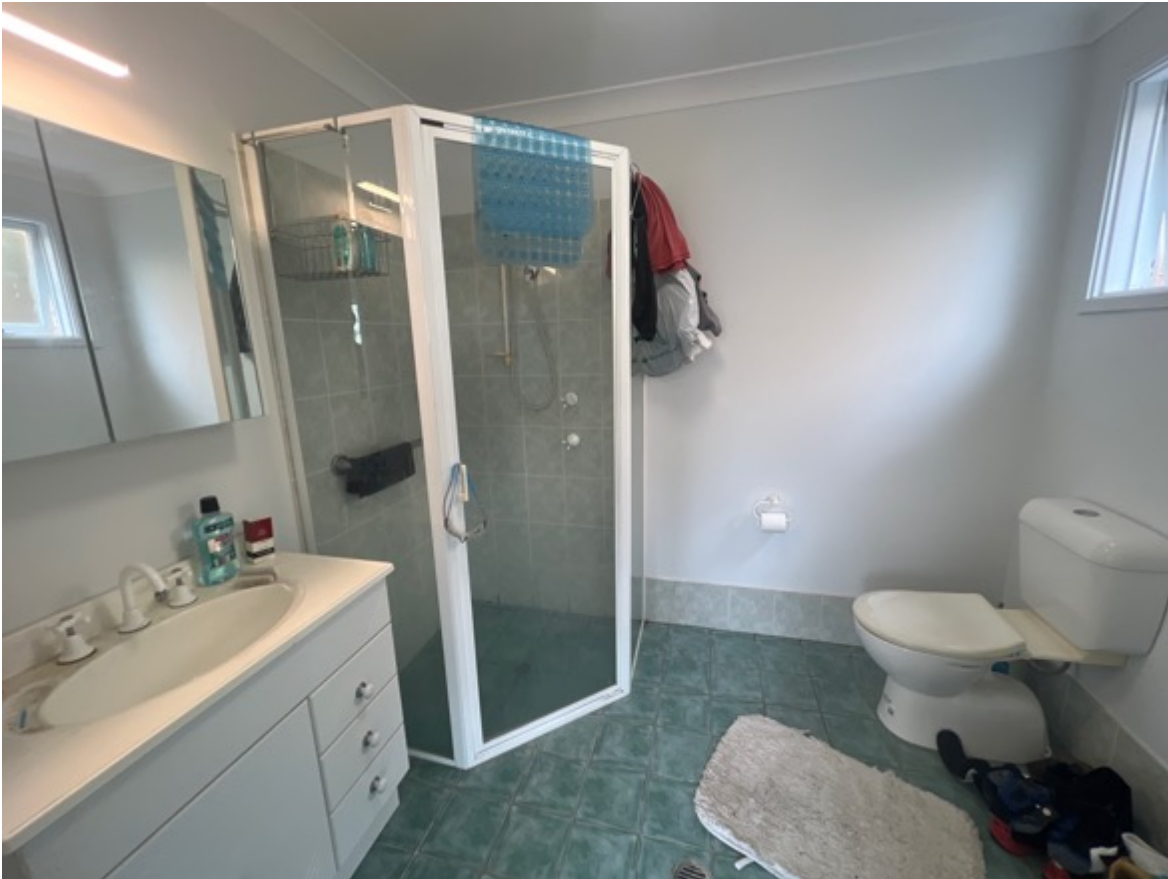
The ensuite bathroom is in serviceable condition.

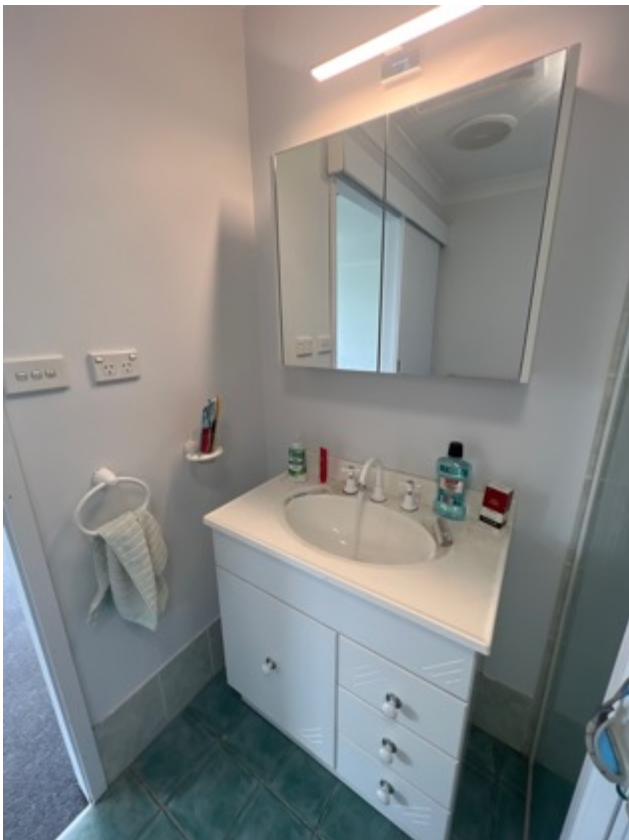
Sub-sink drainage checked was leak free at the time of inspection - taps display minor corrosion.

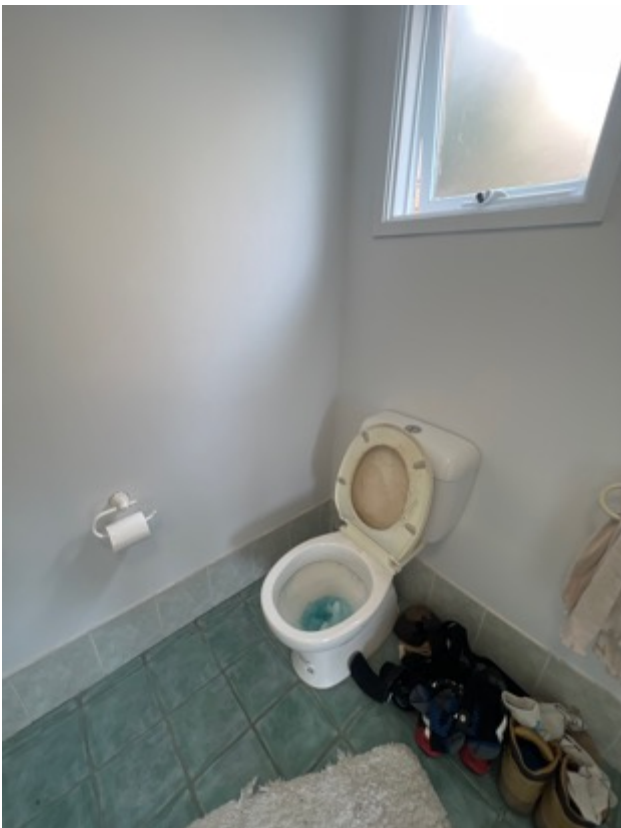
The toilet tested, functioned as intended.

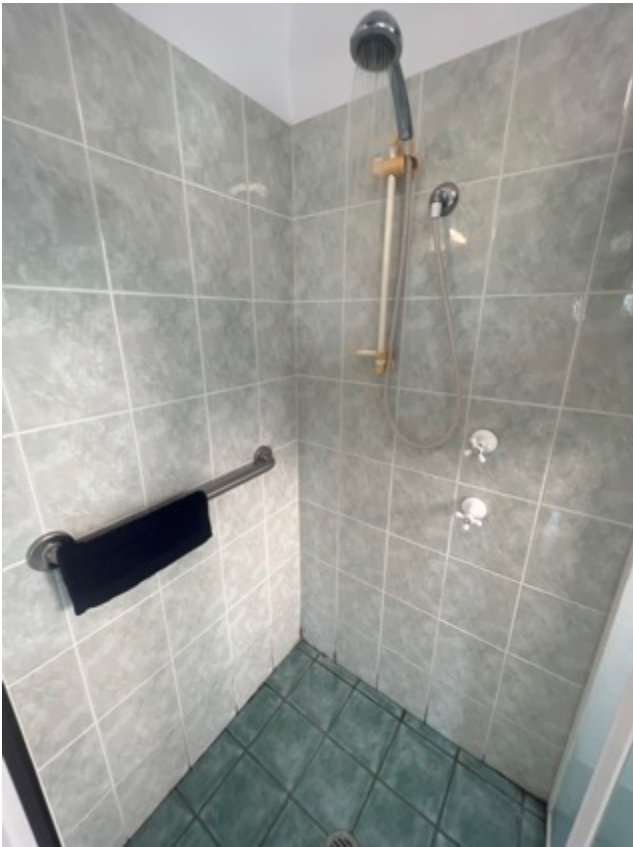
The shower tested, functioned as intended.

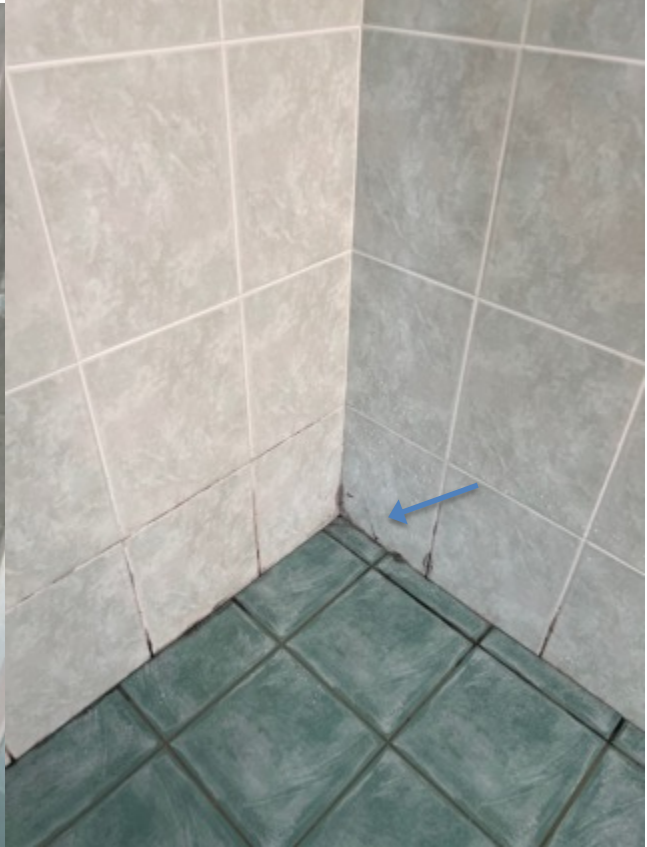
One wall tile is cracked here.

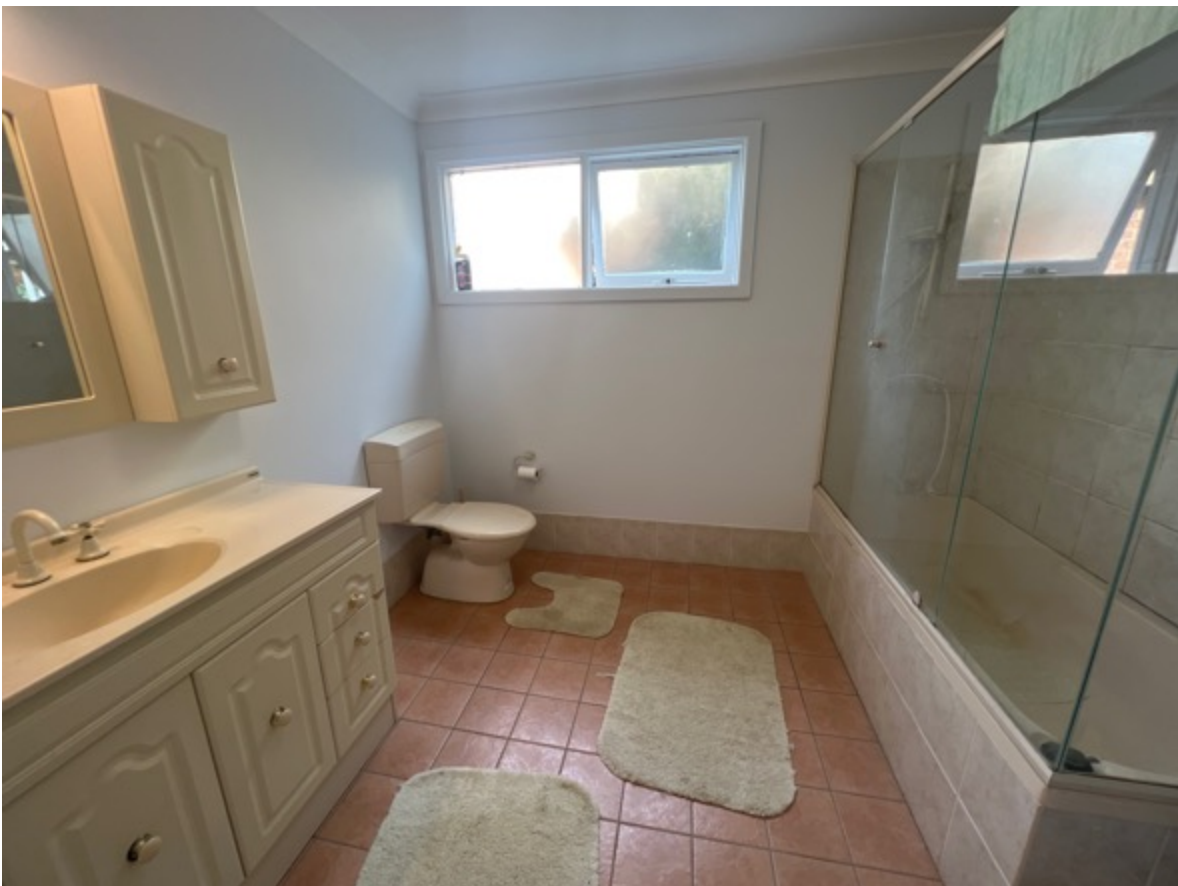
The common bathroom area tested for leaks, was issue free at the time of inspection.

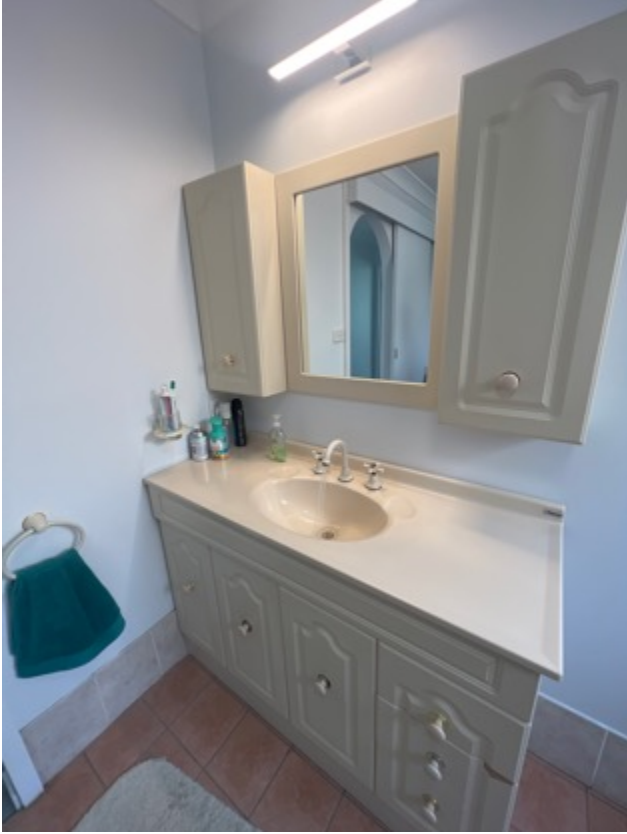
Water pressure tested, is sufficient - the cold water indicator is missing.

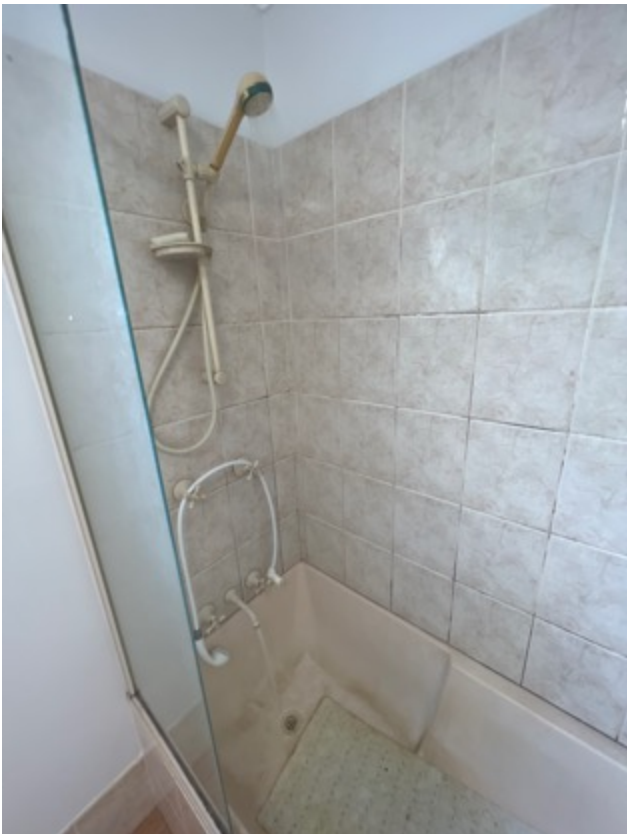
The bath / shower tested, function as intended – minor sections display typical wear.

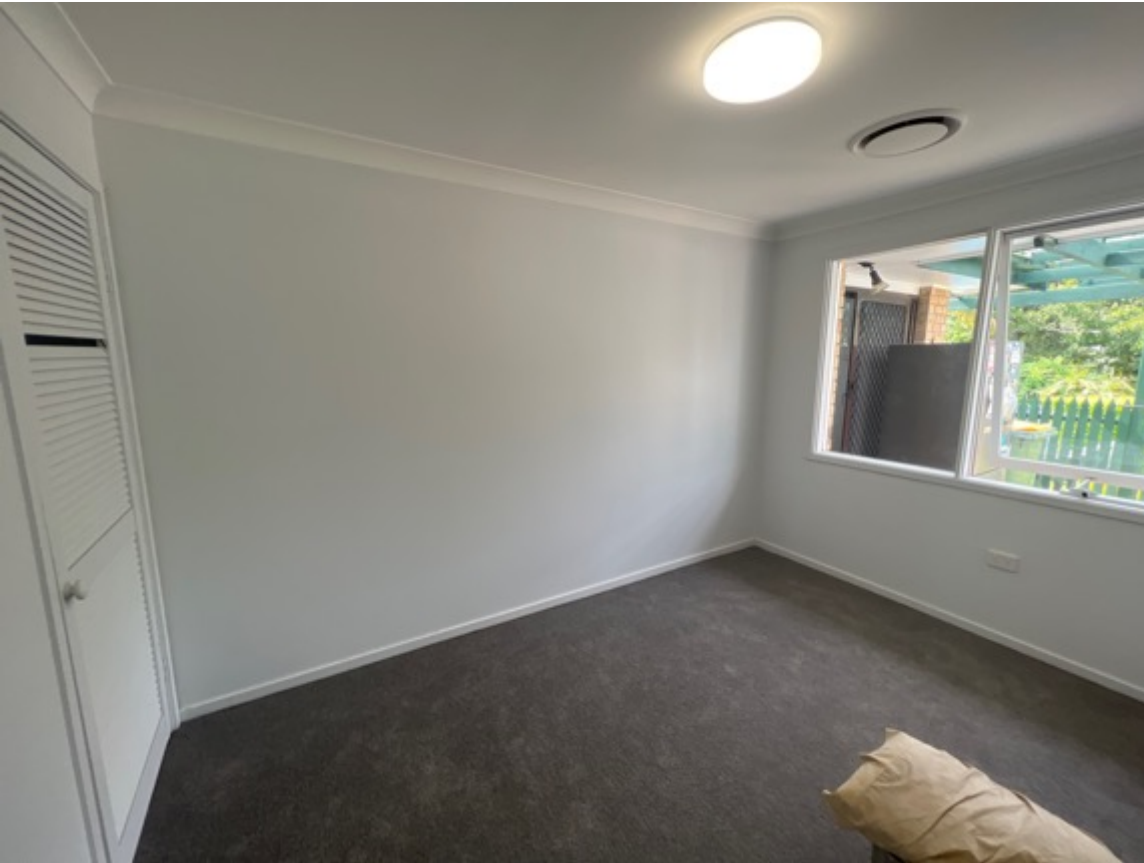
Internal lights tested, function as intended.

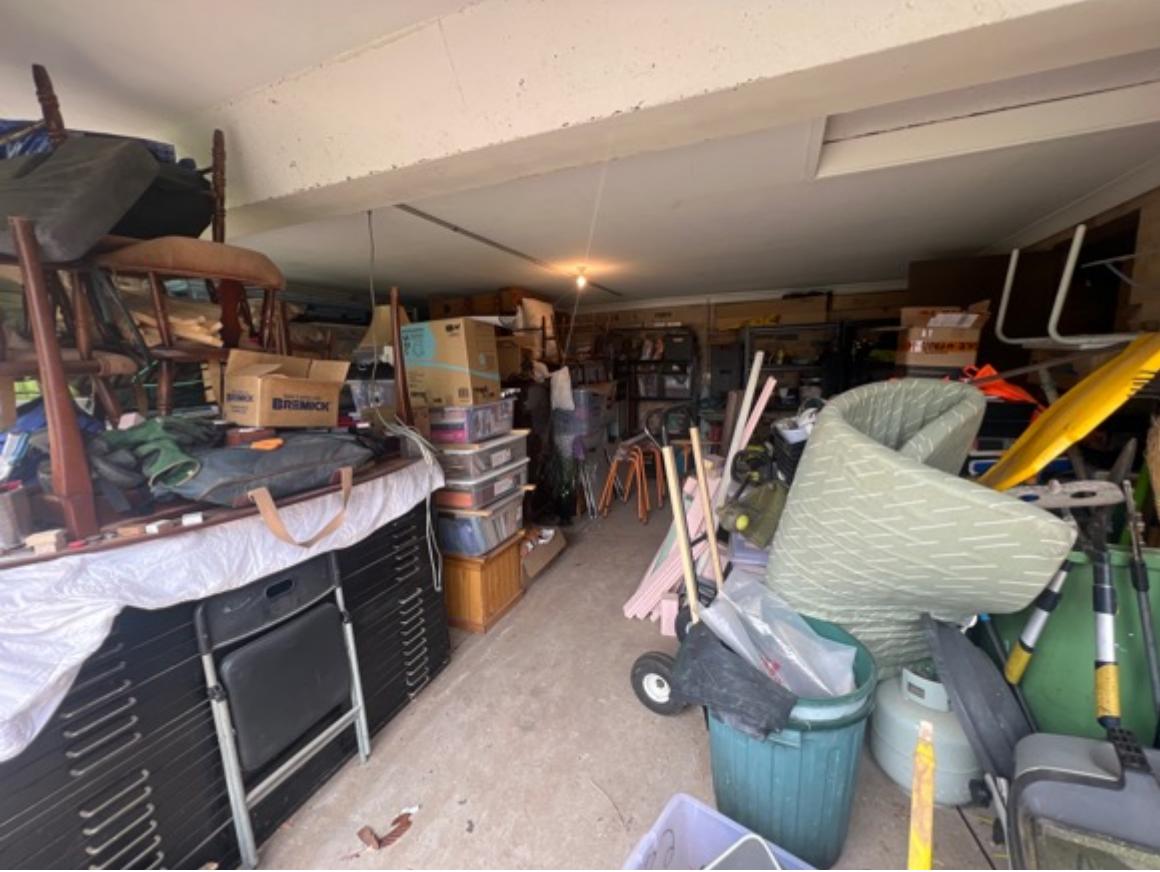
The garage is in serviceable condition - sections of the visual inspection zone are blocked due to stored goods.

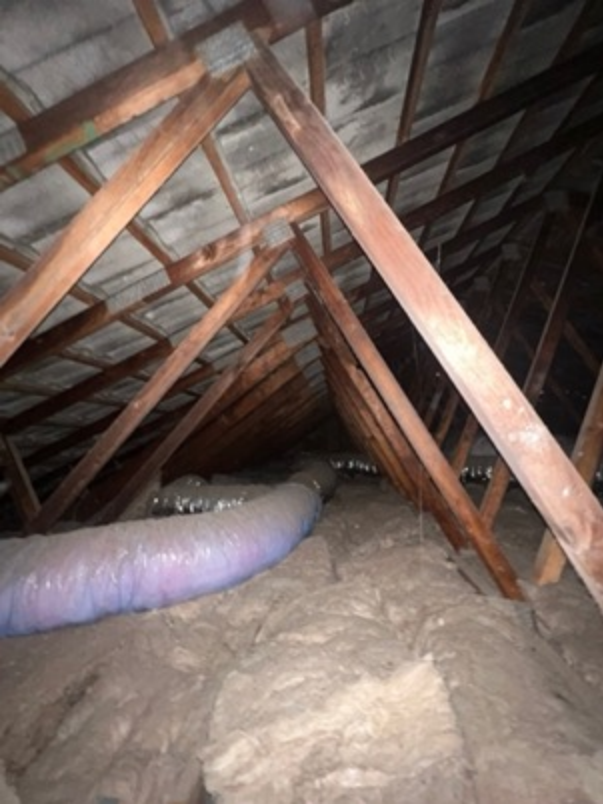
All areas were dry in the roof space at the time of inspection.

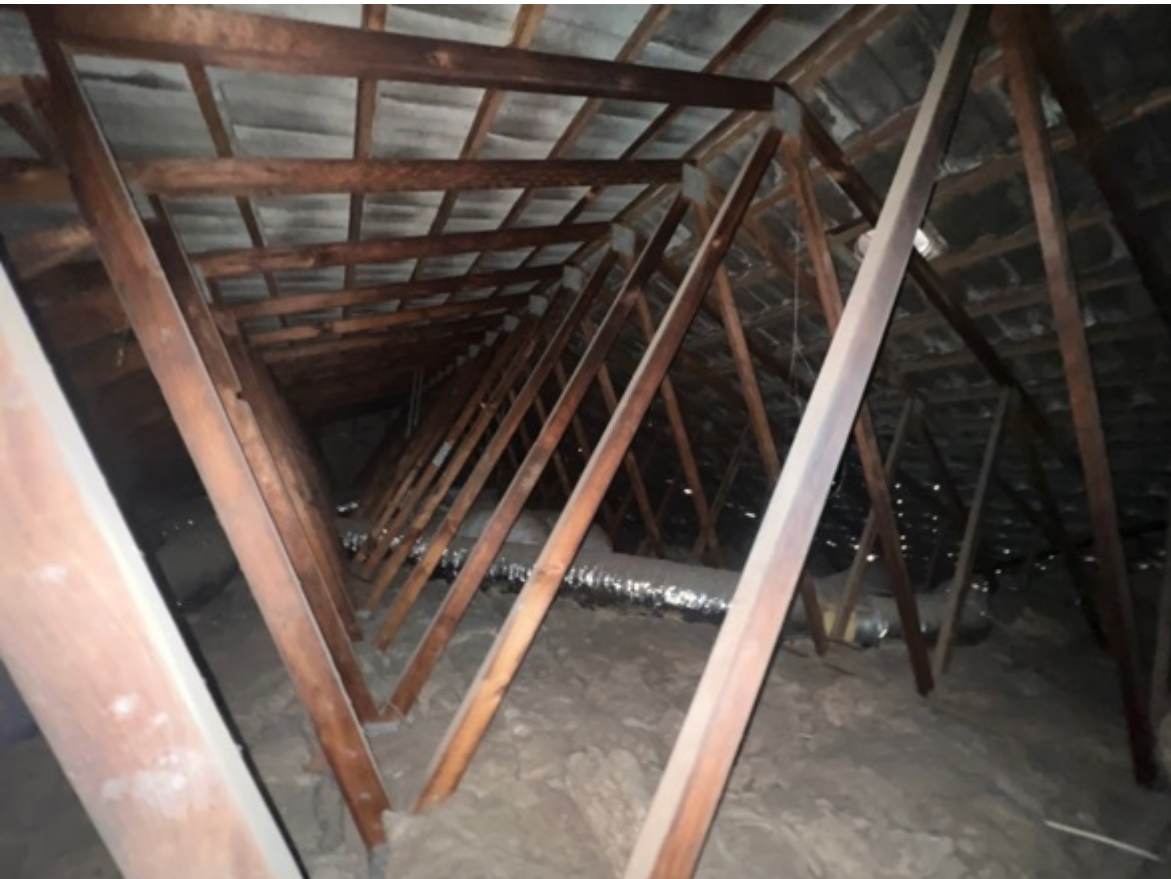
Insulation is installed within the roof space.
