Inspection Report

Nova Home Inspections

17 Cabramurra Street Heckenberg 2168

Pest And Building Inspection

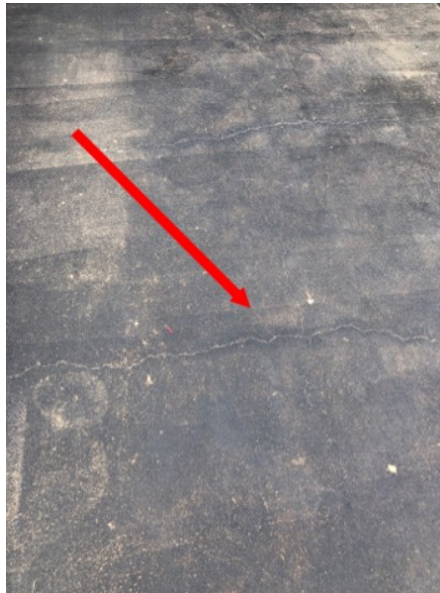
Driveway Condition

Common cracks & settlement were observed on the driveway. Maintenance is recommended. Note: Whilst these cracks appeared to be minor at the time of inspection, we strongly recommend you monitor these cracks and if worsening occurs contact a concreter for further advice.

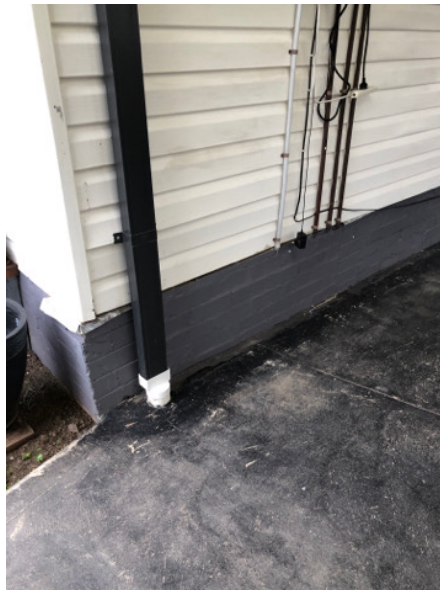
Condition

On visual inspection, the general condition of the exterior walls is serviceable for the age. Paneling/cladding damaged. Recommendations: Have a carpenter assess and repair. Movement to brickwork between original piers noted. Not part of the original structure.

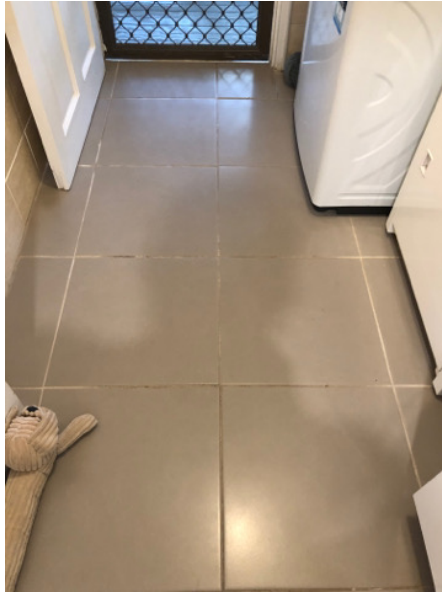
Flooring

Unevenness visible in floor - Floor linings may require removal to ascertain cause. Recommendations: A qualified carpenter should be engaged for advice and recommendations re levelling.

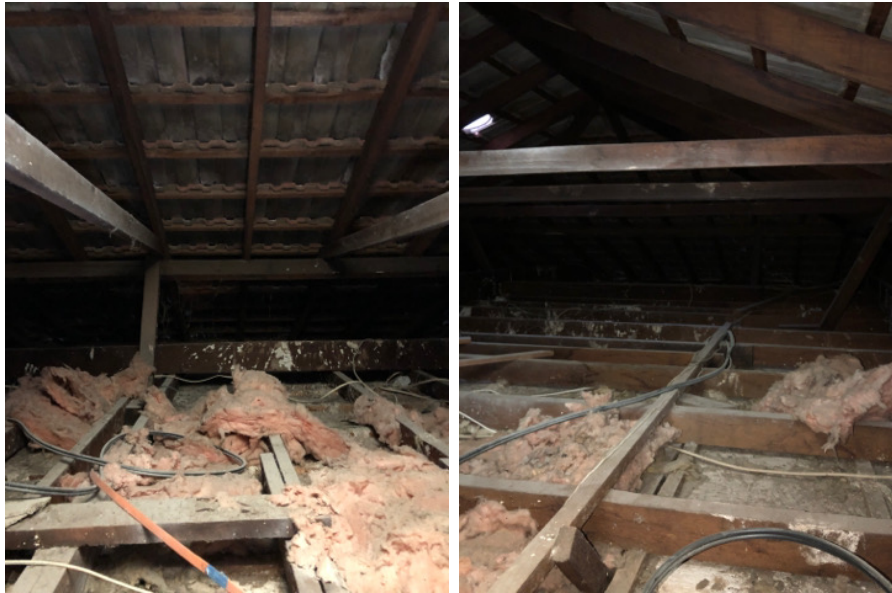
Restricted Areas

There is insulation present in the roof space/void. This is preventing a full inspection of ceiling joists from being undertaken. It is strongly recommended that full access be gained as it could be harbouring timber pest activity, damage or defects.

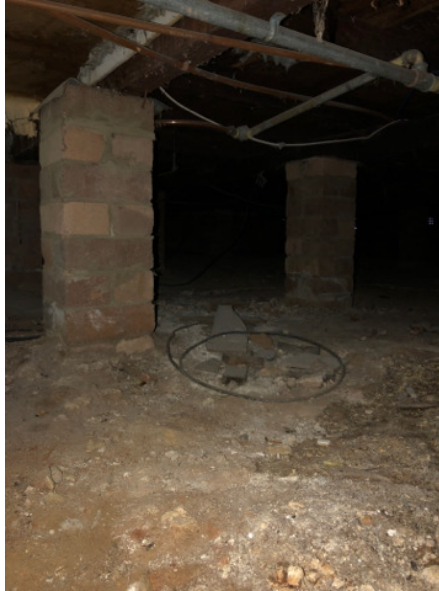
Dampness in sub floor soil. Damp sub floor soil should be avoided as it can cause fungal decay, mould and possibly footings problems. Recommendations: A qualified drainage plumber should be engaged for advice and recommendations.

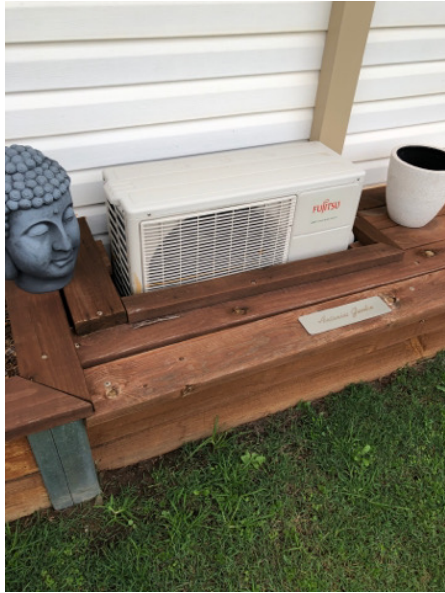
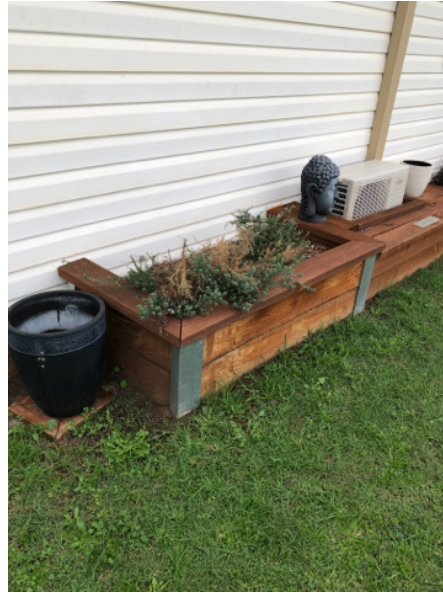
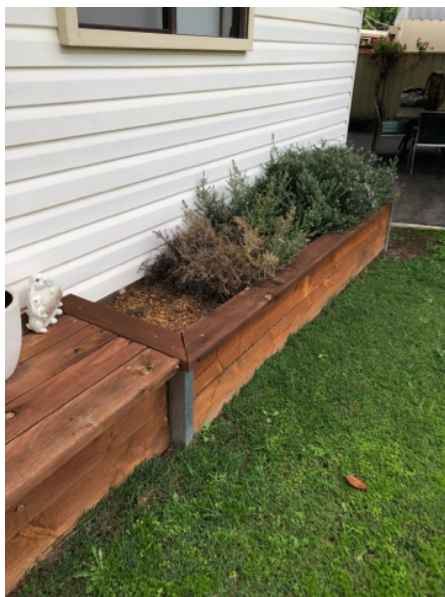
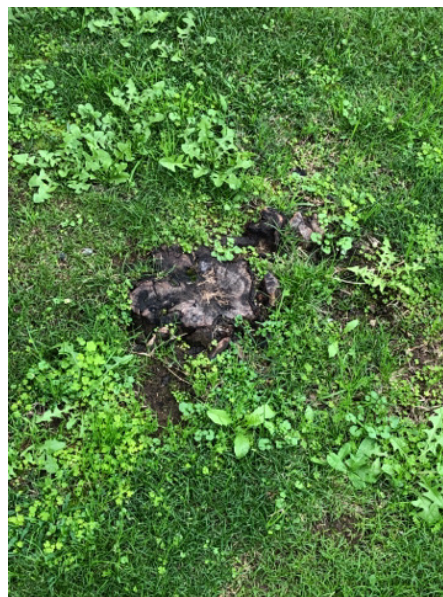
Old tree stumps are located throughout the site. These need to be removed, as they are conducive conditions for a termite nest. The degree of risk is moderate to high.

Garden beds against walls are conducive to termite activity and may conceal termite entry. Recommend garden beds be moved away from the building.
