Visual Timber Pest

Inspection & Report

Report in accordance with AS 4349.3-2010

Job No:	12440LC
Client Name:	Mervyn Horne C/- David Horne
Contact Phone:	0409 897 119
Email:	cpo67@bigpond.com
Address of Property Inspected:	12 Sunjewel Boulevard, Currimundi, Queensland 4551

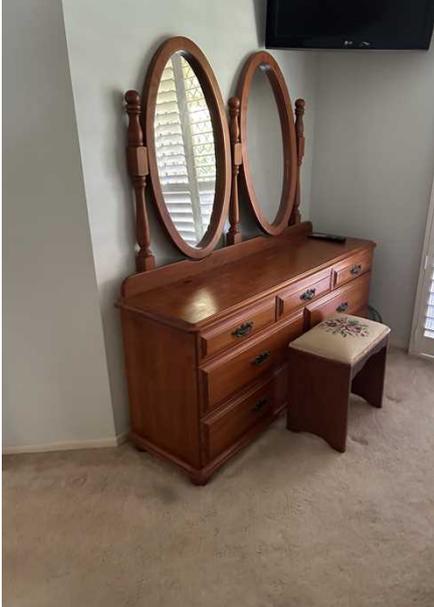
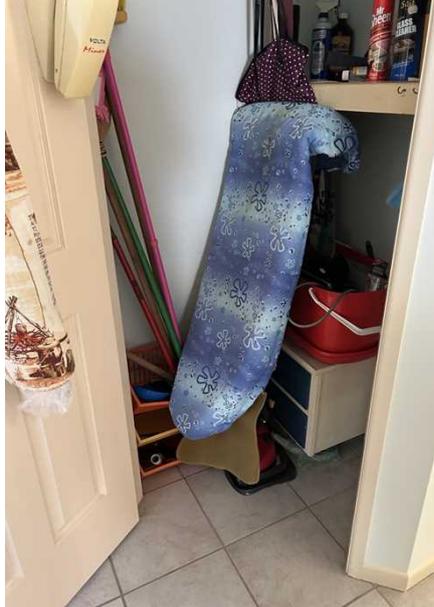
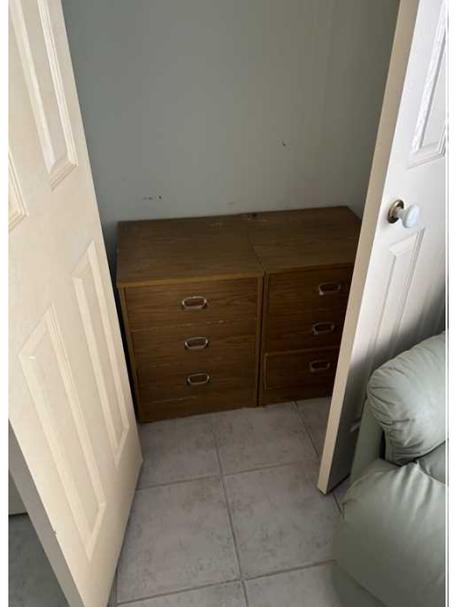
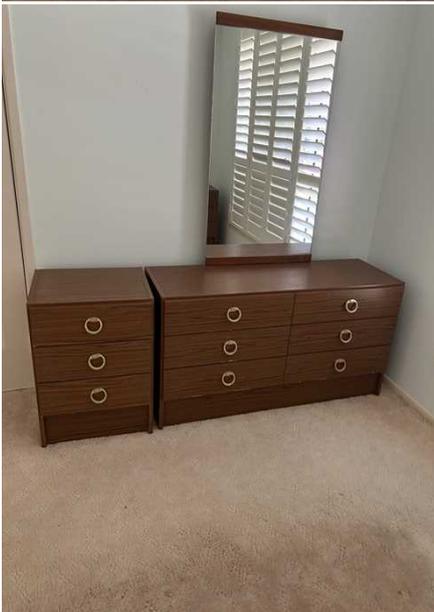
Area(s) in which Visual Inspection was Obstructed or Restricted and the Reason(s) why include:

Interior due to

Furniture, Fixtures, Stored articles, Floor coverings, Flooring, Clothing, Wall linings

Further Inspections are strongly recommended to areas where Reasonable Access is Unavailable, Obstructed or Restricted or a High Risk of possible Timber Pests and /or Damage exists.
