Inspection Report

Certified Building Inspection Services

26 Marsanne Cl, Cessnock, NSW, 2325

Pest And Building Inspection

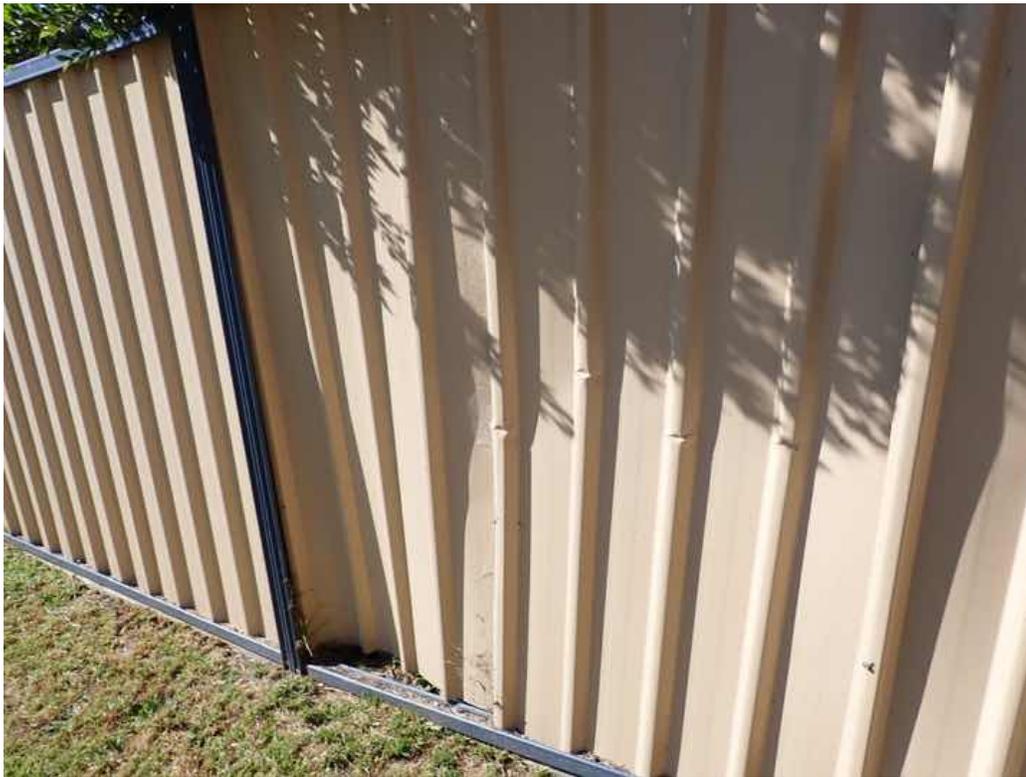
General age and damage to fence components - Recommendations: A qualified fencing contractor should be engaged for repairs

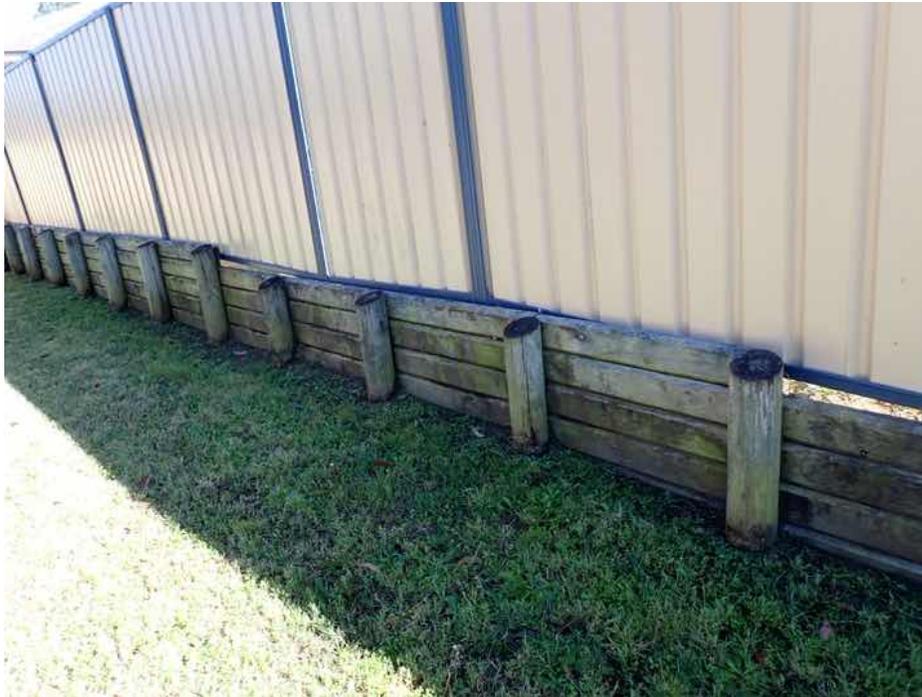
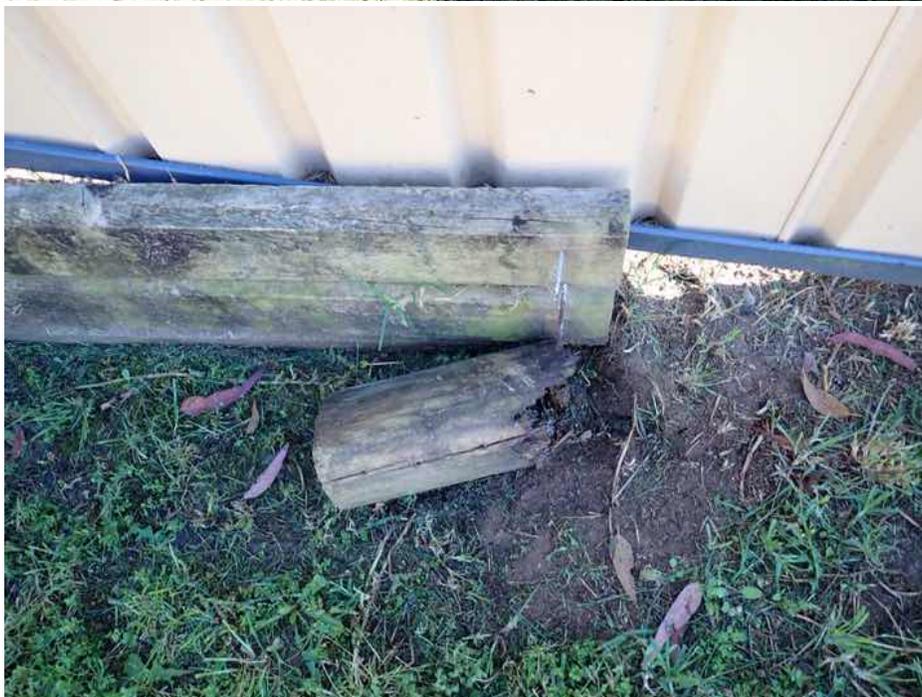
Post has rotted but is not affecting the wall. Recommendations: A qualified landscaping contractor should be engaged for repairs and recommendations.

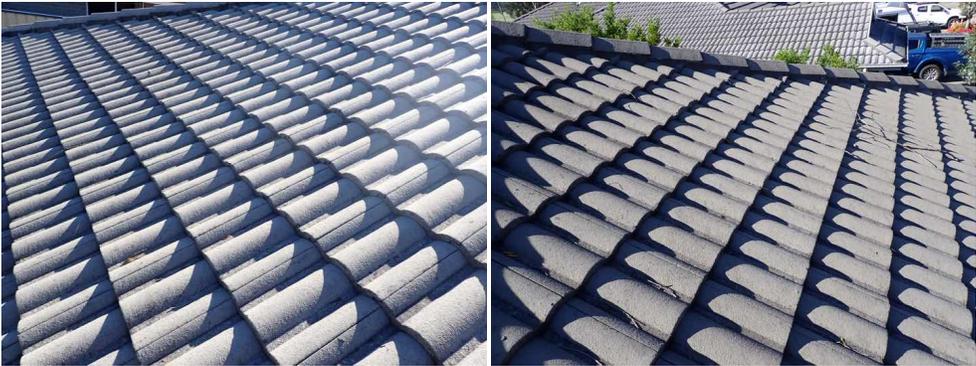
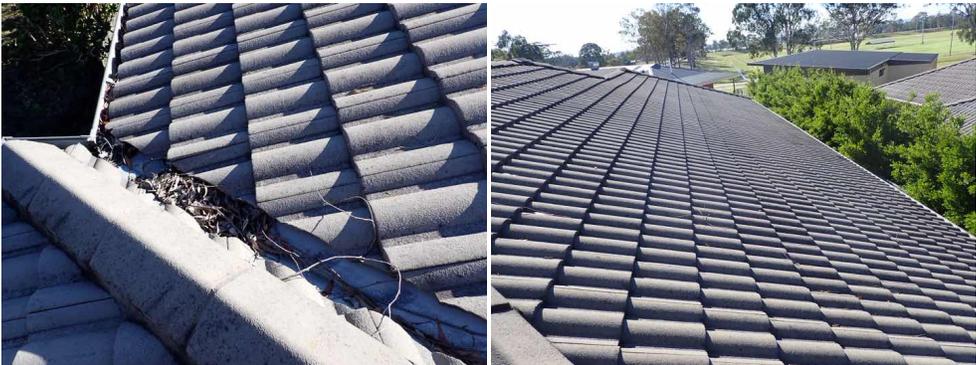
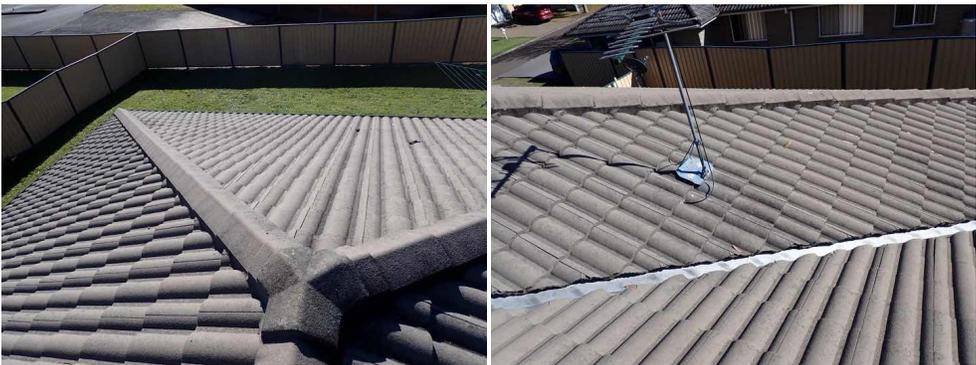
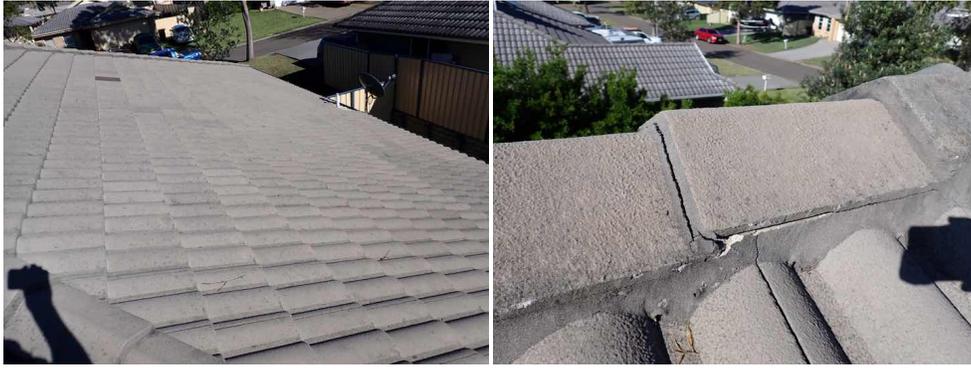
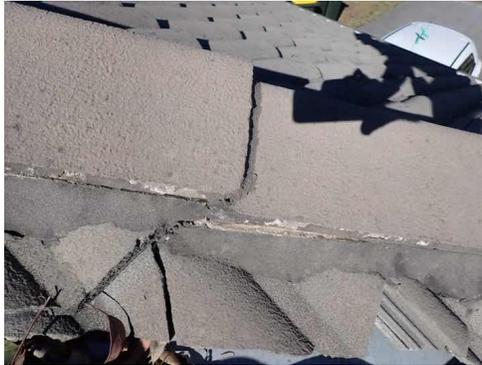
On inspection, defects were noted that may require further assessment and recommendations by licensed roofer.

Mortar cracks visible. We recommend having these repaired by a licensed roofer as they contribute to water ingress. Whilst common on properties of this age we recommend repair it may result in water ingress into the roof cavity

There is Debris present in the valleys or on roof. This can cause water to build up and overflow back into the roof space. I recommend you remove the debris from the roof

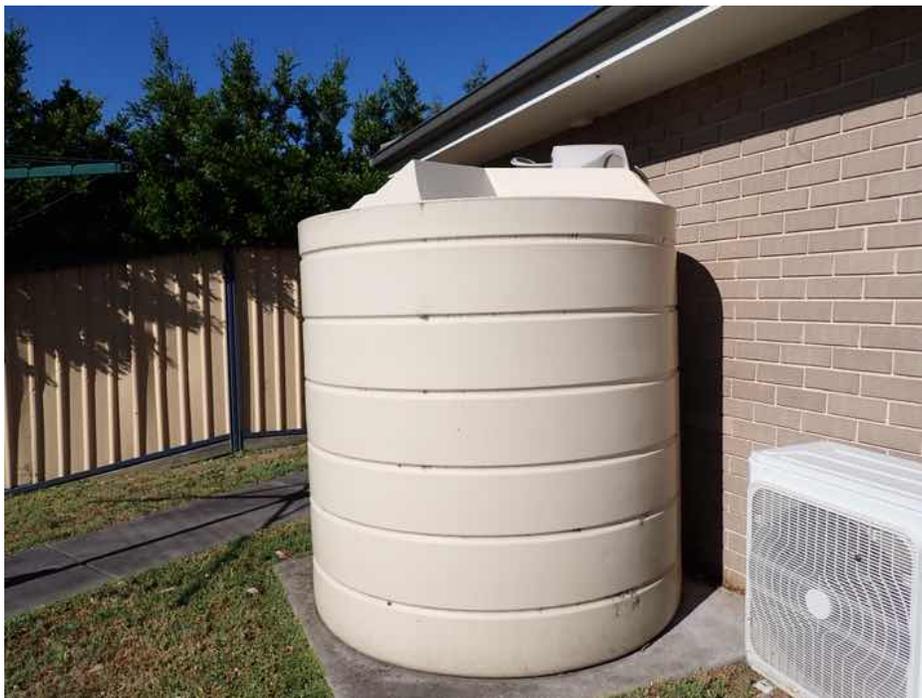
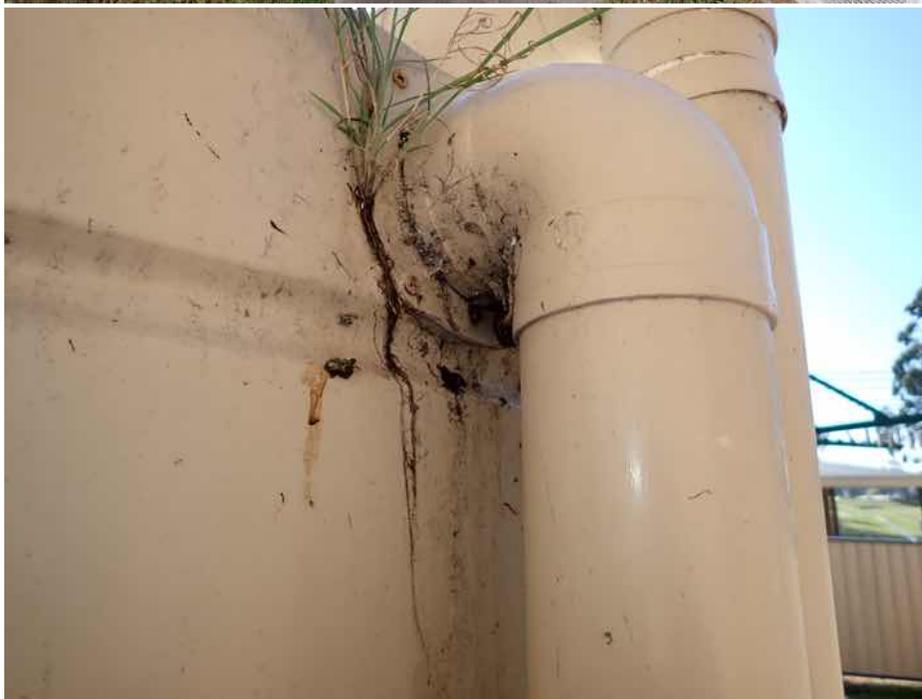
Leaking pipe section. Recommendations: Assessment conducted by a licensed plumber advised.

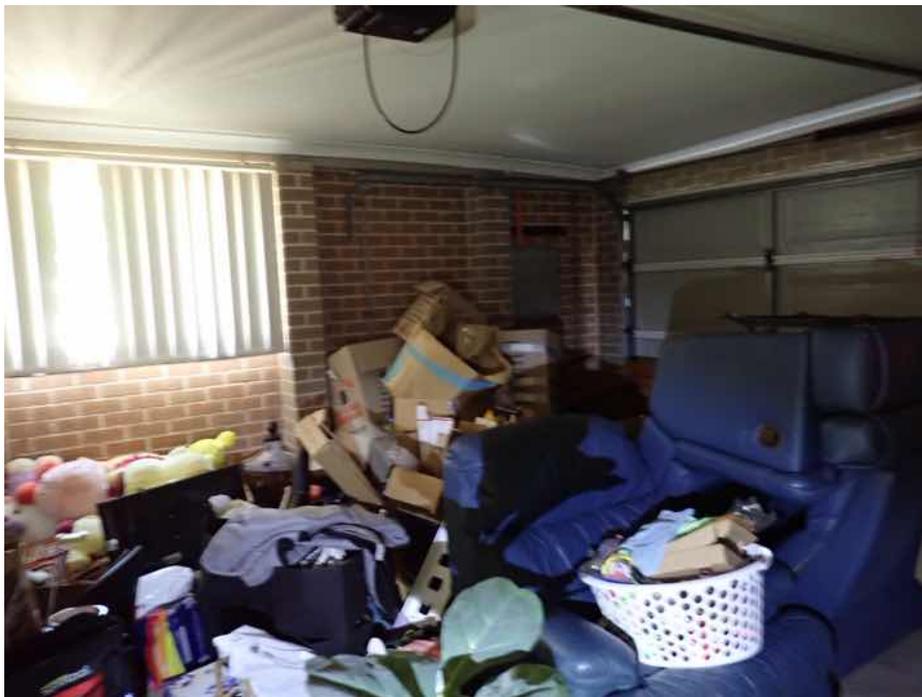
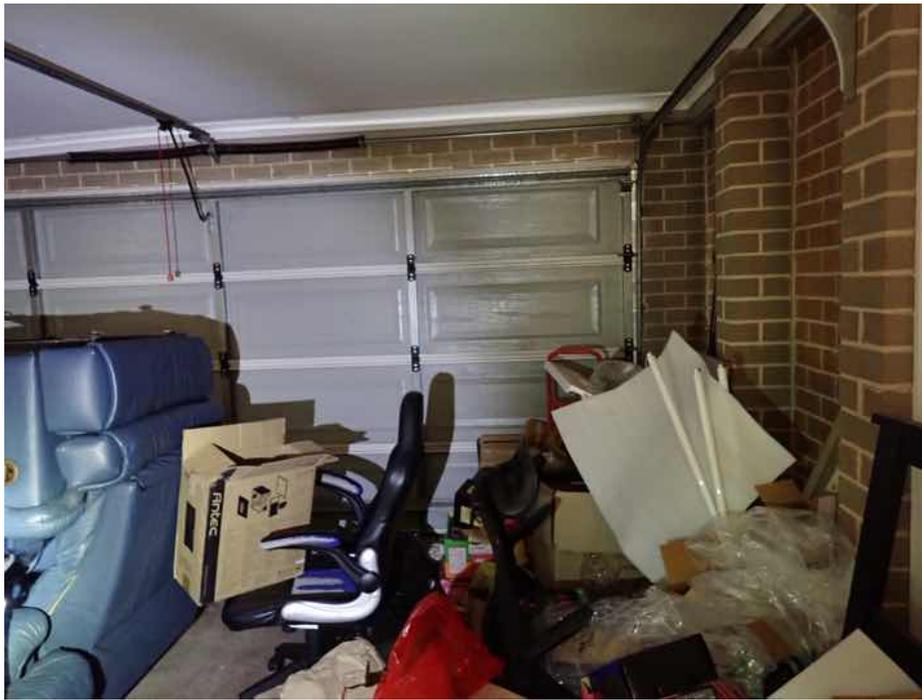
On inspection, defects were present that will require further assessing and recommendations by licensed and qualified trades persons, please read below for details.

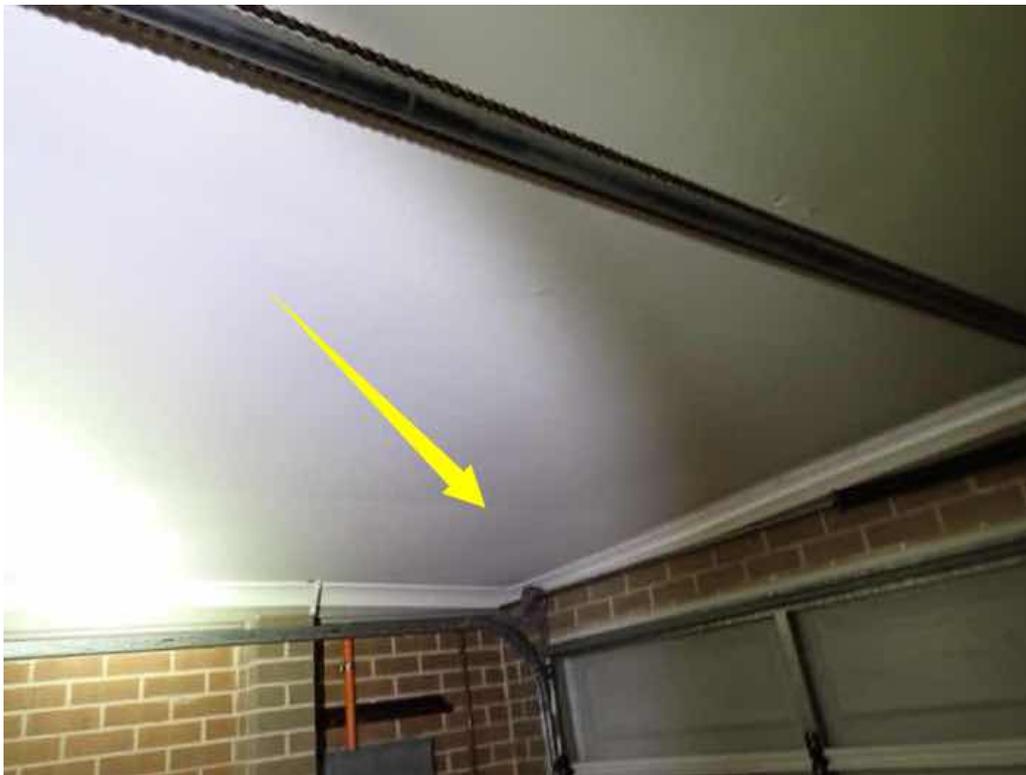
Ceiling sagging - Recommendations: I recommend you contact a licensed plasterer for further advice and recommendations.

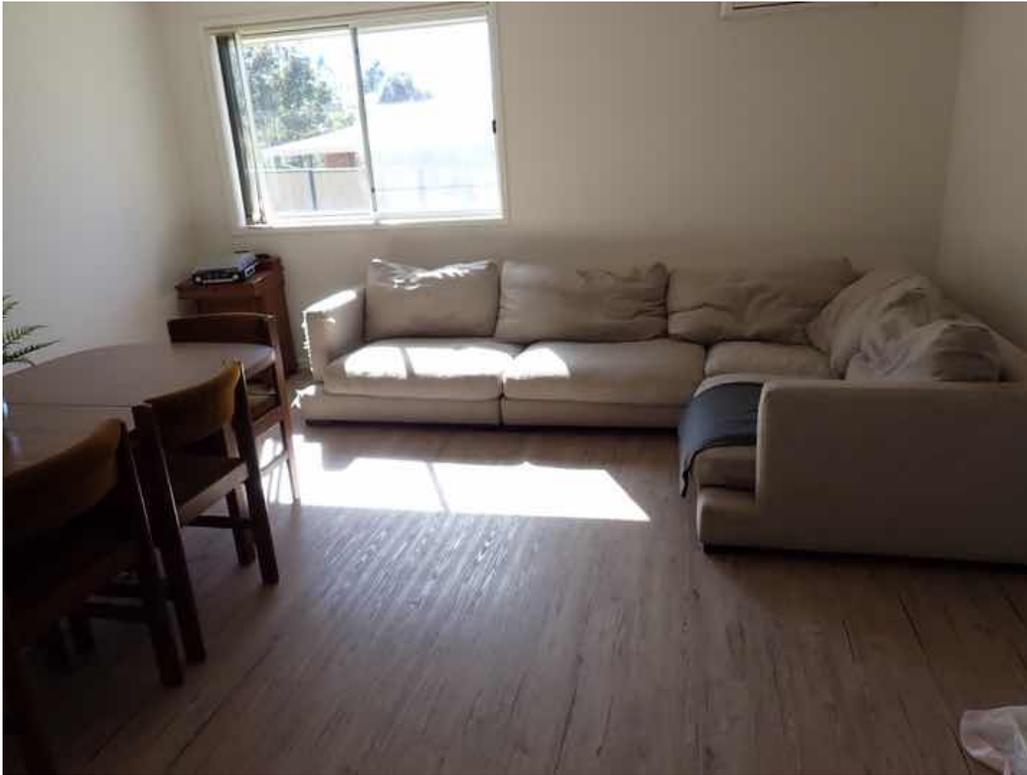
Damage to cornice due to the settlement of roof trusses. A common visual defect, not a structural issue. Contact a plasterer for repairs

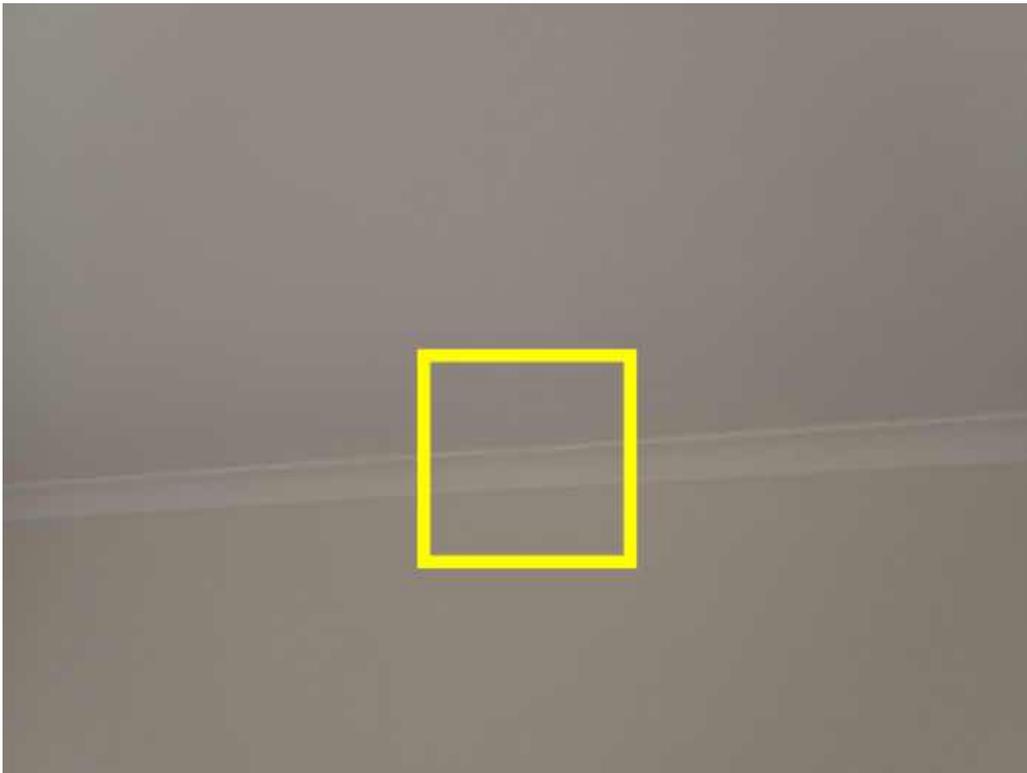
General ageing and/or denting and/ or typical minor separation of architraves and skirting boards and the like is evident on wall linings - Recommendations: A qualified painter should be engaged to assess and repair as required.

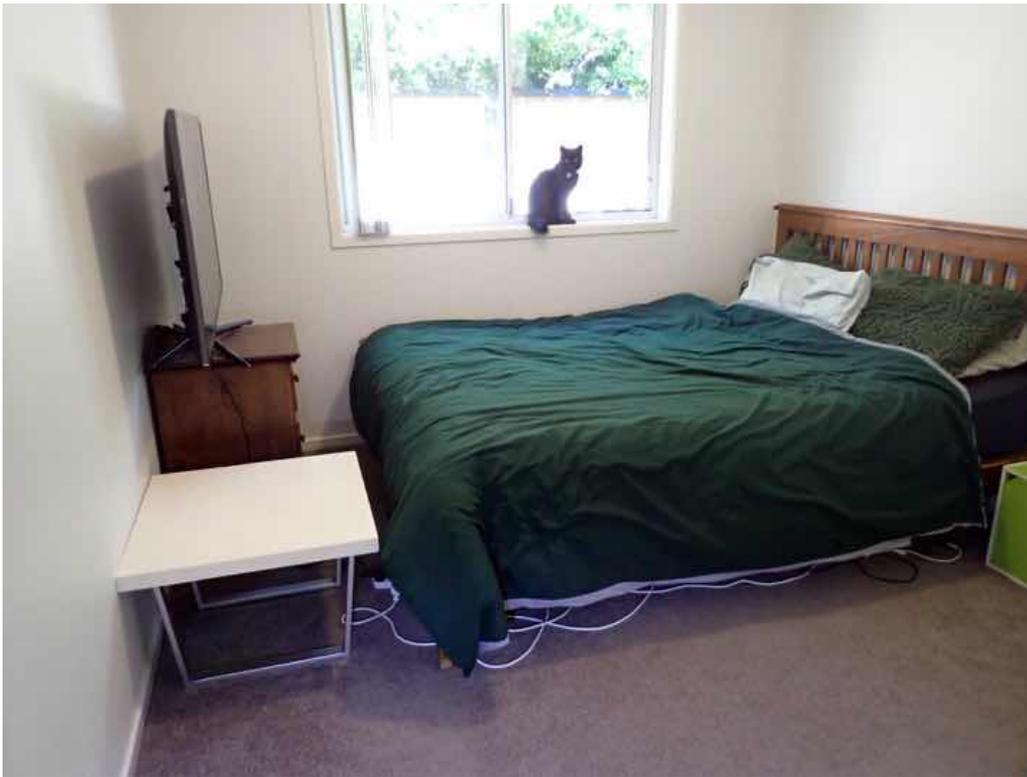
General ageing/marks and/or denting and the like is evident on ceiling linings - Recommendations: A qualified painter should be engaged to assess and repair as required.

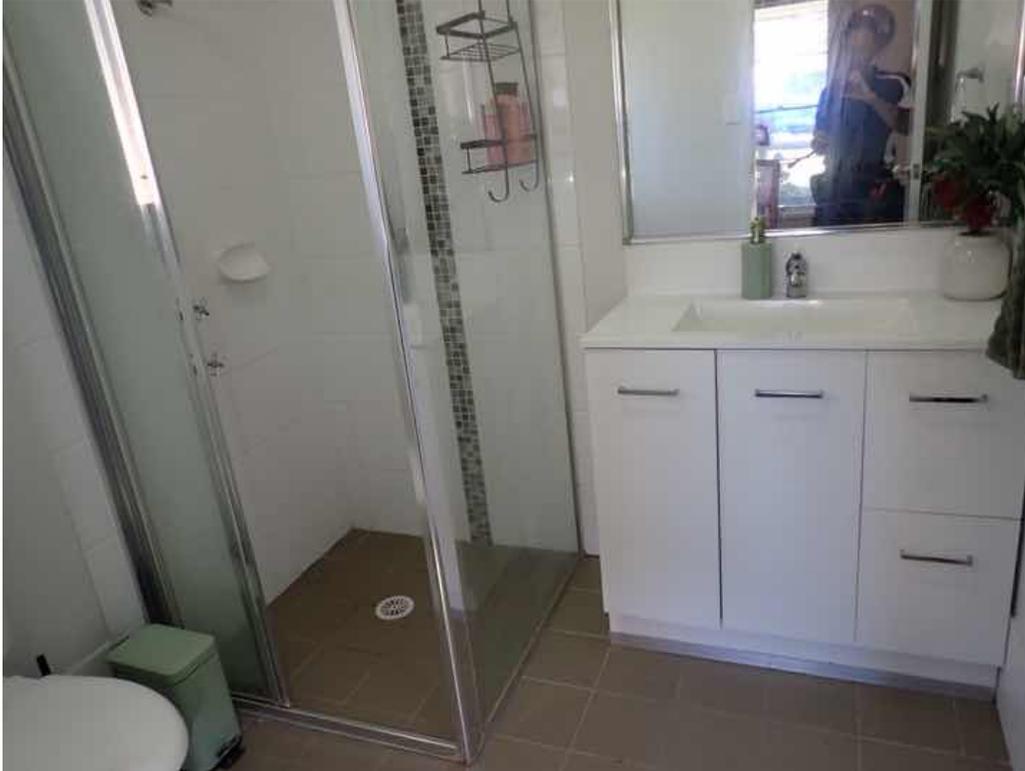
Tile grout deterioration. Shower is not currently leaking but you should Re-grout / seal the shower tiles in areas to prevent future leaks. A qualified tiler should be engaged for advice and recommendations.

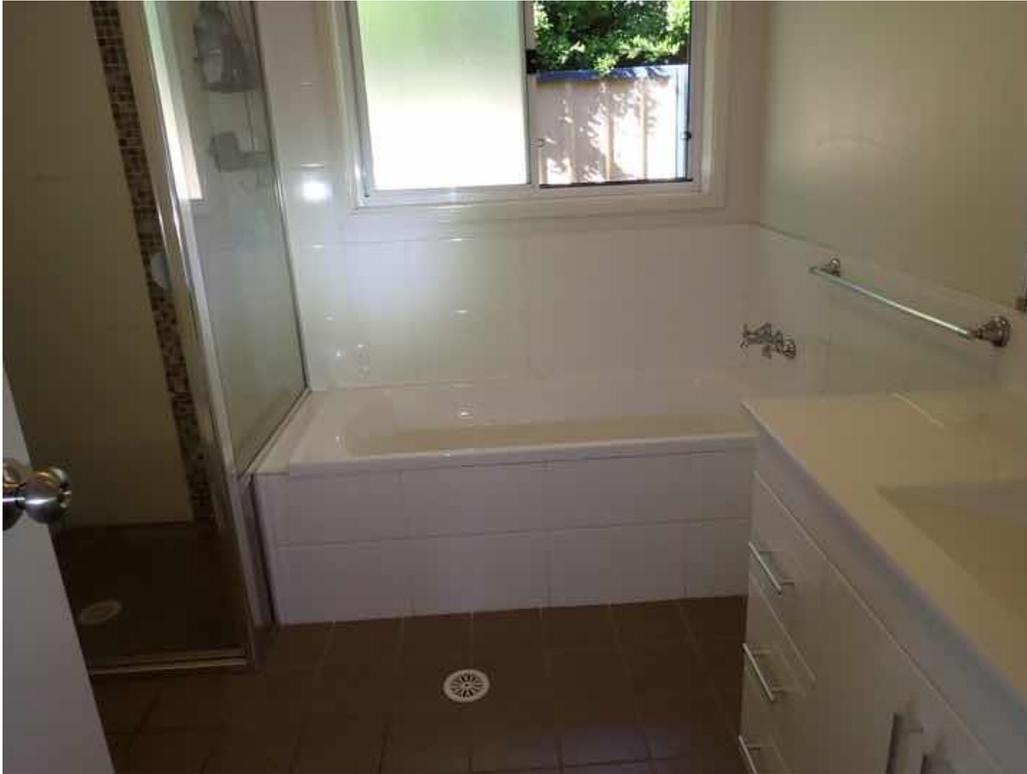
Door / frame deterioration - General age/damage has occurred to door frame, face or components.

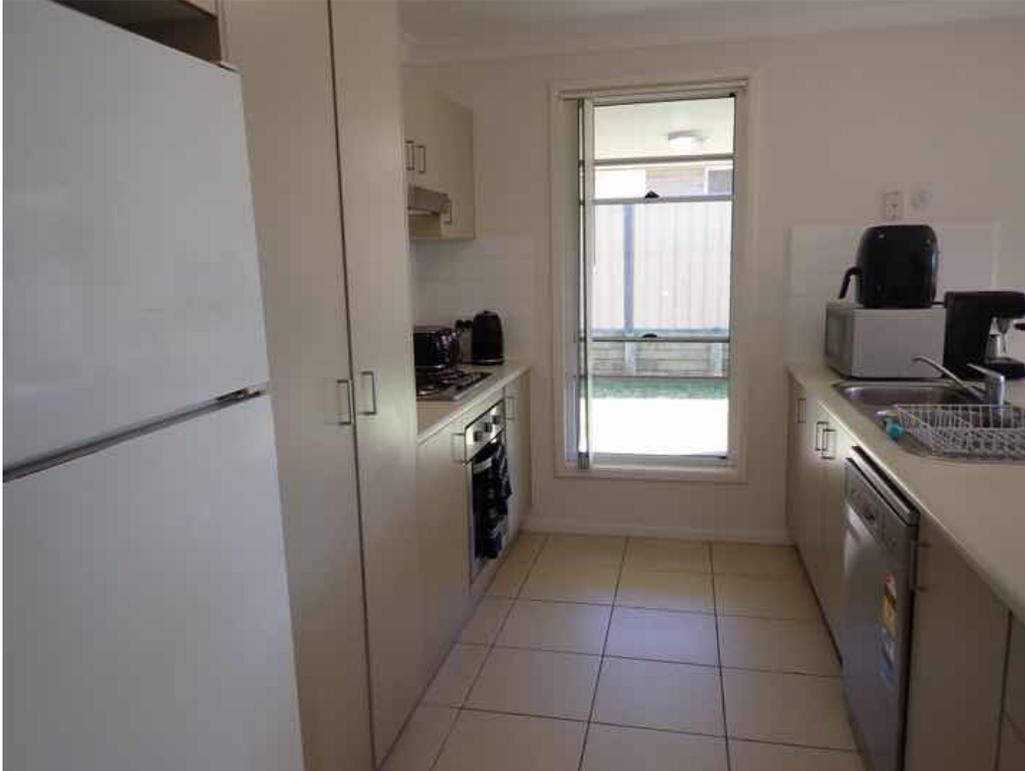
General ageing and/or denting and/or wear and/or previous wall patching and the like is evident on wall linings - Recommendations: A qualified painter should be engaged to assess and repair as required.

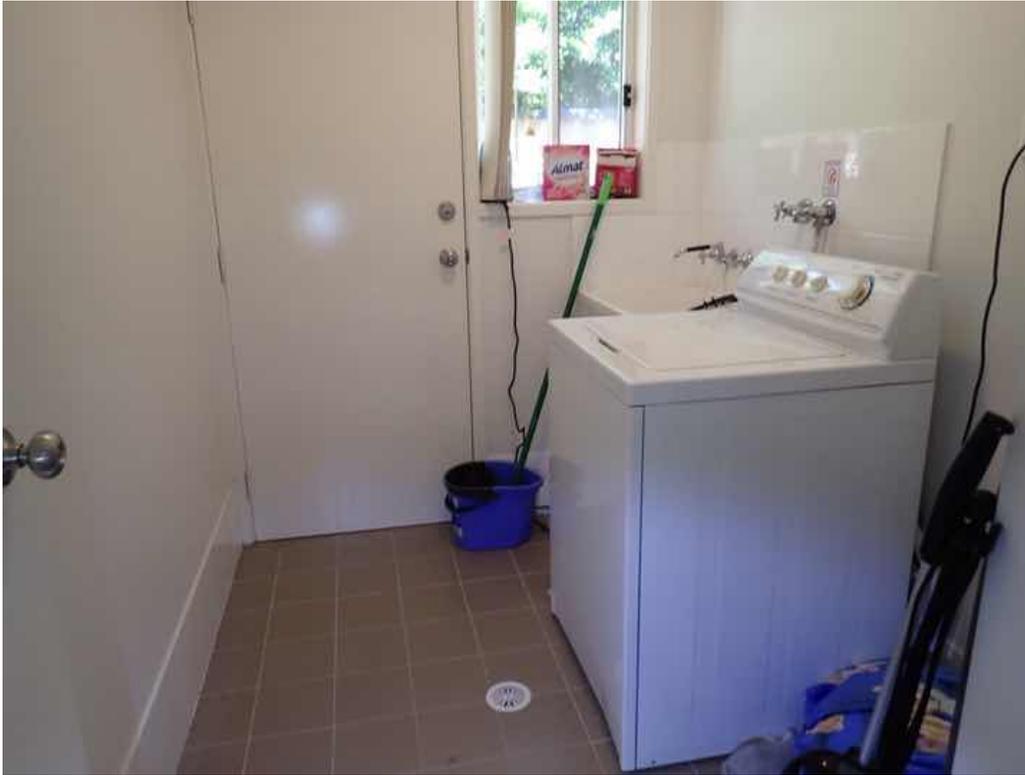
Laundry door / frame deterioration - Recommendations: A qualified painter should be engaged for advice and recommendations.
