Inspection Report

Nova Home Inspections

3 Horesham Place Chipping Norton 2170

Pest And Building Inspection

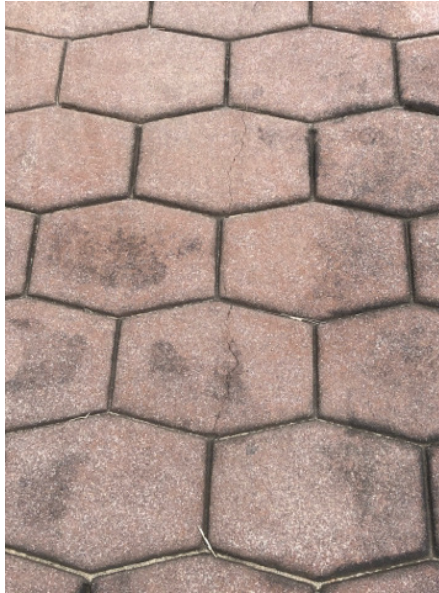
Driveway Condition

Common cracks & settlement were observed on the driveway. Maintenance is recommended. Note: Whilst these cracks appeared to be minor at the time of inspection, we strongly recommend you monitor these cracks and if worsening occurs contact a concreter for further advice.

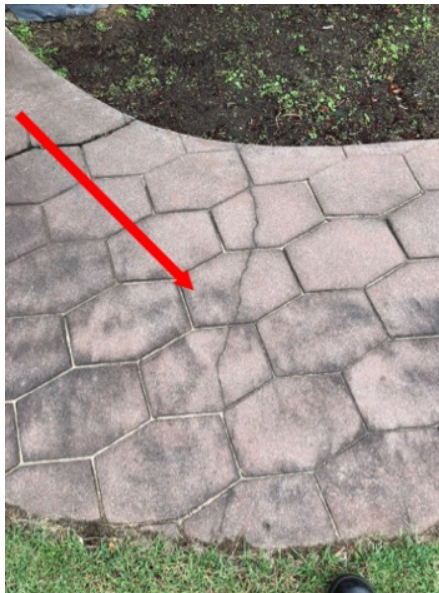
Pathways Condition

Common cracks and settlement were observed on paths. This may not have any effect on the actual structural integrity of the dwelling itself. Maintenance is recommended. Note: Whilst these cracks appeared to be minor at the time of inspection, we strongly recommend you monitor these cracks and if worsening occurs contact a concreter for further advice.

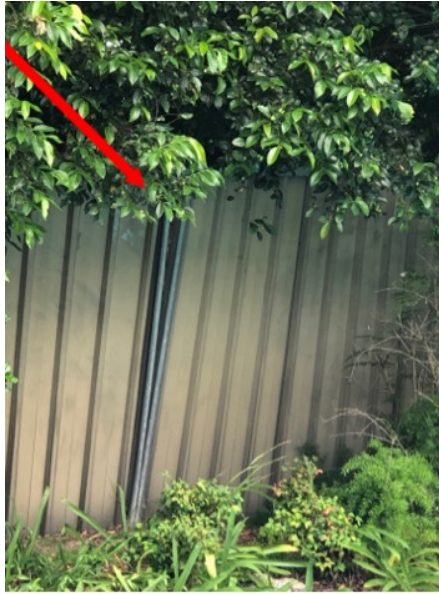
Overall Condition

Fence leaning- Recommendations: Repairs are required by fencing contractor to avoid unsafe conditions.

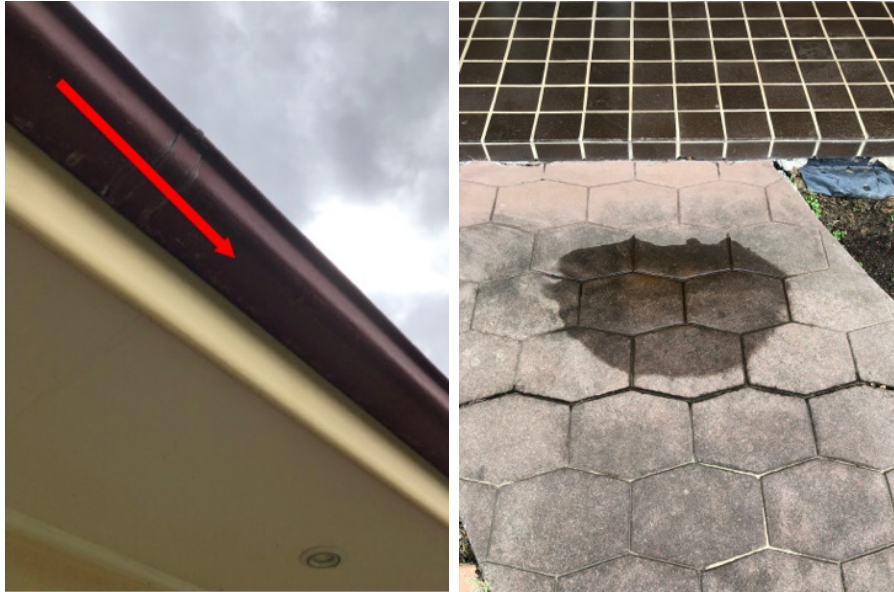
There is evidence of leaking gutters. Contact a roof plumber for advice and repairs.

Gutter rust/penetrations- The guttering has excessive rust where leaking will occur. Recommendations: The gutters require replacement by a roof plumber.

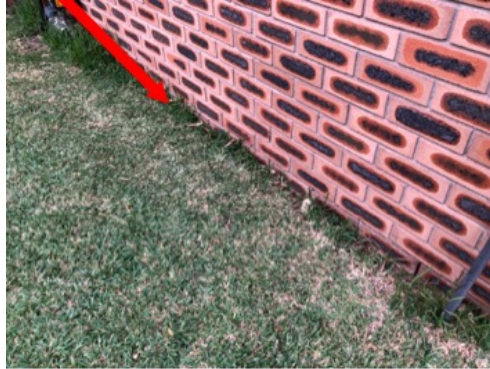
Findings

Some weep holes partially covered - Recommendations: Lower finished ground levels to fully expose all weep holes on the lower brick courses around the dwelling.

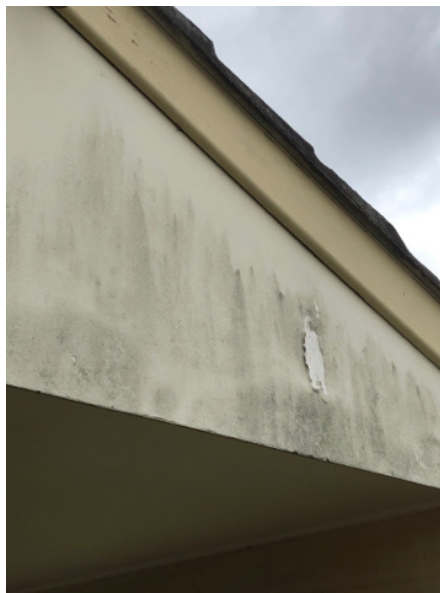
The external paint has deteriorated . External wall paint preserves and protects the building elements. Contact a licensed painter for repairs.

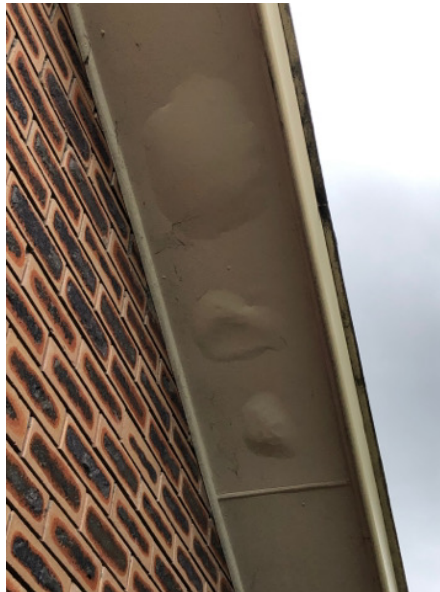
Eave Condition

Bubbling eave lining paint. Normally due to overflowing/blocked or leakage guttering. A qualified roof plumber should be engaged for advice and recommendations.

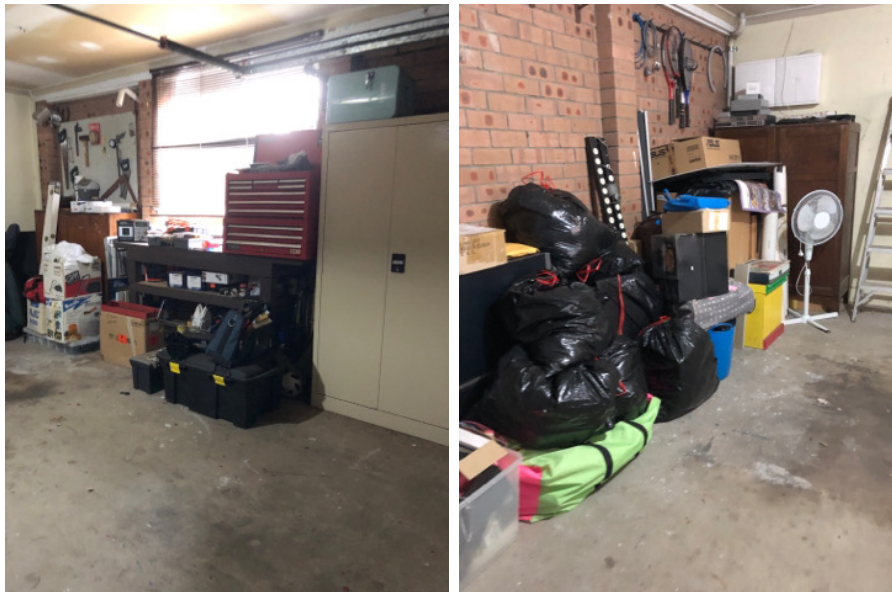
Storage items restricted a full and thorough inspection of this area. Defects may exist in the inaccessible areas. It is strongly recommended that full access be granted to enable a thorough inspection as there may be timber pest activity, damage or defects. Note: Where vehicles and storage has restricted a full inspection it is advised that this area be cleared so a full and unobstructed inspection can be carried out.

Lining restricted a full and thorough inspection of this area. Defects may exist in the inaccessible areas. It is strongly recommended that full access be granted to enable a thorough inspection as there may be timber pest activity, damage or defects.

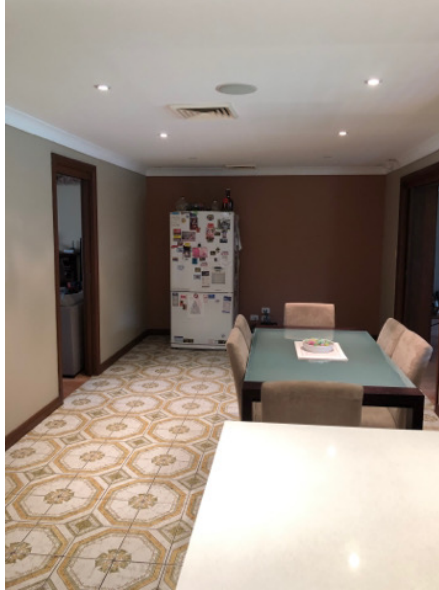
Dining Room

On inspection, defects were present that will require further assessing and recommendations by a qualified trades persons, please read below for details.

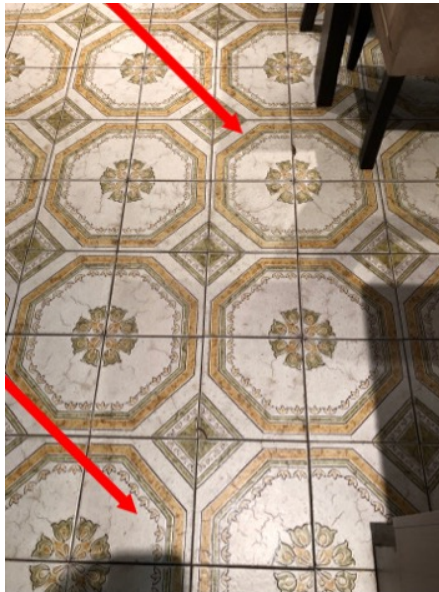
Flooring

Cracked floor tiles noted - Recommendations: A qualified tiler should be engaged for repairs.

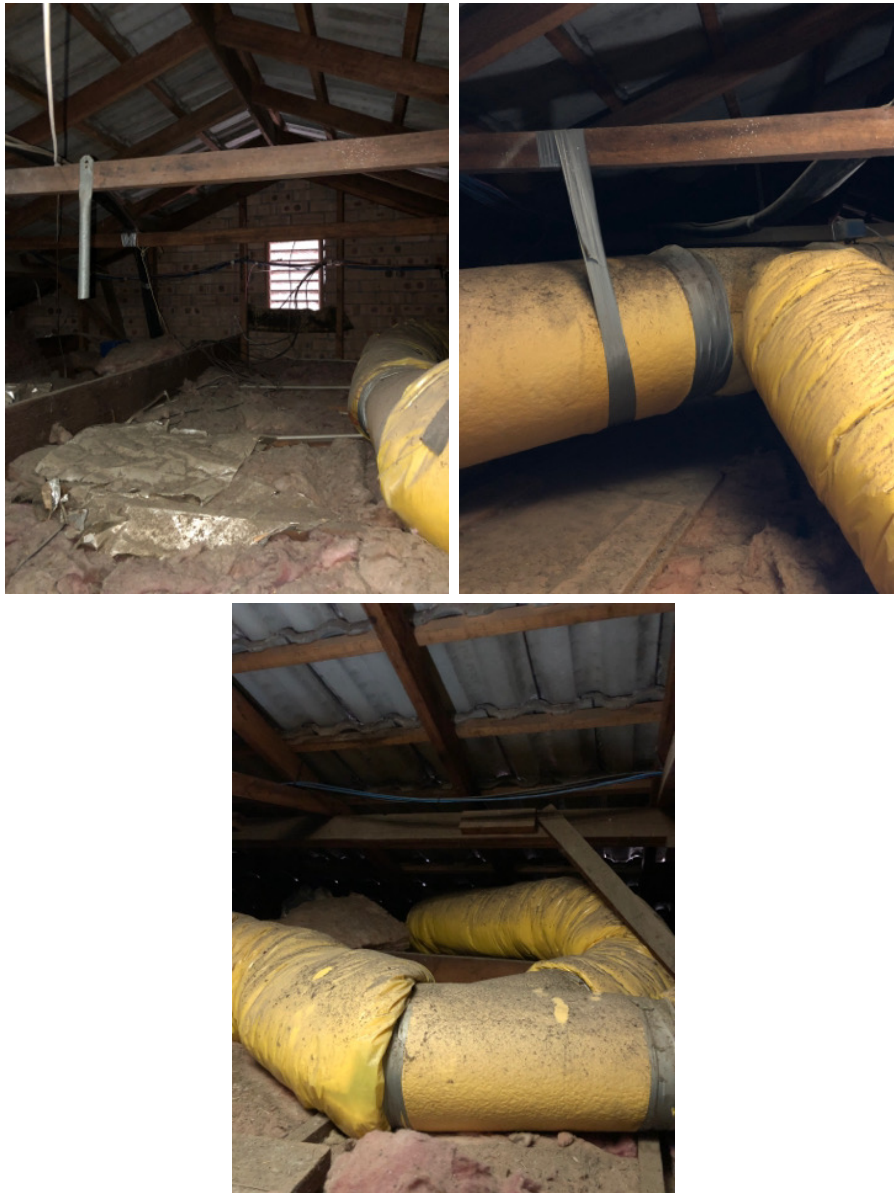
There is heating and/or cooling ducting present in the roof space/void. This is preventing a full inspection from being undertaken. It is strongly recommended that full access be gained as it could be harbouring timber pest activity, damage or defects.

There is insulation present in the roof space/void. This is preventing a full inspection of ceiling joists from being undertaken. It is strongly recommended that full access be gained as it could be harbouring timber pest activity, damage or defects.

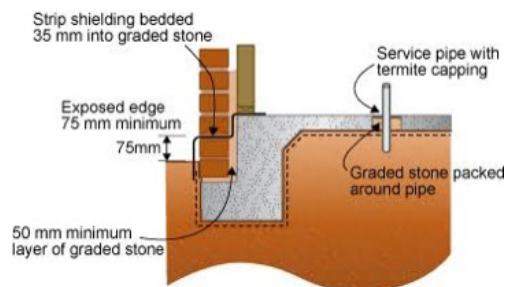
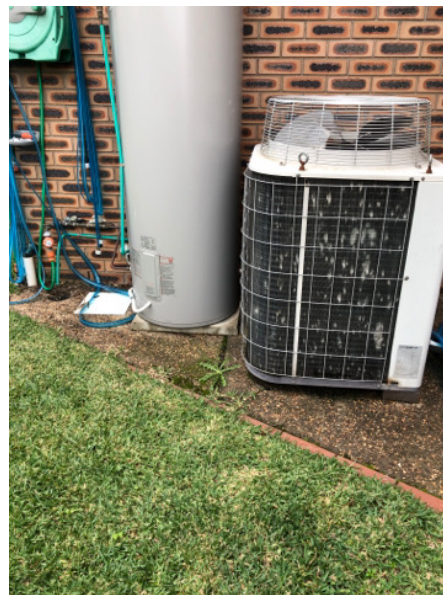
The slab edge is not exposed. (See photograph below for recommended adequate exposure) the degree of risk is high. The slab edge must be exposed so that a thorough inspection can be conducted for any termite infestation/access points.

Vents/weep holes covered by soil/debris. This provides concealed entry for termites. The degree of risk is high. Vents and weep holes need to be clear of any debris and fully open.
