Checklist Inspections

6 Shaddock Avenue

Inspection Date: 18 Jun 2025

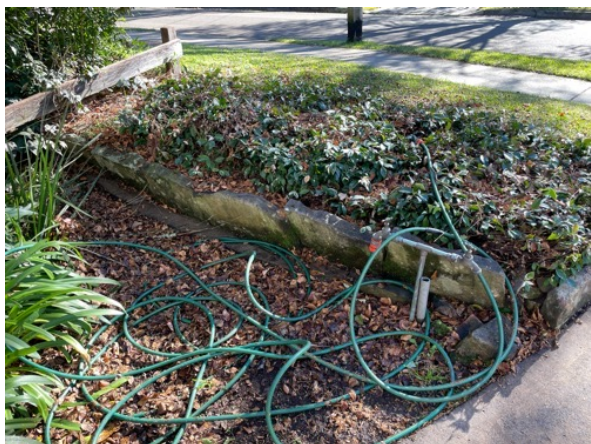
Finding: Retaining wall leaning

The stone retaining wall at the front of the property is on a lean.

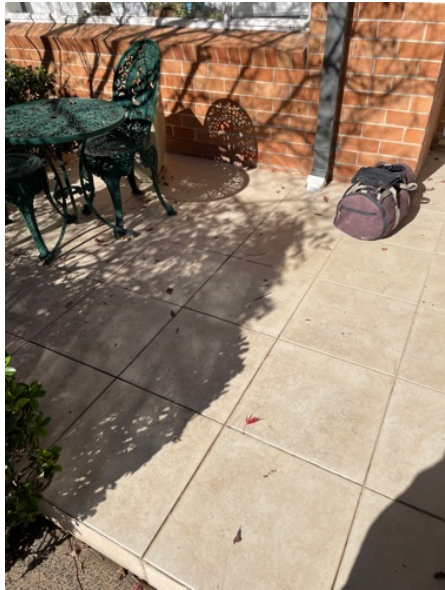
Minor Defect 1.02

Finding: Drummy tiles

Drummy tiles were identified on the floor of the patio at the front of the building.

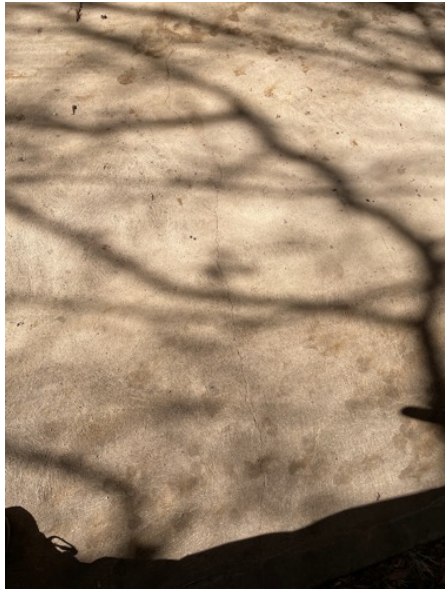
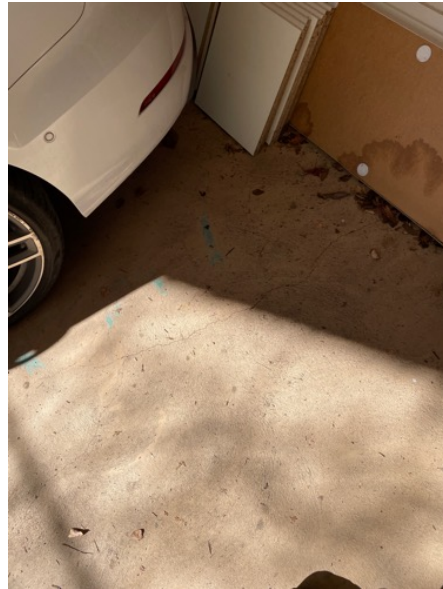
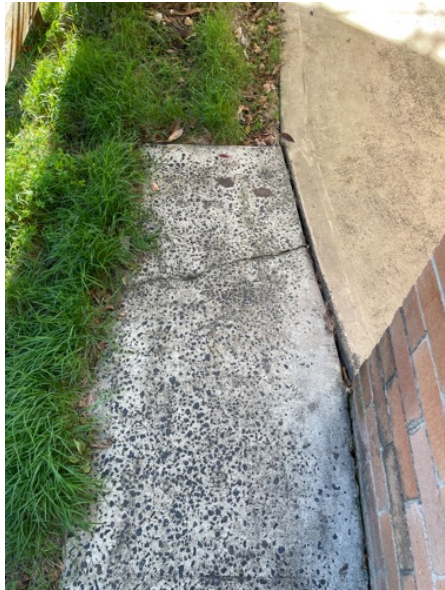
Minor Defect 1.03

Finding: Cracked concrete

Cracking was identified in the sections of the concrete slab of the carport and paths around the property.

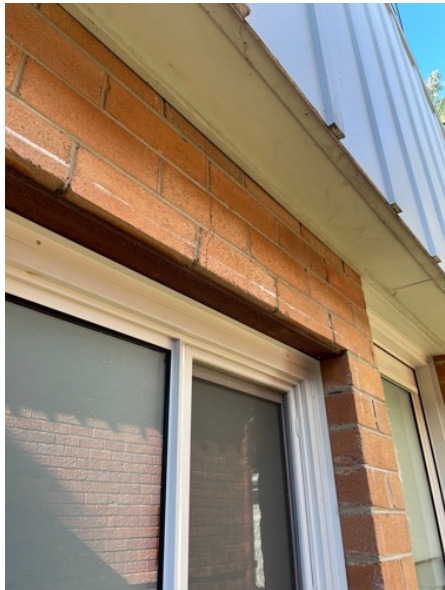
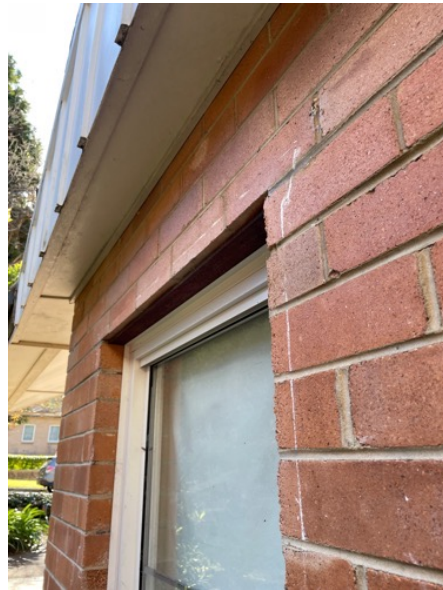
Minor Defect 1.04

Finding: Rusting lintels

Rust was identified on several lintels for the windows of the building.

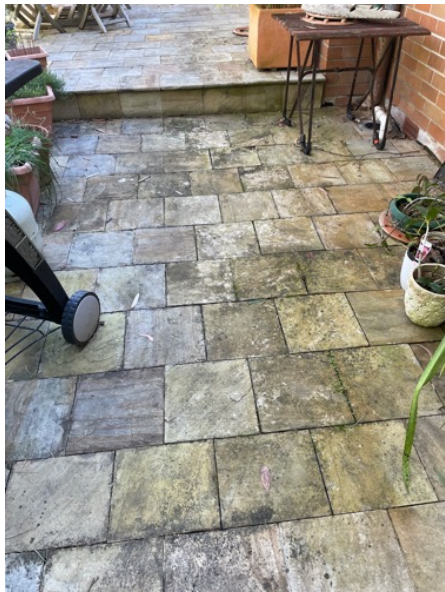
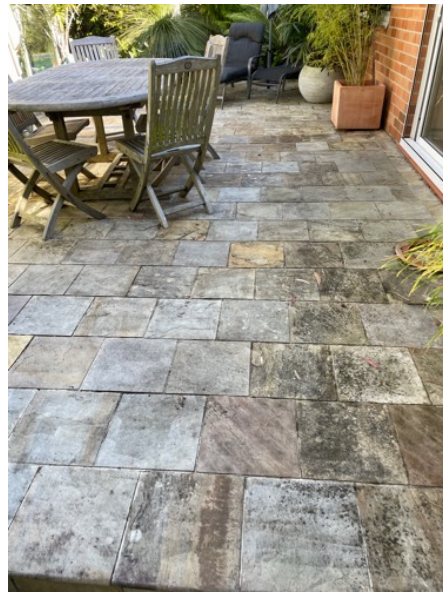
Minor Defect 1.05

Finding: Drummy pavers

Drummy pavers were identified on the floor of the patio at the rear of the building.

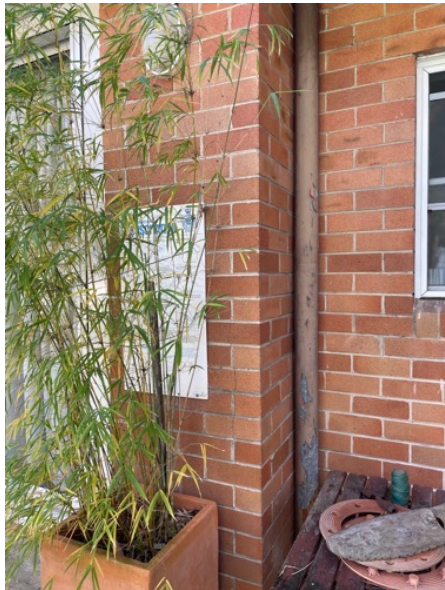
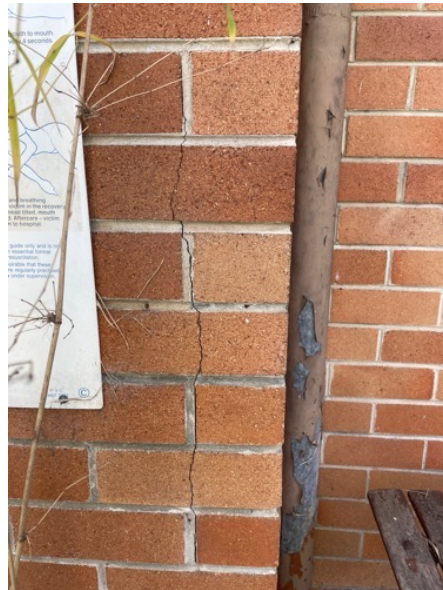
Minor Defect 1.06

Finding: Cracked brickwork

Cracking was identified in a section of the external wall at the rear of the building.

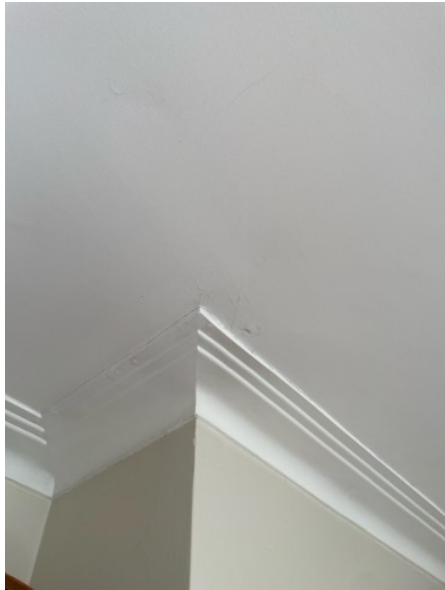
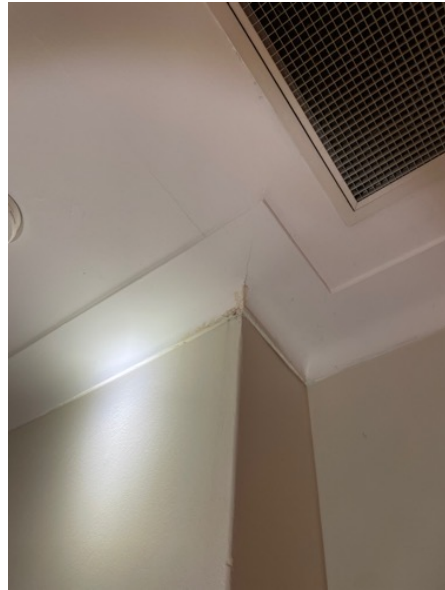
Minor Defect 1.07

Finding: Water penetration

Evidence of water penetration was identified in a section of the ceiling in the living area and hallway.

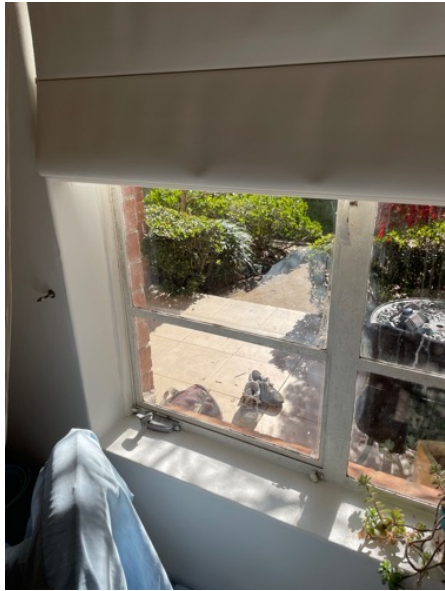
Minor Defect 1.08

Finding: Damaged winder

The winder for one of the windows in the first bedroom was not operational at the time of inspection.

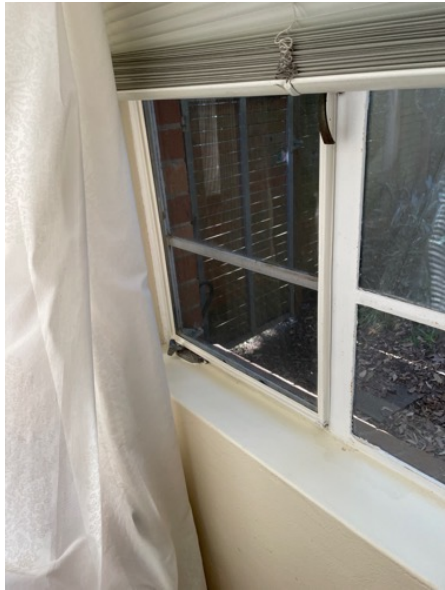
Minor Defect 1.09

Finding: Damaged winder

The winder for one of the windows in the second bedroom was not operational at the time of inspection.

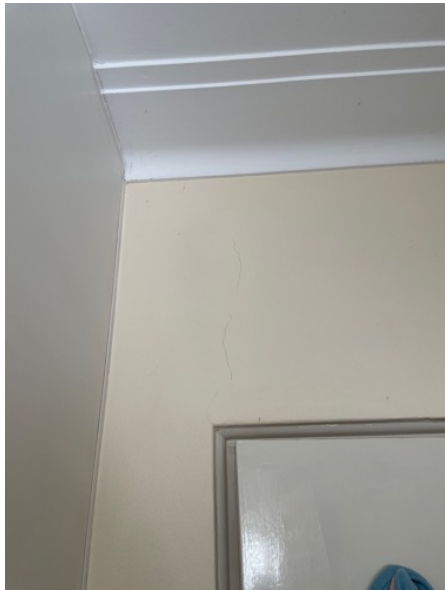
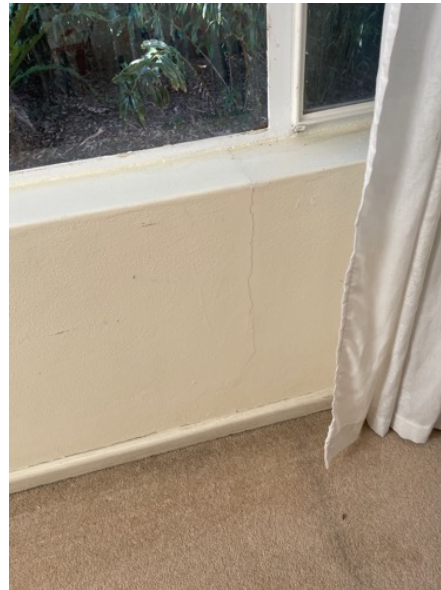
Minor Defect 1.10

Finding: Cracked brickwork

Cracking was identified in sections of the internal walls of the second bedroom.

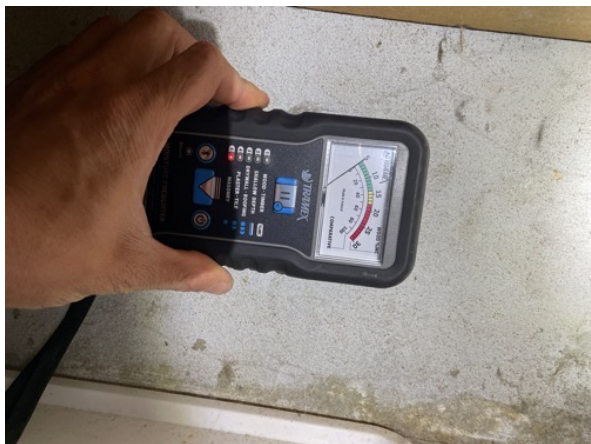
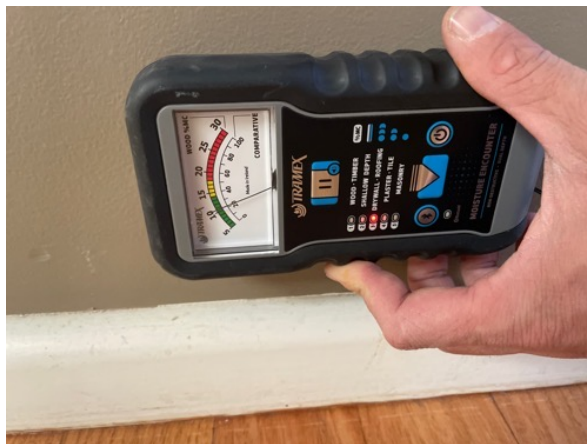
Finding: Moisture behind shower

A moisture meter was used to identify moisture in the wall behind the shower where possible, with an acceptable amount present.

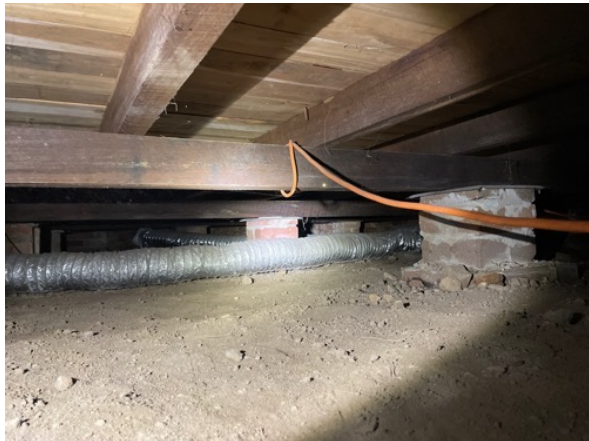
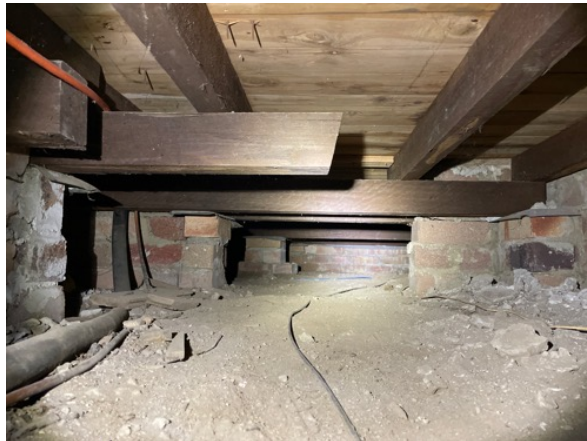
For your information 2.03

Finding: Obstruction

Ducting and low clearance were restricting access to the centre and eastern end of the subfloor.

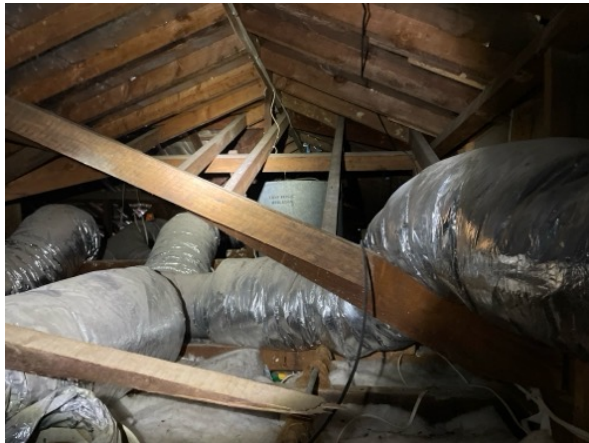
For your information 2.05

Finding: Obstruction

Ducting and roof members were restricting access to one end of the roof space.

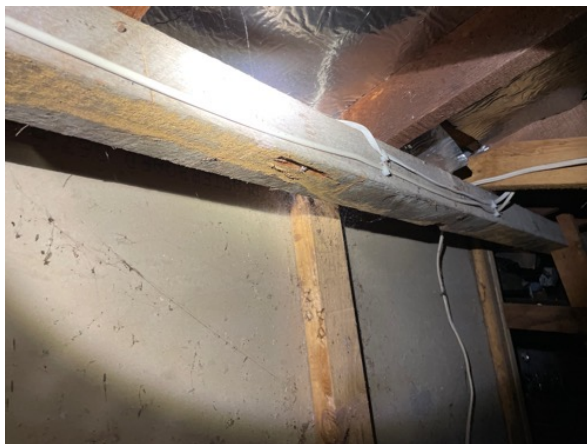
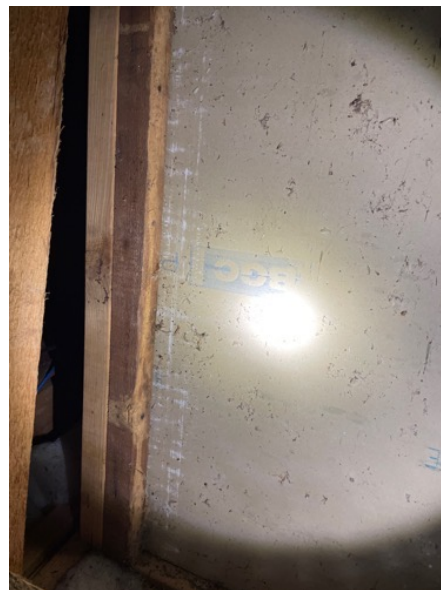
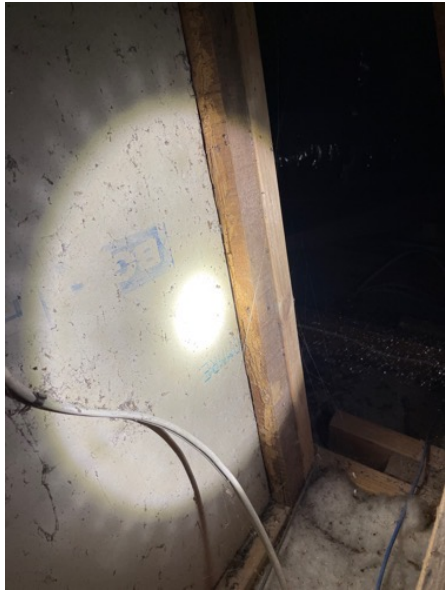
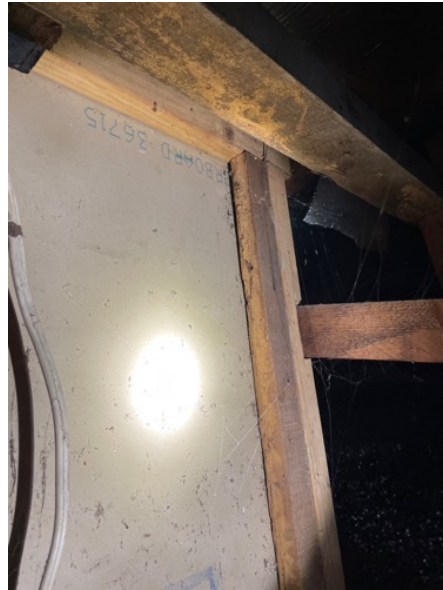
Finding: Termite workings

Old termite workings were identified on the framing for the skylight well near the entrance to the roof space.

1. Yes - treatment of Timber Pest Attack is required.
2. In addition to this Report a Subterranean Termite Management Proposal to help manage the risk of future subterranean termite access to buildings and structures is recommended.

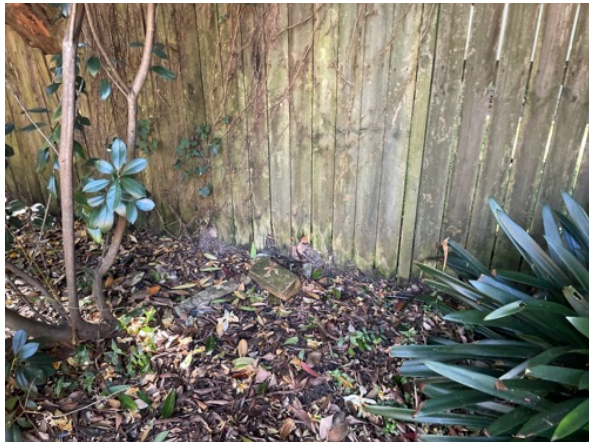
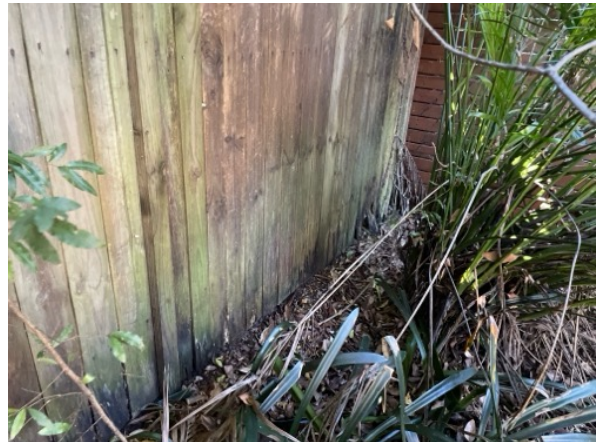
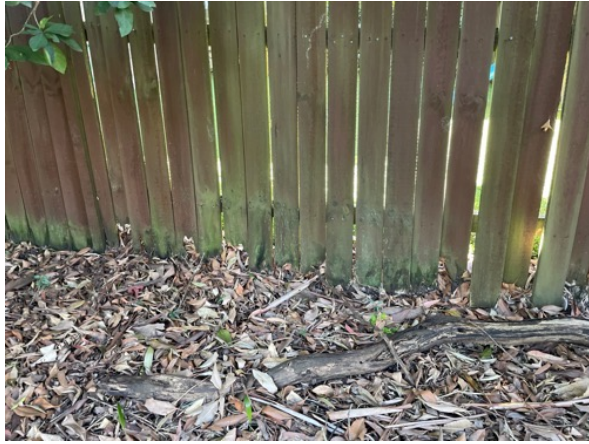
Finding: Wood rot

Fungal decay was identified at the base of numerous fence palings.

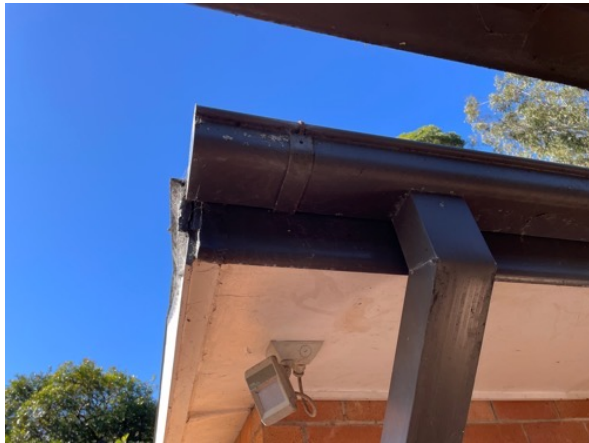
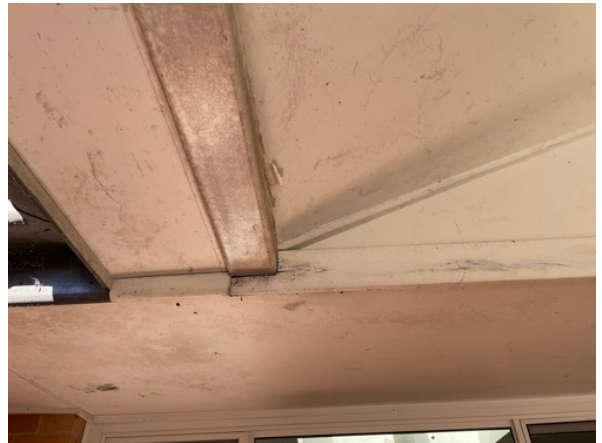
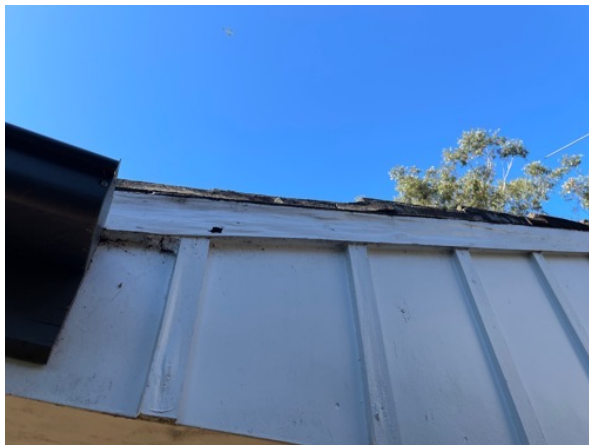
Timber pest attack 3.03

Finding: Wood rot

Fungal decay was identified in sections of the fascia and barge boards at the front of the building.

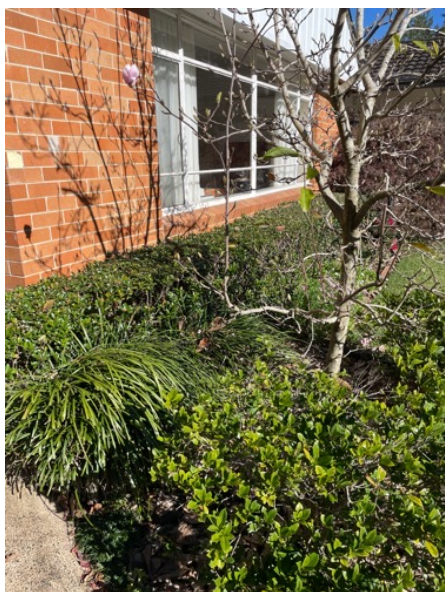
Conditions conducive to timber pest attack 3.04

Finding: Inspection zone limited

Built up areas abutting the building limit the visual inspection zone for termites and pose a risk for concealed entry. Dense vegetation limits the visual inspection zone for fence lines and garden beds.

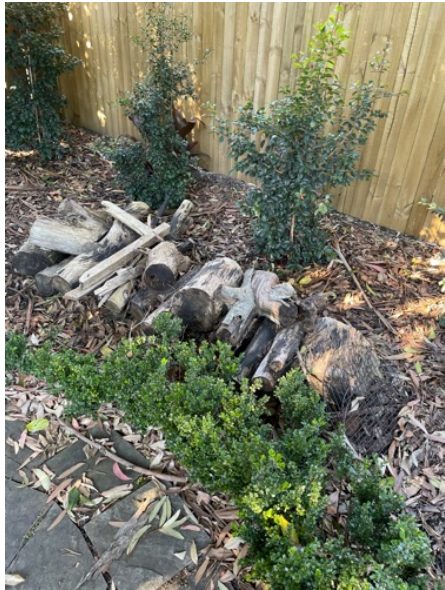
Conditions conducive to timber pest attack 3.05

Finding: Loose logs

Loose logs left lying in contact with the ground is a potential area for timber pests to infest.

3. Yes - removal of Conditions Conducive to Timber Pest Attack is necessary.
