## **Visual Property Inspection Report**

Complies with Australian Standard AS 4349.1-2007 & 4349.3

**26 Fairchild Street  
Raymond Terrace, NSW 2324**

**June 18, 2026**

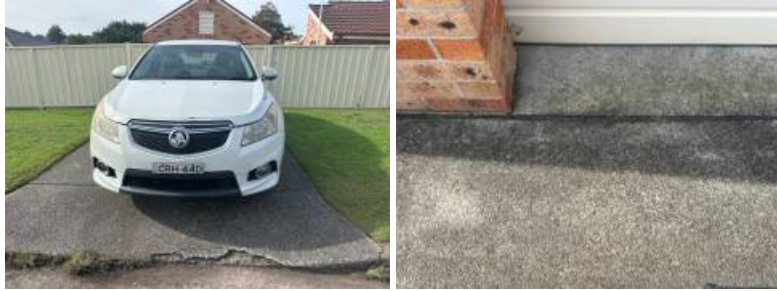
The concrete driveway stands in fair condition. The concrete driveway has some visible cracking that should be monitored for further movement.

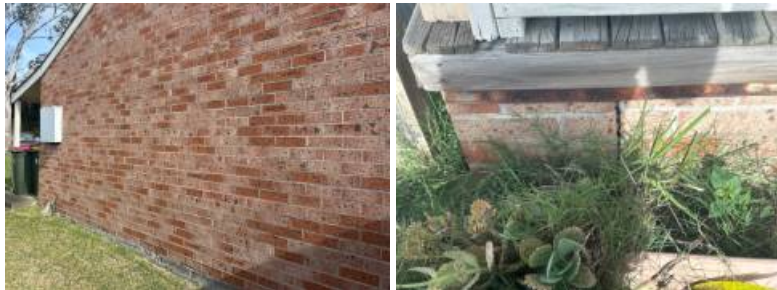
The condition of the walls is generally fair. Cracks are evident to masonry. Visible cracking appears minor. Periodic maintenance may be required. Please refer to section of this report - CRACKING OF BUILDING ELEMENTS for additional details. Expansion joints should be filled with sika flex to prevent moisture/vermin entering wall cavity. Gap around electrical meter box should be filled with trim/silicone to prevent moisture/vermin entering wall cavity. Paint to front timber posts has deteriorated. Wet rot is present to front posts.

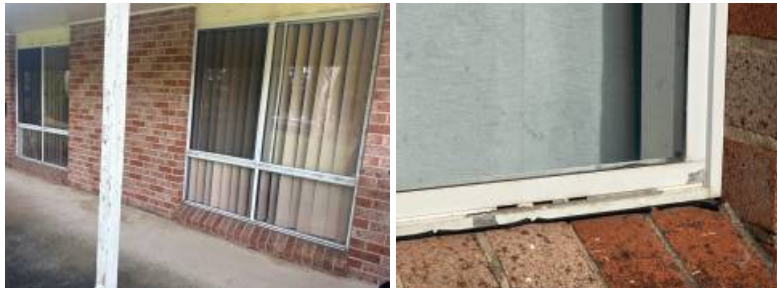
The condition of the exterior of the windows is generally fair. Insect screen/s are damaged and require repair or replacement.

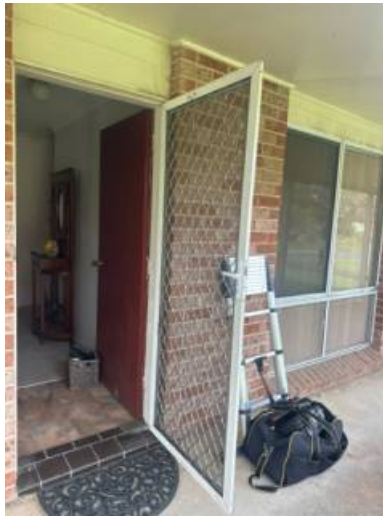
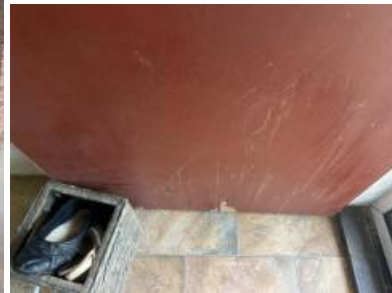
Front elevation. Rear elevation.

The condition of the exterior of the doors is generally fair. Door closers to insect screens are missing. Bottom of timber doors have deteriorated, minor repairs required.

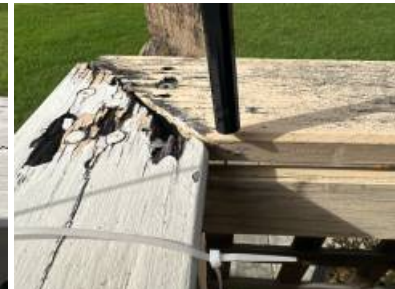
Wet rot is present to parts of the handrail.

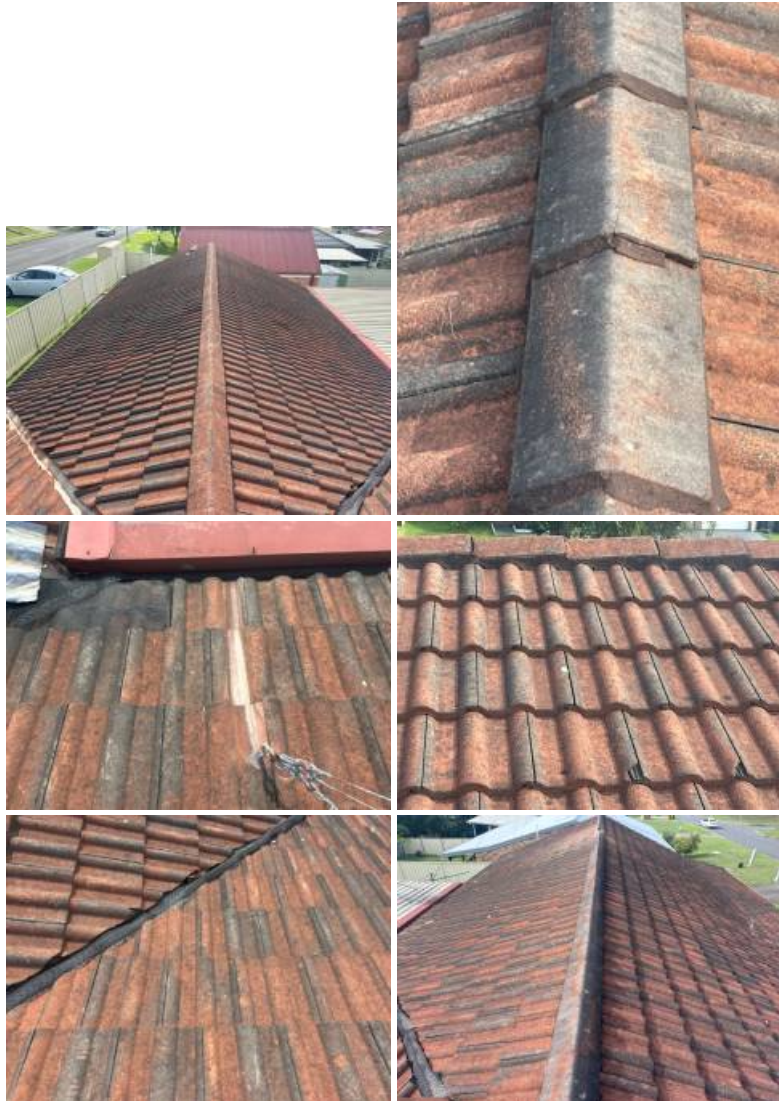
The overall condition of the roof coverings is fair. A small number of cracked roof tiles were noted and should be replaced. Mortar beds to the hip and ridge capping are cracked and require maintenance or re bedding and pointing in areas.

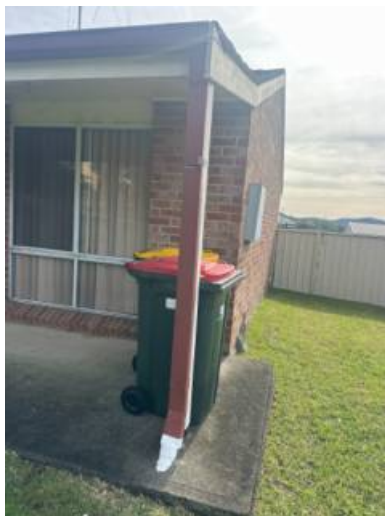
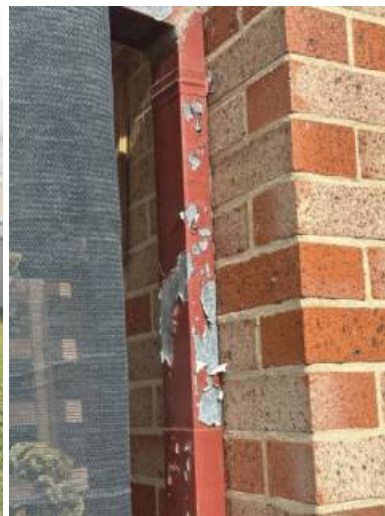
Appear to be in serviceable condition. PVC stormwater connection to downpipes is damaged and will require repair. Excess water around the building can cause structural damage.

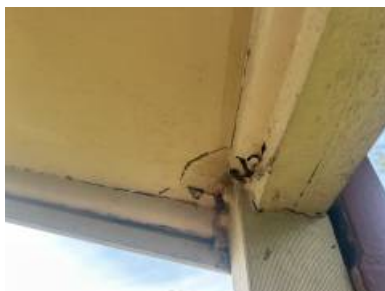
The eaves appear to be lined with fibre cement sheeting. The overall condition of the eaves lining is fair. Minor repairs/maintenance required prior to next repainting. Wet rot is present to front eave trim/beam.

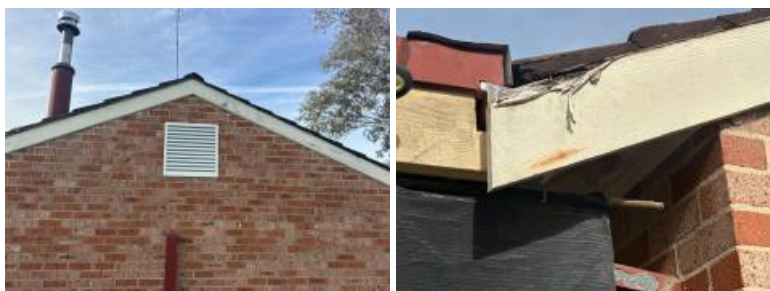
The overall condition of the fascias/bargeboards is fair. The paint work is deteriorating; Consider maintenance as well as a cosmetic upgrade.

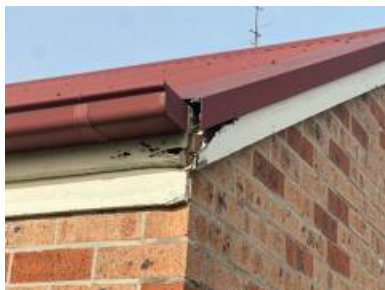
*Fascias & Bargeboards Condition:* The overall condition of the fascias/bargeboards is fair. Moderate wet rot decay is present to some sections of the timber fascias/bargeboards. Maintenance and or replacement of damaged timber will be required. The paint work is deteriorating; Consider maintenance as well as a cosmetic upgrade.

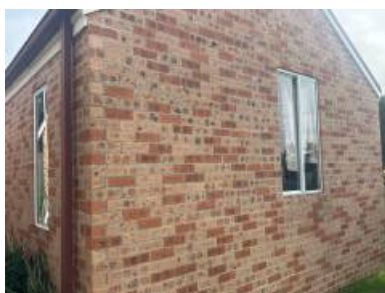
The condition of the exterior of the windows is generally fair. Insect screen/s have not been provided and should be installed.

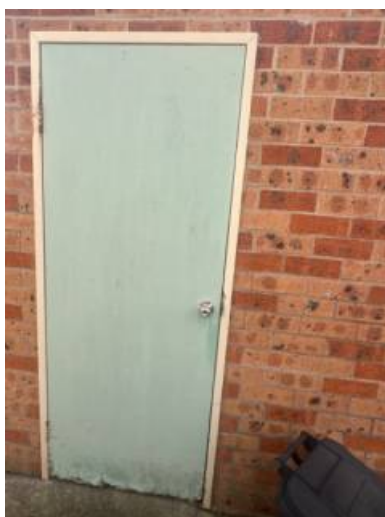
The external door is beyond repair and requires replacement.

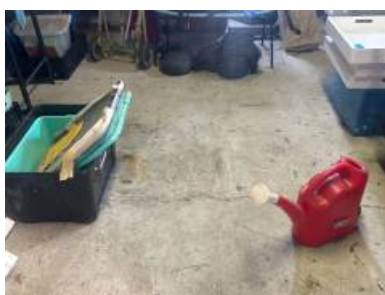
The concrete floor is generally in fair condition. The concrete floor shows signs of minor cracking. Please refer to section of this report - CRACKING OF BUILDING ELEMENTS for additional details.

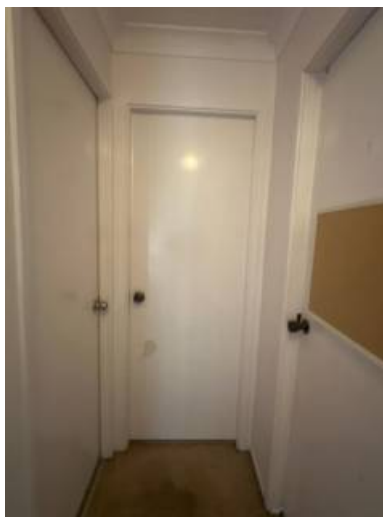
The condition of the doors is generally fair. Some doors bind and adjustments are required to ensure correct operation. The condition of the door hardware is generally fair. Some minor repairs or maintenance will be required. Door frames are scratched and will require repairs prior to next repainting. Recommend that the installation of door stops be provided to all of the doors.

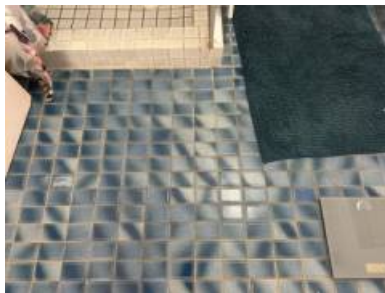
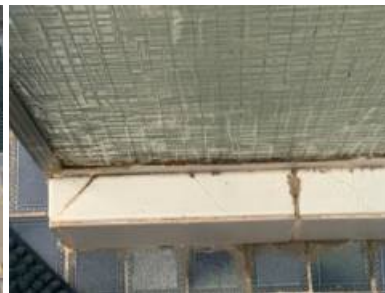
The condition of the tiles is generally fair. Some cracked tiles were noted in this area. Consider repair or replacement of damaged tiles.

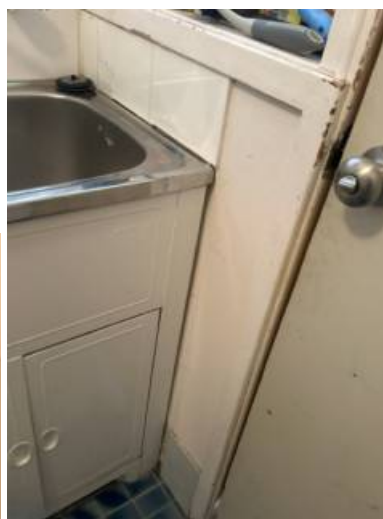
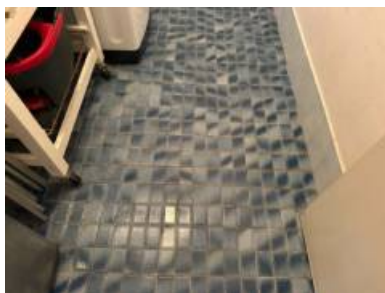
The condition of the tiles is generally fair. Some drummy, loose tiles were noted and these areas will require repair and or replacement. Movement and or settlement cracking to the junctions around fixtures should be filled with a flexible sealant to provide an acceptable finish and prevent water penetration.

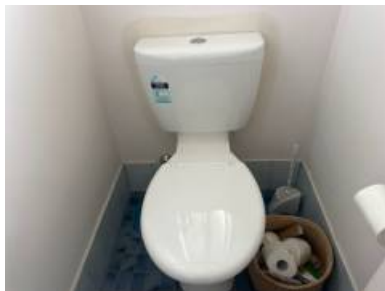
The toilet appears to be in working order. Toilet area is restrictive and the door swings inwards. In case of an emergency the door cannot be readily removed from the outside. Recommend liftoff hinges be installed to the door to comply with current Standards.

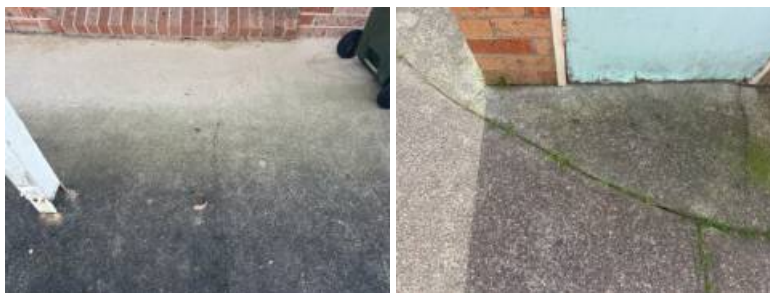
Crack Type: Differential movement cracking Located: Garage Driveway Pathways Width: 0.5mm Length: Various.

Due to the unpredictable nature of cracking in building elements it is not possible for the inspector to determine past or future occurrences that have or will impact cracking in this building. Because of these unknowns and the possibility of concealed defects related to cracking in building elements we recommend an engineer be consulted prior to acceptance or purchase this building.

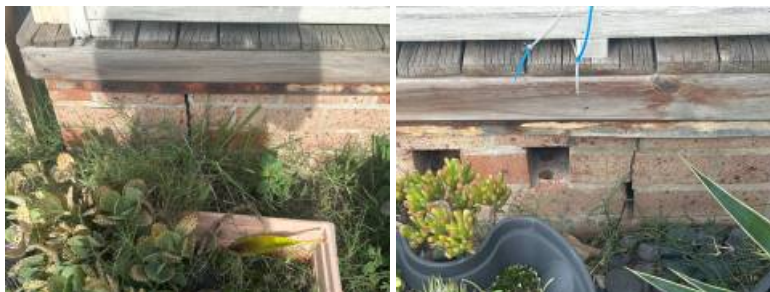
Crack Type: Vertical cracking Differential movement cracking Located: Under deck.

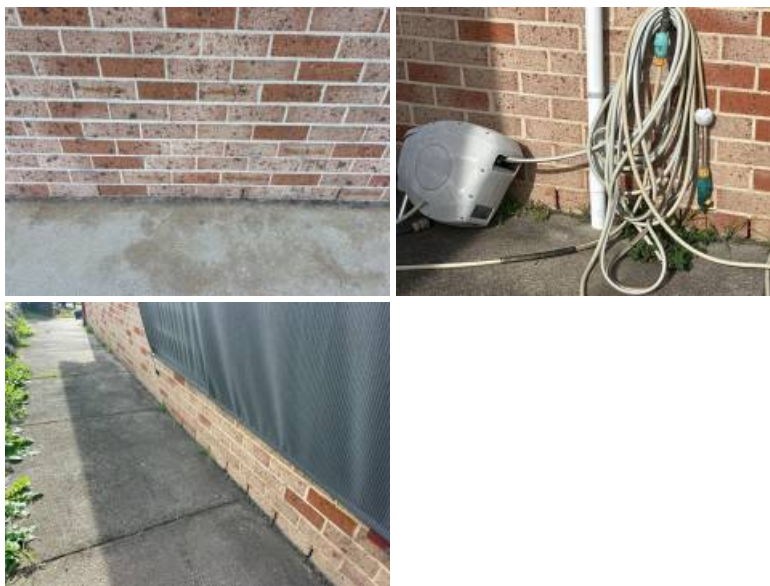
The level of some external paths, paved areas or soil is either higher than, or at a similar level, as that of the internal floors. This situation could allow concealed termite entry. We strongly recommend the lowering of these to below the internal floor level to reduce the risk of concealed termite entry.

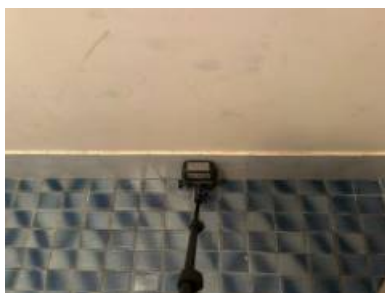
High moisture levels were detected to some internal walls as noted below. The moisture was considered higher than acceptable for the property inspected. This can be an indicator of a free moisture source (water leak) or possible timber pest activity. In all cases where a high moisture level is encountered, we strongly recommend further investigations be carried out to determine the cause of this situation. Moisture was tested in the range of: 23-25%
