BUILDING AND TIMBER PEST REPORT

56 Centaurus Cres
Regents Park, QLD 4118

BYB
13/05/2025

Pre-Purchase Inspection - Residential Building Report

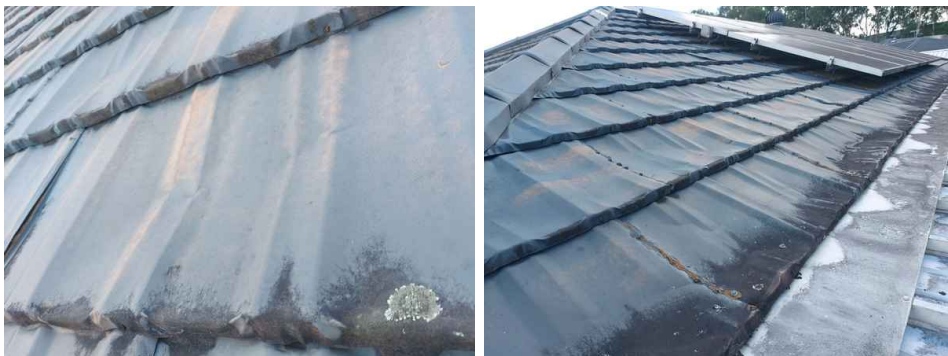
The metal tiles to the roof were observed to be dented.

Dented tiles will not perform as originally designed, and can lead to ponding of water, corrosion and leaking.

Further investigation by a roofing specialist is recommended to determine the extent of damage, and cost of repair.

Contact a qualified roofing professional.

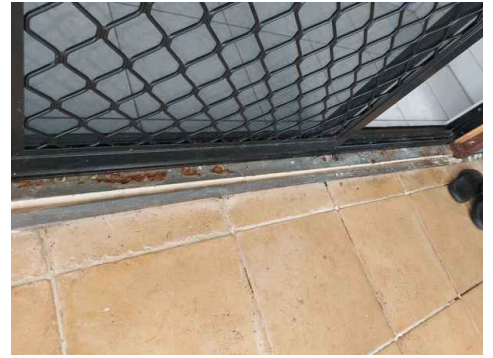
Minor-Moderate Attention Recommended
DAMAGE TO SLIDING DOOR FRAME/TRIM

Further evaluation and correction recommended

Contact a qualified professional.

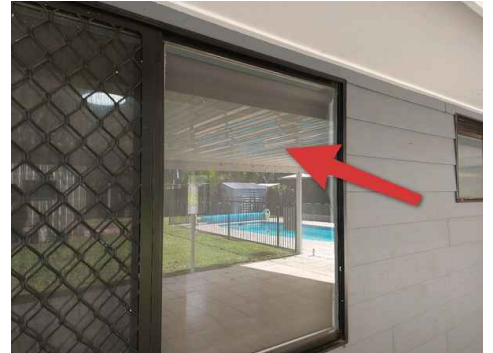
12.4.1 Window Exteriors

Minor-Moderate Attention Recommended
CRACKED/BROKEN PANE

Window(s) had a cracked/broken pane of glass.

Further evaluation and correction recommended.

Contact a qualified window repair/installation contractor.

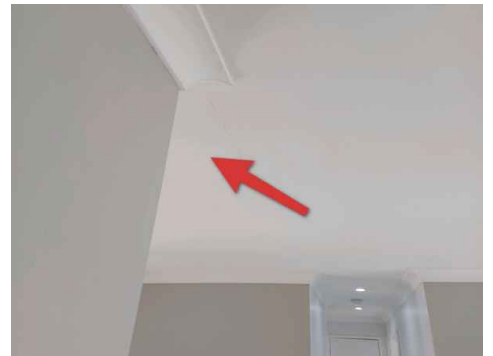
MINOR CRACKS

There are minor cracks in the ceilings. This is a common condition with this type of construction and at the time of inspection appeared to be slight and appearance defect. The cracks can be repaired or painted, and expansion joints installed where appropriate. We recommend repair by a qualified plasterer.

Note: if the condition worsens/deteriorates, further evaluation and correction recommended by a structural engineer.

Contact a qualified drywall contractor.

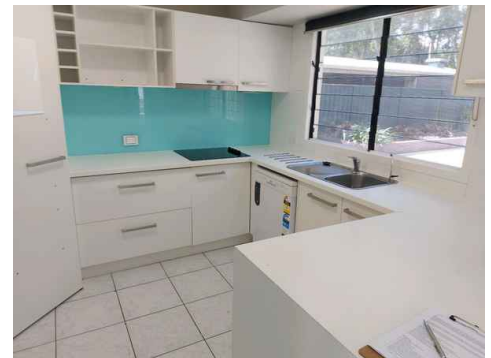
**MODERATE
DETERIORATION**

The kitchen cabinets exhibited moderate general deterioration.

Contact a qualified professional.

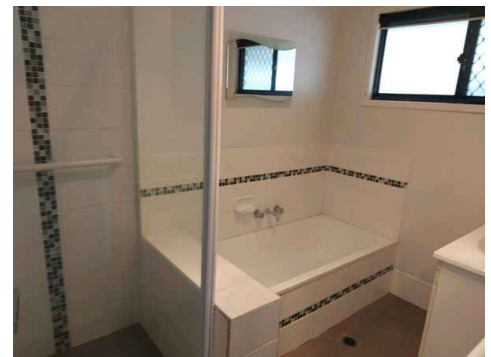
**MODERATE DETERIORATION**

Wear and tear, minor damage observed.

Maintenance recommended.

Contact a qualified professional.

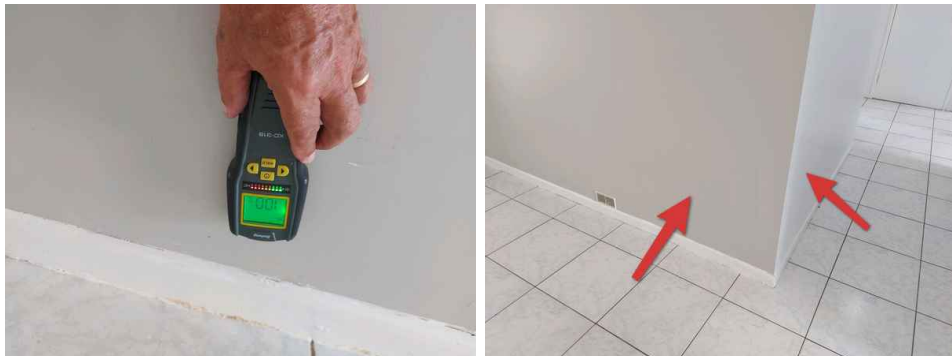
15.1.2 General

**HIGH MOISTURE READING**

Moisture intrusion in the building is classed as conditions conducive to building and timber pest activity. Further investigation by a competent qualified professional to identify the source/cause of the moisture intrusion is recommended. Action is required to rectify this condition and repair any damage caused

Contact a qualified professional.

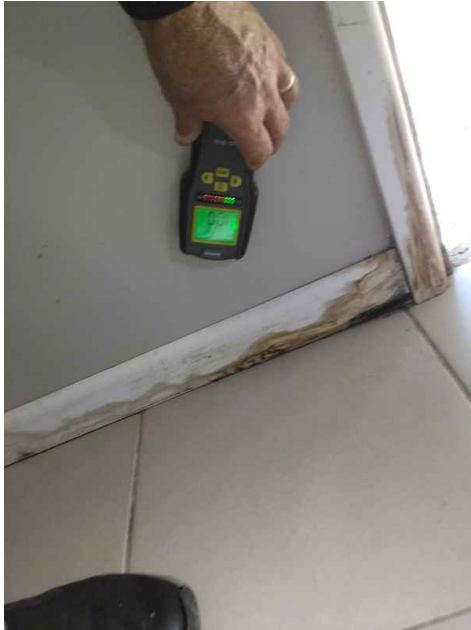
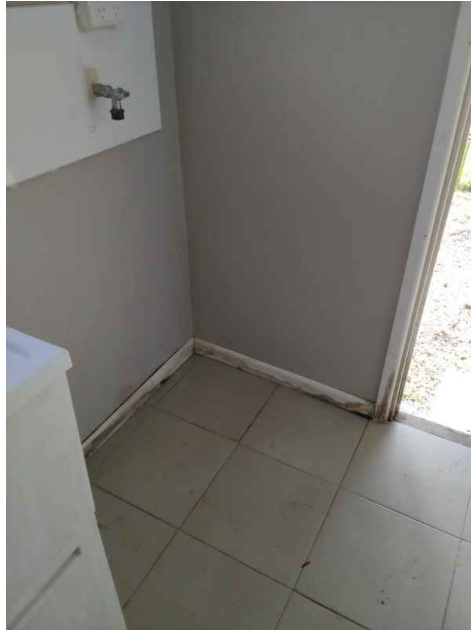
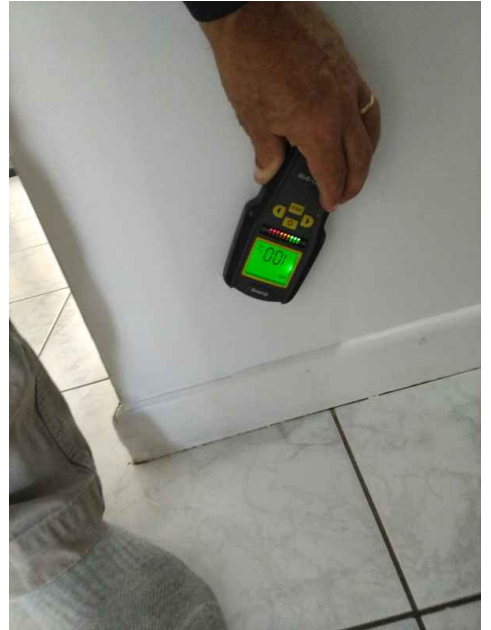
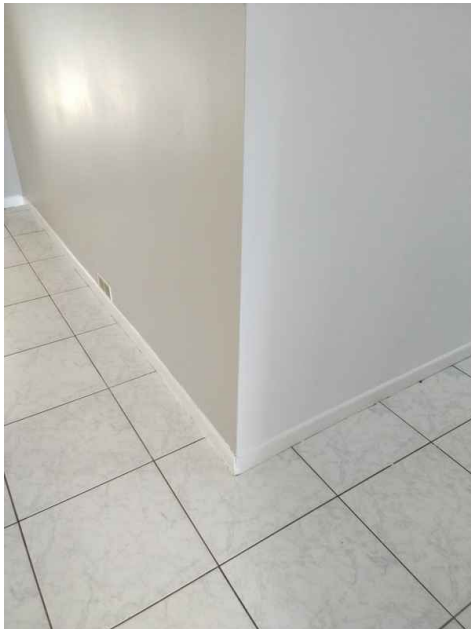
20.3.1 Presence of Excessive Moisture

**HIGH MOISTURE DETECTED**

High moisture was observed within the building. Moisture intrusion in the building is classed as conditions conducive to timber pest activity. Further investigation by a competent qualified professional to identify the source/cause of the moisture intrusion is recommended. Action is be required to rectify this condition and repair any damage caused.

Contact a qualified professional.

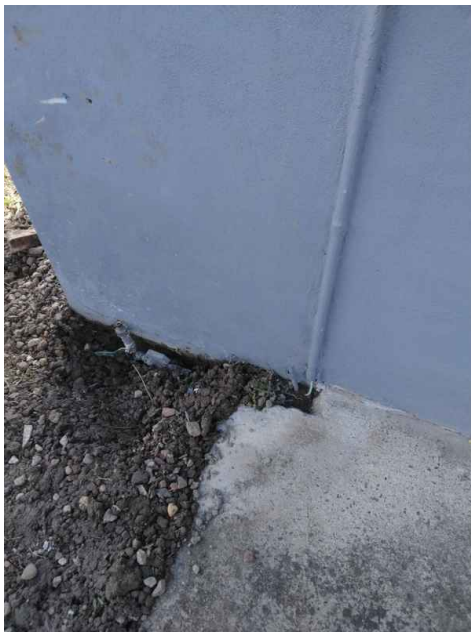
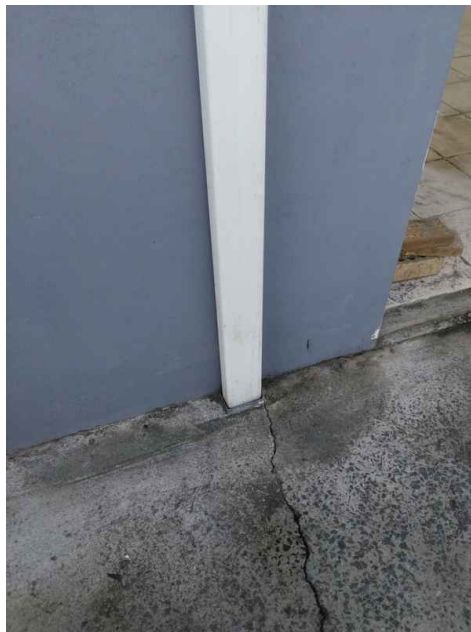
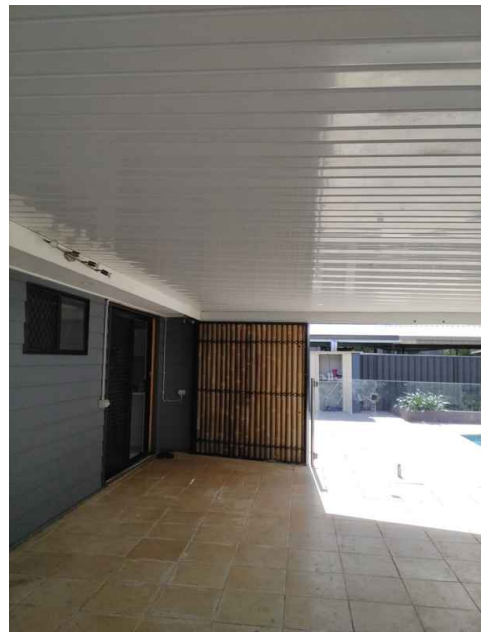
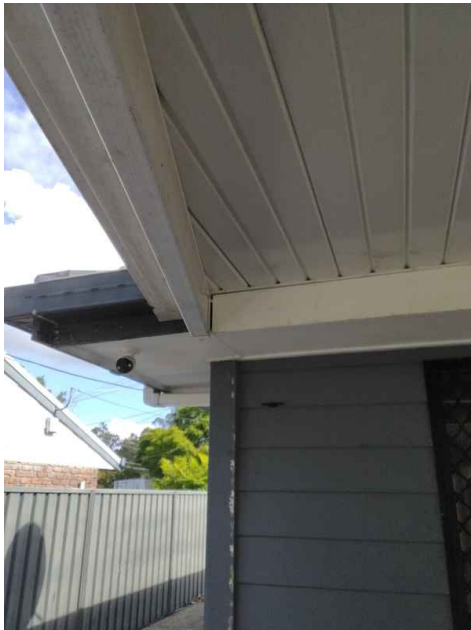
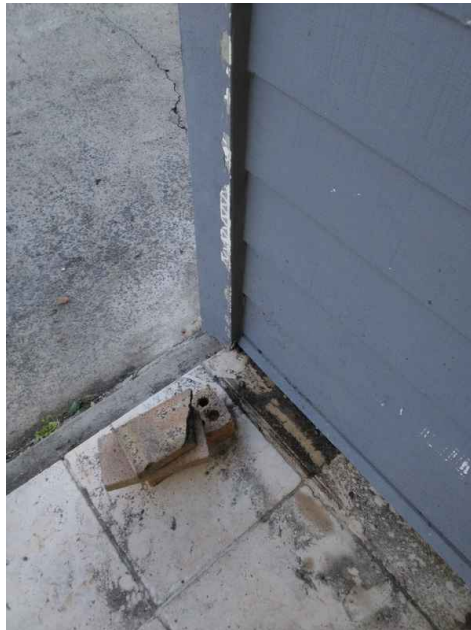
20.4.1 Bridging and Breaching of Termite Barriers and Inspection Zones

Minor-Moderate Attention Recommended

Rectify this condition, Reinspect, and maintain a clear inspection zone around the building

Contact a qualified professional.

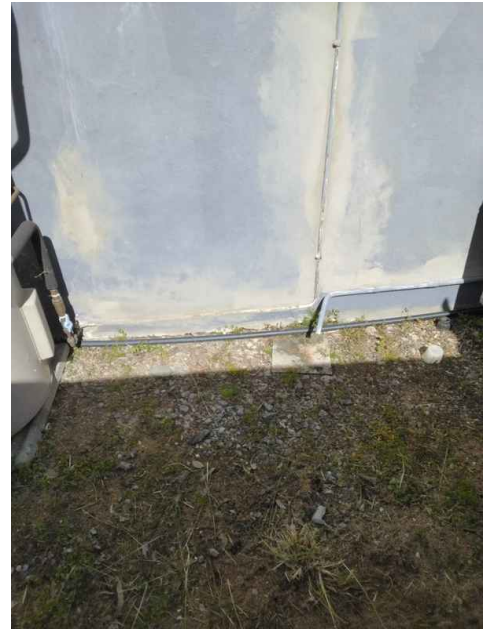
20.4.2 Bridging and
Breaching of Termite
Barriers and Inspection Zones

Minor-Moderate Attention Recommended

INADEQUATE CLEARANCE FROM GROUND

Inadequate clearance can allow hidden termite entry and moisture problems. Further evaluation and correction recommended.

Contact a qualified professional.

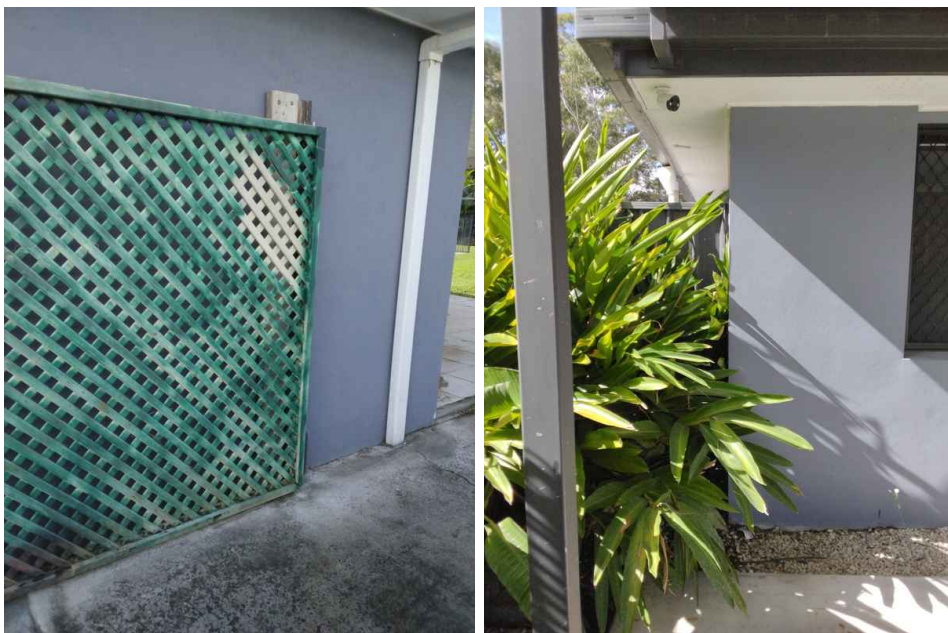
20.4.3 Bridging and Breaching of Termite Barriers and Inspection Zones

Minor-Moderate Attention Recommended

Further evaluation and correction recommended

Contact a qualified professional.

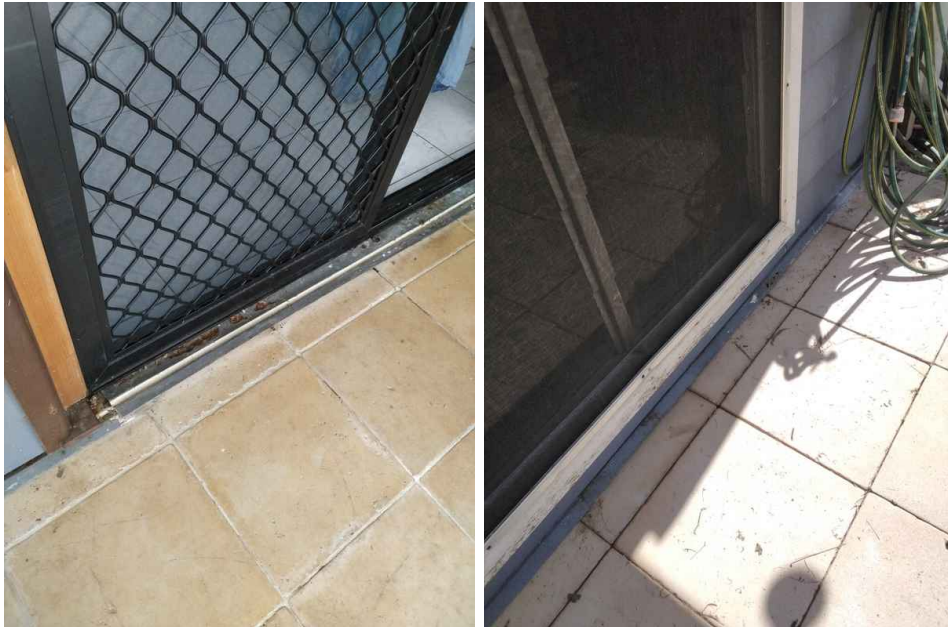
20.4.4 Bridging and Breaching of Termite Barriers and Inspection Zones

Minor-Moderate Attention Recommended

RUSTED/DETERIORATED/MISSING TERMITE CAPS

Sections of termite shields are damaged and/or rusting. This can allow for hidden entry of termites, and will require repair or replacement, or consider alternative method of termite protection.

Consult a termite specialist for recommendations.

Contact a qualified pest control specialist.
