# Property and Timber Pest Report

Property Address: 153 Singer Street Wynnum 4178

Inspection Date: 2 Jul 2025

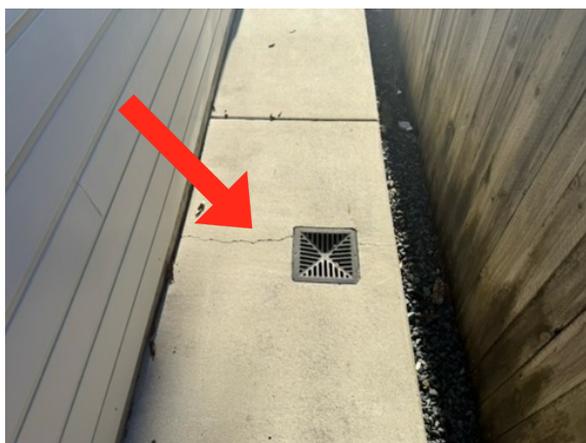
### Minor Defect 1.01

**Finding:** Concrete Hardstand - cracking

Movement cracking to external paths due to general movement / deterioration of subgrade

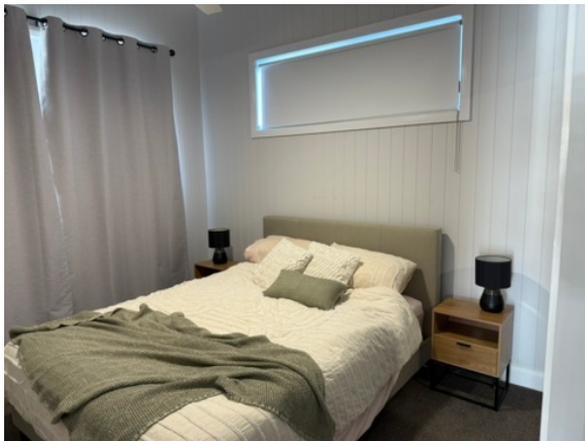
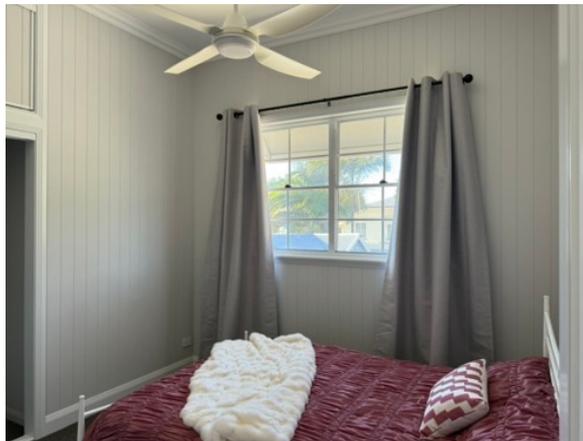
### For your information 2.01

**Location:** All Internal Areas  
**Finding:** Inspection obstructions  
Furniture to rooms inhibits visual inspection

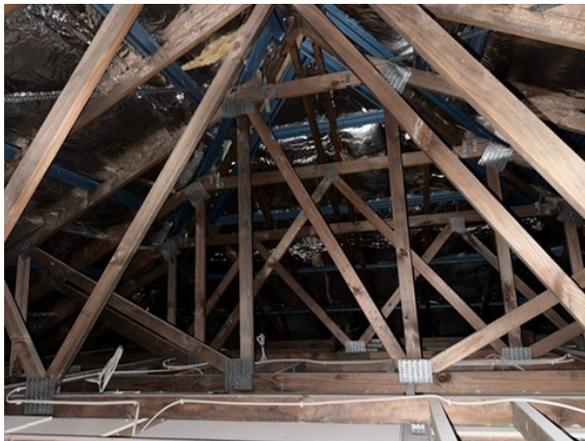
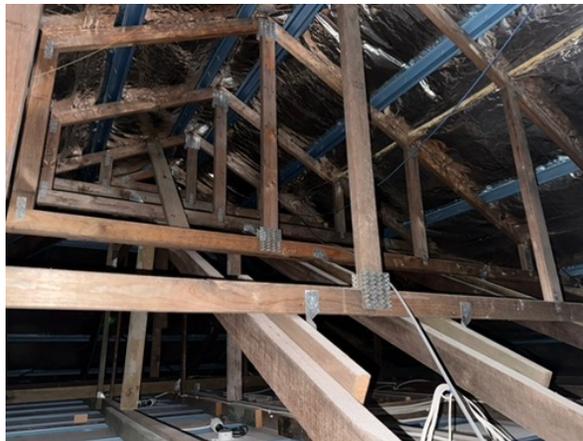
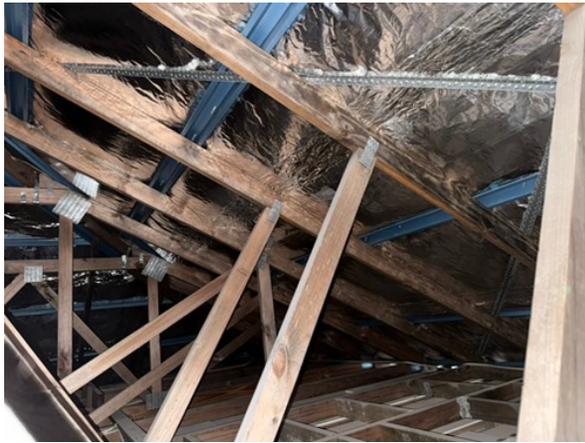
### For your information 2.02

**Location:** Roofspace  
**Finding:** Roofspace - General Note  
Good condition for extent accessible

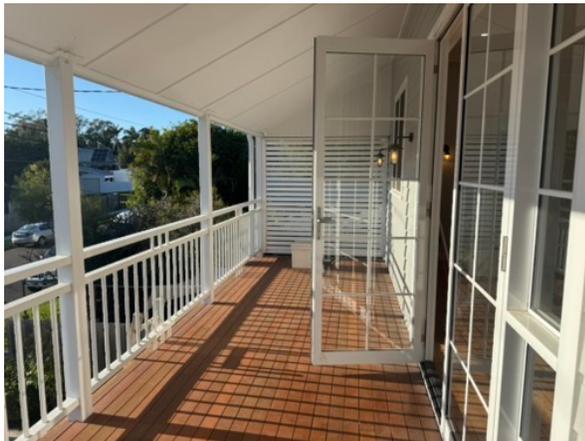
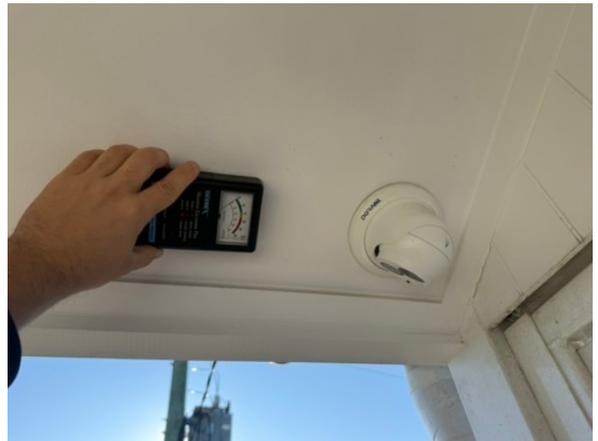
### For your information 2.03

**Location:** Front Deck

**Finding:** General Note

Good condition. No evidence of water penetration to skillion roof. Gutters well serviced

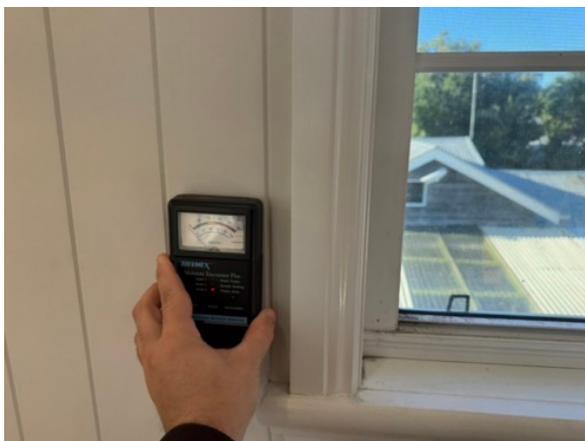
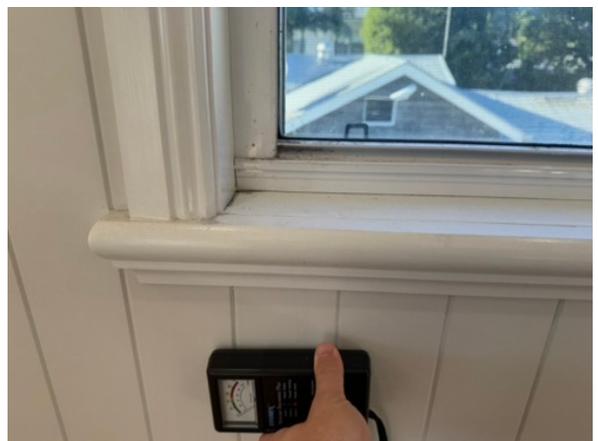
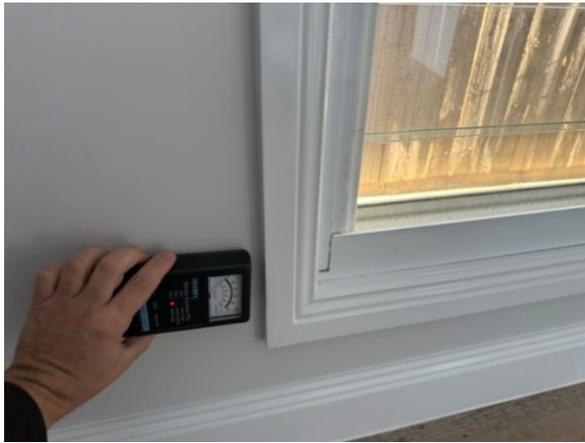
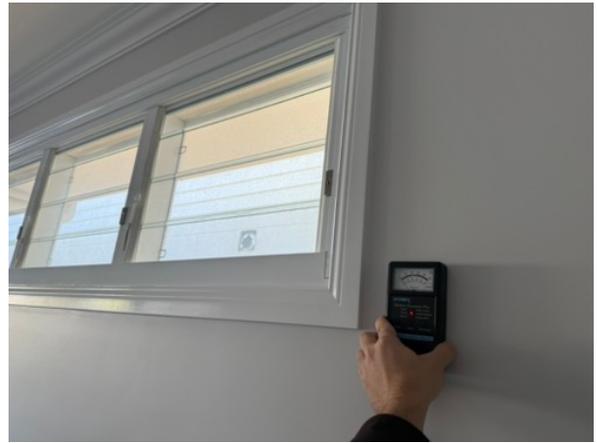
### For your information 2.04

**Location:** All Internal Areas

**Finding:** General Note

No evidence of water penetration around windows

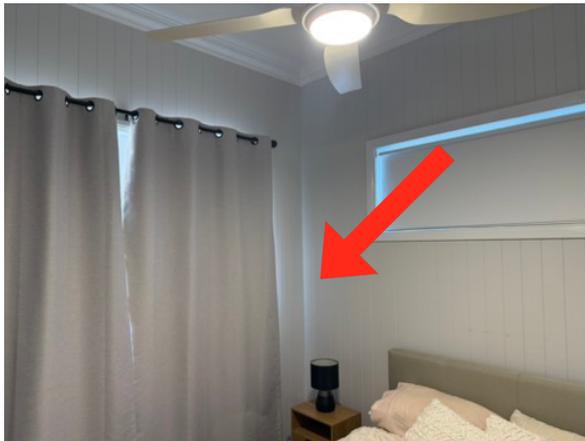
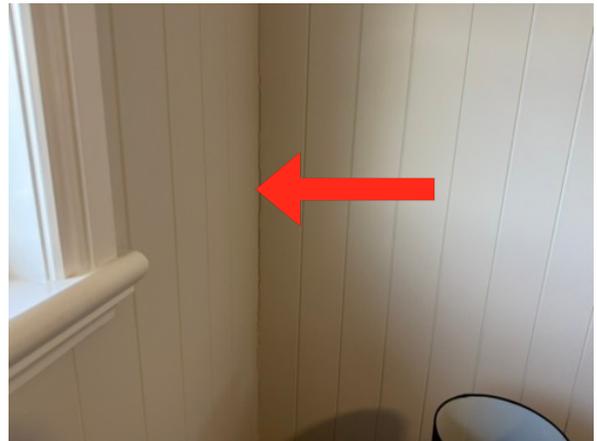
### For your information 2.05

**Location:** Master bedroom  
**Finding:** General expansion cracking in internal corner  
Typical for VJ wall panelling

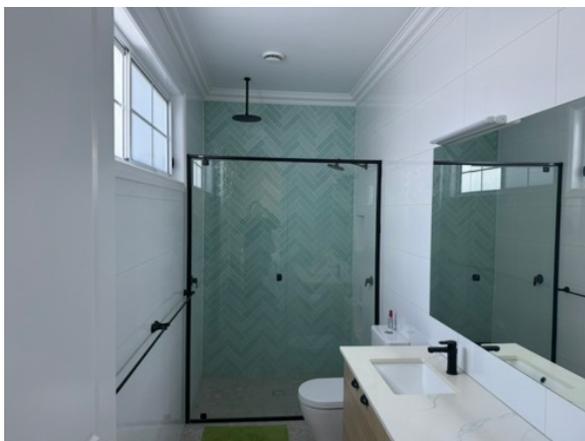
### For your information 2.06

**Location:** Bathroom  
**Finding:** General Note  
Good condition

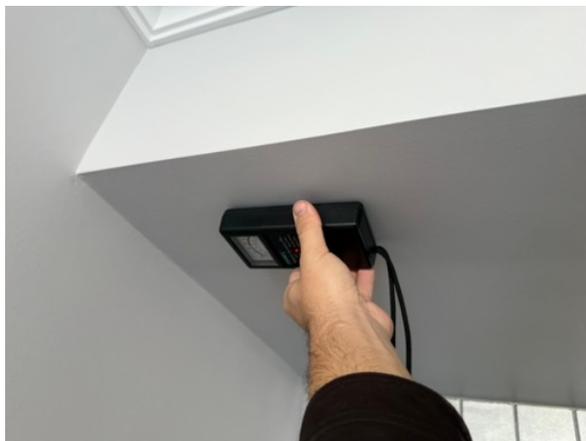
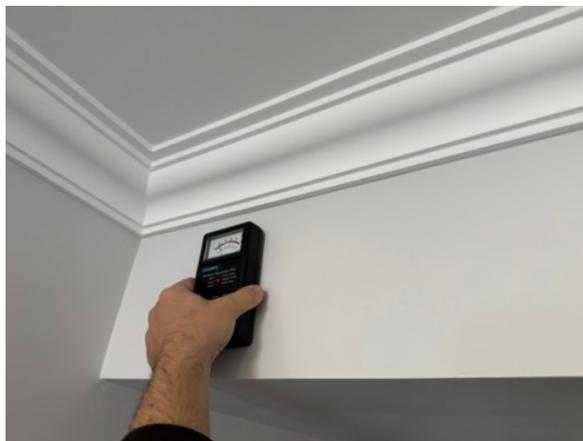
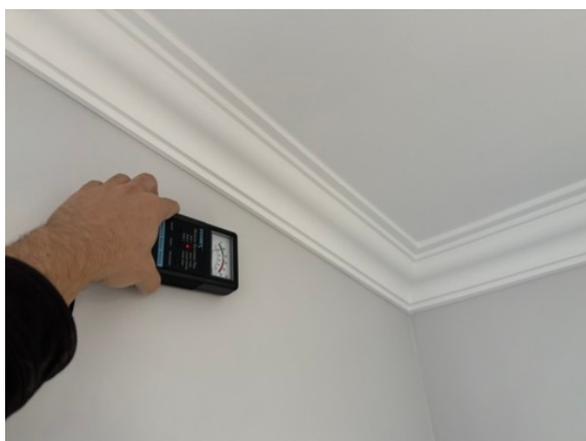
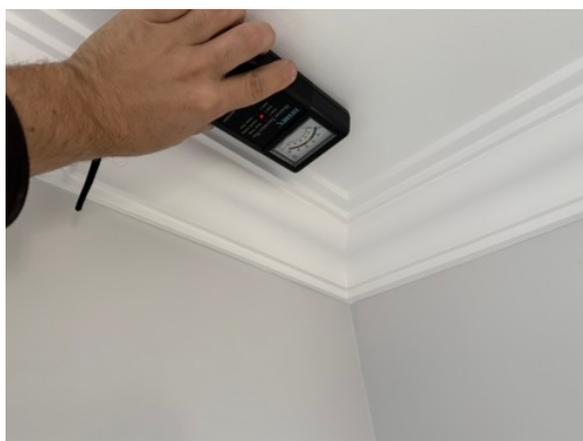
## For your information 2.07

**Location:** Ground Level

**Finding:** General note

Testing for moisture readings undertaken to ceiling areas directly under wet areas. No evidence of water penetration

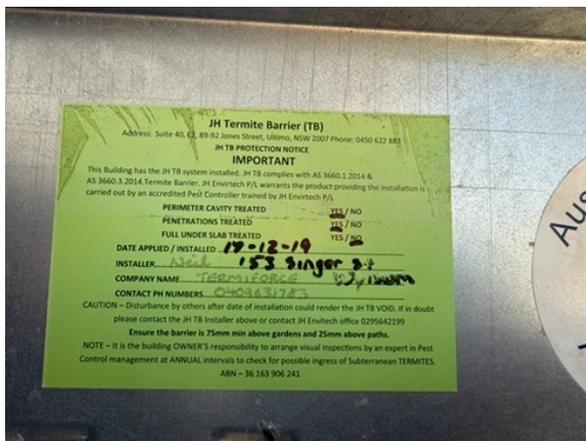
**Finding:** Termite - Installation Certificate

Recommend undertaking annual inspections to maintain warranty
