VISUAL BUILDING & PEST INSPECTION REPORT

Complies with Australian Standard 4349.1 & 4349.6

**Inspected Property:
53 Haigh Avenue Belrose**

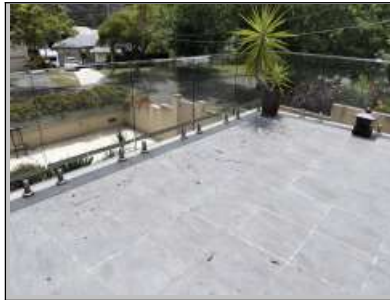
Front elevation.

The general condition of this structure is fair.

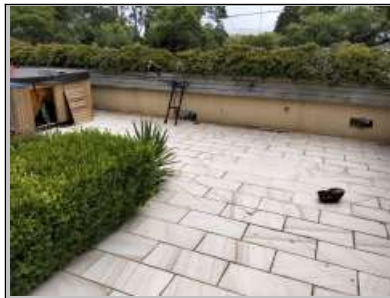
Front elevation.

Constructed from concrete or masonry. The general condition of this structure is fair.

The drummy, loose floor tiles require repair.

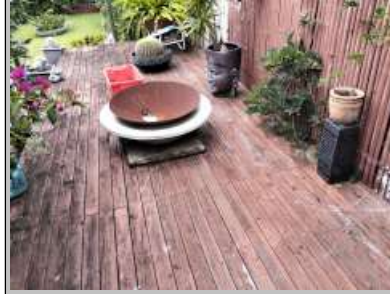
Rear elevation.

Where an external structure is constructed from timber or has significant timber components, and exposed to the elements, a suitably qualified engineer should inspect the structure to determine if it is structurally sound. We cannot determine or advise what weight the structure can hold The general condition of this structure is fair.

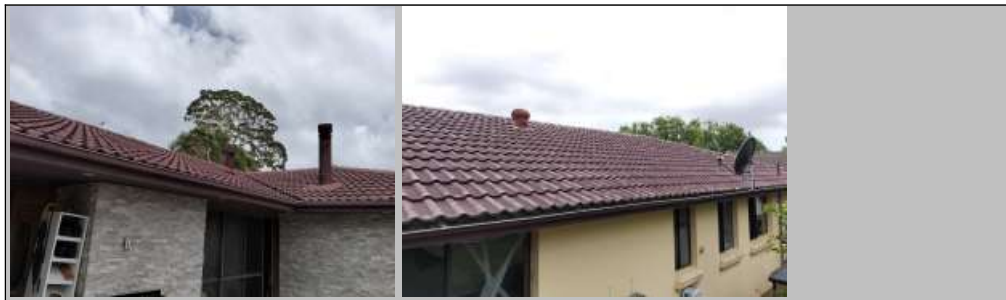
The roof is of pitched construction.

The overall condition of the roof coverings is fair.

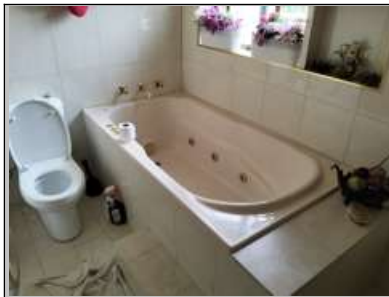
Adjacent to hall.

The shower recess was tested and there was no visible water penetration to surrounding areas. **IMPORTANT NOTE:** This test may not reveal water leaks until the shower is put into constant use and surrounding areas monitored over a period of time. A spa bath is present however, due to the requirement to fill the unit above jet level for testing the spa was not tested for adequacy or reliability. Defects may be present and not detected.

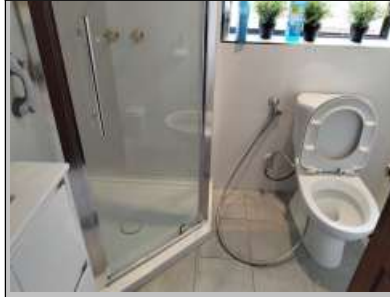
Rear.

The shower recess was tested and there was no visible water penetration to surrounding areas. IMPORTANT NOTE: This test may not reveal water leaks until the shower is put into constant use and surrounding areas monitored over a period of time.

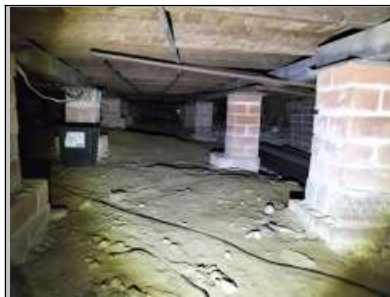
The building is constructed on a combination of strip footings, piers and concrete slab. The footings appear to be generally sound.

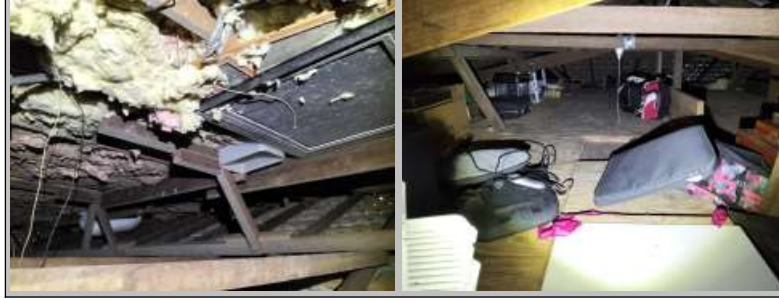
Insulation is present in the roof cavity. This restricted inspection to some roofing timbers. Removal of insulation is not within the scope of a standard visual inspection report, however as in accordance with "industry best standard" the inspector will lift insulation in 3 areas in roof void.

Lining material has been placed over some ceiling timbers for storage purposes which prevented inspection of those covered timbers.

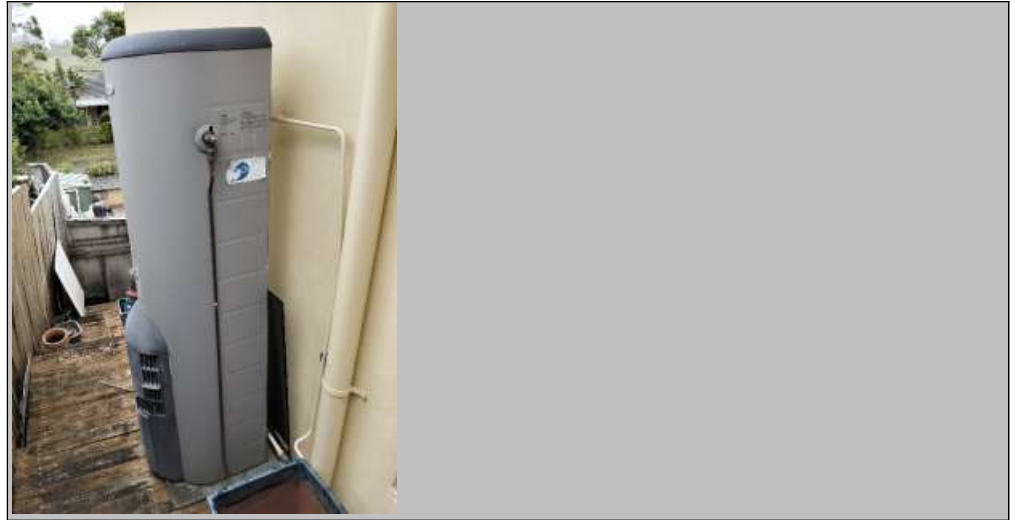
Gas hot water system: Mains pressure: Located externally: The hot water system appears to be in working condition. No specific tests other than running the hot water tap were carried out. No determination has been made as to the suitability or adequacy of the hot water system in relation to capacity or otherwise.

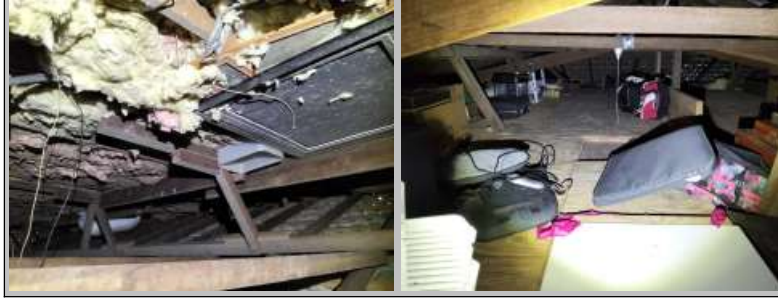
Insulation is present in the roof cavity. This restricted inspection to some roofing timbers. Removal of insulation is not within the scope of a standard visual inspection report, however as in accordance with "industry best standard" the inspector will lift insulation in 3 areas in roof void.

Lining material has been placed over some ceiling timbers for storage purposes which prevented inspection of those covered timbers.
