# Property and Timber Pest Report

Property Address: 3 Junction St Samford Village 4520

Inspection Date: 10 Jul 2026

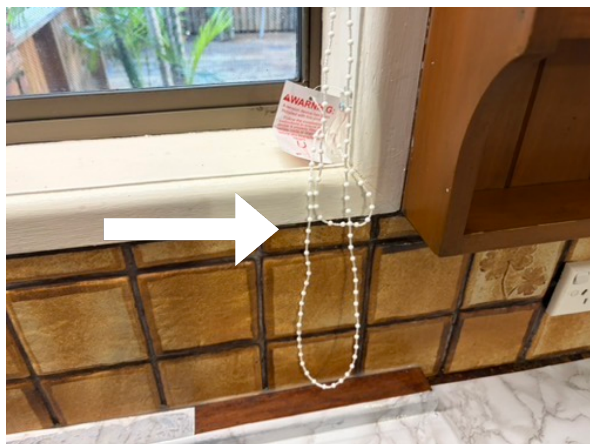
### Serious Safety Hazard 1.01

**Finding:** Curtains / Blinds - safety hook - installation

Pull chords to curtains not secured with safety hooks. Present strangulation risk

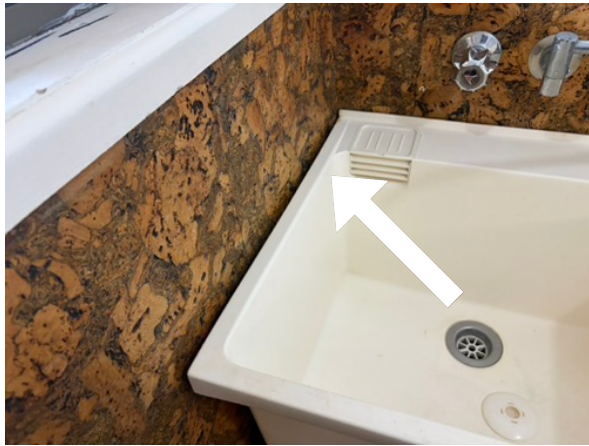
### Major Defect 2.01

**Finding:** Laundry - Splashback - not installed

Recommend installing splash back to laundry sink

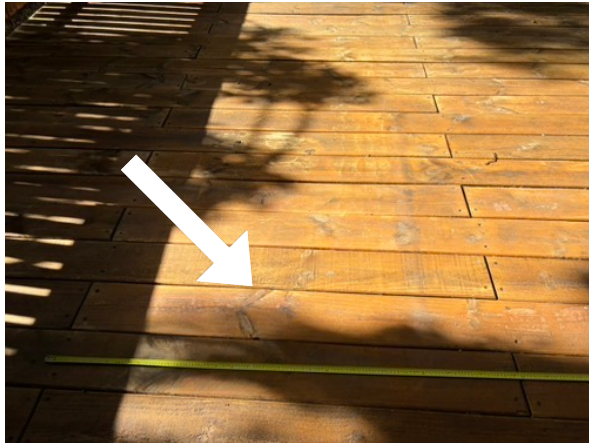
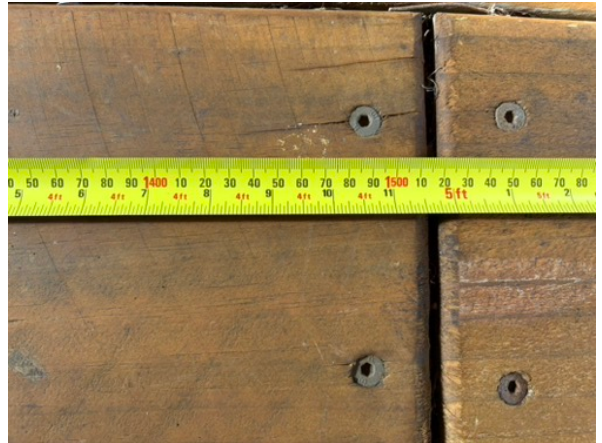
## Major Defect 2.02

**Location:** Deck - Rear

**Finding:** Deck- installation

Deck joists are spanned too far apart. Recommend engaging qualified carpenter to rectify

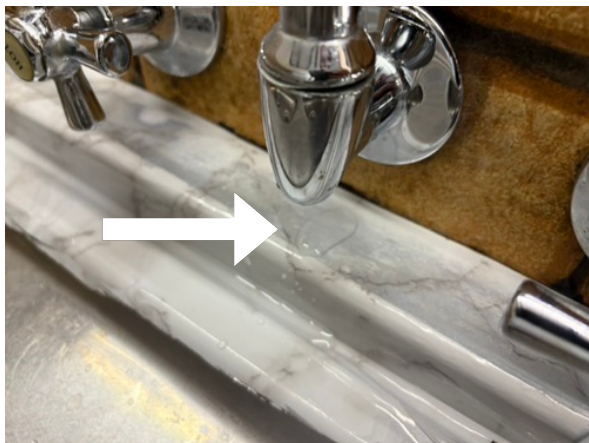
## Major Defect 2.04

**Location:** Kitchen

**Finding:** Tap - leak

Kitchen top leaks at base when in use.

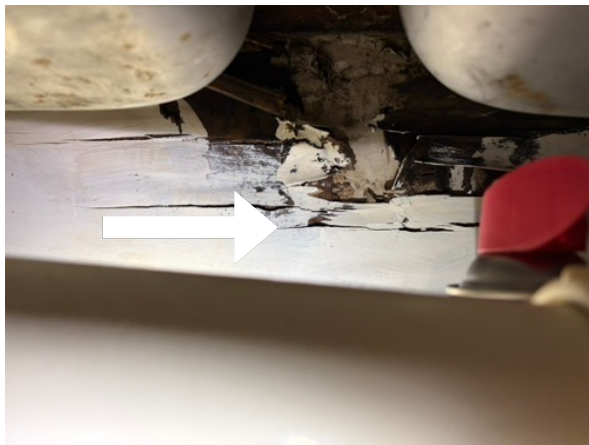
**Location:** Kitchen

**Finding:** Cabinet - rot

Kitchen cabinet is rotted due to water penetration.

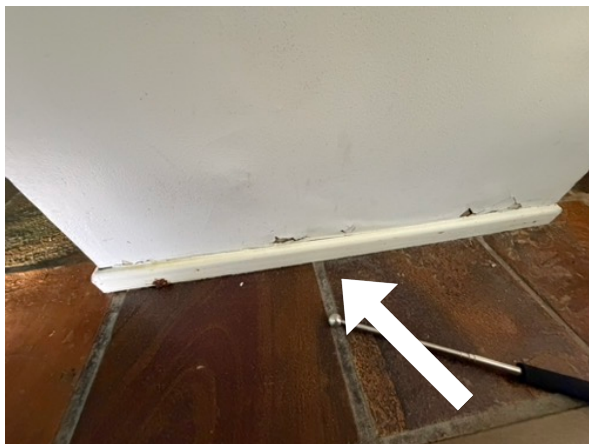
## Major Defect 2.05

**Location:** Kitchen

Wall flexes at base indicating damage / compromised wall framing

Recommend engaging qualified tradesmen to conduct invasive inspection.

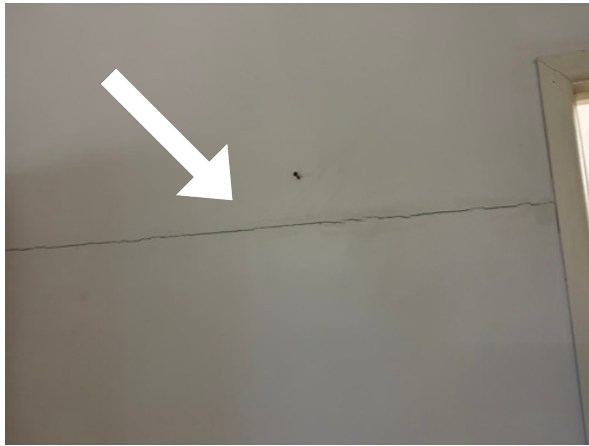
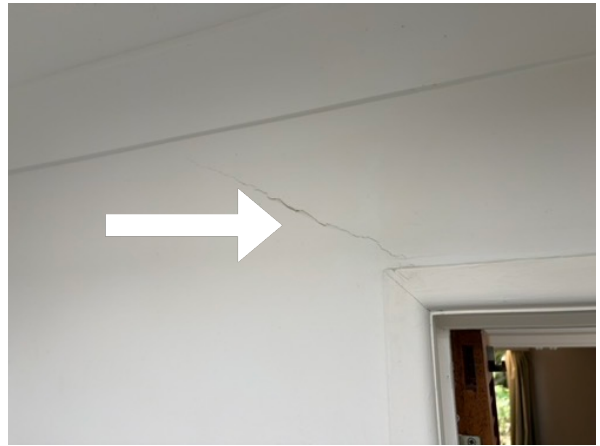
### Minor Defect 3.01

**Finding:** Wall Sheeting - Hairline Cracking

General movement cracking to wall sheeting - typical for age of dwelling

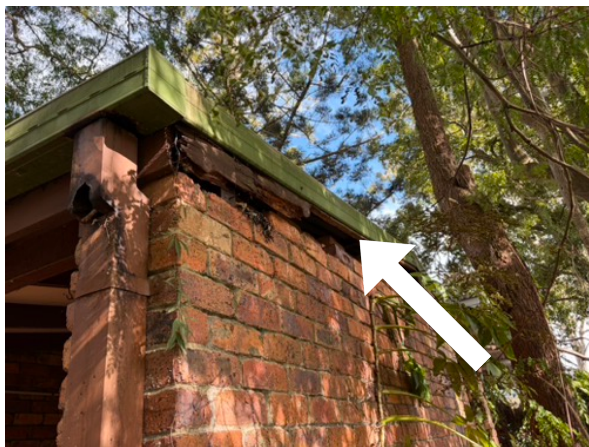
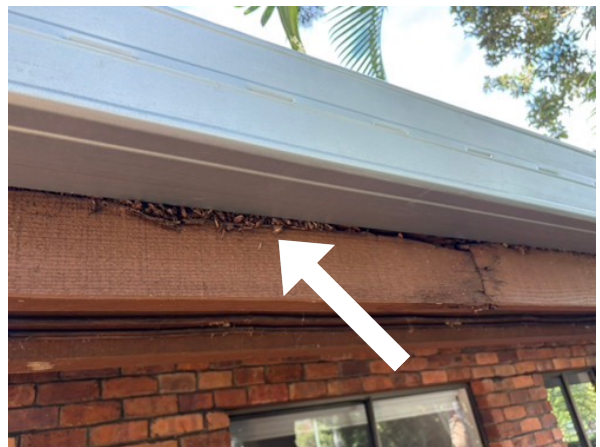
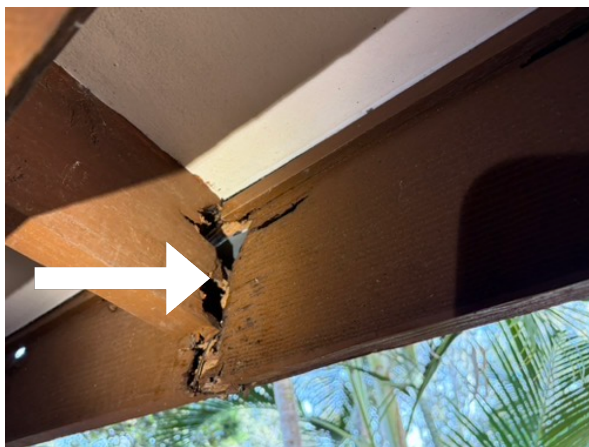
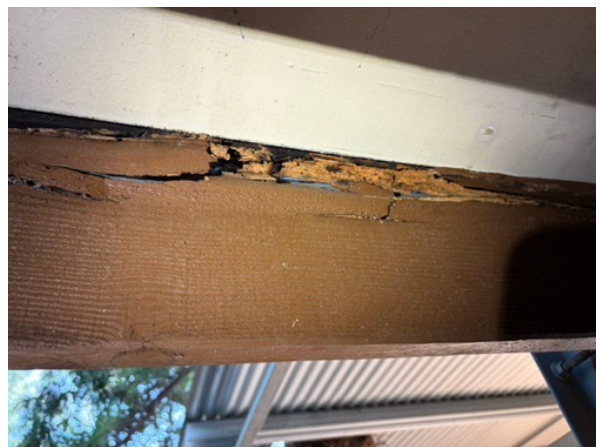
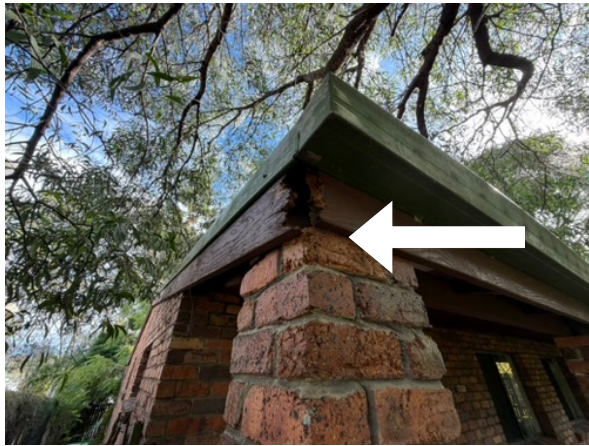
### Minor Defect 3.02

**Location:** Roof exterior

**Finding:** Roofing - Fascia - Material Deterioration

Timber fascia experiencing wood rot. Typical for age of dwelling. Recommend removal of deteriorated segments of fascia, patching and resealing.

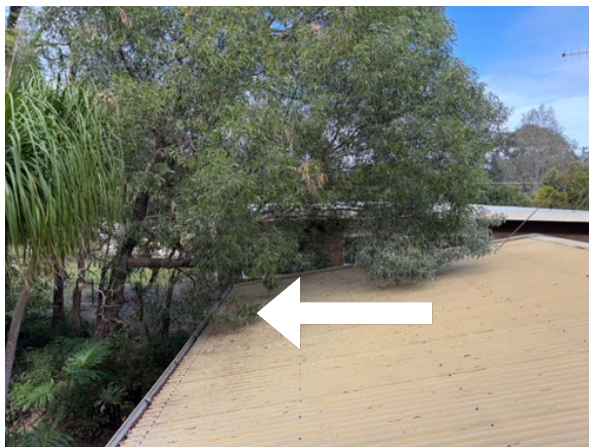
### Minor Defect 3.03

**Location:** Roof exterior

**Finding:** Roofing - Gutters - Maintenance

Eaves gutters filled with leaf litter. Require more regular maintenance / installation of gutter guard

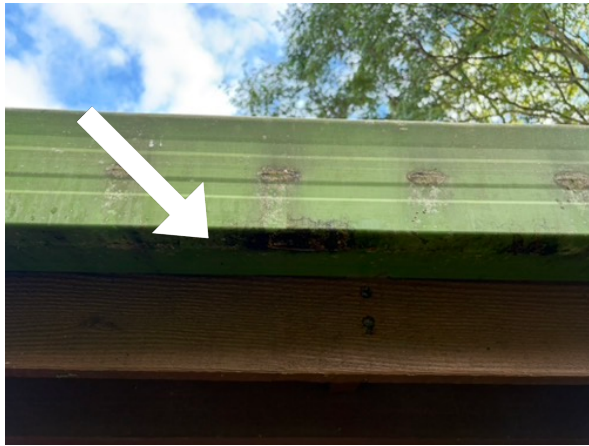
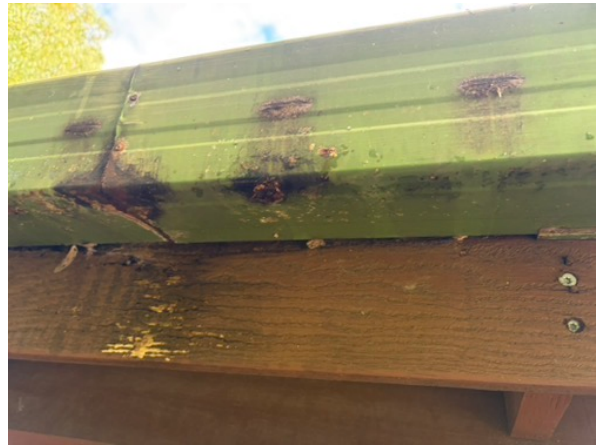
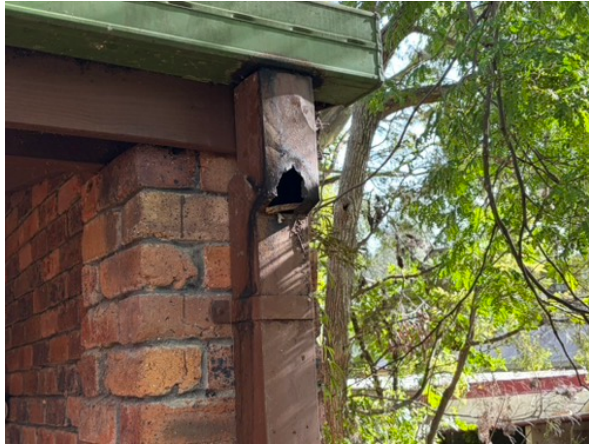
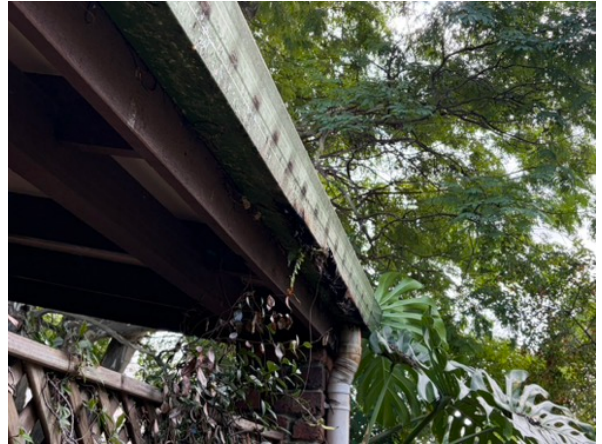
### Minor Defect 3.04

**Location:** Roof exterior

**Finding:** Roofing - Gutters - Replacement

Gutter line heavily deteriorated. Recommend replacement

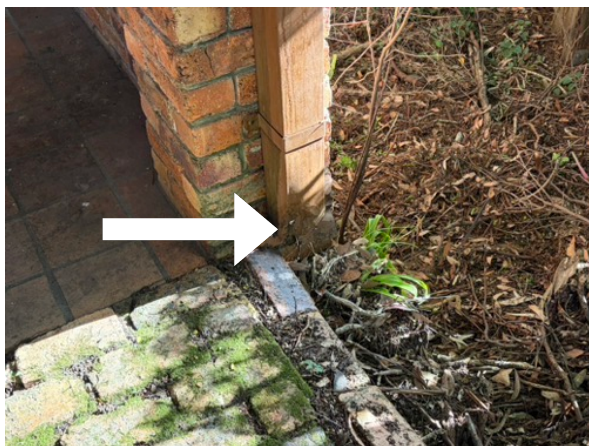
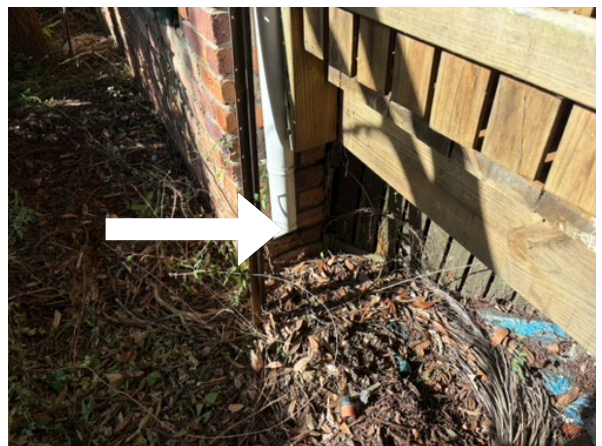
### Minor Defect 3.05

**Location:** All External Areas  
**Finding:** Downpipe- installation  
Downpipe not connected to stormwater creates overland flow of water

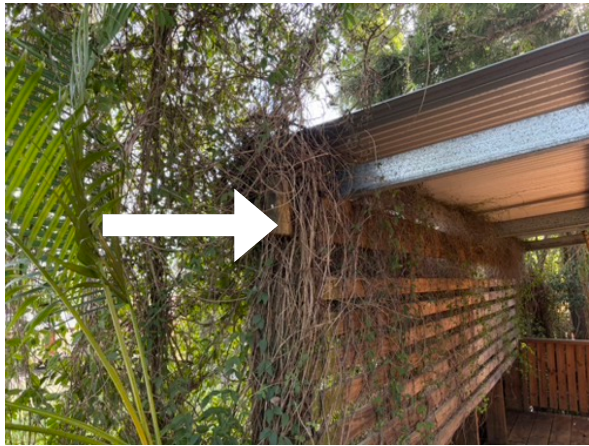
### Minor Defect 3.06

**Location:** Patio  
**Finding:** Roof - gutter  
No gutter installed to patio roof creates overland flow of water

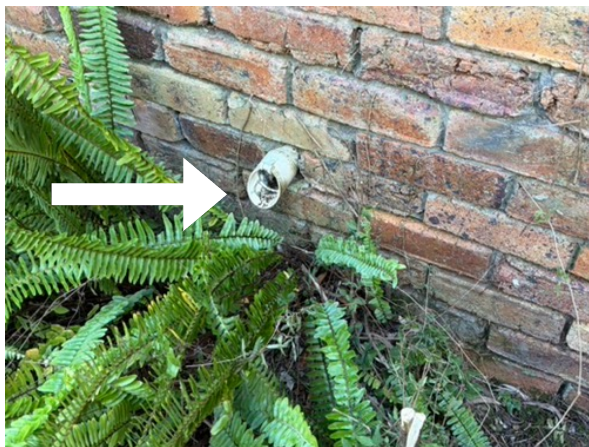
### Minor Defect 3.07

**Location:** All External Areas

**Finding:** Drainage pipe - operational

Drainage pipe missing frog's mouth lid allows possible vermin penetration. Recommend replacing.

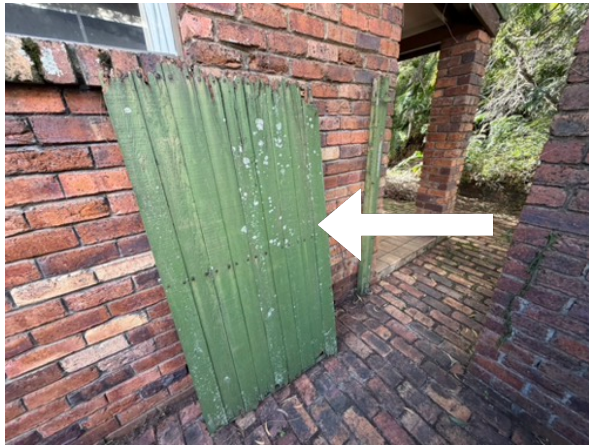
### Minor Defect 3.08

**Location:** All External Areas

**Finding:** Gate - installation

Timber Gate has detached from frame.

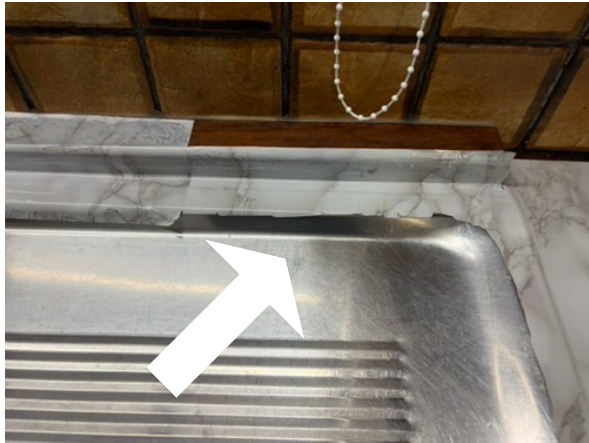
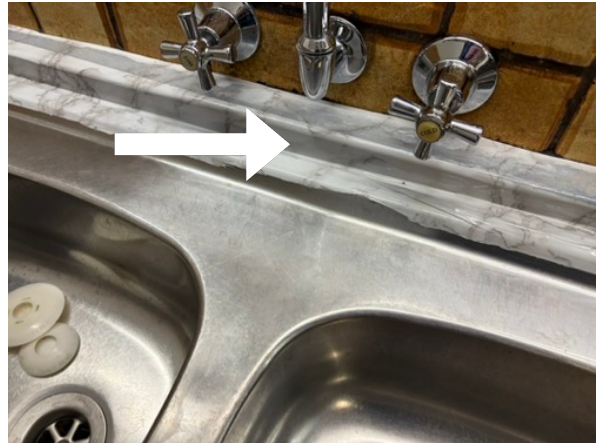
### Minor Defect 3.09

**Location:** Kitchen  
**Finding:** Bench - installation  
Poor finish to kitchen bench film installation

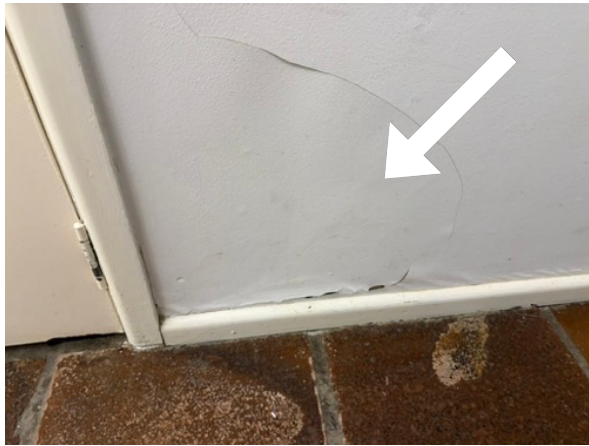
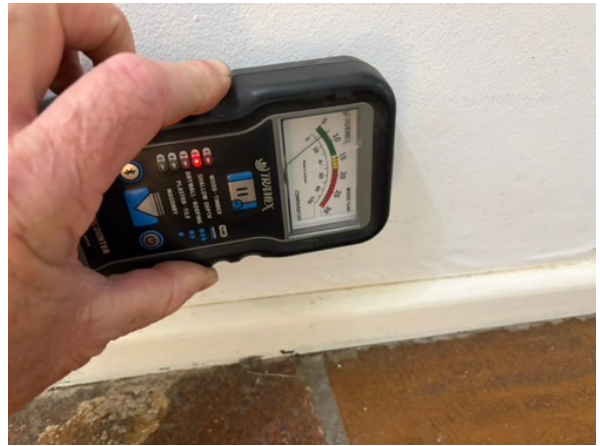
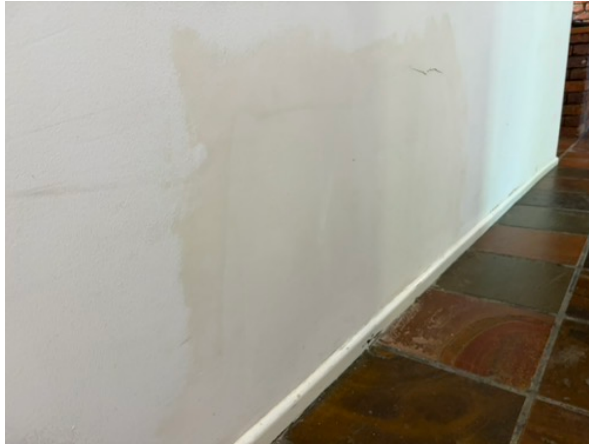
### Minor Defect 3.10

**Location:** Hallway  
**Finding:** Wall - plaster  
Poor finish to painting and plaster at base of wall in hallway. No moisture detected at time of inspection.

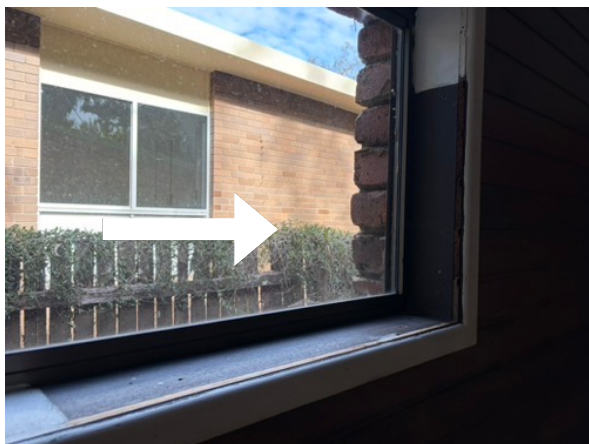
### Minor Defect 3.11

**Location:** Master bedroom

**Finding:** Window - paint

Poor paint finished the window frame in master bedroom

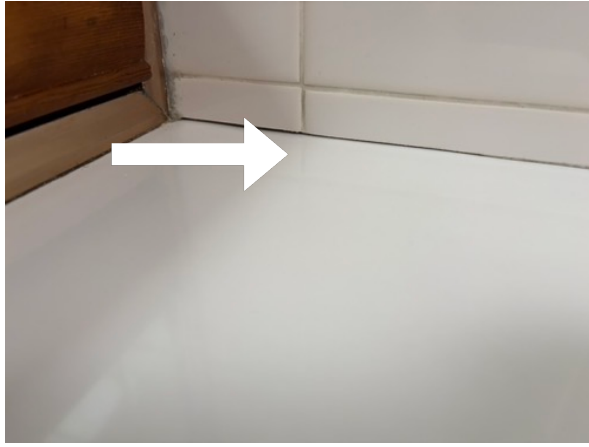
### Minor Defect 3.12

**Location:** Ensuite

**Finding:** Bathroom - splashback

Silicone seal to base of splash back deteriorated. Risk of water entering down side of tub.  
Recommend replacing deteriorated silicone

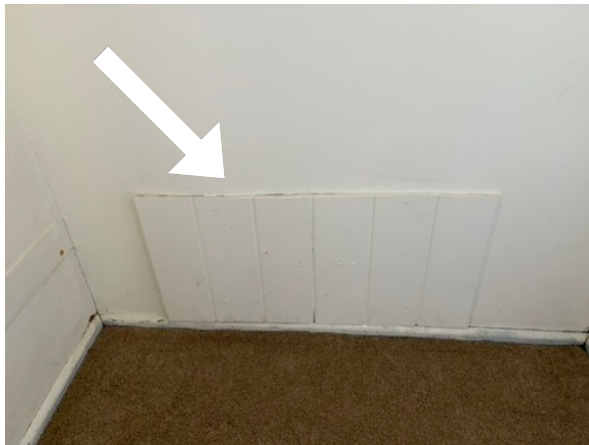
### Minor Defect 3.13

**Location:** Master bedroom

**Finding:** Wall - patch  
Poor patch to wall at base on opposite side of shower

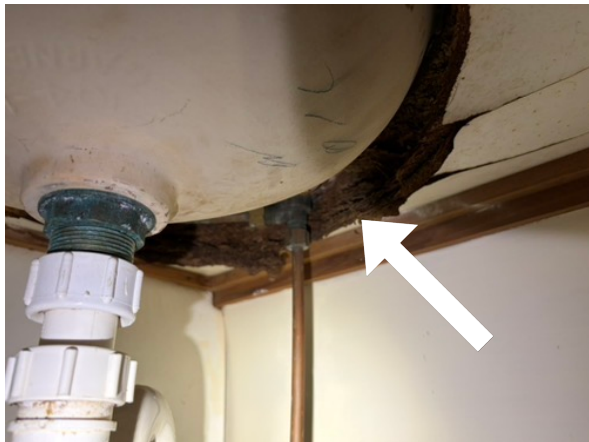
### Minor Defect 3.14

**Location:** Bathroom

**Finding:** Vanity - damage  
Base of vanity top has significant deterioration

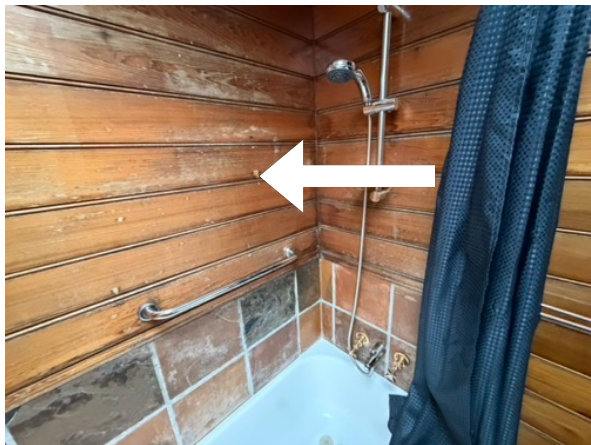
### Minor Defect 3.15

**Location:** Bathroom

**Finding:** Shower - damage  
Poor finish to timber wall panel due to water exposure

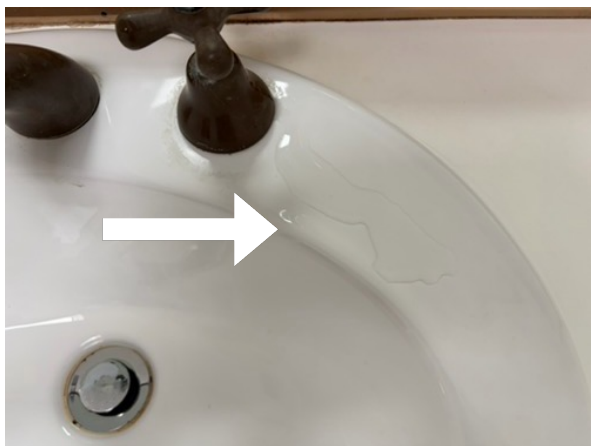
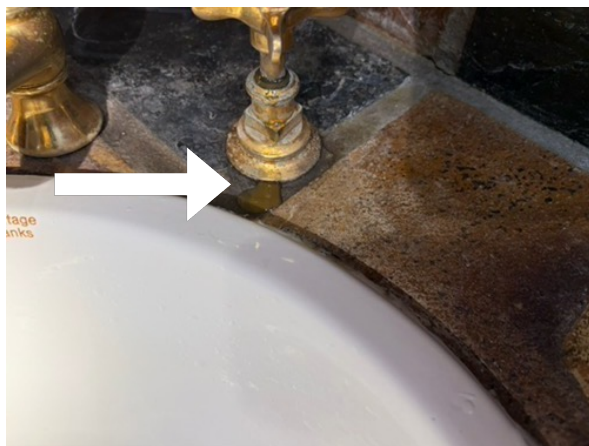
### Minor Defect 3.16

**Location:** Bathrooms

**Finding:** Tap - leak  
Bathroom taps leak at base when in use.

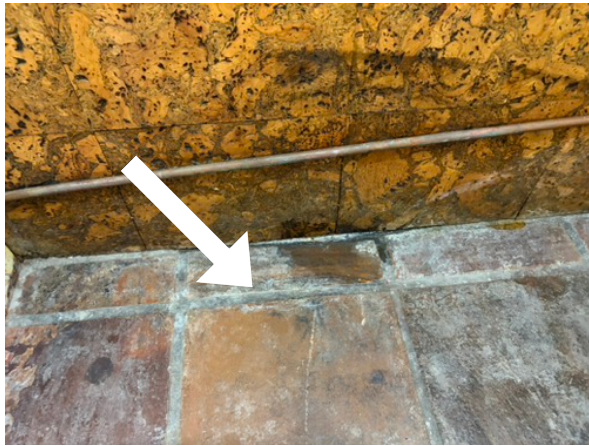
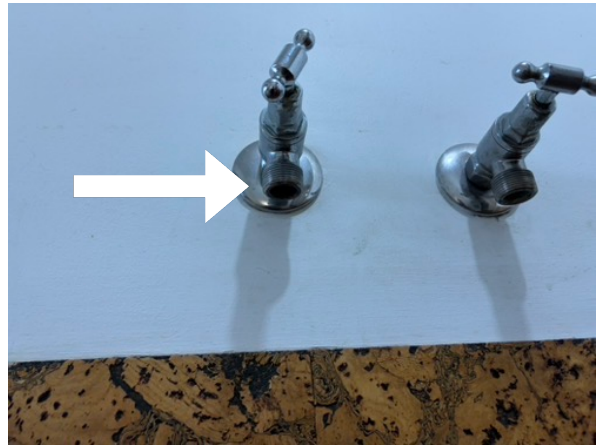
### Minor Defect 3.17

**Location:** Laundry

**Finding:** Tap - leak  
Laundry tap has a leak . Recommend engaging qualified plumber to rectify

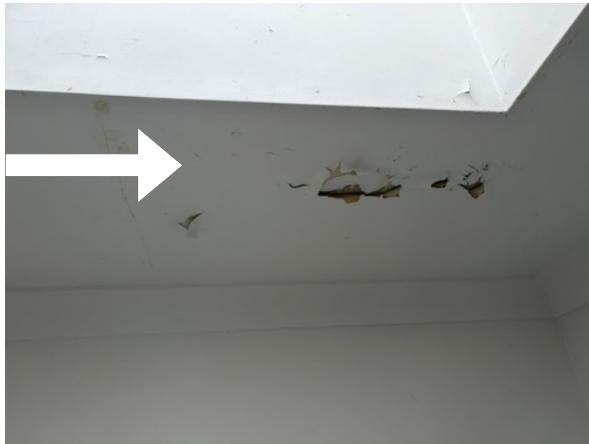
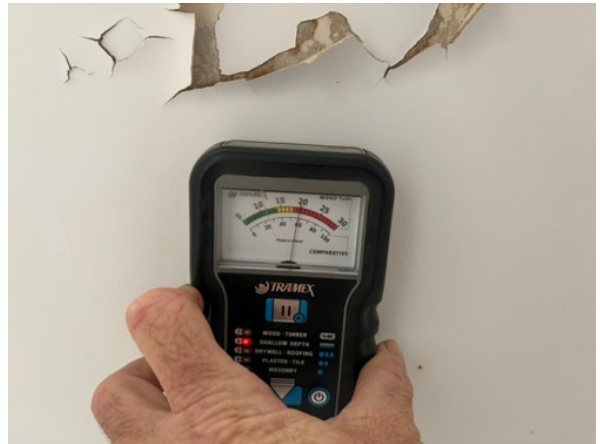
### Minor Defect 3.18

**Location:** Ensuite

**Finding:** Bathroom - Ceiling - Water Staining

Evidence of previous water damage to ceiling. No evidence of active leaks at time of inspection. High level moisture detected at time of inspection. Possibly incidental from shower use and high humidity from shower

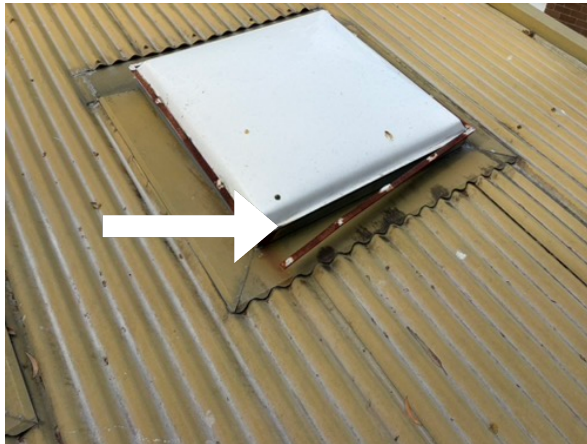
**Location:** Roof exterior

**Finding:** Skylight  
Recommend touch up to seals around skylights

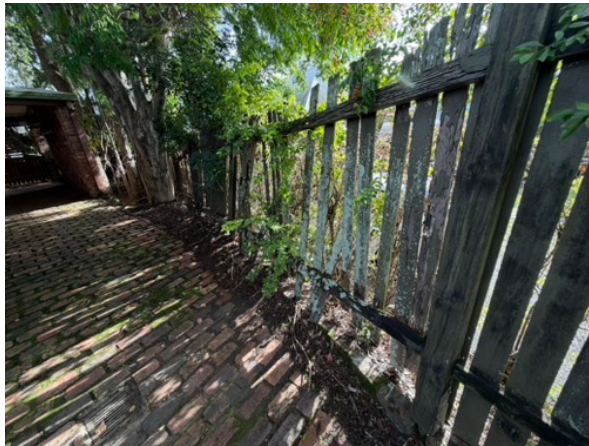
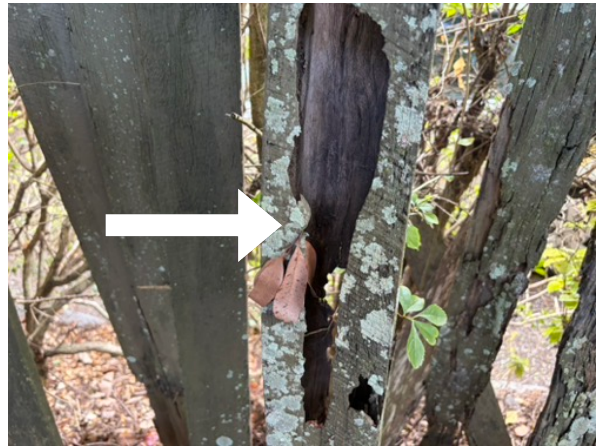
#### Timber pest attack 5.01

**Location:** The site  
**Finding:** Fencing - Termite Damage  
 Evidence of previous termite damage

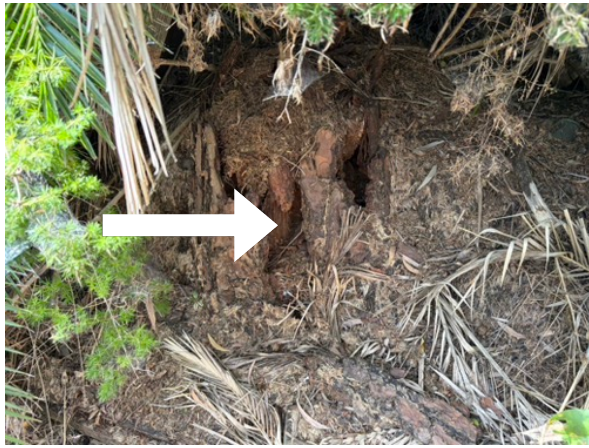
#### Timber pest attack 5.02

**Location:** The site  
**Finding:** Termite Damage - Tree Stumps  
 Evidence of previous termite damage. Recommend removal of decaying tree stumps

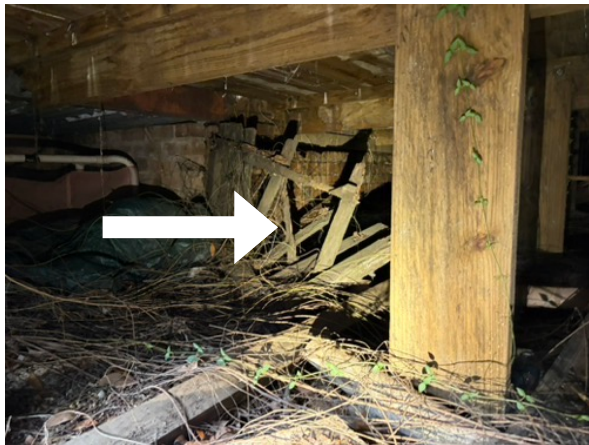
### Timber pest attack 5.03

**Location:** Deck - Rear

**Finding:** Termite - Previous Workings

Evidence of inactive termite damage and tracks . Recommend undertaking annual inspections and undertaking preventative advice outlined in this Report

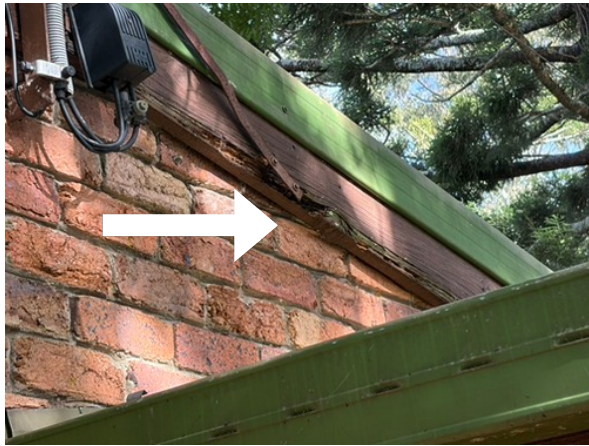
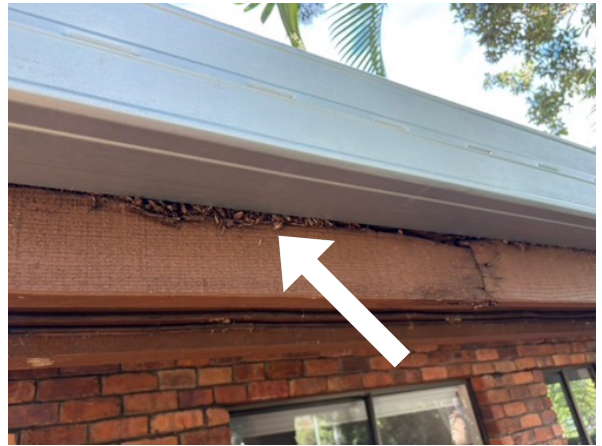
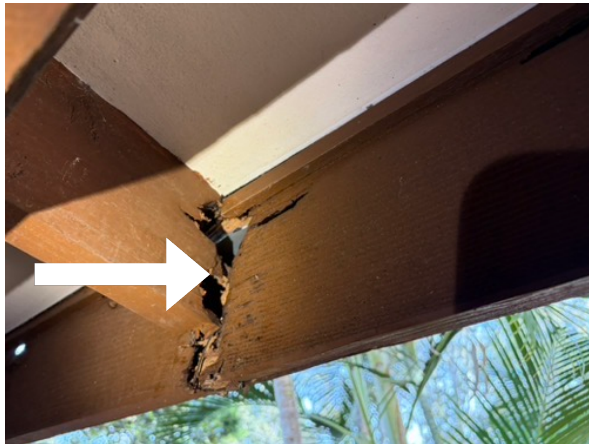
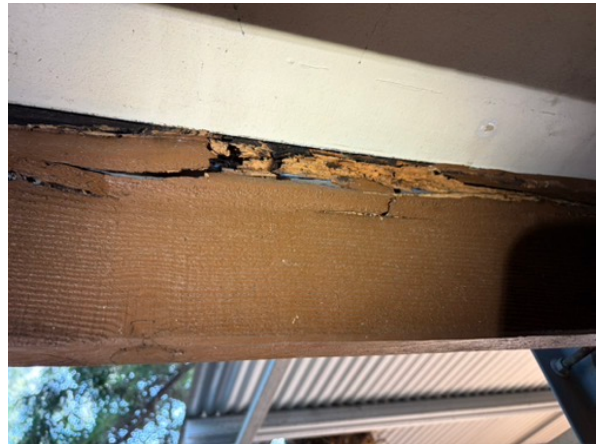
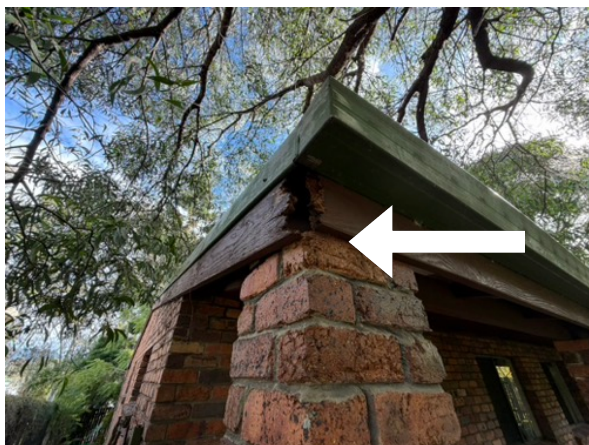
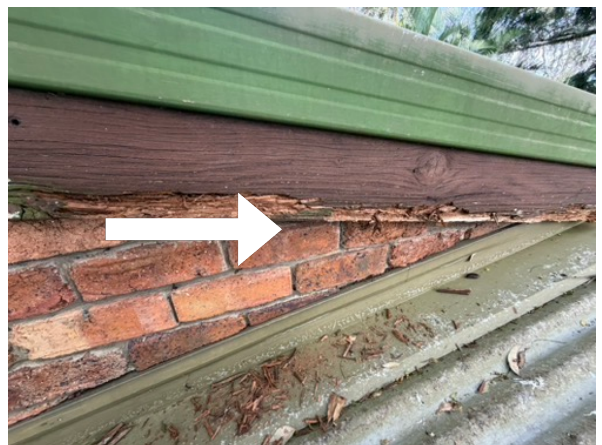
**Finding:** Roofing - Fascia - Wood Rot

Extensive wood rot to timber fascias- Refer to Building Inspection section of this Report for recommendations .

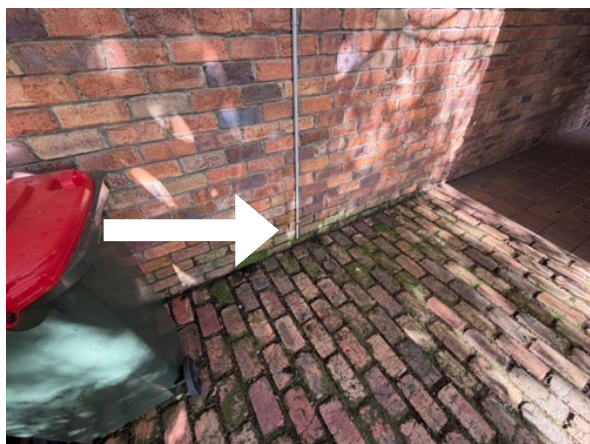
## Conditions conducive to timber pest attack 5.05

**Finding:** Termite - condensation line - installation

Condensation line venting against slab edge. Recommend extending to vent into drainage outlet.

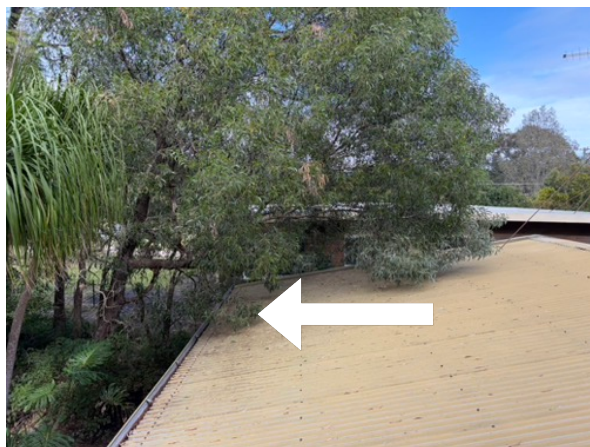
## Conditions conducive to timber pest attack 5.06

**Finding:** Termite - Vegetation- Concealed Entry

In direct contact with exterior of dwelling. Compromising visual inspection barrier. Recommend trimming back vegetation

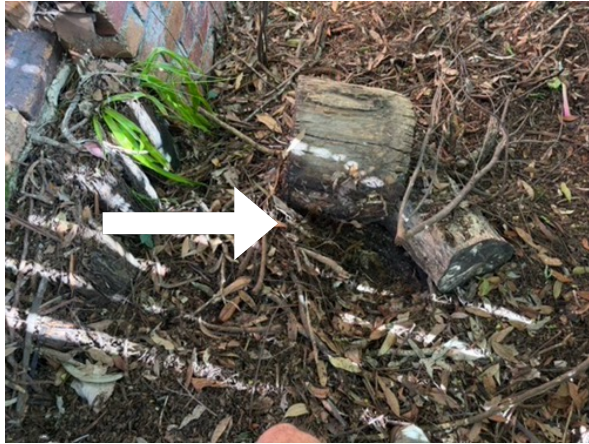
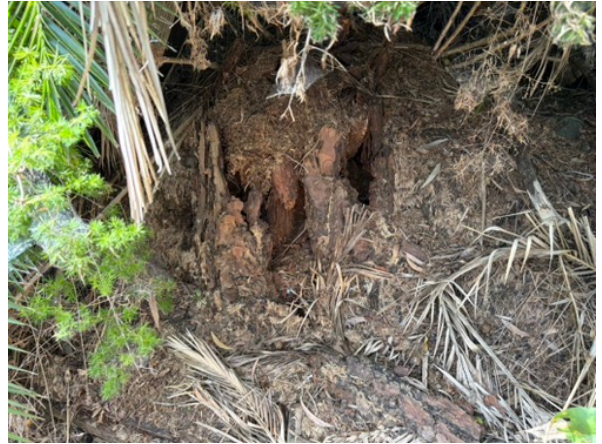
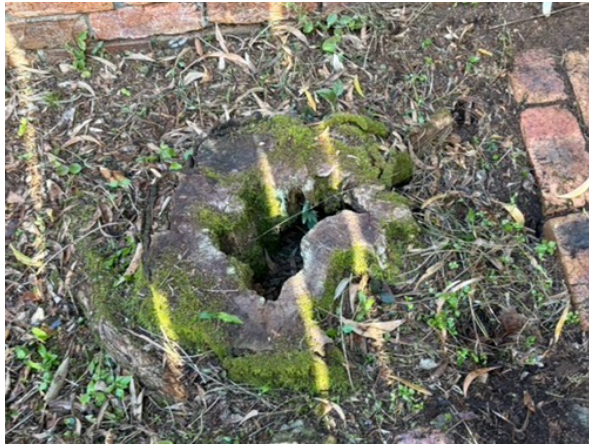
## Conditions conducive to timber pest attack 5.07

**Finding:** Tree stump/logs

Old tree stumps and logs create conducive conditions for termite activity. Recommend removing where possible.
