VISUAL BUILDING & PEST INSPECTION REPORT

Complies with Australian Standard 4349.1 & 4349.6

17 Paxton Street Frenchs Forest

16.4.26

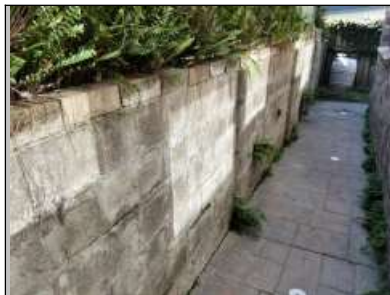
The masonry retaining walls appear in acceptable condition.

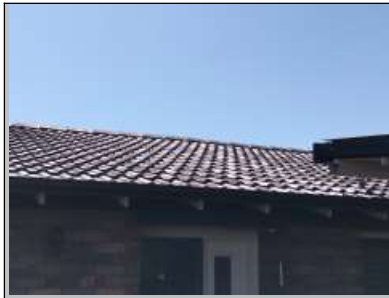
The overall condition of the roof coverings is good.

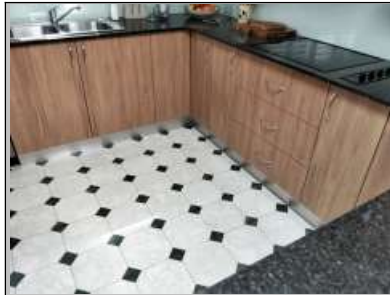
The condition of the fixtures is generally good. A glass splashback is located over the benchtop area. Glass appears to be in serviceable condition.

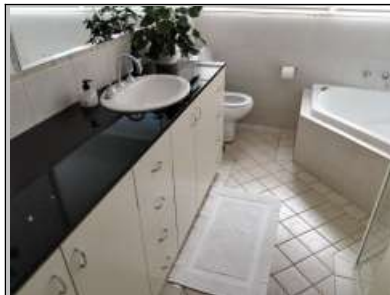
Adjacent to hall.

The shower recess was tested and there was no visible water penetration to surrounding areas. IMPORTANT NOTE: This test may not reveal water leaks until the shower is put into constant use and surrounding areas monitored over a period of time.

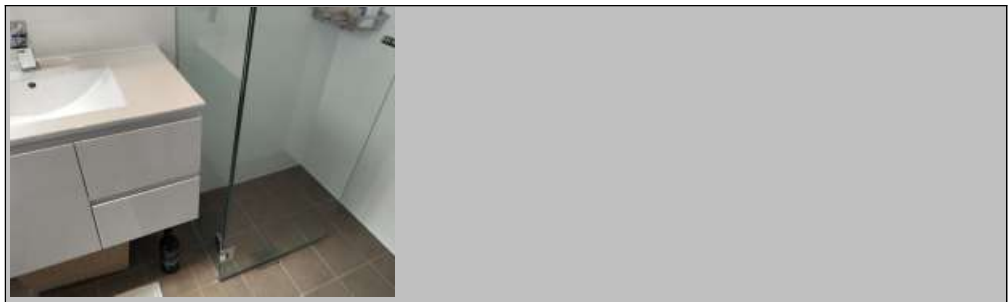
Rear.

The shower recess was tested and there was no visible water penetration to surrounding areas. IMPORTANT NOTE: This test may not reveal water leaks until the shower is put into constant use and surrounding areas monitored over a period of time.

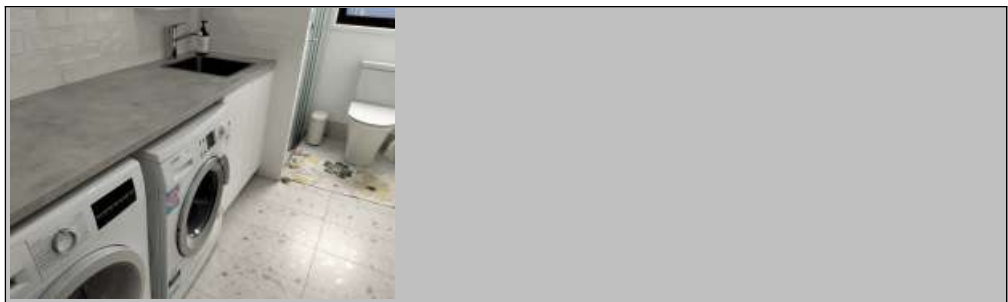
Downstairs.

The shower recess was tested and there was no visible water penetration to surrounding areas. IMPORTANT NOTE: This test may not reveal water leaks until the shower is put into constant use and surrounding areas monitored over a period of time.

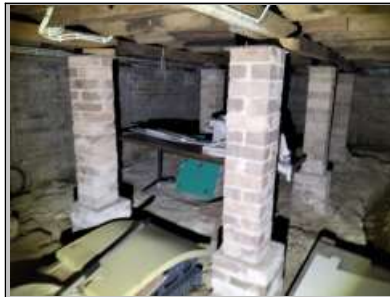
The building is constructed on a combination of strip footings and piers. The footings appear to be generally sound.

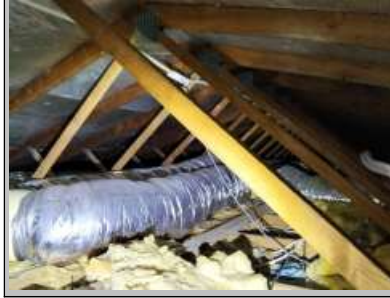
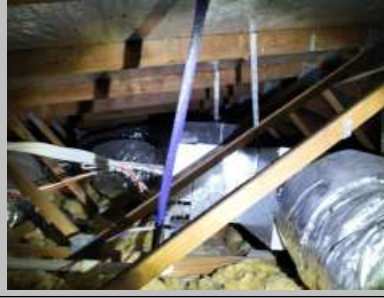
Insulation is present in the roof cavity. This restricted inspection to some roofing timbers. Removal of insulation is not within the scope of a standard visual inspection report, however as in accordance with "industry best standard" the inspector will lift insulation in 3 areas in roof void.

Ducting associated with air-conditioning or heating restricted inspection.

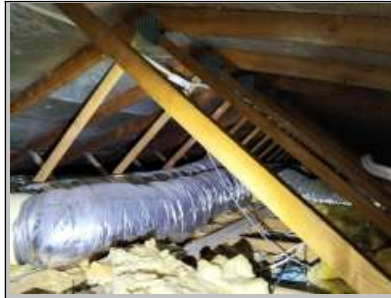
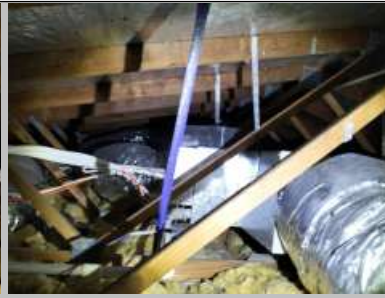
Insulation is present in the roof cavity. This restricted inspection to some roofing timbers. Removal of insulation is not within the scope of a standard visual inspection report, however as in accordance with "industry best standard" the inspector will lift insulation in 3 areas in roof void.

Ducting associated with air-conditioning or heating restricted inspection.

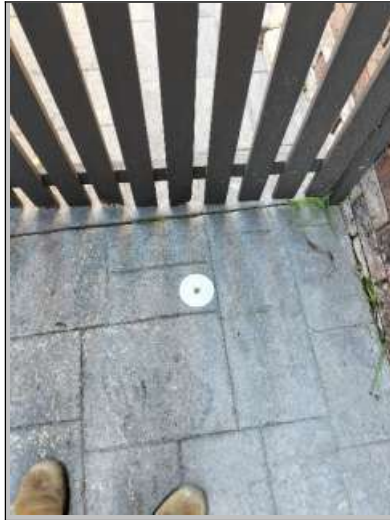
Yes - We found evidence that a termite treatment may have been carried out to this property. The following evidence was found during our inspection; We found evidence of a termite baiting system present at the property.
