# BUILDING AND TIMBER PEST INSPECTION - VR

Complies with Australian Standard AS 4349.1-2007 & AS 4349.3-2010  
Inspection of Buildings Part 1 & Part 3: Pre-Purchase  
Inspections of Residential Buildings - Appendix C

4/85 Warrimoo Drive  
Quakers Hill, NSW 2763, Australia

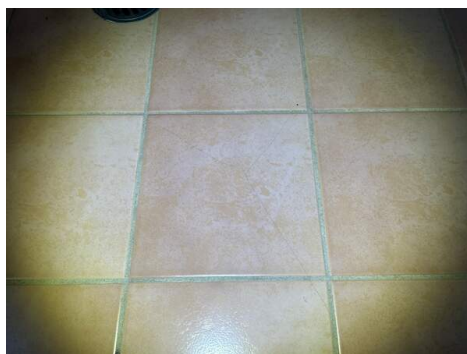
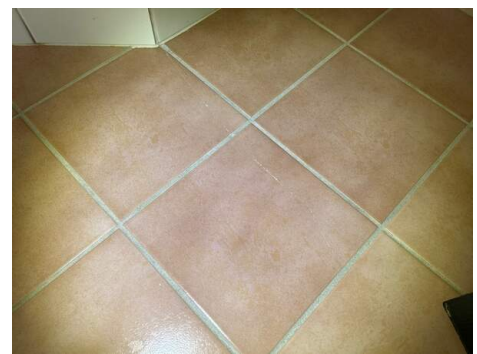
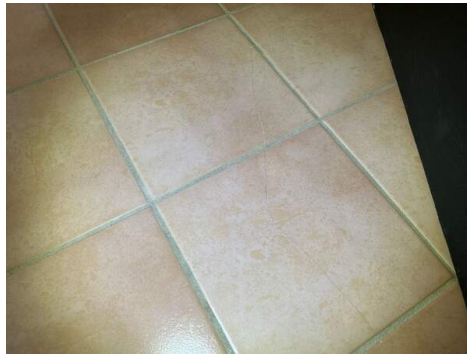
### 7.3.1 Tiles - Cracked or Damaged

Cracking was evident to the tiling in this area at the time of inspection.

While the damage appears to be minor, If left unmanaged, water penetration to surrounding areas may lead to secondary water damage, which is likely necessitate repair work to other affected building elements. A tiling contractor should be appointed to replace affected tiles as well as a leak detection specialist to ensure the area has not encountered water egress as a result.

| Defect Significance: | Minor Defect |

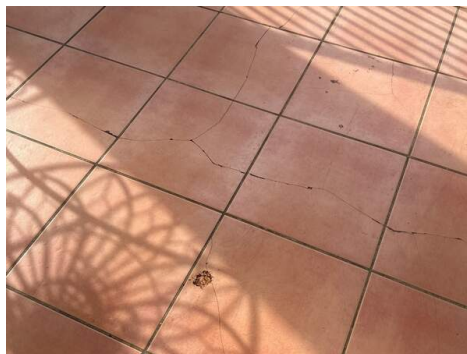
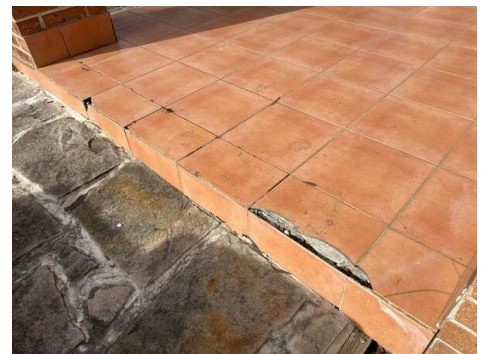
#### 7.3.2 Cracked floor tiles evident - Fine

Cracking in the floor tiles was evident in this area at the time of inspection.

Expansion and contractions in the floor foundations may have caused movement and resulted in the cracking to tiles in this area.

Cracked tiles throughout the household may detract from the overall appearance of the affected areas.

| Defect Significance: | Minor Defect |

While not considered a matter of urgency, replacement of cracked floor tiles is advised as a solution. A tiling contractor or general handyperson may be appointed to perform these works at client discretion.

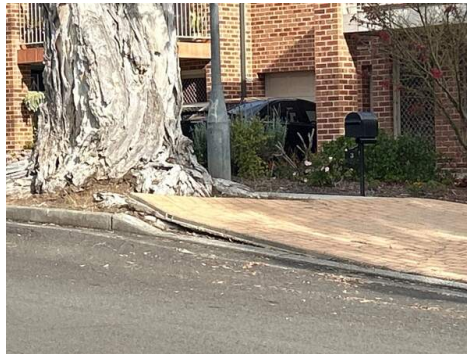
Photo Ref #6

### 7.3.3 Concrete Slab Sections - Raised or Settled

Unfinished or substandard building works are likely to degrade more quickly and may create potential for secondary defects.

| Defect Significance: | Minor Defect |

Recommended trade to be contacted: Concretor or Building Contractor

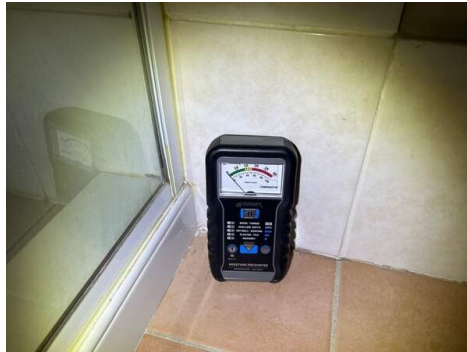
Photo Ref #7

### 7.7.2 Moisture Meter Reading: Low or Zero

Upon inspecting the wall and door frames as shown, there was no evidence or only low levels of moisture detected.

Recommended action: No immediate action required; monitor as needed.

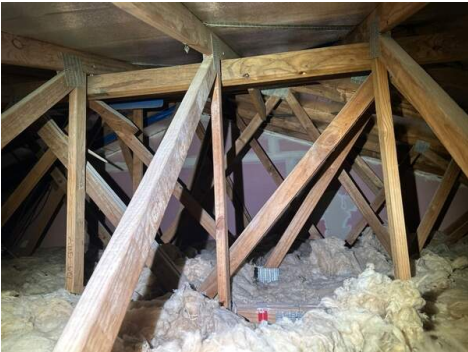
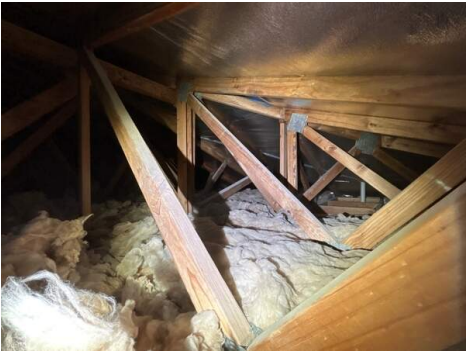
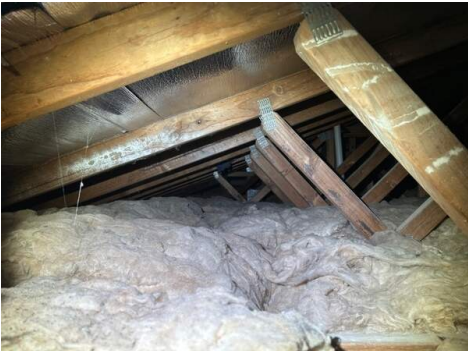
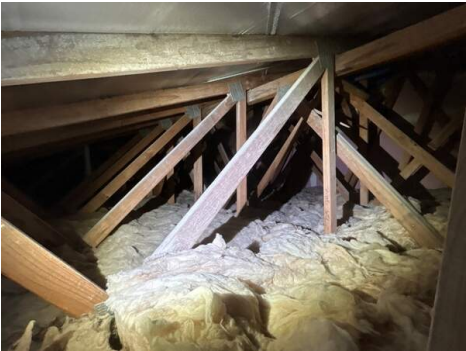
| EXPLANATIONS | <div>Building: Main Building</div> <div>Area: Roof Void</div> <div>Location: Roof Space</div> <div>Finding Significance: For Information Purposes</div> <div>Comments: Bulk Insulation and Low Clearance</div> | |

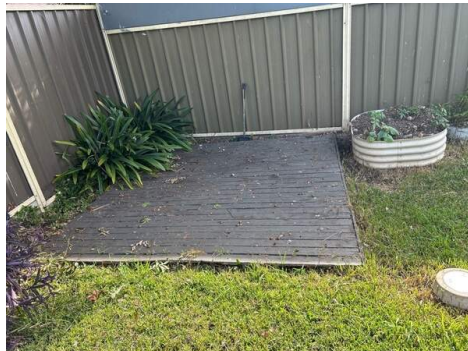
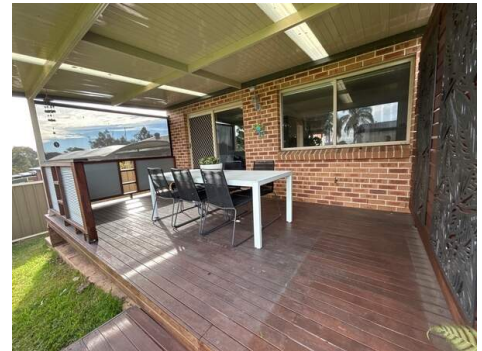
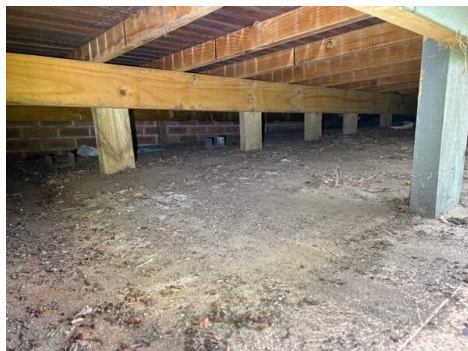
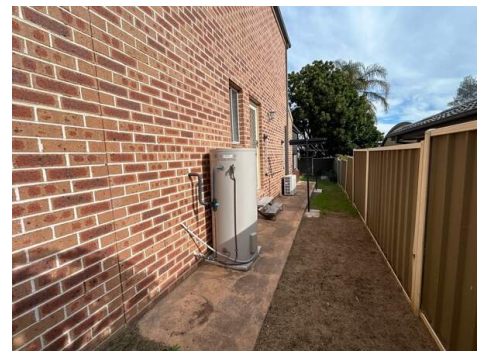
Building: Main Building  
Area: Exterior  
Location: Yard Side, Rear & Under Decking Area  
Finding Significance: For Information Purposes  
Comments: Stored Items, Services, Decking and Low Clearance
