# Inspection Report

## Certified Building Inspection Services

**32 Angophora Dr, Pokolbin, NSW, 2335**

### Pest And Building Inspection

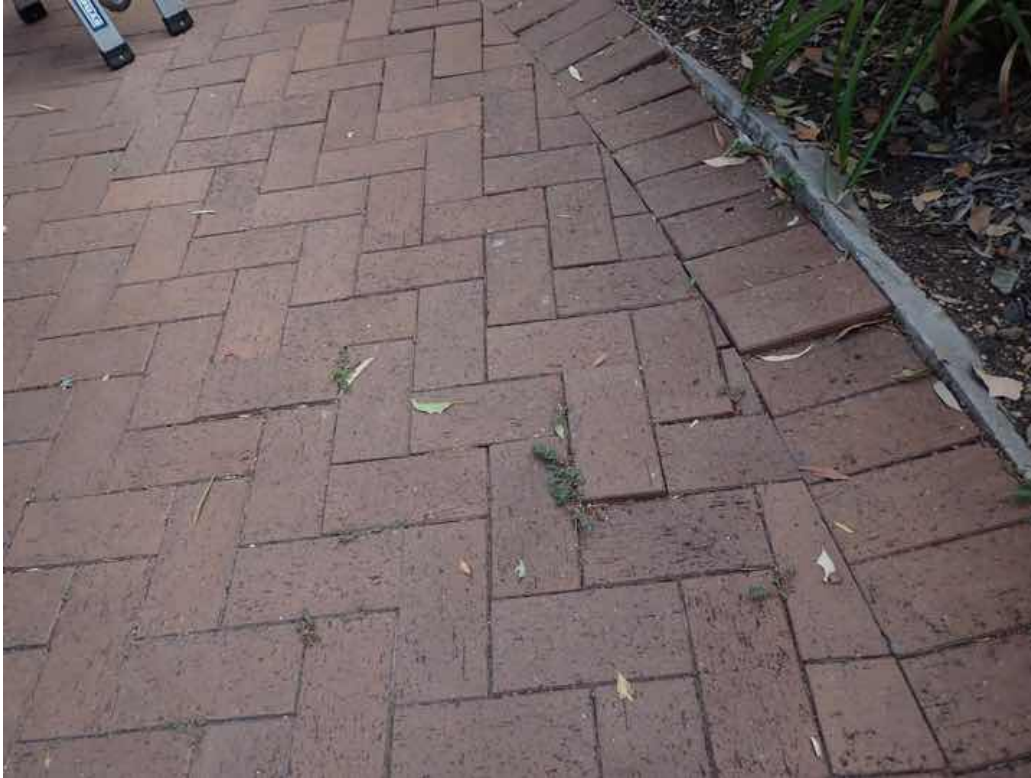
Surface raised and settled in some areas.

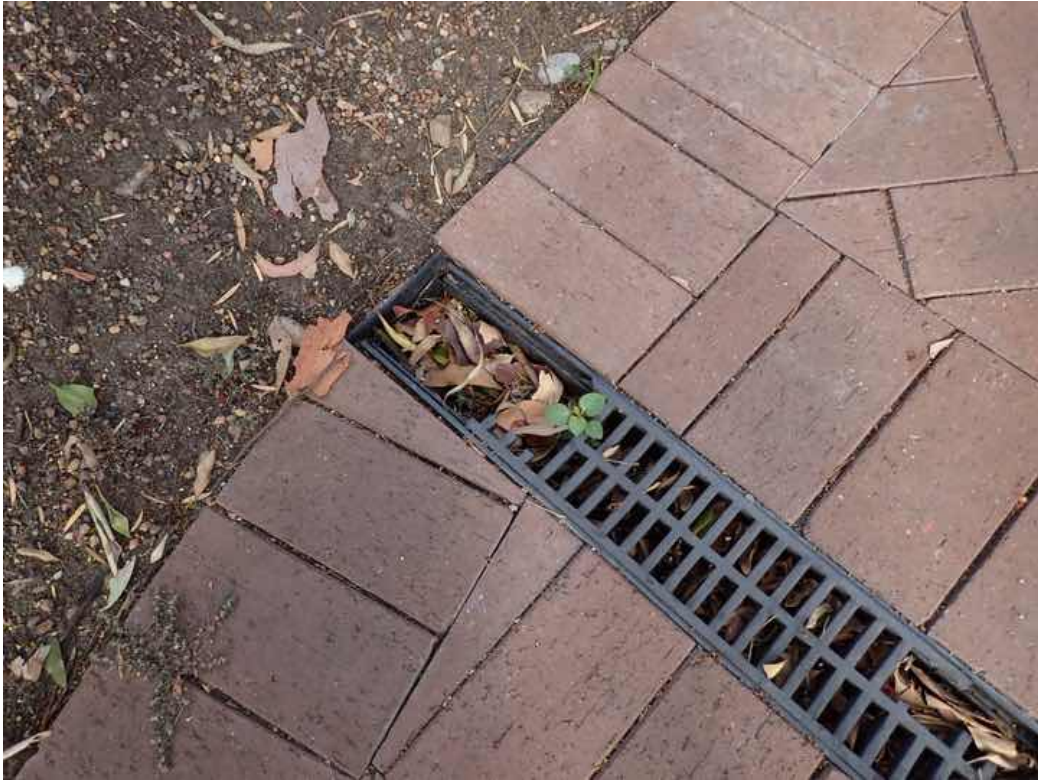
Debris evident in/around drains - Requires cleaning out.

repairs required to drain. contact a licenced plumber for repairs

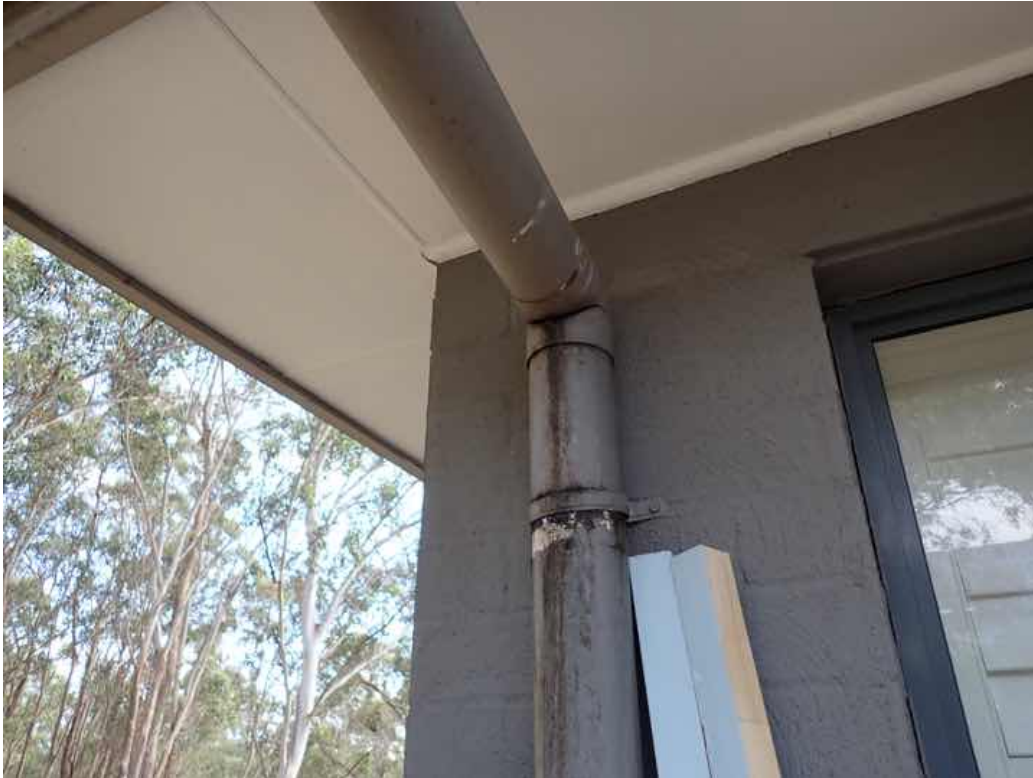
Leaking down pipe joins visible. This can be conducive to termite infestation and cause water damage to cladding over time. Recommendations: A qualified roof plumber should be engaged to repair.

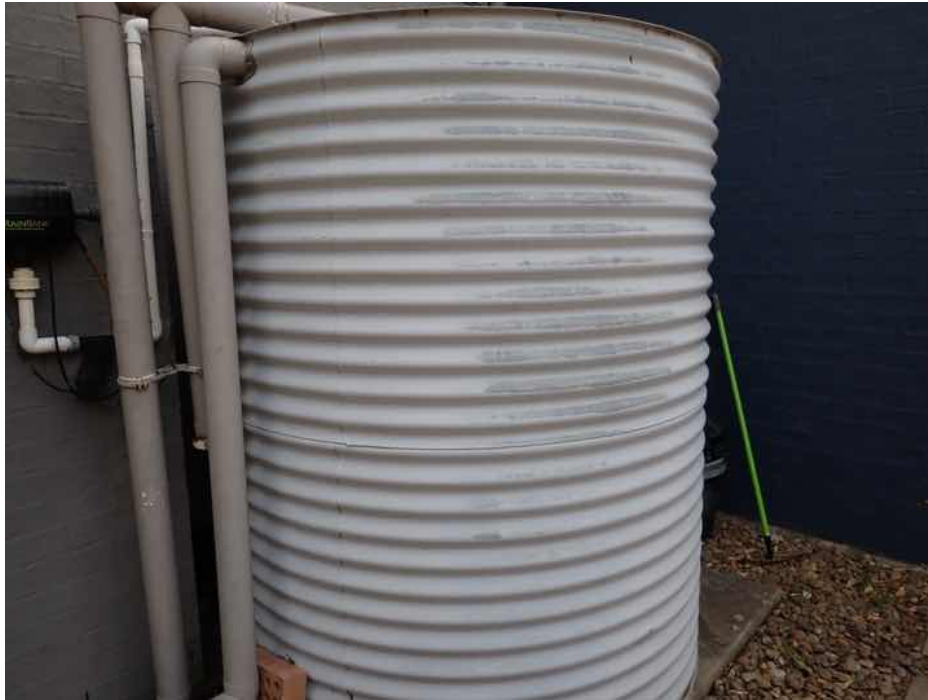
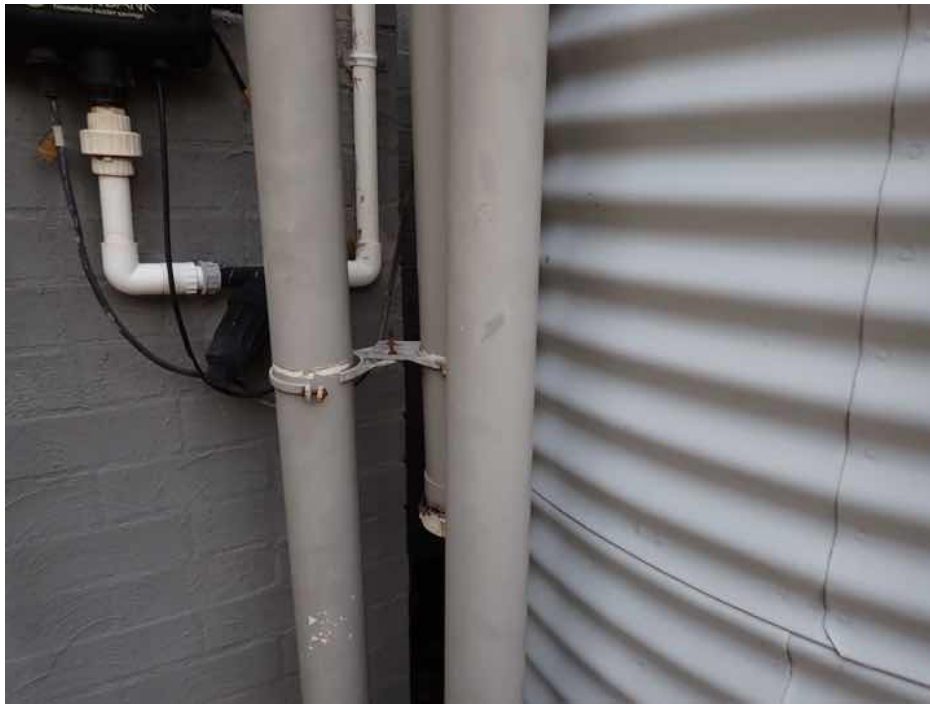
Pipe bracket broken. Recommendations: Assessment conducted by a licensed plumber advised.

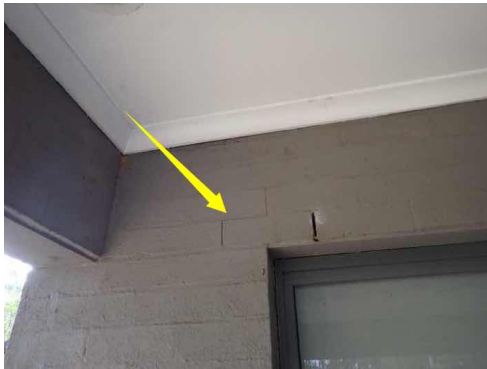
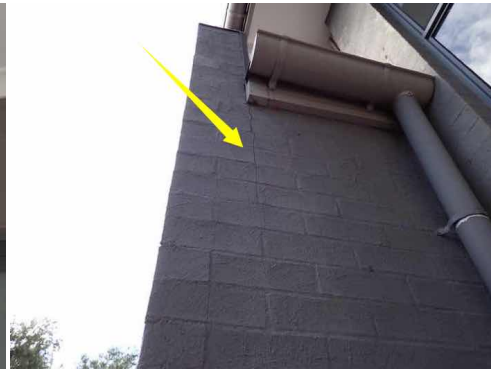
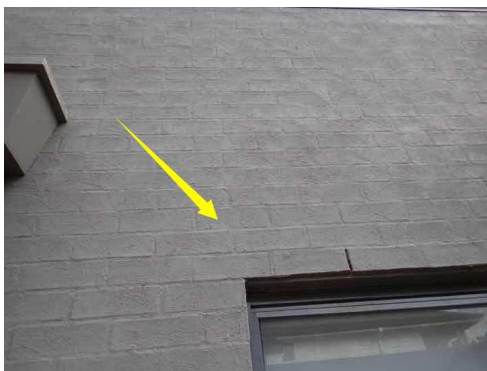
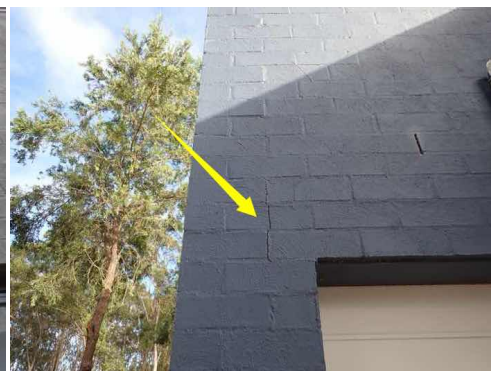
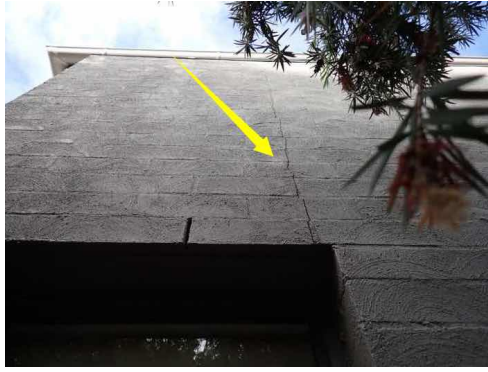
There appears to have been some settlement in the building which has caused some cracking to the walls. This can also cause some doors to bind or be out of square. In the inspectors opinion these cracks are due to settlement, usually due to ground movement and subsequent movement to building materials can be expected. Any cracks should be monitored and if cracks increase in size, further investigation should be carried out

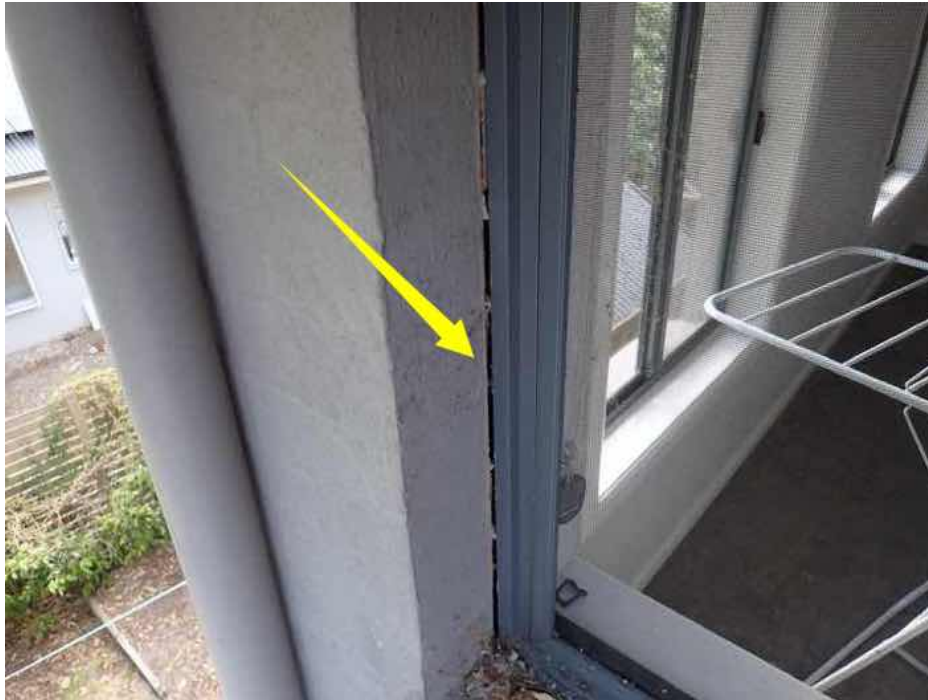
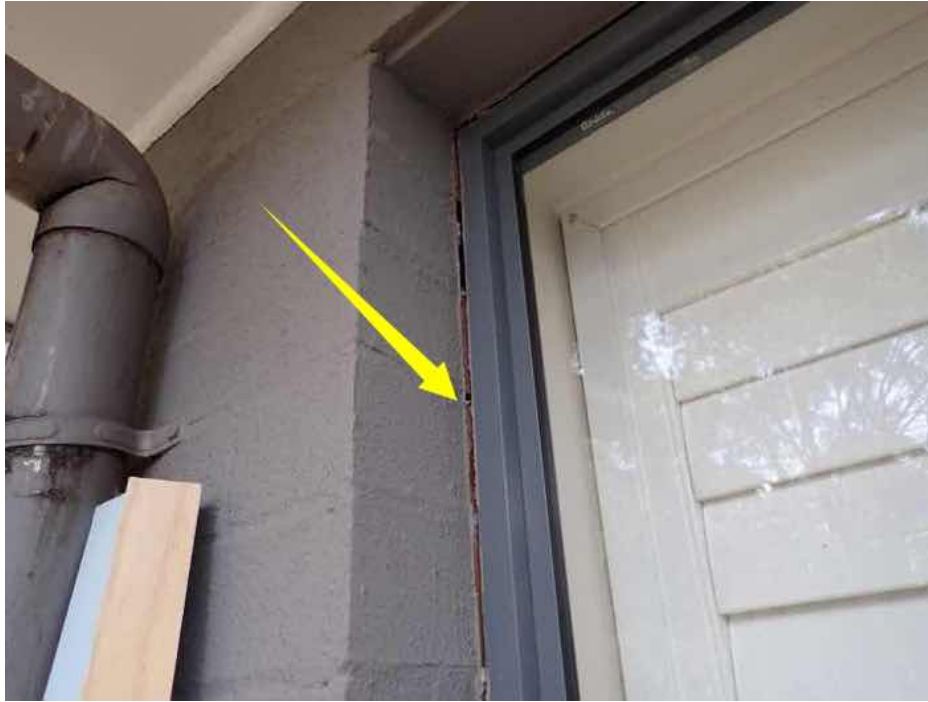
Gaps between window frame and wall evident - This can be due to poor workmanship, wall movement, footings settlement. Recommendations: sealing gaps required

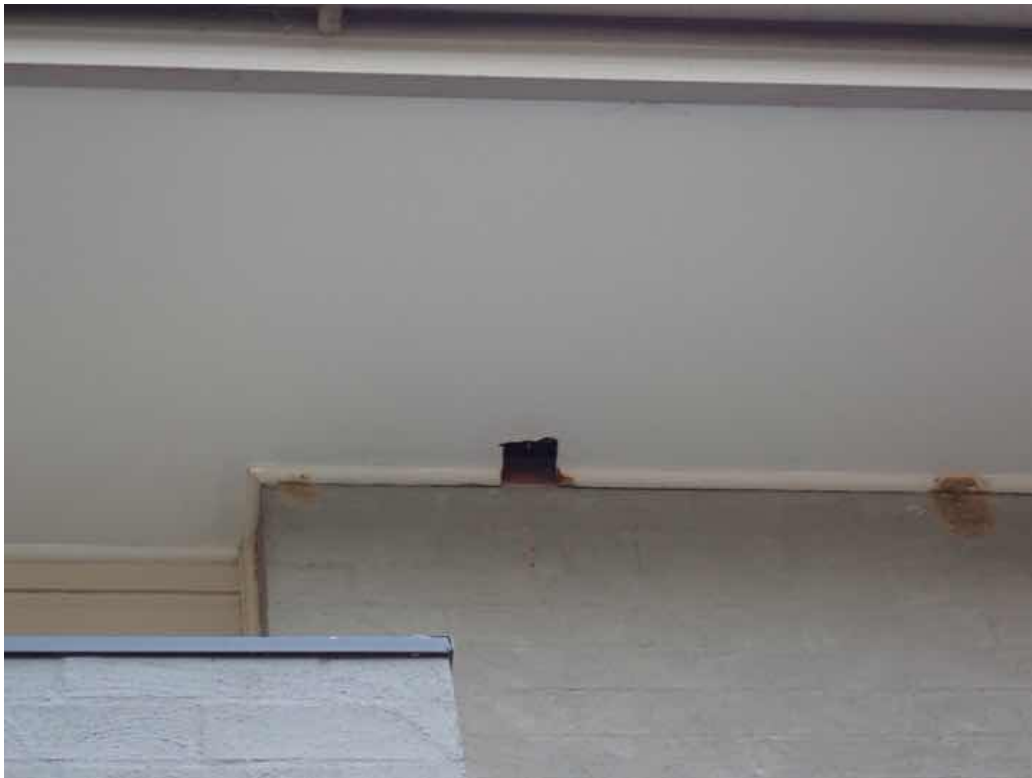
Eave lining damage visible. Recommendations: A qualified carpenter should be engaged for repairs.

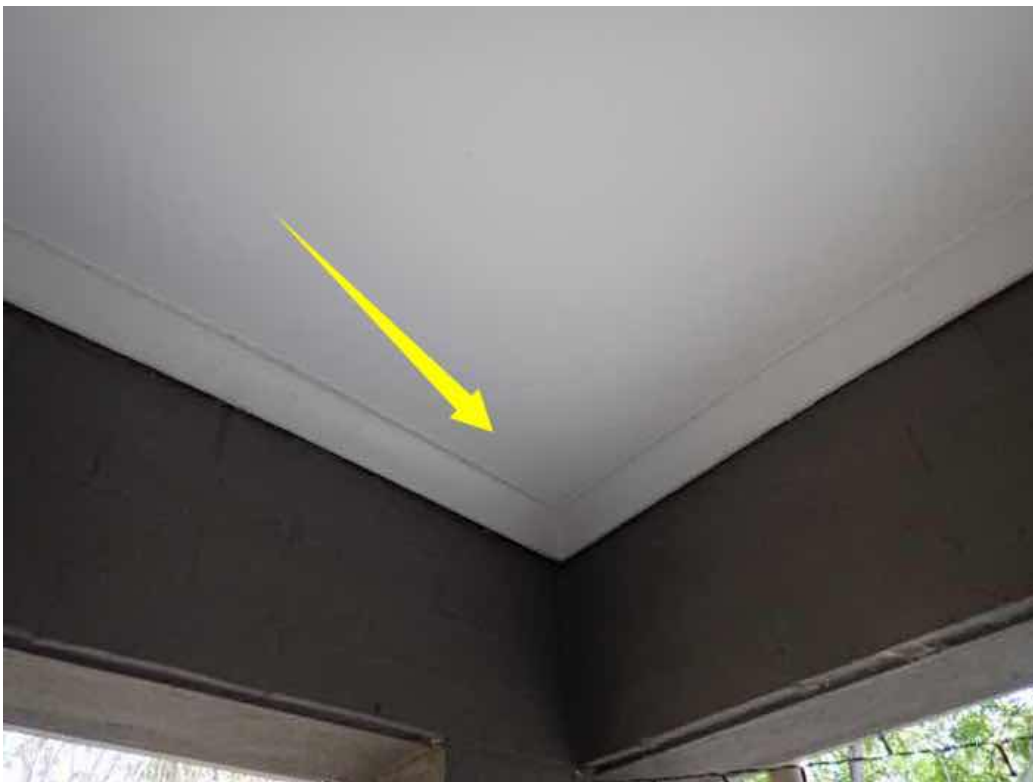
Minor sag noted to ceiling. Currently not causing any issues

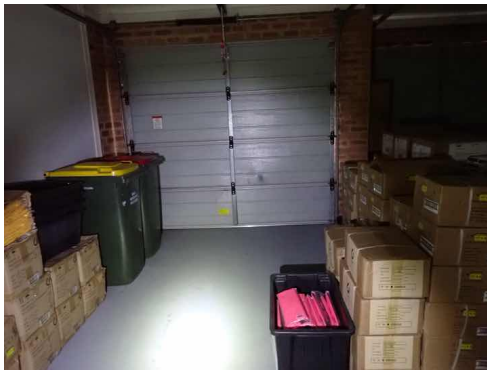
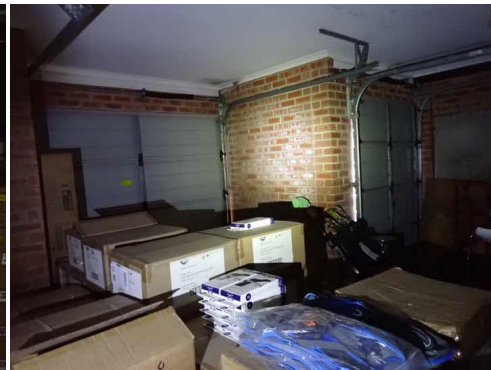
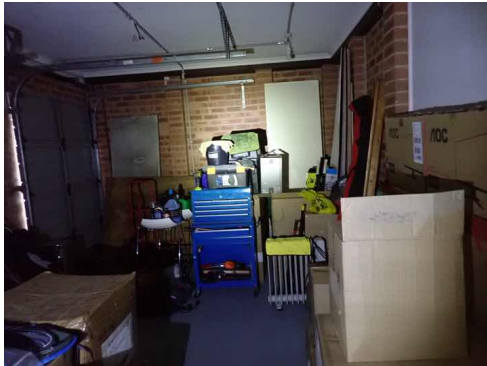
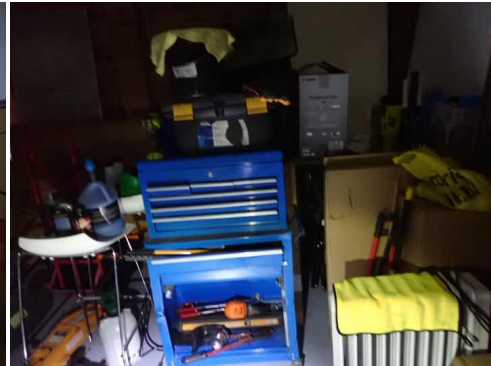
Garage roller door face has minor damage - General repairs required

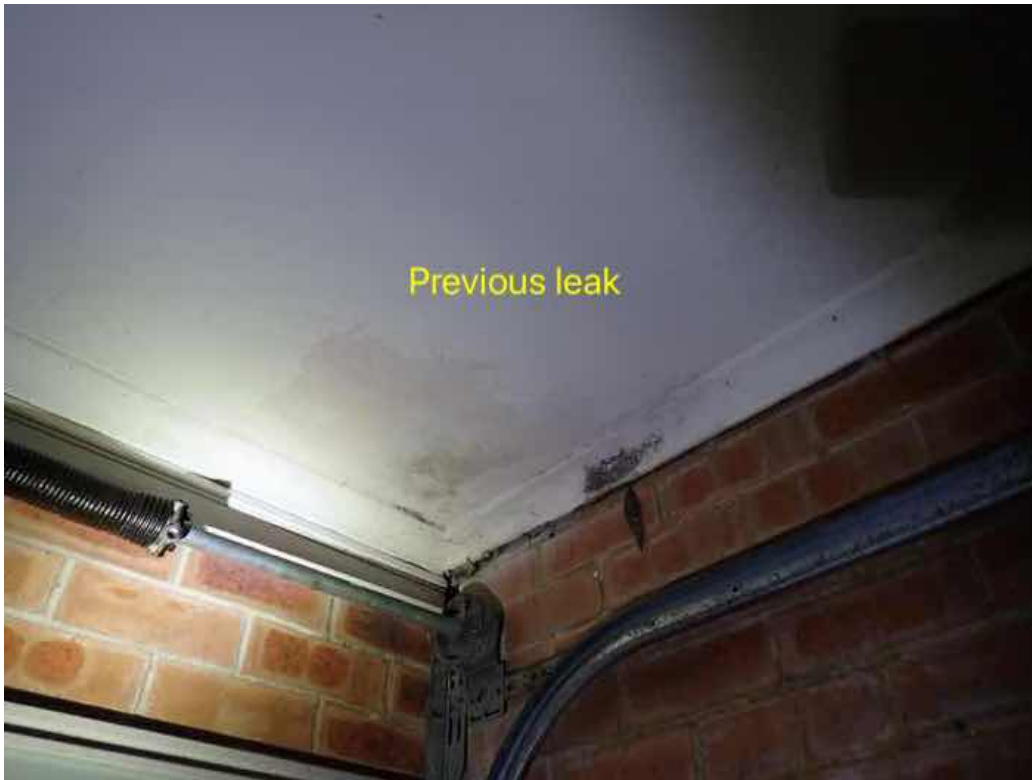
Ceiling paint flake/deterioration is evident. Recommendations: General maintenance / painting as required.

Ceiling stains - No moisture readings obtained from same. Recommendations: These may have been repaired, however, you will need to monitor after a prolonged period of rainfall - If leaking persists, a qualified plumber should be engaged for advice and recommendations. It is strongly recommended that all water damaged plaster replaced by a qualified plasterer due to potential detachment or collapse. Considered a Safety Hazard

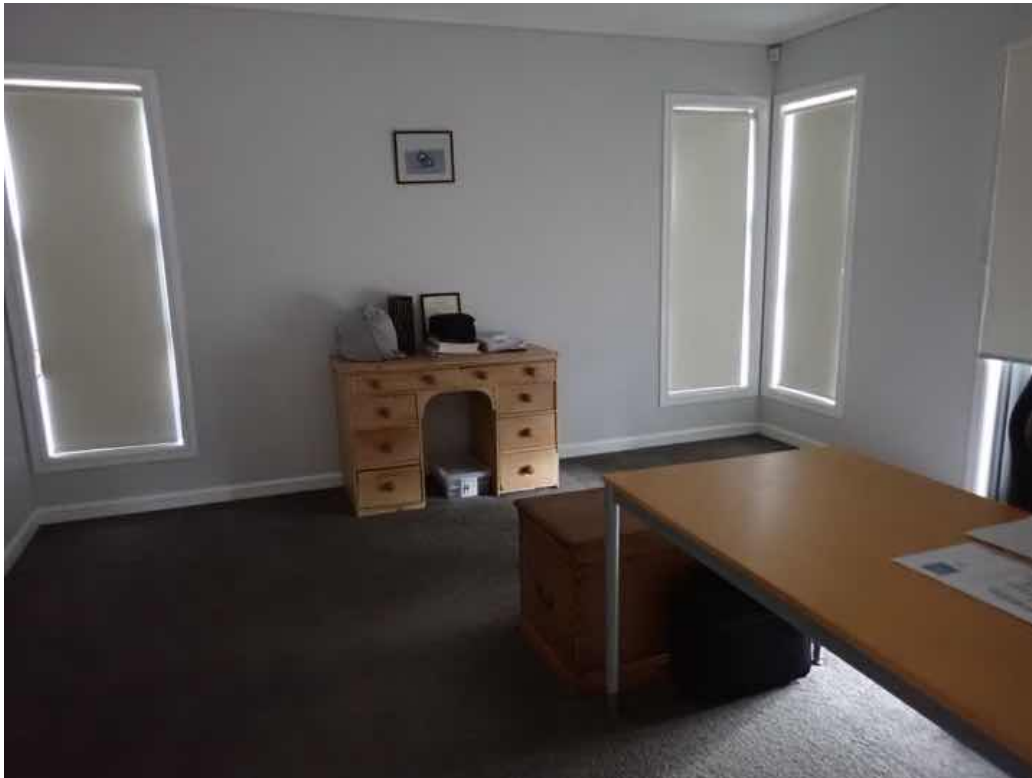
General ageing and/or denting and/or typical separation of architraves and skirting boards and the like is evident on wall linings - Recommendations: A qualified painter should be engaged to assess and repair as required.

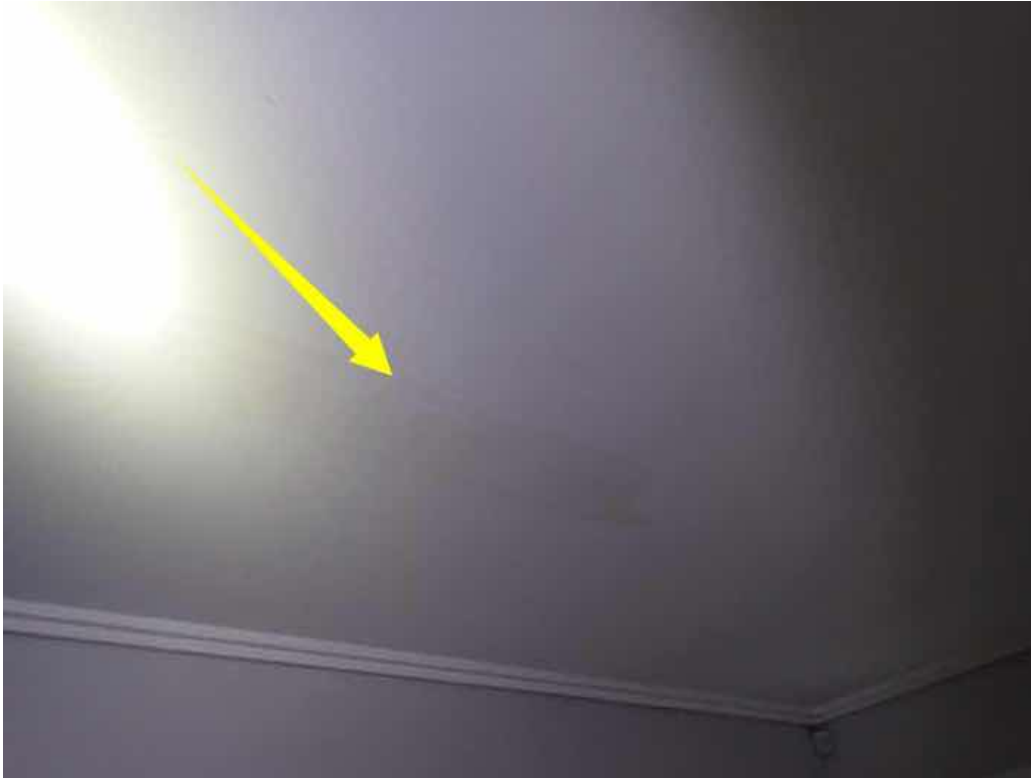
Ceiling stains - No moisture readings obtained. Recommendations: These may have been repaired, however, you will need to monitor after a prolonged period of rainfall - If leaking persists, a qualified roofer should be engaged for advice and recommendations.

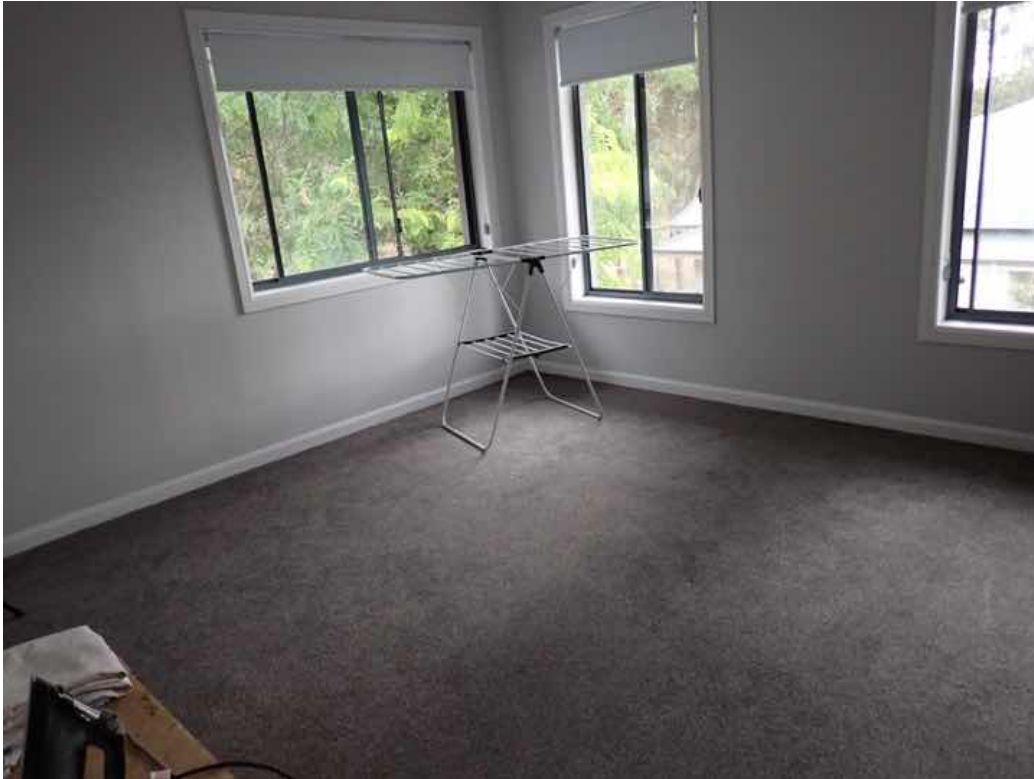
General ageing and/or denting and/or typical minor separation of architraves and skirtingboards and the like is evident on wall linings - Recommendations: A qualified painter should be engaged to assess and repair as required.

Settlement Cracks Noted. These are typical and generally patch and paint will suffice, however we recommend monitor these cracks,

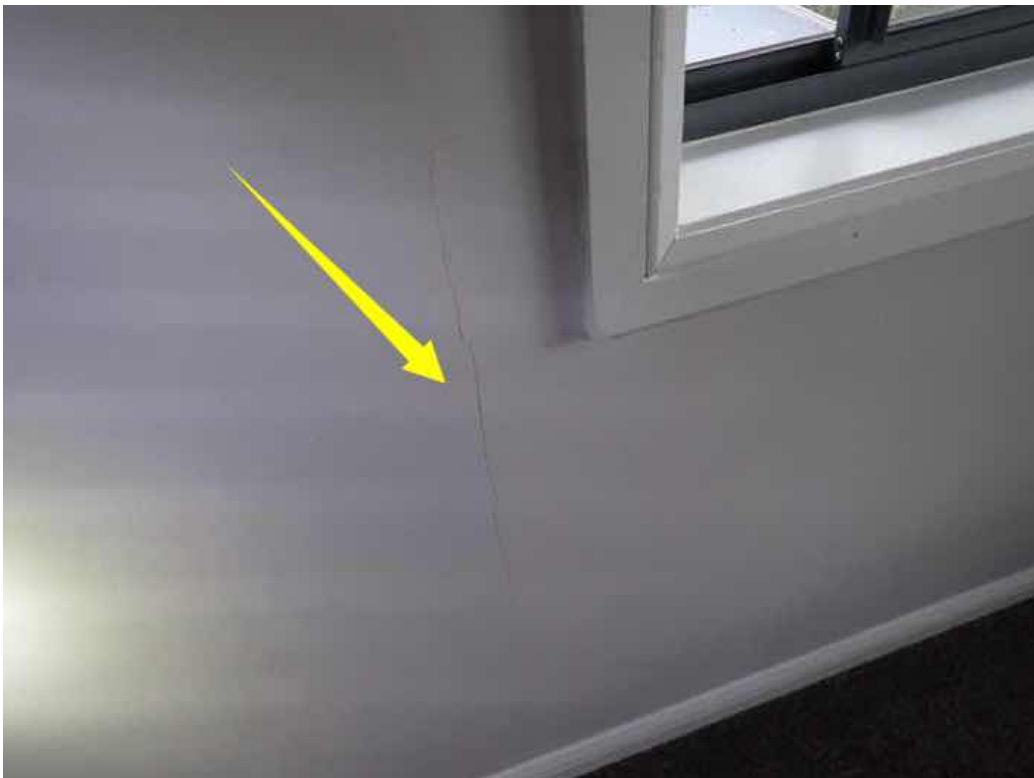
General ageing and/or denting and the like is evident on wall linings - Recommendations: A qualified painter should be engaged to assess and repair as required.

Settlement Cracks Noted. These are typical and generally patch and paint will suffice, however we recommend monitor these cracks.

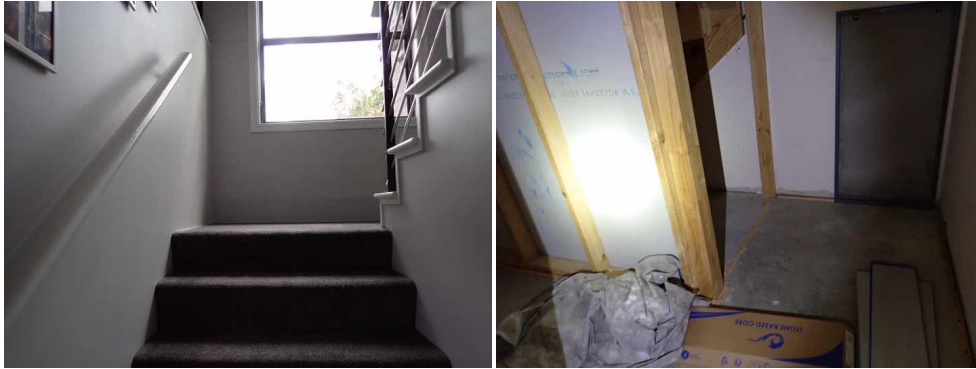
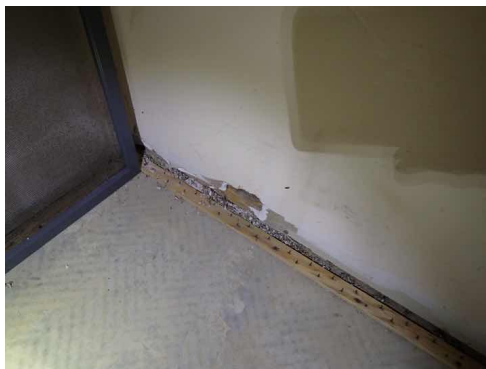
Impact damage to wall noted. Patch and paint will generally suffice, however see a qualified plasterer for further advice

Settlement Cracks Noted . These are typical and generally patch and paint will suffice, however Monitoring these cracks advised

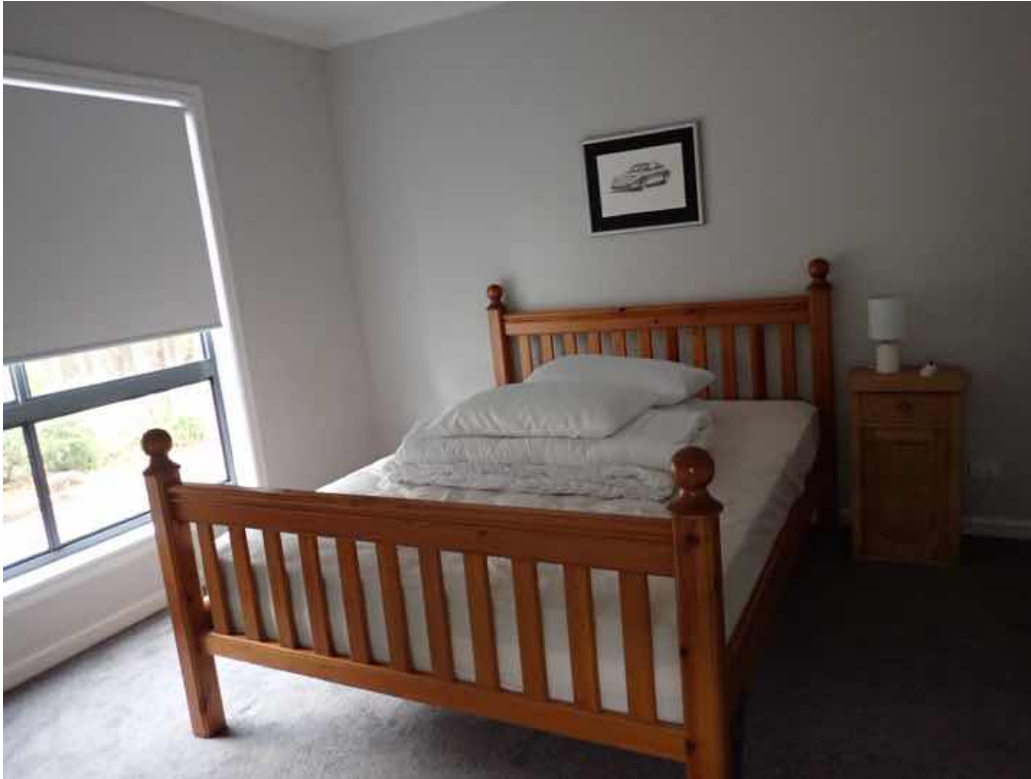
General ageing and/or denting and/or typical separation of architraves and skirting boards and the like is evident on wall linings - Recommendations: A qualified painter should be engaged to assess and repair as required.

Settlement Cracks Noted in corners. These are typical and generally patch and paint will suffice, however we recommend monitor these cracks

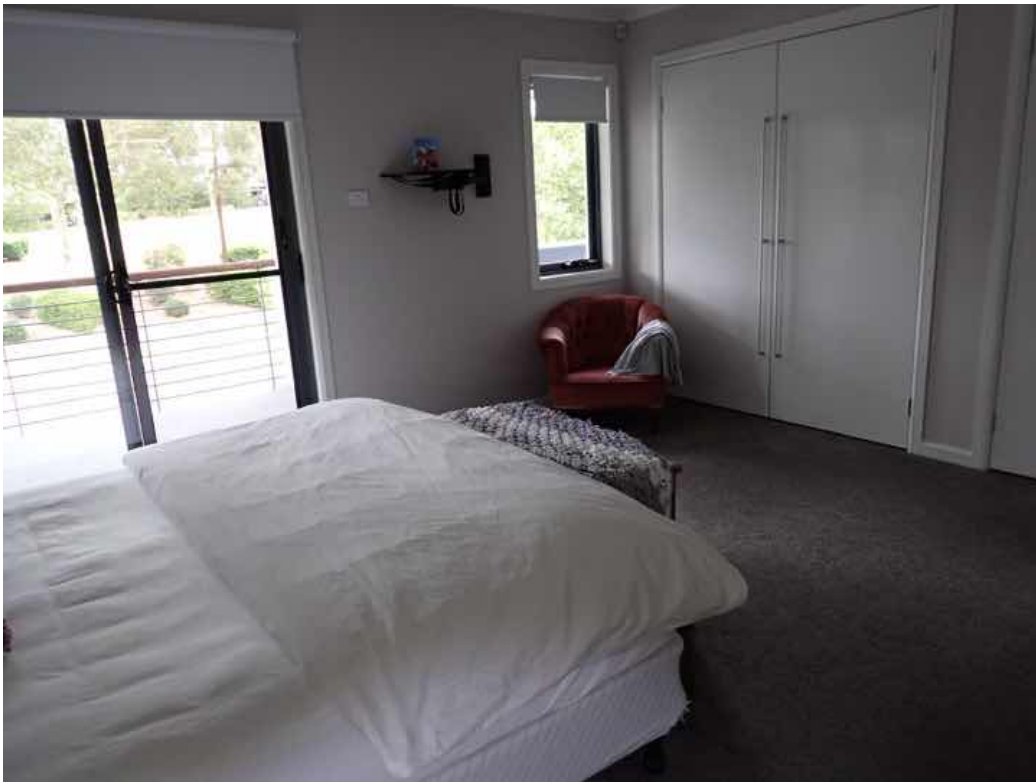
Cupboard door handle broken

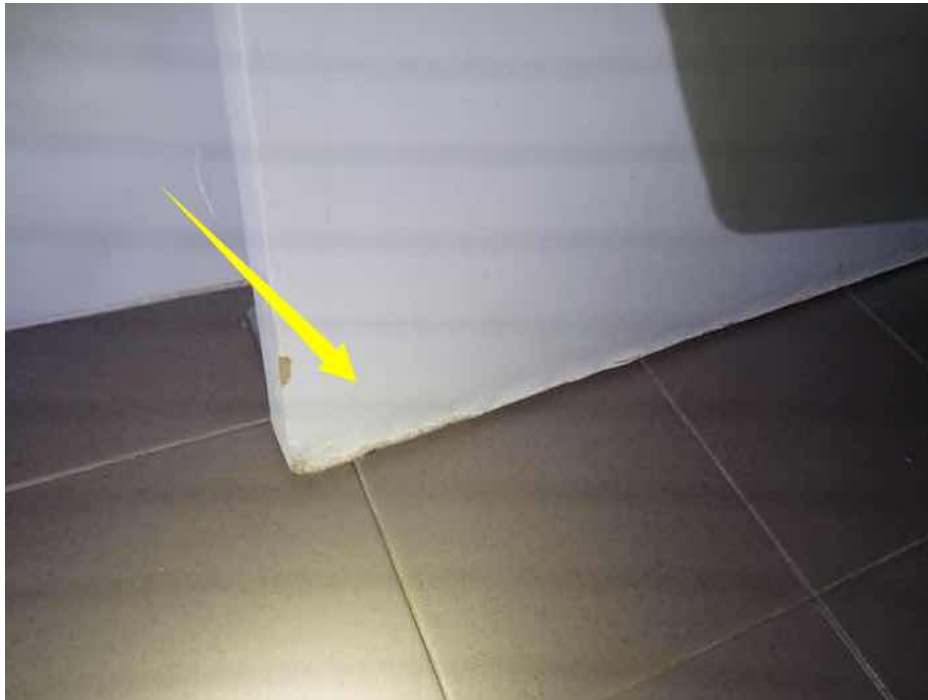
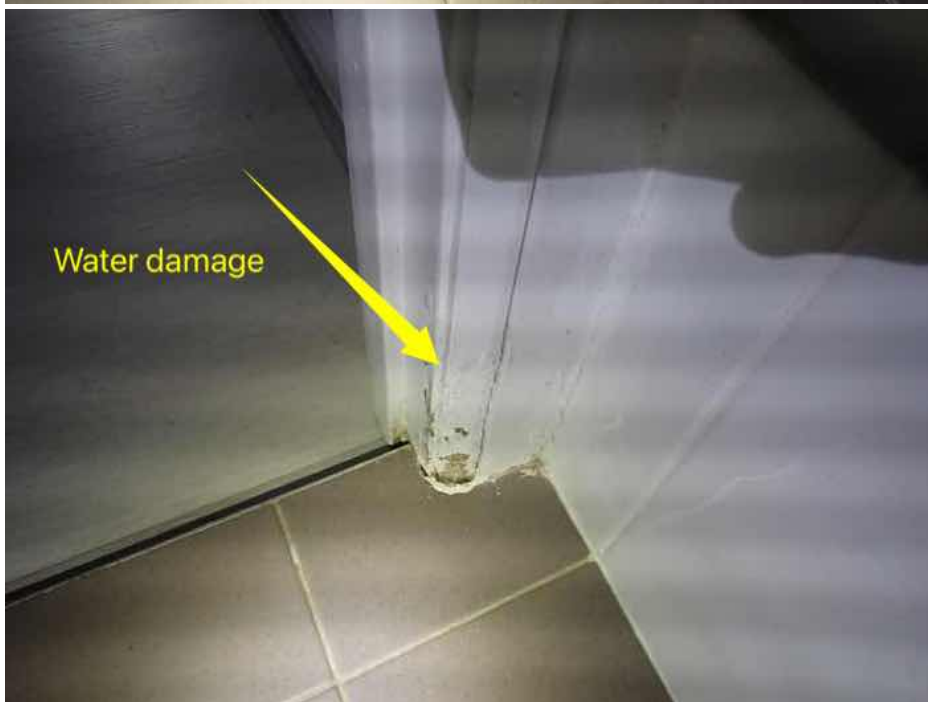
Door / frame deterioration - General age/deterioration has occurred to door frame, face or components.

Water damage to bottom of doorjamb/architrave. This is due to poor design as Architrave sits inside tiles rather than on top of tiles. Contact a carpenter for repairs

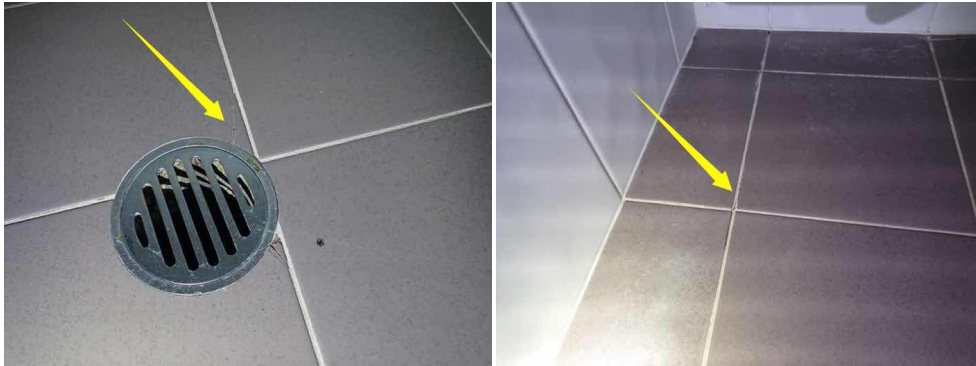
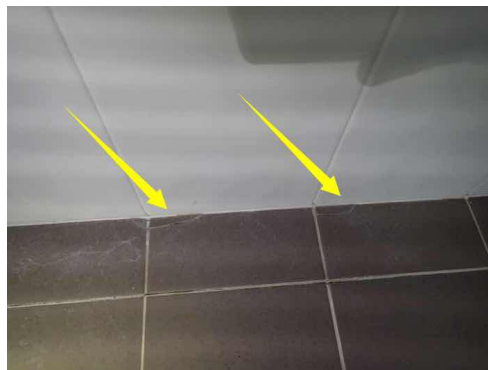
Shower head is leaking. A qualified plumber should be engaged for advice and recommendations.

Cracked tiles and deteriorated grout noted. Currently not causing any leaks but this should be repaired at the earliest as this has the potential to lead to many related issues such as damp, water ingress to other areas. Contact a licensed tiler for repairs and recommendation

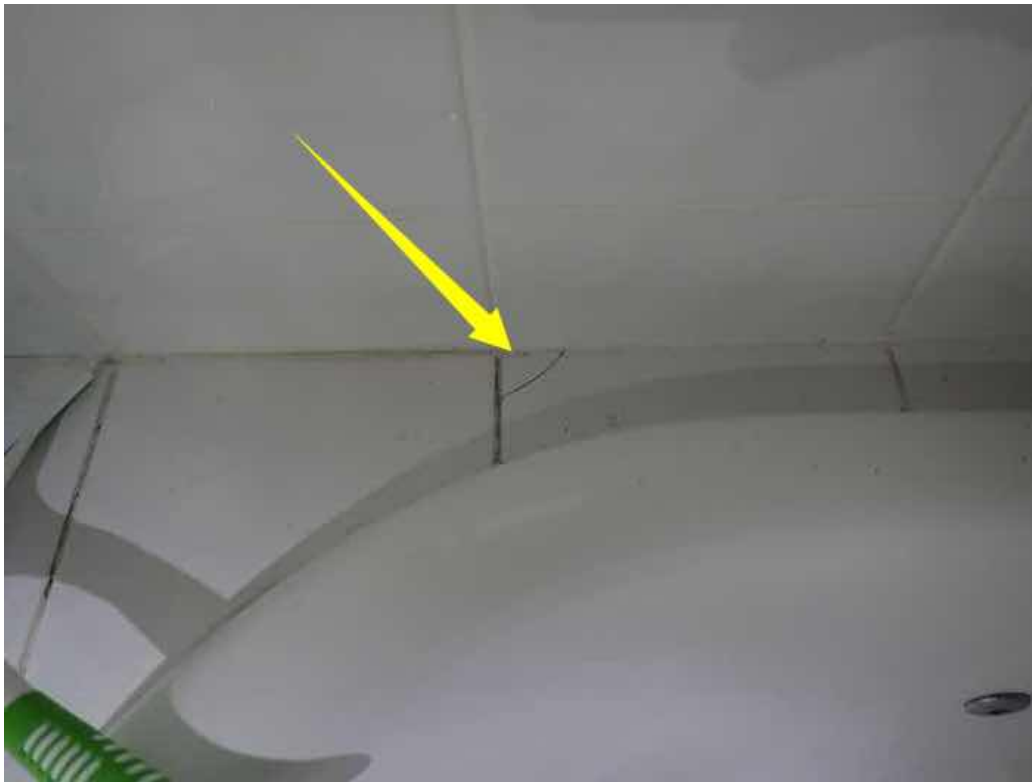
Cracked tiles around bath. Currently not causing any leaks but this should be repaired at the earliest as this has the potential to lead to many related issues such as damp, water ingress to other areas. Contact a licensed tiler for repairs and recommendation

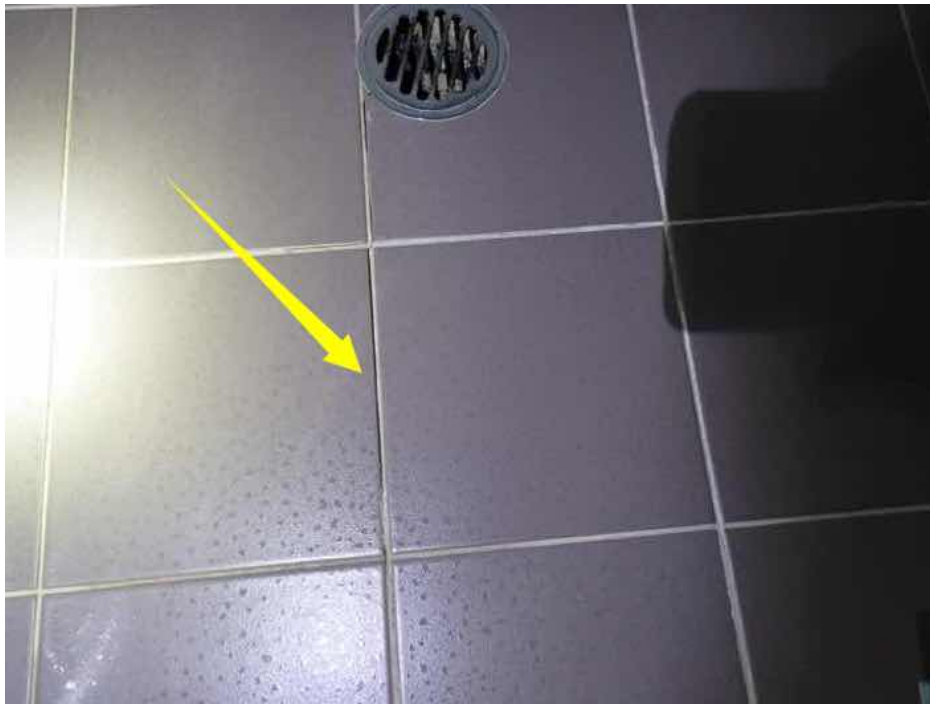
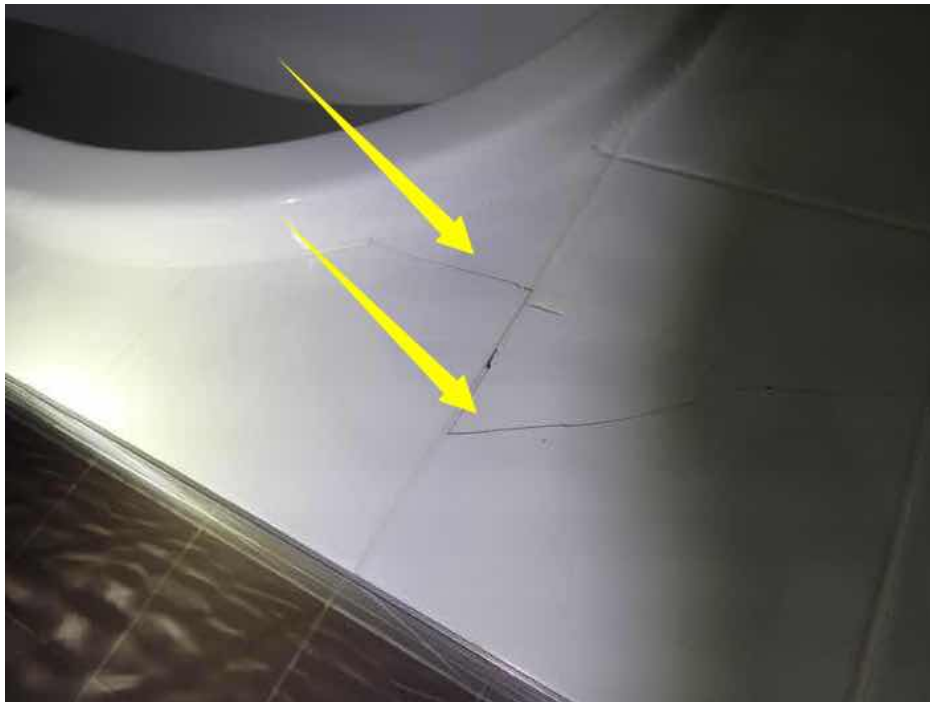
Cracked tiles. Currently not causing any leaks but this should be repaired at the earliest as this has the potential to lead to many related issues such as damp, water ingress to other areas. Contact a licensed tiler for repairs and recommendation

Tile grout deterioration. Shower is not currently leaking but you should Re-grout / seal the shower tiles in areas to prevent future leaks. A qualified tiler should be engaged for advice and recommendations.

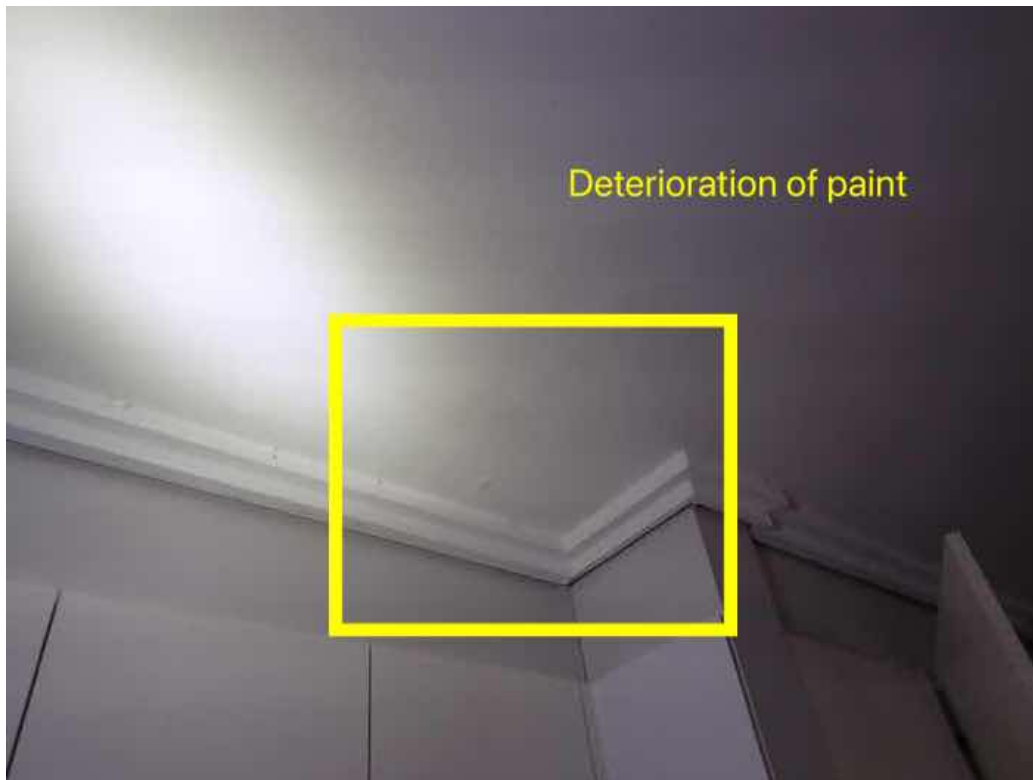
General ageing and deterioration and the like is evident on ceiling linings - Recommendations: A qualified painter should be engaged to assess and repair as required.

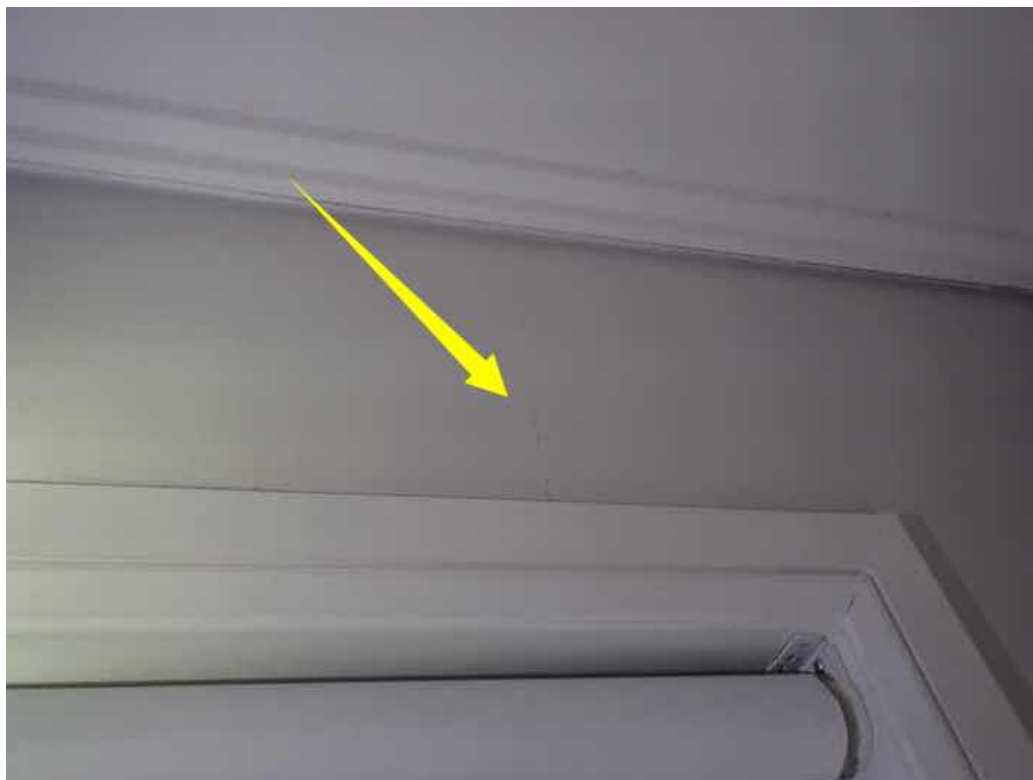
General ageing and/or denting and/or wear and/or previous wall patching and the like is evident on wall linings - Recommendations: A qualified painter should be engaged to assess and repair as required.

Settlement Cracks Noted . These are typical and generally patch and paint will suffice, however Monitoring these cracks advised for 12 months and if become wider or longer, you will need to contact a structural engineers to assess.

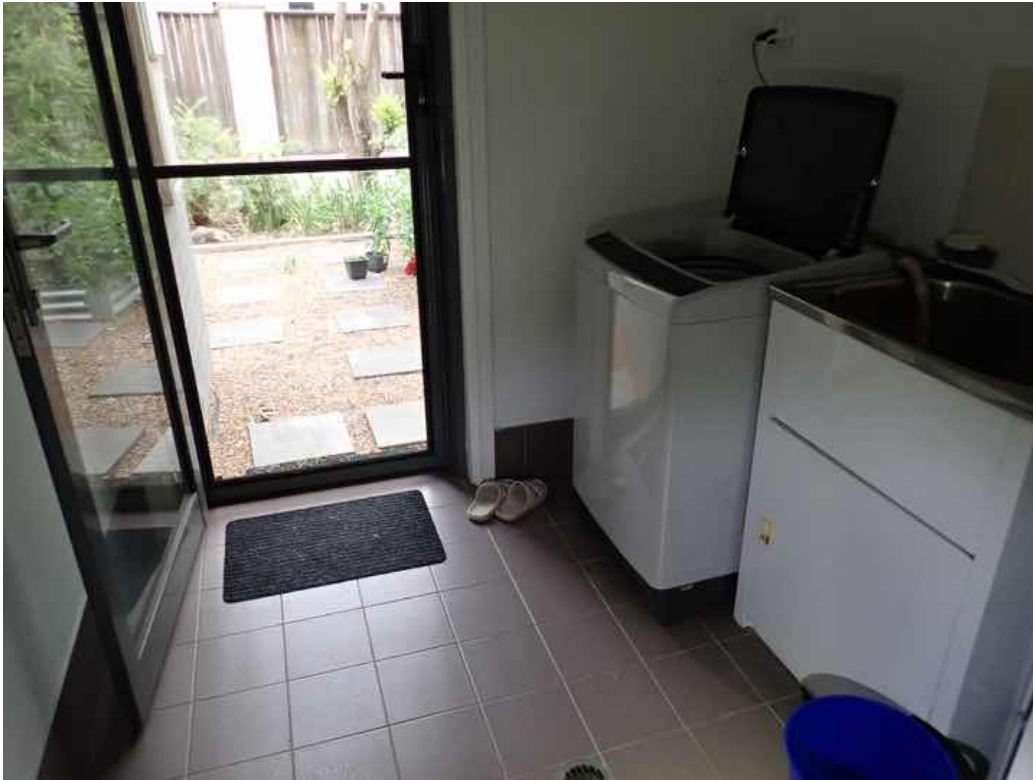
Settlement Cracks and movement in corners Noted . These are typical and generally patch and paint will suffice, however Monitoring these cracks advised
