388-390 Murray rd Preston

Job- Investigate video footage of water bubbling out of front steps.

## RE: Site Investigation at 388 Murray Road, Preston

A site investigation was undertaken on 15 August 2025. The purpose of the investigation was to provide remedial recommendations for two external stairs.

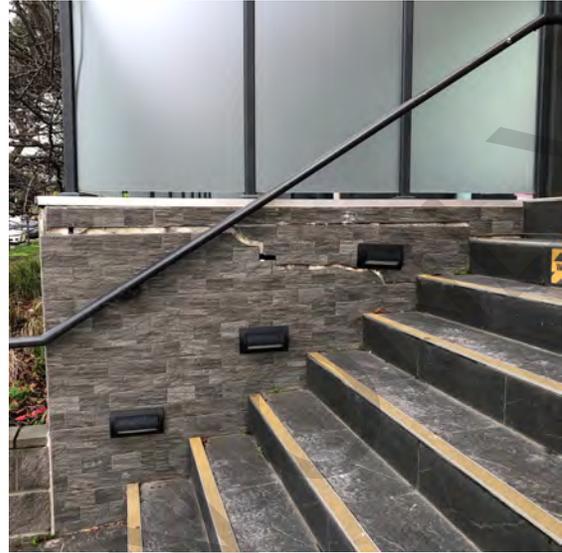
Fig 2. Wing wall at west end of steps. Treads have an obvious slope towards the south. Crack width varies indicating a rotation of the wall and steps.

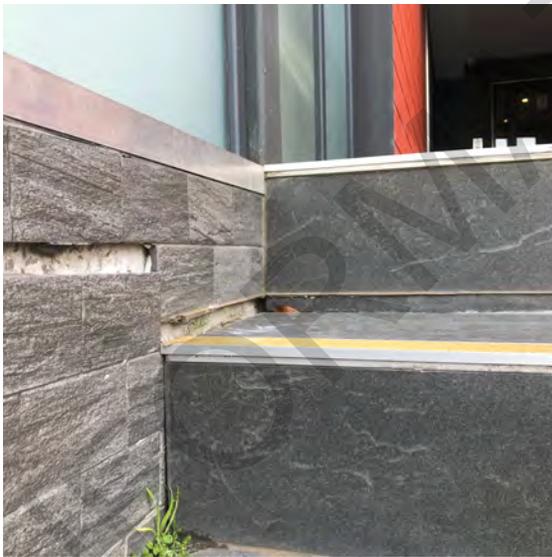
Fig 3. Gap indicates vertical settlement of the steps in addition to rotation.

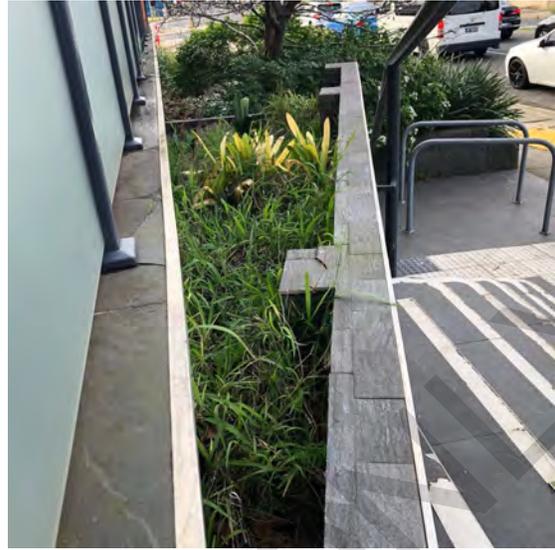
Fig 6. Top view of north wing wall. Retained soil has caused the top of the wall to rotate towards the south.

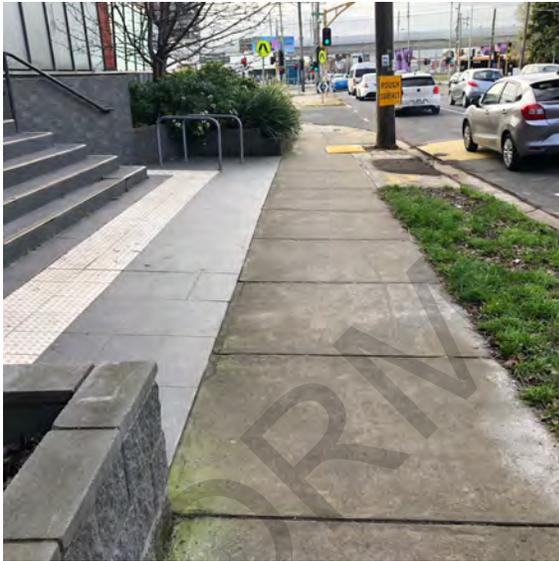
Fig 7. Tiled slab between steps and council footpath may need to be replaced after steps have been rebuilt.

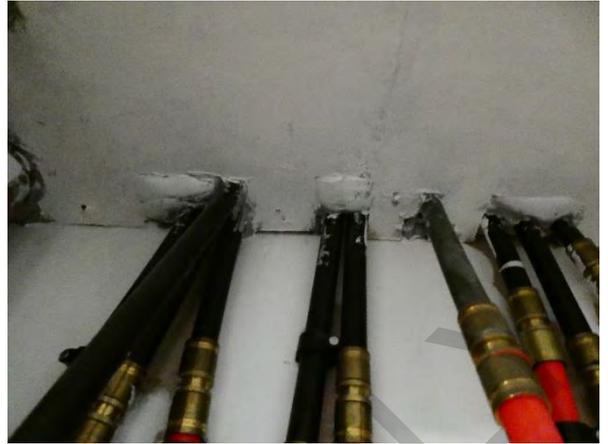
Photograph 4. Unable to determine the ceilings in some services cupboards, should be fire resistant. Penetrations reasonably sealed.

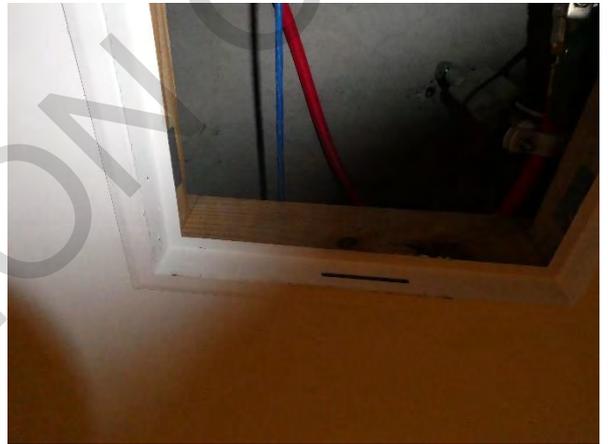
Photograph 6. All floor construction found to be concrete with the exception of the upper story – to roof. Penetrations from sole occupancy units to common property hallways generally fire sealed.

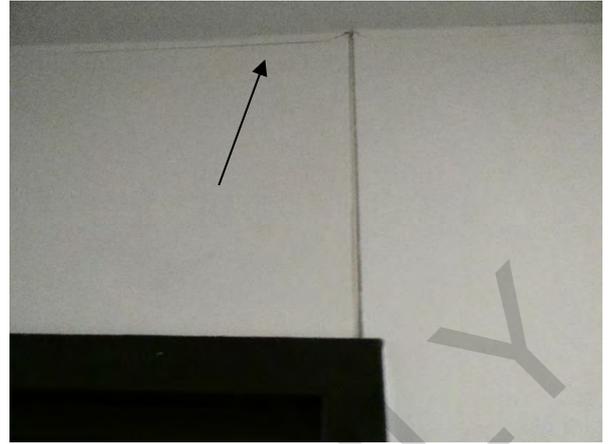
Photograph 10. In the location of 2.25 an articulation joint has been formed, however there is continued movement in the building evidenced by the crack in the wall/ceiling junction.

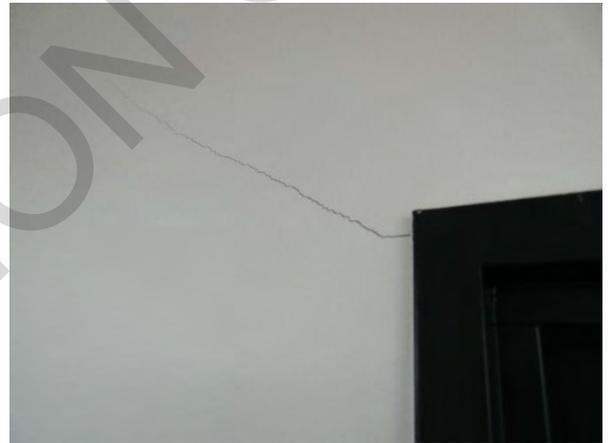
Photograph 12. In the location of 4.18 building movement has caused cracking of the plasterboard at the door entry.

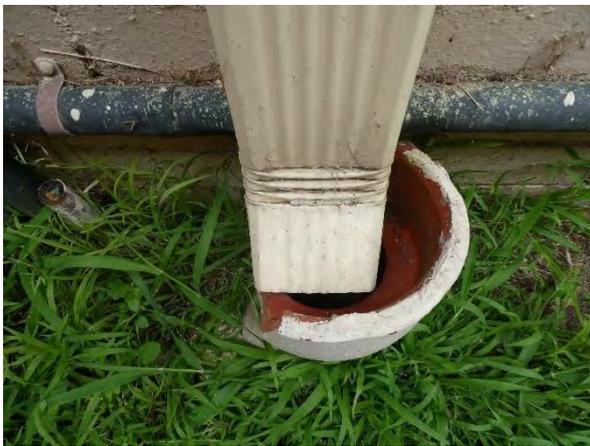
Photograph 17. Broken stormwater – earthenware - drain which allows uncontrolled stormwater to discharge onto the ground in the location of the sink hole.

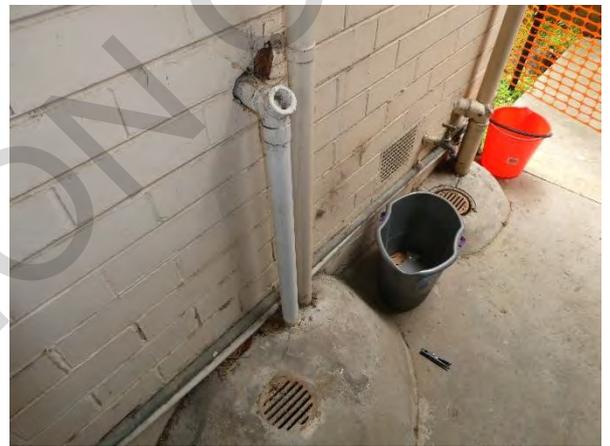
Photograph 18. There are other underground earthenware drains in close proximity to the sinkhole, these need to be checked to ensure they remain sealed.

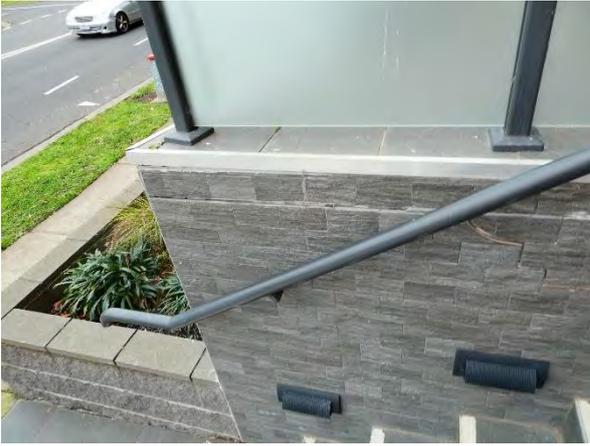
Photograph 21. Private lot terrace adjacent to the steps, damage to the façade consistent with footing movement.

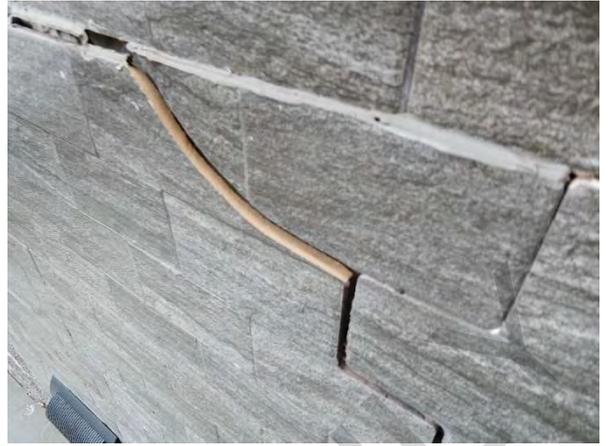
Photograph 22. Damage from possible settlement of the footing.

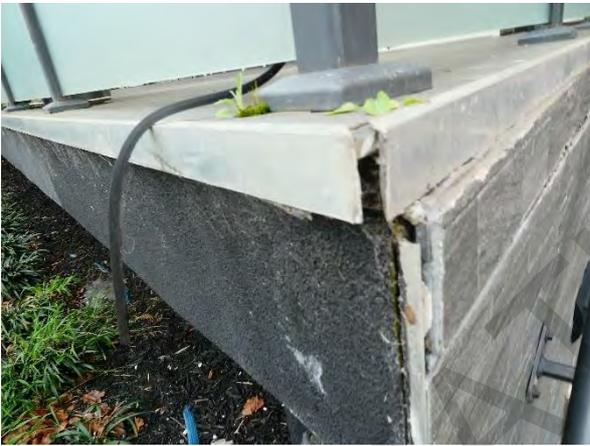
Photograph 23. Terrace adjacent to front entry has shifted.

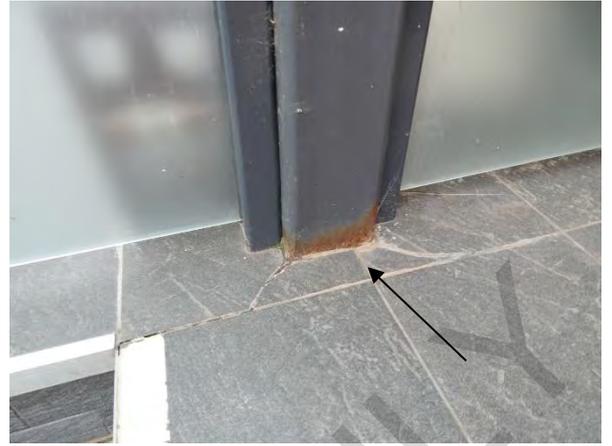
Photograph 26. Steel post has evidence of corrosion on the base.

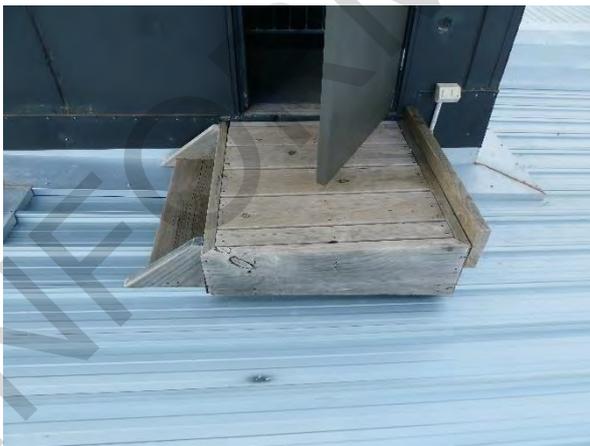
Photograph 27. Treated timber structure placed directly onto the metal roof sheets.

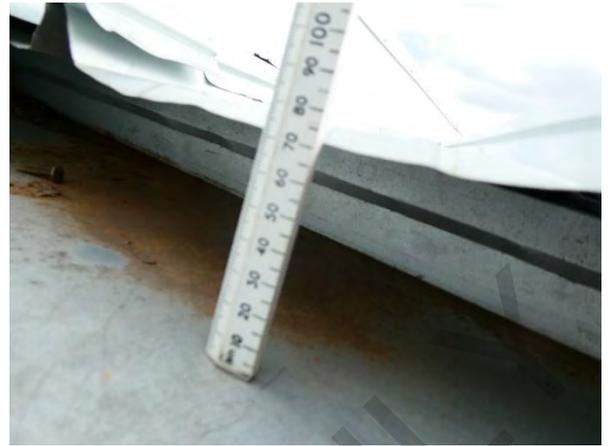
Photograph 36. One roof box gutter found to be very shallow – approximately 70mm.

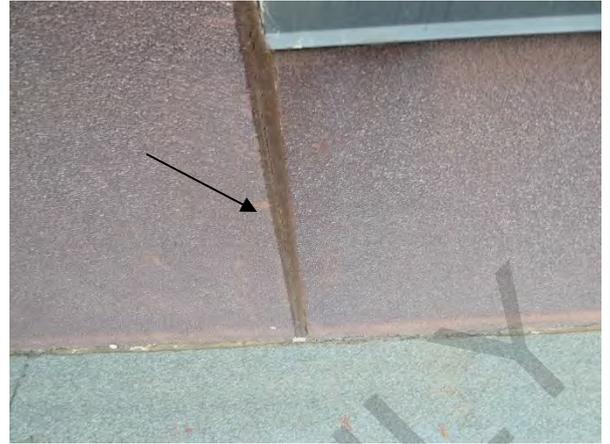
Photograph 44. Closer view, sealant split open, material sealed at the base.

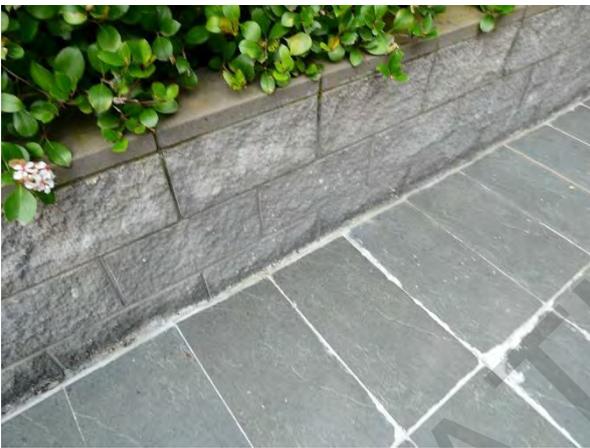
Photograph 49. The planter boxes have been poorly constructed allowing moisture to exit at the base of the wall.

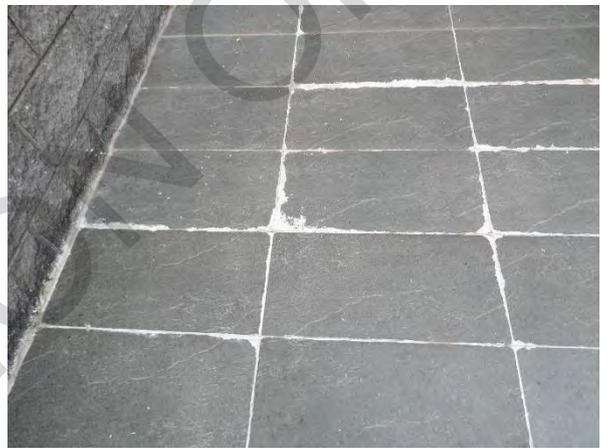
Photograph 50. Efflorescence is evident throughout the terrace tiling, emanating from grout lines.

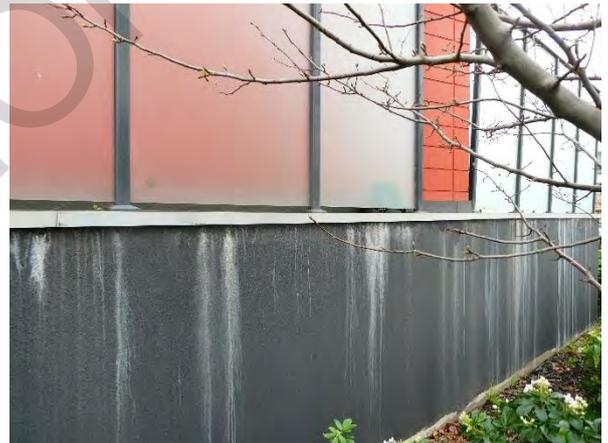
Photograph 56. Further view.

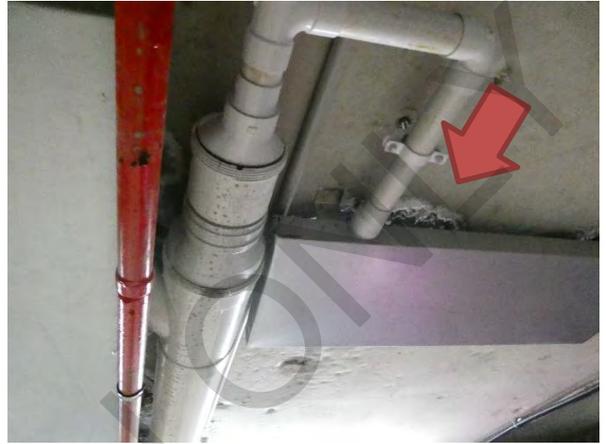
Photograph 58. Active water leaks into the basement continue, stainless steel trays are evident in locations under the terrace and planter boxes over.

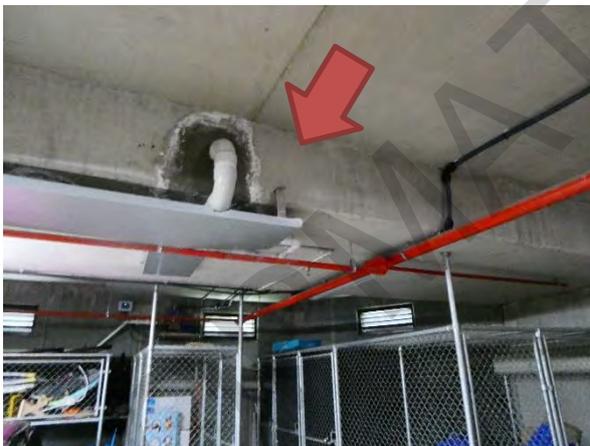
Photograph 59. Active water leak into the basement. These salt laden salt stain surfaces.

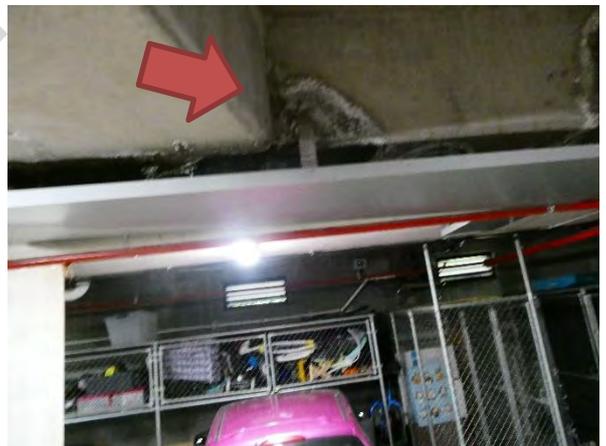
Photograph 60. Further view.

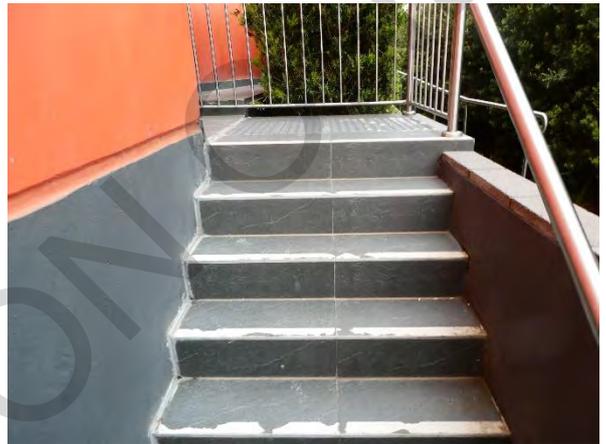
Photograph 64. Entry stairs, tactile markers require replacement.

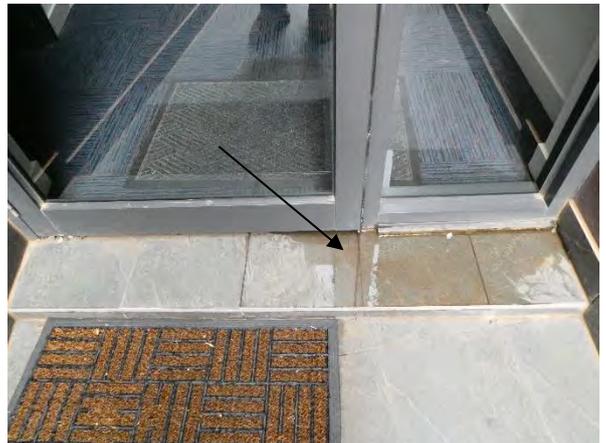
Photograph 66. Stormwater ponds at the entry door due to a lack of fall in the floor tiling. The water was observed entering the building under the door. There is an insufficient hob or freeboard under the entry door.

A compliant hob/freeboard has not been formed under the door entry to prevent stormwater entering the building. A diagram of a compliant door hob/freeboard from AS4654.2 has been provided below.

Water entry into the building was observed. Efflorescence, which is a building defect as detailed in the Victorian Building Authority's Guide to Standards and Tolerances, is evident throughout the entry floor tiling.

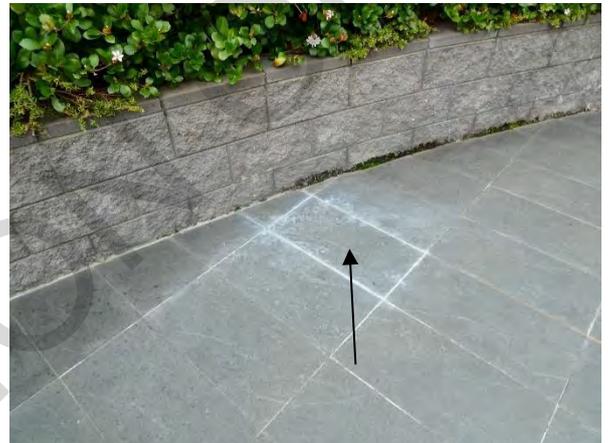
Photograph 68. Moss at the base of the planter box block works and efflorescence in the tile grout lines indicate water egress from the planter box.

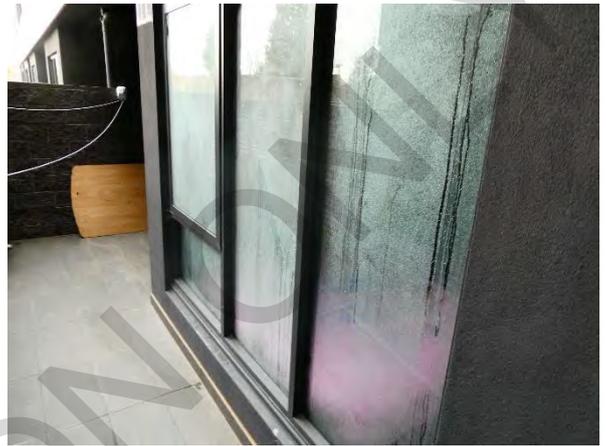
Photograph 71. This is considered to be a large amount of moisture.

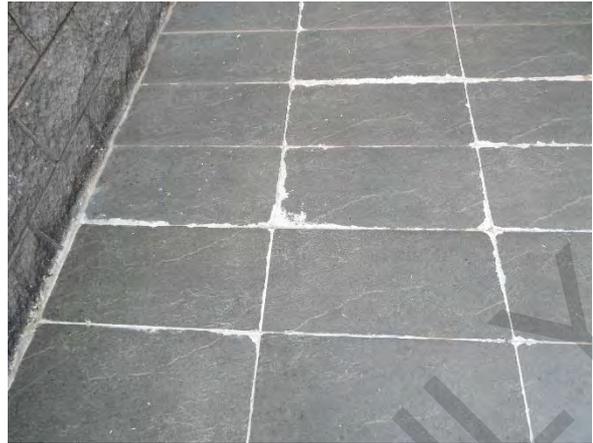
*Photograph 50. Efflorescence is evident throughout the terrace tiling, emanating from grout lines.*

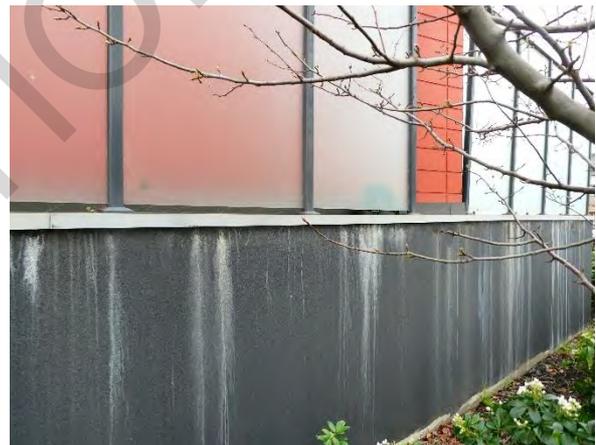
*Photograph 56. Further view.*

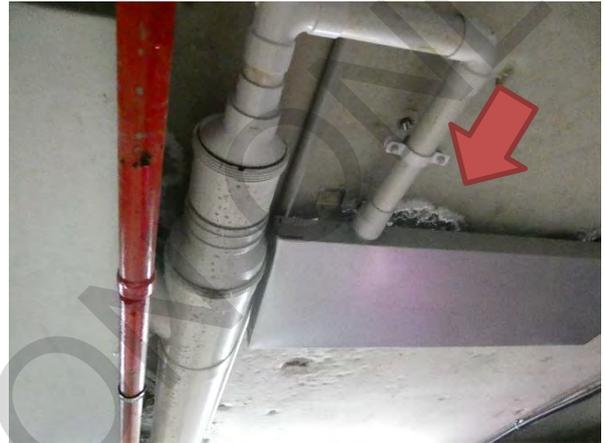
Photograph 58. Active water leaks into the basement continue, stainless steel trays are evident in locations under the terrace and planter boxes over.

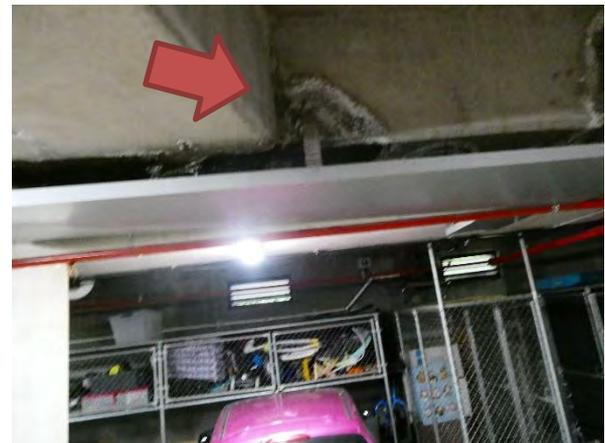
Photograph 60. Further view.

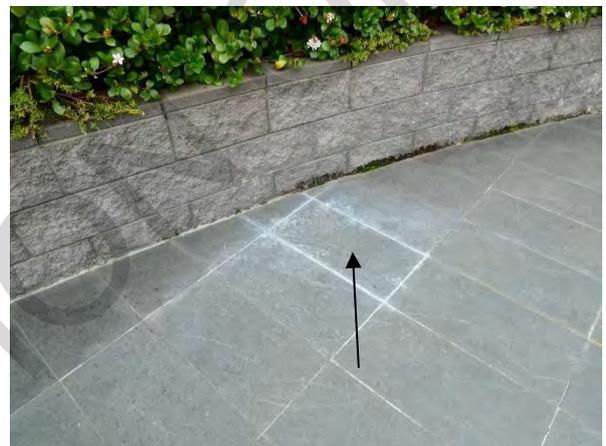
*Photograph 68. Moss at the base of the planter box block works and efflorescence in the tile grout lines indicate water egress from the planter box.*

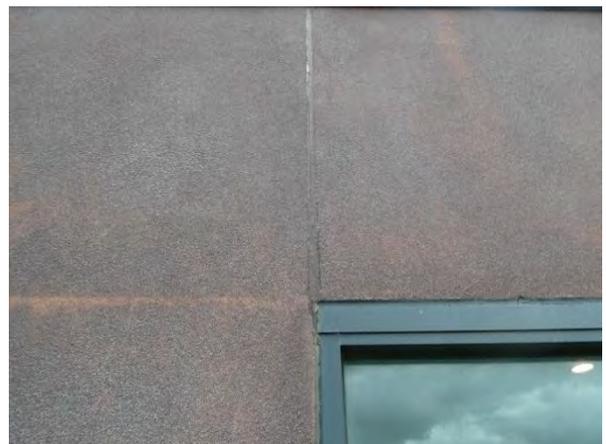
Photograph 42. Articulation joint has split open allowing moisture into the wall cavity which has been sealed at the base. Horizontal joint in the sheet also visible.

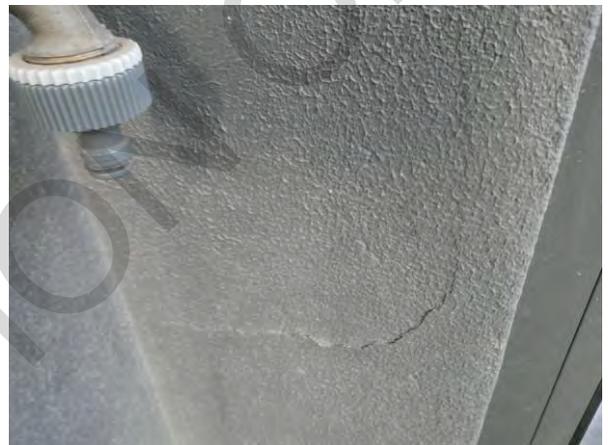
Photograph 8. Cracked render coat, external cladding is sealed behind skirting tiles.

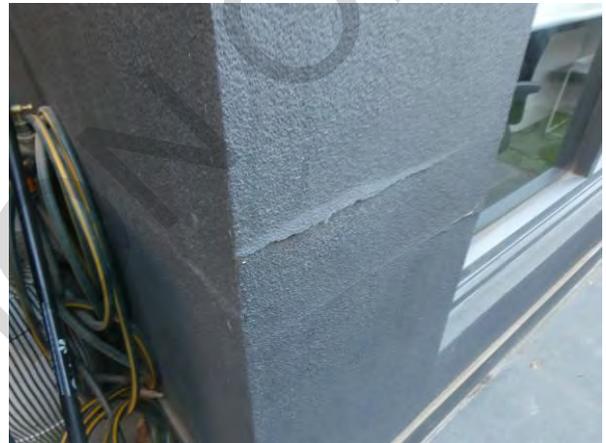
Photograph 14. There is cracked and damaged render coat over EPS foam cladding.

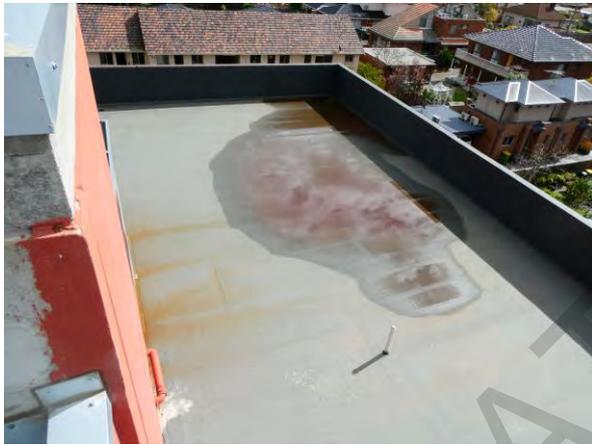
Photograph 17. The roof top terrace ponds with stormwater.

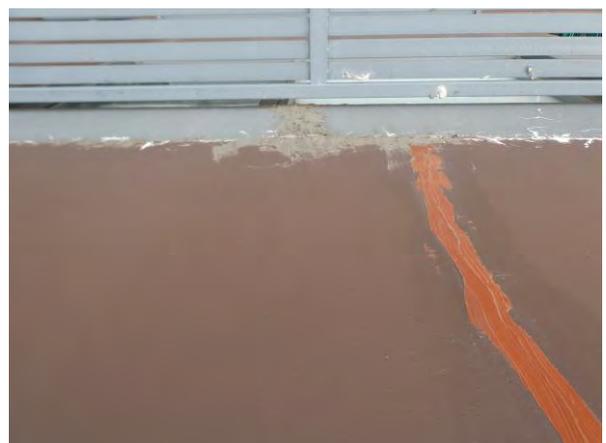
Photograph 20. Large crack in the precast panel has been sealed by smearing sealant into the joint.

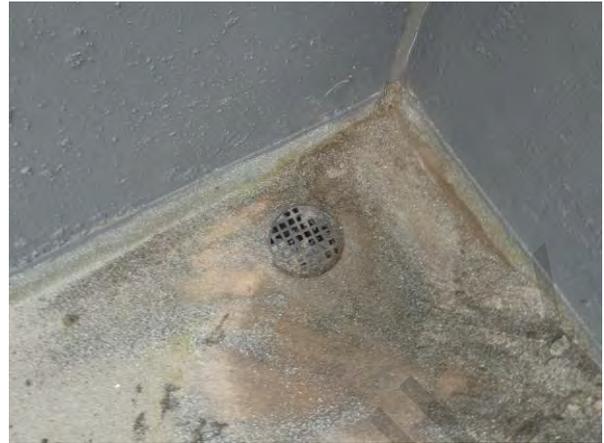
Photograph 22. Stormwater ponds around drains on the roof top terrace.

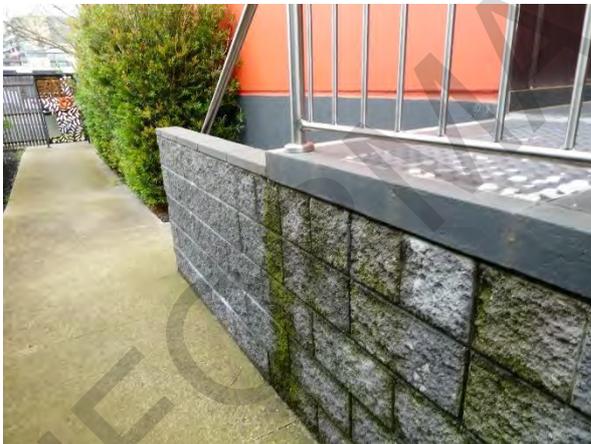
*Photograph 63. North entry stairs to the building. There is water emanating from under the tiling and leeching down the wall.*

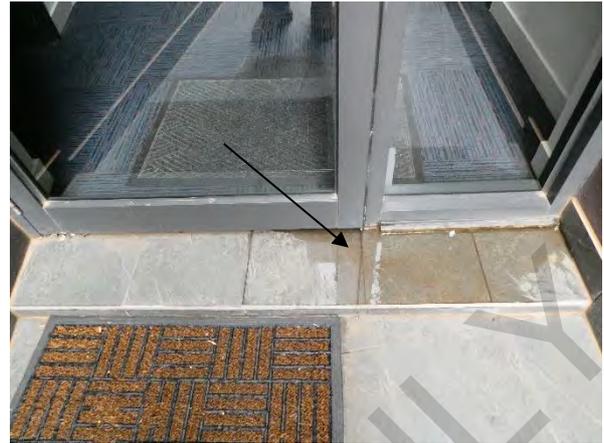
Photograph 66. Stormwater ponds at the entry door due to a lack of fall in the floor tiling. The water was observed entering the building under the door. There is an insufficient hob or freeboard under the entry door.
