VISUAL BUILDING & PEST INSPECTION REPORT

Complies with Australian Standard 4349.1 & 4349.6

20 Holland Crescent Frenchs Forest

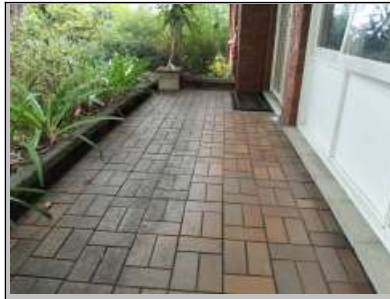
Front elevation.

Constructed from concrete or masonry. The condition of the structure is generally acceptable.

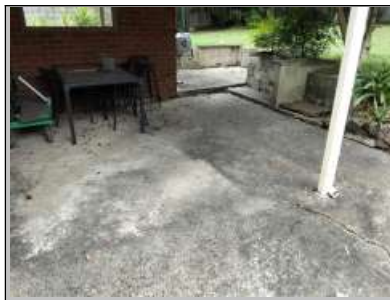
Rear elevation.

Constructed from concrete or masonry. The condition of the structure is generally acceptable.

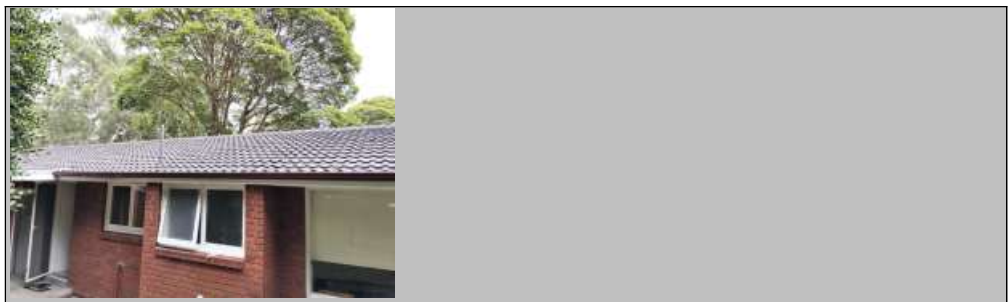
The overall condition of the roof coverings is fair. Visible deflection was noted to the roofline. For more detail see section under "Roof System Internal".

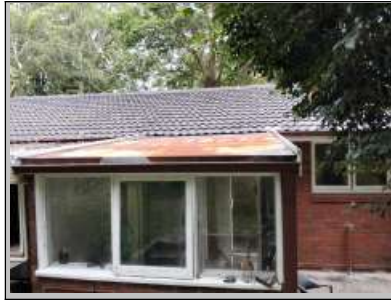
Rear elevation.

The metal roofing is rusted and requires treatment to prevent further deterioration.

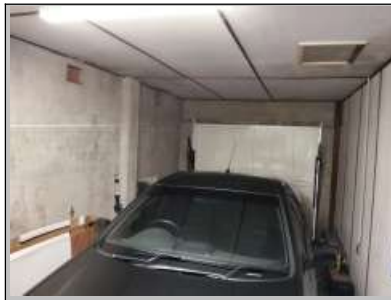
Garage.

The structure is generally in fair condition.

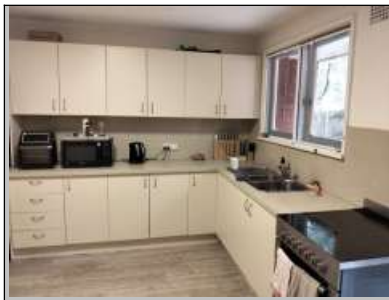
The condition of the fixtures is generally fair. A stone splashback is located over the benchtop area. Stone appears to be in serviceable condition.

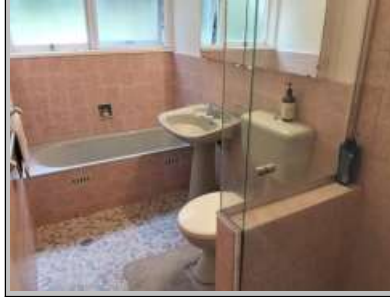
Rear.

The shower recess was tested and there was no visible water penetration to surrounding areas. IMPORTANT NOTE: This test may not reveal water leaks until the shower is put into constant use and surrounding areas monitored over a period of time.

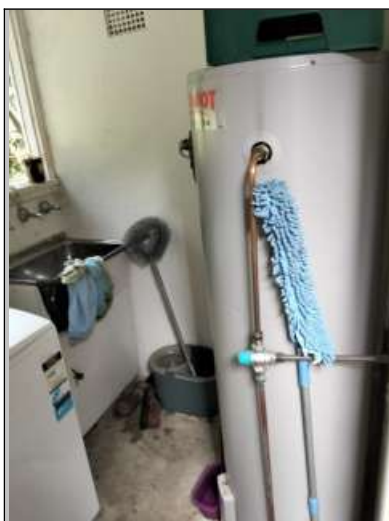
Mains electric hot water system: Mains pressure: Located in the laundry: The hot water system appears to be in working condition. No specific tests other than running the hot water tap were carried out. No determination has been made as to the suitability or adequacy of the hot water system in relation to capacity or otherwise.

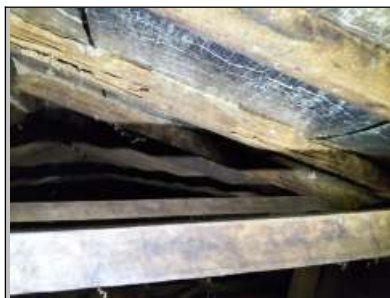
Affected Roof Timbers

Yes - Inspection revealed currently inactive termite attack (damaged timbers and/or termite workings) within this area including but not necessarily limited to the following timbers and the areas listed below.

Ceiling joists. Rafters. Hanging beam.

Visible timber damage appears moderate to severe. Please refer to the building report for details or if a building inspection was not commissioned we recommend a builder inspection and report on the property. Refer to the definitions section of this report - Section 1.6 - Timber Damage.
