# Inspection Report

## Nova Home Inspections

**32 Guise Ave Casula**

Report/Agreement #           06121902007870  
 Inspection Date:               06 Dec 2019  
 Inspection Time:               01:30 pm

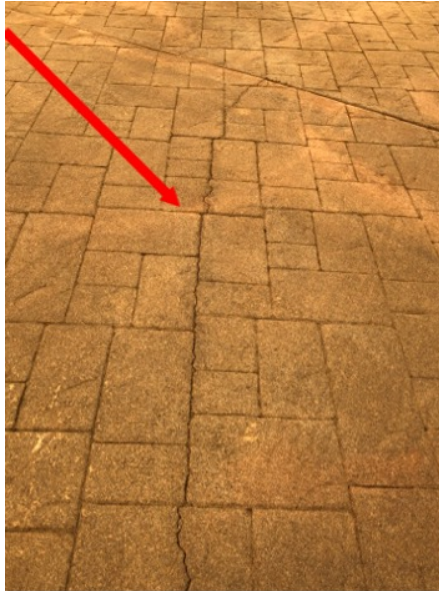
Common cracks & settlement were observed on the driveway. Maintenance is recommended. Note: Whilst these cracks appeared to be minor at the time of inspection, we strongly recommend you monitor these cracks and if worsening occurs contact a concreter for further advice.

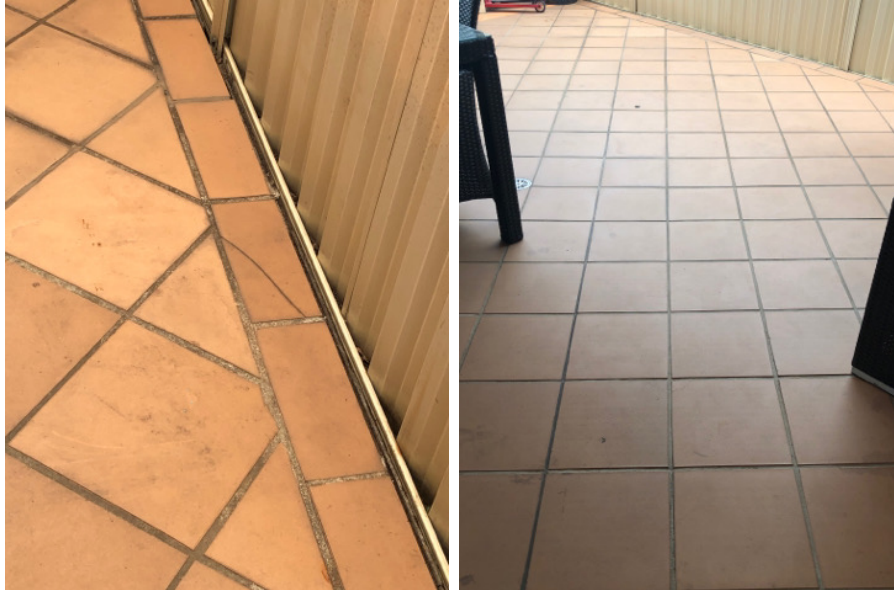
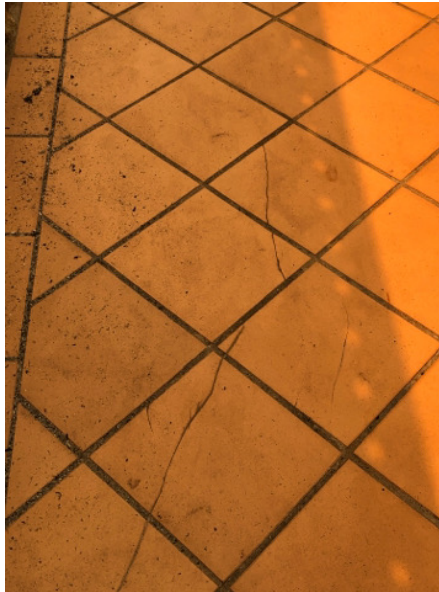
General cracking to sections of tiles and tile joints. Possible causes are thermal expansion and settlement of paths. Re-grout and replace any damaged tiles as required. Drummy tiles should be replaced by a licensed tiler.

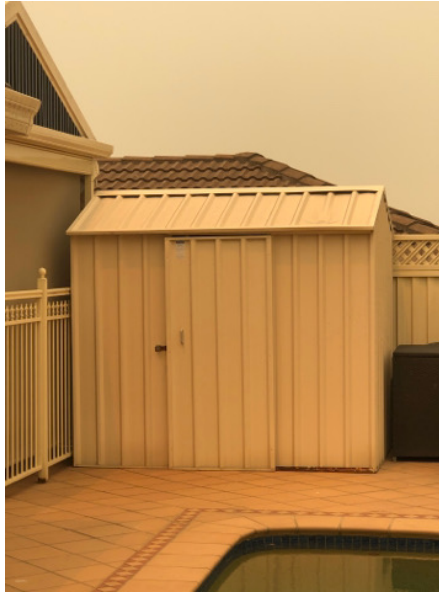
The building is in fair usable condition.

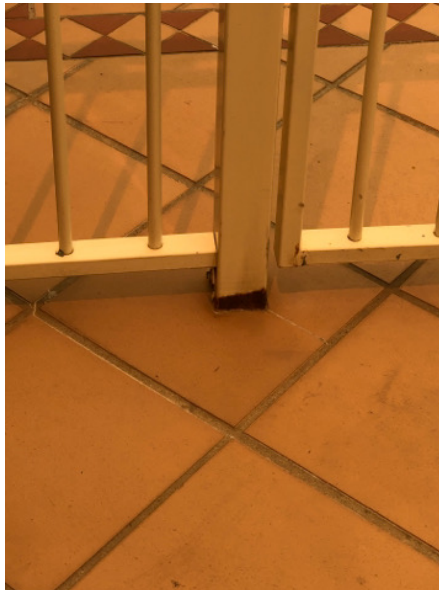
Rust to pool fencing noted. Recommend treatment or replacement where necessary.

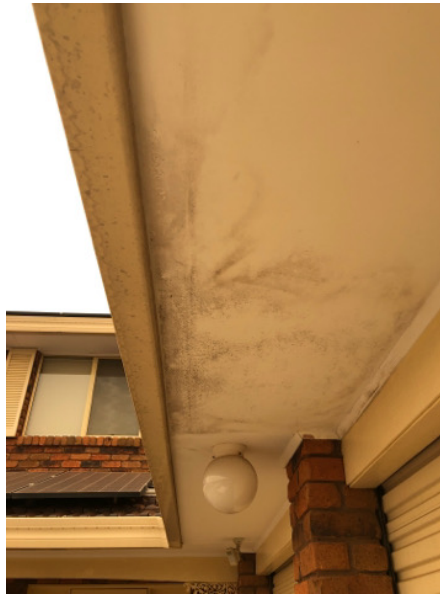
Eave lining stains observed. Normally this occurs due to overflow in blocked gutters. Recommendations. Gutters should be kept clear of debris and eave linings can then be painted or repaired as required.

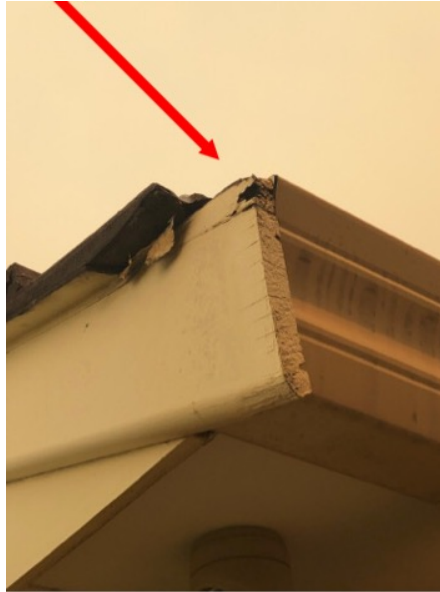
Timber fungal decay (rot) visible. Recommendations: A qualified carpenter should be engaged to replace all affected timbers.

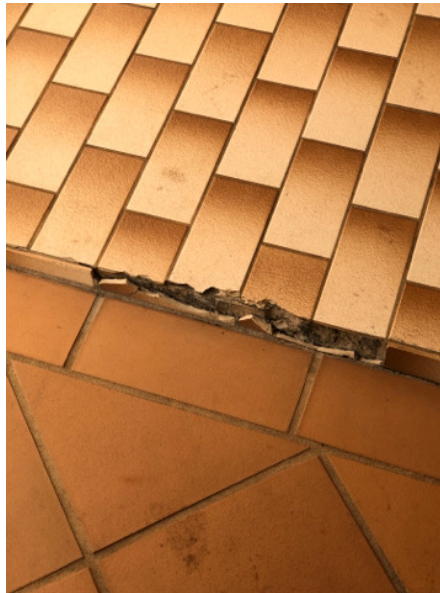
Tile cracks evident on entry patio/porch - Recommendations: Engage a qualified tiling contractor to repair. Chipped tiles should be replaced by a licensed tiler.

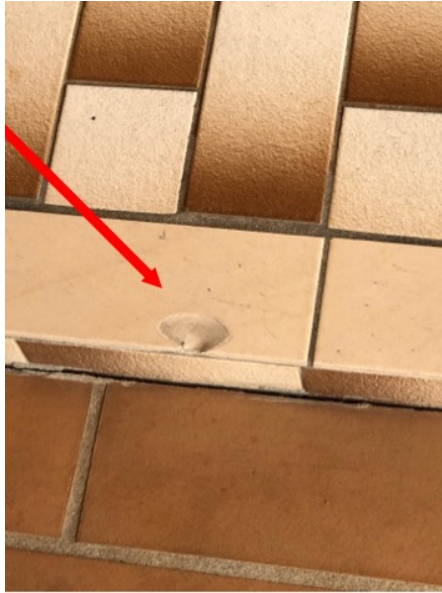
Chipped tiles should be replaced by a licensed tiler.

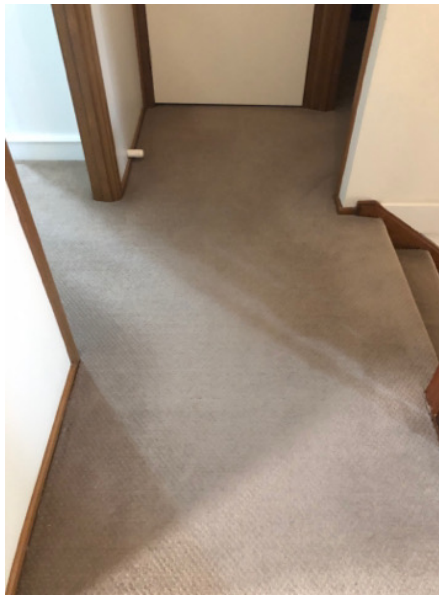
Squeaky floor boards noted. Re-fixing the floor boards may fix this issue.

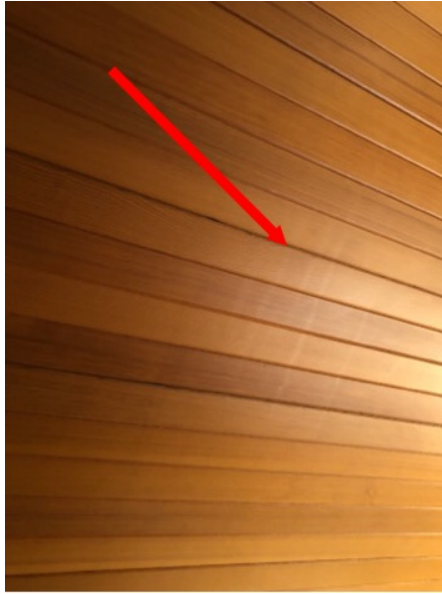
Ceiling stains - No moisture readings obtained. Recommendations: These may have been repaired, however, you will need to monitor after a prolonged period of rainfall - If leaking persists, a qualified plumber should be engaged for advice and recommendations. All water damaged plaster replaced by a qualified plasterer.

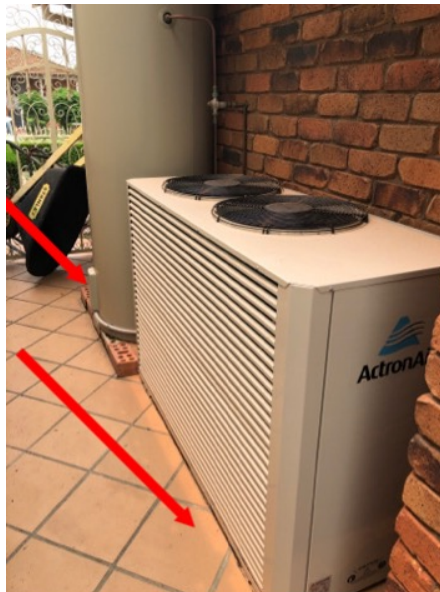
Hot water unit overflow not connected to drain. This provides conducive conditions for termite infestation. The degree of risk is moderate to high. Engage plumber to rectify.

Garden beds against walls are conducive to termite activity and may conceal termite entry. Recommend garden beds be moved away from the building.
