# Inspection Report

**1 Eucalypt Place, Heritage Park, QLD, 4118**

Report/Agreement #      140125112928608

Inspection Date:      14 Jan 2025

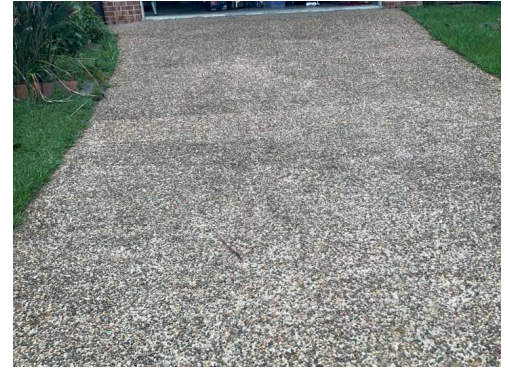
Common cracks were observed on the driveway. Whilst these cracks appeared to be typical at the time of inspection, we strongly recommend you monitor these cracks and if worsening occurs contact a concreter for further advice.

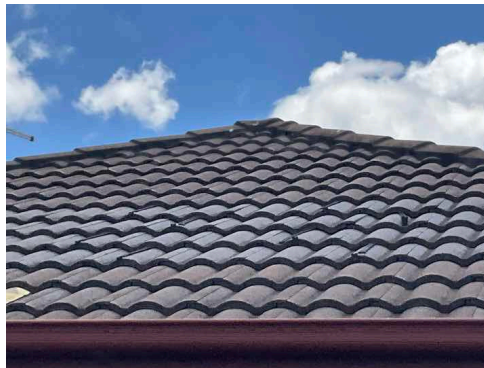
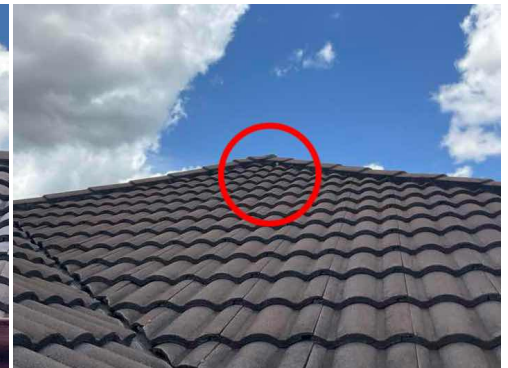
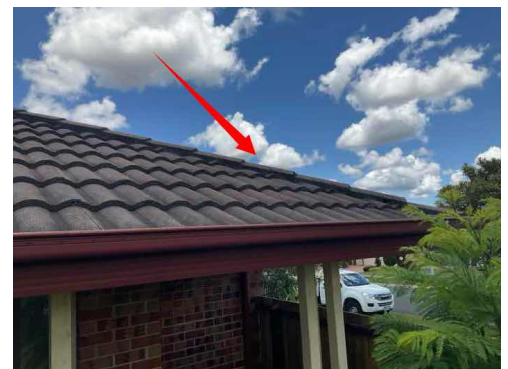
On inspection, defects were noted that may require further assessment and recommendations by licensed roofer.

Mortar cracks visible. We recommend having these repaired by a qualified roofer as they may contribute to water ingress.

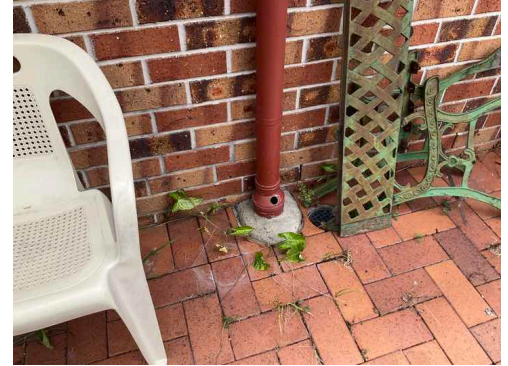
The downpipe base is damaged/cracked. This has the potential to cause leaking. Recommendations: A qualified plumber should be engaged for repairs.

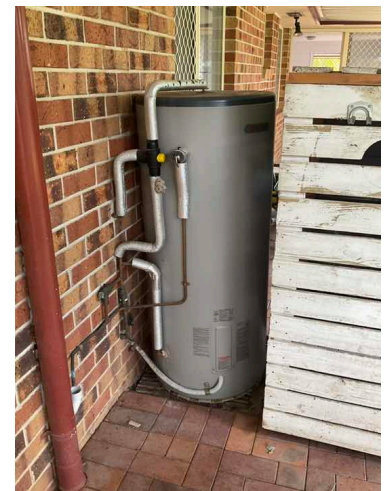
Brick weep holes are concealed in areas and should always be kept clear of earth, concrete and vegetation as this provides an entry point for moisture to enter structural wall frames and undetected termite entry, recommend 75mm clearance refer to timber pest inspection report.

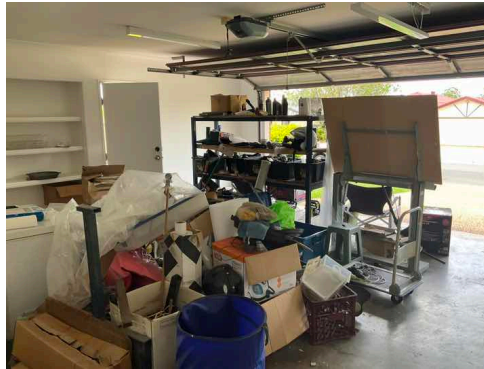
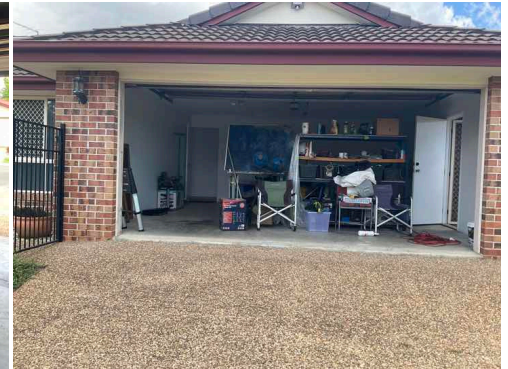
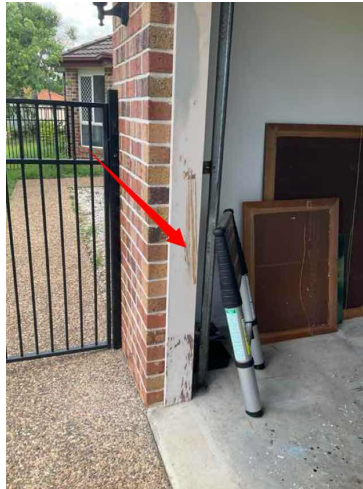
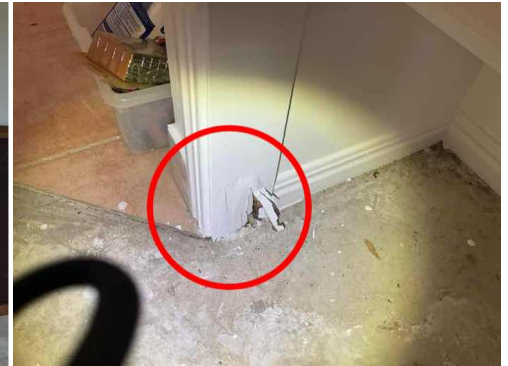
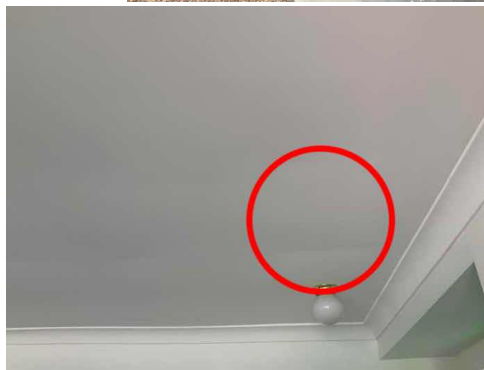
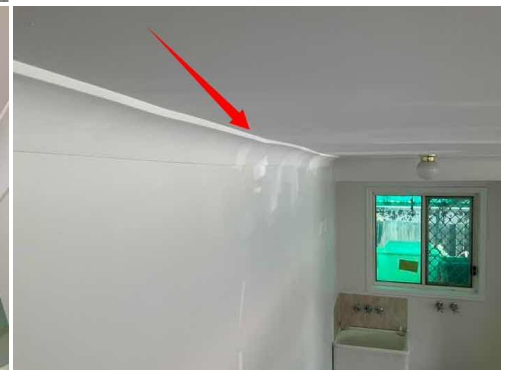
GARAGE - CARPORT	Garaging	Internal Wall Findings	Evidence of previous termite workings noted. No live termites detected at the time of the inspection Recommend a qualified carpenter to further information . Where visual evidence of termite workings and/or damage is reported, but no live termites were present at the time of inspection, you must realise that it is possible that termites are still active in the immediate vicinity and the termites may continue to cause further damage. It is not possible, without benefit of further investigation and inspection over a period of time, to ascertain whether any infestation is active or inactive. Active termites may simply have not been present at the time of inspection due to a prior disturbance, climatic conditions, or they may have been utilising an alternative feeding source. Continued, regular, inspections are essential. Unless written evidence of a termite protection program in accord with "Australian Standard 3660" is provided, a treatment should always be considered to reduce the risk of further attack.

On inspection, defects were present that will require further assessing and recommendations by qualified trades persons, please read below for details.

Evidence of previous termite workings noted. No live termites detected at the time of the inspection. Recommend a qualified carpenter to further investigate. Where visual evidence of termite workings and/or damage is reported, but no live termites were present at the time of inspection, you must realise that it is possible that termites are still active in the immediate vicinity and the termites may continue to cause further damage. It is not possible, without benefit of further investigation and inspection over a period of time, to ascertain whether any infestation is active or inactive. Active termites may simply have not been present at the time of inspection due to a prior disturbance, climatic conditions, or they may have been utilising an alternative feeding source. Continued, regular, inspections are essential. Unless written evidence of a termite protection program in accord with "Australian Standard 3660" is provided, a treatment should always be considered to reduce the risk of further attack.

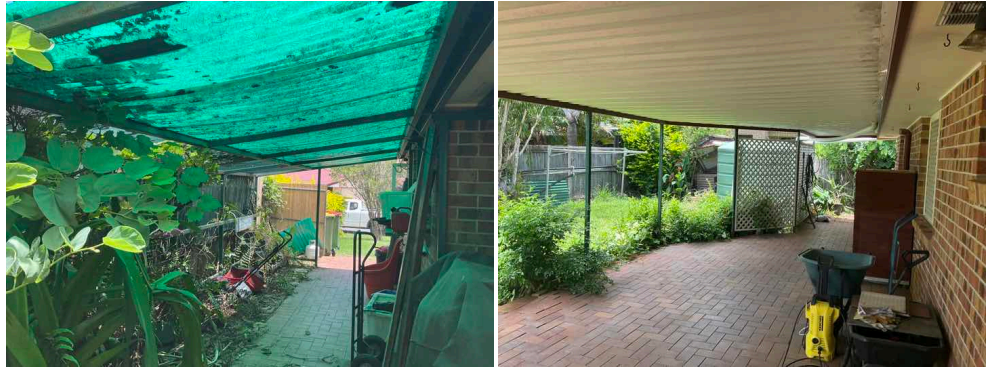
Some rust beginning to attack the metal members. Have checked by a suitably qualified tradesman.

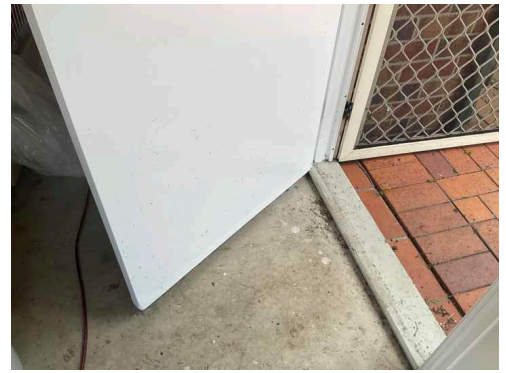
Rear door / frame deterioration - General age/damage has occurred to door frame, face or components. Recommendations: A qualified carpenter should be engaged for advice and recommendations.

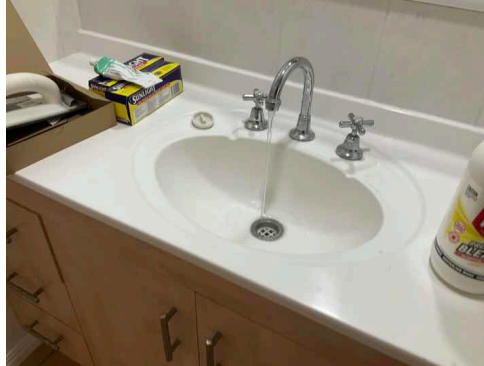
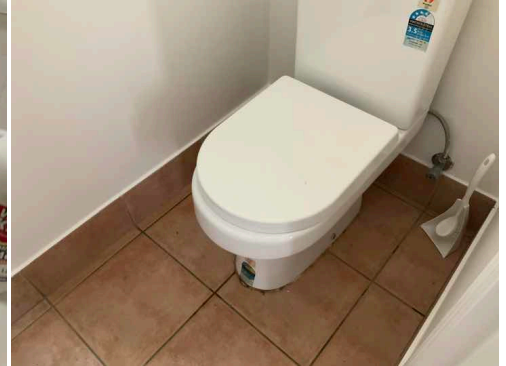
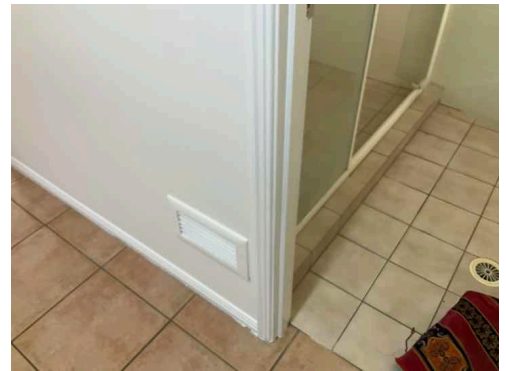
On inspection, defects were present that will require further assessing and recommendations by licensed and qualified trades persons, please read below for details.

Upon visual inspection, it is advised to engage a licensed waterproofing specialist to assess and seal all joins or junctions in wet areas effectively. This action is crucial to mitigate potential water leaks and subsequent damage. Accurate assessment of moisture can not be achieved due to the property being vacant at the time of the inspection

Pan is loose at the base. Contact a qualified plumber for repairs.

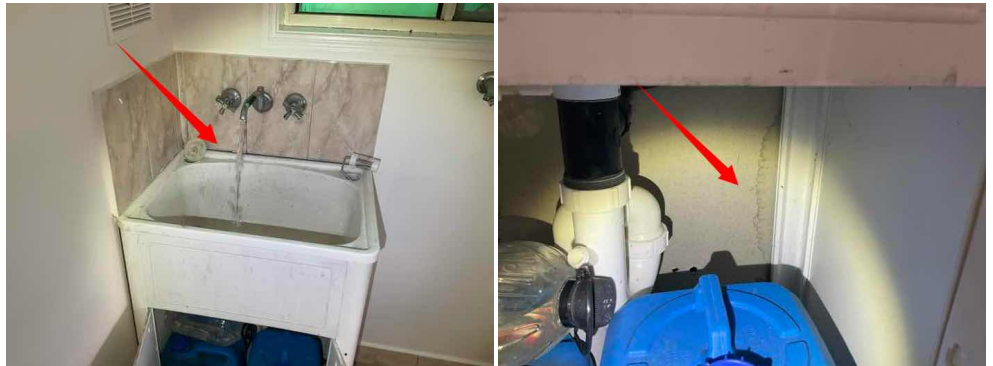
KITCHEN & LAUNDRY	Laundry	Taps and Tub	Moisture staining to wall linings below laundry tub, no evidence of leaking was detected at the time of the inspection. Advise engaging a qualified plumber for further investigation
CONCLUSION	Condition Of Inspected Structure	The incidence of Major Defects	The incidence of major defects in this residential building as compared with similar buildings is considered TYPICAL

Bench top and splash back junction sealing deteriorated. Re-sealing by a plumber or general maintenance contractor is recommended to prevent water access behind the bench.

Moisture staining to wall linings below laundry tub, no evidence of leaking was detected at the time of the inspection. Advise engaging a qualified plumber for further investigation

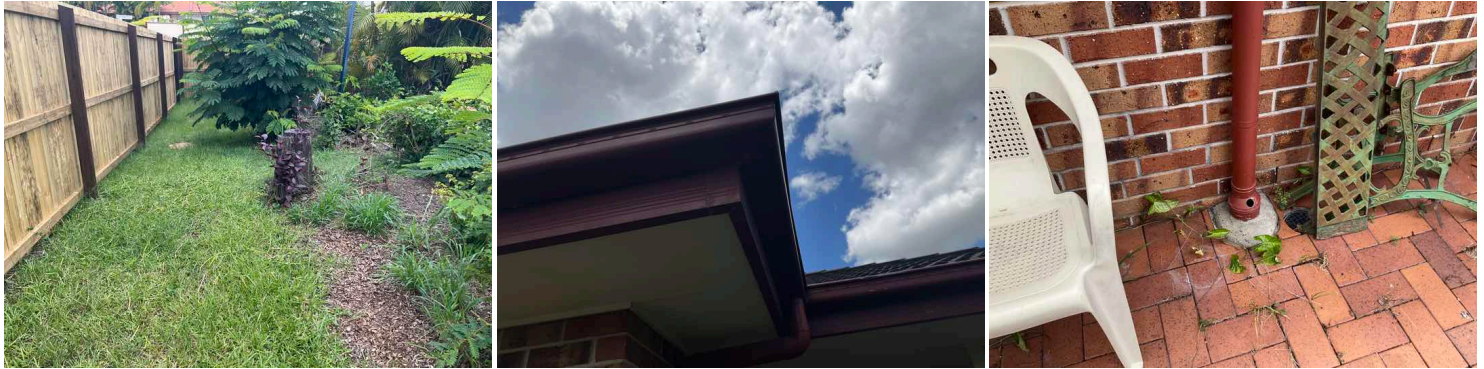
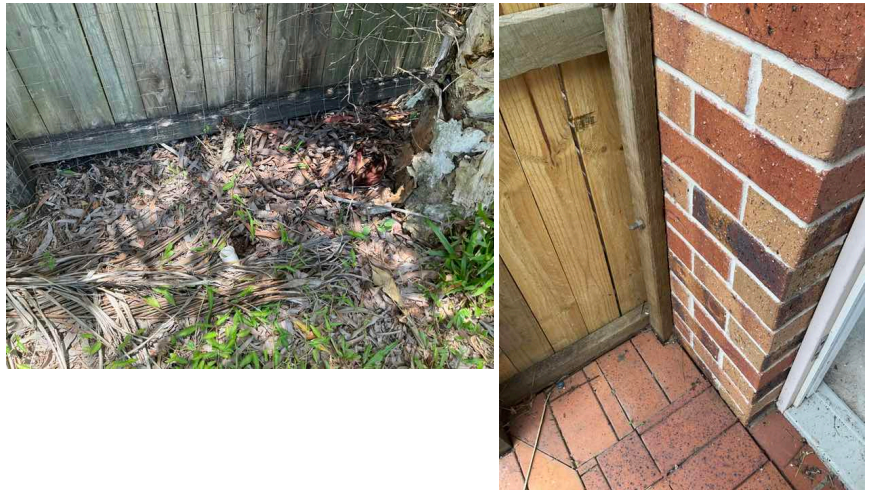
Vents/weep holes covered by soil/debris. This provides concealed entry for termites. Vents and weep holes need to be clear of any debris and fully open.

Areas where high moisture/previous moisture & fungal decay have been identified  
Garden/landscape timbers
