Pre Purchase Building and Pest Report

Inspection Address

32 The Comenarra Parkway, Thornleigh, NSW, 2120

Report/Agreement #	02122212501693
Inspection Date:	02 Dec 2022
Inspection Time:	12:50 pm

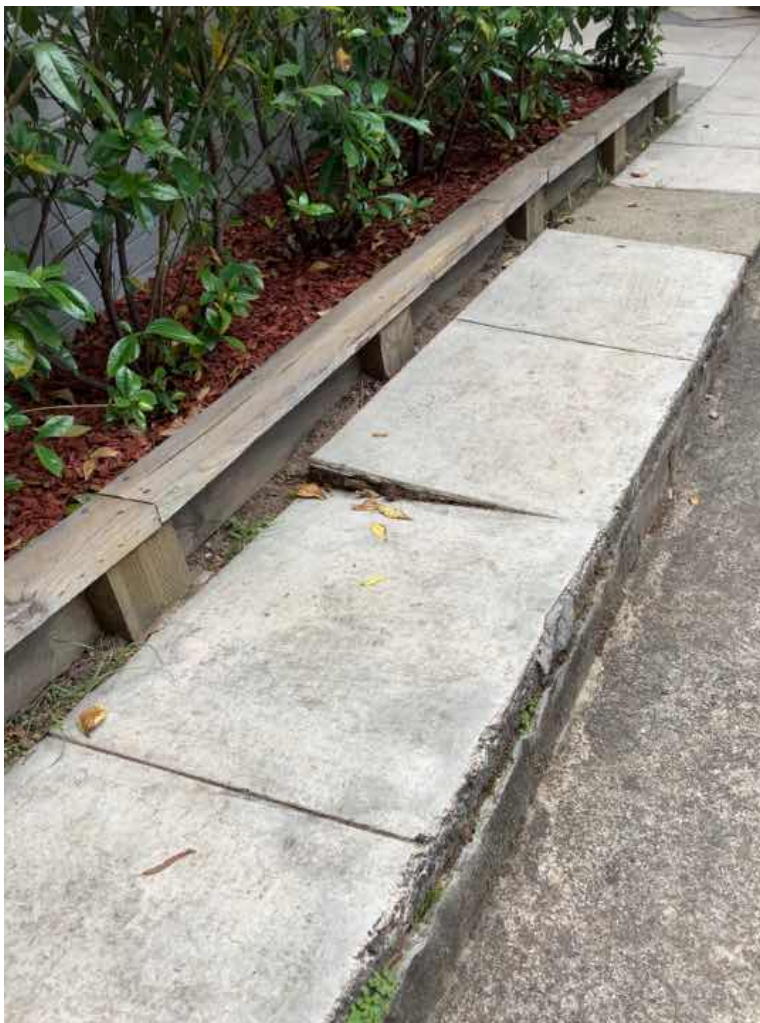
Pathways Condition

Surface raised and settled in some areas. This can cause water ponding. Relaying recommended.

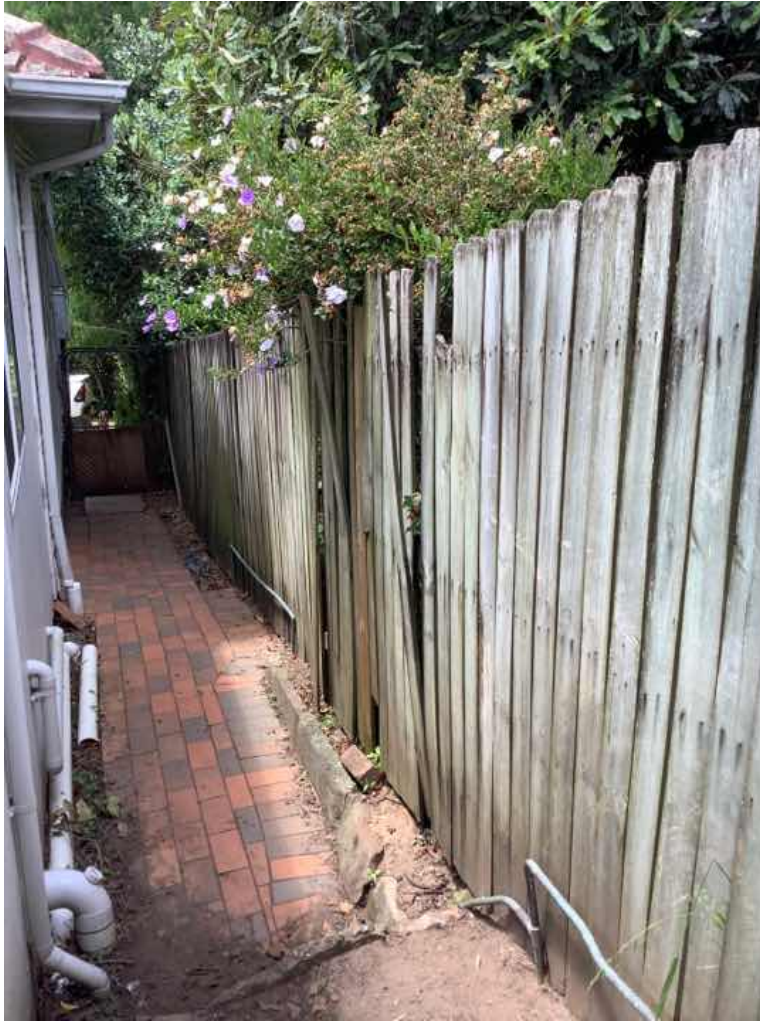
General age to left side fence components - Recommendations: General upkeep and maintenance. A qualified fencing contractor should be engaged for repairs

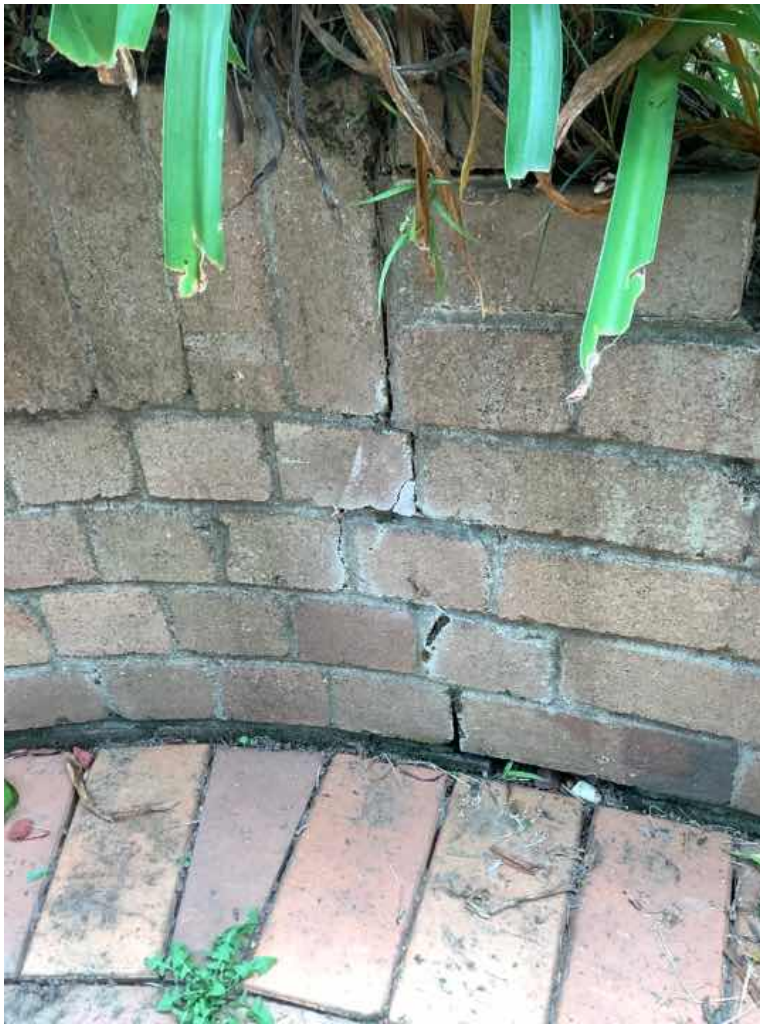
Retaining wall cracking - Recommendations: A qualified brick layer should be engaged for advice and recommendations.

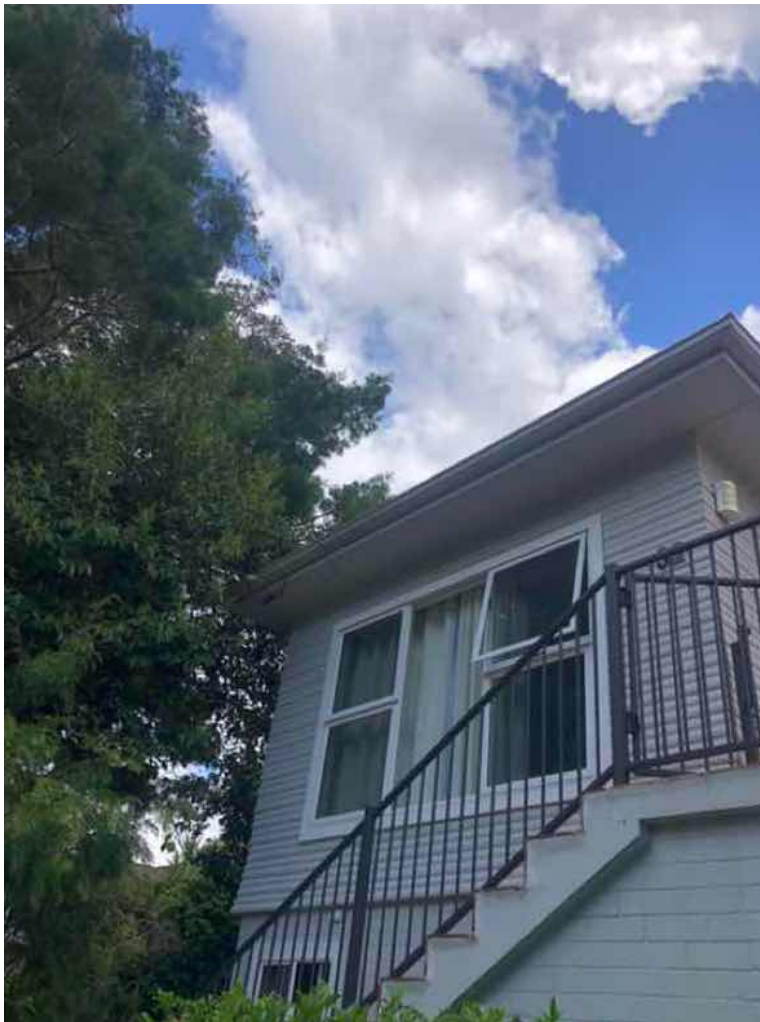
Trees are overhanging roof areas. Recommendations: These should be cut back away from the roof line and gutters.

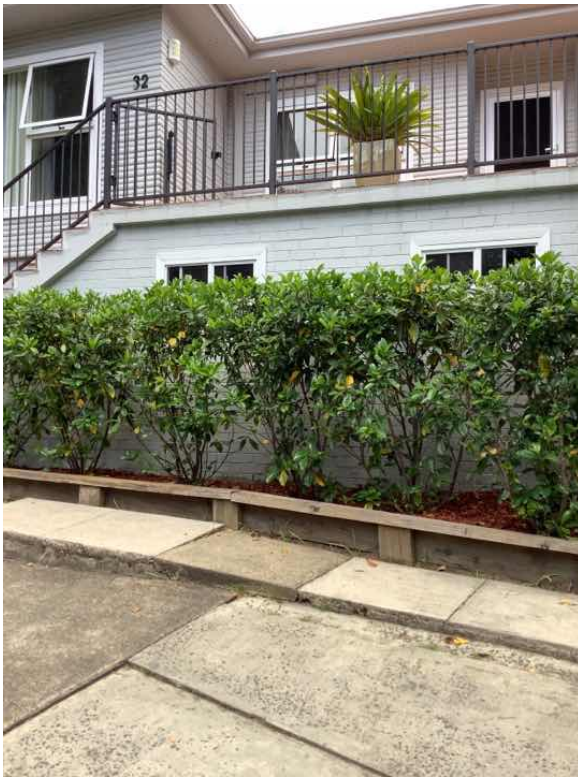
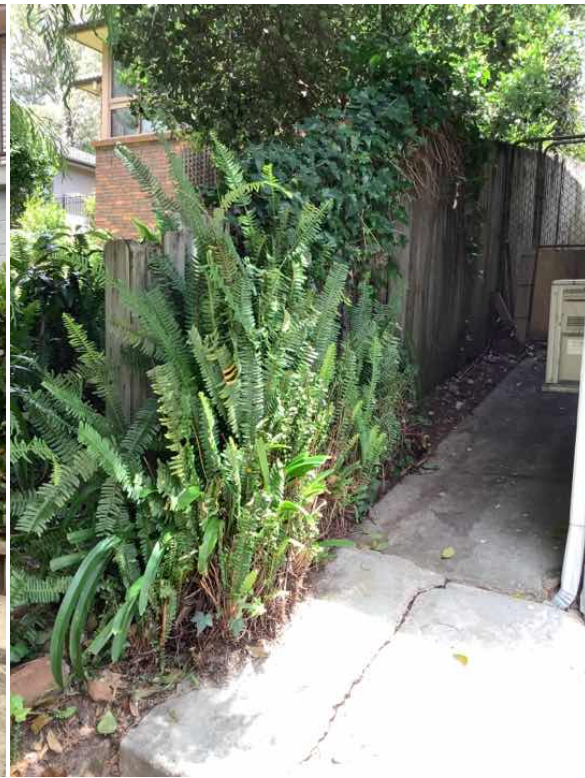
All vegetation growing against the building/fencing requires cutting back to prevent long term maintenance problems such as pest and vermin infestation.

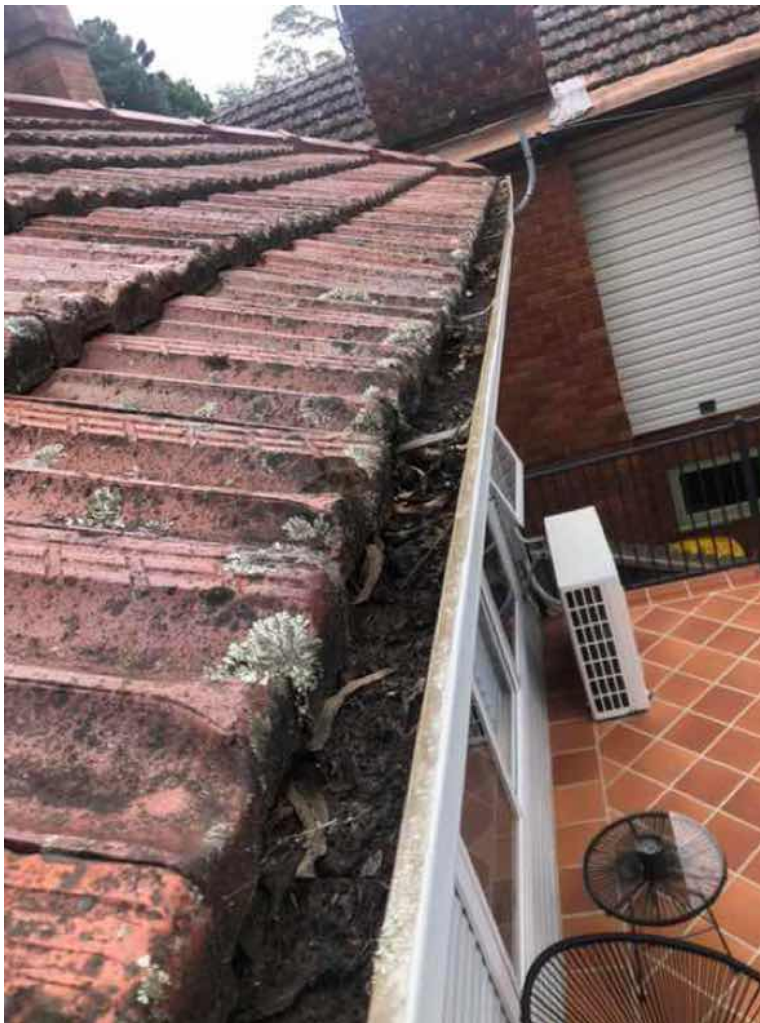
Debris in guttering areas- this requires cleaning out to prevent blocking of down pipes and leaking into eaves and fascia. Also regularly clean to prevent ponding. Ponding water will contribute to rust.

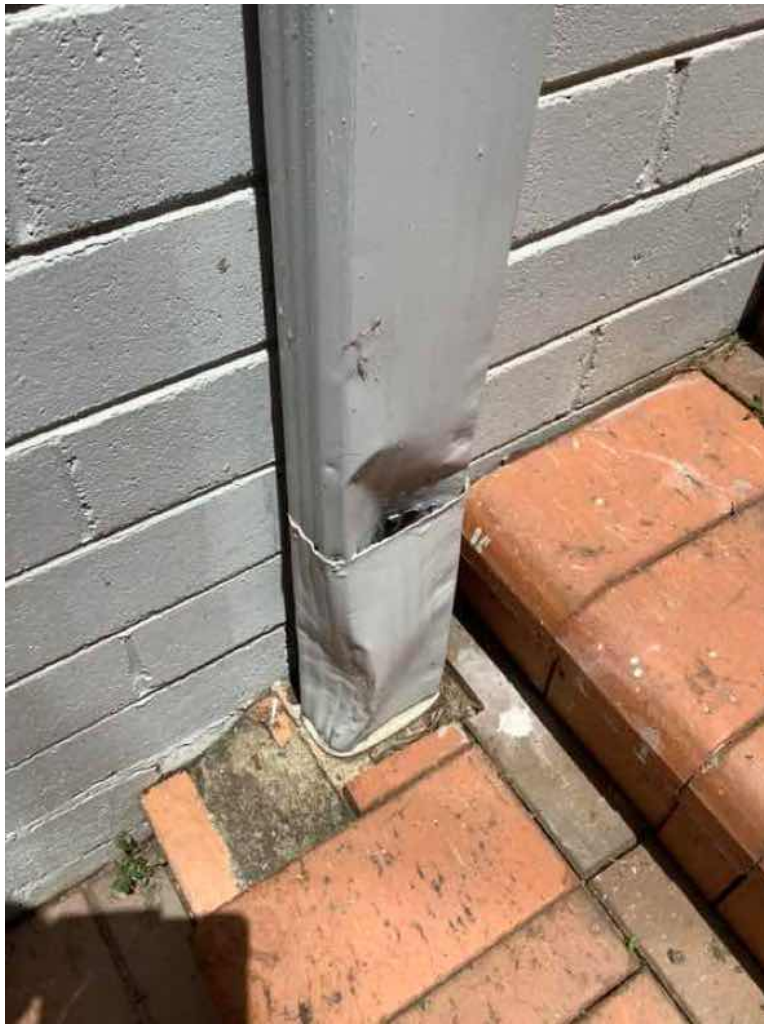
Impact damage noted to down pipe on right side. Contact a roof plumber for replacement as required.

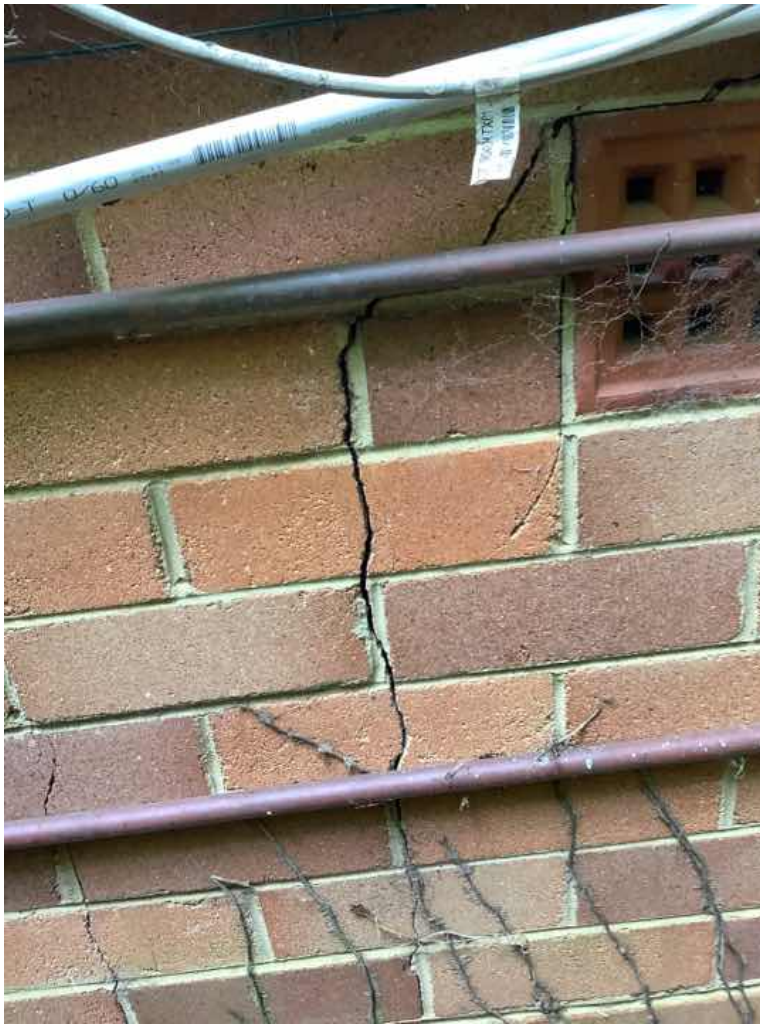
There appears to have been some settlement in the building which has caused some cracking to the walls on left side. These crack are catergorized as 0 to 2. This can also cause some doors to bind or be out of square. In the inspectors opinion these cracks are due to settlement, usually due to ground movement and subsequent movement to building materials can be expected. Any cracks should be monitored and if cracks increase in size, further investigation should be carried out by a structural engineer.

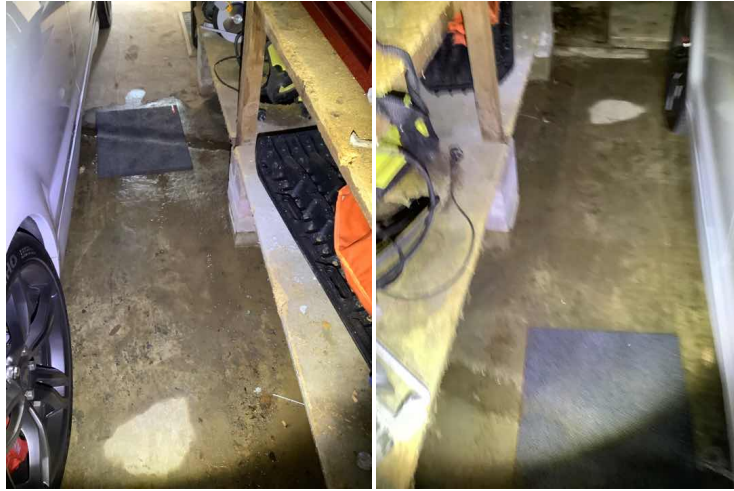
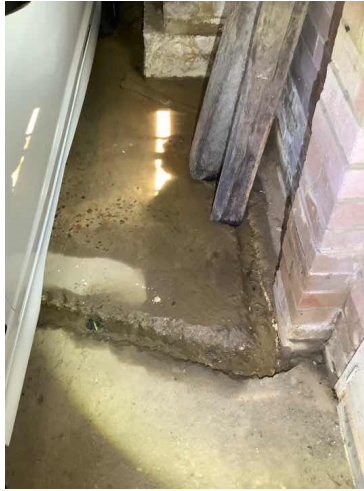
Water appears to have penetrated via the subfloor at rear of garage. Drainage may be required. Recommendations: A qualified plumber should be engaged for advice and recommendations.

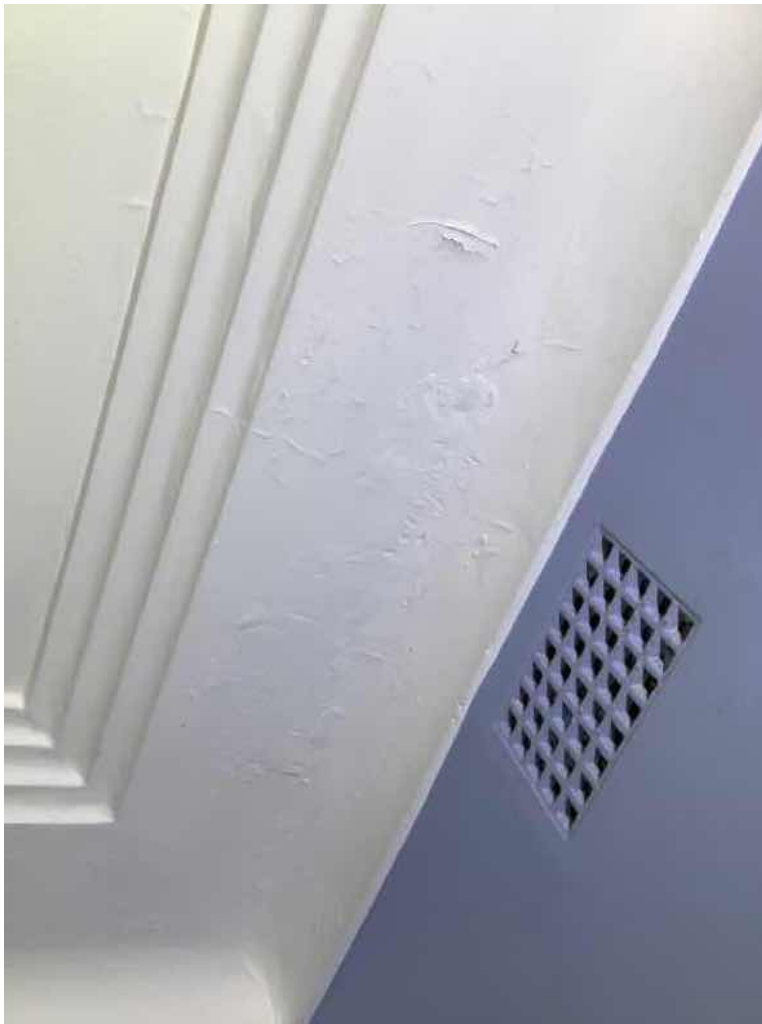
Patching was visible to the ceiling/walls, however further repairs are optional.

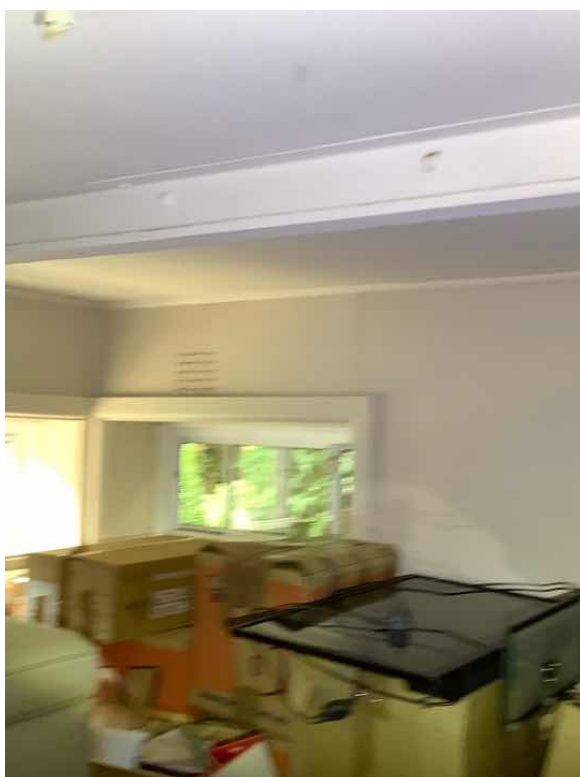
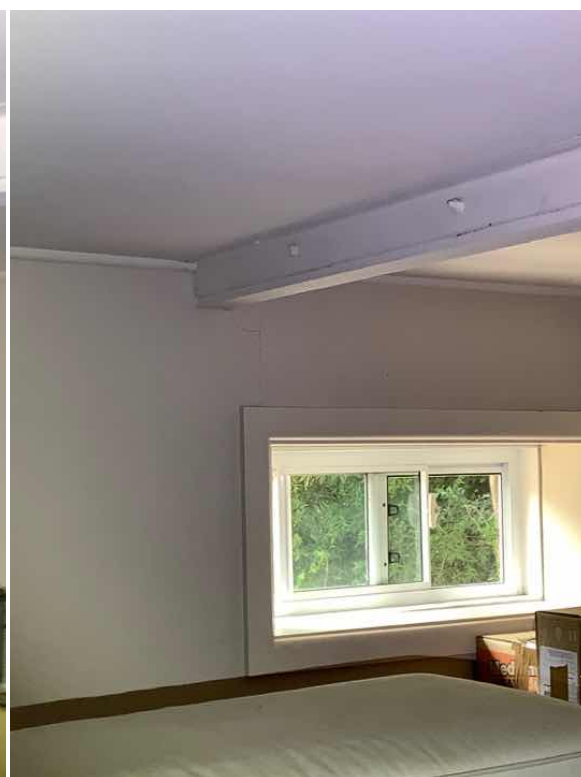
Minor cracking is evident to the wall finishes which should patch and paint successfully if repairs are carried out in a tradelike manner.

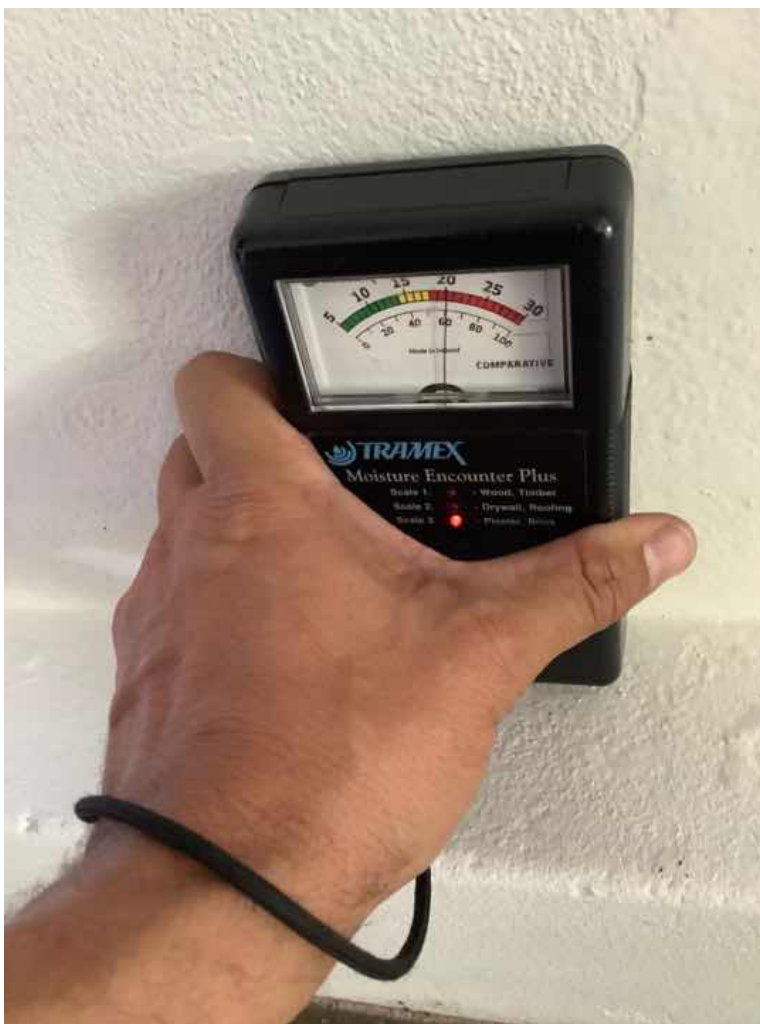
Moderate to high moisture readings were detected to on wall possibly due to lack of a suitable damp course, lack of ventilation to subfloor areas, or inadequate surface drainage to external perimeters. Rectification is required to prevent future deterioration.

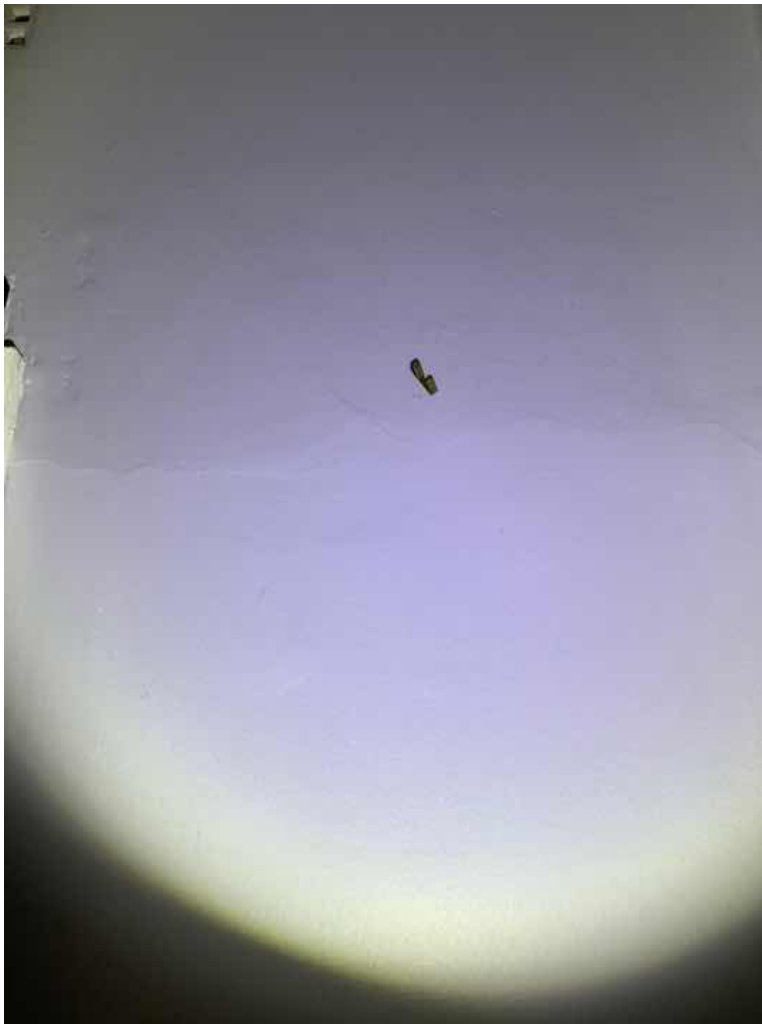
Minor cracking is evident to the wall finishes which should patch and paint successfully if repairs are carried out in a tradelike manner.

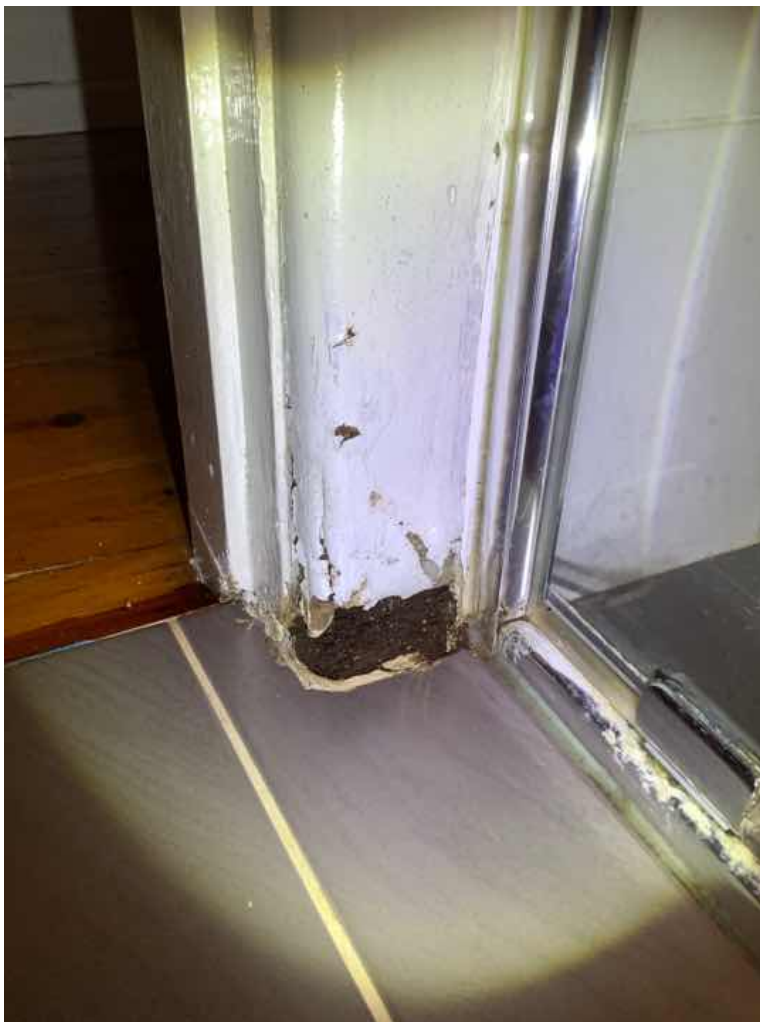
Rot observed to the door frame .This may be related to the shower recess due to being near the door.

Recommendations: I advise re-sealing the shower recess junctions by a qualified by damp proofing contractor.

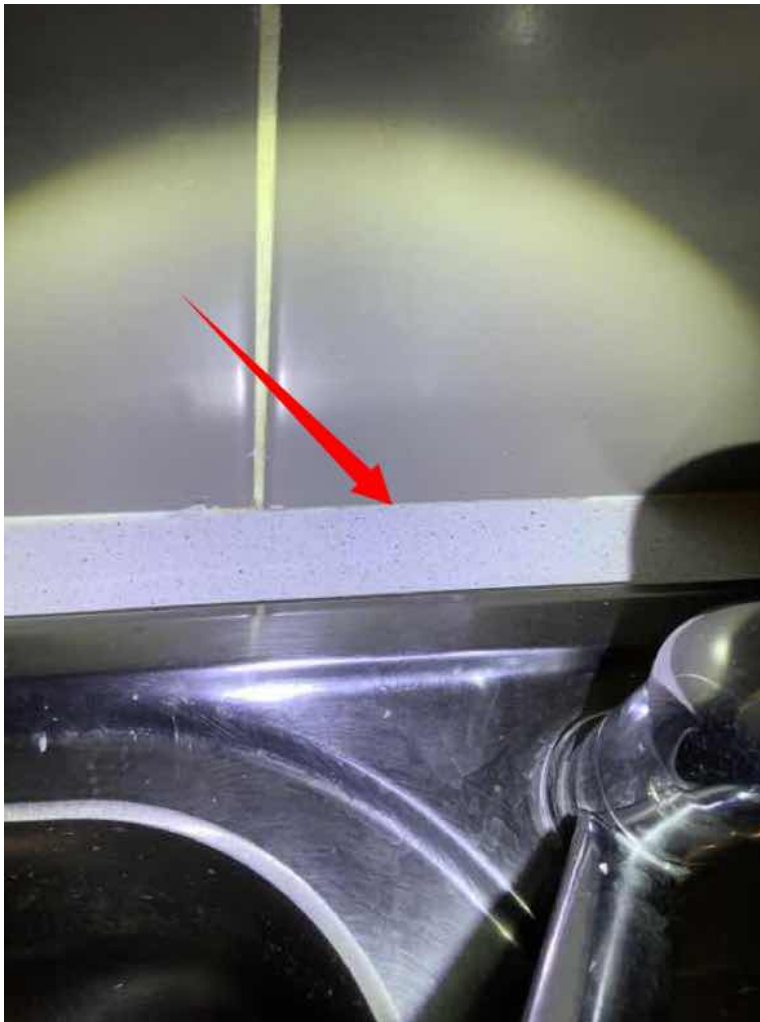
Bench top and splash back junction sealing deteriorated - Recommendations: Re-sealing by a plumber or general maintenance contractor is recommended to prevent water access behind the bench.

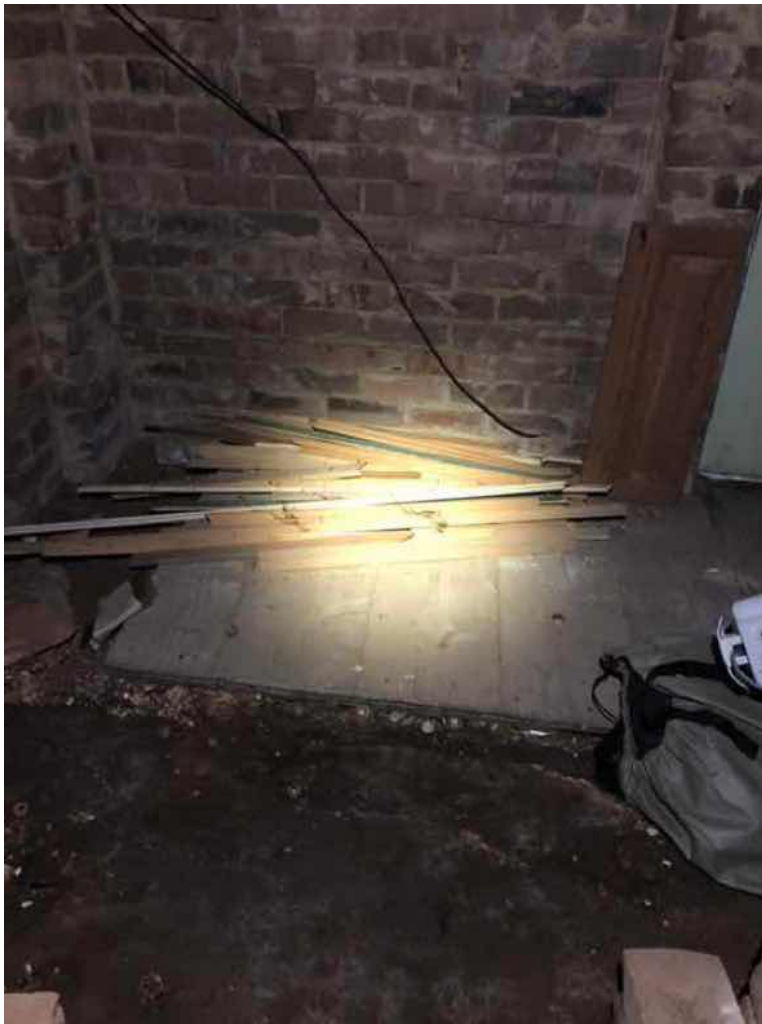
There was debris and other material in the subfloor, we recommend cleaning these to aid with ventilation and reduce the likely hood of rodents and pests.

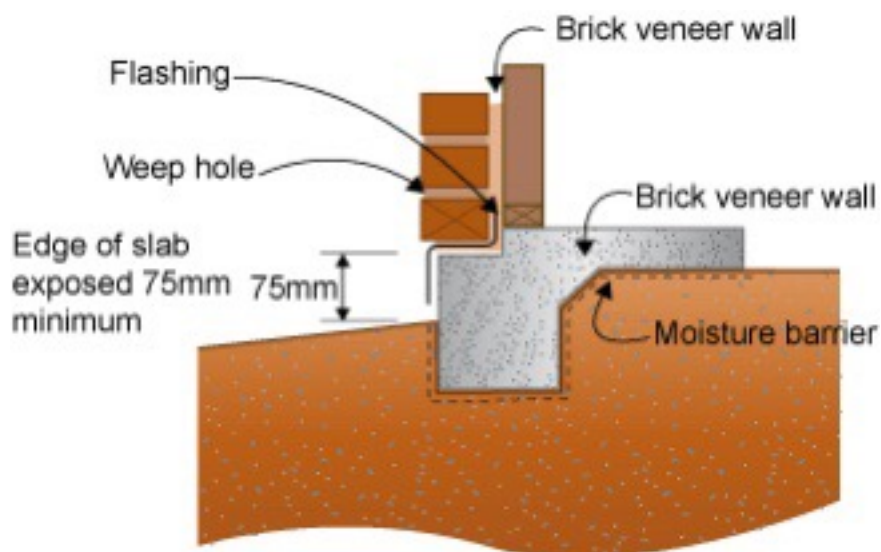
Is the slab edge adequately exposed?

No. Slab edge should be exposed a minimum of 75mm.
