## BUILDING AND TIMBER PEST REPORT

14 Candlenut St  
Ripley, QLD 4306

BYB  
15/04/2025

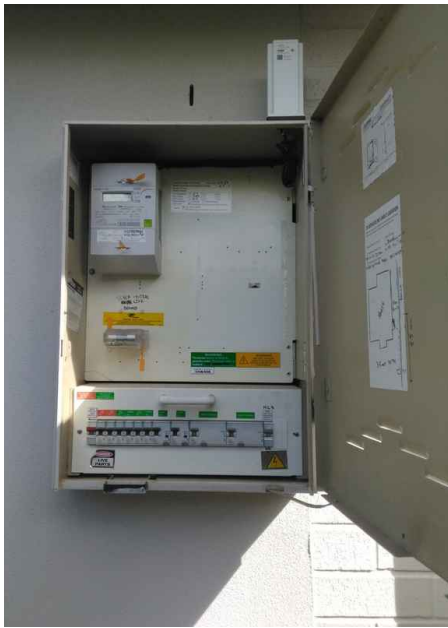
A safety switch was observed, but not tested. It is recommended that the electrical system is fully inspected by a qualified electrician prior to use

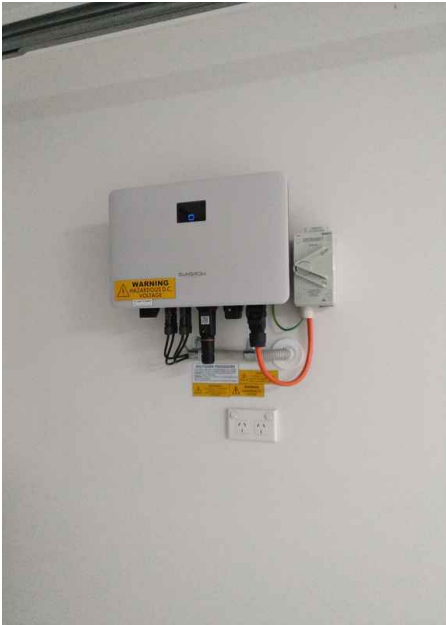
A solar power system including Panels and/or Inverter was observed, but no testing was conducted. Consult a Qualified Electrician to determine the adequacy and current status.

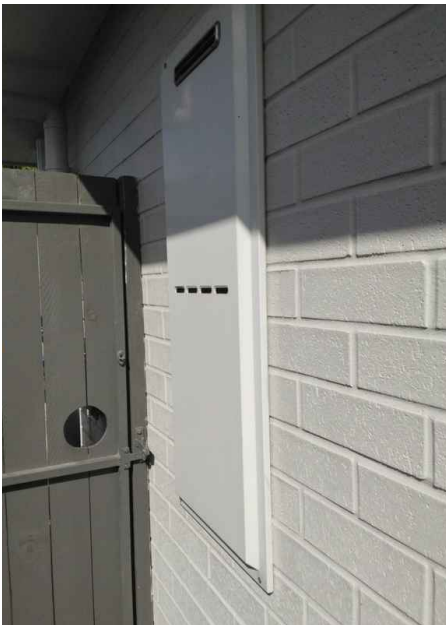
Gas hotwater system

No specific tests were carried out. No determination has been made as to the compliance, suitability or adequacy of the hot water system in relation to capacity, function or lifespan.

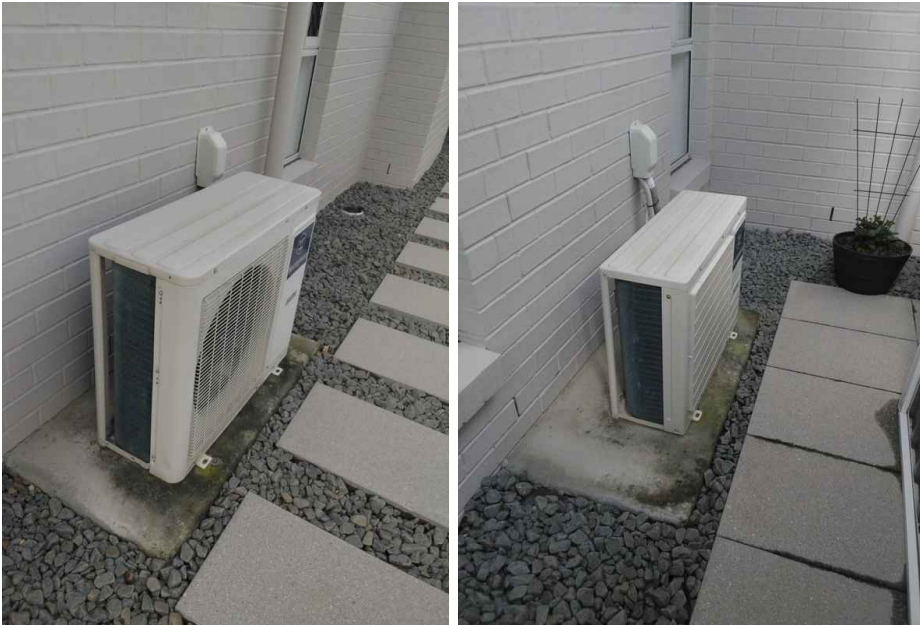
Air-conditioning is installed to the property but has not been tested/inspected. We recommend a licensed air conditioning specialist to determine the status of the units.

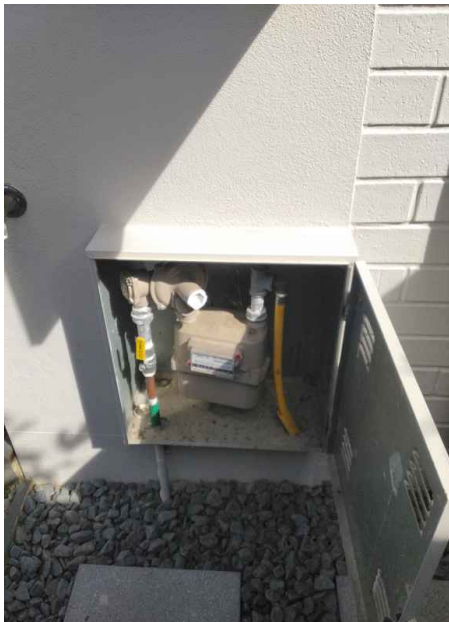
Reticulated Gas (Underground Lines)

A gas system was installed at the Property but was not inspected, tested, or checked for compliance. We recommend testing and inspection by a qualified Gas Plumber prior to use

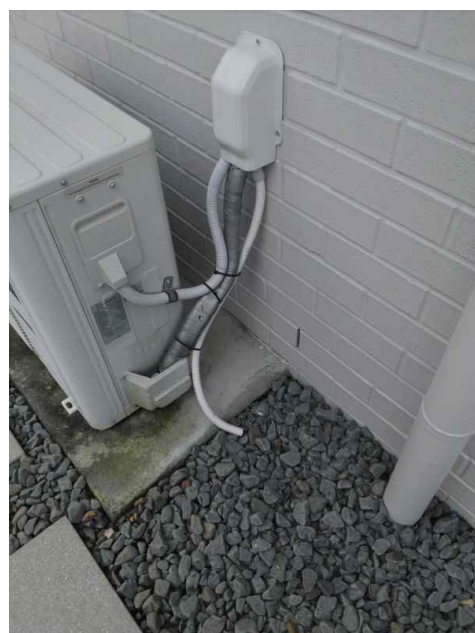
### 6.3.1 Air Conditioning

Minor-Moderate Attention Recommended

#### **DRAINS NEAR FOUNDATIONS**

Excess moisture near the buildings can cause structural issues and encourage timber pest activity.

Best practice is to drain into stormwater (downpipe or other surface drainage) to prevent excess moisture near the building.

Contact a qualified professional.

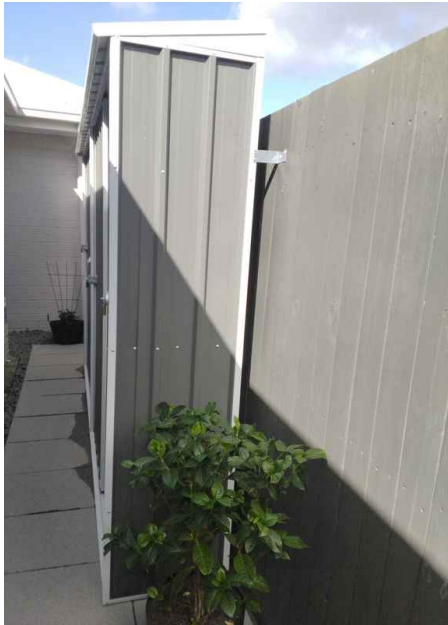
The base of some Timber posts are below ground level or not visible. Access and inspection of any posts is recommended.

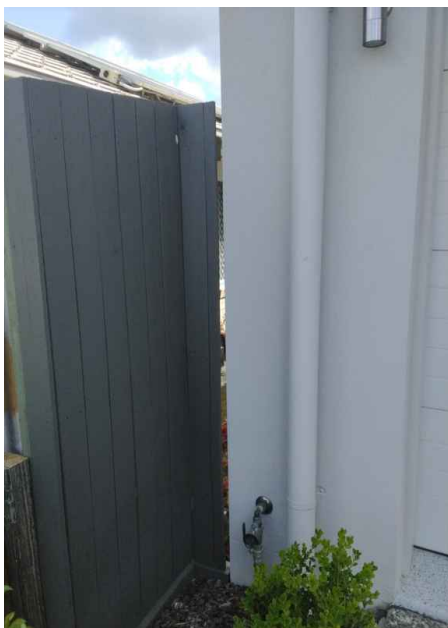
The ability to inspect external walls located in close proximity to title boundaries was limited due to insufficient access.

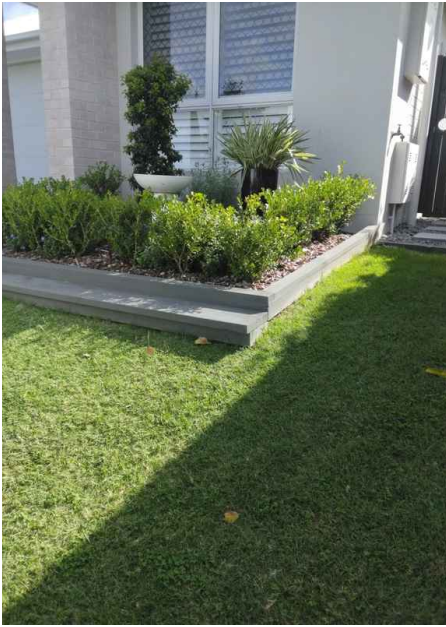
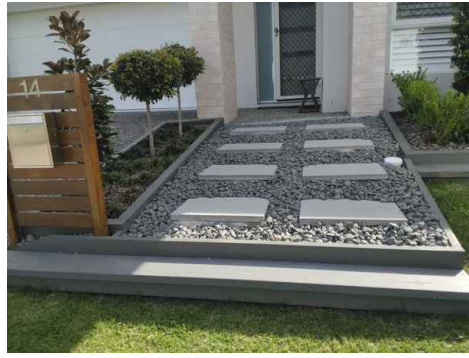
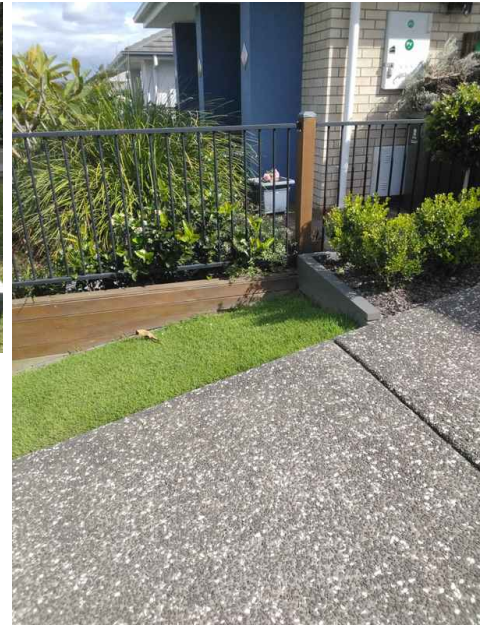
**Site and Exterior: Landscaping Timbers**

Timber in direct contact with the ground and or soil produces are ready food source for termites. Susceptible Timbers used in a hazardous environment are prone to fungal decay. It is recommended that you remove this condition order to prevent timber pest activity.

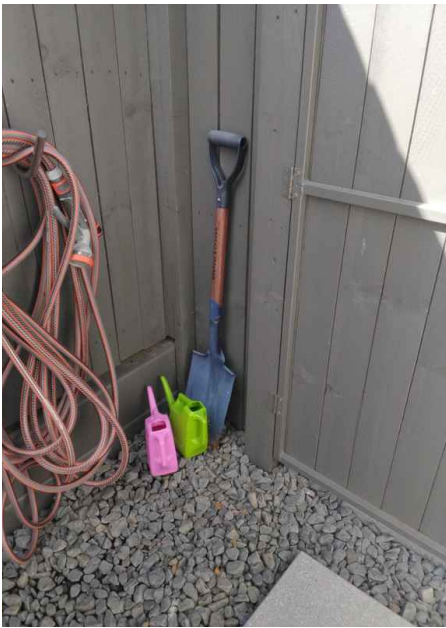
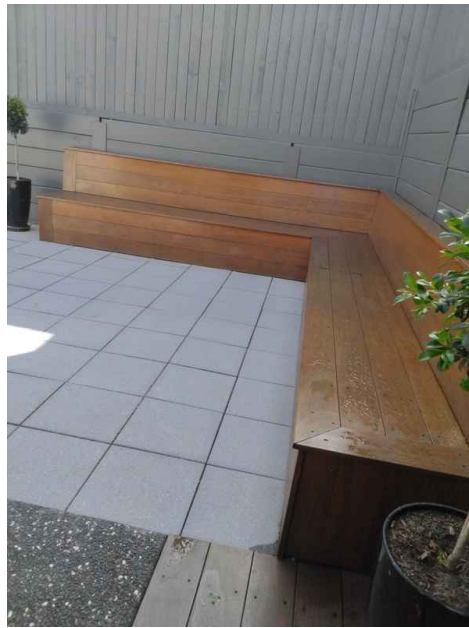
### Site and Exterior: Timber in ground contact

Timber in contact with the ground will raise the moisture content of timber creating conditions conducive to fungal decay. Action is required to remove this condition in order to prevent timber pest activity and structural damage occurring.

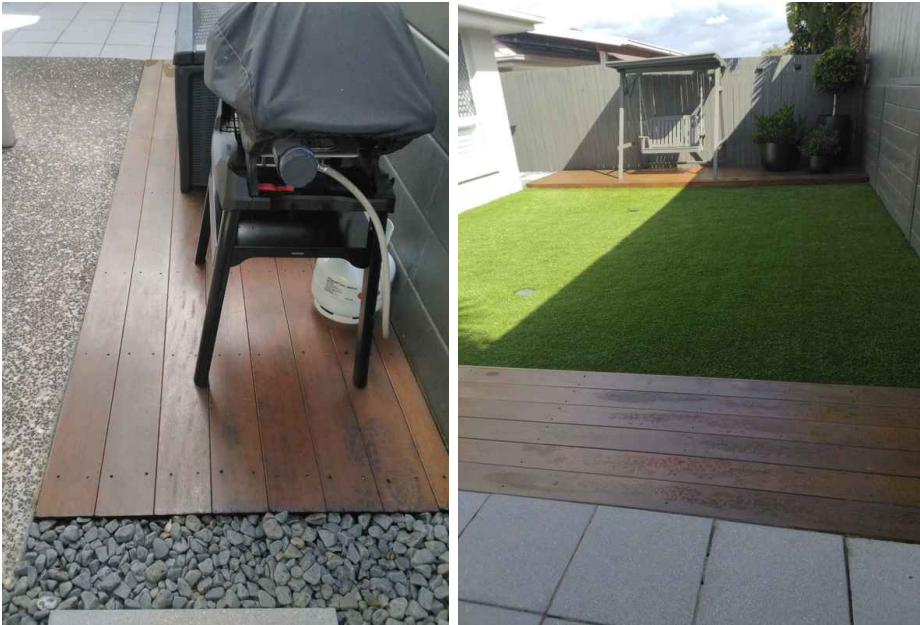
### Site and Exterior: Deck in contact with the ground

Timber deck close to ground The long term performance of timber decking in weather exposed situations is dependant on regular and effective maintenance. The frequency of maintenance will depend on the type of finish and the degree of exposure to the weather.

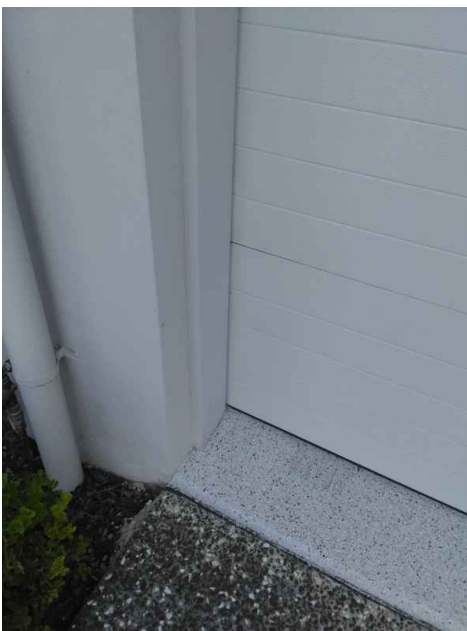
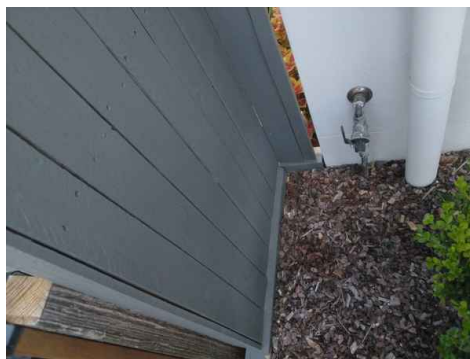
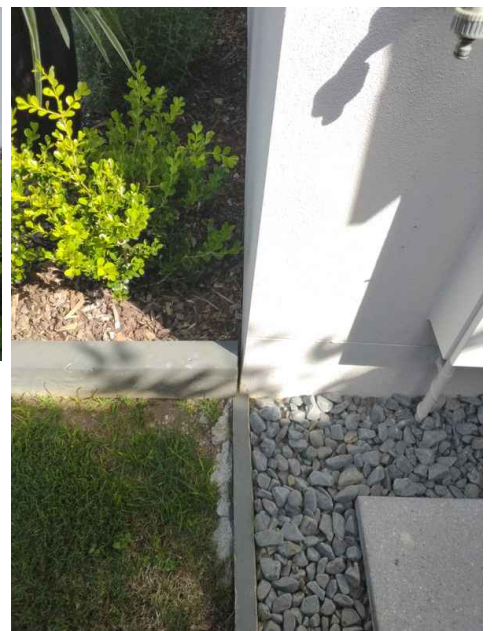
19.4.1 Bridging and Breaching of Termite Barriers and Inspection Zones

Minor-Moderate Attention Recommended

Rectify this condition, Reinspect, and maintain a clear inspection zone around the building

Contact a qualified professional.
