PRE PURCHASE PROPERTY INSPECTION

8 Burgan Place, North Lakes.

Visual Pre Purchase Building & Timber Pest Inspection Report

To comply with Australian Standard AS4349.1-2007 and AS4349.3-2010

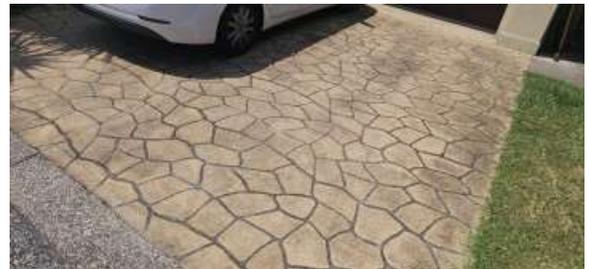
The concrete driveway stands in fair condition.

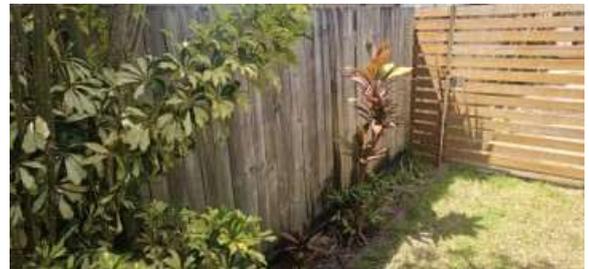
The fences are generally in fair condition but some repairs or maintenance are required.

Wet rot decay and defects were noted to the wooden fencing. Repairs and or replacement of damaged timber will be required.

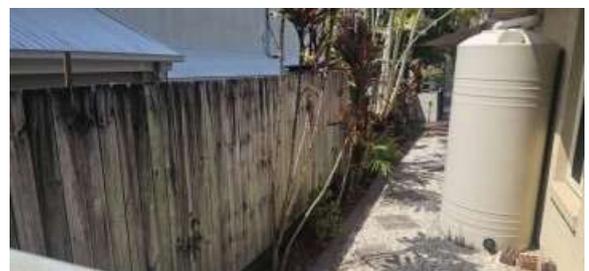
The fences are generally in fair condition but some repairs or maintenance are required.

The fences are leaning and repairs will be required.

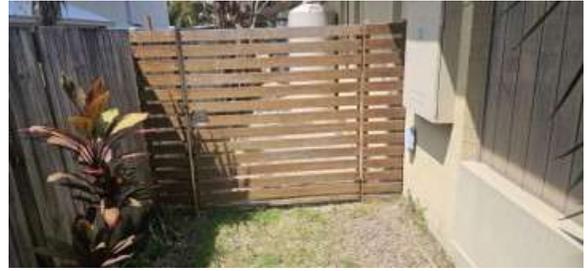
Fence gate/s require repair or replacement.

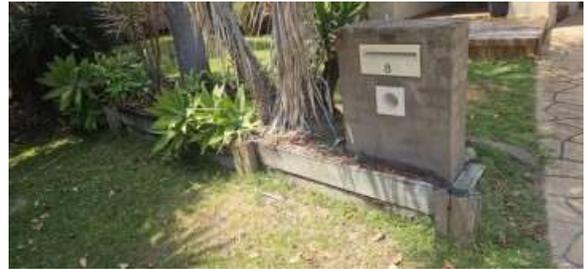
The timber retaining walls show deterioration and should be monitored for additional movement.

Wet rot decay was noted to the retaining wall. Repairs and or replacement of damaged timber will be required.

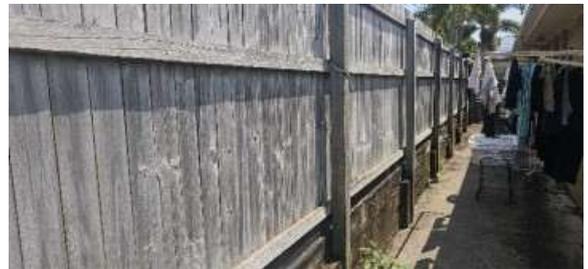
The timber retaining walls show deterioration and should be monitored for additional movement.

Wet rot decay was noted to the retaining wall. Repairs and or replacement of damaged timber will be required.

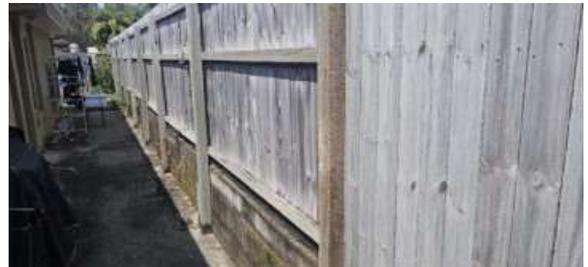
The timber retaining walls show deterioration and should be monitored for additional movement.

Wet rot decay was noted to the retaining wall. Repairs and or replacement of damaged timber will be required.

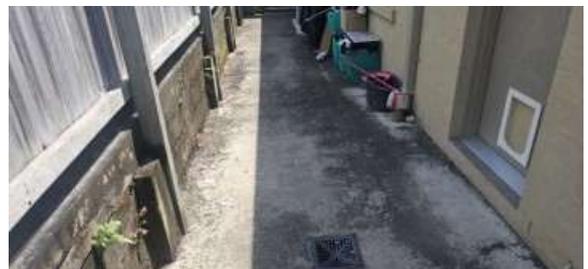
The paths/paved areas are in fair condition.

The paths/paved areas have some visible cracking and damaged areas may require repair and or replacement.

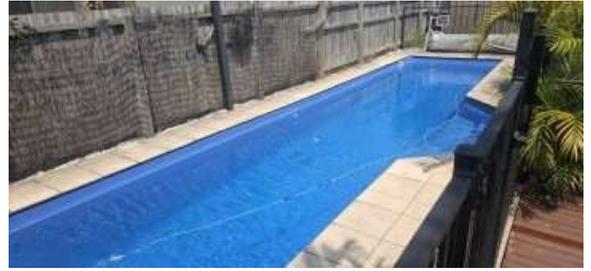
A swimming pool is present. This inspection specifically excludes any inspection of the pool, safety fences or surrounds. An inspection should be made by a specialist pool inspector to determine the condition of the pool, safety fencing and surrounds.

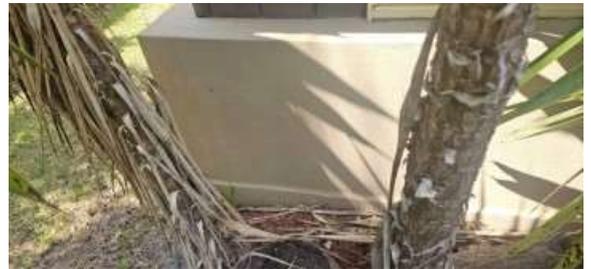
The condition of the walls is generally fair. Cracks are evident to masonry. Visible cracking appears minor. Periodic maintenance may be required. Please refer to section of this report - CRACKING OF BUILDING ELEMENTS for additional details.

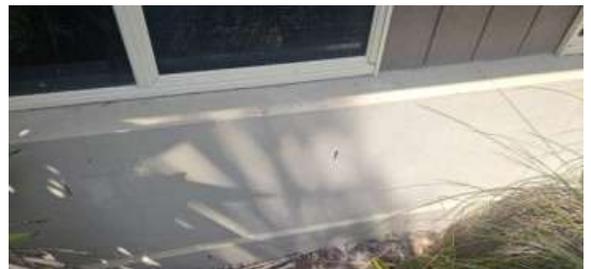
Cracks are evident to masonry. Visible cracking appears minor. Periodic maintenance may be required. Please refer to section of this report - CRACKING OF BUILDING ELEMENTS for additional details.

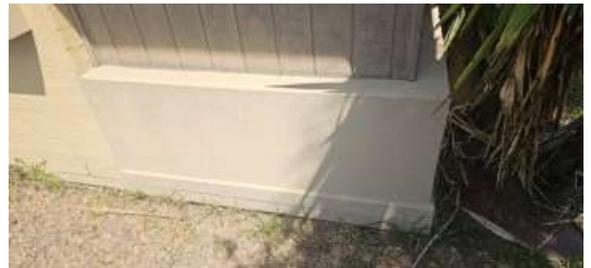
Cracks are evident to masonry. Visible cracking appears minor. Periodic maintenance may be required. Please refer to section of this report - CRACKING OF BUILDING ELEMENTS for additional details.

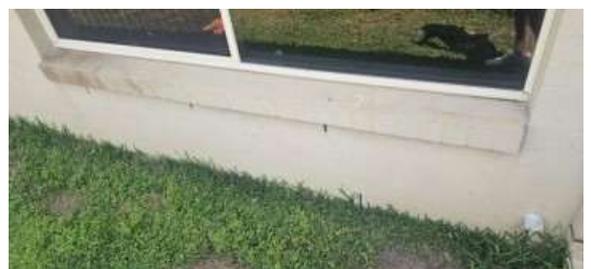
Cracks are evident to masonry. Visible cracking appears minor. Periodic maintenance may be required. Please refer to section of this report - CRACKING OF BUILDING ELEMENTS for additional details.

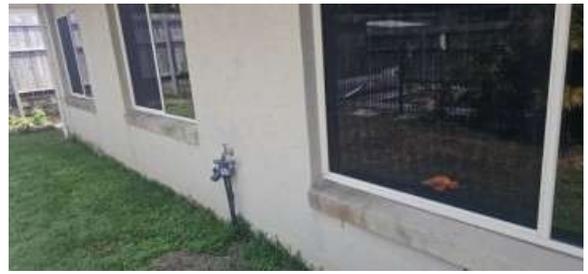
Minor maintenance and or repair required prior to next repainting.

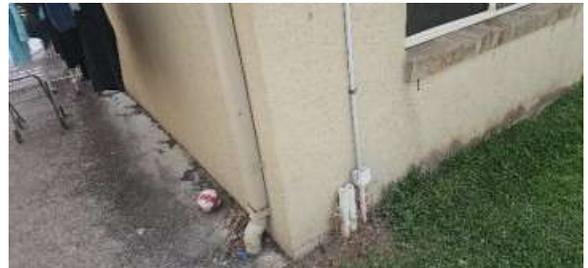
Cement render to the external walls is damaged and will require repair and maintenance.

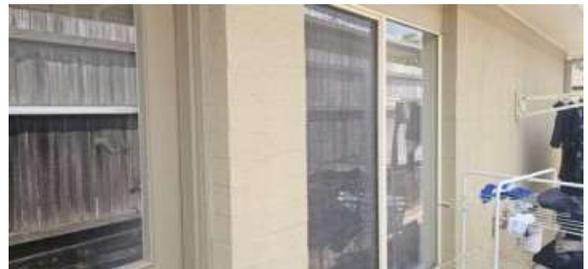
The condition of the exterior of the windows is generally fair.
Insect screen/s are damaged and require repair or replacement.

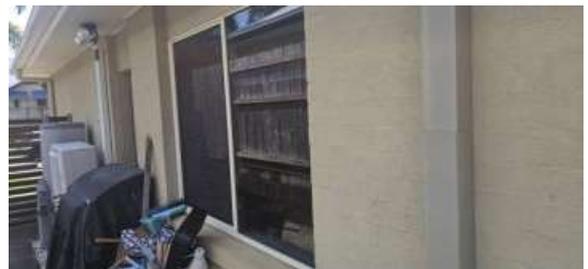
Insect screen/s are damaged and require repair or replacement.

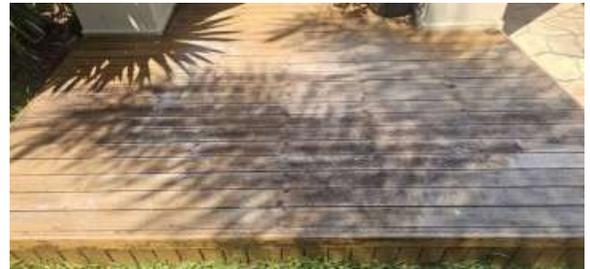
Defects Or Maintenance Items:
Age and weathering noted and repairs required.

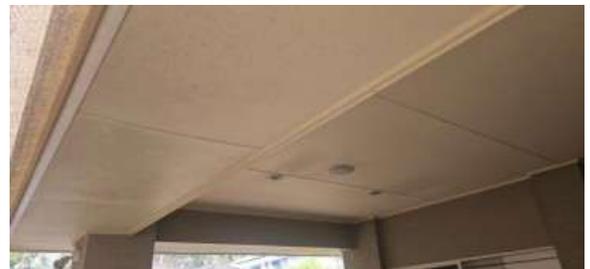
Defects Or Maintenance Items:
Mould was noted to the eaves lining. The cause of this mould should be further investigated by an expert in mould detection and analysis. Recommend a specialist be commissioned to report on all mould present to this property.

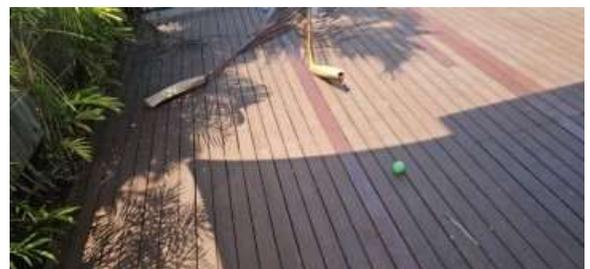
Repairs required in areas to deck
Some timbers of this structure are in contact with soil. This situation can allow concealed termite entry and we recommend that modifications be made.

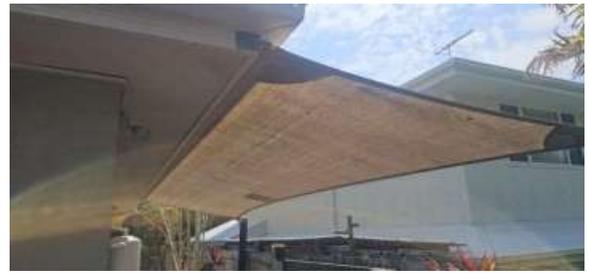
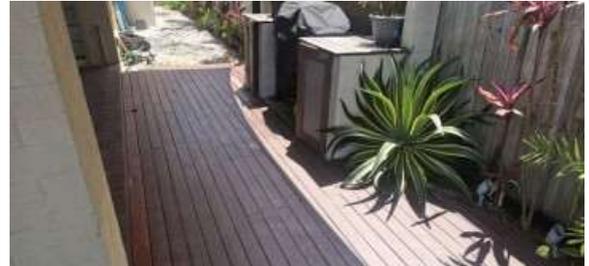
Access was not possible below some or all of the structure due to the method of construction. It is possible that building defects may be present below inaccessible areas however, no comment is made or opinion offered on any area where full access is not available. We STRONGLY recommend that access be gained to all inaccessible areas.

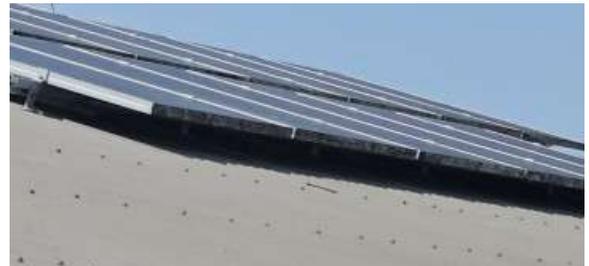
Solar panels have been installed to the external roof surface restricting inspection of the roofing material. Defects and or roofing material damages that can lead to water entry may be in areas not accessible.

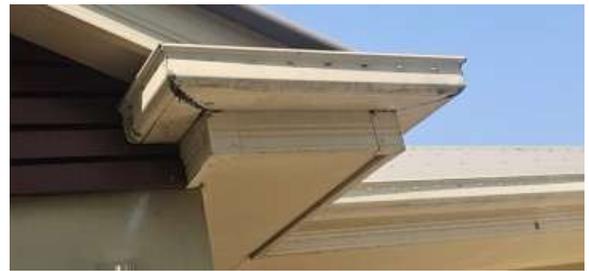
Guttering joints are leaking and repairs/maintenance required.
Water is ponding in the gutters and they require realigning.

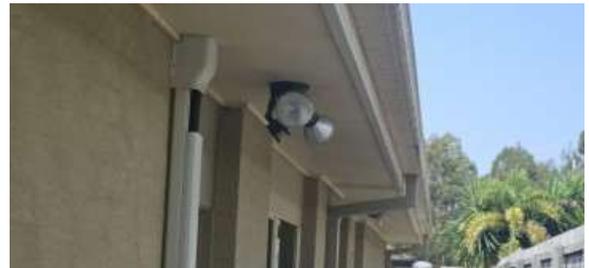
Mould was noted to the eaves lining. The cause of this mould should be further investigated by an expert in mould detection and analysis. Recommend a specialist be commissioned to report on all mould present to this property.
Water is ponding in the gutters and they require realigning.

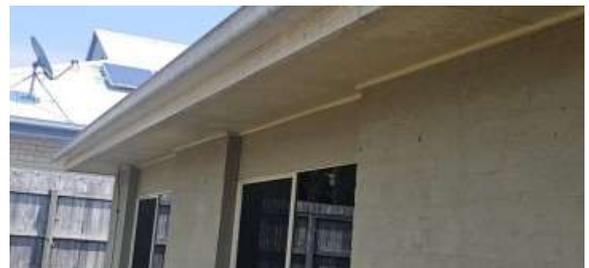
Mould was noted to the eaves lining. The cause of this mould should be further investigated by an expert in mould detection and analysis. Recommend a specialist be commissioned to report on all mould present to this property.
Water is ponding in the gutters and they require realigning.

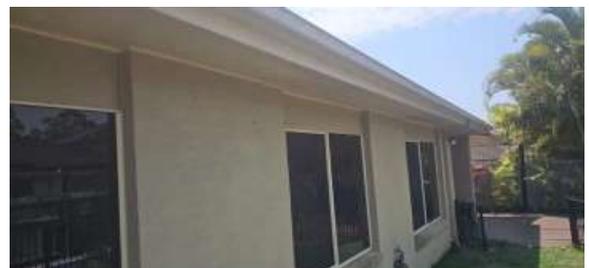
Mould was noted to the eaves lining. The cause of this mould should be further investigated by an expert in mould detection and analysis. Recommend a specialist be commissioned to report on all mould present to this property.
Water is ponding in the gutters and they require realigning.

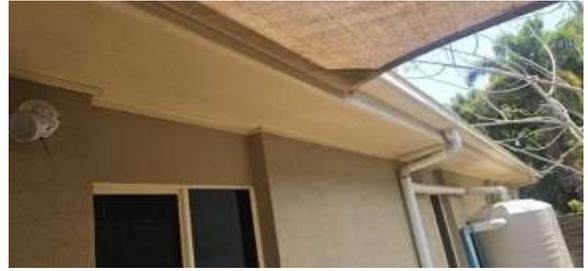
Mould was noted to the eaves lining. The cause of this mould should be further investigated by an expert in mould detection and analysis. Recommend a specialist be commissioned to report on all mould present to this property.

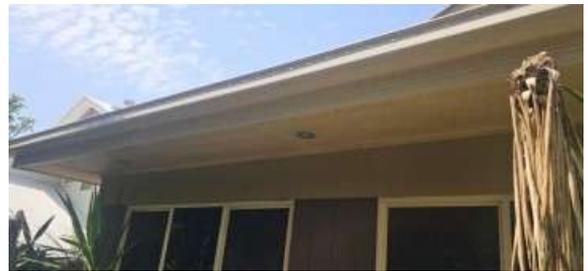
Mould was noted to the eaves lining. The cause of this mould should be further investigated by an expert in mould detection and analysis. Recommend a specialist be commissioned to report on all mould present to this property.
Water is ponding in the gutters and they require realigning.

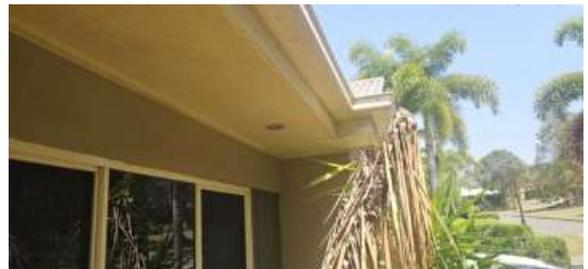
Mould was noted to the eaves lining. The cause of this mould should be further investigated by an expert in mould detection and analysis. Recommend a specialist be commissioned to report on all mould present to this property.
Water is ponding in the gutters and they require realigning.

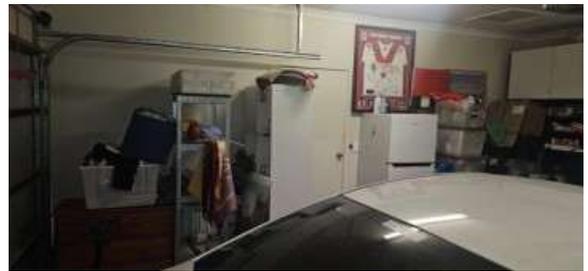
The structure is partially lined preventing inspection to some framing timbers. Inspection to sections of the exterior was restricted due to the stored goods. These goods must be removed to enable a more complete report to be submitted.

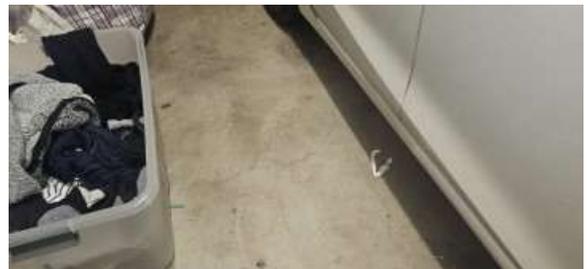
The concrete floor is generally in fair condition. The concrete floor shows signs of minor cracking. Please refer to section of this report - CRACKING OF BUILDING ELEMENTS for additional details.

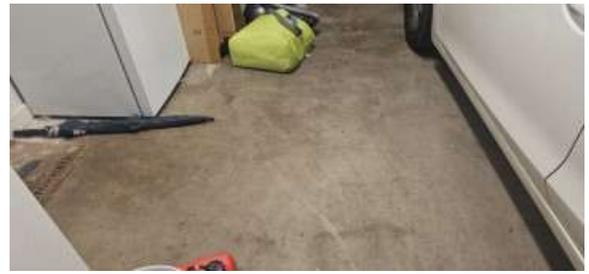
The concrete floor shows signs of minor cracking. Please refer to section of this report - CRACKING OF BUILDING ELEMENTS for additional details.

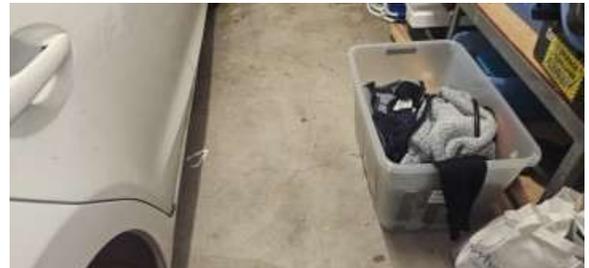
The concrete floor shows signs of minor cracking. Please refer to section of this report - CRACKING OF BUILDING ELEMENTS for additional details.

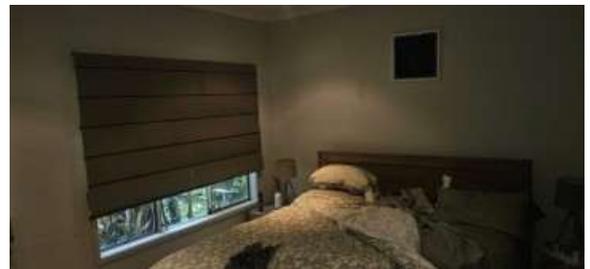
Minor maintenance and or repairs are required to ceiling prior to next repainting.

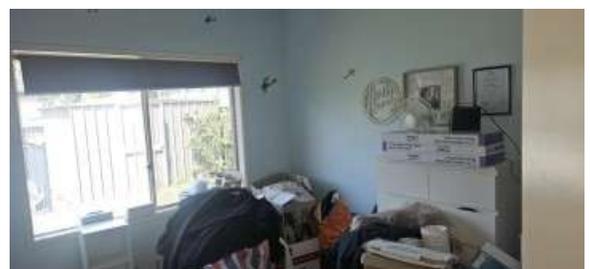
BEDROOM THREE:

Minor maintenance and or repairs required to walls prior to next repainting.
The door binds and adjustments are required to ensure correct operation.

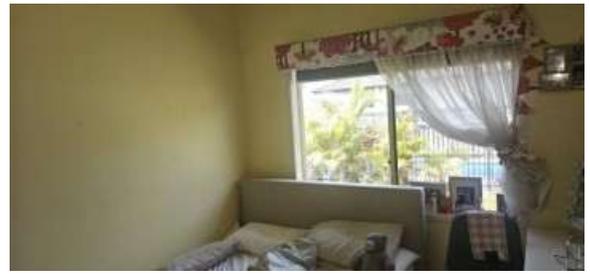
BEDROOM FOUR:

Wear and tear noted to carpet in areas.

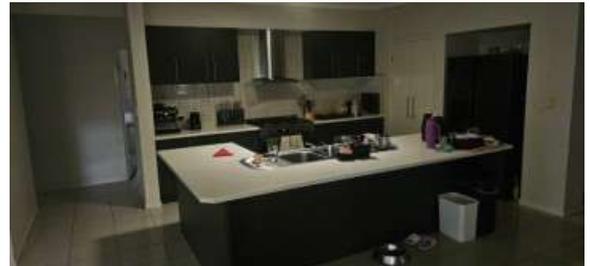
Minor maintenance and or repairs are required to the ceiling
Minor damage noted to tiles requiring surface repair.

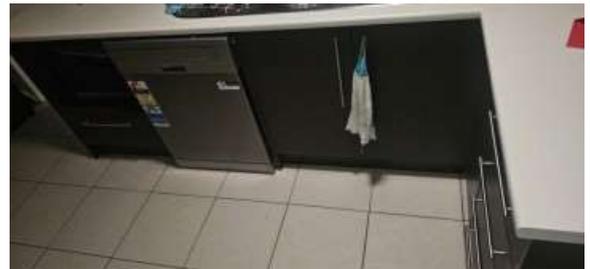
The condition of the fixtures is generally fair.
Wear and tear is noted to cabinets and some maintenance or repairs will be required.
Maintenance and adjustments should be considered to doors/drawers to provide smooth operation.

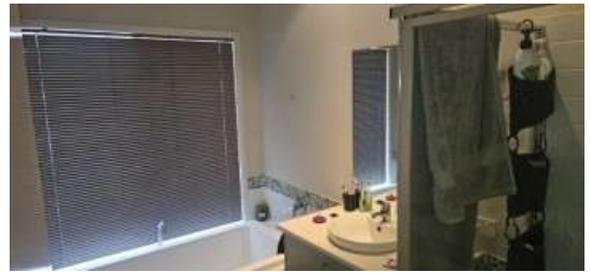
Minor cracking noted to plasterboard and repairs required.

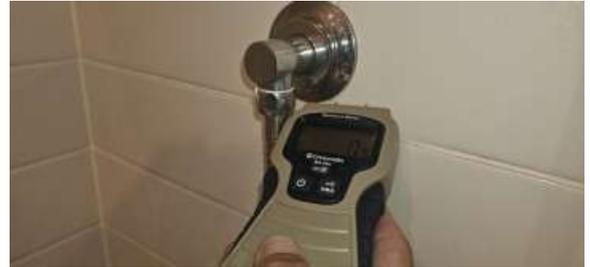
The shower recess was tested and there was no visible water penetration to surrounding areas. IMPORTANT NOTE: This test may not reveal water leaks until the shower is put into constant use and surrounding areas monitored over a period of time. Junction of wall finish and shower base should be resealed appropriately to prevent water entry to wall cavity.

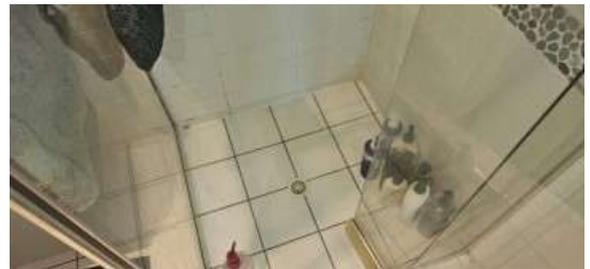
Junction of wall finish and shower base should be resealed appropriately to prevent water entry to wall cavity.

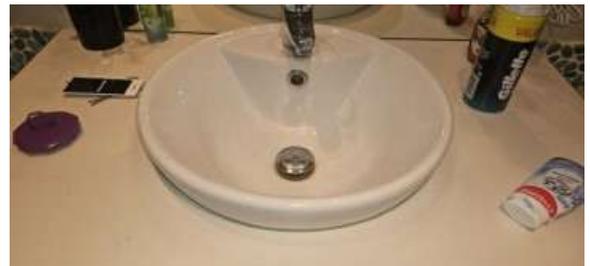
Recommend all aging, worn and or missing tap hardware be professionally serviced and or upgraded.

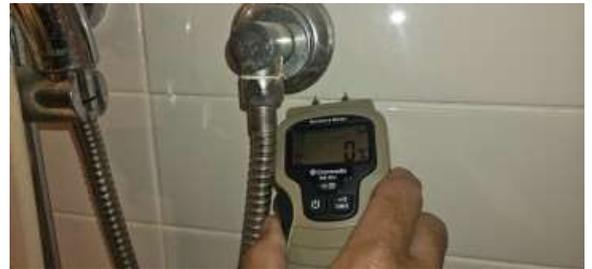
The shower recess was tested and there was no visible water penetration to surrounding areas. **IMPORTANT NOTE:** This test may not reveal water leaks until the shower is put into constant use and surrounding areas monitored over a period of time. Junction of wall finish and shower base should be resealed appropriately to prevent water entry to wall cavity.
