# Property and Timber Pest Report

Property Address: 1 Junction St Samford Village 4520

Inspection Date: 10 Jul 2026

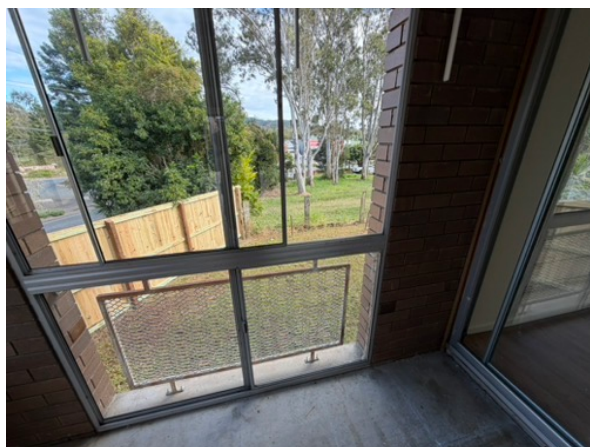
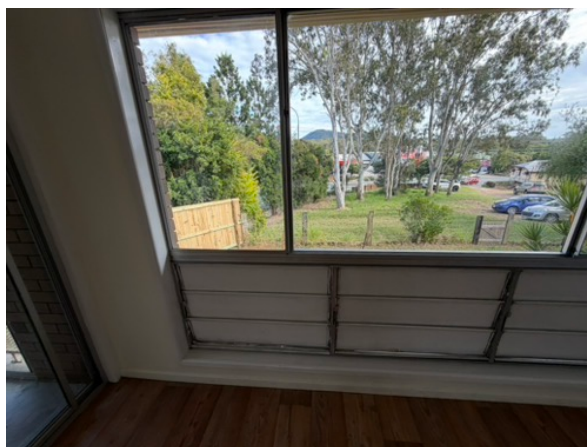
### Serious Safety Hazard 1.01

**Finding:** Windows- Upper Level - Operational

Window restrictors not fitted. Fall from height risk. Recommend engaging a suitably qualified contractor to install restrictors to limit openings in excess of 125mm or installing security screens to prevent fall from height risk

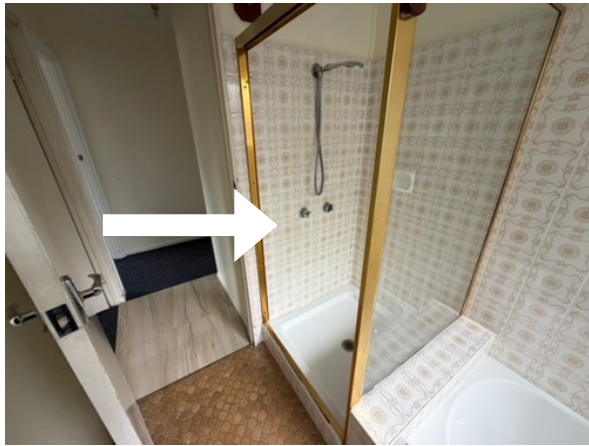
### Major Defect 2.01

**Finding:** Shower - operational

Shower is missing door allowing water to enter floor space

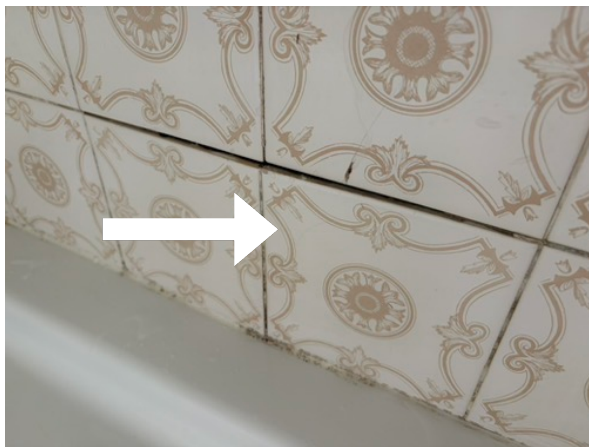
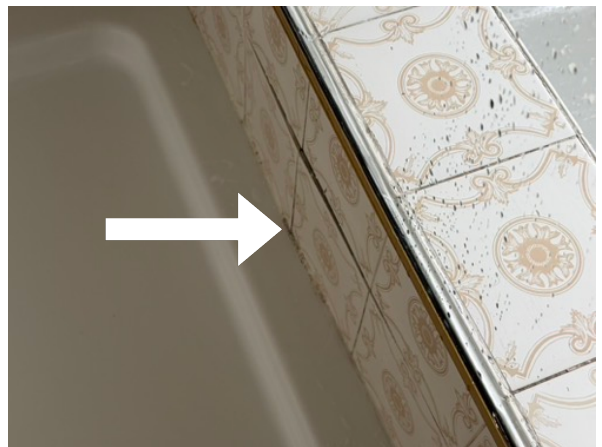
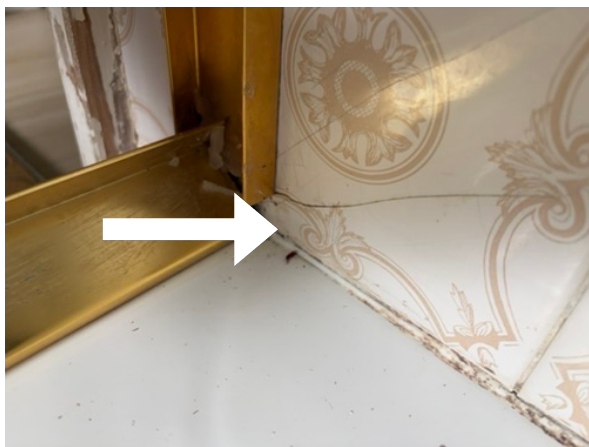
## Major Defect 2.02

**Location:** Bathroom

**Finding:** Shower - tiles

Tiles and grout have deteriorated and detached from wall allowing water penetration to framework. Recommend engaging qualified tiler to rectify

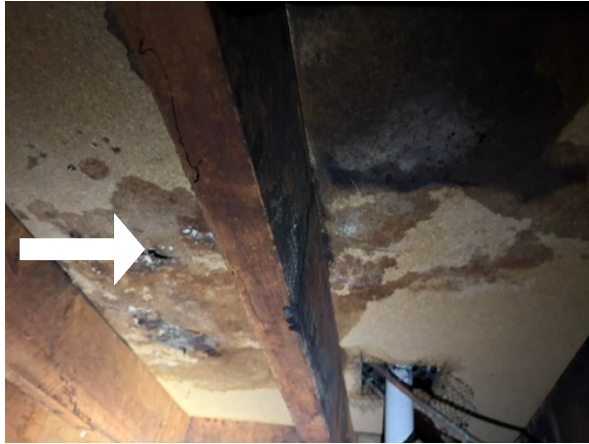
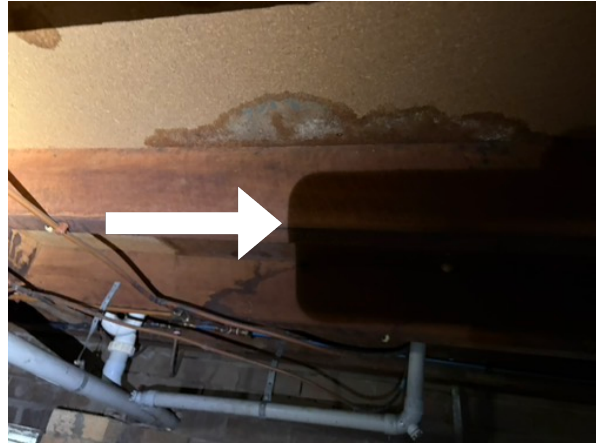
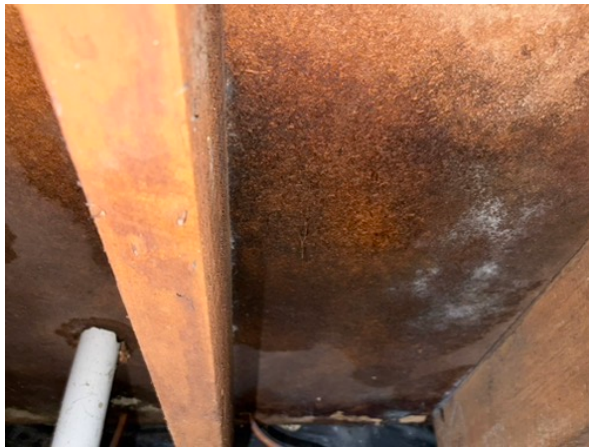
## Major Defect 2.03

**Location:** Subfloor Bathroom

**Finding:** Flooring - staining

Water staining/ damage under bathroom area due to damaged shower tiles. Recommend

engaging qualified builder to rectify

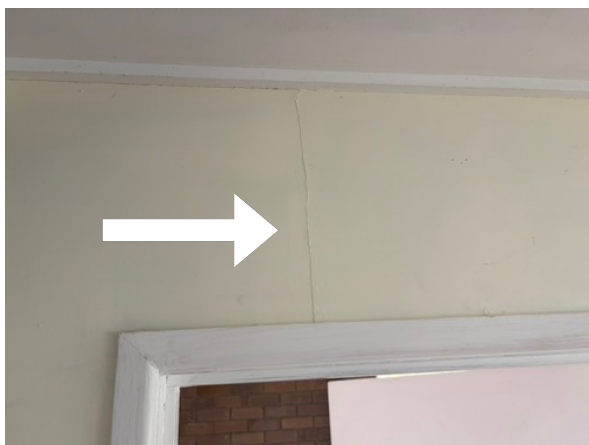
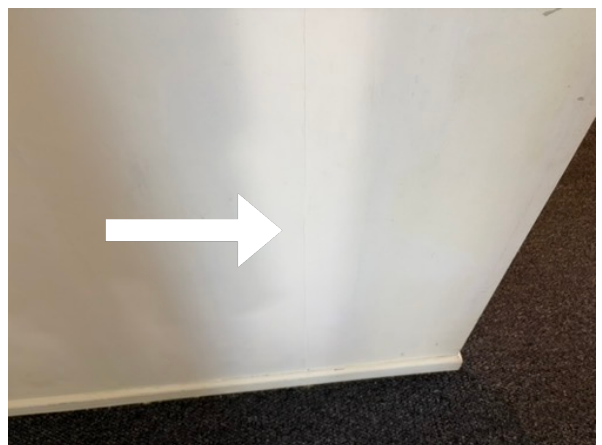
### Minor Defect 3.01

**Finding:** Wall Sheeting - Hairline Cracking

General movement cracking to wall sheeting - typical for age of dwelling

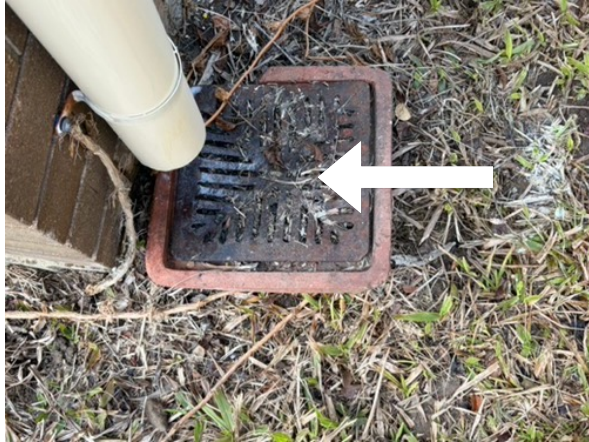
## Minor Defect 3.02

**Location:** The site

**Finding:** Site Drainage - Operational

Landscape drainage pit heads filled with debris. Not operating as intended

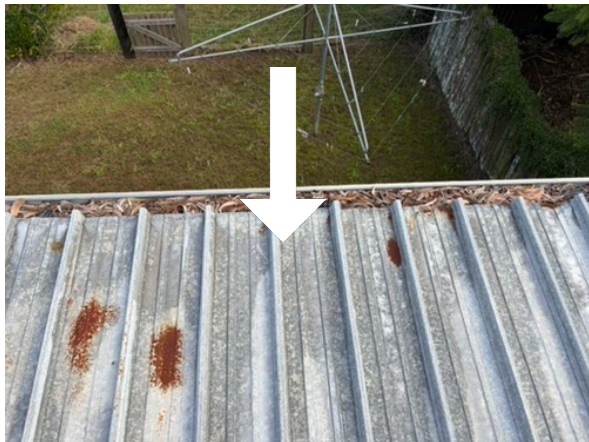
## Minor Defect 3.03

**Location:** Roof exterior

**Finding:** Roofing - Gutters - Maintenance

Eaves gutters filled with leaf litter. Require more regular maintenance / installation of gutter guard

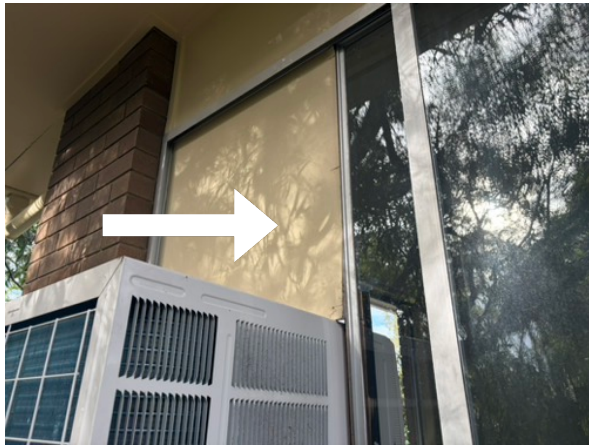
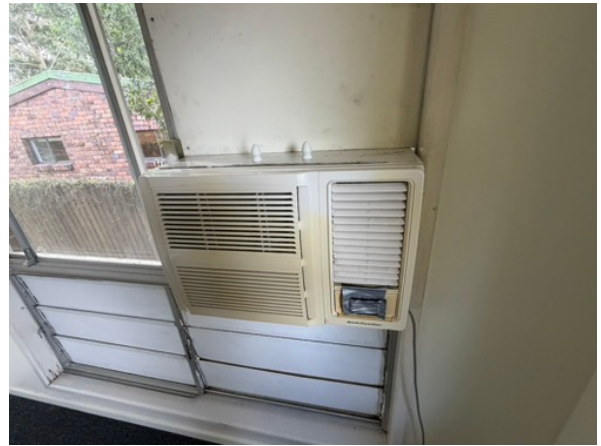
## Minor Defect 3.04

**Location:** Bedroom

**Finding:** Air con - installation

Poor seal around air con box

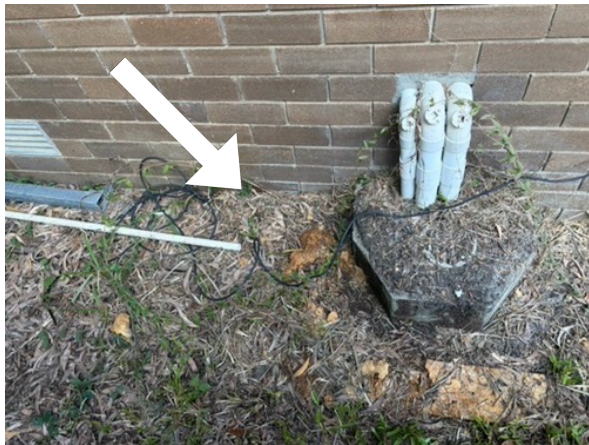
### Minor Defect 3.05

**Location:** All External Areas  
**Finding:** Cable - installation  
Data/aerial cable left on ground

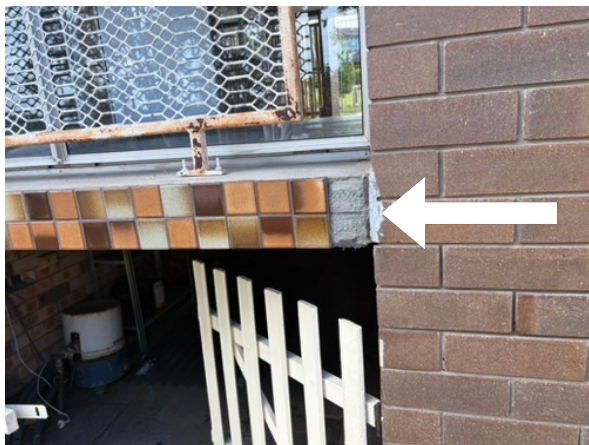
### Minor Defect 3.06

**Location:** All External Areas  
**Finding:** Tiles - installation  
Facia tiles missing

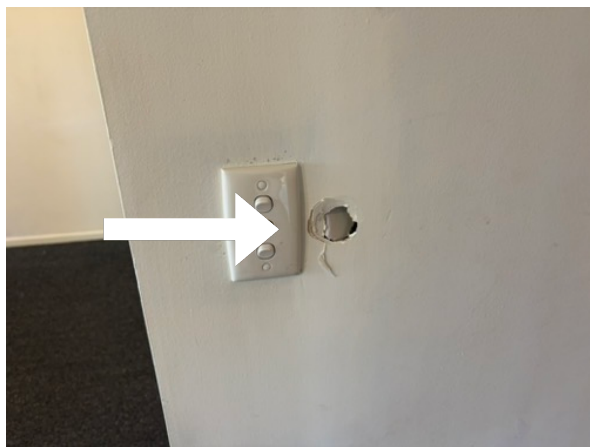
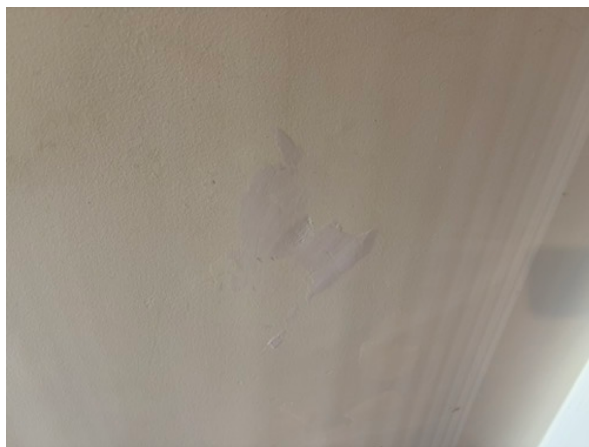
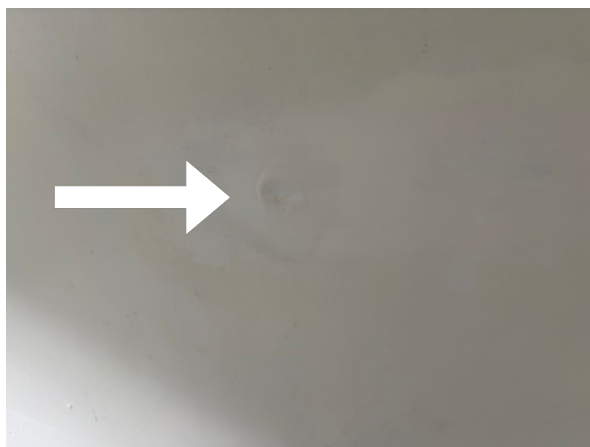
## Minor Defect 3.07

**Location:** All Internal Areas

**Finding:** Walls - paint

Poor finish to walls and doors in areas throughout dwelling

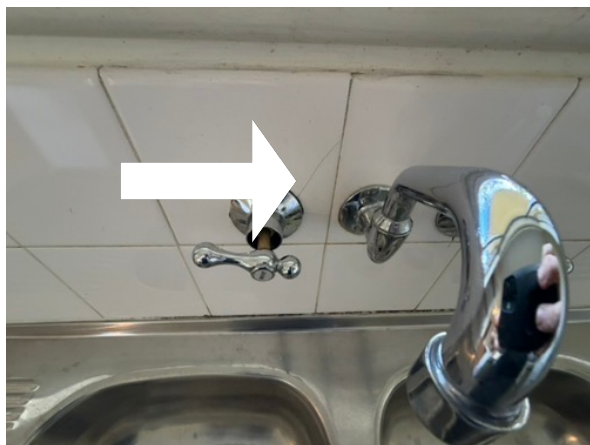
## Minor Defect 3.08

**Location:** Kitchen

**Finding:** Tile - damage

Hairline crack to splashback tile

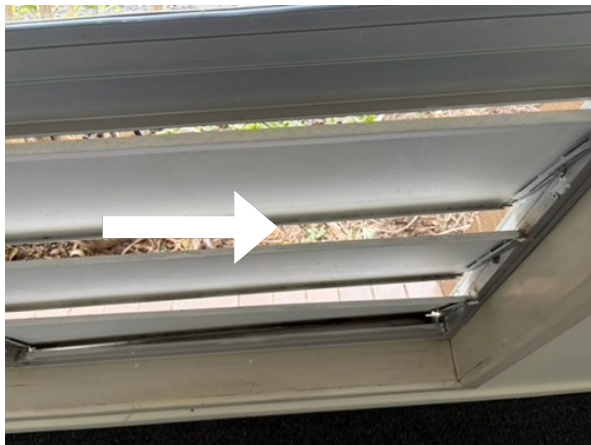
### Minor Defect 3.09

**Location:** Bedrooms

**Finding:** Louvers- operational  
Aluminium louvers do not close properly

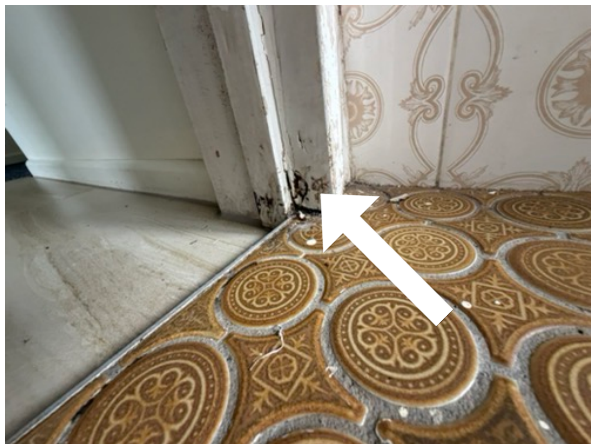
### Minor Defect 3.10

**Location:** Bathroom

**Finding:** Door jamb- rot  
Base of door jamb has rot due to incidental water damage

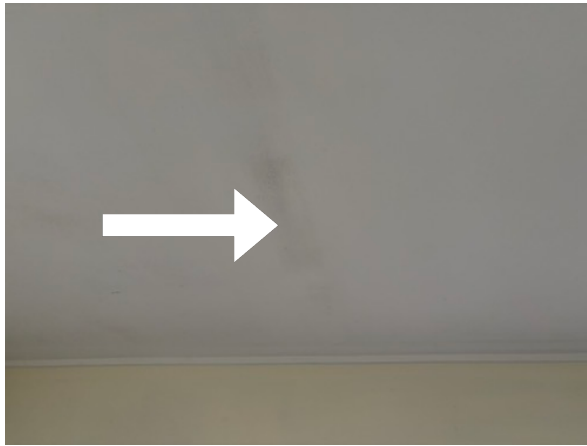
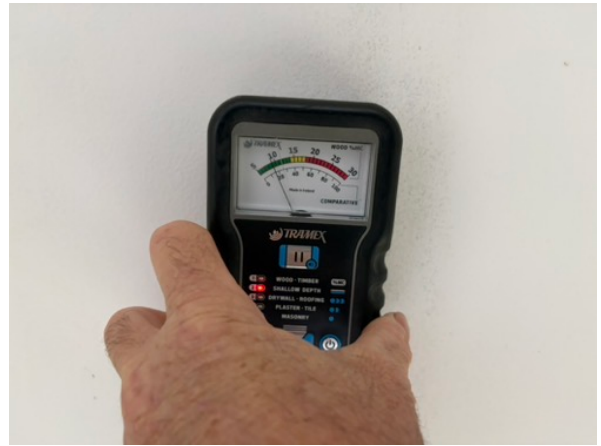
### Minor Defect 3.11

**Location:** All Internal Areas

**Finding:** Ceiling -paint  
Paint distortion to ceiling in areas. No moisture detected at time of inspection

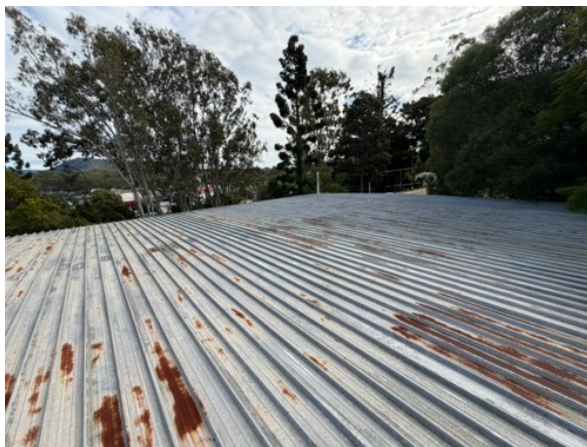
## Minor Defect 3.12

**Location:** Roof exterior

**Finding:** Roof - rust

Surface rust to roof sheets. Recommend engaging qualified roofer to apply rust prevention to avoid further deterioration

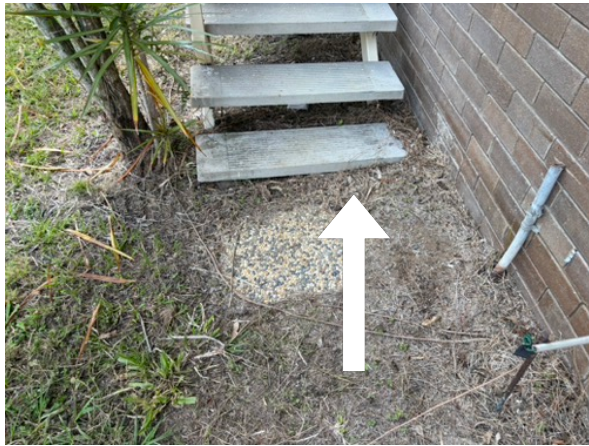
## Minor Defect 3.13

**Location:** Rear Stairs

**Finding:** Stairs - installation

Uneven step rise and ground level creates trip hazard. Recommend removing and installing concrete landing

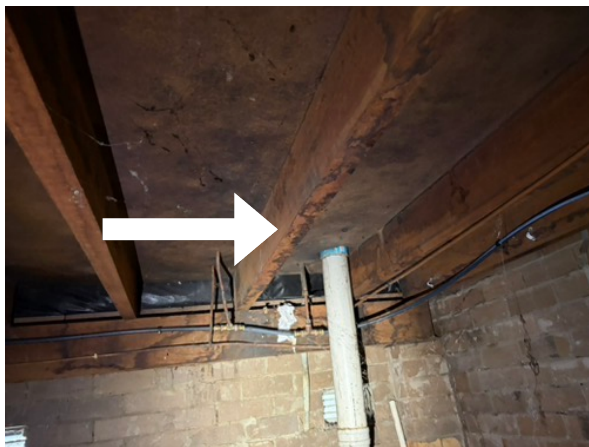
### Minor Defect 3.14

**Location:** Subfloor Laundry

**Finding:** Flooring- stain

Water staining to flooring under laundry. No tiles or waterproofing to area due to age/design of dwelling. Recommend engaging qualified builder to rectify

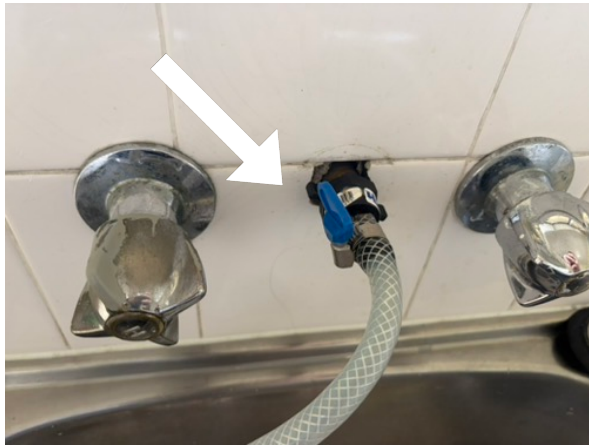
### Minor Defect 3.15

**Location:** Laundry

**Finding:** Tap - operational

Laundry tap missing cover plate allows water penetration to frame

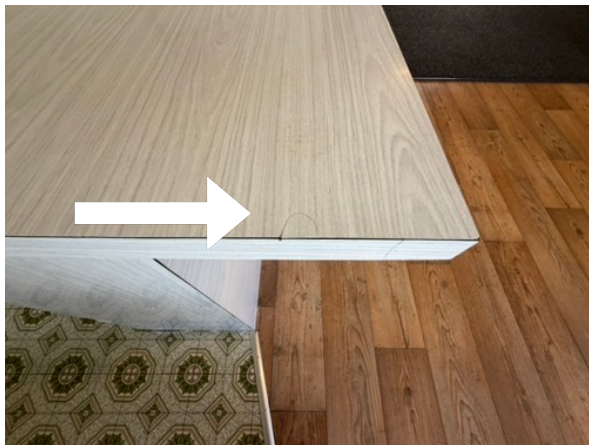
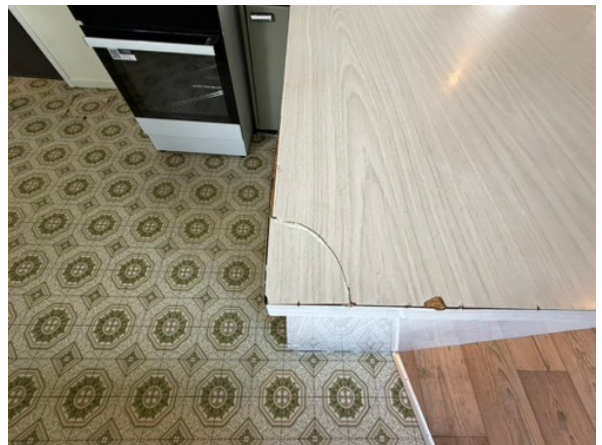
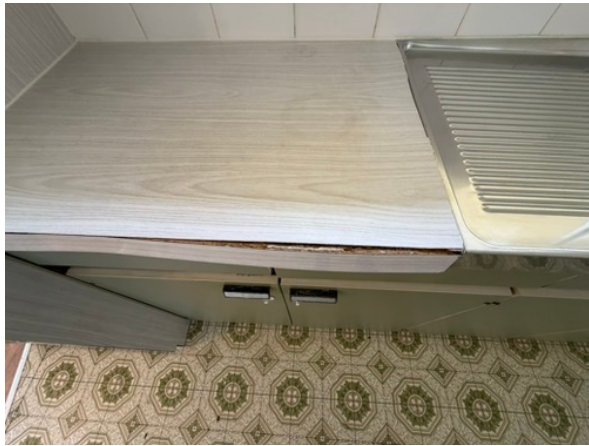
**Location:** Kitchen

**Finding:** Kitchen Bench - Warping  
Laminate Benchtop warping due to water penetration.

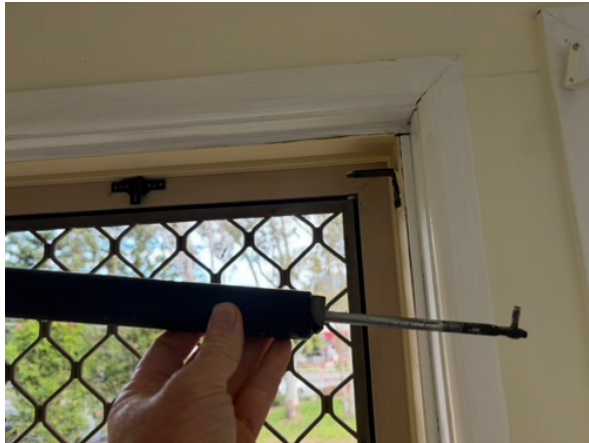
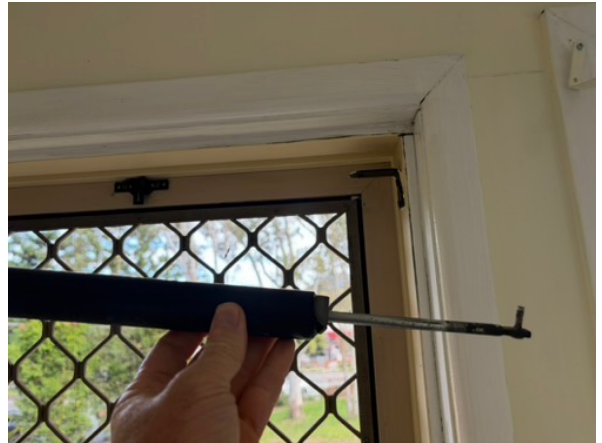
## For your information 4.02

**Location:** Laundry  
**Finding:** Door - operational  
Self closer has detached from frame

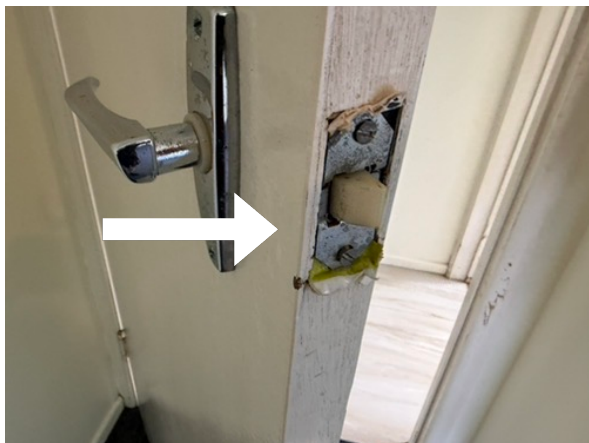
## For your information 4.03

**Location:** Bedroom  
**Finding:** Door - installation  
Door latch installed the wrong way around

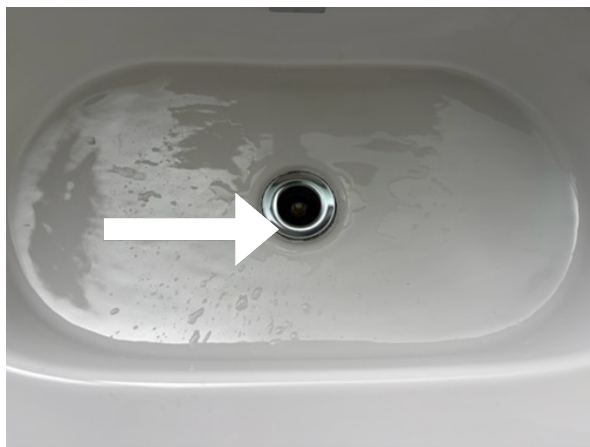
## For your information 4.04

**Location:** Bathroom

**Finding:** Sink- operational

Sink is missing plug attachment which allows debris to enter

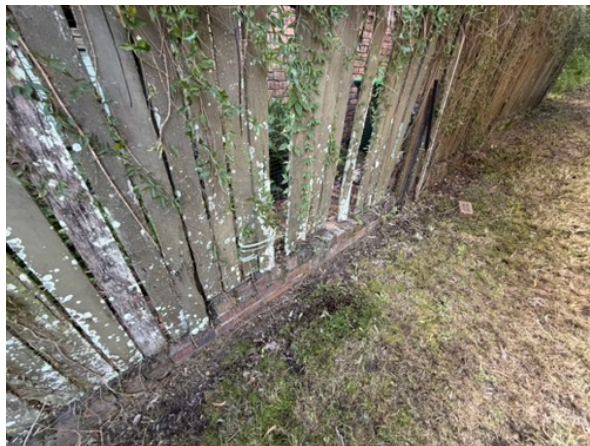
## Timber pest attack 5.01

**Location:** The site  
**Finding:** Fencing - Termite Damage  
 Evidence of previous termite damage

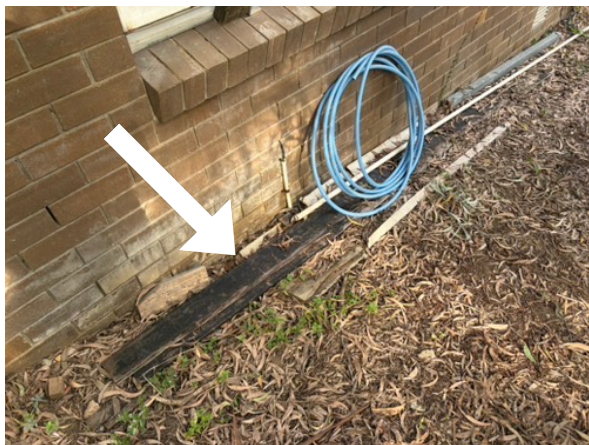
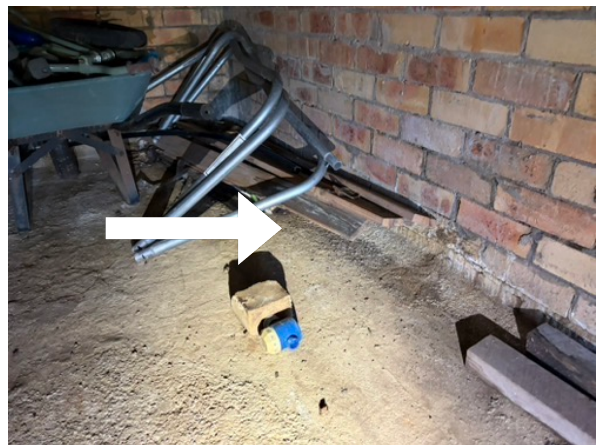
## Conditions conducive to timber pest attack 5.02

**Finding:** Stored timber

Stored timber in direct contact with ground creates conducive conditions for termite activity. Recommend removing.
