Building & Pest Inspection Report

PRO VISION PROPERTY INSPECTIONS

14 Panorama Close, Fletcher, New South Wales, 2287

Inspection Date: 22 Oct 2024

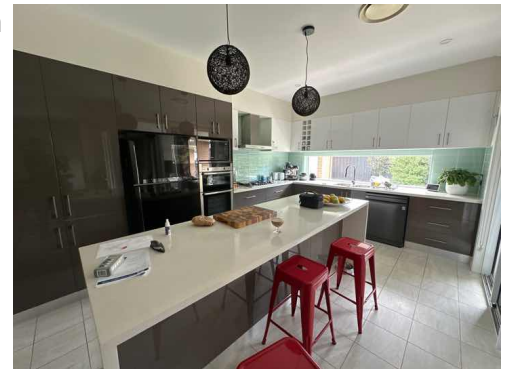
Minor cracks floor tiles. A qualified tiler should be engaged for repairs.

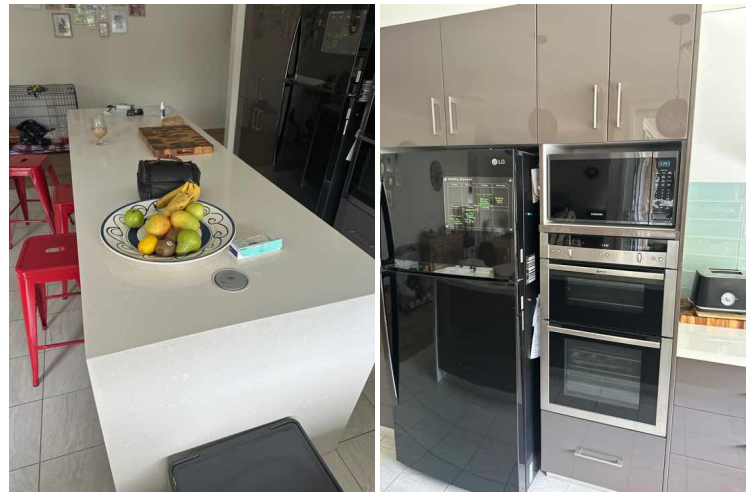
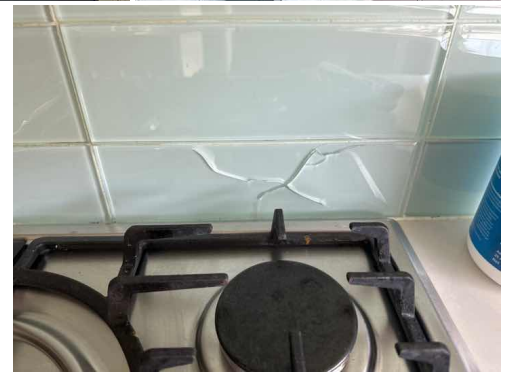
Cracked glass tile to splash back. Refer to a tiler for repairs

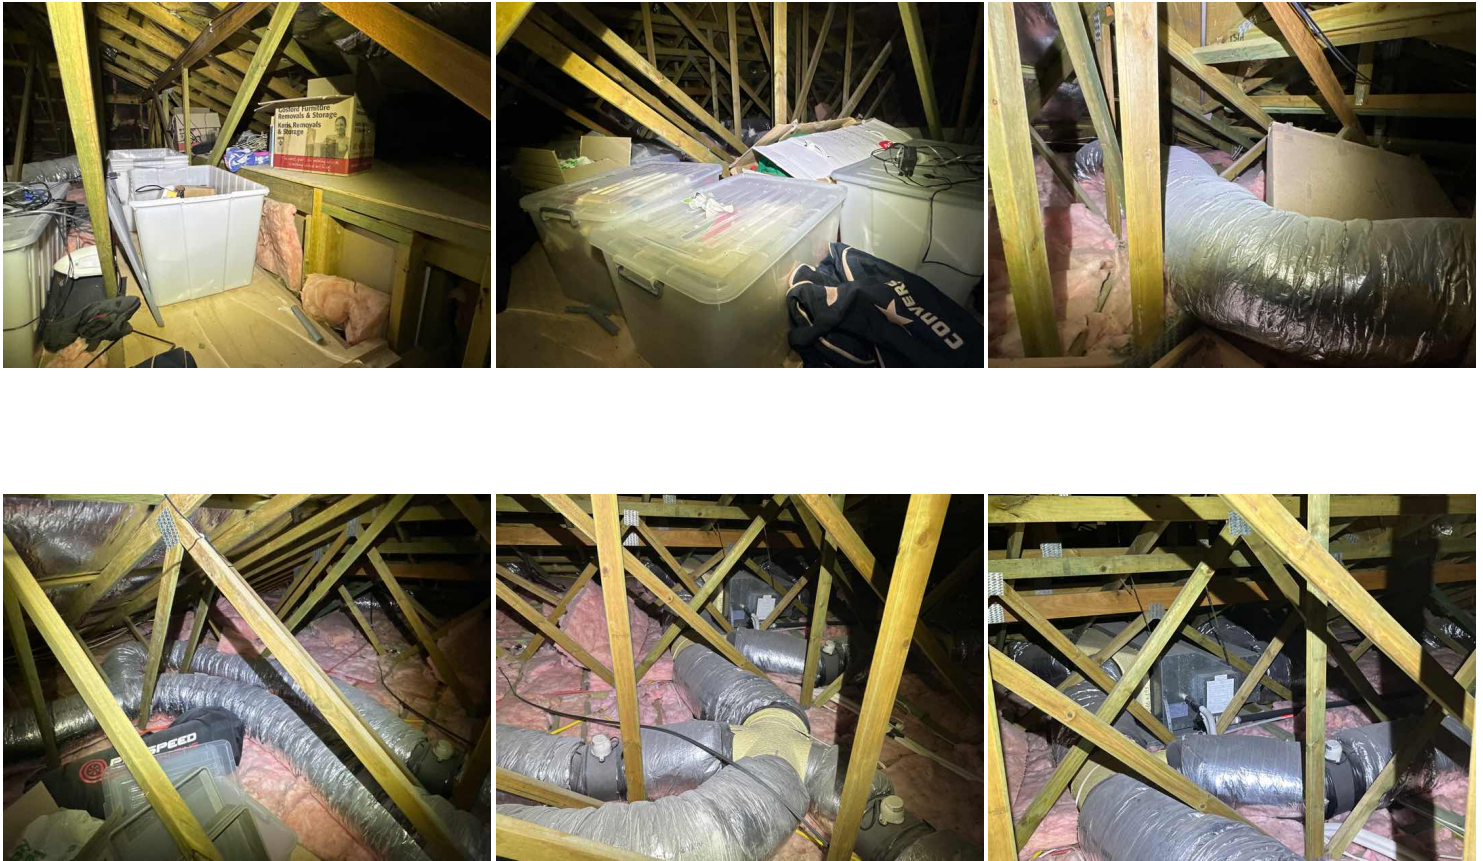
There is storage present throughout the roof void which is preventing a full/thorough visual inspection taking place. It is strongly recommended that full access be granted to enable a thorough inspection to take place as it could be harbouring timber pest activity, damage or defects.

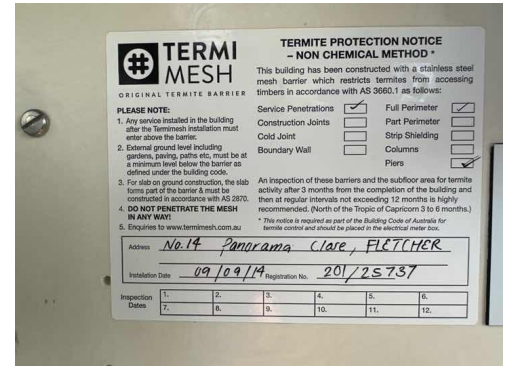
Yes, a durable notice was found in the meter box during the inspection. Refer to the company name on the durable notice and/or the vendor for any further information regarding treatments, or treatment warranty information

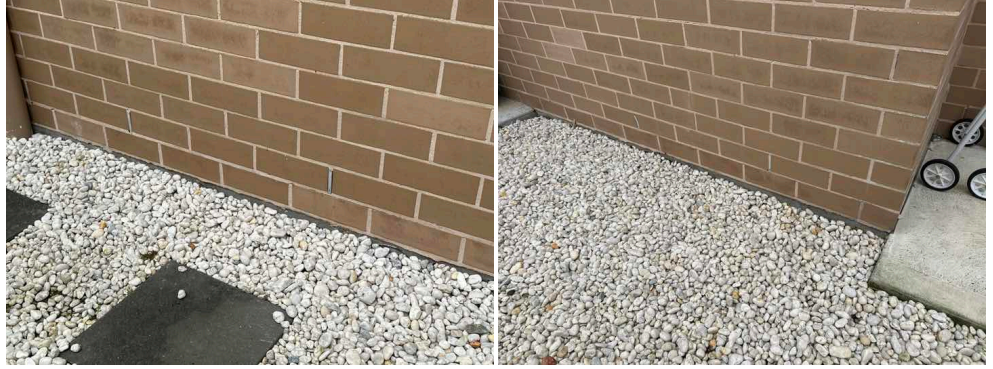
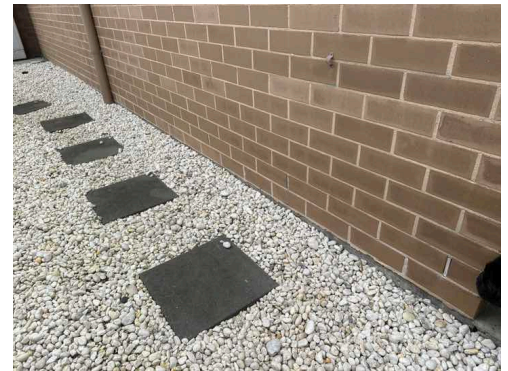
The slab edge is not exposed. The slab edge must be exposed at least 75mm so that a thorough inspection can be conducted for any termite infestation/entry points.
