702/180 Livingstone Rd, Marrickville NSW 2204

# STRATA REPORT

**702/180 Livingstone Rd, Marrickville NSW 2204**

## Preliminary Major Building Defects Report

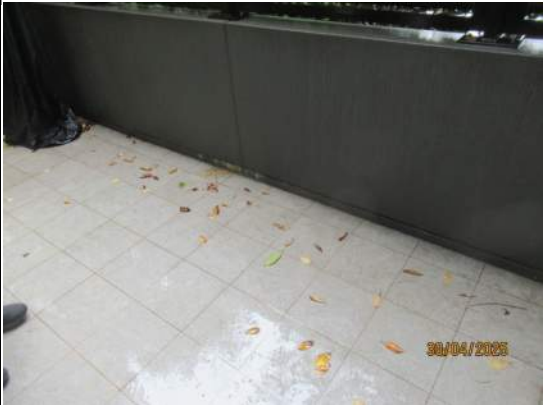
| Item | Area | Defect | Substantiation | Actions | Defect Photograph |
|---|---|---|---|---|---|
| SOU. A1.000 1 | Building A1 Unit 108 Courtyard | Efflorescence leaching from base of planter box wall indicating a failure of the waterproofing membrane to the planter box. | <p>Further investigations are required to verify the presence of the alleged defect.</p> <p>Further investigations were conducted on the 7/10/25. The presence of efflorescence emanating from the planter box wall exists above the termination height of the adjacent planter box waterproofing. The mechanical fixings to the top of the wall securing the privacy screens have been installed without sealing the base of the fixing to the wall allowing for water ingress. The fixing directly above the point of failure is within 20mm of the edge of the panel and has likely compromised the panel. The joint sealant has failed and the weatherproofing to the wall has failed and hence does not meet the requirements of AS4654.2 for weatherproof walls above waterproof membrane terminations.</p> <p>The Builder has failed to effectively weatherproof the wall above an external waterproofing system allowing for premature degradation of the building elements.</p> <p>It is the author's opinion that the Builder has breached the following warranties:</p> <p>HBA Part 2C clause 18B(a) breach: 'a warranty that the work will be done with due care and skill and in accordance with the plans and specifications set out in the contract';</p> <p>HBA Part 2C clause 18B(b) breach: 'a warranty that all materials supplied by the holder or person will be good and suitable for the purpose for which they are used and that, unless otherwise stated in the contract, those materials will be new'; and</p> <p>HBA Part 2C clause 18B(c) breach: 'a warranty that the work will be done in accordance with, and will comply with, this or any other law'.</p> <p>The defect also represents a failure by the Builder to comply with the following requirement(s):</p> <p>BCA SECTION B STRUCTURE – PART B1 STRUCTURAL PROVISIONS: FUNCTIONAL STATEMENTS BF1.1: 'A building or structure is to withstand the combination of loads and other actions to which it may be reasonably subjected.'</p> <p>BCA SECTION F HEALTH AND AMENITY – PART F1 DAMP AND WEATHERPROOFING: Deemed to Satisfy Provisions F1.4: "Waterproof membranes for external above ground use must comply with AS4654 Parts 1 and 2."</p> | <p>Temporarily remove the privacy screens to the perimeter of the courtyard. Seal all mechanical fixing penetrations to the facade coating with a compatible product in accordance with the manufacturers guidelines. Remove the failed joint sealant from the horizontal and vertical joints around the wall panels. Install a backing rod. Reinstate the joint sealant as per manufacturers recommendations including and primers. After curing of the sealant, prepare and repaint the affected surfaces to the nearest architectural break to match existing finishes in accordance with the requirements of AS2311. Reinstate the privacy screens utilising shims beneath to create separation from the base plate to the wall to avoid the retention of water by capillary action. Alternatively both the base plates and associated fixings must be sealed utilising a flexible sealant to prevent water from becoming trapped beneath the base plates. This can only be done if the base plate is solid without penetration at the post.</p> | <p>IMG_5589.JPG 30/04/25 9:44 AM</p> |

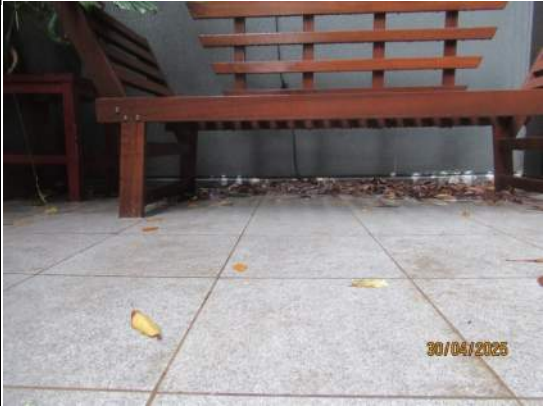
| Item | Area | Defect | Substantiation | Actions | Defect Photograph |
|---|---|---|---|---|---|
| SOU. A1.000 2 | Building A1 Unit 108 Courtyard | Efflorescence leaching from the partition wall to the neighbouring courtyard indicating a failure of the waterproofing to either the courtyards and or weatherproof coating afforded to the partition wall.<br><b>This is the same as the previous item.</b> | <p>Further investigations are required to verify the presence of the alleged defect.</p> <p>Further investigations were conducted on the 7/10/25. The presence of efflorescence emanating from the planter box wall exists above the termination height of the adjacent planter box waterproofing. The mechanical fixings to the top of the wall securing the privacy screens have been installed without sealing the base of the fixing to the wall allowing for water ingress. The joint sealant has failed and the weatherproofing to the wall has failed and hence does not meet the requirements of AS4654.2 for weatherproof walls above waterproof membrane terminations.</p> <p>The Builder has failed to effectively weatherproof the wall above an external waterproofing system allowing for premature degradation of the building elements.</p> <p>It is the author's opinion that the Builder has breached the following warranties:</p> <p>HBA Part 2C clause 18B(a) breach: 'a warranty that the work will be done with due care and skill and in accordance with the plans and specifications set out in the contract';</p> <p>HBA Part 2C clause 18B(b) breach: 'a warranty that all materials supplied by the holder or person will be good and suitable for the purpose for which they are used and that, unless otherwise stated in the contract, those materials will be new'; and</p> <p>HBA Part 2C clause 18B(c) breach: 'a warranty that the work will be done in accordance with, and will comply with, this or any other law'.</p> <p>The defect also represents a failure by the Builder to comply with the following requirement(s):</p> <p>BCA SECTION B STRUCTURE – PART B1 STRUCTURAL PROVISIONS: FUNCTIONAL STATEMENTS BF1.1: 'A building or structure is to withstand the combination of loads and other actions to which it may be reasonably subjected.'</p> <p>BCA SECTION F HEALTH AND AMENITY – PART F1 DAMP AND WEATHERPROOFING: Deemed to Satisfy Provisions F1.4: "Waterproof membranes for external above ground use must comply with AS4654 Parts 1 and 2."</p> | <p>Temporarily remove the privacy screens to the perimeter of the courtyard. Seal all mechanical fixing penetrations to the facade coating with a compatible product in accordance with the manufacturers guidelines. Remove the failed joint sealant from the horizontal and vertical joints around the wall panels. Install a backing rod. Reinstate the joint sealant as per manufacturers recommendations including and primers. After curing of the sealant, prepare and repaint the affected surfaces to the nearest architectural break to match existing finishes in accordance with the requirements of AS2311. Reinstate the privacy screens utilising shims beneath to create separation from the base plate to the wall to avoid the retention of water by capillary action. Alternatively both the base plates and associated fixings must be sealed utilising a flexible sealant to prevent water from becoming trapped beneath the base plates. This can only be done if the base plate is solid without penetration at the post.</p> | <p>IMG_5590.JPG 30/04/25 9:45 AM</p> |

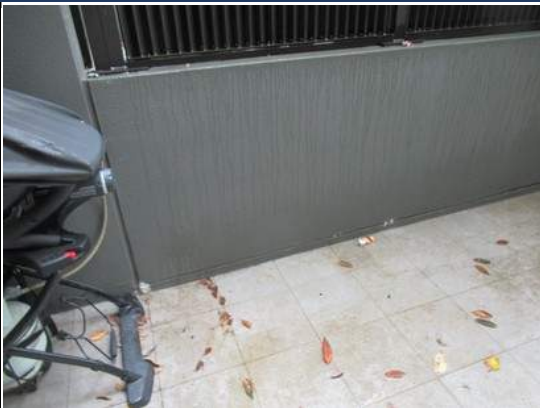
| Item | Area | Defect | Substantiation | Actions | Defect Photograph |
|---|---|---|---|---|---|
| SOU. A1.000 3 | Building A1 Unit 109 Courtyard | Efflorescence leaching from the partition wall to the neighbouring courtyard indicating a failure of the waterproofing to either the courtyards and or weatherproof coating afforded to the partition wall. | <p>Further investigations are required to verify the presence of the alleged defect. Further investigations were conducted on the 7/10/25. The presence of efflorescence emanating from the planter box wall exists above the termination height of the adjacent planter box waterproofing. The mechanical fixings to the top of the wall securing the privacy screens have been installed without sealing the base of the fixing to the wall allowing for water ingress. The joint sealant has failed and the weatherproofing to the wall has failed and hence does not meet the requirements of AS4654.2 for weatherproof walls above waterproof membrane terminations.</p> <p>The Builder has failed to effectively weatherproof the wall above an external waterproofing system allowing for premature degradation of the building elements.</p> <p>It is the author's opinion that the Builder has breached the following warranties:</p> <p>HBA Part 2C clause 18B(a) breach: 'a warranty that the work will be done with due care and skill and in accordance with the plans and specifications set out in the contract';</p> <p>HBA Part 2C clause 18B(b) breach: 'a warranty that all materials supplied by the holder or person will be good and suitable for the purpose for which they are used and that, unless otherwise stated in the contract, those materials will be new'; and</p> <p>HBA Part 2C clause 18B(c) breach: 'a warranty that the work will be done in accordance with, and will comply with, this or any other law'.</p> <p>The defect also represents a failure by the Builder to comply with the following requirement(s):</p> <p>BCA SECTION B STRUCTURE – PART B1 STRUCTURAL PROVISIONS: FUNCTIONAL STATEMENTS BF1.1: 'A building or structure is to withstand the combination of loads and other actions to which it may be reasonably subjected.'</p> <p>BCA SECTION F HEALTH AND AMENITY – PART F1 DAMP AND WEATHERPROOFING: Deemed to Satisfy Provisions F1.4: "Waterproof membranes for external above ground use must comply with AS4654 Parts 1 and 2."</p> | <p>Temporarily remove the privacy screens to the perimeter of the courtyard. Seal all mechanical fixing penetrations to the facade coating with a compatible product in accordance with the manufacturers guidelines. Remove the failed joint sealant from the horizontal and vertical joints around the wall panels. Install a backing rod. Reinstall the joint sealant as per manufacturers recommendations including and primers. After curing of the sealant, prepare and repaint the affected surfaces to the nearest architectural break to match existing finishes in accordance with the requirements of AS2311. Reinstall the privacy screens utilising shims beneath to create separation from the base plate to the wall to avoid the retention of water by capillary action. Alternatively both the base plates and associated fixings must be sealed utilising a flexible sealant to prevent water from becoming trapped beneath the base plates. This can only be done if the base plate is solid without penetration at the post.</p> | <p>IMG_0151.JPG 30/04/25 10:50 AM</p> |

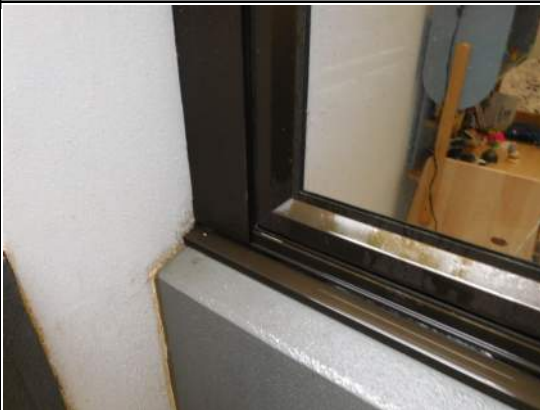
| Item | Area | Defect | Substantiation | Actions | Defect Photograph |
|---|---|---|---|---|---|
| SOU. A1.000 4 | Building A1 Unit 109 Bed 2 North East Corner | Evidence of water ingress associated with the bedroom window. | <p>Further investigations are required to verify the presence of the alleged defect. Further investigations were conducted on the 7/10/25. Water ingress was identified bypassing the sub sill to the right hand side of the window as viewed internally.</p> <p>The Builder has failed to prevent water from bypassing the facade.</p> <p>It is the author's opinion that the Builder has breached the following warranties:</p> <ul style="list-style-type: none"> <li>HBA Part 2C clause 18B(a) breach: 'a warranty that the work will be done with due care and skill and in accordance with the plans and specifications set out in the contract';</li> <li>HBA Part 2C clause 18B(b) breach: 'a warranty that all materials supplied by the holder or person will be good and suitable for the purpose for which they are used and that, unless otherwise stated in the contract, those materials will be new';</li> <li>HBA Part 2C clause 18B(c) breach: 'a warranty that the work will be done in accordance with, and will comply with, this or any other law'; and</li> <li>HBA Part 2C clause 18B(e) breach: 'a warranty that, if the work consists of the construction of a dwelling, the making of alterations or additions to a dwelling or the repairing, renovation, decoration or protective treatment of a dwelling, the work will result, to the extent of the work conducted, in a dwelling that is reasonably fit for occupation as a dwelling'.</li> </ul> <p>The defect also represents a failure by the Builder to comply with the following requirement:</p> <p>BCA - Section F Health and Amenity - Part F1 Damp and Weatherproofing: FP1.4: 'A roof and external wall (incl openings around windows and doors) must prevent the penetration of water that could cause - (a) unhealthy or dangerous conditions, or loss of amenity to occupants, and (b) undue dampness or deterioration of building element'.</p> <p>BCA SECTION F HEALTH AND AMENITY – PART F1 DAMP AND WEATHERPROOFING: Deemed to Satisfy Provisions F1.13 Glazed assemblies: "Subject to (b) and (c), the following glazed assemblies in an external wall, must comply with AS2047 requirements for resistance to water penetration: (i) Windows. (ii) Sliding and swinging glazed doors with a frame, including french and bi-fold doors with a frame. (iii) Adjustable louvres."</p> | <p>Remove the window. Conduct any necessary repairs to the sub sill and any associated water stops which may be present. Reinstall door set to ensure the requirements of Section F of the BCA and AS2047 are met. Following reinstallation, conduct spray test of window to verify the success of the repairs (suggested method AAMA 501.2-03). Provide test report to Owners. Repaint all affected internal surfaces in accordance with AS2311.</p> | <p>DSCN3038.JPG 7/10/25 8:23 AM</p> |

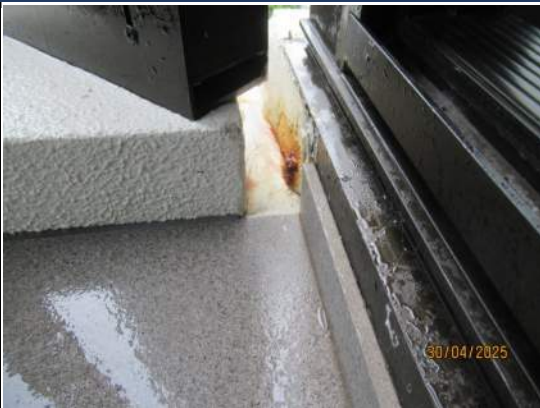
| Item | Area | Defect | Substantiation | Actions | Defect Photograph |
|---|---|---|---|---|---|
| SOU. A1.000 5 | Building A1 Unit 202 Balcony Overflow | Exposed steel reinforcement located in the overflow slot of the balcony hob corroding. | <p>The Builder has failed to provide sufficient concrete coverage to embedded steel when the slab was constructed as per AS3600:Concrete Structures.</p> <p>The author considers the recorded defects to be non-compliant with the following statutory requirements:<br/>HBA Part 2C clause 18B(a) breach: 'a warranty that the work will be done with due care and skill and in accordance with the plans and specifications set out in the contract,<br/>HBA Part 2C clause 18B(c) breach: 'a warranty that the work will be done in accordance with, and will comply with, this or any other law'; and</p> <p>The defects also represent failures by the Builder to comply with one of, or a combination of the following:<br/>BCA SECTION B STRUCTURE – PART B1 STRUCTURAL PROVISIONS: FUNCTIONAL STATEMENTS BF1.1:<br/><i>A building or structure is to withstand the combination of loads and other actions to which it may be reasonably subjected.</i><br/>BCA SECTION B STRUCTURE – PART B1 STRUCTURAL PROVISIONS: DEEMED-TO-SATISFY PROVISIONS: B1.4: DETERMINATION OF STRUCTURAL RESISTANCE OF MATERIALS AND FORMS OF CONSTRUCTION:<br/><i>The structural resistance of materials and forms of construction must be determined in accordance with the following, as appropriate:</i><br/>(b) Concrete:<br/>(i) Concrete construction (including reinforced and prestressed concrete): AS3600.</p> | Break out concrete, remove corroded ferrous material, treat with zinc rich primer (minimum 28%), patch using non shrink repair mortar. Reinstate waterproof membrane at repair location. | <p>IMG_5595.JPG 30/04/25 9:52 AM</p> |

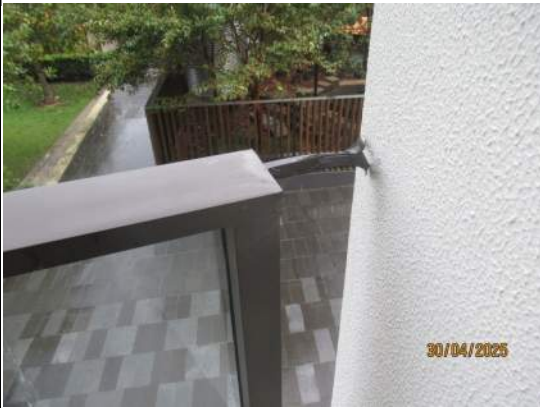
| Item | Area | Defect | Substantiation | Actions | Defect Photograph |
|---|---|---|---|---|---|
| SOU. A1.000 6 | Building A1 Unit 202 Balcony Balustrade | Balcony balustrade missing end cap with glazing gasket protruding leading to instability of the glazed barrier system. | <p>The Builder has failed to provide a fall prevention barrier which will not deteriorate under normal use.</p> <p>The author considers the recorded defects to be non-compliant with the following statutory requirements:<br/>HBA Part 2C clause 18B(a) breach: 'a warranty that the work will be done with due care and skill and in accordance with the plans and specifications set out in the contract,<br/>HBA Part 2C clause 18B(b) breach: 'a warranty that all materials supplied by the holder or person will be good and suitable for the purpose for which they are used and that, unless otherwise stated in the contract, those materials will be new;<br/>HBA Part 2C clause 18B(c) breach: 'a warranty that the work will be done in accordance with, and will comply with, this or any other law'; and<br/>HBA Part 2C clause 18B(e) breach: 'a warranty that, if the work consists of the construction of a dwelling, the making of alterations or additions to a dwelling or the repairing, renovation, decoration or protective treatment of a dwelling, the work will result, to the extent of the work conducted, in a dwelling that is reasonably fit for occupation as a dwelling';</p> <p>The defects also represent failures by the Builder to comply with one of, or a combination of the following:<br/>BCA SECTION B STRUCTURE – PART B1 STRUCTURAL PROVISIONS: FUNCTIONAL STATEMENTS BF1.1:<br/><i>A building or structure is to withstand the combination of loads and other actions to which it may be reasonably subjected.</i></p> | Remove and reinstall glass panel and replace end cap to retain glazing rubber. | <p>IMG_5597.JPG 30/04/25 9:54 AM</p> |

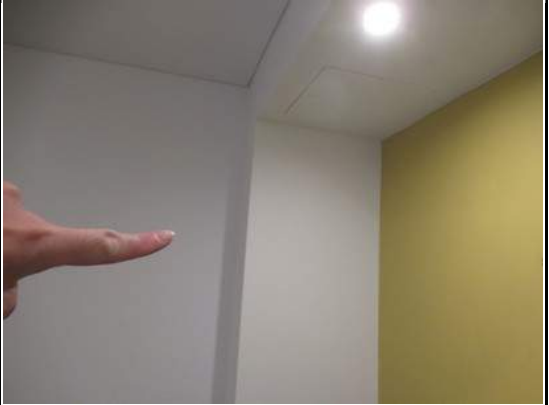
| Item | Area | Defect | Substantiation | Actions | Defect Photograph |
|---|---|---|---|---|---|
| SOU. A1.000 8 | Building A1 Unit 601 Study | Resident reported sounds of water dripping coming from services bulkhead in south east corner of study. | Further investigations are required to verify the cause of the alleged defect. We were not granted access to this Unit at the allocated time. Based on our initial visual inspection, the lack of visible water damage which would be expected to result from an active leak, and after review of the mechanical services plan, we believe the reported noise to be most likely associated with an air conditioning condensate line. Without further evidence we would consider this to be a maintenance issue. | No action required by Builder at this time. This is currently considered a maintenance issue. | <p>IMG_0414.JPG 30/04/25 12:34 PM</p> |

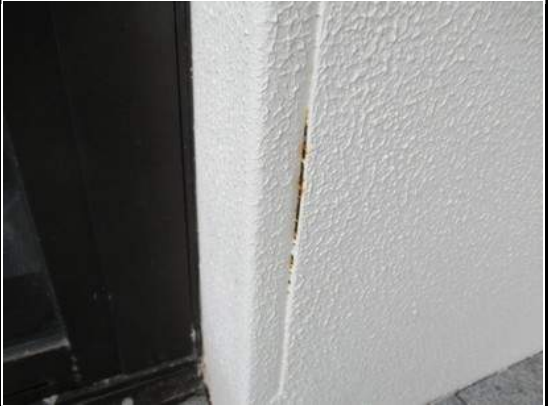
| Item | Area | Defect | Substantiation | Actions | Defect Photograph |
|---|---|---|---|---|---|
| SOU. A1.000 9 | Building A1 Unit 705 Balcony | Wall lining on balcony delaminating from framework and evidence of corrosion from behind the lining. | <p>The Builder has failed to effectively secure and seal the facade panel.</p> <p>The author considers the recorded defects to be non-compliant with the following statutory requirements:</p> <p>HBA Part 2C clause 18B(a) breach: 'a warranty that the work will be done with due care and skill and in accordance with the plans and specifications set out in the contract;</p> <p>HBA Part 2C clause 18B(b) breach: 'a warranty that all materials supplied by the holder or person will be good and suitable for the purpose for which they are used and that, unless otherwise stated in the contract, those materials will be new; and</p> <p>HBA Part 2C clause 18B(c) breach: 'a warranty that the work will be done in accordance with, and will comply with, this or any other law'.</p> <p>The defects also represent failures by the Builder to comply with one of, or a combination of the following:</p> <p>BCA SECTION B STRUCTURE – PART B1 STRUCTURAL PROVISIONS: FUNCTIONAL STATEMENTS BF1.1:<br/>A building or structure is to withstand the combination of loads and other actions to which it may be reasonably subjected.</p> <p>BCA - SECTION F HEALTH AND AMENITY - Part F1 DAMP AND WEATHERPROOFING: PERFORMANCE REQUIREMENTS FP:1.4:<br/>'A roof and external wall (incl openings around windows and doors) must prevent the penetration of water that could cause.<br/>(a) unhealthy or dangerous conditions, or loss of amenity to occupants, and<br/>(b) undue dampness or deterioration of building element'.</p> | Remove delaminated panel and assess structure behind. Repair structure as required and reinstate facade panel. Seal the joints and paint to match existing coating to nearest architectural break. | <p>IMG_0540.JPG 30/04/25 1:12 PM</p> |

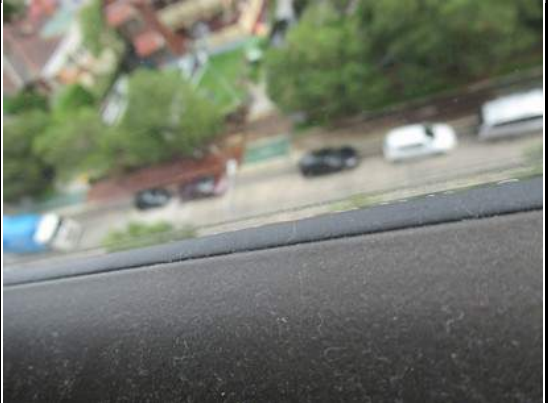
| Item | Area | Defect | Substantiation | Actions | Defect Photograph |
|---|---|---|---|---|---|
| SOU.<br>A1.001<br>0 | Building A1<br>Unit 709 | Louvre window to living room does not operate effectively with panels always remaining unsealed allowing for water and air infiltration. | <p>The Builder has failed to provide a window resistant to air and water infiltration in accordance with AS2047.</p> <p>The author considers the recorded defects to be non-compliant with the following statutory requirements:</p> <p>HBA Part 2C clause 18B(a) breach: 'a warranty that the work will be done with due care and skill and in accordance with the plans and specifications set out in the contract,</p> <p>HBA Part 2C clause 18B(b) breach: 'a warranty that all materials supplied by the holder or person will be good and suitable for the purpose for which they are used and that, unless otherwise stated in the contract, those materials will be new;</p> <p>HBA Part 2C clause 18B(c) breach: 'a warranty that the work will be done in accordance with, and will comply with, this or any other law'; and</p> <p>HBA Part 2C clause 18B(e) breach: 'a warranty that, if the work consists of the construction of a dwelling, the making of alterations or additions to a dwelling or the repairing, renovation, decoration or protective treatment of a dwelling, the work will result, to the extent of the work conducted, in a dwelling that is reasonably fit for occupation as a dwelling';</p> <p>The defects also represent failures by the Builder to comply with one of, or a combination of the following:</p> <p>BCA - SECTION F HEALTH AND AMENITY - Part F1 DAMP AND WEATHERPROOFING: PERFORMANCE REQUIREMENTS FP:1.4:</p> <p>'A roof and external wall (incl openings around windows and doors) must prevent the penetration of water that could cause.</p> <p>(a) unhealthy or dangerous conditions, or loss of amenity to occupants, and</p> <p>(b) undue dampness or deterioration of building element'.</p> <p>BCA - SECTION F HEALTH AND AMENITY - Part F1 DAMP AND WEATHERPROOFING: DEEMED-TO-SATISFY PROVISIONS F1.13:</p> <p>(a) Subject to (b) and (c), the following glazed assemblies in an external wall, must comply with AS 2047 requirements for resistance to water penetration:</p> <p>(i) windows...</p> | Assess window components and repair or replace defective items to restore window to correct operating condition. | <p>IMG_0567.JPG 30/04/25 1:22 PM</p> |

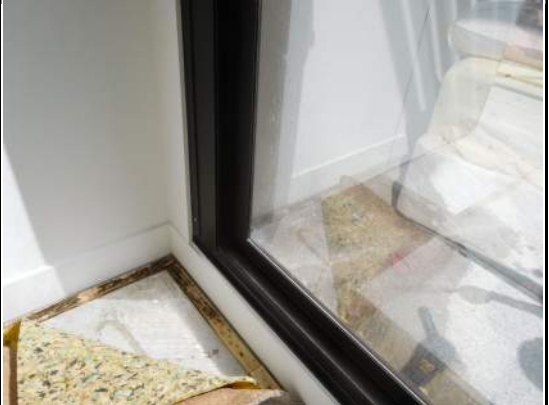
| Item | Area | Defect | Substantiation | Actions | Defect Photograph |
|---|---|---|---|---|---|
| SOU.<br>A1.001<br>1 | Building A1<br>Unit 902<br>Master Bedroom<br>Balcony<br>Door | Water ingress and associated damage identified to the south west corner of the master bedroom associated with the door sill to the balcony. | <p>Further investigations are required to verify the cause of the alleged defect.</p> <p>Further investigations were conducted on the 23/09/25. We were unable to replicate a leak at this location. There is evidence of repairs to junction of the sub sill and underlying waterproof membrane in the form of a black sealant applied over the grey membrane at the same location as the internal damage. Additional repairs may have been conducted. The concrete slab exhibited slightly high relative moisture readings, not of the level to indicate current failure. We note that the presence of mould has increased since our initial inspection. Mould damage remains to the carpet and associated accessories which requires remediation and is considered incomplete remedial work.</p> <p>The author considers the recorded defects to be non-compliant with the following statutory requirements:</p> <p>HBA Part 2C clause 18B(a) breach: 'a warranty that the work will be done with due care and skill and in accordance with the plans and specifications set out in the contract; and</p> <p>HBA Part 2C clause 18B(c) breach: 'a warranty that the work will be done in accordance with, and will comply with, this or any other law'.</p> | <p>Request details of the dates, methodology, and products used in any repairs conducted to this window by the builder for record keeping purposes.</p> <p>Remove and replace all water damaged carpet and associated accessories and conduct mould removal as required. Repaint all affected internal surfaces in accordance with AS2311.</p> <p>We recommend the resident continues to monitor the situation.</p> | <p>DSCN2549.JPG 23/09/25 1:31 PM</p> |

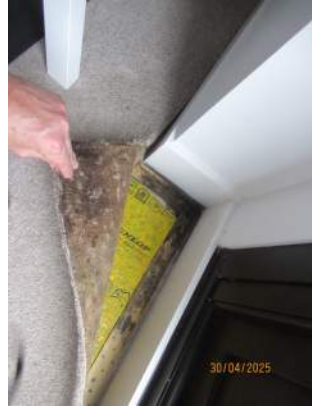
| Item | Area | Defect | Substantiation | Actions | Defect Photograph |
|---|---|---|---|---|---|
| SOU.<br>A1.001<br>2 | Building A1<br>Unit 902<br>Study Nook | Water ingress and associated damage identified to the southern balcony door at the study nook. | <p>Further investigations are required to verify the cause of the alleged defect. Further investigations were conducted on the 23/09/25. Localised repairs have been conducted to the waterproof membrane of the terrace externally. We were able to replicate a leak bypassing the sub sill at the right hand end of the window as viewed internally. Repair attempt has been unsuccessful. Mould damage remains to the carpet and associated accessories and will require replacement following repairs.</p> <p>The Builder has failed to prevent water from bypassing the facade.</p> <p>The author considers the recorded defects to be non-compliant with the following statutory requirements:</p> <ul style="list-style-type: none"> <li>· HBA Part 2C clause 18B(a) breach: 'a warranty that the work will be done with due care and skill and in accordance with the plans and specifications set out in the contract,'</li> <li>· HBA Part 2C clause 18B(b) breach: 'a warranty that all materials supplied by the holder or person will be good and suitable for the purpose for which they are used and that, unless otherwise stated in the contract, those materials will be new,'</li> <li>· HBA Part 2C clause 18B(c) breach: 'a warranty that the work will be done in accordance with, and will comply with, this or any other law'; and</li> <li>· HBA Part 2C clause 18B(e) breach: 'a warranty that, if the work consists of the construction of a dwelling, the making of alterations or additions to a dwelling or the repairing, renovation, decoration or protective treatment of a dwelling, the work will result, to the extent of the work conducted, in a dwelling that is reasonably fit for occupation as a dwelling';</li> </ul> <p>The defects also represent failures by the Builder to comply with one of, or a combination of the following:</p> <ul style="list-style-type: none"> <li>· BCA - SECTION F HEALTH AND AMENITY - Part F1 DAMP AND WEATHERPROOFING: PERFORMANCE REQUIREMENTS FP:1.4:<br/>'A roof and external wall (incl openings around windows and doors) must prevent the penetration of water that could cause:<br/>(a) unhealthy or dangerous conditions, or loss of amenity to occupants, and<br/>(b) undue dampness or deterioration of building elements'.</li> <li>· BCA - SECTION F HEALTH AND AMENITY - Part F1 DAMP AND WEATHERPROOFING: DEEMED-TO-SATISFY PROVISIONS F1.13:<br/>(a) Subject to (b) and (c), the following glazed assemblies in an external wall, must comply with AS 2047 requirements for resistance to water penetration:<br/>(i) windows...</li> </ul> | <p>Remove the window. Conduct any necessary repairs to the sub sill, waterproofing terminations, and any associated water stops which may be present. Reinstall door set to ensure the requirements of Section F of the BCA and AS2047 are met. Following reinstallation, conduct spray test of window to verify the success of the repairs (suggested method AAMA 501.2-03). Provide test report to Owners. Remove and replace all water damaged carpet and associated accessories and conduct mould removal as required. Repaint all affected internal surfaces in accordance with AS2311.</p> | <p>IMG_5689.JPG 30/04/25 12:48 PM</p> |

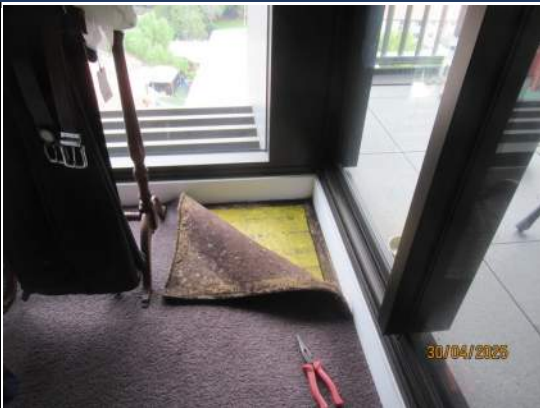
| Item | Area | Defect | Substantiation | Actions | Defect Photograph |
|---|---|---|---|---|---|
| SOU. A1.001 3 | Building A1 Unit 1002 Master Bedroom | Water ingress and associated damage identified to the junction of the windows and balcony doors of the master bedroom. | <p>Further investigations are required to verify the cause of the alleged defect. Further investigations were conducted on the 23/09/25. We found that repairs had been conducted by way of introducing a negatively applied waterproof membrane to the interior of the balcony hob. This is not considered a solution under any circumstances and only traps water within the wall. The exterior balcony waterproofing appeared to have some patching applied with may small gaps left in the flexible sealant. We were unable to replicate a leak but remain sceptical about the repairs applied. Heavily mould affected carpet remains which will require replacement.</p> <p>The author considers the recorded defects to be non-compliant with the following statutory requirements:<br/> HBA Part 2C clause 18B(a) breach: 'a warranty that the work will be done with due care and skill and in accordance with the plans and specifications set out in the contract; and<br/> HBA Part 2C clause 18B(c) breach: 'a warranty that the work will be done in accordance with, and will comply with, this or any other law'.</p> | <p>Request details of the dates, methodology, and products used in any repairs conducted to this window by the builder for record keeping purposes.</p> <p>Remove and replace all water damaged carpet and associated accessories and conduct mould removal as required. Repaint all affected internal surfaces in accordance with AS2311.</p> <p>We recommend the resident continues to monitor the situation.</p> | <p>IMG_5707.JPG 30/04/25 1:18 PM</p> |

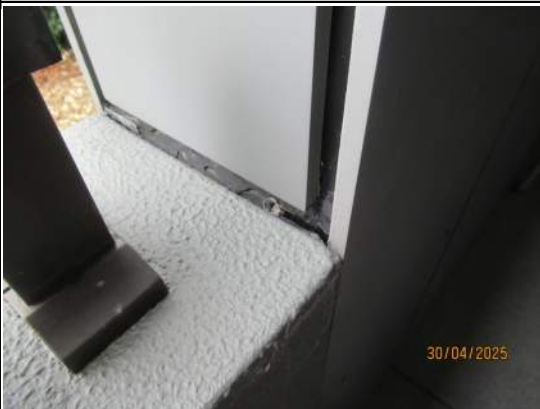
| Item | Area | Defect | Substantiation | Actions | Defect Photograph |
|---|---|---|---|---|---|
| SOU. A1.001 4 | Building A1 Unit 1003 Balcony South | A hole in the weather seal to the abutment of the concrete parapet wall and lightweight cladding at the southern end of the balcony allowing water ingress. | <p>The Builder has failed to effectively seal the facade panel.</p> <p>The author considers the recorded defects to be non-compliant with the following statutory requirements:<br/> HBA Part 2C clause 18B(a) breach: 'a warranty that the work will be done with due care and skill and in accordance with the plans and specifications set out in the contract;<br/> HBA Part 2C clause 18B(b) breach: 'a warranty that all materials supplied by the holder or person will be good and suitable for the purpose for which they are used and that, unless otherwise stated in the contract, those materials will be new; and<br/> HBA Part 2C clause 18B(c) breach: 'a warranty that the work will be done in accordance with, and will comply with, this or any other law'.</p> <p>The defects also represent failures by the Builder to comply with one of, or a combination of the following:<br/> BCA SECTION B STRUCTURE – PART B1 STRUCTURAL PROVISIONS: FUNCTIONAL STATEMENTS BF1.1:<br/> A building or structure is to withstand the combination of loads and other actions to which it may be reasonably subjected.<br/> BCA - SECTION F HEALTH AND AMENITY - Part F1 DAMP AND WEATHERPROOFING: PERFORMANCE REQUIREMENTS FP:1.4:<br/> 'A roof and external wall (incl openings around windows and doors) must prevent the penetration of water that could cause.<br/> (a) unhealthy or dangerous conditions, or loss of amenity to occupants, and<br/> (b) undue dampness or deterioration of building element'.</p> | <p>Remove existing sealant joint. Verify condition of associated flashing. Remediate flashing if required. Reseal joint in accordance with facade contractors specifications. Make good surrounding finishes as required.</p> | <p>IMG_5717.JPG 30/04/25 1:39 PM</p> |

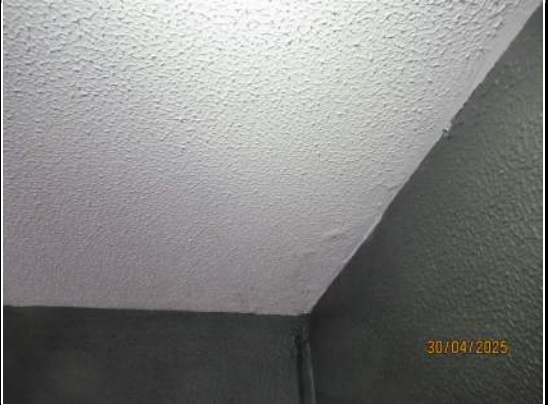
| Item | Area | Defect | Substantiation | Actions | Defect Photograph |
|---|---|---|---|---|---|
| SOU.<br>A1.001<br>5 | Building A1<br>Unit 1003<br>Balcony<br>North East<br>Soffit | Blistering to the painted coating on the soffit at the north east corner indicating a failure of the rooftop waterproofing above. | <p>Further investigations are required to verify the presence of the alleged defect.</p> <p>Further investigations were conducted on the 30/09/25. Slightly elevated moisture readings were taken from the site of the damage on Unit 1003's soffit. The rooftop above has had repairs conducted to the slab to wall abutment. The facade coating placed over the joint sealant at the abutment of the corner wall panels has failed and is allowing water ingress which is creating blisters and delamination of the weatherproof facade coating. After conducting spray testing of the affected area we were unable to create any increases in moisture content to the soffit below, however water is penetrating behind the facade coating which may be contributing to the damage witnessed.</p> <p>The author considers the recorded defects to be non-compliant with the following statutory requirements:</p> <p>HBA Part 2C clause 18B(a) breach: 'a warranty that the work will be done with due care and skill and in accordance with the plans and specifications set out in the contract;</p> <p>HBA Part 2C clause 18B(b) breach: 'a warranty that all materials supplied by the holder or person will be good and suitable for the purpose for which they are used and that, unless otherwise stated in the contract, those materials will be new'; and</p> <p>HBA Part 2C clause 18B(c) breach: 'a warranty that the work will be done in accordance with, and will comply with, this or any other law'.</p> <p>The defects also represent failures by the Builder to comply with one of, or a combination of the following:</p> <p>BCA SECTION B STRUCTURE – PART B1 STRUCTURAL PROVISIONS: FUNCTIONAL STATEMENTS BF1.1:</p> <p>A building or structure is to withstand the combination of loads and other actions to which it may be reasonably subjected.</p> <p>BCA - SECTION F HEALTH AND AMENITY - Part F1 DAMP AND WEATHERPROOFING: PERFORMANCE REQUIREMENTS FP:1.4:</p> <p>'A roof and external wall (incl openings around windows and doors) must prevent the penetration of water that could cause.</p> <p>(a) unhealthy or dangerous conditions, or loss of amenity to occupants, and</p> <p>(b) undue dampness or deterioration of building element'.</p> | <p>Remove the damaged facade coating concealing the joint. Inspect and repair the flexible joint as required. Prepare and reapply the facade coating to nearest architectural break with overlaps onto existing coating as per manufacturers recommendations. Remove damaged soffit coating to the balcony. Prepare patch and repaint to match existing coating. All paint work to be done in accordance with the requirements of AS2311.</p> | <p>IMG_5721.JPG 30/04/25 1:42 PM</p> |

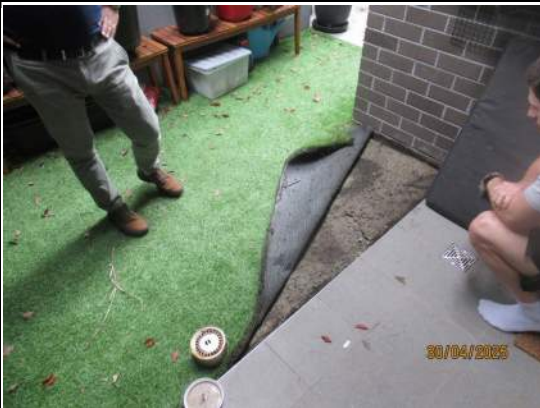
| Item | Area | Defect | Substantiation | Actions | Defect Photograph |
|---|---|---|---|---|---|
| SOU. A2.000 1 | Building A2 Unit G01 Courtyard | Natural ground concealed beneath synthetic turf is subsidising. Diagnostech attended investigate defect 22/09/2025. | Further investigations are required to verify the presence of the alleged defect. Diagnostech attended to investigate this defect on 22/09/2025. The turfed area exists beyond the northern boundary of the carpark structure below and was designed essentially as a planter box. We understand that following construction, plantings were removed and this had a thin concrete base poured over the soil and the turf applied. The subsidence likely results from inadequate compacting and preparation of the soil below prior to the turf being applied. | No action required. Not a Builder's defect. | <p>30/04/2025</p> <p>IMG_5726.JPG 30/04/25 2:50 PM</p> |

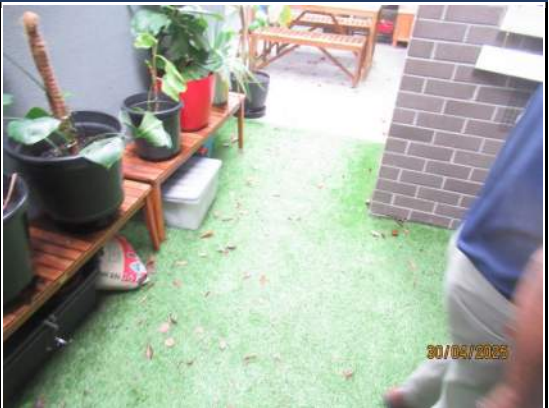
| Item | Area | Defect | Substantiation | Actions | Defect Photograph |
|---|---|---|---|---|---|
| SOU. A2.000 3 | Building A2 Unit G01 Ground Floor Courtyard | No overflow to afforded courtyard. | <p>The Builder has failed to provide adequate provision for overflow of the drainage system to the balcony.</p> <p>The author considers the recorded defects to be non-compliant with the following statutory requirements:<br/> HBA Part 2C clause 18B(a) breach: 'a warranty that the work will be done with due care and skill and in accordance with the plans and specifications set out in the contract; and<br/> HBA Part 2C clause 18B(c) breach: 'a warranty that the work will be done in accordance with, and will comply with, this or any other law'.</p> <p>The defects also represent failures by the Builder to comply with one of, or a combination of the following:<br/> BCA SECTION F HEALTH AND AMENITY – PART F1 DAMP AND WEATHERPROOFING: FUNCTIONAL STATEMENTS FF1.2:<br/> <i>A building is to be constructed to provide resistance to moisture penetration from the outside including rising from the ground.</i><br/> BCA SECTION F HEALTH AND AMENITY – PART F1 DAMP AND WEATHERPROOFING: Performance Requirement FP1.3:<br/> <i>A drainage system for the disposal of surface water must –<br/> (a) convey surface water to an appropriate outfall; and<br/> (b) undue dampness or deterioration of building elements.</i><br/> BCA SECTION F HEALTH AND AMENITY – PART F1 DAMP AND WEATHERPROOFING: Deemed-to-Satisfy Provisions F1.1:<br/> <i>Stormwater drainage must comply with AS3500.3</i></p> | Install overflow provision to the balcony at height greater than the f.f.l. and primary drainage outlet and lesser than the waterproofing termination height at the balcony doors. Overflow is to be incorporated into the waterproof membrane system as per the requirements of AS4654.2. | <p>30/04/2025</p> <p>IMG_5728.JPG 30/04/25 2:51 PM</p> |

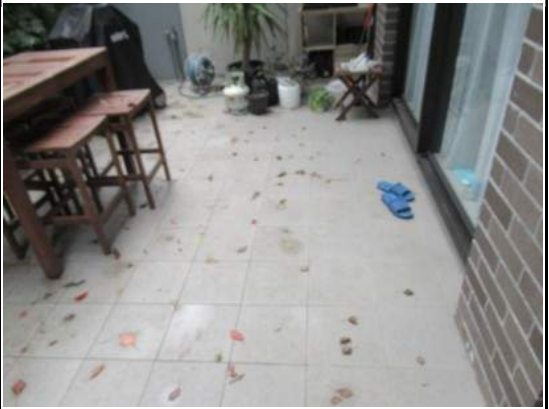
| Item | Area | Defect | Substantiation | Actions | Defect Photograph |
|---|---|---|---|---|---|
| SOU. A2.000 4 | Building A2 Unit G02 Ground Floor Courtyard | No overflow to afforded courtyard. | <p>The Builder has failed to provide adequate provision for overflow of the drainage system to the balcony.</p> <p>The author considers the recorded defects to be non-compliant with the following statutory requirements:<br/> HBA Part 2C clause 18B(a) breach: 'a warranty that the work will be done with due care and skill and in accordance with the plans and specifications set out in the contract; and<br/> HBA Part 2C clause 18B(c) breach: 'a warranty that the work will be done in accordance with, and will comply with, this or any other law'.</p> <p>The defects also represent failures by the Builder to comply with one of, or a combination of the following:<br/> BCA SECTION F HEALTH AND AMENITY – PART F1 DAMP AND WEATHERPROOFING: FUNCTIONAL STATEMENTS FF1.2:<br/> <i>A building is to be constructed to provide resistance to moisture penetration from the outside including rising from the ground.</i><br/> BCA SECTION F HEALTH AND AMENITY – PART F1 DAMP AND WEATHERPROOFING: Performance Requirement FP1.3:<br/> <i>A drainage system for the disposal of surface water must –<br/> (a) convey surface water to an appropriate outfall; and<br/> (b) undue dampness or deterioration of building elements.</i><br/> BCA SECTION F HEALTH AND AMENITY – PART F1 DAMP AND WEATHERPROOFING: Deemed-to-Satisfy Provisions F1.1:<br/> <i>Stormwater drainage must comply with AS3500.3</i></p> | Install overflow provision to the balcony at height greater than the f.f.l. and primary drainage outlet and lesser than the waterproofing termination height at the balcony doors. Overflow is to be incorporated into the waterproof membrane system as per the requirements of AS4654.2. | <p>IMG_0774.JPG 30/04/25 3:31 PM</p> |

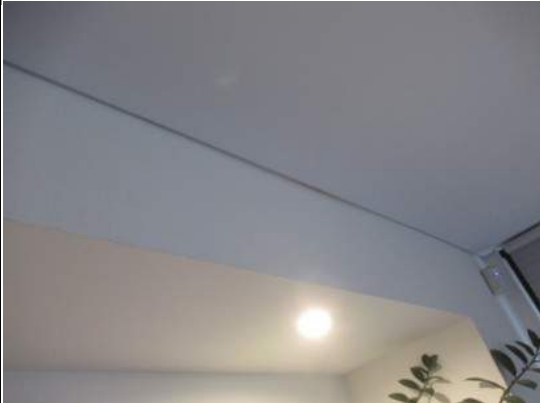
| Item | Area | Defect | Substantiation | Actions | Defect Photograph |
|---|---|---|---|---|---|
| SOU. A2.000 7 | Building A2 Unit 174 Living Room | Water staining to ceiling/bulkhead at south of living room. | <p>Further investigations are required to verify the presence of the alleged defect. Further investigations were conducted on the 29/10/25. Resident reported that a leak within the bulkhead associated with the bathroom above had been repaired. A visual inspection of the ceiling space and electronic moisture readings taken showed no signs of current water ingress. Cosmetic repairs are of poor quality with discolouration of the painted surface likely due to poor paint preparation or inadequate coats. This is considered incomplete remedial works.</p> <p>The author considers the recorded defects to be non-compliant with the following statutory requirements:<br/> HBA Part 2C clause 18B(a) breach: 'a warranty that the work will be done with due care and skill and in accordance with the plans and specifications set out in the contract; and<br/> HBA Part 2C clause 18B(c) breach: 'a warranty that the work will be done in accordance with, and will comply with, this or any other law'.</p> | <p>Request details of the dates, methodology, and products used in any repairs conducted to this window by the builder for record keeping purposes.</p> <p>Prepare and repaint the bulkhead to the nearest architectural break and in accordance with the requirements of AS2311.</p> | <p>IMG_0715.JPG 30/04/25 3:11 PM</p> |

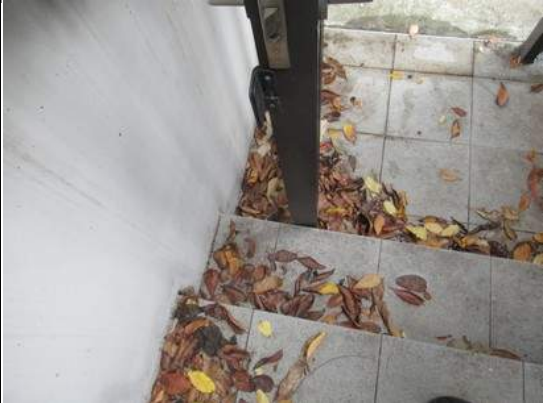
| Item | Area | Defect | Substantiation | Actions | Defect Photograph |
|---|---|---|---|---|---|
| SOU. A2.000 8 | Building A2 Unit 174 Ground Floor Courtyard | Gate does not fully open without fouling on the stair riser. | <p>The Builder has failed to provide effective access and egress from the building the building.</p> <p>It is the author's opinion that the Builder has breached the following warranties:</p> <p>HBA Part 2C clause 18B(a) breach: 'a warranty that the work will be done with due care and skill and in accordance with the plans and specifications set out in the contract';</p> <p>HBA Part 2C clause 18B(b) breach: 'a warranty that all materials supplied by the holder or person will be good and suitable for the purpose for which they are used and that, unless otherwise stated in the contract, those materials will be new';</p> <p>HBA Part 2C clause 18B(c) breach: 'a warranty that the work will be done in accordance with, and will comply with, this or any other law'; and</p> <p>HBA Part 2C clause 18B(e) breach: 'a warranty that, if the work consists of the construction of a dwelling, the making of alterations or additions to a dwelling or the repairing, renovation, decoration or protective treatment of a dwelling, the work will result, to the extent of the work conducted, in a dwelling that is reasonably fit for occupation as a dwelling'.</p> <p>The defect also represents a failure by the Builder to comply with the following requirement(s):</p> <p>BCA SECTION D ACCESS AND EGRESS – PART DP1:</p> <p>Access must be provided, to the degree necessary, to enable –</p> <p>(a) People to –</p> <p>... (ii) approach the building from any accessible associated building ...</p> <p>BCA SECTION D ACCESS AND EGRESS – PART DP2:</p> <p>So that people can move safely to and within a building, it must have –</p> <p>... (b) any doors installed to avoid risk of occupants –</p> <p>(i) Having their egress impeded; or</p> <p>(ii) Being trapped in the building...</p> | <p>A narrower gate is to be installed in place of the existing gate to allow full opening of the gate. All surrounding finishes affected by the works are to be made good including any render, paint work, tiling, and waterproofing.</p> | <p>IMG_0735.JPG 30/04/25 3:15 PM</p> |

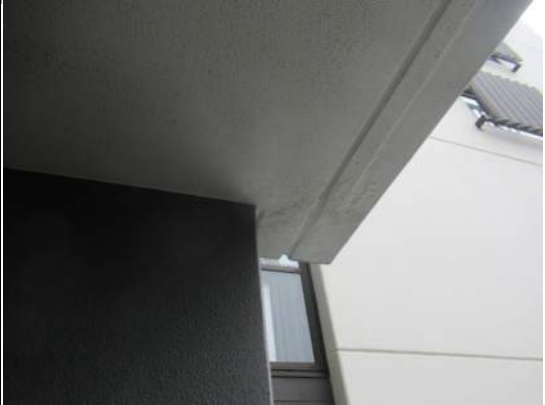
| Item | Area | Defect | Substantiation | Actions | Defect Photograph |
|---|---|---|---|---|---|
| SOU. A2.000 9 | Building A2 Unit 201 Balcony Soffit | <p>Blistering paint indicating water penetration from either the facade or balcony above.</p> <p>The waterproofing to the balcony of Unit 301/178 has failed.</p> | <p>Further investigations are required to verify the presence of the alleged defect.</p> <p>Further investigations were conducted on the 22/09/25 by way of obstructing the drainage to the balcony of Unit 301 above and conducting a flood test. Within minutes of initiating the flood test, water began appearing through the drip groove to the outer edge of the balcony indicating a failure of the waterproofing system installed to Unit 301 above.</p> <p>The Builder has failed to effectively waterproof the balcony of Unit 301/178.</p> <p>It is the author's opinion that the Builder has breached the following warranties:</p> <p>HBA Part 2C clause 18B(a) breach: 'a warranty that the work will be done with due care and skill and in accordance with the plans and specifications set out in the contract';</p> <p>HBA Part 2C clause 18B(b) breach: 'a warranty that all materials supplied by the holder or person will be good and suitable for the purpose for which they are used and that, unless otherwise stated in the contract, those materials will be new'; and</p> <p>HBA Part 2C clause 18B(c) breach: 'a warranty that the work will be done in accordance with, and will comply with, this or any other law'.</p> <p>The defect also represents a failure by the Builder to comply with the following requirement(s):</p> <p>BCA SECTION F HEALTH AND AMENITY – PART F1 DAMP AND WEATHERPROOFING: Performance Requirements FP1.4: A roof and external wall must prevent the penetration of water that could cause - (b) undue dampness or deterioration of building elements.</p> <p>BCA SECTION F HEALTH AND AMENITY – PART F1 DAMP AND WEATHERPROOFING: Deemed to Satisfy Provisions F1.4: Waterproof membranes for external above ground use must comply with AS4654 Parts 1 and 2.</p> | <p>Demolish existing tiles, bedding material and remove existing waterproofing and full height glazing to the Unit 301/178 balcony. Prepare surface, apply new sand and cement based screed with minimum 1:100 falls to drainage over the prepared substrate. Apply new waterproofing system to the balcony ensuring all termination details including around doors, perimeter walls, and overflows are done in accordance with AS4654.2. Apply new tiled finishes. Ensure compliance of existing door set and reinstall. If compliance cannot be verified, new door sets will be required for reinstallation. Prepare and repaint all affected surfaces to the Unit 301/178 balcony and Unit 201/178 balcony soffit in accordance with the requirements of AS2311 and to match existing finishes. Note: These works will require regulated designs under the D&amp;BP Act.</p> | <p>IMG_1333.JPG 30/04/25 4:11 PM</p> |

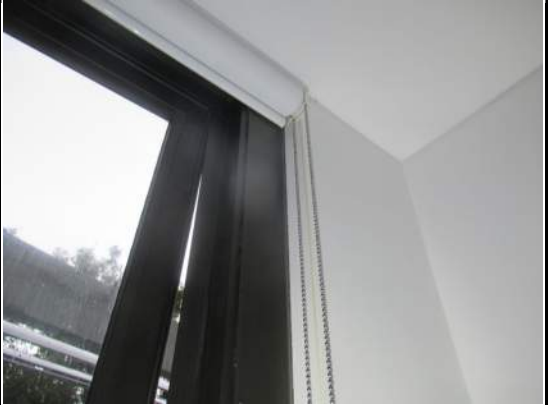
| Item | Area | Defect | Substantiation | Actions | Defect Photograph |
|---|---|---|---|---|---|
| SOU. A2.001 0 | Building A2 Unit 309 Bedroom 1 | Evidence of water ingress associated with the head of the Bedroom 1 window in addition to mould to the carpet edging below. | Further investigations are required to verify the cause of the alleged defect. Further investigations were conducted on the 29/09/25 by way of abseiling the exterior of the building and conducting water testing of the window opening. We were unable to replicate a leak indicated by the internal water marks and damage. As viewed from the exterior there appears to have been repairs made to the flexible sealant around the window fenestration. | Builder to provide dates, methodology, and products used in any repairs conducted to this window for record keeping purposes. | <br>IMG_1338.JPG 30/04/25 4:19 PM |

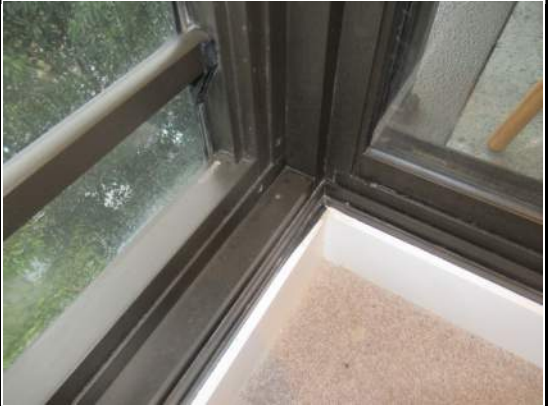
| Item | Area | Defect | Substantiation | Actions | Defect Photograph |
|---|---|---|---|---|---|
| SOU. A2.001 1 | Building A2 Unit 403 Living Room | Evidence of water ingress associated with the living room window. Damp carpet and mould present to the carpet at the left hand side of the window as viewed internally. | <p>Further investigations are required to verify the cause of the alleged defect. Further investigations were conducted on 22/09/2025 and confirmed leaks associated with both the end gaskets to the louvre panels and the head flashing/capping to the window.</p> <p>The Builder has failed to prevent water from bypassing the facade.</p> <p>It is the author's opinion that the Builder has breached the following warranties:</p> <p>HBA Part 2C clause 18B(a) breach: 'a warranty that the work will be done with due care and skill and in accordance with the plans and specifications set out in the contract';</p> <p>HBA Part 2C clause 18B(b) breach: 'a warranty that all materials supplied by the holder or person will be good and suitable for the purpose for which they are used and that, unless otherwise stated in the contract, those materials will be new';</p> <p>HBA Part 2C clause 18B(c) breach: 'a warranty that the work will be done in accordance with, and will comply with, this or any other law'; and</p> <p>HBA Part 2C clause 18B(e) breach: 'a warranty that, if the work consists of the construction of a dwelling, the making of alterations or additions to a dwelling or the repairing, renovation, decoration or protective treatment of a dwelling, the work will result, to the extent of the work conducted, in a dwelling that is reasonably fit for occupation as a dwelling'.</p> <p>The defect also represents a failure by the Builder to comply with the following requirement:</p> <p>BCA - Section F Health and Amenity - Part F1 Damp and Weatherproofing: FP1.4: 'A roof and external wall (incl openings around windows and doors) must prevent the penetration of water that could cause - (a) unhealthy or dangerous conditions, or loss of amenity to occupants, and (b) undue dampness or deterioration of building element'.</p> <p>BCA SECTION F HEALTH AND AMENITY – PART F1 DAMP AND WEATHERPROOFING: Deemed to Satisfy Provisions F1.13 Glazed assemblies: "Subject to (b) and (c), the following glazed assemblies in an external wall, must comply with AS2047 requirements for resistance to water penetration: (i) Windows. (ii) Sliding and swinging glazed doors with a frame, including french and bi-fold doors with a frame. (iii)Adjustable louvres."</p> | Replace the failed gaskets to the window. Remove external head flashing. Inspect opening. Reinstall head flashing to ensure the requirements of Section F of the BCA and AS2047 are met. Following reinstallation, conduct spray test of window to verify the success of the repairs (suggested method AAMA 501.2-03). Provide test report to Owners. Remove and replace all water damaged carpet and associated accessories and conduct mould removal as required. Repaint all affected internal surfaces in accordance with the requirements of AS2311. | <br>IMG_1346.JPG 30/04/25 4:38 PM |

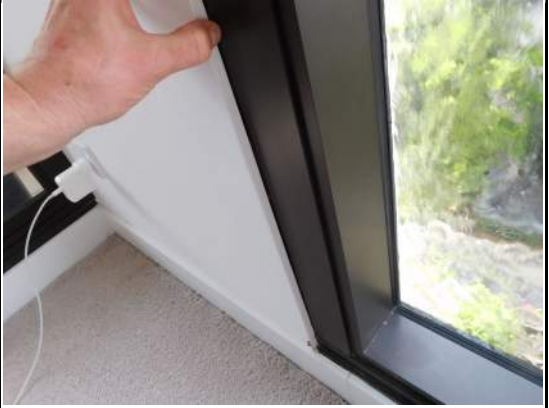
| Item | Area | Defect | Substantiation | Actions | Defect Photograph |
|---|---|---|---|---|---|
| SOU. A2.001 2 | Building A2 Unit 409 Living Room | Evidence of water ingress associated with the east facing living room window. | <p>Further investigations are required to verify the cause of the alleged defect. Further investigations were conducted on the 29/09/25 by way of abseiling the exterior of the building and conducting water testing of the window opening. We were unable to replicate a leak indicated by the internal water marks and damage. As viewed from the exterior there appears to have been repairs made to the flexible sealant around the window fenestration.</p> <p>The internal plasterboard lining remains bowed and detached from its underlying framing with some blistering paint remaining to the lower portion of the wall. This is considered incomplete remedial work.</p> <p>The author considers the recorded defects to be non-compliant with the following statutory requirements:<br/>HBA Part 2C clause 18B(a) breach: 'a warranty that the work will be done with due care and skill and in accordance with the plans and specifications set out in the contract'; and<br/>HBA Part 2C clause 18B(c) breach: 'a warranty that the work will be done in accordance with, and will comply with, this or any other law'.</p> | <p>Request details of the dates, methodology, and products used in any repairs conducted to this window by the builder for record keeping purposes.</p> <p>Refix plasterboard lining to the framing. Patch, prepare and paint to the nearest architectural; break in accordance with the requirements of AS2311.</p> | <p>DSCN2692.JPG 29/09/25 10:20 AM</p> |

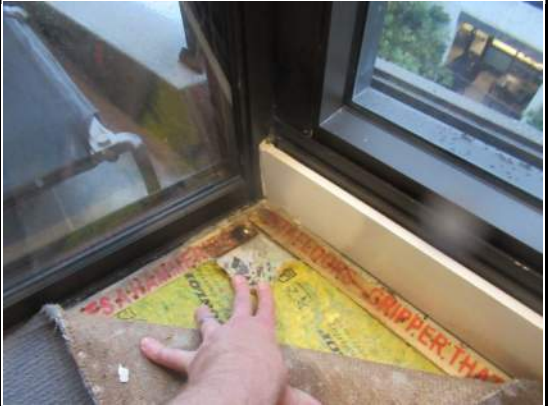
| Item | Area | Defect | Substantiation | Actions | Defect Photograph |
|---|---|---|---|---|---|
| SOU. A2.001 3 | Building A2 Unit 410 Living Room | Evidence of water ingress associated with the living room window. | <p>Further investigations are required to verify the cause of the alleged defect. Further investigations were conducted on the 22/09/2025. A leak was identified through the junction of the fixed panel to the balcony doors between the stile and the bottom rail at the external corner of the living room.</p> <p>The Builder has failed to prevent water from bypassing the facade.</p> <p>It is the author's opinion that the Builder has breached the following warranties:<br/>HBA Part 2C clause 18B(a) breach: 'a warranty that the work will be done with due care and skill and in accordance with the plans and specifications set out in the contract';<br/>HBA Part 2C clause 18B(b) breach: 'a warranty that all materials supplied by the holder or person will be good and suitable for the purpose for which they are used and that, unless otherwise stated in the contract, those materials will be new';<br/>HBA Part 2C clause 18B(c) breach: 'a warranty that the work will be done in accordance with, and will comply with, this or any other law'; and<br/>HBA Part 2C clause 18B(e) breach: 'a warranty that, if the work consists of the construction of a dwelling, the making of alterations or additions to a dwelling or the repairing, renovation, decoration or protective treatment of a dwelling, the work will result, to the extent of the work conducted, in a dwelling that is reasonably fit for occupation as a dwelling'.</p> <p>The defect also represents a failure by the Builder to comply with the following requirement:<br/>BCA - Section F Health and Amenity - Part F1 Damp and Weatherproofing: FP1.4: "A roof and external wall (incl openings around windows and doors) must prevent the penetration of water that could cause - (a) unhealthy or dangerous conditions, or loss of amenity to occupants, and (b) undue dampness or deterioration of building element."</p> <p>BCA SECTION F HEALTH AND AMENITY – PART F1 DAMP AND WEATHERPROOFING: Deemed to Satisfy Provisions F1.13 Glazed assemblies: "Subject to (b) and (c), the following glazed assemblies in an external wall, must comply with AS2047 requirements for resistance to water penetration: (i) Windows. (ii) Sliding and swinging glazed doors with a frame, including french and bi-fold doors with a frame. (iii) Adjustable louvres."</p> | <p>Remove the fixed panel of the balcony door assembly. Dismantle and reassemble with all joints appropriately sealed in accordance with the manufacturers original requirements. Reinstall fixed panel. Remove and replace all water damaged carpet and associated accessories and conduct mould removal as required. Repaint all affected internal surfaces in accordance with AS2311. Following repair, conduct spray test of window to verify the success of the repairs (suggested method AAMA 501.2 -03). Provide test report to Owners.</p> | <p>IMG_1360.JPG 30/04/25 4:52 PM</p> |

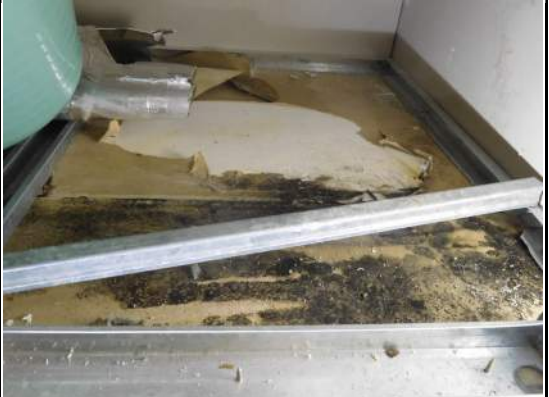
| Item | Area | Defect | Substantiation | Actions | Defect Photograph |
|---|---|---|---|---|---|
| SOU. A2.001 4 | Building A2 Unit 903 Entry | Resident advised that there is a leak associated with the bathroom affecting Unit 806 below. The resident of Unit 806 was not available to verify at the time of inspection. | <p>Further investigations are required to verify the cause of the alleged defect. Further investigations were conducted on the 29/09/2025. The property manager confirmed that a leak associated with the above bathroom had been resolved. Electronic moisture readings taken within the ceiling space showed no evidence of current water ingress. A bucket had been left in the ceiling beneath the faulty plumbing trap. This was dry and assumed a precaution following repairs. The ceiling below has been painted but the plasterboard ceiling viewed from above shows extensive mould damage. This is considered incomplete remedial work.</p> <p>The author considers the recorded defects to be non-compliant with the following statutory requirements:<br/> HBA Part 2C clause 18B(a) breach: 'a warranty that the work will be done with due care and skill and in accordance with the plans and specifications set out in the contract; and<br/> HBA Part 2C clause 18B(c) breach: 'a warranty that the work will be done in accordance with, and will comply with, this or any other law'.</p> | Remove the water damaged and mould affected plasterboard. Replace the plasterboard and set all joints in accordance with AS2589. Prepare and paint the ceiling below in accordance with the requirements of AS2311. | <p>DSCN2719.JPG 29/09/25 1:03 PM</p> |
