702/180 Livingstone Rd, Marrickville NSW 2204

# STRATA REPORT

**702/180 Livingstone Rd, Marrickville NSW 2204**

## Preliminary Major Building Defects Report

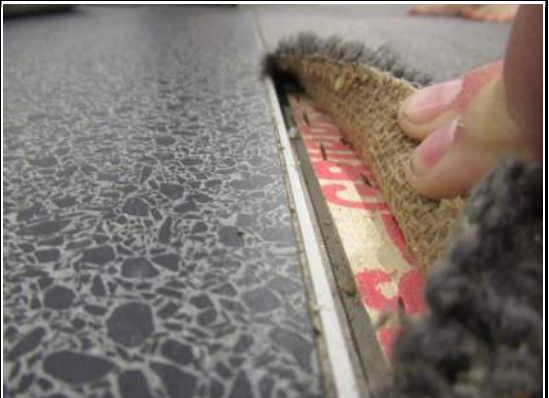
| Item | Area | Defect | Substantiation | Actions | Defect Photograph |
|---|---|---|---|---|---|
| SOU. A2.001 5 | Building A2 Unit 410 Kitchen | Carpet edging grip strip spikes can be felt through the carpet at the threshold of the hallway to the kitchen tiles. | <p>The Builder has failed to utilise suitably sized grip strips for the carpet installed leaving an unsafe walking surface.</p> <p>The author considers the recorded defects to be non-compliant with the following statutory requirements:<br/> HBA Part 2C clause 18B(a) breach: 'a warranty that the work will be done with due care and skill and in accordance with the plans and specifications set out in the contract,<br/> HBA Part 2C clause 18B(b) breach: 'a warranty that all materials supplied by the holder or person will be good and suitable for the purpose for which they are used and that, unless otherwise stated in the contract, those materials will be new;<br/> HBA Part 2C clause 18B(c) breach: 'a warranty that the work will be done in accordance with, and will comply with, this or any other law'; and<br/> HBA Part 2C clause 18B(e) breach: 'a warranty that, if the work consists of the construction of a dwelling, the making of alterations or additions to a dwelling or the repairing, renovation, decoration or protective treatment of a dwelling, the work will result, to the extent of the work conducted, in a dwelling that is reasonably fit for occupation as a dwelling';</p> | Conduct inspection of the carpeted areas of the Unit to identify if any other locations are affected. Locally remove carpet to affected areas and replace grip strips with alternative versions featuring shorter length tacks more suitable to the thickness of carpet installed. | <p>IMG_1369.JPG 30/04/25 5:02 PM</p> |

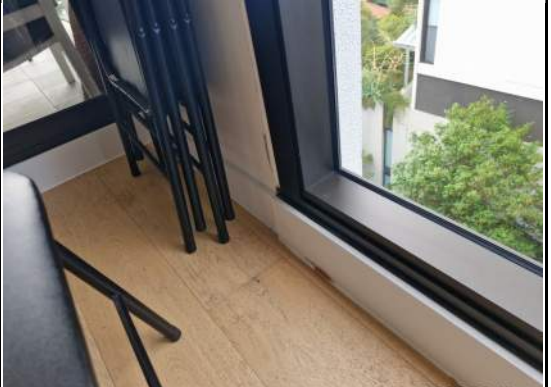
| Item | Area | Defect | Substantiation | Actions | Defect Photograph |
|---|---|---|---|---|---|
| SOU. A2.001 8 | Building A2 Unit 509 Living Room | Evidence of water ingress associated with the north east corner of the living rooms eastern window. | <p>Further investigations are required to verify the cause of the alleged defect. Further investigations were conducted on the 29/09/25 by way of abseiling the exterior of the building and conducting water testing of the window opening. We were unable to replicate a leak indicated by the internal water marks and damage. As viewed from the exterior there appears to have been repairs made to the flexible sealant around the window fenestration. Water damage remains to the plasterboard ling adjacent the window and to the skirting boards. This is considered incomplete remedial works.</p> <p>The author considers the recorded defects to be non-compliant with the following statutory requirements:</p> <ul style="list-style-type: none"> <li>HBA Part 2C clause 18B(a) breach: 'a warranty that the work will be done with due care and skill and in accordance with the plans and specifications set out in the contract; and</li> <li>HBA Part 2C clause 18B(c) breach: 'a warranty that the work will be done in accordance with, and will comply with, this or any other law'.</li> </ul> | <p>Prepare, patch, and paint waterdamaged plasterboard and timber skirting elements in accordance with the requirements of AS2311.</p> <p>Request details of the dates, methodology, and products used in any repairs conducted to this window by the builder for record keeping purposes.</p> | <p>1 May 2025 9:23:49 am<br/>TimePhoto_20250501_092349.jpg 1/05/25 9:23 AM -33.907176,151.153135</p> |

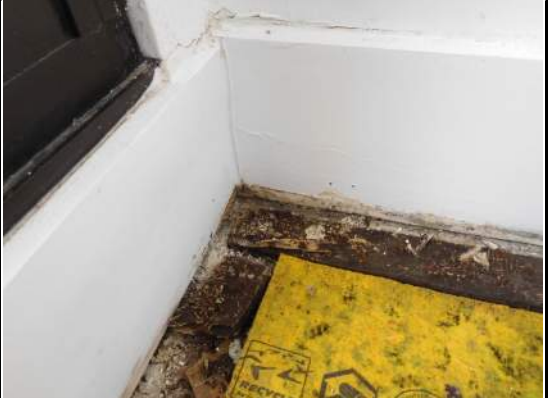
| Item | Area | Defect | Substantiation | Actions | Defect Photograph |
|---|---|---|---|---|---|
| SOU. A2.001 9 | Building A2 Unit 902 Bedroom 1 | Evidence of water ingress with the north west corner wall of bedroom 1. | <p>Further investigations are required to verify the cause of the alleged defect. Further investigations were conducted on the 23/09/2025. A leak was identified bypassing the end of the door sill and emanating beneath the skirting. The waterproofing termination should prevent this.</p> <p>The Builder has failed to prevent water from bypassing the facade.</p> <p>It is the author's opinion that the Builder has breached the following warranties:</p> <ul style="list-style-type: none"> <li>HBA Part 2C clause 18B(a) breach: 'a warranty that the work will be done with due care and skill and in accordance with the plans and specifications set out in the contract';</li> <li>HBA Part 2C clause 18B(b) breach: 'a warranty that all materials supplied by the holder or person will be good and suitable for the purpose for which they are used and that, unless otherwise stated in the contract, those materials will be new';</li> <li>HBA Part 2C clause 18B(c) breach: 'a warranty that the work will be done in accordance with, and will comply with, this or any other law'; and</li> <li>HBA Part 2C clause 18B(e) breach: 'a warranty that, if the work consists of the construction of a dwelling, the making of alterations or additions to a dwelling or the repairing, renovation, decoration or protective treatment of a dwelling, the work will result, to the extent of the work conducted, in a dwelling that is reasonably fit for occupation as a dwelling'.</li> </ul> <p>The defect also represents a failure by the Builder to comply with the following requirement:</p> <ul style="list-style-type: none"> <li>BCA - Section F Health and Amenity - Part F1 Damp and Weatherproofing: FP1.4: 'A roof and external wall (incl openings around windows and doors) must prevent the penetration of water that could cause - (a) unhealthy or dangerous conditions, or loss of amenity to occupants, and (b) undue dampness or deterioration of building element'.</li> <li>BCA SECTION F HEALTH AND AMENITY – PART F1 DAMP AND WEATHERPROOFING: Deemed to Satisfy Provisions F1.13 Glazed assemblies: "Subject to (b) and (c), the following glazed assemblies in an external wall, must comply with AS2047 requirements for resistance to water penetration: (i) Windows. (ii) Sliding and swinging glazed doors with a frame, including french and bi-fold doors with a frame. (iii) Adjustable louvres."</li> </ul> | <p>Remove door set to access and assess waterproofing termination. Repair waterproofing termination as required. Reinstall sub sill ensuring end caps are in good condition and properly sealed. Replace if required. Reinstall door set to ensure the requirements of Section F of the BCA and AS2047 are met. Following reinstallation, conduct spray test of window to verify the success of the repairs (suggested method AAMA 501.2-03). Provide test report to Owners. Remove and replace all water damaged carpet and associated accessories and conduct mould removal as required. Repaint all affected internal surfaces in accordance with AS2311.</p> | <p>DSCN2455.JPG 23/09/25 10:39 AM</p> |

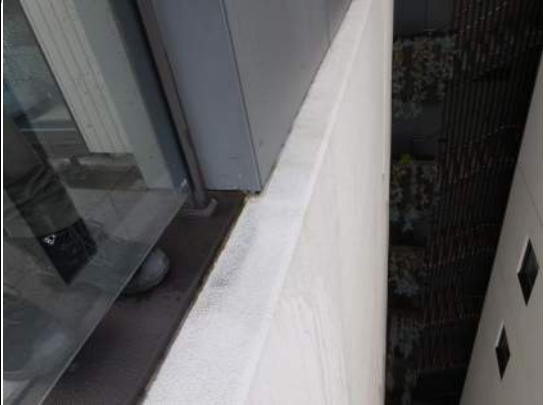
| Item | Area | Defect | Substantiation | Actions | Defect Photograph |
|---|---|---|---|---|---|
| SOU.<br>A2.002<br>0 | Building A2<br>Unit 902<br>Bedroom 2 | Evidence of water ingress associated with the south west corner of the balcony doors. | <p>Further investigations are required to verify the cause of the alleged defect.</p> <p>Further investigations were conducted on the 23/09/2025. No leak was identified associated with the balcony doors but a leak was identified associated with the external fibre cement cladding sheet installed atop the perimeter hob to the external facade of the building. When water tested at the base of the fibre cement panels, water quickly appeared internally beneath the internal skirting board.</p> <p>The Builder has failed to prevent water from bypassing the facade.</p> <p>It is the author's opinion that the Builder has breached the following warranties:</p> <ul style="list-style-type: none"> <li>· HBA Part 2C clause 18B(a) breach: 'a warranty that the work will be done with due care and skill and in accordance with the plans and specifications set out in the contract';</li> <li>· HBA Part 2C clause 18B(b) breach: 'a warranty that all materials supplied by the holder or person will be good and suitable for the purpose for which they are used and that, unless otherwise stated in the contract, those materials will be new';</li> <li>· HBA Part 2C clause 18B(c) breach: 'a warranty that the work will be done in accordance with, and will comply with, this or any other law'; and</li> <li>· HBA Part 2C clause 18B(e) breach: 'a warranty that, if the work consists of the construction of a dwelling, the making of alterations or additions to a dwelling or the repairing, renovation, decoration or protective treatment of a dwelling, the work will result, to the extent of the work conducted, in a dwelling that is reasonably fit for occupation as a dwelling'.</li> </ul> <p>The defect also represents a failure by the Builder to comply with the following requirement:</p> <ul style="list-style-type: none"> <li>· BCA - Section F Health and Amenity - Part F1 Damp and Weatherproofing: FP1.4: 'A roof and external wall (incl openings around windows and doors) must prevent the penetration of water that could cause - (a) unhealthy or dangerous conditions, or loss of amenity to occupants, and (b) undue dampness or deterioration of building element'.</li> </ul> | <p>Remove external panel. Assess all sarking, flashing, and joints. Repair as required and reinstate external linings. Following reinstallation, conduct spray test of facade elements and surroundings to verify the success of the repairs (suggested method AAMA 501.2-03). Provide test report to Owners. Remove and replace all water damaged carpet and associated accessories and conduct mould removal as required. Repaint all affected internal and external surfaces in accordance with AS2311.</p> | <p>DSCN2435.JPG 23/09/25 10:28 AM</p> |

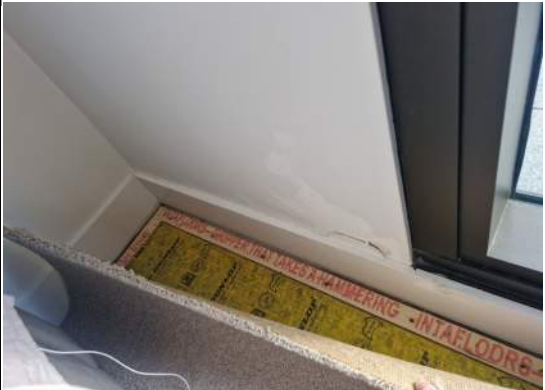
| Item | Area | Defect | Substantiation | Actions | Defect Photograph |
|---|---|---|---|---|---|
| SOU.<br>A2.002<br>1 | Building A2<br>Unit 903<br>Bedroom 2 | Evidence of water ingress associated with the bedroom 2 north west window. | <p>Further investigations are required to verify the cause of the alleged defect.</p> <p>Further investigations were conducted on the 23/09/25 by way of water testing the exterior of the affected windows. We were unable to replicate a leak. Repairs had been conducted just prior to our attendance. The plaster to the internal walls was still wet. After lifting the external pavers we could see that localised waterproofing repairs have been conducted beneath the window sill, the extent of which was not clear. Internal repairs remained incomplete but were in progress.</p> <p>The author considers the recorded defects to be non-compliant with the following statutory requirements:</p> <ul style="list-style-type: none"> <li>· HBA Part 2C clause 18B(a) breach: 'a warranty that the work will be done with due care and skill and in accordance with the plans and specifications set out in the contract'; and</li> <li>· HBA Part 2C clause 18B(c) breach: 'a warranty that the work will be done in accordance with, and will comply with, this or any other law'.</li> </ul> | <p>Request details of the dates, methodology, and products used in any repairs conducted to this window by the builder for record keeping purposes.</p> | <p>TimePhoto_20250501_134557.jpg 1/05/25 1:45 PM -33.907796,151.153228</p> |

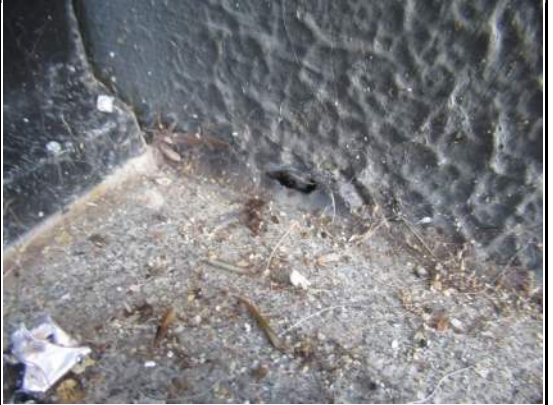
| Item | Area | Defect | Substantiation | Actions | Defect Photograph |
|---|---|---|---|---|---|
| SOU.<br>A2.002<br>3 | Building A2<br>Unit 1001<br>Balcony | Overflow outlet<br>concealed by<br>finished tile level. | <p>The Builder has failed to provide adequate provision for overflow of the drainage system to the balcony.</p> <p>The author considers the recorded defects to be non-compliant with the following statutory requirements:</p> <ul style="list-style-type: none"> <li>· HBA Part 2C clause 18B(a) breach: 'a warranty that the work will be done with due care and skill and in accordance with the plans and specifications set out in the contract; and</li> <li>· HBA Part 2C clause 18B(c) breach: 'a warranty that the work will be done in accordance with, and will comply with, this or any other law'.</li> </ul> <p>The defects also represent failures by the Builder to comply with one of, or a combination of the following:</p> <ul style="list-style-type: none"> <li>· BCA SECTION F HEALTH AND AMENITY – PART F1 DAMP AND WEATHERPROOFING: FUNCTIONAL STATEMENTS FF1.2:<br/><i>A building is to be constructed to provide resistance to moisture penetration from the outside including rising from the ground.</i></li> <li>· BCA SECTION F HEALTH AND AMENITY – PART F1 DAMP AND WEATHERPROOFING: Performance Requirement FP1.3:<br/><i>A drainage system for the disposal of surface water must –</i><br/><i>(a) convey surface water to an appropriate outfall; and</i><br/><i>(b) undue dampness or deterioration of building elements.</i></li> <li>· BCA SECTION F HEALTH AND AMENITY – PART F1 DAMP AND WEATHERPROOFING: Deemed-to-Satisfy Provisions F1.1:<br/><i>Stormwater drainage must comply with AS3500.3</i></li> </ul> | <p>Install overflow provision to the balcony at height greater than the f.f.l. and primary drainage outlet and lesser than the waterproofing termination height at the balcony doors. Overflow is to be incorporated into the waterproof membrane system as per the requirements of AS4654.2.</p> | <p>IMG_1409.JPG 1/05/25 10:30 AM</p> |

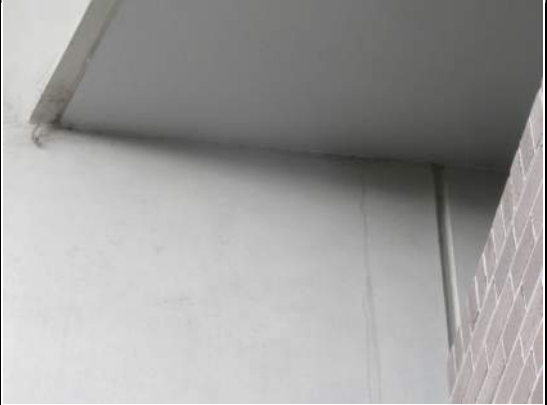
| Item | Area | Defect | Substantiation | Actions | Defect Photograph |
|---|---|---|---|---|---|
| SOU. B.0003 | Building B Unit G09 Balcony Soffit | Evidence of a leak associated with the planter box forming the soffit of Unit G09 associated with Unit 208 above at both ends of the Unit. | <p>Further investigations are required to verify the presence of the alleged defect. Further investigations were conducted on the 7/10/25. A localised water test was conducted by way of introducing water to the planter of the corresponding Unit 208 above. The water was left to run for a period of approximately 18 hours. Following the test, while only a slight gloss indicating water penetration was noted, highly elevated electronic moisture readings were detected at the sites of the existing water staining indicating a failure of the waterproof membrane to the Unit 208 planter box.</p> <p>The Builder has failed to effectively waterproof the planter box and prevent the penetration of water through structural concrete elements.</p> <p>It is the author's opinion that the Builder has breached the following warranties:<br/> HBA Part 2C clause 18B(a) breach: 'a warranty that the work will be done with due care and skill and in accordance with the plans and specifications set out in the contract';<br/> HBA Part 2C clause 18B(b) breach: 'a warranty that all materials supplied by the holder or person will be good and suitable for the purpose for which they are used and that, unless otherwise stated in the contract, those materials will be new'; and<br/> HBA Part 2C clause 18B(c) breach: 'a warranty that the work will be done in accordance with, and will comply with, this or any other law'.</p> <p>The defect also represents a failure by the Builder to comply with the following requirement(s):<br/> BCA SECTION B STRUCTURE – PART B1 STRUCTURAL PROVISIONS: FUNCTIONAL STATEMENTS BF1.1: 'A building or structure is to withstand the combination of loads and other actions to which it may be reasonably subjected.'<br/> BCA SECTION F HEALTH AND AMENITY – PART F1 DAMP AND WEATHERPROOFING: Deemed to Satisfy Provisions F1.4: "Waterproof membranes for external above ground use must comply with AS4654 Parts 1 and 2."</p> | <p>It is not envisaged that localised repair will be feasible and that comprehensive repairs will be needed requiring regulated designs be issued under the D&amp;BPA Act. Remove the contents of the planter box. If possible, store plantings for reinstatement. Prepare the substrate and re waterproof the planter box in strict accordance with the requirements of AS4654.2 including all drainage and overflow details. Flood test the planter box for 24 hours prior to reinstatement of soil and plants and provide a report to the Owners. Reinstall soil and plants following successful flood test.</p> | <p>IMG_1575.JPG 1/05/25 1:26 PM</p> |

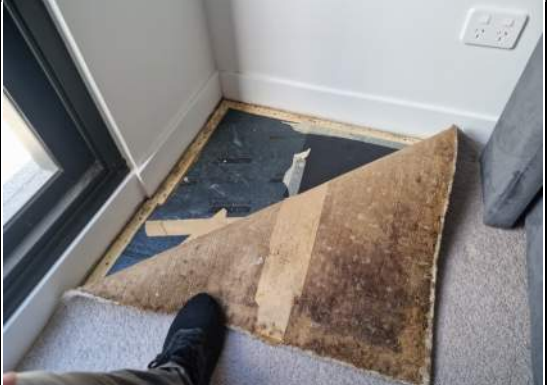
| Item | Area | Defect | Substantiation | Actions | Defect Photograph |
|---|---|---|---|---|---|
| SOU. B.0004 | Building B Unit 205 Bedroom 1 | Evidence of water ingress associated with the south east window of bedroom 1. | <p>Further investigations are required to verify the cause of the alleged defect. Further investigations were conducted on the 10/10/25 by way of water testing the window and abutting elements from the external balcony, including waterproofing terminations beneath the window and control joints between the external concrete wall panels. We were unable to replicate a leak indicated by the internal mould and water damage. We understand that the Builder had conducted repair works to mitigate water ingress previously which involved opening up the plasterboard walls around the door and southern wall and applying negative membranes and sealants. There is no evidence externally of any repair works having been conducted. Water damage remains to the carpet and associated accessories. This is considered incomplete remedial work.</p> <p>The author considers the recorded defects to be non-compliant with the following statutory requirements:<br/> HBA Part 2C clause 18B(a) breach: 'a warranty that the work will be done with due care and skill and in accordance with the plans and specifications set out in the contract'; and<br/> HBA Part 2C clause 18B(c) breach: 'a warranty that the work will be done in accordance with, and will comply with, this or any other law'.</p> | <p>Request details of the dates, methodology, and products used in any repairs conducted to this window by the builder for record keeping purposes.<br/> Remove and replace all water damaged carpet and associated accessories and conduct mould removal as required. Repaint all affected internal surfaces in accordance with AS2311.<br/> We recommend the resident continues to monitor the situation.</p> | <p>1 May 2025 11:11:39 am<br/> TimePhoto_20250501_111139.jpg 1/05/25 11:11 AM -33.907793,151.153461</p> |

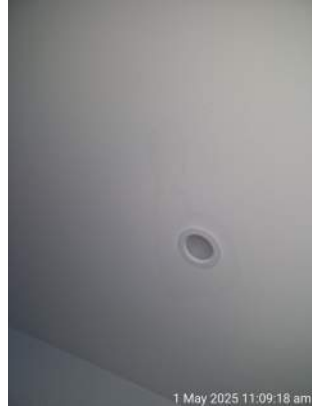
| Item | Area | Defect | Substantiation | Actions | Defect Photograph |
|---|---|---|---|---|---|
| SOU. B.0005 | Building B Unit 205 Kitchen | Water staining to kitchen ceiling. | <p>Further investigations are required to verify the presence of the alleged defect. Further investigation were conducted on the 30/09/25. Resident had reported that a leak from a Unit above had been repaired. We verified that there was no ongoing water ingress or moisture within the ceiling void. The quality of the repairs to the ceiling is poor with further sanding and painting required. This is considered incomplete remedial work.</p> <p>The author considers the recorded defects to be non-compliant with the following statutory requirements:<br/> HBA Part 2C clause 18B(a) breach: 'a warranty that the work will be done with due care and skill and in accordance with the plans and specifications set out in the contract; and<br/> HBA Part 2C clause 18B(c) breach: 'a warranty that the work will be done in accordance with, and will comply with, this or any other law'.</p> | Request details of the dates, methodology, and products used in any repairs conducted by the builder for record keeping purposes.<br>Patch, prepare and paint the ceiling to the nearest architectural break in accordance with the requirements of AS2311. | <p>TimePhoto_20250501_110919.jpg 1/05/25 11:09 AM -33.907843,151.153625</p> |

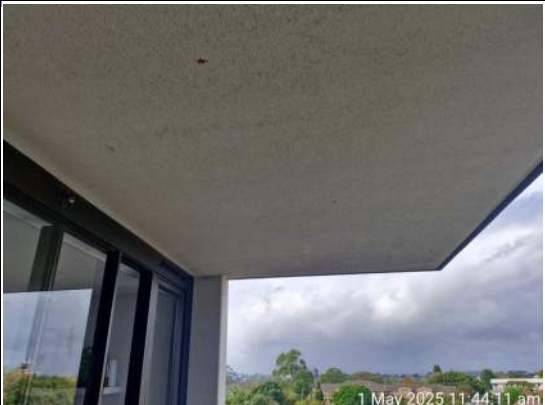
| Item | Area | Defect | Substantiation | Actions | Defect Photograph |
|---|---|---|---|---|---|
| SOU. B.0007 | Building B Unit 305 Balcony Soffit | Corrosion of ferrous material at surface of soffit due to inadequate concrete prep or reinforcement coverage. | <p>The Builder has failed to provide sufficient concrete coverage to embedded steel when the slab was constructed as per AS3600:Concrete Structures.</p> <p>The author considers the recorded defects to be non-compliant with the following statutory requirements:<br/> HBA Part 2C clause 18B(a) breach: 'a warranty that the work will be done with due care and skill and in accordance with the plans and specifications set out in the contract,<br/> HBA Part 2C clause 18B(c) breach: 'a warranty that the work will be done in accordance with, and will comply with, this or any other law'; and</p> <p>The defects also represent failures by the Builder to comply with one of, or a combination of the following:<br/> BCA SECTION B STRUCTURE – PART B1 STRUCTURAL PROVISIONS: FUNCTIONAL STATEMENTS BF1.1:<br/> A building or structure is to withstand the combination of loads and other actions to which it may be reasonably subjected.<br/> BCA SECTION B STRUCTURE – PART B1 STRUCTURAL PROVISIONS: DEEMED-TO-SATISFY PROVISIONS: B1.4: DETERMINATIO OF STRUCTURAL RESISTANCE OF MATERIALS ANF FORMS OF CONSTRUCTION:<br/> The structural resistance of materials and forms of construction must be determined in accordance with the following, as appropriate:<br/> (a) Concrete:<br/> (i) Concrete construction (including reinforced and prestressed concrete): AS3600.</p> | Break out concrete, remove corroded ferrous material, treat with zinc rich primer (minimum 28%), patch using non shrink repair mortar. Reinstate painted coating to the soffit to match the existing to the nearest architectural break. | <p>TimePhoto_20250501_114411.jpg 1/05/25 11:44 AM -33.907833,151.153571</p> |

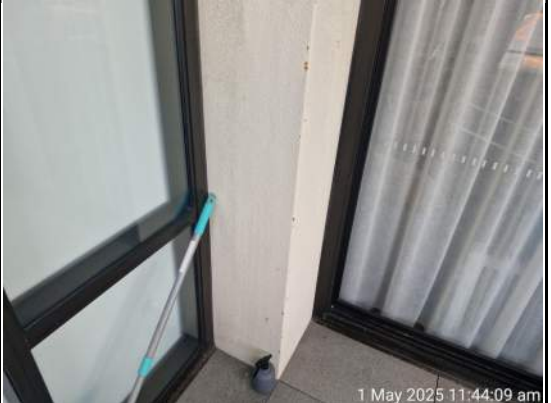
| Item | Area | Defect | Substantiation | Actions | Defect Photograph |
|---|---|---|---|---|---|
| SOU. B.0008 | Building B Unit 305 Balcony Riser | Corrosion of corner trim to riser resulting from inadequate protection of ferrous material. | <p>The Builder has failed to effectively secure and seal the facade panel.</p> <p>The author considers the recorded defects to be non-compliant with the following statutory requirements:</p> <p>HBA Part 2C clause 18B(a) breach: 'a warranty that the work will be done with due care and skill and in accordance with the plans and specifications set out in the contract';</p> <p>HBA Part 2C clause 18B(b) breach: 'a warranty that all materials supplied by the holder or person will be good and suitable for the purpose for which they are used and that, unless otherwise stated in the contract, those materials will be new; and</p> <p>HBA Part 2C clause 18B(c) breach: 'a warranty that the work will be done in accordance with, and will comply with, this or any other law'.</p> <p>The defects also represent failures by the Builder to comply with one of, or a combination of the following:</p> <p>BCA SECTION B STRUCTURE – PART B1 STRUCTURAL PROVISIONS: FUNCTIONAL STATEMENTS BF1.1:<br/>A building or structure is to withstand the combination of loads and other actions to which it may be reasonably subjected.</p> <p>BCA SECTION F HEALTH AND AMENITY – PART F1 DAMP AND WEATHERPROOFING: FUNCTIONAL STATEMENTS FF1.2:<br/>A building is to be constructed to provide resistance to moisture penetration from the outside including rising from the ground.</p> | Remove corroded corner setting bead and replace with PVC bead. Set corner using suitably water resistant setting compound and repaint panels to match the existing finish and to the nearest architectural break. | <p>1 May 2025 11:44:09 am<br/>TimePhoto_20250501_114409.jpg 1/05/25 11:44 AM -33.907820,151.153564</p> |

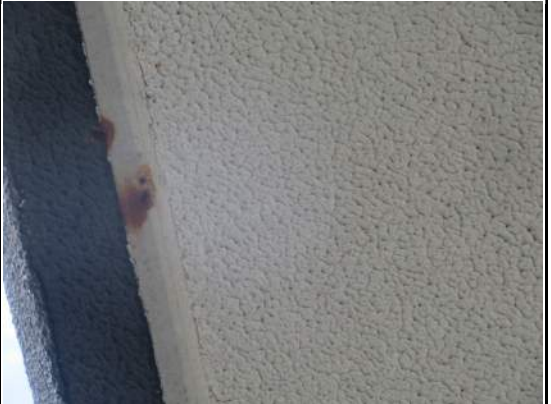
| Item | Area | Defect | Substantiation | Actions | Defect Photograph |
|---|---|---|---|---|---|
| SOU. B.0009 | Building B Unit 307 Balcony Soffit | Corrosion of ferrous material at surface of soffit due to inadequate concrete prep or reinforcement coverage. | <p>The Builder has failed to provide sufficient concrete coverage to embedded steel when the slab was constructed as per AS3600:Concrete Structures.</p> <p>The author considers the recorded defects to be non-compliant with the following statutory requirements:</p> <p>HBA Part 2C clause 18B(a) breach: 'a warranty that the work will be done with due care and skill and in accordance with the plans and specifications set out in the contract';</p> <p>HBA Part 2C clause 18B(c) breach: 'a warranty that the work will be done in accordance with, and will comply with, this or any other law'; and</p> <p>The defects also represent failures by the Builder to comply with one of, or a combination of the following:</p> <p>BCA SECTION B STRUCTURE – PART B1 STRUCTURAL PROVISIONS: FUNCTIONAL STATEMENTS BF1.1:<br/>A building or structure is to withstand the combination of loads and other actions to which it may be reasonably subjected.</p> <p>BCA SECTION B STRUCTURE – PART B1 STRUCTURAL PROVISIONS: DEEMED-TO-SATISFY PROVISIONS: B1.4: DETERMINATIO OF STRUCTURAL RESISTANCE OF MATERIALS ANF FORMS OF CONSTRUCTION:<br/>The structural resistance of materials and forms of construction must be determined in accordance with the following, as appropriate:<br/>(a) Concrete:<br/>(i) Concrete construction (including reinforced and prestressed concrete): AS3600.</p> | Break out concrete, remove corroded ferrous material, treat with zinc rich primer (minimum 28%), patch using non shrink repair mortar. Reinststate painted coating to the soffit to match the existing to the nearest architectural break. | <p>IMG_1541.JPG 1/05/25 12:39 PM</p> |

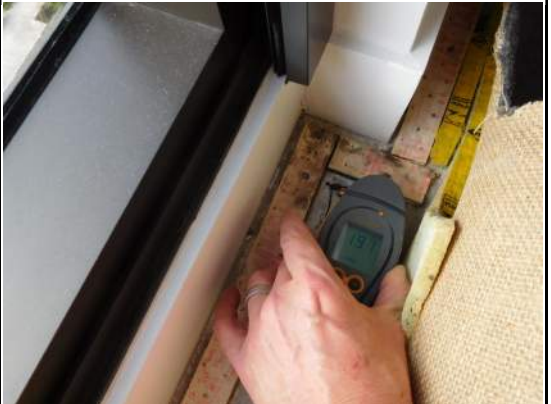
| Item | Area | Defect | Substantiation | Actions | Defect Photograph |
|---|---|---|---|---|---|
| SOU. B.0010 | Building B Unit 402 Bedroom 2 | Evidence of water ingress associated with the north east corner of the bedroom window. | <p>Further investigations are required to verify the cause of the alleged defect. Further investigations were conducted on the 30/09/25 by way of abseiling the exterior of the building and conducting water testing of the window opening. We were unable to replicate a leak indicated by the internal mould and water damage. As viewed from the exterior there appears to have been repairs made to the flexible sealant around the window fenestration. Water damage remains to the carpet and associated accessories. This is considered incomplete remedial work.</p> <p>The author considers the recorded defects to be non-compliant with the following statutory requirements:</p> <p>HBA Part 2C clause 18B(a) breach: 'a warranty that the work will be done with due care and skill and in accordance with the plans and specifications set out in the contract; and</p> <p>HBA Part 2C clause 18B(c) breach: 'a warranty that the work will be done in accordance with, and will comply with, this or any other law'.</p> | <p>Request details of the dates, methodology, and products used in any repairs conducted to this window by the builder for record keeping purposes.</p> <p>Remove and replace all water damaged carpet and associated accessories and conduct mould removal as required. Repaint all affected internal surfaces in accordance with AS2311.</p> <p>We recommend the resident continues to monitor the situation.</p> | <p>DSCN2777.JPG 30/09/25 8:36 AM</p> |

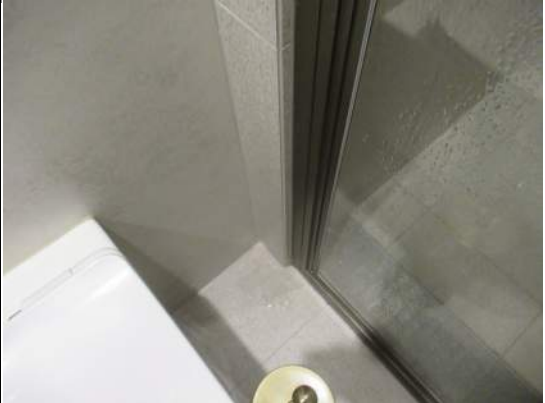
| Item | Area | Defect | Substantiation | Actions | Defect Photograph |
|---|---|---|---|---|---|
| SOU. B.0011 | Building B Unit 506 Bathroom | Water accumulating in sub frame of shower screen and leaking out following water source being removed. | <p>Shower screen not sealed at all junctions in accordance with AS3740.</p> <p>The author considers the recorded defects to be non-compliant with the following statutory requirements:<br/>HBA Part 2C clause 18B(a) breach: 'a warranty that the work will be done with due care and skill and in accordance with the plans and specifications set out in the contract; and<br/>HBA Part 2C clause 18B(c) breach: 'a warranty that the work will be done in accordance with, and will comply with, this or any other law'.</p> <p>The defects also represent failures by the Builder to comply with one of, or a combination of the following:<br/>BCA SECTION F HEALTH AND AMENITY – PART F1 DAMP AND WEATHERPROOFING: DEEMED-TO-SATISFY PROVISIONS F1.7:<br/>(a) In a Class 2 and 3 building and a Class 4 part of a building, building elements in wet areas must –<br/>(ii) comply with AS3740.</p> | Seal shower screen in accordance with the requirements of AS3740. | <p>IMG_1327.JPG 30/04/25 3:46 PM</p> |

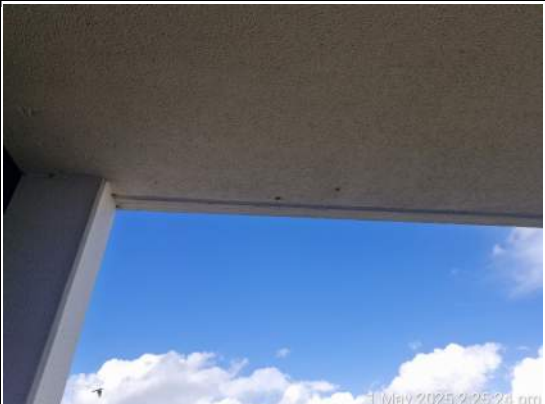
| Item | Area | Defect | Substantiation | Actions | Defect Photograph |
|---|---|---|---|---|---|
| SOU. B.0012 | Building B Unit 605 Balcony Soffit | Corrosion of ferrous material at surface of soffit due to inadequate concrete prep or reinforcement coverage. | <p>The Builder has failed to provide sufficient concrete coverage to embedded steel when the slab was constructed as per AS3600:Concrete Structures.</p> <p>The author considers the recorded defects to be non-compliant with the following statutory requirements:<br/>HBA Part 2C clause 18B(a) breach: 'a warranty that the work will be done with due care and skill and in accordance with the plans and specifications set out in the contract;<br/>HBA Part 2C clause 18B(c) breach: 'a warranty that the work will be done in accordance with, and will comply with, this or any other law'; and</p> <p>The defects also represent failures by the Builder to comply with one of, or a combination of the following:<br/>BCA SECTION B STRUCTURE – PART B1 STRUCTURAL PROVISIONS: FUNCTIONAL STATEMENTS BF1.1:<br/>A building or structure is to withstand the combination of loads and other actions to which it may be reasonably subjected.<br/>BCA SECTION B STRUCTURE – PART B1 STRUCTURAL PROVISIONS: DEEMED-TO-SATISFY PROVISIONS: B1.4: DETERMINATIO OF STRUCTURAL RESISTANCE OF MATERIALS ANF FORMS OF CONSTRUCTION:<br/>The structural resistance of materials and forms of construction must be determined in accordance with the following, as appropriate:<br/>(a) Concrete:<br/>(i) Concrete construction (including reinforced and prestressed concrete): AS3600.</p> | Break out concrete, remove corroded ferrous material, treat with zinc rich primer (minimum 28%), patch using non shrink repair mortar. Reinstate painted coating to the soffit to match the existing to the nearest architectural break. | <p>TimePhoto_20250501_142524.jpg 1/05/25 2:25 PM -33.907838,151.153553</p> |

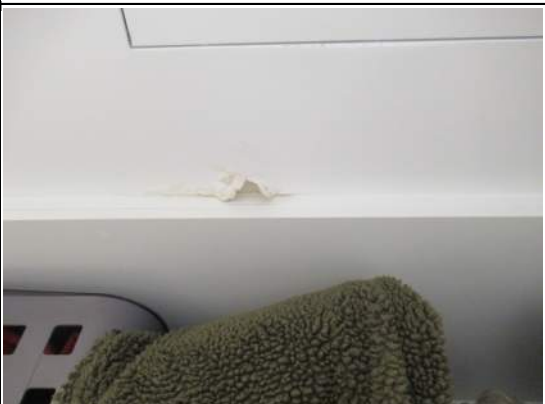
| Item | Area | Defect | Substantiation | Actions | Defect Photograph |
|---|---|---|---|---|---|
| SOU. B.0013 | Building B Unit 607 Entry Way | Evidence of water damage to the ceiling directly above the laundry cupboard doors. | <p>Further investigations are required to verify the presence of the alleged defect.<br/>Further investigations were conducted on the 30/09/25. The ceiling cavity was accessed and a leaking tempering valve was identified as the source of the damage.<br/>This does not qualify as a major defect and is considered a maintenance issue for the OC.</p> | No action required by the Builder. | <p>IMG_1672.JPG 1/05/25 3:09 PM</p> |

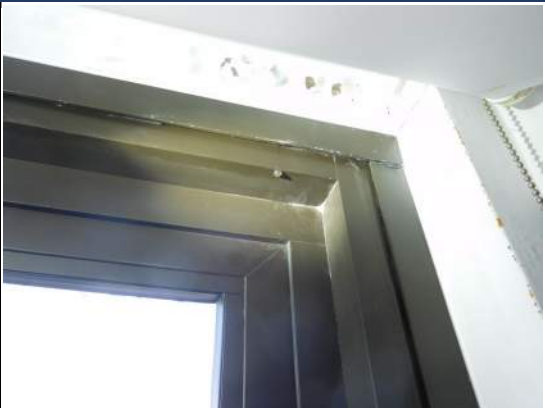
| Item | Area | Defect | Substantiation | Actions | Defect Photograph |
|---|---|---|---|---|---|
| SOU. B.0014 | Building B Unit 607 Living Room | Evidence of water ingress associated with the living room window. | <p>Further investigations are required to verify the cause of the alleged defect. Further investigations were conducted on 30/09/2025. The window was water tested externally via abseil. After approximately 45 minutes of testing water began emanating from the window head. As viewed externally the joint sealant to the fenestration appeared to be in good condition leaving the problem to be associated with the sub head and or head flashing.</p> <p>The Builder has failed to prevent water from bypassing the facade.</p> <p>It is the author's opinion that the Builder has breached the following warranties:<br/> HBA Part 2C clause 18B(a) breach: 'a warranty that the work will be done with due care and skill and in accordance with the plans and specifications set out in the contract';<br/> HBA Part 2C clause 18B(b) breach: 'a warranty that all materials supplied by the holder or person will be good and suitable for the purpose for which they are used and that, unless otherwise stated in the contract, those materials will be new';<br/> HBA Part 2C clause 18B(c) breach: 'a warranty that the work will be done in accordance with, and will comply with, this or any other law'; and<br/> HBA Part 2C clause 18B(e) breach: 'a warranty that, if the work consists of the construction of a dwelling, the making of alterations or additions to a dwelling or the repairing, renovation, decoration or protective treatment of a dwelling, the work will result, to the extent of the work conducted, in a dwelling that is reasonably fit for occupation as a dwelling'.</p> <p>The defect also represents a failure by the Builder to comply with the following requirement:<br/> BCA - Section F Health and Amenity - Part F1 Damp and Weatherproofing: FP1.4: 'A roof and external wall (incl openings around windows and doors) must prevent the penetration of water that could cause - (a) unhealthy or dangerous conditions, or loss of amenity to occupants, and (b) undue dampness or deterioration of building element'.</p> <p>BCA SECTION F HEALTH AND AMENITY – PART F1 DAMP AND WEATHERPROOFING: Deemed to Satisfy Provisions F1.13 Glazed assemblies: "Subject to (b) and (c), the following glazed assemblies in an external wall, must comply with AS2047 requirements for resistance to water penetration: (i) Windows. (ii) Sliding and swinging glazed doors with a frame, including french and bi-fold doors with a frame. (iii) Adjustable louvres."</p> | <p>Remove the window. Assess all components of the window and associated sub sill, jambs, head, and any other flashings which may be present. Replace any defective components and reinstall in accordance with the manufacturers recommendations and ensuring the requirements of Section F of the BCA and AS2047 are met. Following reinstallation, conduct spray test of window to verify the success of the repairs (suggested method AAMA 501.2 -03). Provide test report to Owners. Remove and replace all water plasterboard in accordance with the requirements of AS589 and conduct mould removal as required. Repaint all affected internal surfaces to the nearest architectural break in accordance with the requirements of AS2311.</p> | <p>DSCN2825.JPG 30/09/25 10:33 AM</p> |

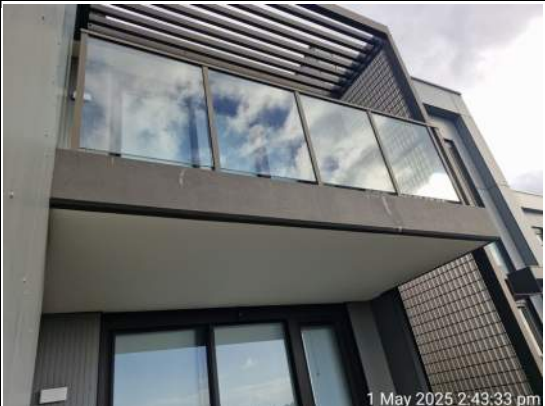
| Item | Area | Defect | Substantiation | Actions | Defect Photograph |
|---|---|---|---|---|---|
| SOU. B.0015 | Building B Unit 701 Balcony Upper Slab Edge | Evidence of efflorescence leaching from the waterproofing associated with the balcony of Unit 801 above. | <p>Further investigations are required to verify the cause of the alleged defect. Further investigations were conducted on the 7/10/25. Access was gained to Unit 801 above. The site of the damage is above the waterproofing termination height of the balcony indicating the waterproofing is most likely intact and not associated with the efflorescence. The render to the top of the balcony hob has separated from the substrate and cracked the facade coating. Water ingress is likely occurring via the balustrade posts. The separation of the render and facade coating has corrupted the waterproofing system requirements of AS4654.2 for weatherproof walls above waterproof membrane terminations.</p> <p>The Builder has failed to effectively weatherproof the hob above an external waterproofing system allowing for premature degradation of the building elements.</p> <p>It is the author's opinion that the Builder has breached the following warranties:<br/> HBA Part 2C clause 18B(a) breach: 'a warranty that the work will be done with due care and skill and in accordance with the plans and specifications set out in the contract';<br/> HBA Part 2C clause 18B(b) breach: 'a warranty that all materials supplied by the holder or person will be good and suitable for the purpose for which they are used and that, unless otherwise stated in the contract, those materials will be new'; and<br/> HBA Part 2C clause 18B(c) breach: 'a warranty that the work will be done in accordance with, and will comply with, this or any other law'.</p> <p>The defect also represents a failure by the Builder to comply with the following requirement(s):<br/> BCA SECTION B STRUCTURE – PART B1 STRUCTURAL PROVISIONS: FUNCTIONAL STATEMENTS BF1.1: 'A building or structure is to withstand the combination of loads and other actions to which it may be reasonably subjected.'</p> <p>BCA SECTION F HEALTH AND AMENITY – PART F1 DAMP AND WEATHERPROOFING: Deemed to Satisfy Provisions F1.4: "Waterproof membranes for external above ground use must comply with AS4654 Parts 1 and 2."</p> | <p>Remove the drummy and loose render. Seal the balustrade posts to prevent water ingress to the hob via the posts. Prepare and render the exposed hob. Prepare patch and paint the newly rendered hob to the nearest architectural break and in accordance with the requirements of AS2311. Ensure the balustrade posts are effectively sealed to the new painted coating.</p> | <p>1 May 2025 2:43:33 pm<br/>TimePhoto_20250501_144333.jpg 1/05/25 2:43 PM -33.907589,151.153471</p> |

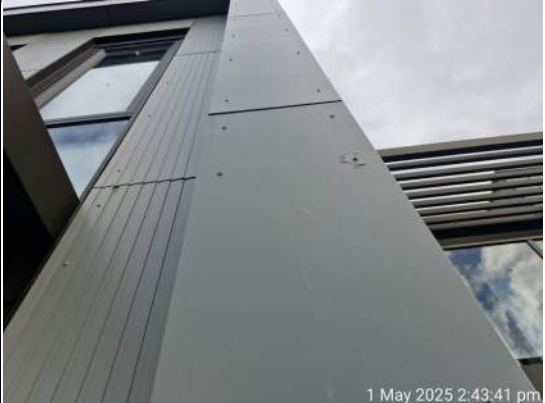
| Item | Area | Defect | Substantiation | Actions | Defect Photograph |
|---|---|---|---|---|---|
| SOU. B.0016 | Building B Unit 701 Balcony Wall | Damage to the CFC panel forming around a mechanical fixing to the external cladding. | <p>The Builder has failed to provide a weather resistant facade element.</p> <p>The author considers the recorded defects to be non-compliant with the following statutory requirements:<br/> HBA Part 2C clause 18B(a) breach: 'a warranty that the work will be done with due care and skill and in accordance with the plans and specifications set out in the contract;<br/> HBA Part 2C clause 18B(b) breach: 'a warranty that all materials supplied by the holder or person will be good and suitable for the purpose for which they are used and that, unless otherwise stated in the contract, those materials will be new; and<br/> HBA Part 2C clause 18B(c) breach: 'a warranty that the work will be done in accordance with, and will comply with, this or any other law'.</p> <p>The defects also represent failures by the Builder to comply with one of, or a combination of the following:<br/> BCA SECTION B STRUCTURE – PART B1 STRUCTURAL PROVISIONS: FUNCTIONAL STATEMENTS BF1.1:<br/> <i>A building or structure is to withstand the combination of loads and other actions to which it may be reasonably subjected.</i><br/> BCA SECTION F HEALTH AND AMENITY – PART F1 DAMP AND WEATHERPROOFING: FUNCTIONAL STATEMENTS FF1.2:<br/> <i>A building is to be constructed to provide resistance to moisture penetration from the outside including rising from the ground.</i></p> | Repair damage to panel and repaint the panel to match the existing finish. | <p>1 May 2025 2:43:41 pm<br/>TimePhoto_20250501_144341.jpg 1/05/25 2:43 PM -33.907611,151.153474</p> |

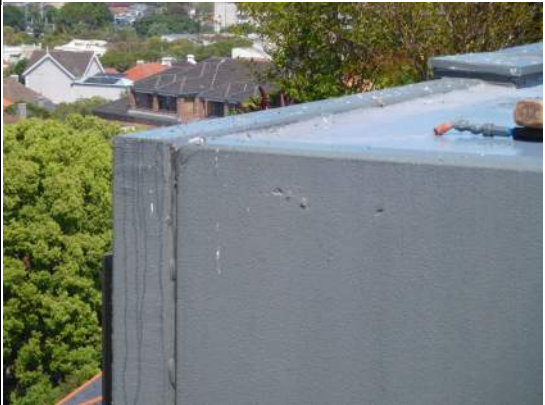
| Item | Area | Defect | Substantiation | Actions | Defect Photograph |
|---|---|---|---|---|---|
| CA. A1.000 1 | Building A1 Rooftop North Eastern Corner Above Unit 1003 | Water identified beneath the membrane coating to the parapet wall coupled with pinholes in the membrane possibly associated with water damage witnessed to the corresponding location of the soffit of Unit 1003's balcony below. | <p>The Builder has failed to prevent water penetrating beneath the membrane.</p> <p>HBA Part 2C clause 18B(a) breach: <i>'a warranty that the work will be done with due care and skill and in accordance with the plans and specifications set out in the contract,'</i></p> <p>HBA Part 2C clause 18B(b) breach: <i>'a warranty that all materials supplied by the holder or person will be good and suitable for the purpose for which they are used and that, unless otherwise stated in the contract, those materials will be new; and'</i></p> <p>HBA Part 2C clause 18B(c) breach: <i>'a warranty that the work will be done in accordance with, and will comply with, this or any other law'.</i></p> <p>The defects also represent failures by the Builder to comply with one of, or a combination of the following:</p> <p>BCA SECTION F HEALTH AND AMENITY – PART F1 DAMP AND WEATHERPROOFING: FUNCTIONAL STATEMENTS FF1.2:<br/>A building is to be constructed to provide resistance to moisture penetration from the outside including rising from the ground.</p> <p>BCA - SECTION F HEALTH AND AMENITY - Part F1 DAMP AND WEATHERPROOFING: PERFORMANCE REQUIREMENTS FP:1.4:<br/>'A roof and external wall (incl openings around windows and doors) must prevent the penetration of water that could cause.<br/>(a) unhealthy or dangerous conditions, or loss of amenity to occupants, and<br/>(b) undue dampness or deterioration of building element'.</p> <p>AS 4654.2 External Waterproofing Membranes for above ground use, Part 2 Design and Installation, Section 1.3 Definitions, Clause 1.3.6 Membrane; <i>'An impervious barrier to liquid or water...'</i></p> | <p>The location of the waterproofing failure should be isolated. The membrane should then be locally removed and reinstated in accordance with the manufacturers specifications and to comply with the requirements of AS4654.2.</p> | <p>DSCN2857.JPG 30/09/25 12:38 PM</p> |

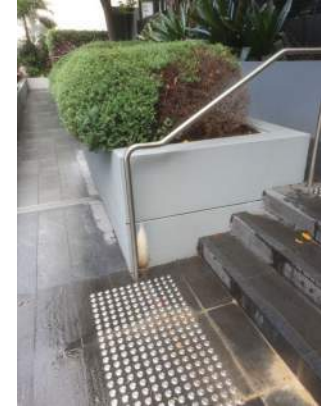
| Item | Area | Defect | Substantiation | Actions | Defect Photograph |
|---|---|---|---|---|---|
| CA.<br>A1.000<br>3 | Building A1<br>Ground<br>Floor<br>Eastern<br>Building<br>Entry<br>Planter Box<br>South of<br>Entry Stairs | Efflorescence leaching from the base of the planter box indicating a failure of the planter boxes waterproof membrane. | <p>Further investigations are required to verify the presence of the alleged defect. Further investigations were conducted on the 7/10/25. The planterbox was water tested and no evidence of waterproofing failure was noted. The joint sealant to the base of the planter box has failed and is allowing for water ingress and egress between the panels creating the efflorescence. The weatherproofing to the wall has failed and hence does not meet the requirements of AS4654.2 for weatherproof walls above waterproof membrane terminations.</p> <p>The Builder has failed to effectively weatherproof the wall above an external waterproofing system allowing for premature degradation of the building elements.</p> <p>It is the author's opinion that the Builder has breached the following warranties:<br/> HBA Part 2C clause 18B(a) breach: 'a warranty that the work will be done with due care and skill and in accordance with the plans and specifications set out in the contract';<br/> HBA Part 2C clause 18B(b) breach: 'a warranty that all materials supplied by the holder or person will be good and suitable for the purpose for which they are used and that, unless otherwise stated in the contract, those materials will be new'; and<br/> HBA Part 2C clause 18B(c) breach: 'a warranty that the work will be done in accordance with, and will comply with, this or any other law'.</p> <p>The defect also represents a failure by the Builder to comply with the following requirement(s):<br/> BCA SECTION B STRUCTURE – PART B1 STRUCTURAL PROVISIONS: FUNCTIONAL STATEMENTS BF1.1:<br/> 'A building or structure is to withstand the combination of loads and other actions to which it may be reasonably subjected.'</p> <p>BCA SECTION F HEALTH AND AMENITY – PART F1 DAMP AND WEATHERPROOFING: Deemed to Satisfy Provisions F1.4: "Waterproof membranes for external above ground use must comply with AS4654 Parts 1 and 2."</p> | <p>Remove the failed joint sealant from around the full perimeter of the planter box. Install a backing rod. Reinstall the joint sealant as per manufacturers recommendations including and primers. After curing of the sealant, prepare and repaint the affected surfaces to the nearest architectural break to match existing finishes in accordance with the requirements of AS2311.</p> | <p>20250501_110401.jpg 1/05/25 11:04 AM -33.908021,151.153123</p> |

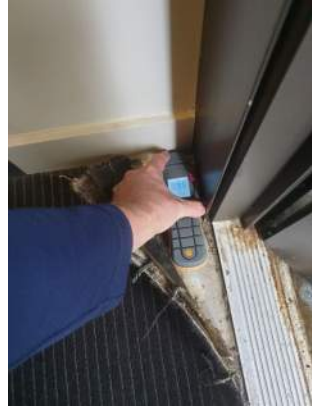
| Item | Area | Defect | Substantiation | Actions | Defect Photograph |
|---|---|---|---|---|---|
| CA.<br>A2.000<br>3 | Building A2<br>Level 3<br>Southern<br>Link<br>Doorway | Water ingress identified at the sill of the aluminium framed door associated with a lack of water shedding or drainage mechanism to the external landing. | <p>The Builder has failed to prevent water entering the building.</p> <p>It is the author's opinion that the Builder has breached the following warranties:</p> <p>HBA Part 2C clause 18B(a) breach: 'a warranty that the work will be done with due care and skill and in accordance with the plans and specifications set out in the contract';</p> <p>HBA Part 2C clause 18B(c) breach: 'a warranty that the work will be done in accordance with, and will comply with, this or any other law'; and</p> <p>HBA Part 2C clause 18B(e) breach: 'a warranty that, if the work consists of the construction of a dwelling, the making of alterations or additions to a dwelling or the repairing, renovation, decoration or protective treatment of a dwelling, the work will result, to the extent of the work conducted, in a dwelling that is reasonably fit for occupation as a dwelling'.</p> <p>The defect also represents a failure by the Builder to comply with the following requirement(s):</p> <ul style="list-style-type: none"> <li>• BCA SECTION F HEALTH AND AMENITY – PART F1 DAMP AND WEATHERPROOFING: FUNCTIONAL STATEMENTS FF1.2:<br/>A building is to be constructed to provide resistance to moisture penetration from the outside including rising from the ground.</li> <li>• BCA - SECTION F HEALTH AND AMENITY - Part F1 DAMP AND WEATHERPROOFING: PERFORMANCE REQUIREMENTS FP.1.4:<br/>'A roof and external wall (incl openings around windows and doors) must prevent the penetration of water that could cause.<br/>(a) unhealthy or dangerous conditions, or loss of amenity to occupants, and<br/>(b) undue dampness or deterioration of building element'.</li> <li>• BCA SECTION F HEALTH AND AMENITY – PART F1 DAMP AND WEATHERPROOFING: Performance Requirement FP1.3:<br/>A drainage system for the disposal of surface water must –<br/>(a) convey surface water to an appropriate outfall; and<br/>(b) undue dampness or deterioration of building elements.</li> </ul> <p>AS 2047 – SECTION 7 INSTALLATION; 7.2 INSTALLATION; 7.2.2 FLASHING:<br/>'Flashing shall be incorporated into the building envelope where it is necessary— (a) to restrict water from entering into the interior of a building from the exterior; (b) to restrict water passing across a cavity to the inner leaf; or (c) to shed water through cladding to the outer face'.</p> <p>AS 4654.2 – SECTION 2 DESIGN AND INSTALLATION; 2.8 TERMINATION OF MEMBRANES; 2.8.3 DOORS AND WINDOWS ONTO EXTERNAL WATERPROOFED AREAS:<br/>'For doors and windows onto external waterproofed areas, the following apply:<br/>(a) Sub-sill flashings shall be included as part of the membrane system.<br/>(b) Where the internal and external finished floor levels do not allow an upturn, the membranes shall be fixed under the sill and terminate into the stormwater system'.</p> | Create water stop at door sill and correct falls to external landing so water drains away from door sill. All works to be incorporated with the associated external waterproof membrane in accordance with AS4654.2 where applicable. | <p>20250501_101826.jpg 1/05/25 10:18 AM -33.908202,151.153824</p> |

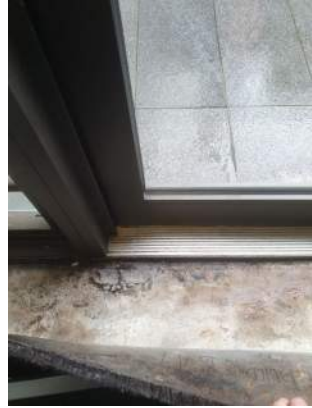
| Item | Area | Defect | Substantiation | Actions | Defect Photograph |
|---|---|---|---|---|---|
| CA.<br>A2.000<br>4 | Building A2<br>Ground<br>Level<br>Eastern<br>Entry<br>Doorway | Water ingress identified at the sill of the aluminium framed door associated with a lack of water shedding or drainage mechanism to the external landing. | <p>The Builder has failed to prevent water entering the building.</p> <p>It is the author's opinion that the Builder has breached the following warranties:</p> <p>HBA Part 2C clause 18B(a) breach: 'a warranty that the work will be done with due care and skill and in accordance with the plans and specifications set out in the contract';</p> <p>HBA Part 2C clause 18B(c) breach: 'a warranty that the work will be done in accordance with, and will comply with, this or any other law'; and</p> <p>HBA Part 2C clause 18B(e) breach: 'a warranty that, if the work consists of the construction of a dwelling, the making of alterations or additions to a dwelling or the repairing, renovation, decoration or protective treatment of a dwelling, the work will result, to the extent of the work conducted, in a dwelling that is reasonably fit for occupation as a dwelling'.</p> <p>The defect also represents a failure by the Builder to comply with the following requirement(s):</p> <ul style="list-style-type: none"> <li>• BCA SECTION F HEALTH AND AMENITY – PART F1 DAMP AND WEATHERPROOFING: FUNCTIONAL STATEMENTS FF1.2:<br/>A building is to be constructed to provide resistance to moisture penetration from the outside including rising from the ground.</li> <li>• BCA - SECTION F HEALTH AND AMENITY - Part F1 DAMP AND WEATHERPROOFING: PERFORMANCE REQUIREMENTS FP.1.4:<br/>'A roof and external wall (incl openings around windows and doors) must prevent the penetration of water that could cause.</li> <li>(a) unhealthy or dangerous conditions, or loss of amenity to occupants, and</li> <li>(b) undue dampness or deterioration of building element'.</li> <li>• BCA SECTION F HEALTH AND AMENITY – PART F1 DAMP AND WEATHERPROOFING: Performance Requirement FP1.3:<br/>A drainage system for the disposal of surface water must –<br/>(a) convey surface water to an appropriate outfall; and</li> <li>(b) undue dampness or deterioration of building elements.</li> </ul> <p>AS 2047 – SECTION 7 INSTALLATION; 7.2 INSTALLATION; 7.2.2 FLASHING:<br/>'Flashing shall be incorporated into the building envelope where it is necessary— (a) to restrict water from entering into the interior of a building from the exterior; (b) to restrict water passing across a cavity to the inner leaf; or (c) to shed water through cladding to the outer face'.</p> <p>AS 4654.2 – SECTION 2 DESIGN AND INSTALLATION; 2.8 TERMINATION OF MEMBRANES; 2.8.3 DOORS AND WINDOWS ONTO EXTERNAL WATERPROOFED AREAS:<br/>'For doors and windows onto external waterproofed areas, the following apply:<br/>(a) Sub-sill flashings shall be included as part of the membrane system.<br/>(b) Where the internal and external finished floor levels do not allow an upturn, the membranes shall be fixed under the sill and terminate into the stormwater system'.</p> | Create water stop at door sill and correct falls to external landing so water drains away from door sill. If this is not possible, introduce grated strip drain to the threshold. All works to be incorporated with the associated external waterproof membrane in accordance with AS4654.2. | <p>20250501_102748.jpg 1/05/25 10:27 AM</p> |

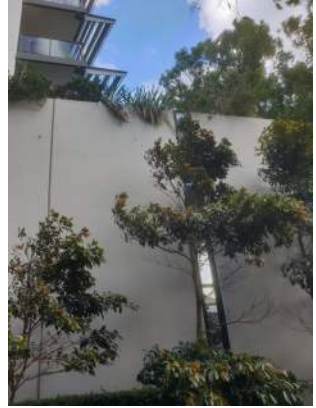
| Item | Area | Defect | Substantiation | Actions | Defect Photograph |
|---|---|---|---|---|---|
| CA.<br>A2.000<br>8 | Building A2<br>Level 2<br>Eastern<br>Facade<br>Northern<br>End | Crack in concrete<br>panel at Level 2<br>balcony. | <p>The Builder has failed to prevent cracking of the structural facade member.</p> <p>The author considers the recorded defects to be non-compliant with the following statutory requirements:</p> <ul style="list-style-type: none"> <li>HBA Part 2C clause 18B(a) breach: 'a warranty that the work will be done with due care and skill and in accordance with the plans and specifications set out in the contract'; and</li> <li>HBA Part 2C clause 18B(c) breach: 'a warranty that the work will be done in accordance with, and will comply with, this or any other law'.</li> </ul> <p>The defects also represent failures by the Builder to comply with one of, or a combination of the following:</p> <p>BCA SECTION B STRUCTURE – PART B1 STRUCTURAL PROVISIONS: FUNCTIONAL STATEMENTS BF1.1:</p> <p>'A building or structure is to withstand the combination of loads and other actions to which it may be reasonably subjected'.</p> | <p>In accordance with the guidelines set out in the NSW Guide to Standards and Tolerances, the crack should be monitored for a period of 12 months. If the crack remains a Category 2 or lower, the crack is considered not defective. If the crack increases above a Category 2 or a notable offset of more than 15mm in a 3m plane is detected, further action will be required.</p> | <p>20250501_110652.jpg 1/05/25 11:06 AM -33.908027,151.153158</p> |

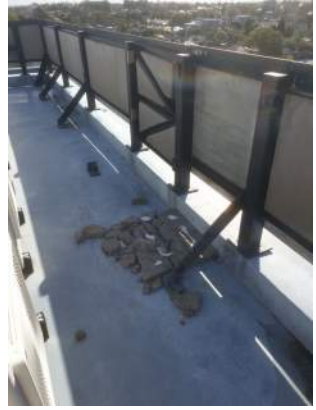
| Item | Area | Defect | Substantiation | Actions | Defect Photograph |
|---|---|---|---|---|---|
| CA.<br>A2.000<br>9 | Building A2<br>Rooftop<br>Northern<br>Acoustic<br>Barrier | Acoustic panel has<br>delaminated from<br>barrier. | <p>The Builder has failed to adequately adhere the acoustic insulation panels to the rooftop plant enclosure.</p> <p>The author considers the recorded defects to be non-compliant with the following statutory requirements:</p> <p>HBA Part 2C clause 18B(a) breach: 'a warranty that the work will be done with due care and skill and in accordance with the plans and specifications set out in the contract,'</p> <p>HBA Part 2C clause 18B(b) breach: 'a warranty that all materials supplied by the holder or person will be good and suitable for the purpose for which they are used and that, unless otherwise stated in the contract, those materials will be new; and</p> <p>HBA Part 2C clause 18B(c) breach: 'a warranty that the work will be done in accordance with, and will comply with, this or any other law';</p> <p>The defects also represent failures by the Builder to comply with one of, or a combination of the following:</p> <p>BCA SECTION B STRUCTURE – PART B1 STRUCTURAL PROVISIONS: FUNCTIONAL STATEMENTS BF1.1:</p> <p>A building or structure is to withstand the combination of loads and other actions to which it may be reasonably subjected.</p> | <p>Replace damaged delaminated acoustic panel using a suitable adhesive.</p> | <p>20250501_140503.jpg 1/05/25 2:05 PM -33.907734,151.153066</p> |

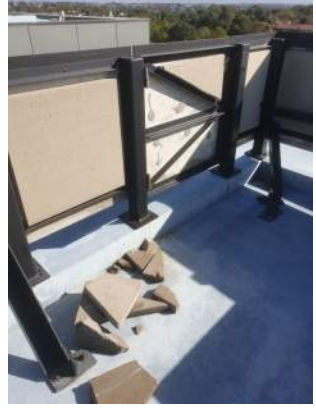
| Item | Area | Defect | Substantiation | Actions | Defect Photograph |
|---|---|---|---|---|---|
| CA.<br>A2.001<br>0 | Building A2<br>Rooftop<br>Southern<br>Acoustic<br>Barrier | Acoustic panel has<br>delaminated from<br>barrier. | <p>The Builder has failed to adequately adhere the acoustic insulation panels to the rooftop plant enclosure.</p> <p>The author considers the recorded defects to be non-compliant with the following statutory requirements:</p> <p>HBA Part 2C clause 18B(a) breach: 'a warranty that the work will be done with due care and skill and in accordance with the plans and specifications set out in the contract,'</p> <p>HBA Part 2C clause 18B(b) breach: 'a warranty that all materials supplied by the holder or person will be good and suitable for the purpose for which they are used and that, unless otherwise stated in the contract, those materials will be new; and</p> <p>HBA Part 2C clause 18B(c) breach: 'a warranty that the work will be done in accordance with, and will comply with, this or any other law';</p> <p>The defects also represent failures by the Builder to comply with one of, or a combination of the following:</p> <p>BCA SECTION B STRUCTURE – PART B1 STRUCTURAL PROVISIONS: FUNCTIONAL STATEMENTS BF1.1:</p> <p>A building or structure is to withstand the combination of loads and other actions to which it may be reasonably subjected.</p> | <p>Replace damaged delaminated acoustic panel using a suitable adhesive.</p> | <p>20250501_140835.jpg 1/05/25 2:08 PM -33.907761,151.152945</p> |

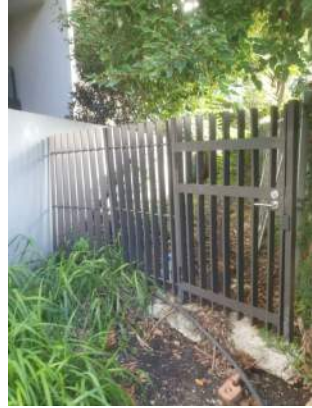
| Item | Area | Defect | Substantiation | Actions | Defect Photograph |
|---|---|---|---|---|---|
| CA.<br>A2.001<br>1 | Building A2<br>North East<br>Corner<br>Boundary<br>Fence and<br>Gate | Inadequate provision of footings and mechanical fixing of the fence structure have left the structure unstable and not secure. | <p>The Builder has failed to adequately secure the fence and gate to facilitate both the safety and security of the property.</p> <p>The author considers the recorded defects to be non-compliant with the following statutory requirements:</p> <p>HBA Part 2C clause 18B(a) breach: 'a warranty that the work will be done with due care and skill and in accordance with the plans and specifications set out in the contract,</p> <p>HBA Part 2C clause 18B(b) breach: 'a warranty that all materials supplied by the holder or person will be good and suitable for the purpose for which they are used and that, unless otherwise stated in the contract, those materials will be new; and</p> <p>HBA Part 2C clause 18B(c) breach: 'a warranty that the work will be done in accordance with, and will comply with, this or any other law'.</p> <p>The defects also represent failures by the Builder to comply with one of, or a combination of the following:</p> <ul style="list-style-type: none"> <li>· BCA SECTION B STRUCTURE – PART B1 STRUCTURAL PROVISIONS: OBJECTIVE B01:</li> </ul> <p>The Objective of this Part is to –</p> <ul style="list-style-type: none"> <li>(a) safeguard people from injury caused by structural failure; and</li> <li>(b) safeguard people from loss of amenity caused by structural behaviour;</li> </ul> <ul style="list-style-type: none"> <li>· BCA SECTION B STRUCTURE – PART B1 STRUCTURAL PROVISIONS: FUNCTIONAL STATEMENTS</li> </ul> <p>BF1.1:</p> <p>A building or structure is to withstand the combination of loads and other actions to which it may be reasonably subjected.</p> | Remove fence and gate structure. Install a reinforced concrete strip footing of adequate dimension to support the structure. Refit the fence and gate structure and replace any damaged or non salvageable components. | <p>20250501_133806.jpg 1/05/25 1:38 PM</p> |
