702/180 Livingstone Rd, Marrickville NSW 2204

# STRATA REPORT

**702/180 Livingstone Rd, Marrickville NSW 2204**

## Preliminary Major Building Defects Report

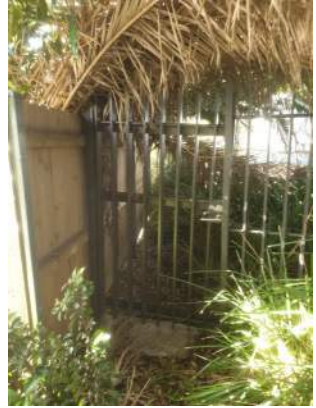
| Item | Area | Defect | Substantiation | Actions | Defect Photograph |
|---|---|---|---|---|---|
| CA. B.0009 | Building B North West Corner Boundary Fence and Gate | Inadequate provision of footings and fixing of the fence structure have left the structure unstable and not secure. The gate affords emergency egress from the basement carpark. | <p>The Builder has failed to adequately secure the fence and gate to facilitate both the safety and security of the property.</p> <p>The author considers the recorded defects to be non-compliant with the following statutory requirements:</p> <p>HBA Part 2C clause 18B(a) breach: 'a warranty that the work will be done with due care and skill and in accordance with the plans and specifications set out in the contract,'</p> <p>HBA Part 2C clause 18B(b) breach: 'a warranty that all materials supplied by the holder or person will be good and suitable for the purpose for which they are used and that, unless otherwise stated in the contract, those materials will be new; and</p> <p>HBA Part 2C clause 18B(c) breach: 'a warranty that the work will be done in accordance with, and will comply with, this or any other law'.</p> <p>The defects also represent failures by the Builder to comply with one of, or a combination of the following:</p> <ul style="list-style-type: none"> <li>· BCA SECTION B STRUCTURE – PART B1 STRUCTURAL PROVISIONS: OBJECTIVE BO1:</li> </ul> <p>The Objective of this Part is to –</p> <p>(a) safeguard people from injury caused by structural failure; and</p> <p>(b) safeguard people from loss of amenity caused by structural behaviour;</p> <ul style="list-style-type: none"> <li>· BCA SECTION B STRUCTURE – PART B1 STRUCTURAL PROVISIONS: FUNCTIONAL STATEMENTS BF1.1:</li> </ul> <p>A building or structure is to withstand the combination of loads and other actions to which it may be reasonably subjected.</p> | Remove fence and gate structure. Install a reinforced concrete strip footing of adequate dimension to support the structure. Refit the fence and gate structure and replace any damaged or non salvageable components. | <p>20250501_133952.jpg 1/05/25 1:39 PM -33.907487,151.153228</p> |

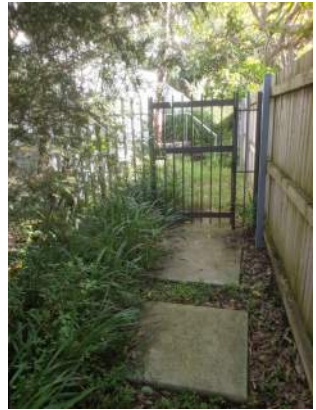
| Item | Area | Defect | Substantiation | Actions | Defect Photograph |
|---|---|---|---|---|---|
| CA. B.0010 | Building B North East Corner Boundary Fence and Gate | Inadequate provision of footings and fixing of the fence structure have left the structure unstable and not secure. The gate affords emergency egress from the basement carpark. | <p>The Builder has failed to adequately secure the fence and gate to facilitate both the safety and security of the property.</p> <p>The author considers the recorded defects to be non-compliant with the following statutory requirements:</p> <p>HBA Part 2C clause 18B(a) breach: 'a warranty that the work will be done with due care and skill and in accordance with the plans and specifications set out in the contract,'</p> <p>HBA Part 2C clause 18B(b) breach: 'a warranty that all materials supplied by the holder or person will be good and suitable for the purpose for which they are used and that, unless otherwise stated in the contract, those materials will be new; and</p> <p>HBA Part 2C clause 18B(c) breach: 'a warranty that the work will be done in accordance with, and will comply with, this or any other law'.</p> <p>The defects also represent failures by the Builder to comply with one of, or a combination of the following:</p> <ul style="list-style-type: none"> <li>· BCA SECTION B STRUCTURE – PART B1 STRUCTURAL PROVISIONS: OBJECTIVE BO1:</li> </ul> <p>The Objective of this Part is to –</p> <p>(a) safeguard people from injury caused by structural failure; and</p> <p>(b) safeguard people from loss of amenity caused by structural behaviour;</p> <ul style="list-style-type: none"> <li>· BCA SECTION B STRUCTURE – PART B1 STRUCTURAL PROVISIONS: FUNCTIONAL STATEMENTS BF1.1:</li> </ul> <p>A building or structure is to withstand the combination of loads and other actions to which it may be reasonably subjected.</p> | Remove fence and gate structure. Install a reinforced concrete strip footing of adequate dimension to support the structure. Refit the fence and gate structure and replace any damaged or non salvageable components. | <p>20250501_135149.jpg 1/05/25 1:51 PM -33.907524,151.153405</p> |

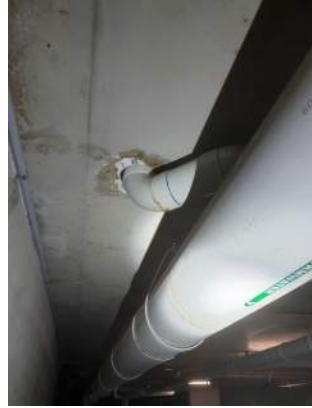
| Item | Area | Defect | Substantiation | Actions | Defect Photograph |
|---|---|---|---|---|---|
| CP.000<br>3 | Carpark<br>Visitor<br>Level<br>Western<br>Boundary<br>Visitor<br>Parking | Active leak from storm water outlet situated above visitor parking bay. | <p>The Builder has failed to manage storm water in accordance with the requirements of AS3500.3 and or waterproofed the outlet in accordance with AS4654.2 leading to uncontrolled water ingress into the carpark.</p> <p>The author considers the recorded defects to be non-compliant with the following statutory requirements:<br/> HBA Part 2C clause 18B(a) breach: 'a warranty that the work will be done with due care and skill and in accordance with the plans and specifications set out in the contract;<br/> HBA Part 2C clause 18B(c) breach: 'a warranty that the work will be done in accordance with, and will comply with, this or any other law'; and</p> <p>The defects also represent failures by the Builder to comply with one of, or a combination of the following:<br/> BCA SECTION F HEALTH AND AMENITY – PART F1 DAMP AND WEATHERPROOFING: FUNCTIONAL STATEMENTS FF1.2:<br/> 'A building is to be constructed to provide resistance to moisture penetration from the outside including rising from the ground'.<br/> BCA - SECTION F HEALTH AND AMENITY - Part F1 DAMP AND WEATHERPROOFING: DEEMED-TO-SATISFY PROVISIONS F1.4 EXTERNAL ABOVE GROUND MEMBRANES:<br/> 'Waterproofing membranes for external above ground use must comply with AS 4654 Parts 1 and 2'.</p> | Locate drainage outlet above and conduct a localised flood test. If the failure is identified to be associated with the waterproofing termination into the drain, take the existing waterproofing back to the substrate, prepare the surface, and re waterproof the termination in accordance with the waterproofing products directions and AS4654.2. If the failure is identified to be associated with the pipe work, replace the defective pipe work. | <p>20250501_144329.jpg 1/05/25 2:43 PM</p> |

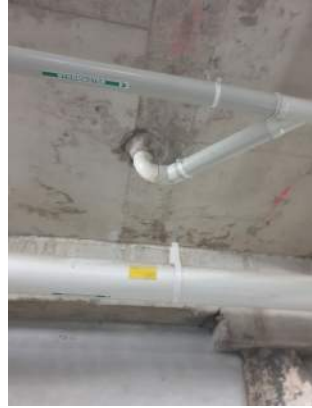
| Item | Area | Defect | Substantiation | Actions | Defect Photograph |
|---|---|---|---|---|---|
| CP.000<br>5 | Carpark<br>Visitor<br>Level<br>Lot 76<br>Parking<br>Bay | Active leak from storm water outlet situated above Lot 76 parking bay (western boundary). | <p>The Builder has failed to manage storm water in accordance with the requirements of AS3500.3 and or waterproofed the outlet in accordance with AS4654.2 leading to uncontrolled water ingress into the carpark.</p> <p>The author considers the recorded defects to be non-compliant with the following statutory requirements:<br/> HBA Part 2C clause 18B(a) breach: 'a warranty that the work will be done with due care and skill and in accordance with the plans and specifications set out in the contract;<br/> HBA Part 2C clause 18B(c) breach: 'a warranty that the work will be done in accordance with, and will comply with, this or any other law'; and</p> <p>The defects also represent failures by the Builder to comply with one of, or a combination of the following:<br/> BCA SECTION F HEALTH AND AMENITY – PART F1 DAMP AND WEATHERPROOFING: FUNCTIONAL STATEMENTS FF1.2:<br/> 'A building is to be constructed to provide resistance to moisture penetration from the outside including rising from the ground'.<br/> BCA - SECTION F HEALTH AND AMENITY - Part F1 DAMP AND WEATHERPROOFING: DEEMED-TO-SATISFY PROVISIONS F1.4 EXTERNAL ABOVE GROUND MEMBRANES:<br/> 'Waterproofing membranes for external above ground use must comply with AS 4654 Parts 1 and 2'.</p> | Locate drainage outlet above and conduct a localised flood test. If the failure is identified to be associated with the waterproofing termination into the drain, take the existing waterproofing back to the substrate, prepare the surface, and re waterproof the termination in accordance with the waterproofing products directions and AS4654.2. If the failure is identified to be associated with the pipe work, replace the defective pipe work. | <p>20250501_144947.jpg 1/05/25 2:49 PM</p> |

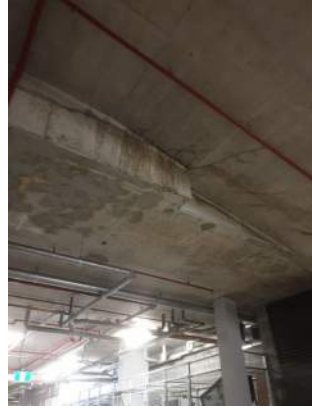
| Item | Area | Defect | Substantiation | Actions | Defect Photograph |
|---|---|---|---|---|---|
| CP.000<br>7 | Carpark<br>Visitor<br>Level<br>Street<br>Level<br>Ramp Soffit | Active water ingress from cold joint between the soffit of the street level driveway and abutting concrete structure. | <p>The Builder has failed to effectively waterproof the driveway joint above allowing for uncontrolled water ingress into the carpark and long term exposure of the steel reinforcement elements within driveway cold joint to water which will lead to spalling and premature failure of the steel elements.</p> <p>The author considers the recorded defects to be non-compliant with the following statutory requirements:<br/>HBA Part 2C clause 18B(a) breach: 'a warranty that the work will be done with due care and skill and in accordance with the plans and specifications set out in the contract; and<br/>HBA Part 2C clause 18B(c) breach: 'a warranty that the work will be done in accordance with, and will comply with, this or any other law'.</p> <p>The defects also represent failures by the Builder to comply with one of, or a combination of the following:<br/>BCA SECTION B STRUCTURE – PART B1 STRUCTURAL PROVISIONS: FUNCTIONAL STATEMENTS BF1.1:<br/>'A building or structure is to withstand the combination of loads and other actions to which it may be reasonably subjected.'<br/>BCA SECTION F HEALTH AND AMENITY – PART F1 DAMP AND WEATHERPROOFING: FUNCTIONAL STATEMENTS FF1.2:<br/>A building is to be constructed to provide resistance to moisture penetration from the outside including rising from the ground.<br/>BCA - SECTION F HEALTH AND AMENITY - Part F1 DAMP AND WEATHERPROOFING: PERFORMANCE REQUIREMENTS FP:1.4:<br/>'A roof and external wall (incl openings around windows and doors) must prevent the penetration of water that could cause.<br/>(a) unhealthy or dangerous conditions, or loss of amenity to occupants, and<br/>(b) undue dampness or deterioration of building element'.<br/>AS 3600 - SECTION 14 JOINTS; EMBEDDED ITEMS AND FIXINGS; 14.1 JOINTS; 14.1.4 JOINT FILLERS AND SEALANTS.</p> | Re detail the cold joint to the driveway in accordance with the requirements of AS3600. | <p>20250501_145416.jpg 1/05/25 2:54 PM</p> |

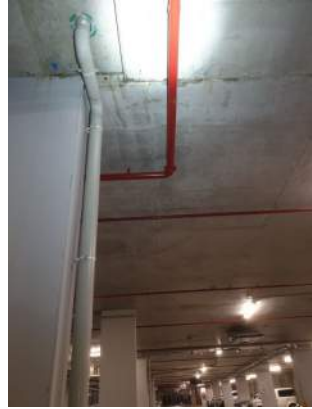
| Item | Area | Defect | Substantiation | Actions | Defect Photograph |
|---|---|---|---|---|---|
| CP.000<br>8 | Carpark<br>B1<br>Base Of<br>Street<br>Level<br>Ramp | Active water ingress from cold joint situated at the base of the street level driveway. | <p>The Builder has failed to effectively waterproof the driveway joint above allowing for uncontrolled water ingress into the carpark and long term exposure of the steel reinforcement elements within driveway cold joint to water which will lead to spalling and premature failure of the steel elements.</p> <p>The author considers the recorded defects to be non-compliant with the following statutory requirements:<br/>HBA Part 2C clause 18B(a) breach: 'a warranty that the work will be done with due care and skill and in accordance with the plans and specifications set out in the contract; and<br/>HBA Part 2C clause 18B(c) breach: 'a warranty that the work will be done in accordance with, and will comply with, this or any other law'.</p> <p>The defects also represent failures by the Builder to comply with one of, or a combination of the following:<br/>BCA SECTION B STRUCTURE – PART B1 STRUCTURAL PROVISIONS: FUNCTIONAL STATEMENTS BF1.1:<br/>'A building or structure is to withstand the combination of loads and other actions to which it may be reasonably subjected.'<br/>BCA SECTION F HEALTH AND AMENITY – PART F1 DAMP AND WEATHERPROOFING: FUNCTIONAL STATEMENTS FF1.2:<br/>A building is to be constructed to provide resistance to moisture penetration from the outside including rising from the ground.<br/>BCA - SECTION F HEALTH AND AMENITY - Part F1 DAMP AND WEATHERPROOFING: PERFORMANCE REQUIREMENTS FP:1.4:<br/>'A roof and external wall (incl openings around windows and doors) must prevent the penetration of water that could cause.<br/>(a) unhealthy or dangerous conditions, or loss of amenity to occupants, and<br/>(b) undue dampness or deterioration of building element'.<br/>AS 3600 - SECTION 19 JOINTS; EMBEDDED ITEMS AND FIXINGS; 19.1 JOINTS; 19.1.4 JOINT FILLERS AND SEALANTS.</p> | Re detail the cold joint to the driveway in accordance with the requirements of AS3600. | <p>20250501_145647.jpg 1/05/25 2:56 PM</p> |

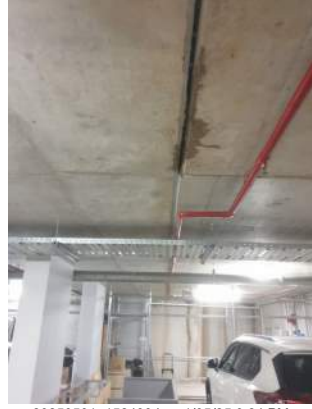
| Item | Area | Defect | Substantiation | Actions | Defect Photograph |
|---|---|---|---|---|---|
| CP.0010 | Carpark B2 Construction Joint Above Lot 167/169 Parking Bays | Active water ingress identified through the construction joint situated between 178 Livingstone and 18 Lilydale affecting B2 parking level and Lot 169 storage cage resulting from waterproofing failure at ground level above. Joint sealant to construction joint at B1 has failed. | <p>The Builder has failed to effectively seal the construction joint in accordance with AS3600.</p> <p>The author considers the recorded defects to be non-compliant with the following statutory requirements:<br/> HBA Part 2C clause 18B(a) breach: 'a warranty that the work will be done with due care and skill and in accordance with the plans and specifications set out in the contract; and<br/> HBA Part 2C clause 18B(c) breach: 'a warranty that the work will be done in accordance with, and will comply with, this or any other law'.</p> <p>The defects also represent failures by the Builder to comply with one of, or a combination of the following:<br/> BCA SECTION B STRUCTURE – PART B1 STRUCTURAL PROVISIONS: FUNCTIONAL STATEMENTS BF1.1:<br/> 'A building or structure is to withstand the combination of loads and other actions to which it may be reasonably subjected.'<br/> AS 3600 - SECTION 14 JOINTS, EMBEDDED ITEMS AND FIXINGS, 14.1 JOINTS, 14.1.4 JOINT FILLERS AND SEALANTS.</p> | Remove existing jointing material. Re detail construction joint in accordance with the requirements of AS3600. | <p>20250501_152433.jpg 1/05/25 3:24 PM</p> |
