Inspection Report

Nova Home Inspections

1/29 Boundary Road Liverpool NSW 2170

Pest And Building Inspection

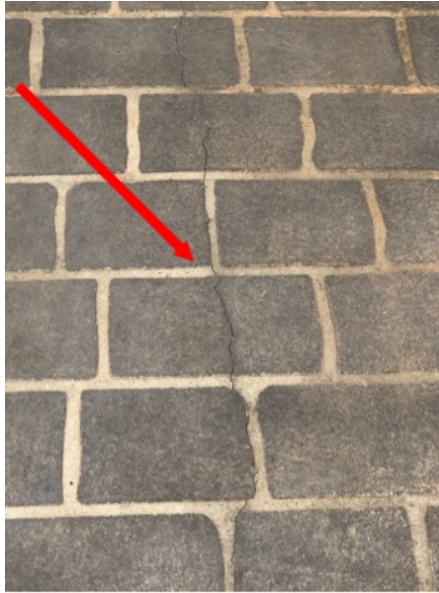
Driveway Condition

Common cracks & settlement were observed on the driveway. Maintenance is recommended. Note: Whilst these cracks appeared to be minor at the time of inspection, we strongly recommend you monitor these cracks and if worsening occurs contact a concreter for further advice.

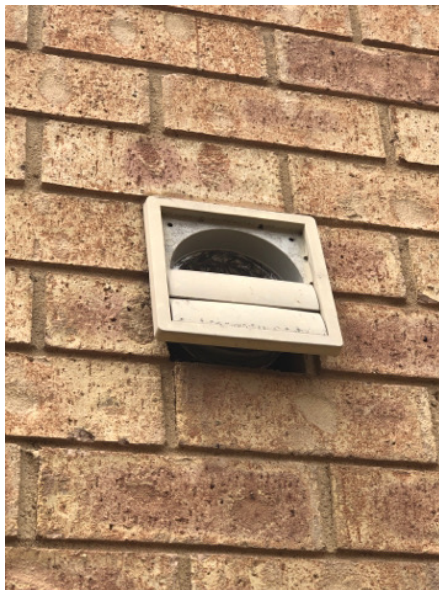
Fan outlet broken, replacement required.

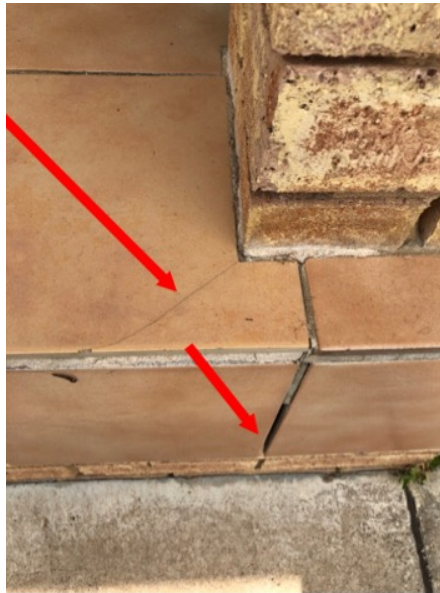
Base or Flooring Condition

Tile cracks evident on entry patio/porch - Recommendations: Engage a qualified tiling contractor to repair. Loose grout requires replacement to make good.

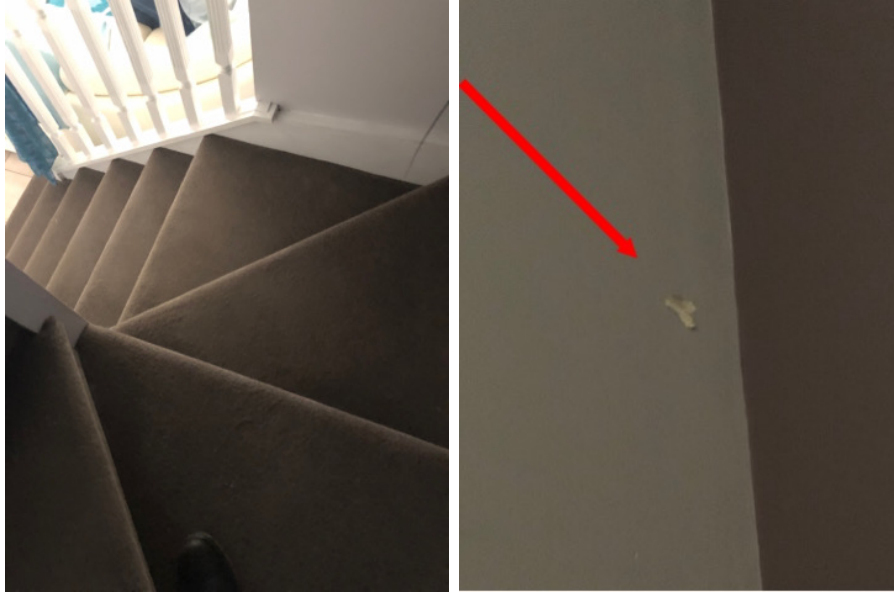
Internal Stair Case

The stair treads squeak and require maintenance by a licensed carpenter

General ageing and/or denting and the like is evident on wall linings - Recommendations: A qualified painter should be engaged to assess and repair as required.

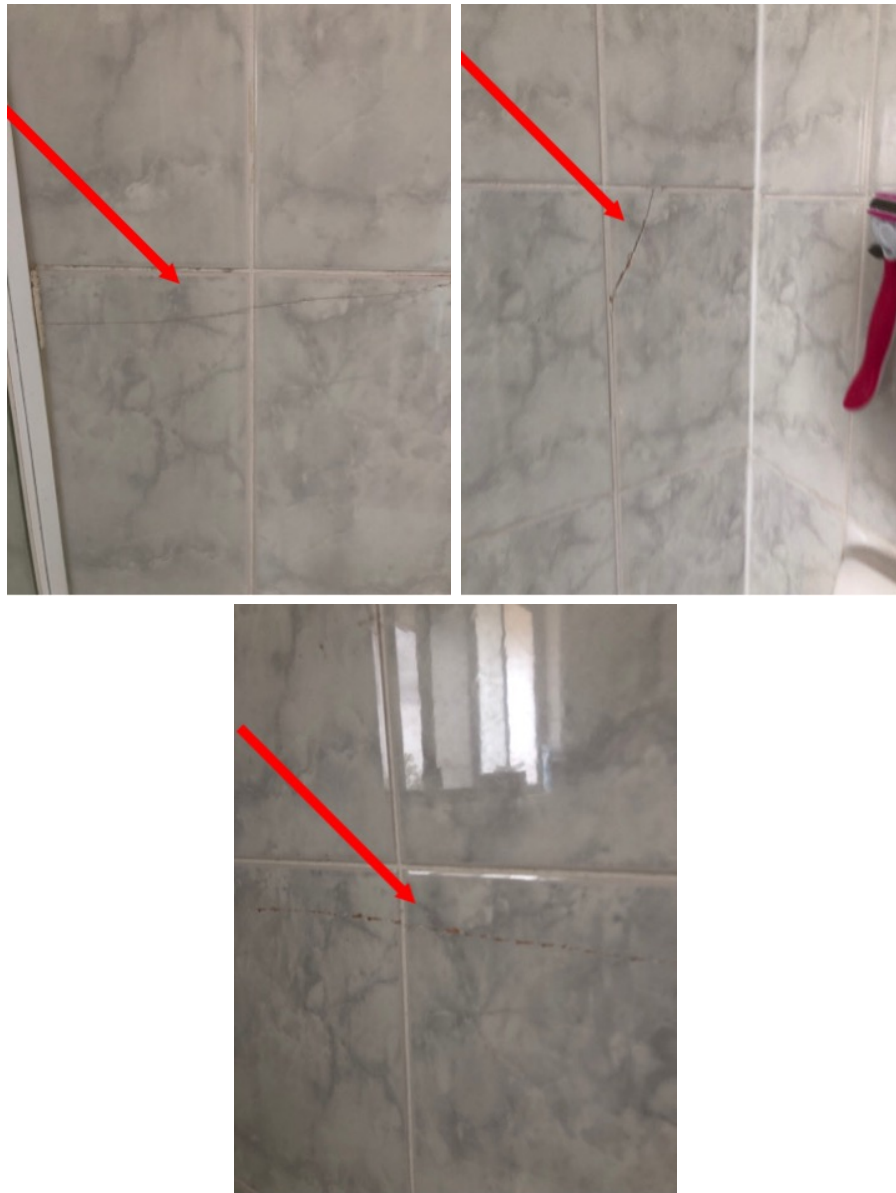
Cracked tile/s noted. A qualified tiler should be engaged for advice and recommendations.

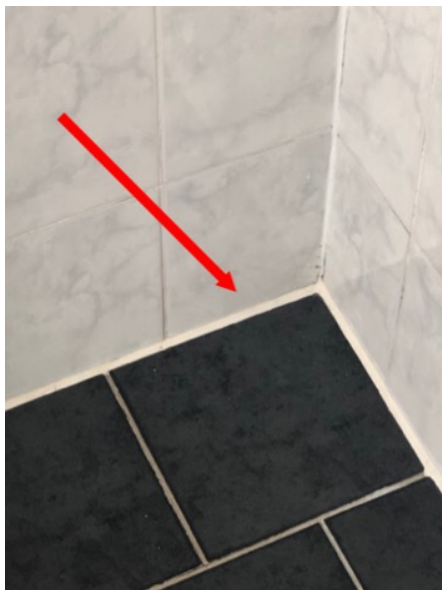
Shower And Bath

Silicone sealant has been applied to the interface of the floor and walls in the shower recess in an apparent attempt to prevent water penetration to surrounding areas. This method of repair can only be considered to be temporary. Further waterproofing may be necessary.

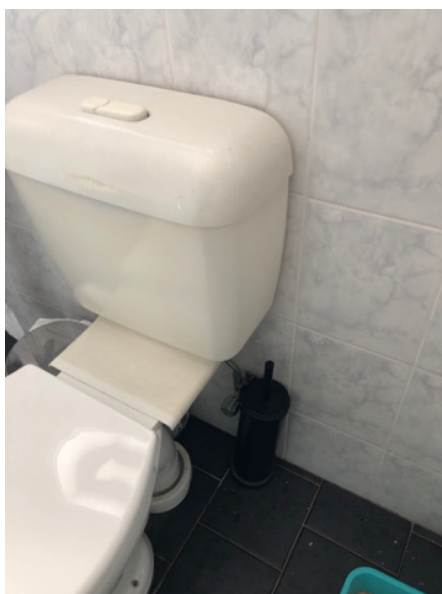
Toilet

The cistern is leaking and should be repaired. Contact a licensed plumber for repairs.

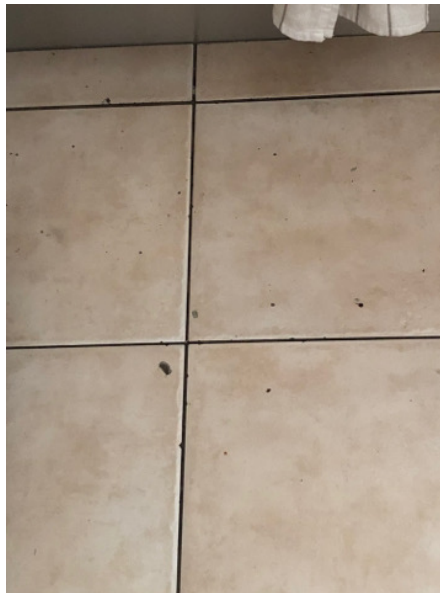
Floor

Some chipped and damaged tiled were noted. Replacement recommended by a qualified tiler

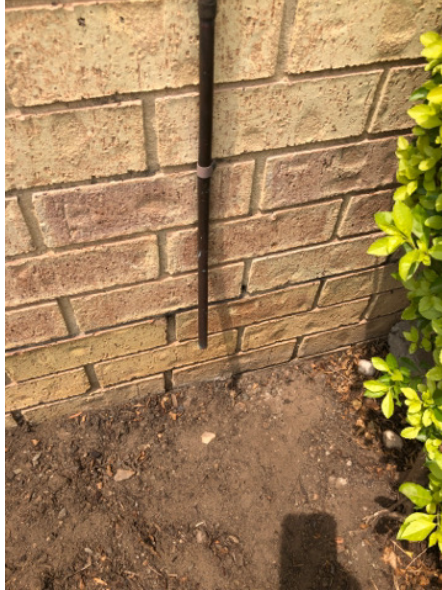
Hot water unit overflow not connected to drain. This provides conducive conditions for termite infestation. The degree of risk is moderate to high. Engage plumber to rectify.
