# Property and Timber Pest Report

Inspection Date: 15 Jul 2026

Property Address: 53 Timbercrest Chase Charlestown 2290

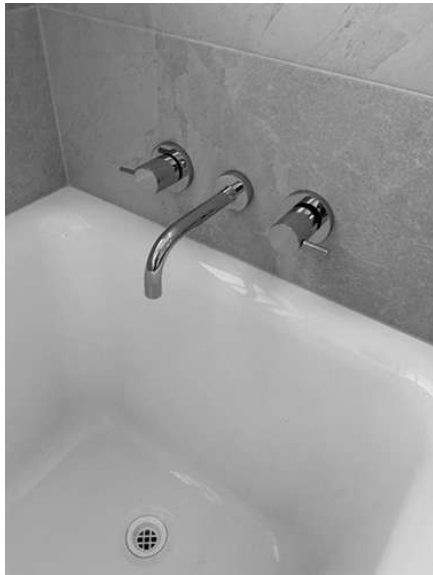
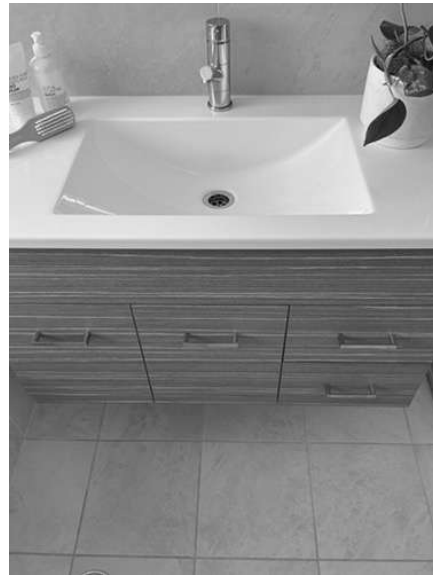
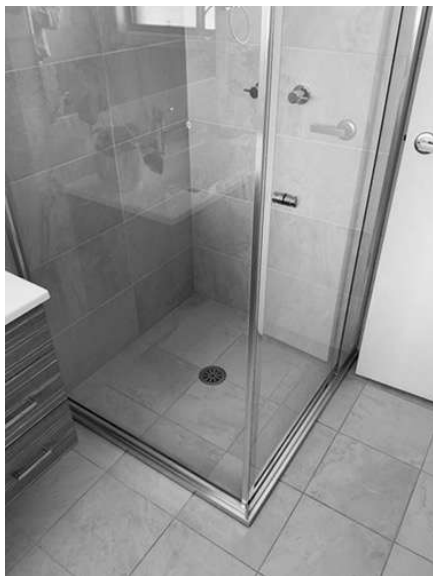
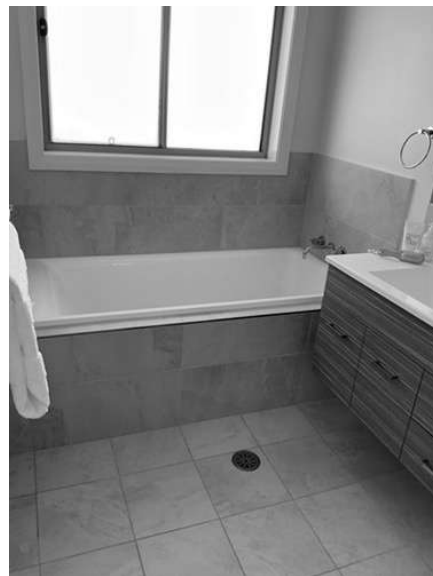
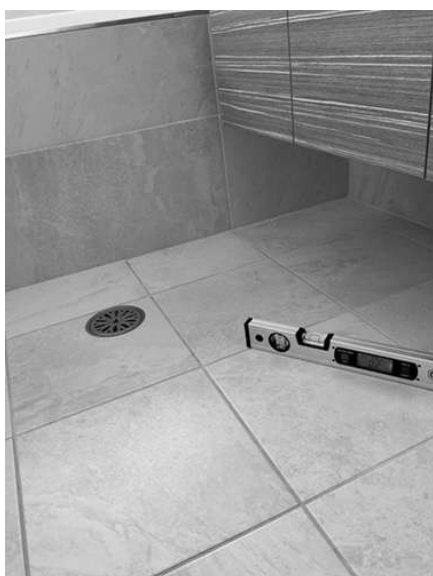
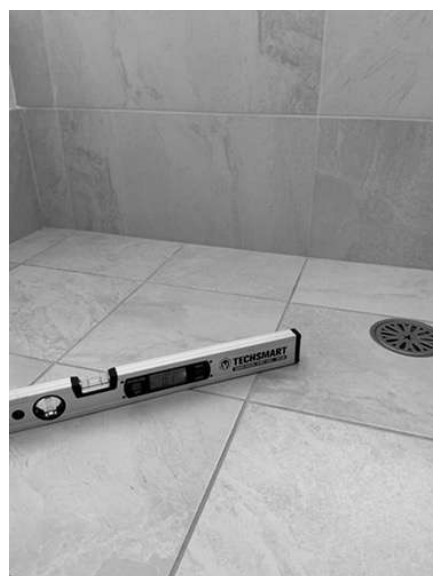
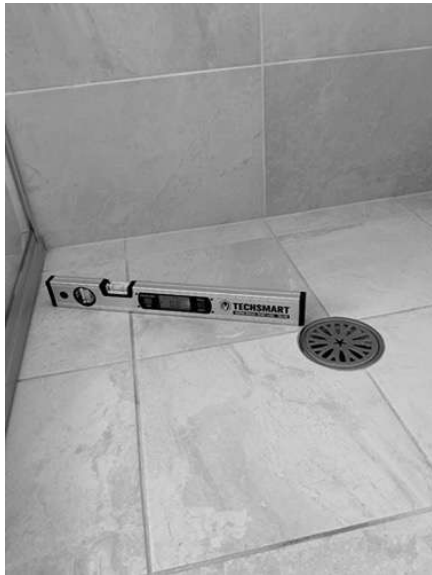
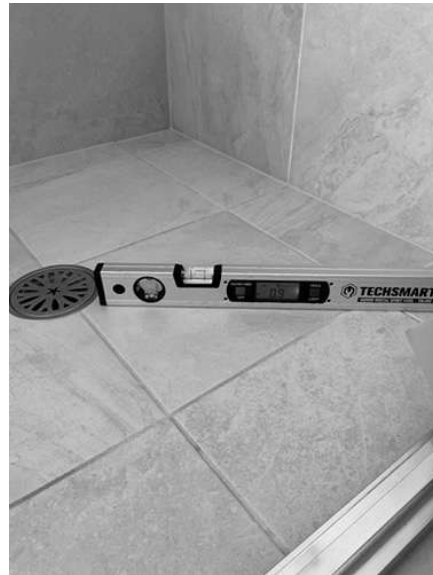
| Finding: | <div><div>Bathroom</div><div>The bathroom is in excellent condition with fixtures and fittings that are high quality and well-maintained. The fall to waste is correctly aligned, showing no signs of waterproofing damage. To maintain the longevity and effectiveness of waterproofing, regularly inspect and reapply silicon seals around the shower and other wet areas as needed. This proactive measure will help prevent potential future leaks or water damage. Regular maintenance of the seals is suggested to ensure a continued barrier against moisture intrusion.</div></div> |

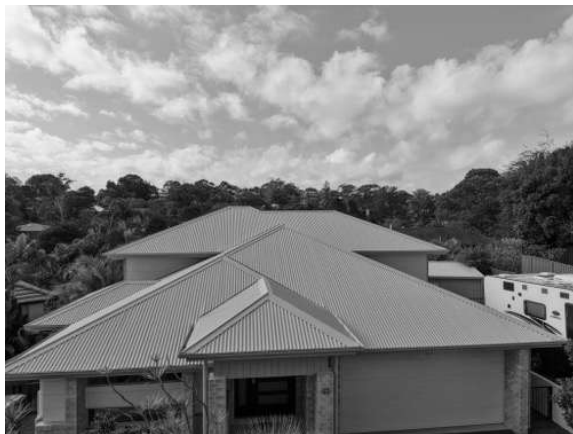
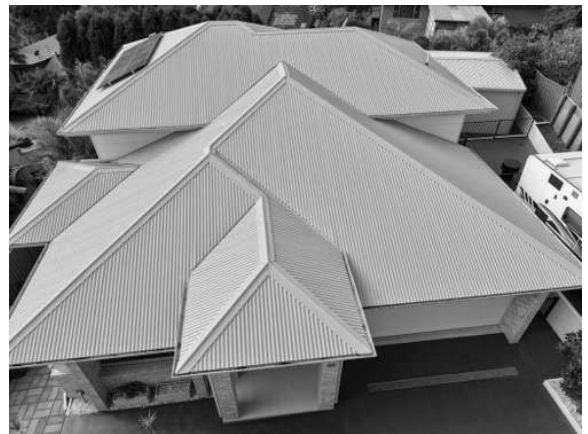
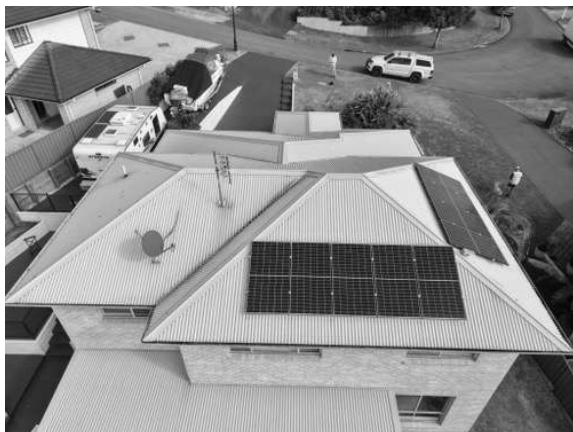
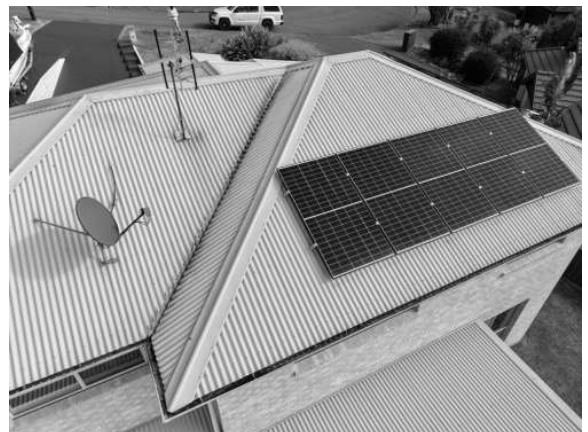
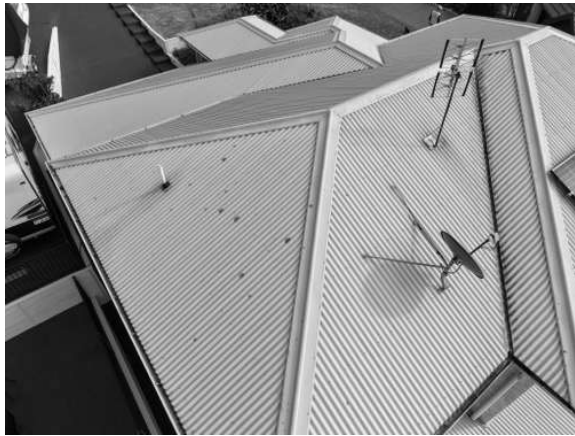
**Location:** Roof exterior

**Finding:** Roof and gutter inspection using drone

The Colorbond roof is generally in good condition. Regular maintenance checks should be scheduled to keep the roof clear of obstructions and to extend its lifespan.

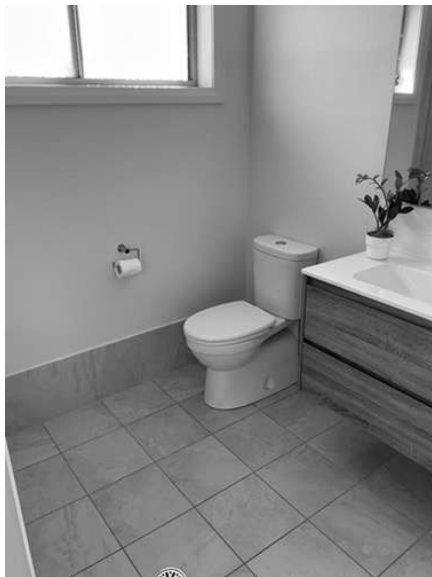
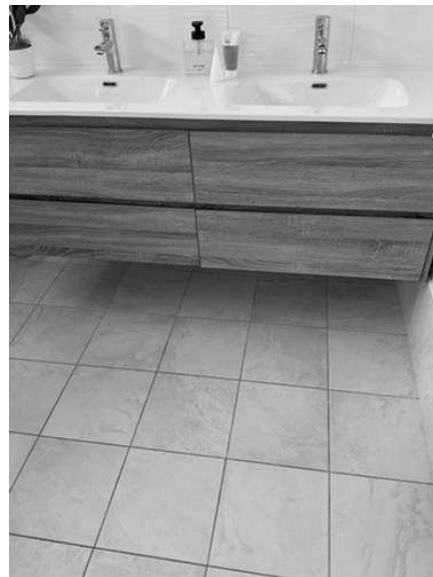
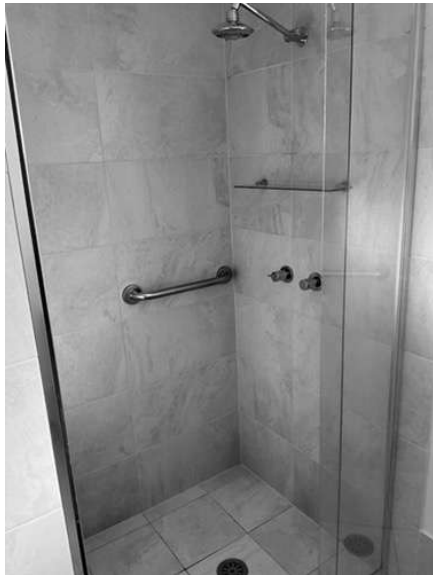
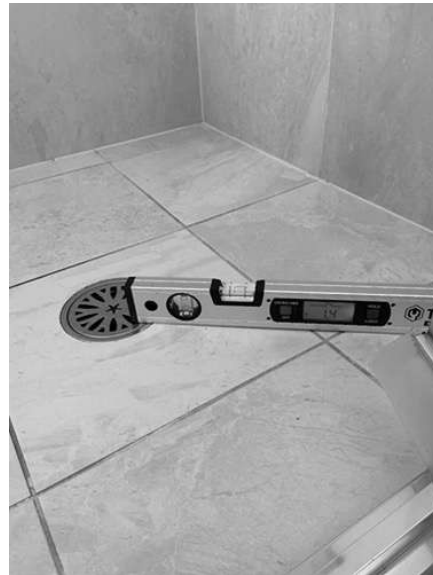
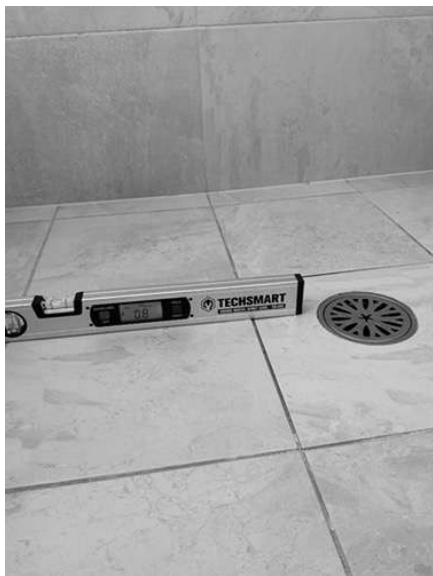
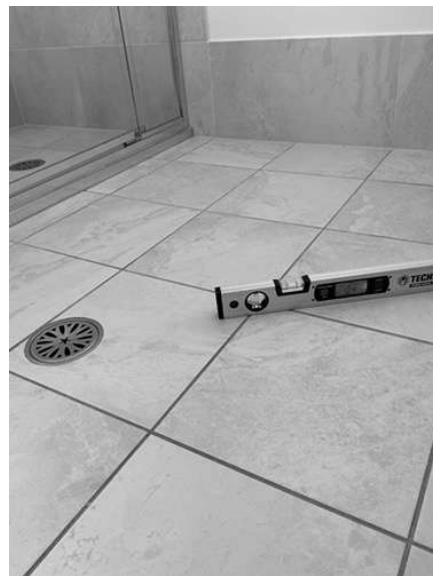
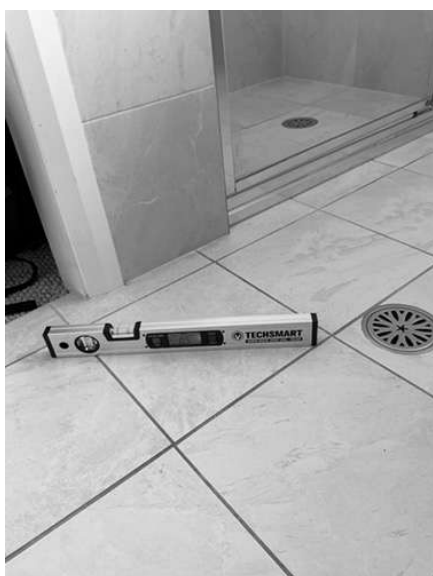
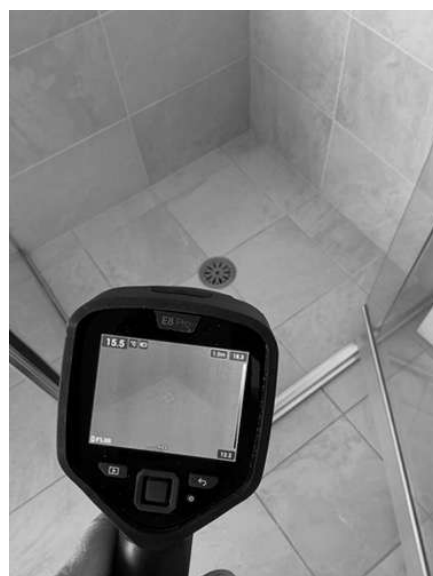
**Location:** Ensuite

**Finding:** Ensuite inspection good

The ensuite is in excellent condition, with the fall to waste correctly aligned and no signs of waterproofing damage. All fixtures and fittings are of high quality and well-maintained. However, to ensure the longevity and continued effectiveness of the waterproofing, it's recommended to regularly inspect the silicon seals around the shower and other wet areas and reapply as necessary to prevent any future leaks or water damage.

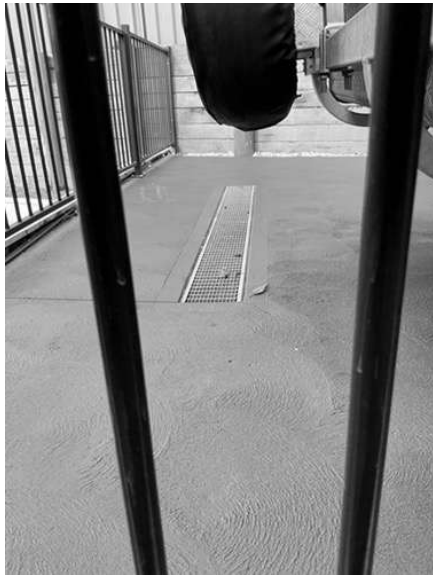
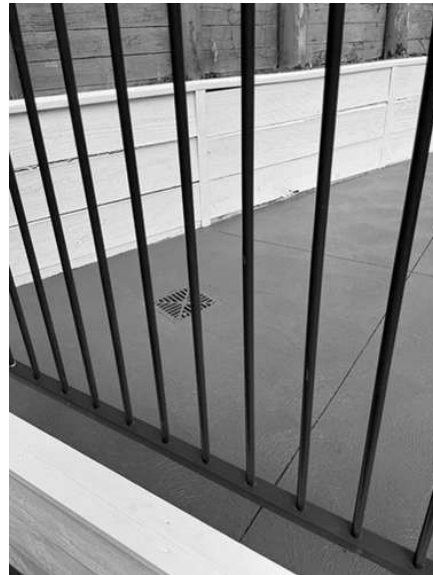
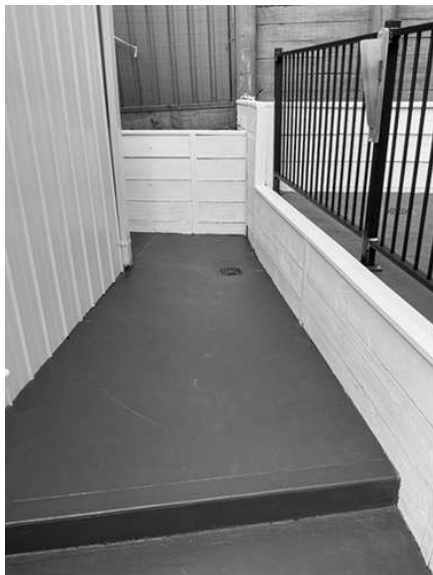
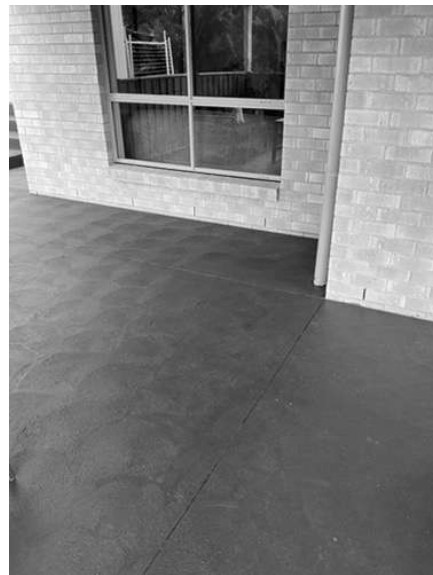
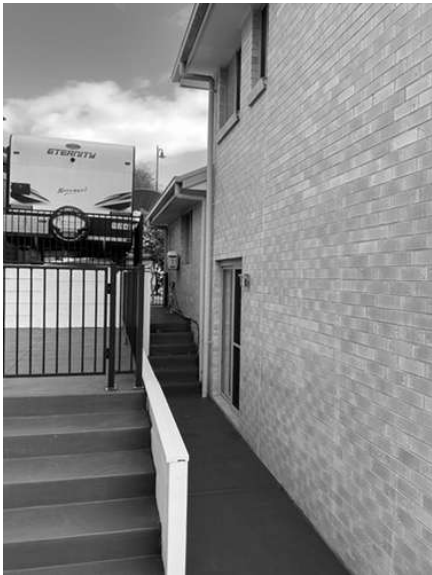
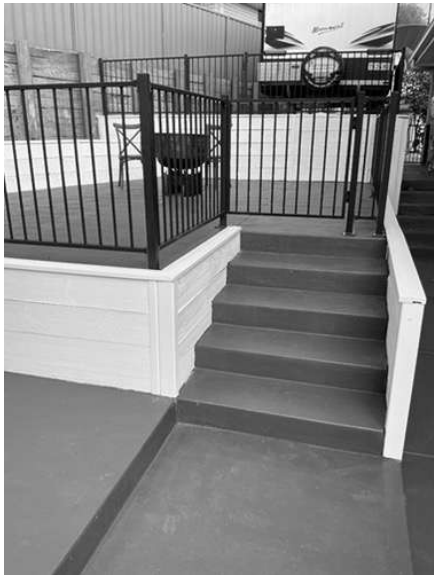
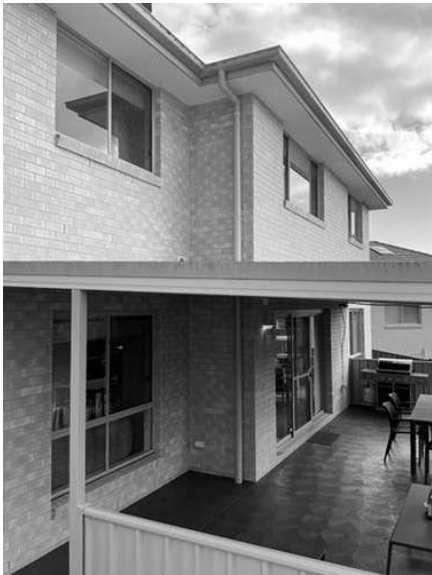
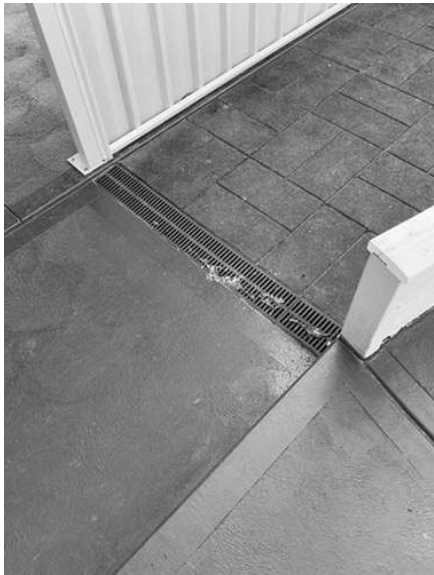
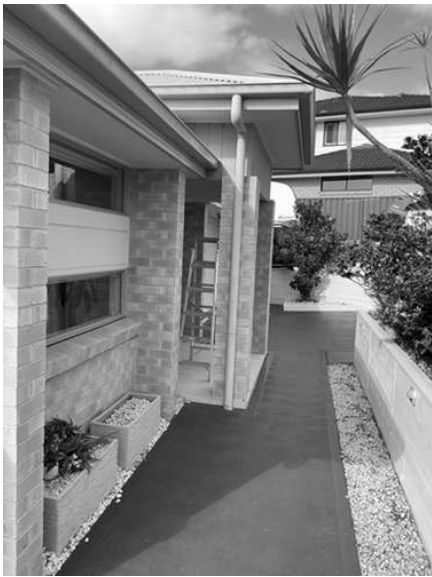
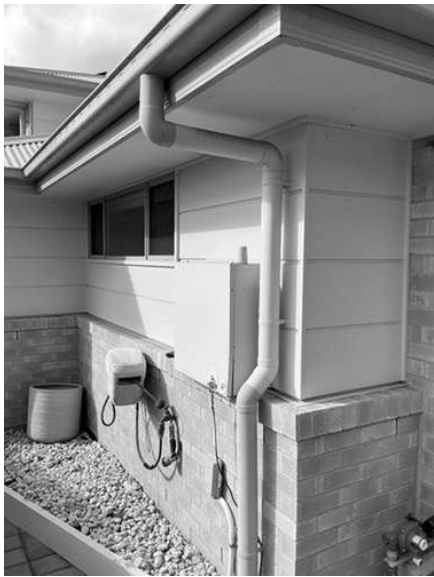
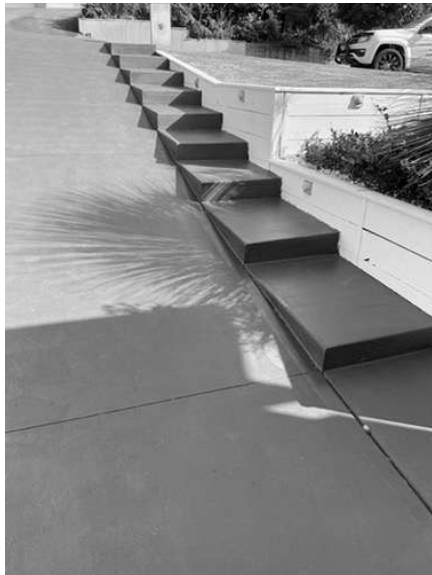
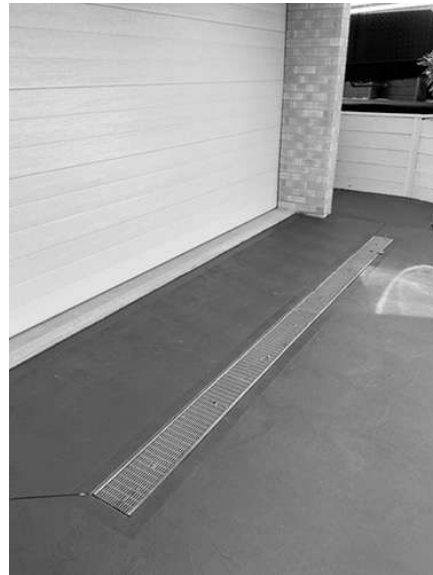
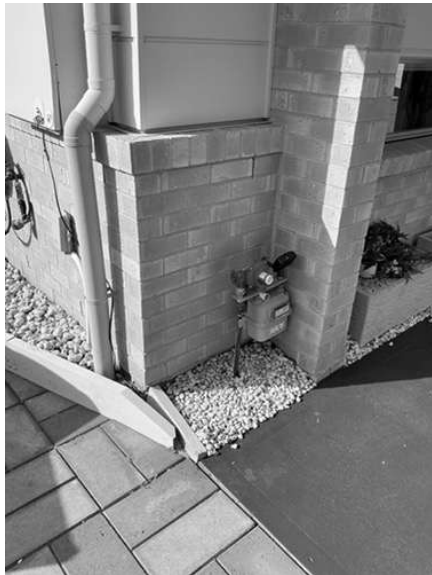
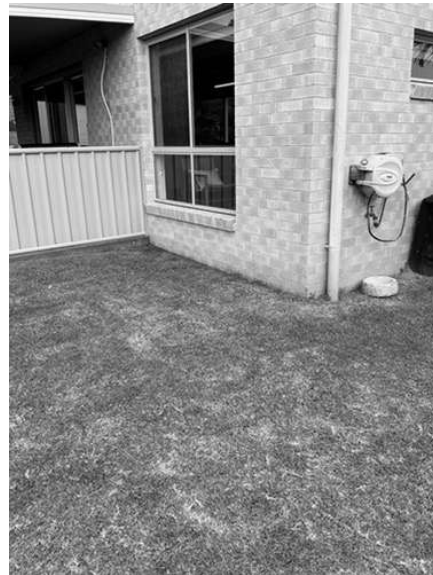
**Location:** All External Areas

**Finding:** Paving and site drainage

The extensive concrete paving across all external areas is installed to high standards, exhibiting correct fall and excellent finishing. Drainage channels and gutter downpipes are present and intact. Regular maintenance of drains and gutters will prevent potential water accumulation issues.

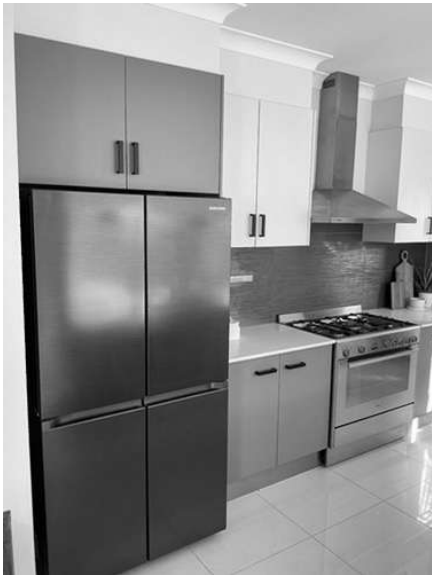
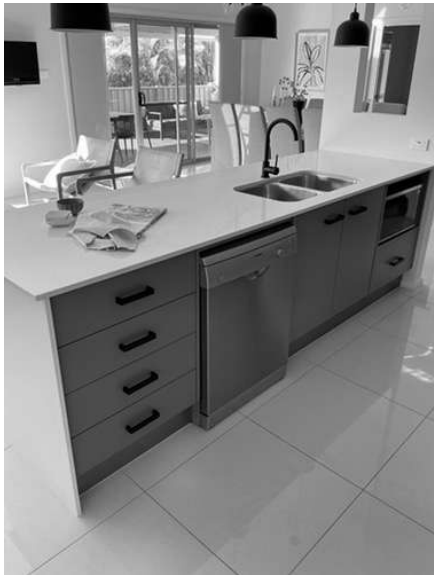
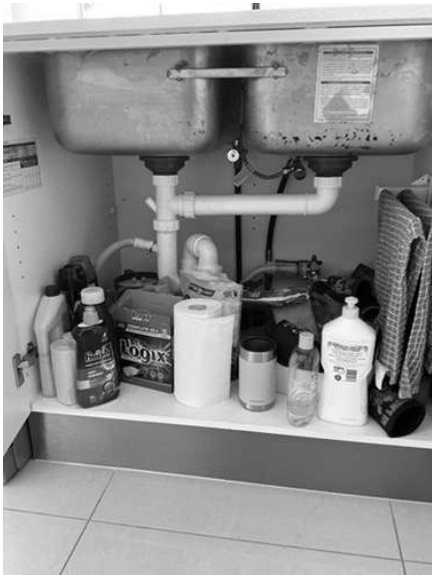
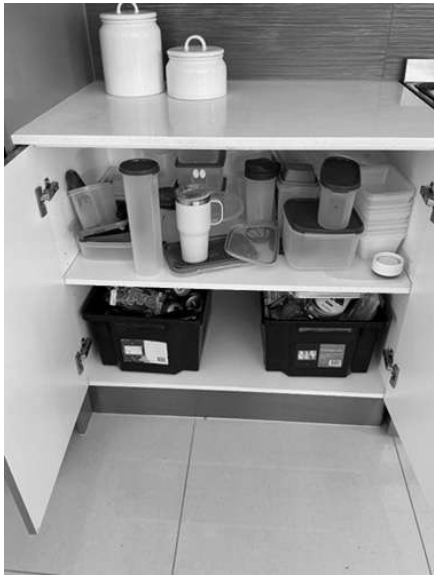
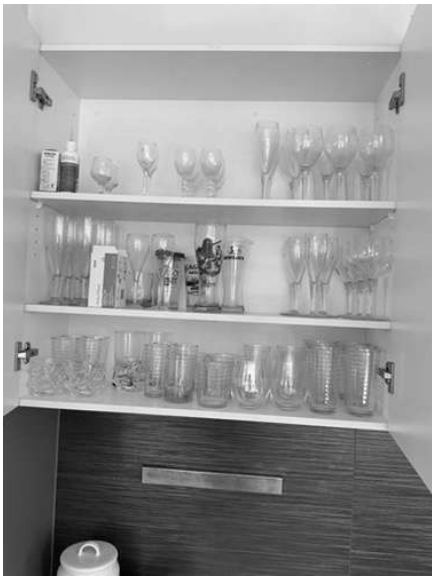
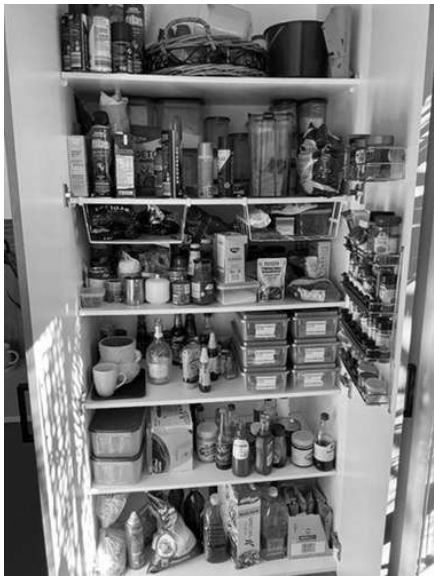
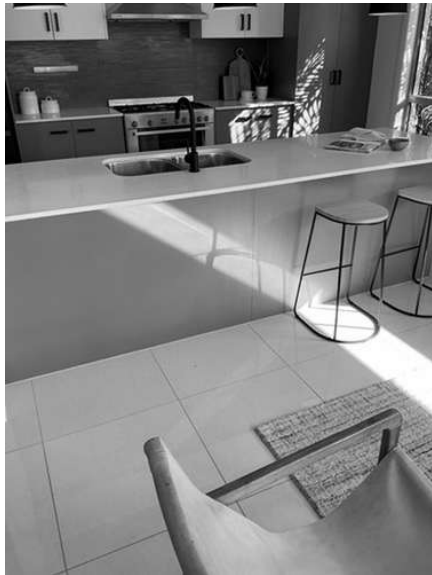
**Location:** Kitchen

**Finding:** Kitchen inspection good

Kitchen has been built to a high standard and maintained well with good quality fixtures and fittings.

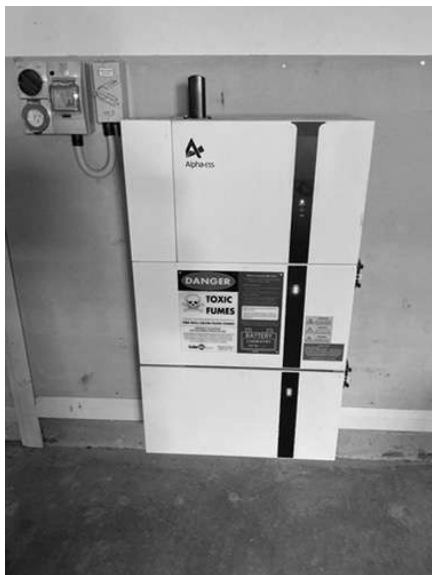
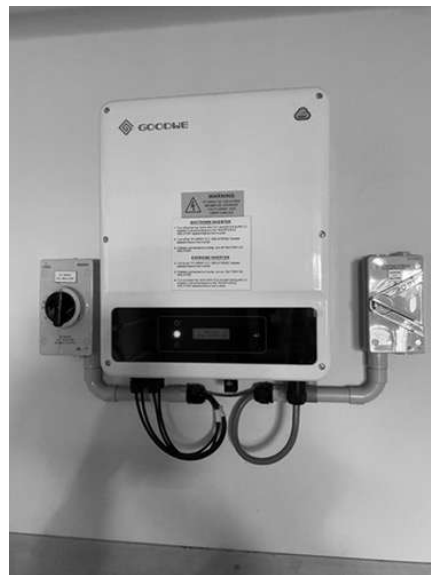
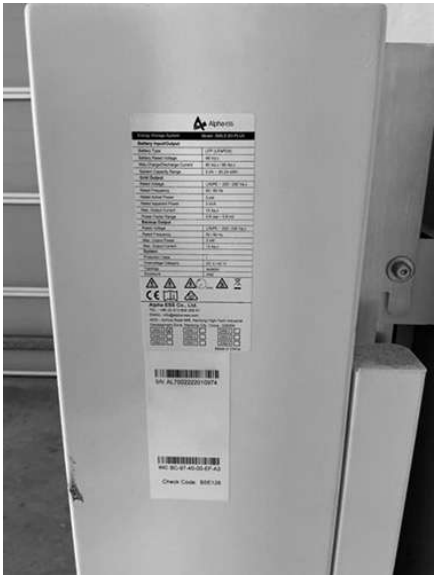
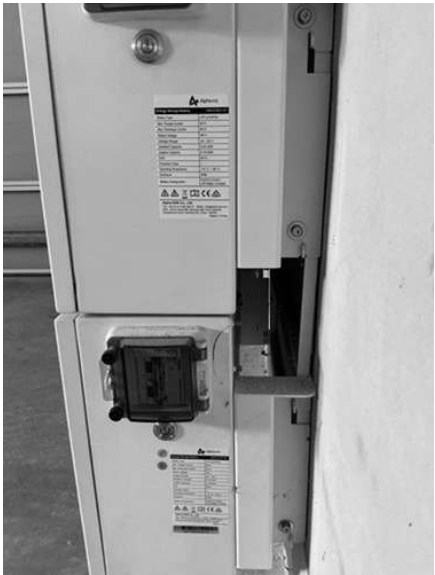
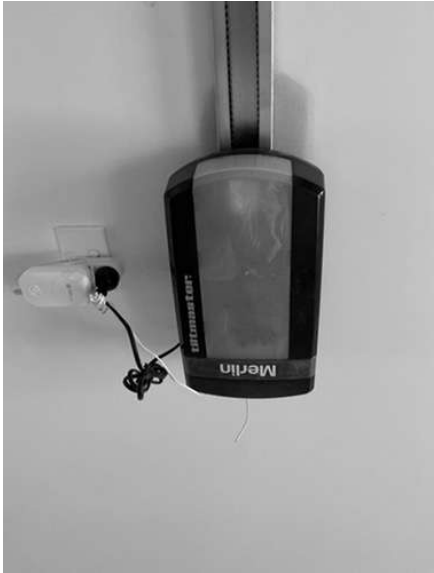
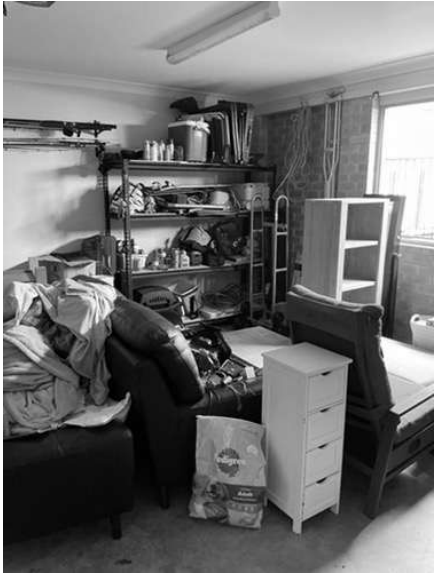
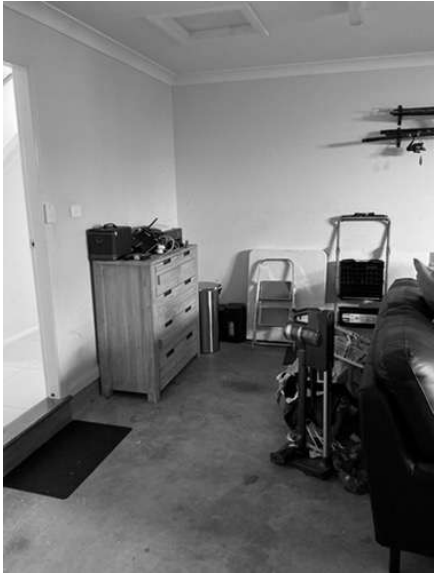
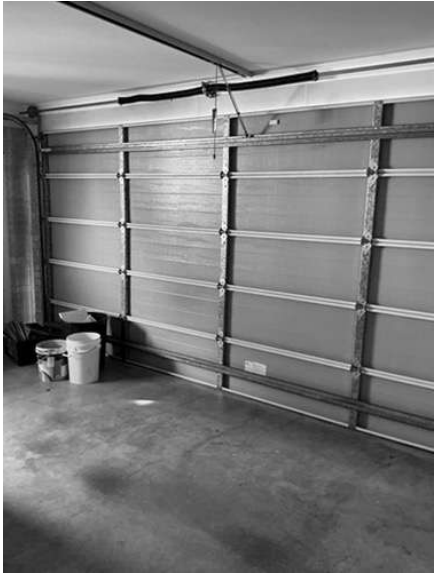
**Location:** Garage

**Finding:** Garage inspection

Garage inspection good, including electric roller door, solar panel inverter and battery power storage all appear to be in working order.

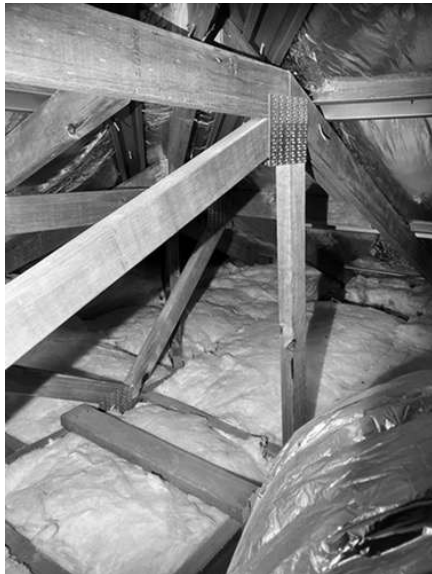
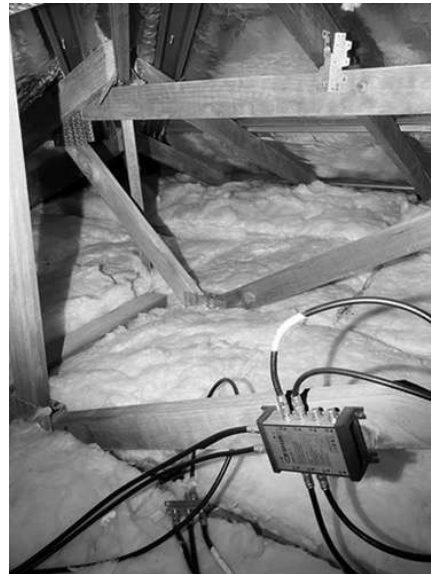
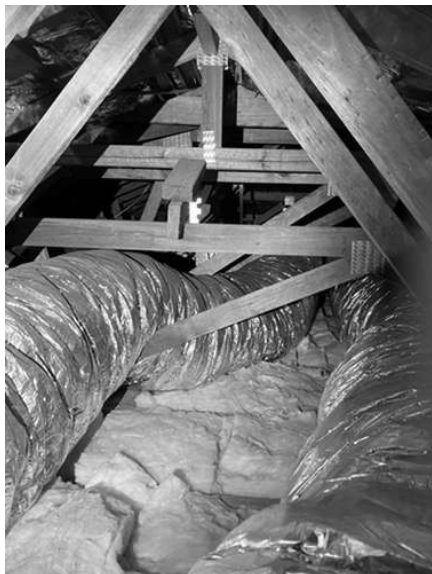
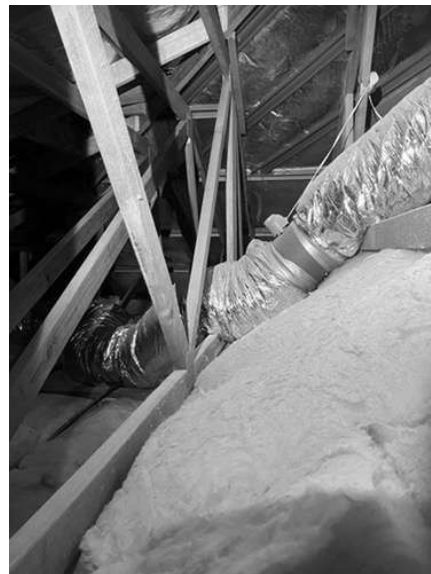
**Location:** Roofspace

**Finding:** Roof space inspection good

The roof space appears structurally sound with timber frame trusses and metal top hat construction. Roof sheet and ceiling insulation all in good condition.

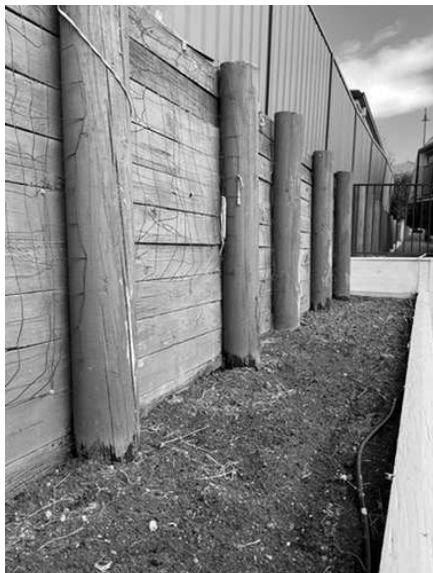
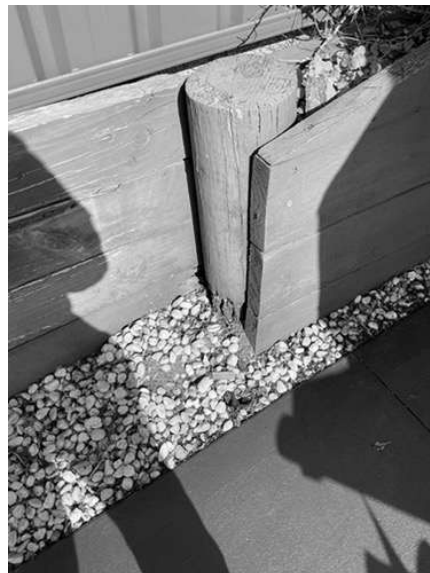
| Finding: | <p>Boundary retaining wall</p> <p>The timber retaining wall along the boundary shows signs of fungal decay, which is typical for its age. This deterioration, observed on the site, may impact the wall's structural integrity over time. It is recommended to evaluate the extent of decay and consider replacing affected sections with treated timber to prevent further deterioration. Regular maintenance and treatment can also help in prolonging the lifespan of the retaining wall.</p> |

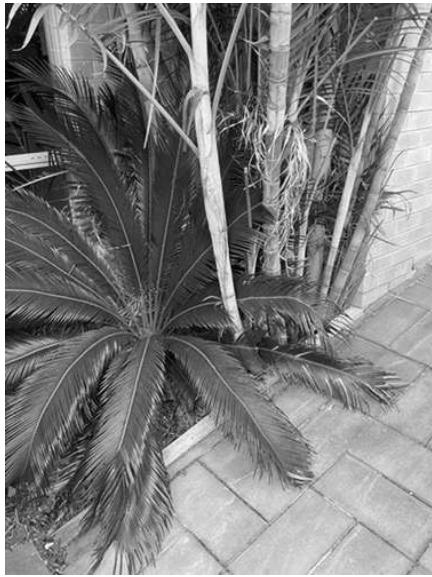
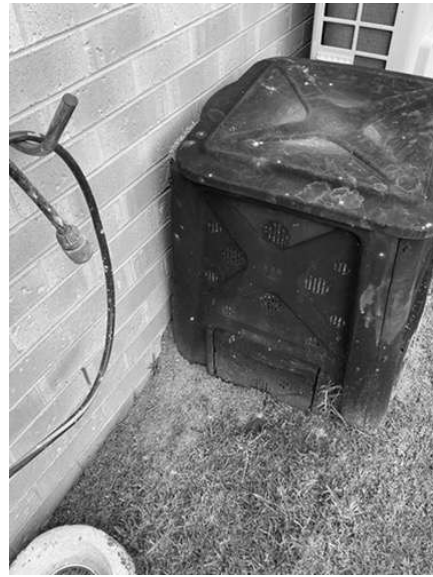
## **Conditions conducive to timber pest attack 2.02**

**Finding:** Vegetation and a mulch bin are positioned against the house, obstructing complete inspection for timber pests. It is advisable to maintain a clear inspection gap around the perimeter to facilitate thorough assessments. Relocation of the garden bed and mulch bin away from the building will help prevent future access issues and reduce the potential for pest infestation. Ensuring proper clearance from the foundation can provide easier access for regular

inspections and maintenance.
