Report: robert brandon-combined building & pest inspection

## Pre Purchase Building Inspection Report

**12 Winifred Street  
Morwell, vic 3840**

**May 8, 2026**

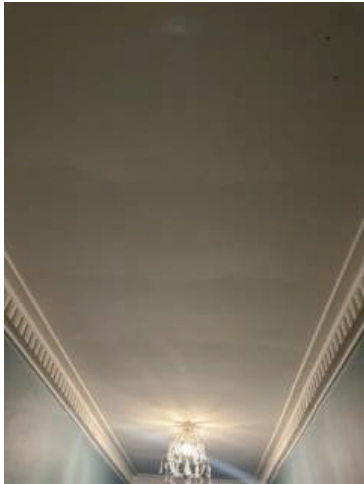
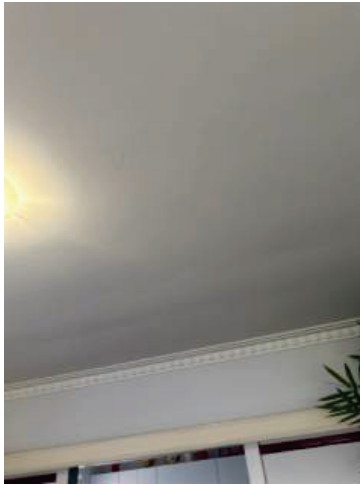
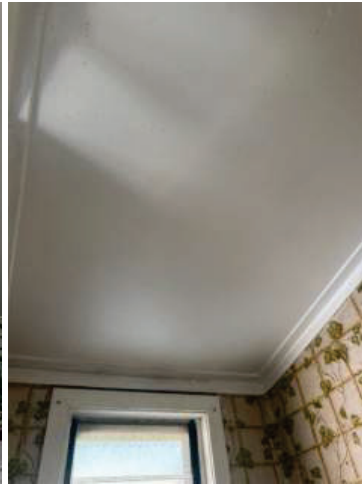
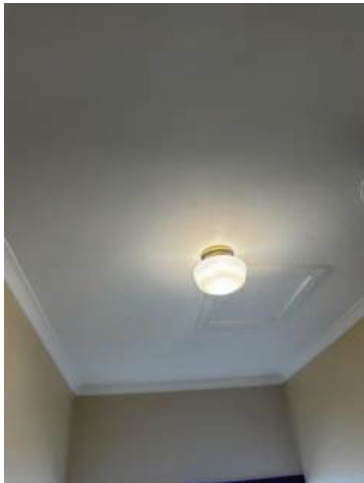
The condition of the ceilings is generally fair.

Minor ceiling lining undulation/sagging was noted within the various rooms. This appears to be due to the adhesive failing between the ceiling lining and ceiling frame. Rectification is suggested to prevent further deterioration. A professional plasterer is required to provide a further assessment and to offer suitable rectification as required.

Although we have no qualifications in the detection of asbestos materials, its possible the ceiling lining within the toilet may contain asbestos. It must be noted that asbestos materials present as a serious health hazard. Due to these associated health risks, asbestos material should not be disturbed in any form, and should be kept maintained and fully sealed to avoid exposure. We strongly recommend further tests be undertaken without delay to determine if asbestos linings are indeed present. These tests and any modifications or removal should only be conducted by a suitably qualified licensed Asbestos contractor.

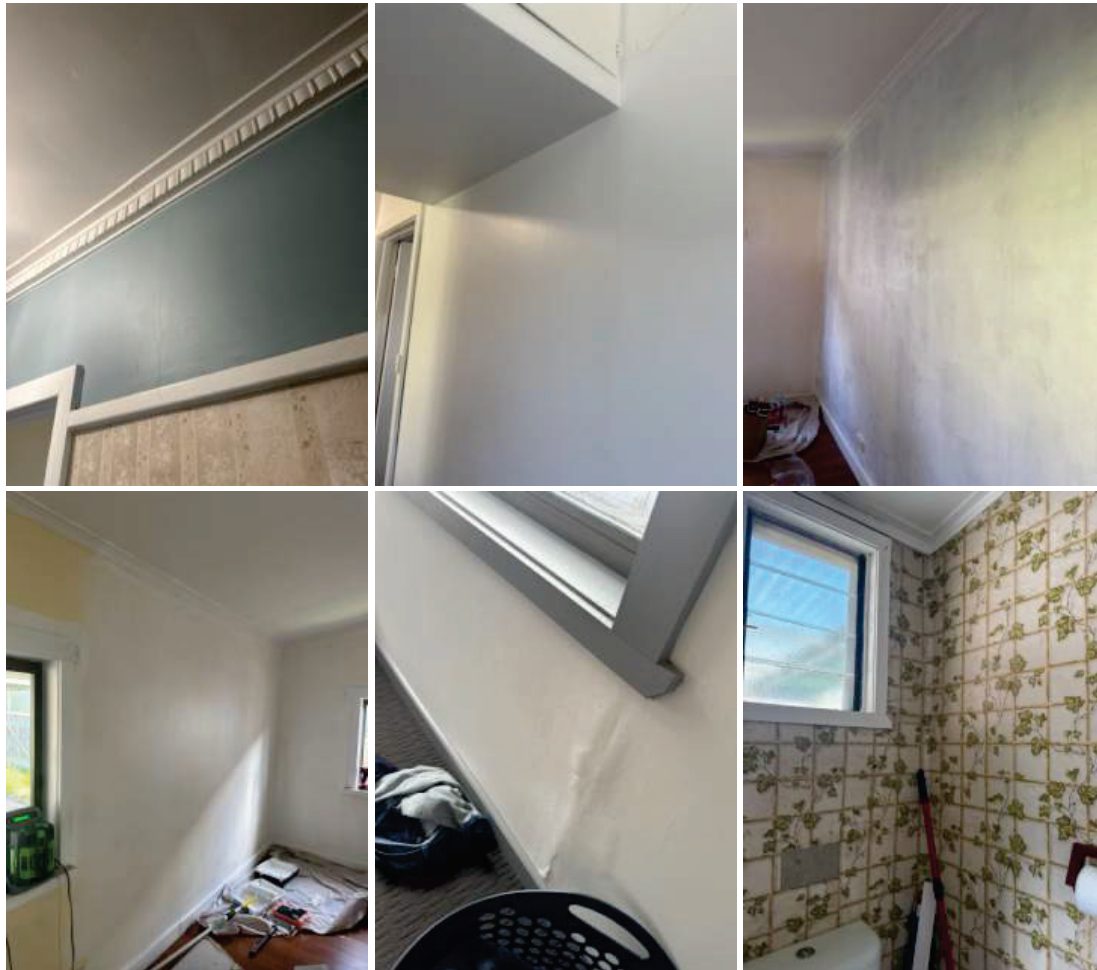
Minor cosmetic settlement cracks were noted to the wall lining within the hallway, Minor cracking can be expected in the type of lining. However, maintenance is required by a suitably qualified plasterer to repair the cracking present.

Cosmetic defective or poor surfaces were noted to wall materials within the various areas and will need repair prior to next painting by a suitably qualified plasterer and/or painter.

Although we have no qualifications in the detection of asbestos materials, its possible the wall lining within the toilet may contain asbestos. It must be noted that asbestos materials present as a serious health hazard. Due to these associated health risks, asbestos material should not be disturbed in any form, and should be kept maintained and fully sealed to avoid exposure. We strongly recommend further tests be undertaken without delay to determine if asbestos linings are indeed present. These tests and any modifications or removal should only be conducted by a suitably qualified licensed Asbestos contractor.

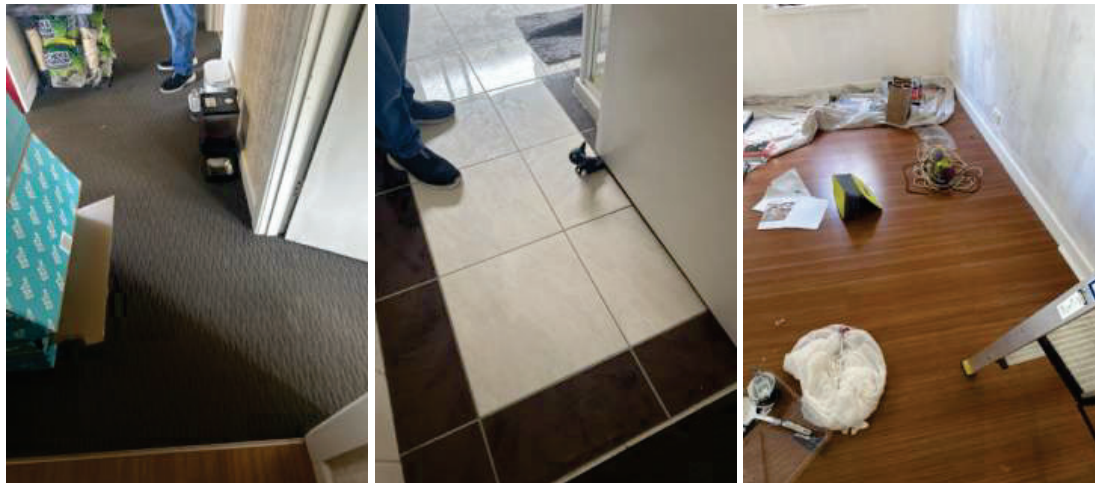
Squeaking flooring was noted within the hallway. This does not appear to be structural, but the floors may require re-fixing to remove the noise. Due to the floor coverings being present over this area, this work should be carried out when the floor coverings are next changed. A licensed builder is required to provide a further assessment and to offer suitable rectification as required.

Floors are uneven (out of level) to the rear section. This may be a result of structural building defects and/or timber pest attack. Please refer to (SUBFLOOR) within the report for further details.

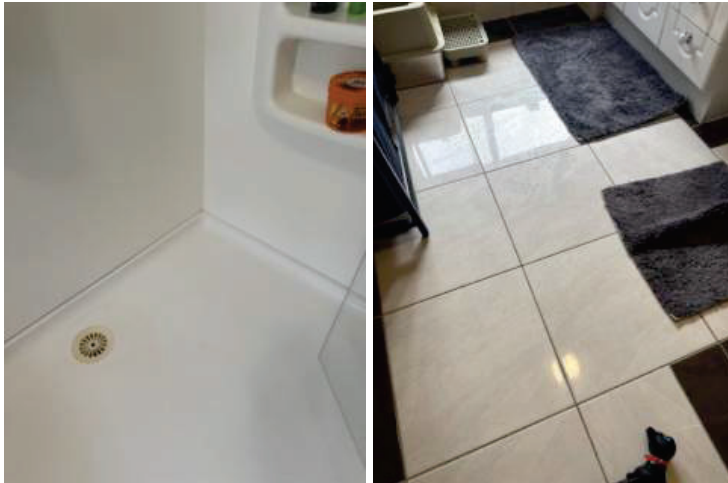
The condition of the lamipanel is generally good.

A flexible sealant should be installed by a suitably qualified professional to the gaps between lamipanel and shower base. This is to prevent water penetration and decay to surrounding components.

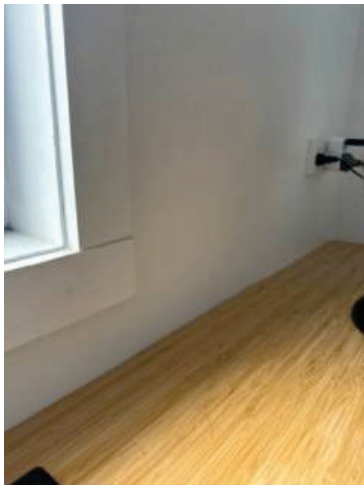
Tiles are not present to the laundry. Recommend tiles be installed to prevent water penetration and decay to surrounding components. A professional tiler is required to provide a further assessment and to offer suitable tile installation as required.

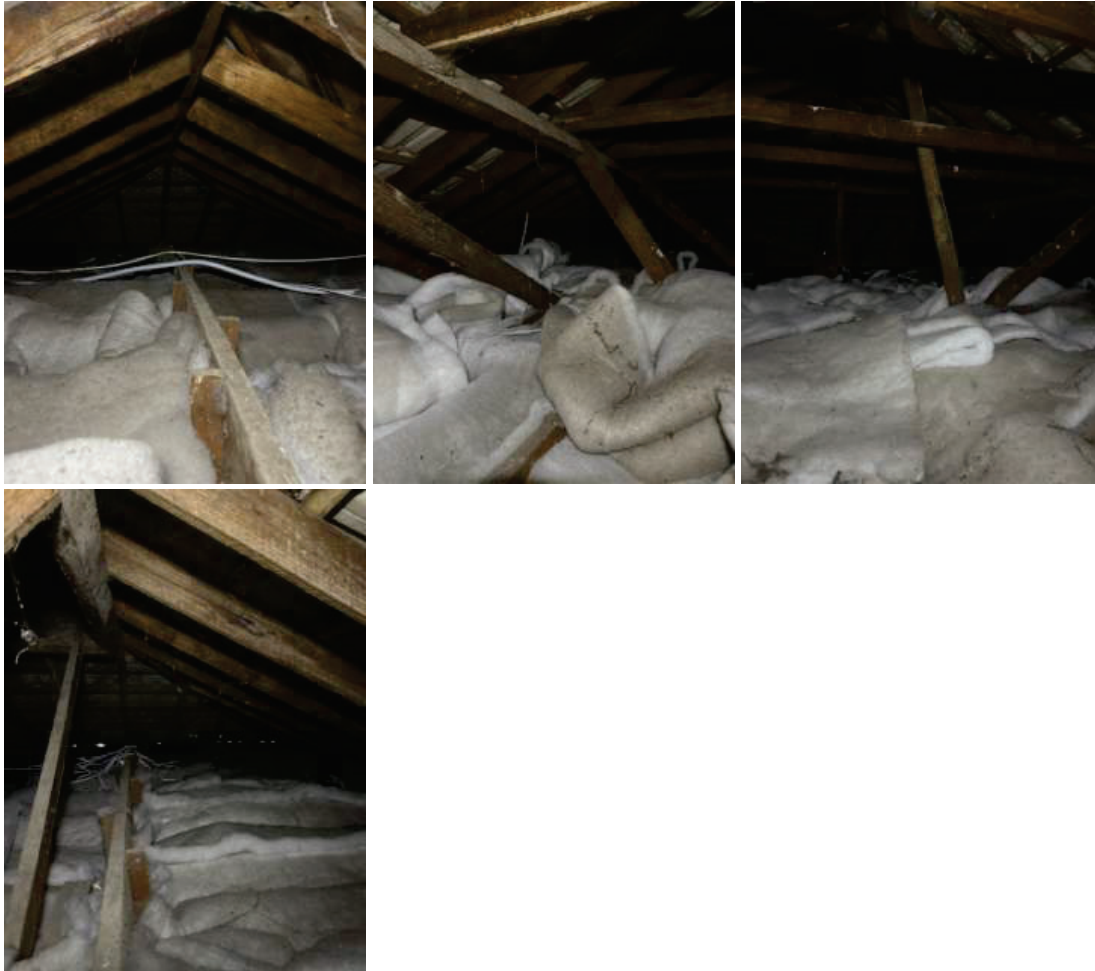
Insulation is present in the roof cavity. This restricted inspection to some roofing timbers (Including but not limited to: Ceiling joist and top wall plates). Removal of insulation is not within the scope of a standard visual inspection report. Defects and or timber pest may be present and not detected.

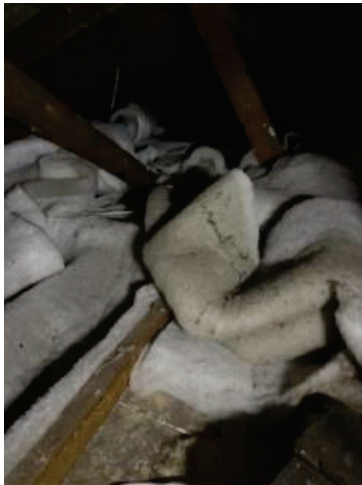
The insulation is out of place and should be re distributed correctly to assure the insulation functions as intended.

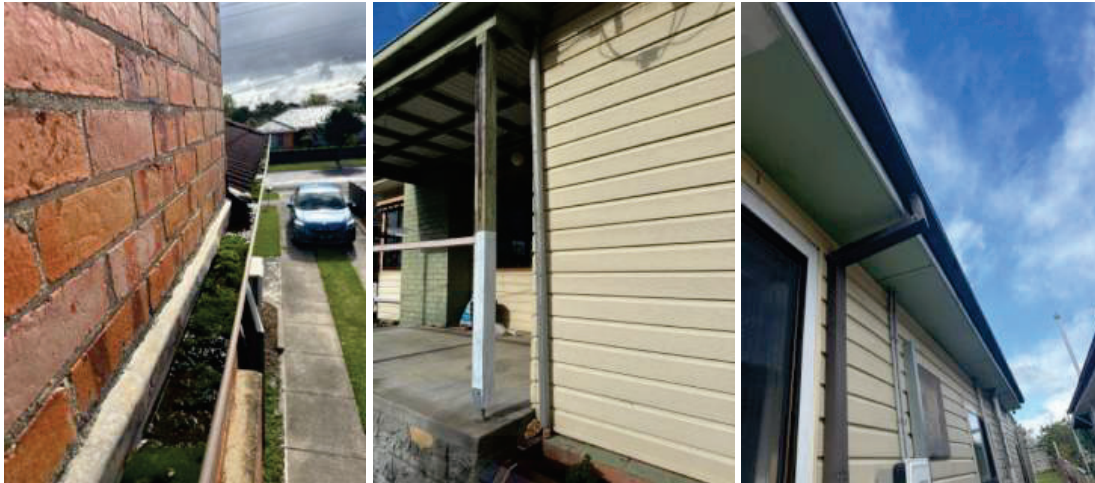
Some downpipes to the front elevations do not appear to be connected to a stormwater dispersal system. These should be connected without delay to prevent decay to surrounding components and to prevent the foundations of the dwelling being damaged. This also effects the timber pest management of the property and may attract termites. A licensed roof plumber is required to provide a further assessment and to offer suitable rectification as required.

Downpipe joints are leaking and should be repaired by a roof plumber, as the free water leaking from the downpipes may affect the foundations of the dwelling and cause potential structural issues and/or attract termites.

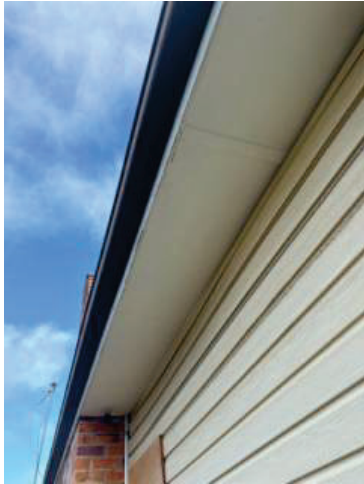
Although we have no qualifications in the detection of asbestos materials, its possible the eave lining may contain asbestos. It must be noted that asbestos materials present as a serious health hazard. Due to these associated health risks, asbestos material should not be disturbed in any form, and should be kept maintained and fully sealed to avoid exposure. We strongly recommend further tests be undertaken without delay to determine if asbestos linings is indeed present. These tests and any modifications or removal should only be conducted by a suitably qualified licensed Asbestos contractor.

The overall condition of the eaves lining is fair.

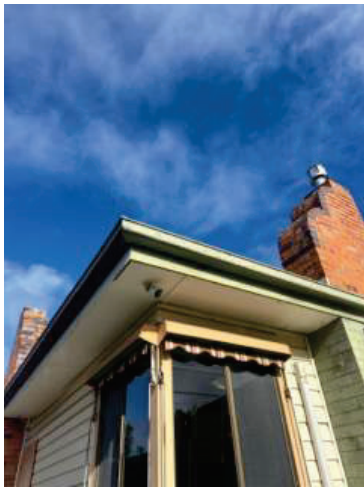
The overall condition of the fascias/bargeboards is fair.

The paint work is deteriorating and maintenance is required by a professional painter to prevent deterioration of the timbers.

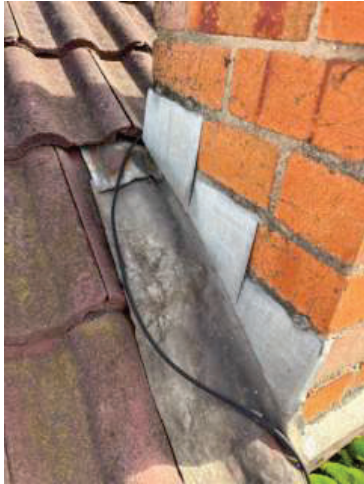
The flashing around the chimney is in fair condition. Some maintenance is required by a licensed roof plumber to prolong the life of the flashing and to prevent water penetration.

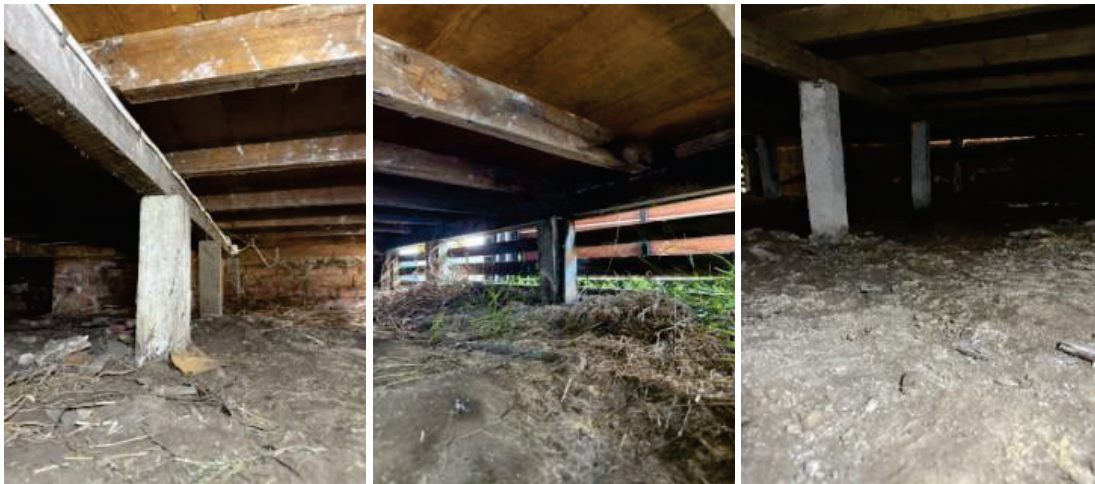
The timber baseboard supports which are attached next to each perimeter stump are in contact with the ground. This timber to ground contact will allow undetected termite entry and is highly conducive to termite attack. All timber to ground contact should be removed to prevent such issues without delay.

The underfloor soil is damp. This may be due to a drainage problem or some other factor. Rectification is required, as this dampness may cause timber deterioration to the floor frame. Damp soil also create conditions highly conducive to termite attack and the source of the damp should be further investigated and addressed by a licensed builder to prevent such issues.

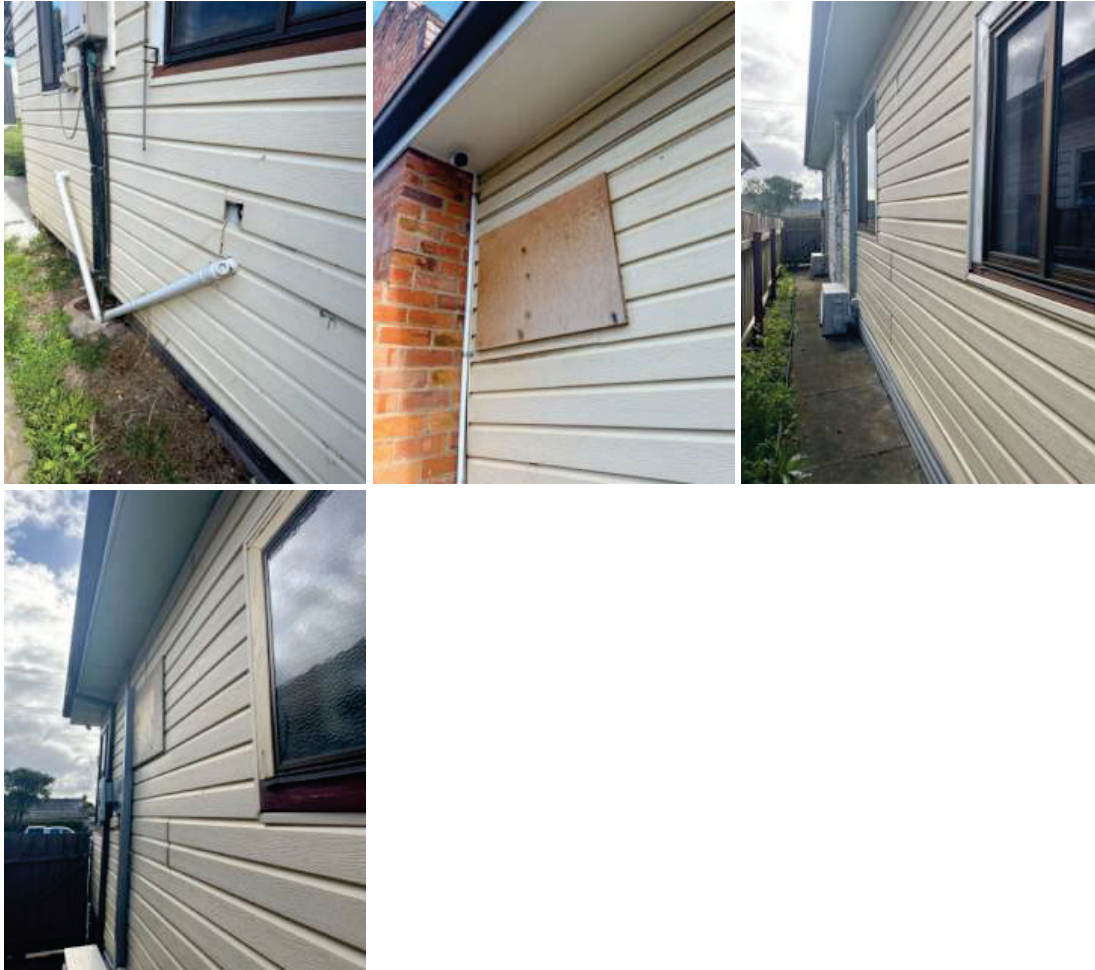
The condition of the walls is generally fair.

Cladding is damaged, repairs and maintenance will be required. A licensed carpenter should be called to make a further evaluation and repairs or rectification as needed.

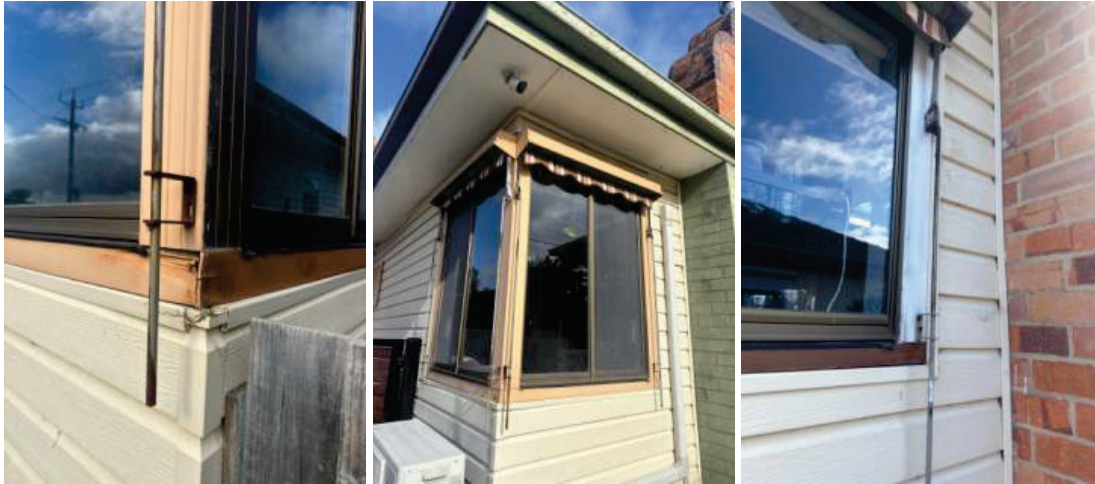
Minor wet rot decay is present to window frames to the front elevation. Maintenance will be required to prolong the life of the windows by a qualified carpenter/ painter.

All external window flashings should be further assessed by a builder in wet conditions. This is to assure all windows are water tight and water penetration is not occurring, which will help prevent structural decay.

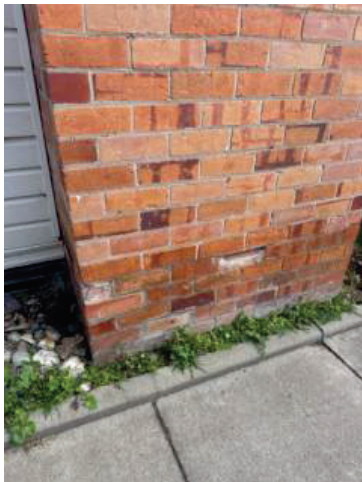
Rising damp is evident in the masonry walls to the left elevations. The damp proof coursing material should be replaced and quotations should be obtained from a suitably qualified contractor.

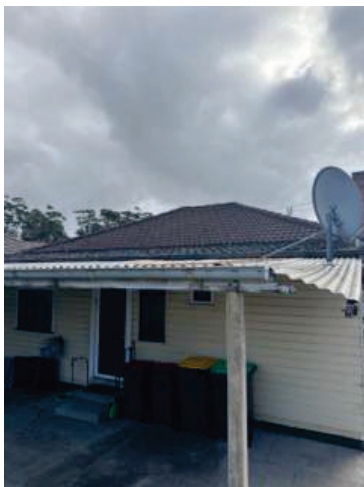
The overall condition of the roof coverings is fair.

Metal roof sheets are surface rusted to the right section and treatment with an anti rust paint is required to prolong the life of the material. A licensed roofing is required to provide a further assessment and to offer suitable rectification as required.

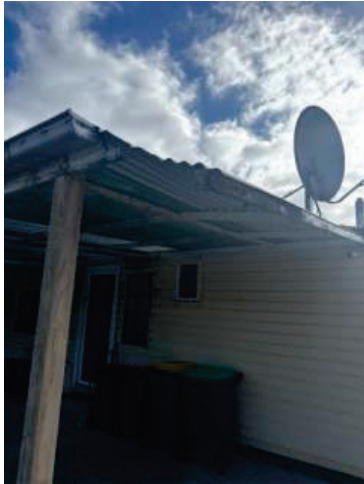
Verandah timber frame to the rear elevation is inadequately supported. The license builder should be called to assess and rectify. This is a major defect.

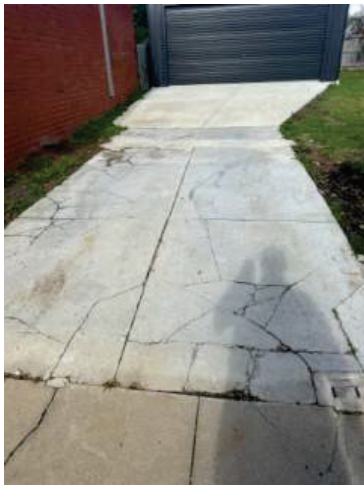
The concrete driveway stands in poor condition.

The concrete driveway has some visible cracking which can be quite typical for a concrete drive. This should be monitored for further movement.

The concrete driveway has subsided in some areas and will require repair. This may present a tripping hazard and rectification is required by a suitably qualified concreter.

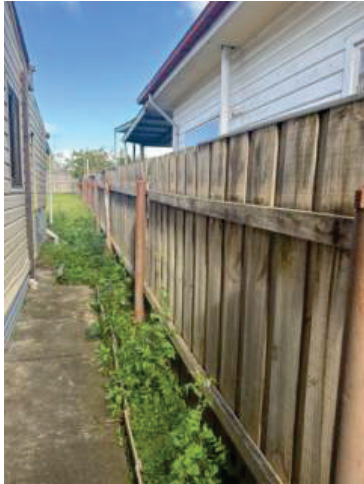
The fences are mainly constructed from timber. The fences are generally in fair condition but some repairs or maintenance is required.

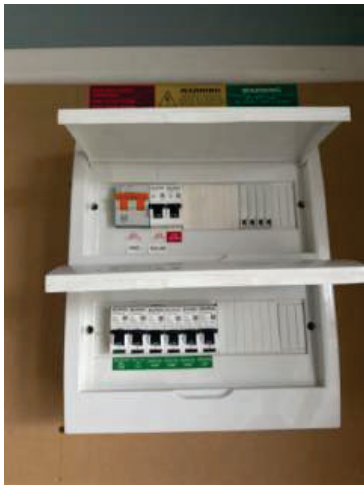
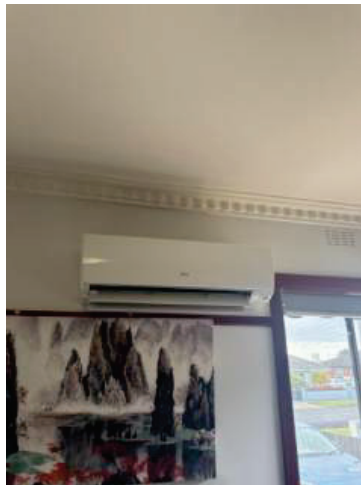
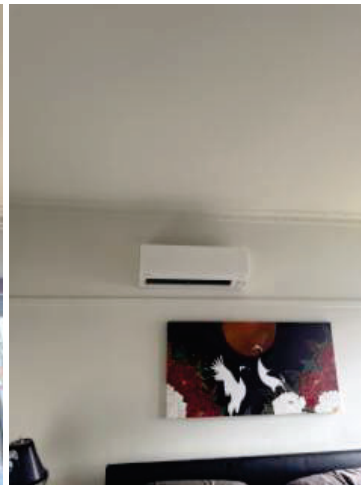
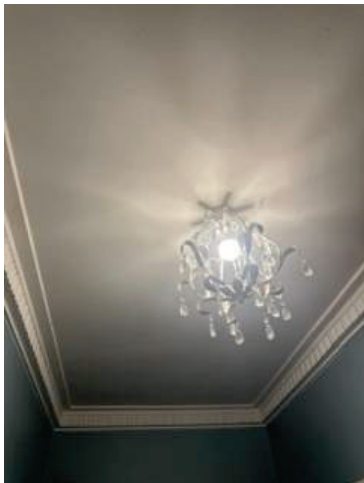
Safety switch is fitted however, the operation or adequacy was not tested and is not commented on. Recommend to contact an licensed electrician to assure the electrical safety switch is functioning as intended.

Smoke detectors are not currently fitted. It is now mandatory that smoke detectors be fitted to the property.

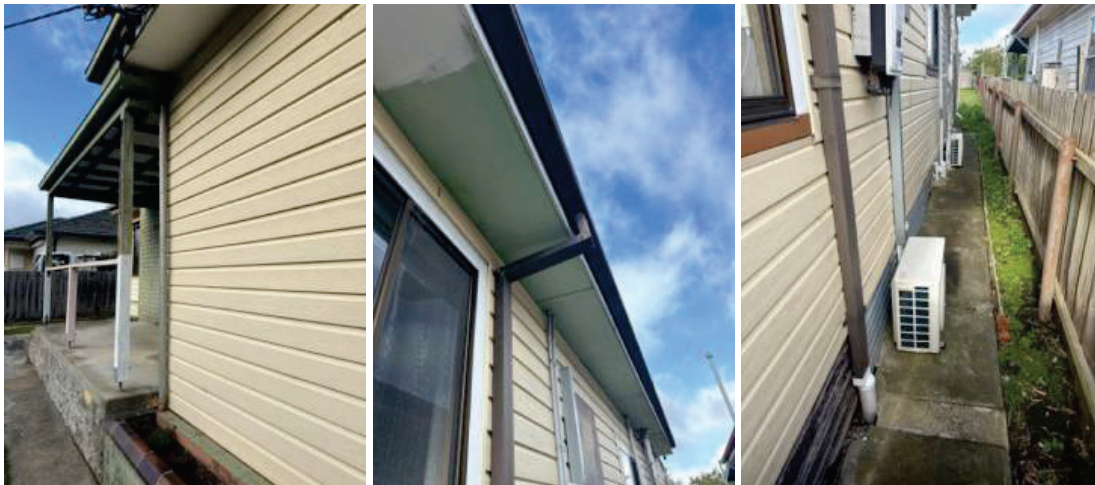
The air-conditioning condenser discharges adjacent to the external walls. We recommend modification so that water is discharged over a drain. Air conditioning units which release water alongside or near to building walls should be piped to a drain (if not possible then several meters away from the building) as the resulting wet area is highly conducive to termites.

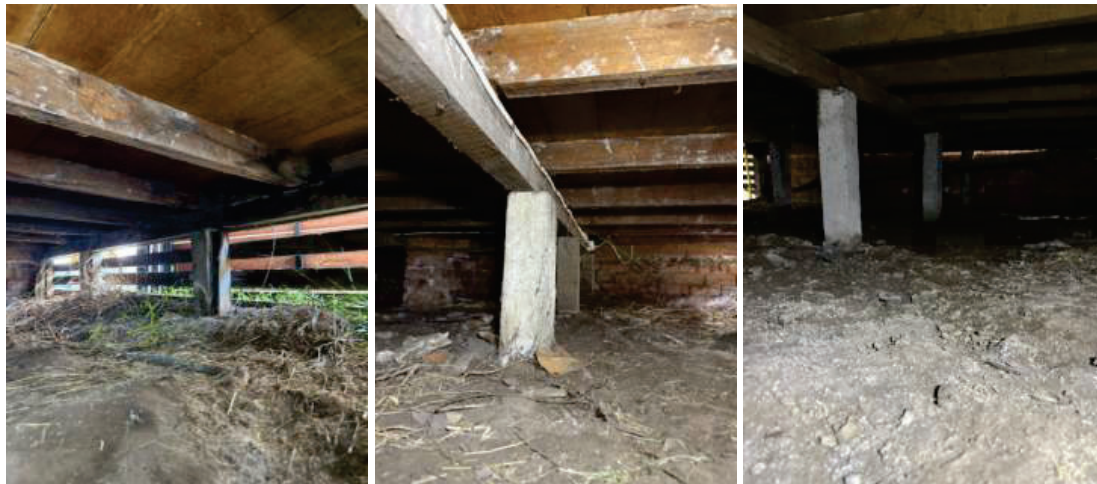
The underfloor soil appears damp. This should be monitored on a regular basis as moist soil conditions are highly conducive to timber pest attack. Poor drainage, especially in the subfloor, greatly increases the likelihood of wood decay and termite attack. We claim no expertise in plumbing and drainage, however it may be that the drainage is inadequate and in need of improvement.
