**VISUAL BUILDING & PEST INSPECTION REPORT**

**Vendor Report**

**36 Barnes Road Frenchs Forest**

12.1.26

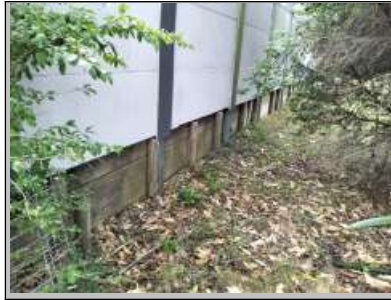
The timber retaining walls appear in acceptable condition.

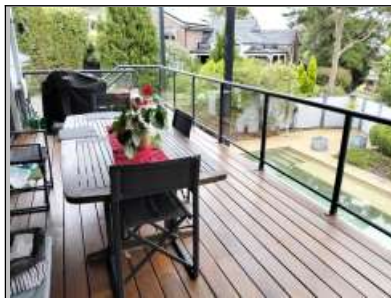
Rear elevation.

The condition of the structure is generally acceptable.

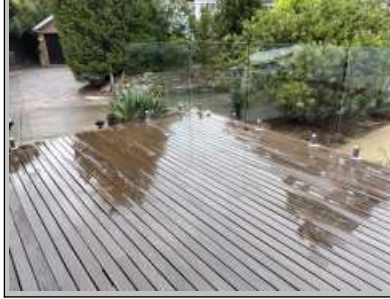
Rear elevation.

Where an external structure is constructed from timber or has significant timber components, and exposed to the elements, a suitably qualified engineer should inspect the structure to determine if it is structurally sound. We cannot determine or advise what weight the structure can hold. The general condition of this structure is fair.

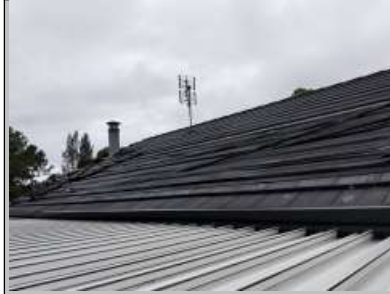
The roof is of pitched construction.

No access was possible to part of the external roof area due to the roof not being accessible from a 3.6 meter ladder.

The overall condition of the roof coverings is fair.

Appear to be in serviceable condition. Some Downpipes are rusting and should be repaired or replaced as necessary. Downpipes appear to be connected to the stormwater dispersal system.

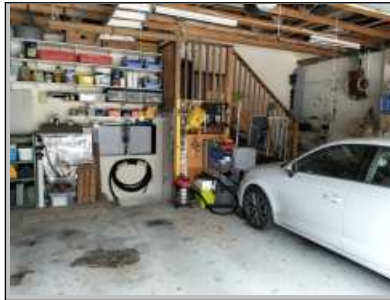
Garage.

The structure is generally in fair condition.

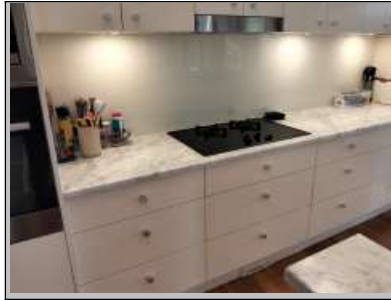
The condition of the fixtures is generally fair. A glass splashback is located over the benchtop area. Glass appears to be in serviceable condition.

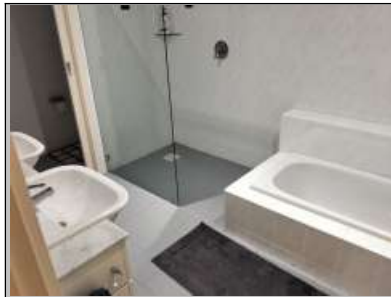
Ground floor.

The shower recess was tested and there was no visible water penetration to surrounding areas. IMPORTANT NOTE: This test may not reveal water leaks until the shower is put into constant use and surrounding areas monitored over a period of time.

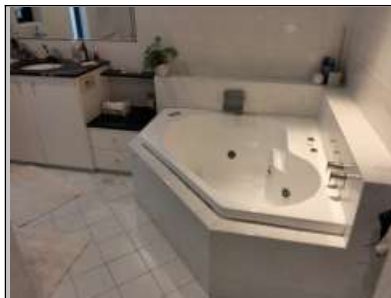
Ground floor.

The shower recess was tested and found to be leaking. Rectification will be required and evaluation of extent of works should be requested from a Licensed Builder, A spa bath is present however, due to the requirement to fill the unit above jet level for testing the spa was not tested for adequacy or reliability. Defects may be present and not detected.

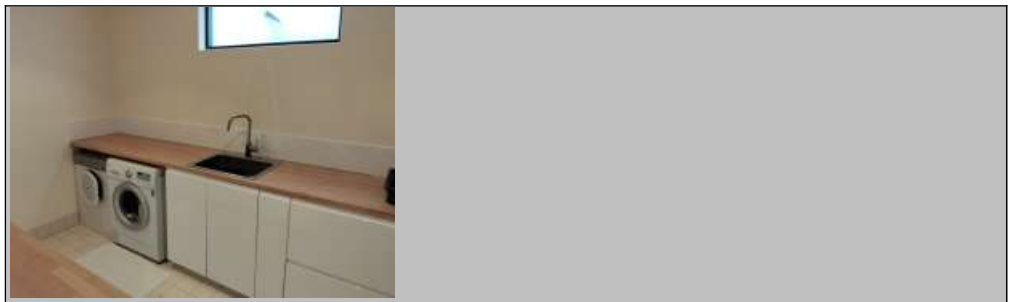
Adjacent to hall.

The tub and taps appear serviceable. Drain appears serviceable.

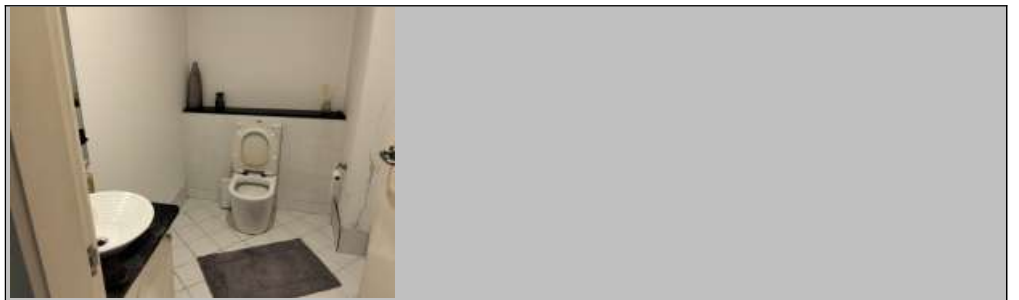
Ground floor.

The toilet appears to be in working order.

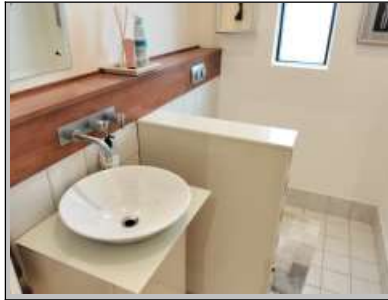
Level one.

The toilet appears to be in working order.

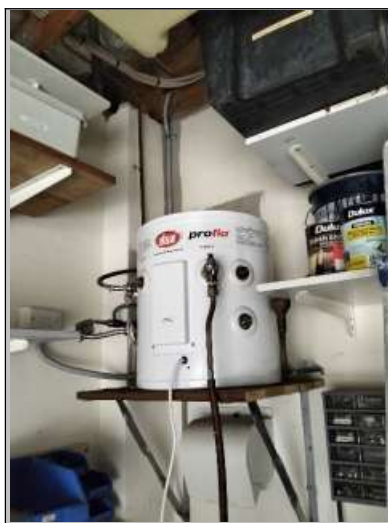
Mains electric hot water system: Mains pressure: Located in the garage: The hot water system appears to be in working condition. No specific tests other than running the hot water tap were carried out. No determination has been made as to the suitability or adequacy of the hot water system in relation to capacity or otherwise.

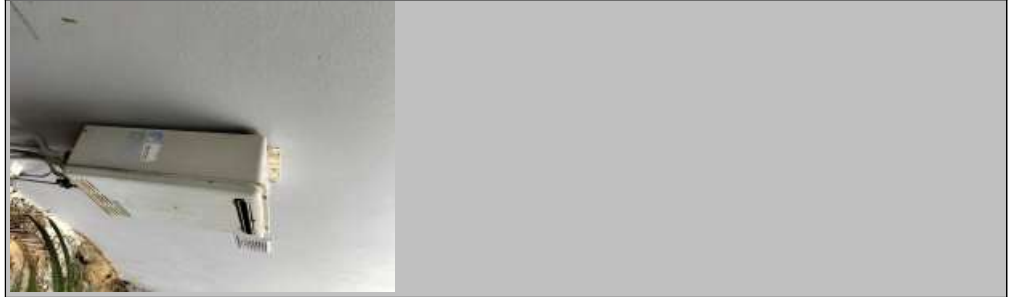
## HOT WATER SERVICE 2

Gas hot water system: Mains pressure: Instantaneous: Located externally: The hot water system appears to be in working condition. No specific tests other than running the hot water tap were carried out. No determination has been made as to the suitability or adequacy of the hot water system in relation to capacity or otherwise.

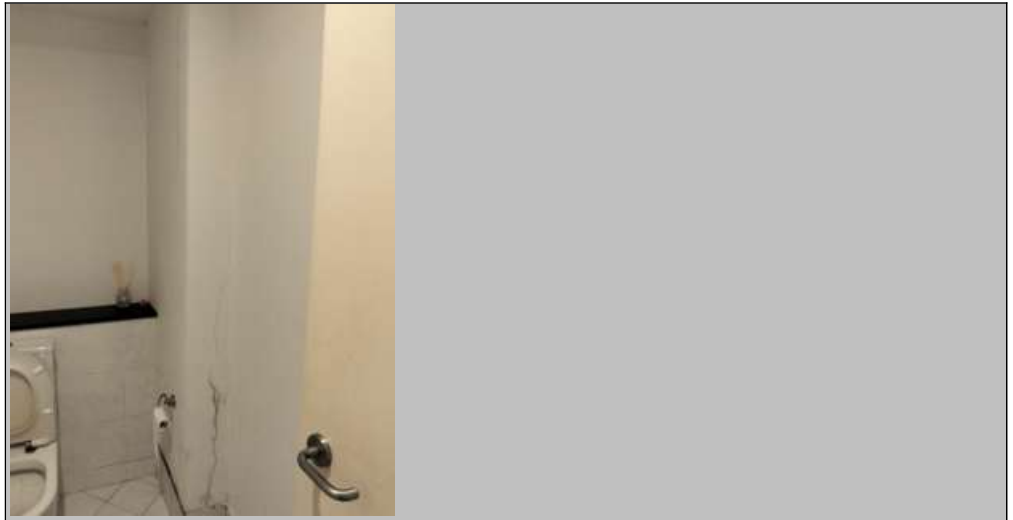
Crack Type: Vertical cracking Located: Toilet Width: 0.5-1mm Length: Various

Due to the unpredictable nature of cracking in building elements it is not possible for the inspector to determine past or future occurrences that have or will impact cracking in this building. Because of these unknowns and the possibility of concealed defects related to cracking in building elements we recommend an engineer be consulted prior to acceptance or purchase this building.

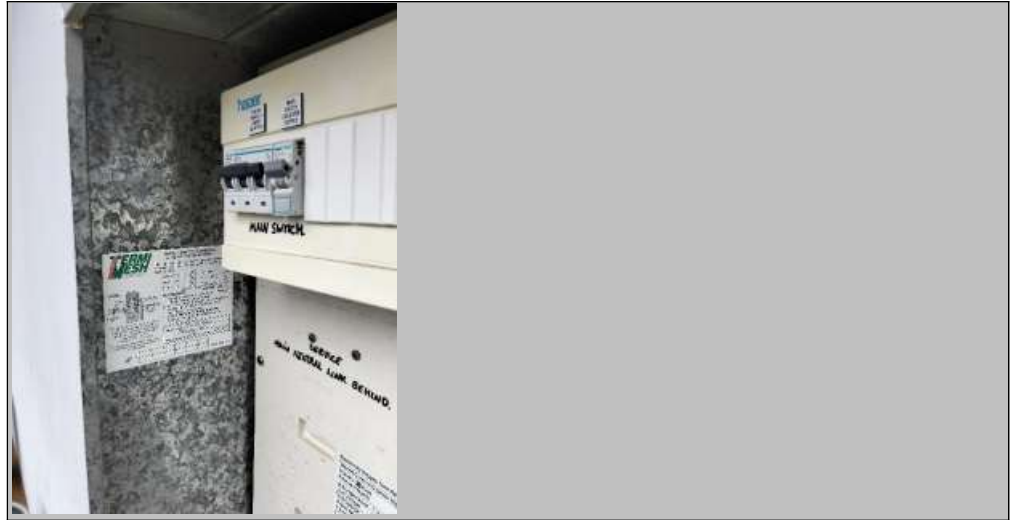
A notice indicates that the property may have been treated during construction in respect to protection against subterranean termite attack.
