Pre-Purchase Inspection - Residential Building Report

Complies with Australian Standard AS 4349.1- 2007 Inspection of Buildings Part 1: Pre-Purchase inspections - Residential buildings

4 Pindari Parade

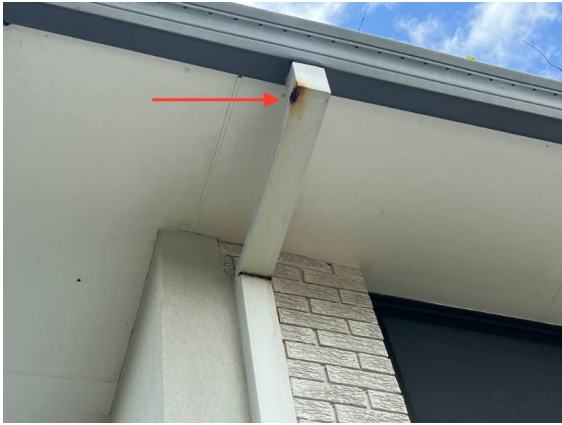
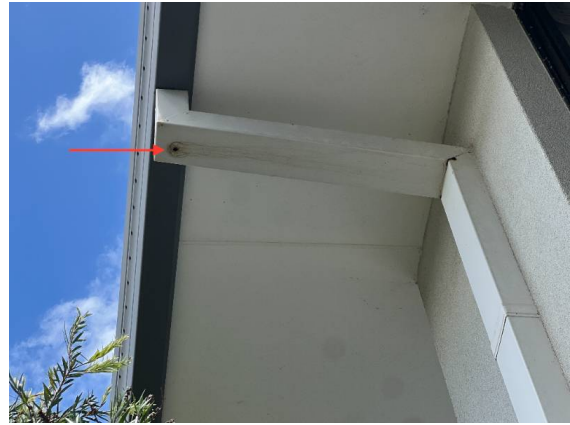
Defect 1. - Roof Exterior

| Defect Summary: | Downpipes |
| Type of Defect: | Material deterioration |
| Description: | Downpipes are rusting |
| Ongoing Consequence: | Continue to rust and leak |

| Building Professional: | Note: This defect should be referred to a qualified building professional for the repairs/scope of work required. |
| | Building Professional Required: Plumber |

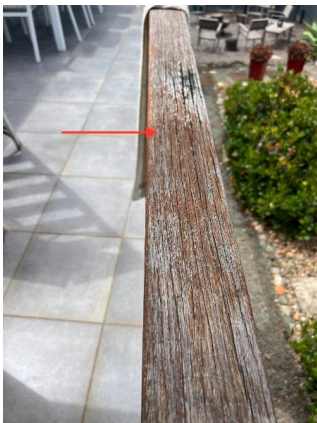
Defect 2. - Exterior

Gaps in wire balustrade are too wide and timber handrail is weathering.

Wide balustrade can allow a child to fall through. Timber handrail will continue to deteriorate

Timber handrail is deteriorating

Note: This defect should be referred to a qualified building professional for the repairs/scope of work required.

Building Professional Required: Carpenter

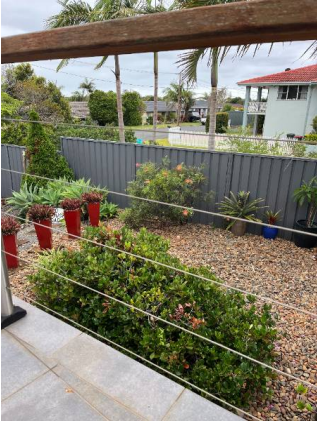
Wire balustrade is loose.

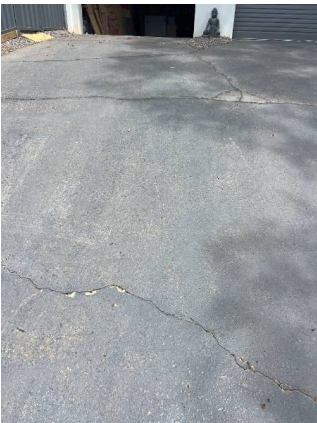
Defect 3. - Exterior

Driveway has cracks

Remain cracked.

Cracks in driveway.

Note: This defect should be referred to a qualified building professional for the repairs/scope of work required.

Building Professional Required: Concreter

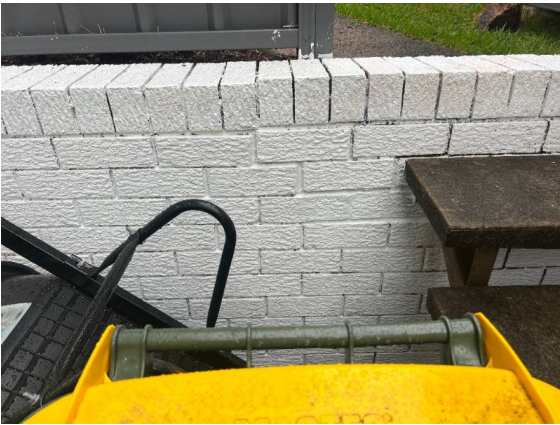
Defect Location: West Side, East Side
Defect Summary: Brick retaining wall and fence.
Type of Defect: Damage
Description: Brick retaining wall and fence have cracked.
Ongoing Consequence: Cracks have been patched but may continue to deteriorate over time.
Opinion of Cracking: Not Applicable
Building Professional: **Note: This defect should be referred to a qualified building professional for the repairs/scope of work required.**
Building Professional Required: Bricklayer

Cracks in brick retaining wall have been patched.

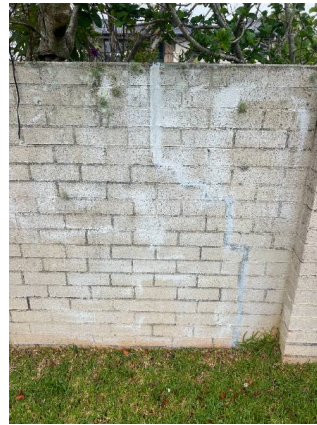
Minor cracks in brick fence have been patched.

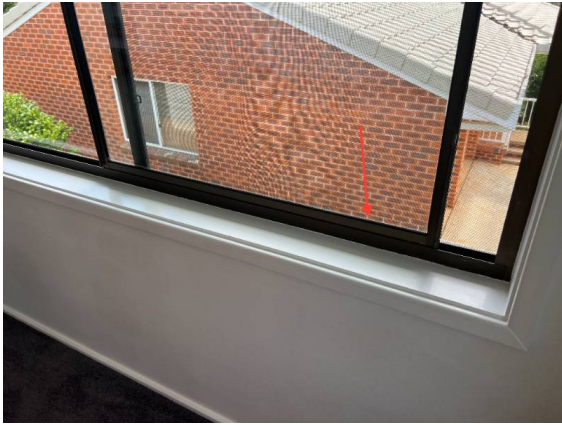
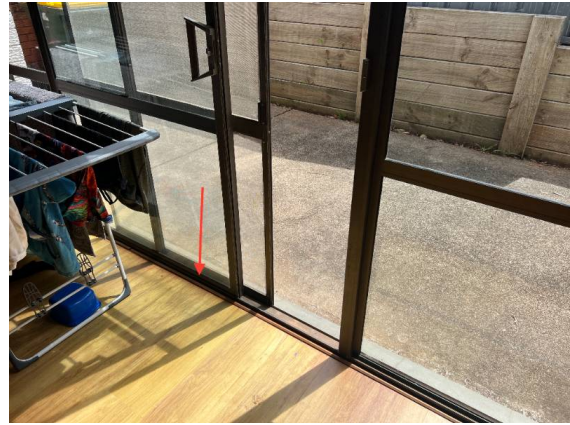
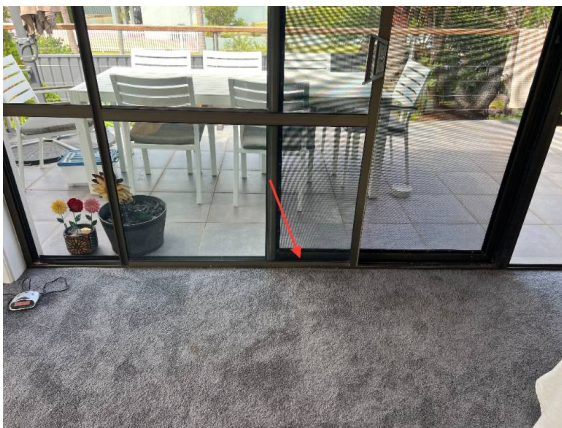
Defect Location: Various Areas
Defect Summary: Metal Windows/Doors - Fittings and Hardware
Type of Defect: Material deterioration, Operational
Description: Rollers on windows and sliding doors have deteriorated
Ongoing Consequence: Difficult to open and close windows and doors.
Opinion of Cracking: Not Applicable
Building Professional: **Note: This defect should be referred to a qualified building professional for the repairs/scope of work required.**
Building Professional Required: Glazier

Windows and sliding doors are difficult to open and close.

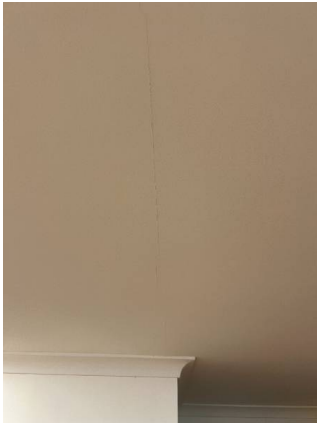
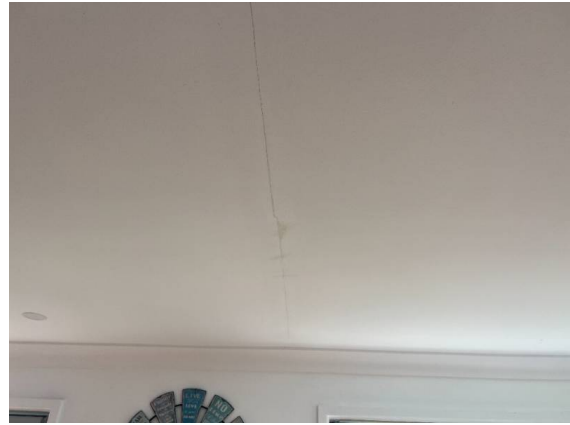
Defect 6. - Interior

Plaster board ceiling has minor cracking.

Remain cracked.

Cracks in ceiling

Note: This defect should be referred to a qualified building professional for the repairs/scope of work required.

Building Professional Required: Plasterer, Painter

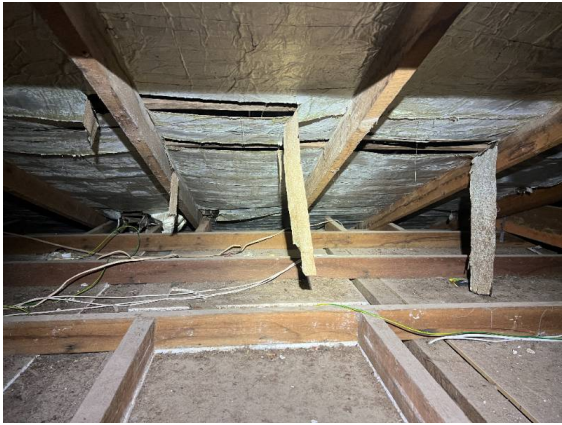
Defect 7. - Roof Void

Parts of the sarking has torn

Could allow condensation to form and fall onto the ceiling.

Parts of the sarking has torn exposing the roof tiles.

Note: This defect should be referred to a qualified building professional for the repairs/scope of work required.

Building Professional Required: Tiler
