NOTICE OF SWIMMING POOL NON-COMPLIANCE

Notice Date: 11 December 2025

Premises to which this notice relates: 53 Haigh Avenue Belrose.

Pool Installation Description: In-ground concrete swimming pool

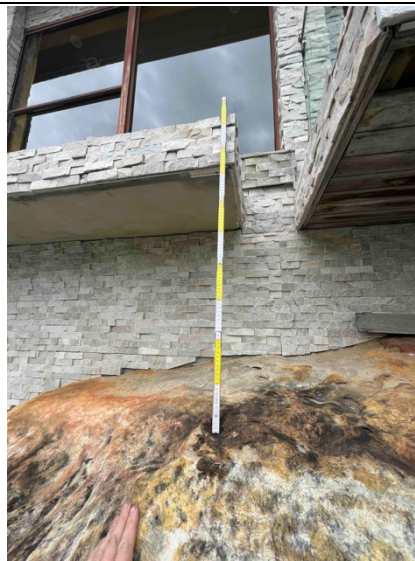
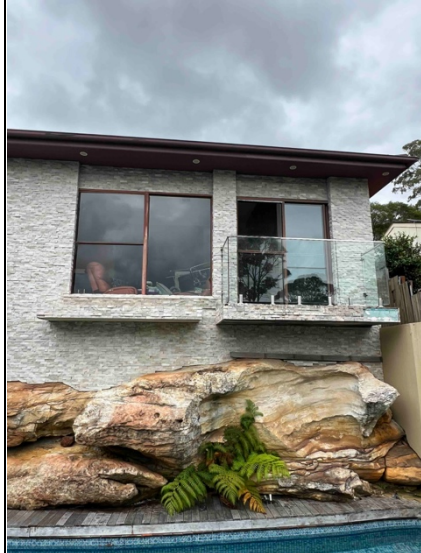
<p>1. Defect/non-compliance identified</p> <p>The balcony's over the pool were 1800 mm or more from the ground however the height between the balcony floor and sandstone rock was less than 1800 mm. The height of the floor of the balcony must be 1800 mm or more from any object greater than 10 mm wide below that could be used by children to climb down into the pool enclosure.</p> <p>Suggested solution for rectification</p> <p>Lower/remove the rock below the balcony so there is at least an 1800mm fall poolside. Alternatively, the balustrade on the balcony could be increased in height so that it is 1200 mm or more in height and ensure it becomes a compliant pool barrier.</p>

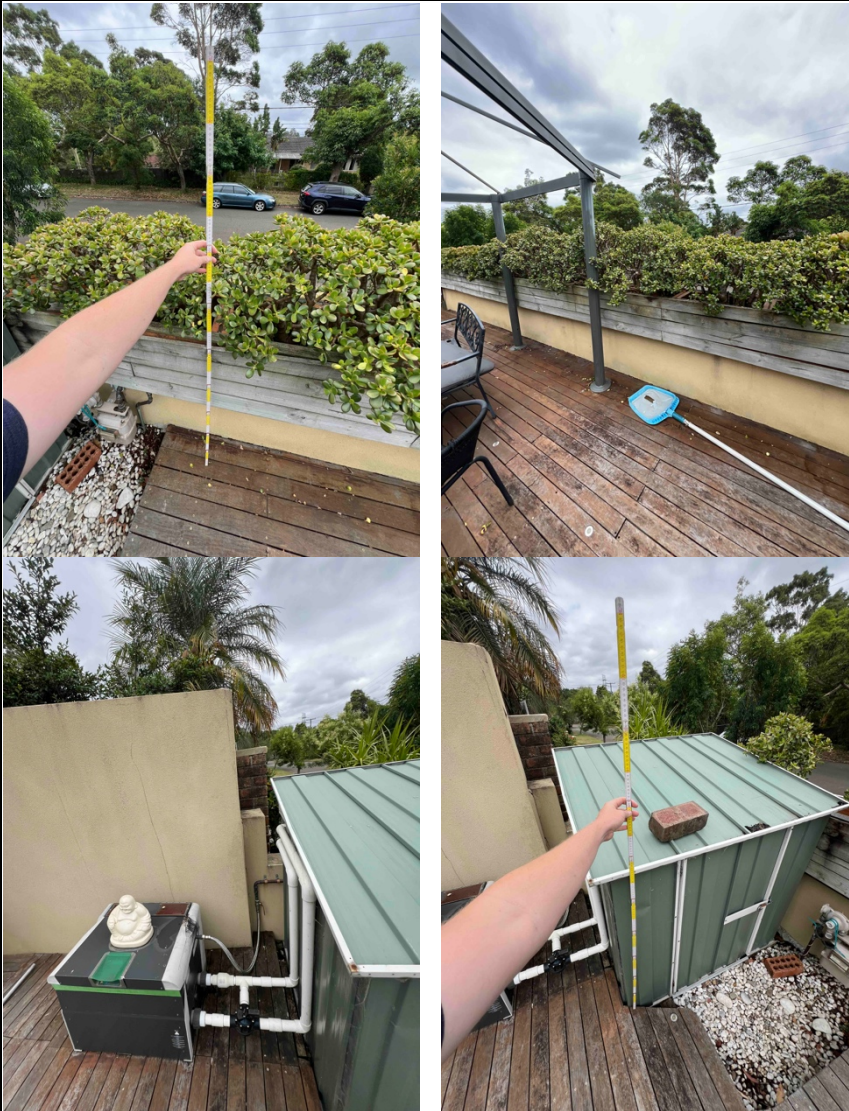
The effective height of the boundary fences was not 1800 mm or more. The height of the fences was measured from the top of the fence to the ground level on the pool side of the fence.

Raise the boundary fences so they are 1800 mm or more in height (measured on the pool side of the fence). The height of a boundary fence is measured from the top of the fence to the ground level on the pool side of the fence. Where there is an object such as pavers, raised garden bed or decking etc within 500 mm of the boundary fence, the 1800 mm in height is measured to that object and not the ground. Alternatively, any ground or surface object on the pool side of the fence could be lowered or removed (500 mm or more away from the fence) so that the 1800 mm effective height of the fence is achieved. If the fence height is increased, the required 900 mm NCZ 5 is required to be measured from the top of the fence so that any fence extension construction provided on top of the existing fence must not have footholds greater than 10 mm wide within 900 mm of the top of the extended fence.

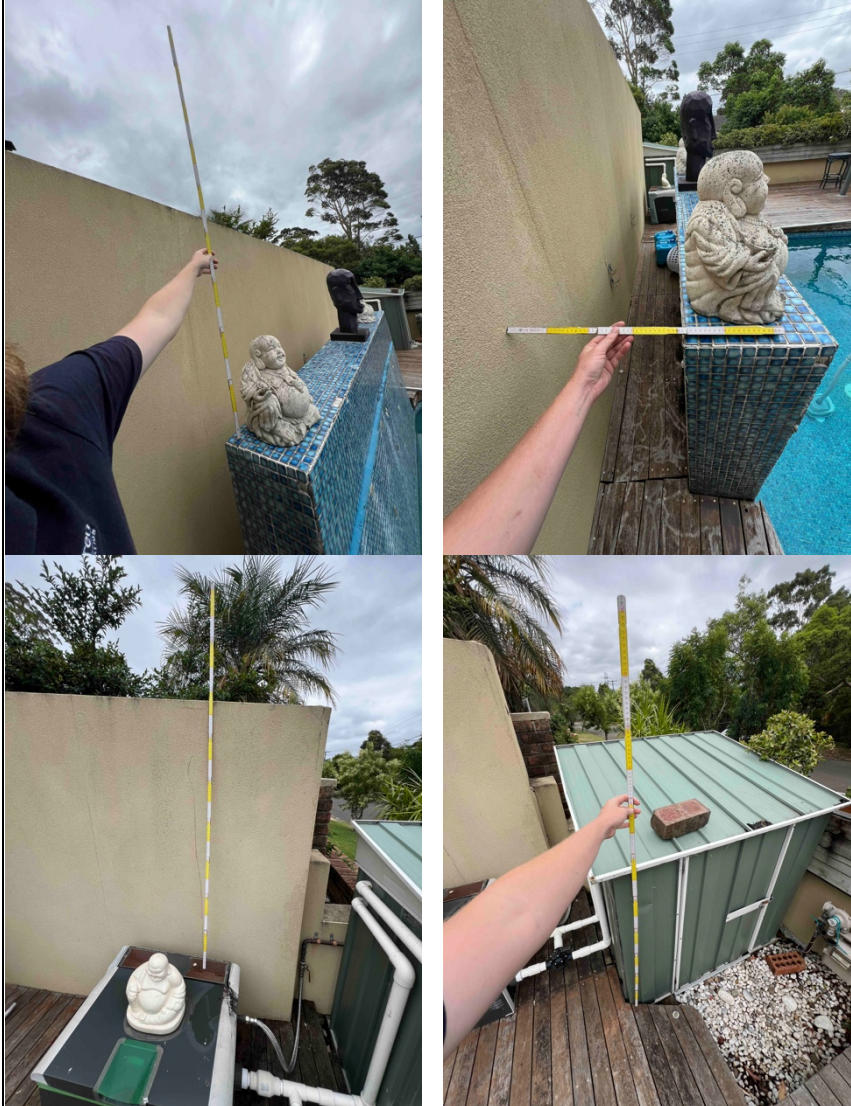
The effective height of the boundary fence was not 1800 mm or more as a pool box/heater and water feature had been erected within 500 mm of the fence. The height of the fence was measured from the top of the fence to the surface of the objects on the pool side of the fence.

The boundary fence must be 1800 mm or more in height and can be rectified by either:
Raising the fence so it is 1800 mm or more in height above the surface level of the pool box/heater and water feature STCA: or

The pool box/heater and water feature could be lowered so that the effective height of the fence is 1800 mm: or

The portion of the pool box/heater and water feature within 500 mm of the fence could be removed so that the 1800 mm effective height of the fence can be measured to the ground and not onto the surface of the pool box/heater and water feature:

The pool box/heater and water feature could be increased in height to 1800mm from pool box/heater and water feature so the fall deterrent is the same as an 1800mm boundary fence.

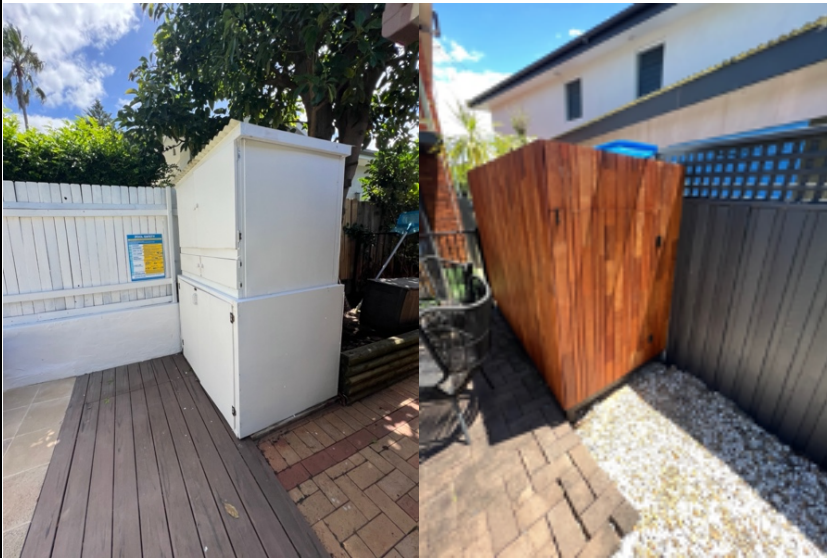
See below examples of 1800mm pool boxes.

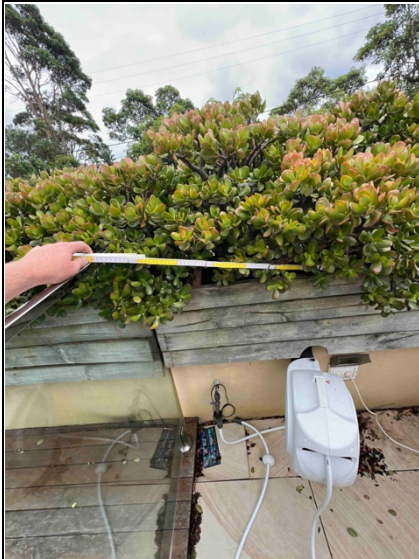
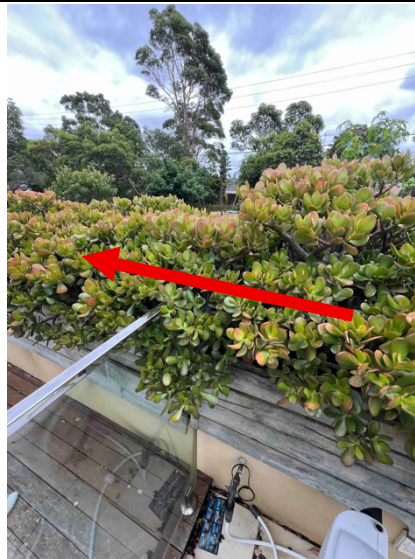
The internal pool fence terminated at a raised garden bed in such a manner that could allow children to climb along the garden bed wall and into the pool enclosure.

Modify the pool fence to prevent children from being able to climb around the end of the pool fence. The pool fence is to either extend 900 mm outward, cantilevering over the garden bed or return 900 mm either way along the retaining wall. With the side return options, a solid fence panel must be fastened to the outer edge of the retaining wall to prevent children from using the bottom rail or top of the retaining wall as a foothold. If the panel cantilevers over the retaining wall, a solid panel is required as an exposed bottom rail may still allow children to use the rail to climb around the pool fence and into the pool enclosure.

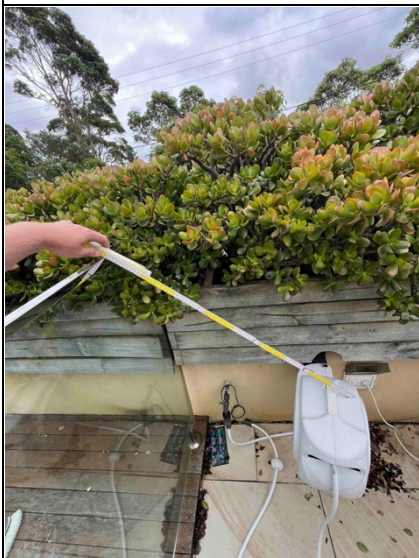
A hose reel and tap were within the 900 mm Non-Climb Zone (NCZ) on the outside of the pool fence. The 900 mm NCZ is required to be kept clear so that children cannot use any object close to the fence to assist them to climb into the pool enclosure.

Remove or relocate the hose reel and tap outside the 900 mm NCZ so it cannot be used to assist children to climb over the fence and into the pool enclosure. The NCZ is a 900 mm arc measured outward from the top most rail on the fence (if there is an upper rail) or the top of the fence and also extends upward above the top of the fence. The NCZ is semi-circular in shape.

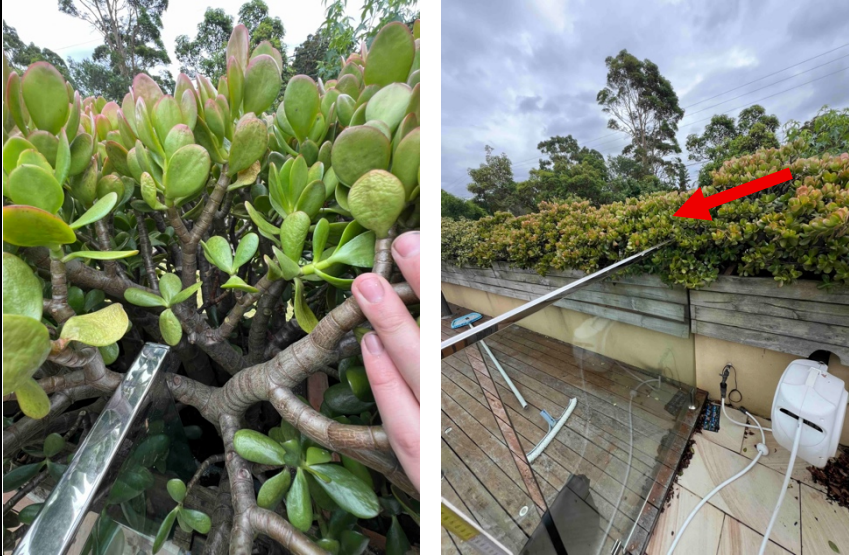
There was a gap greater than 100 mm between the boundary fence and the internal pool fence where the two fences intersected.

Reduce the gap to less than 100 mm using permanent and secure construction.

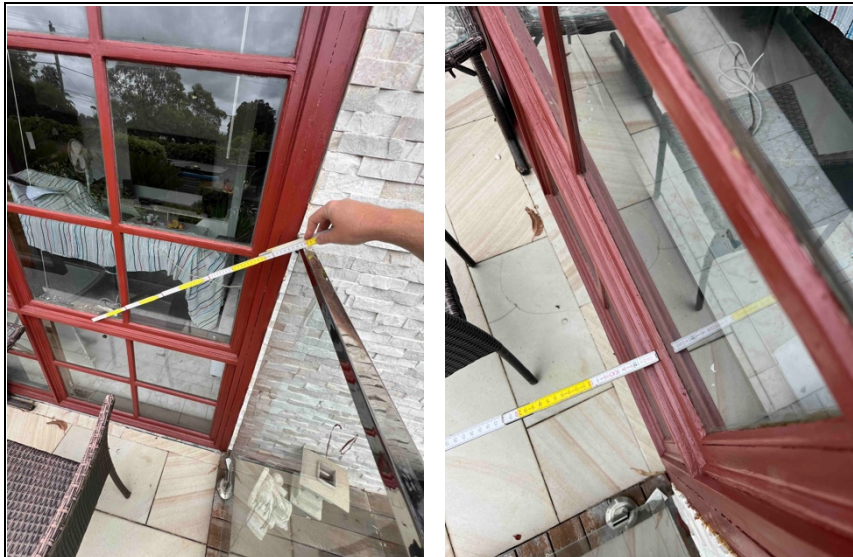
A window sill was within the 900 mm Non-Climb Zone (NCZ) outside the pool fence. The 900 mm NCZ is required to be kept clear so that children cannot use any climbable object on the outside of the pool fence to climb into the pool enclosure.

The window sill bricks must not be able to be used as a foothold. The sill bricks can be either:

- Reduced to less than 10 mm wide; or
- The upper surface of the sill bricks must have a very steep angled top surface so children cannot gain a grip on that surface. The upper surface must have an angle greater than 60° to be considered not a foothold. The climbable object can be provided with any permanent object (such as a purpose-made timber block) that is securely fastened to the upper surface of the sill bricks which effectively creates a new angled top surface which must be greater than 60°; or
- The sill bricks can be fully shielded with Perspex or similar so the upper surface cannot be accessed by young children; or
- The fence can be relocated away from the sill bricks so they are outside the NCZ; or
- The fence can be raised in height to the point where the sill bricks are effectively outside the NCZ.

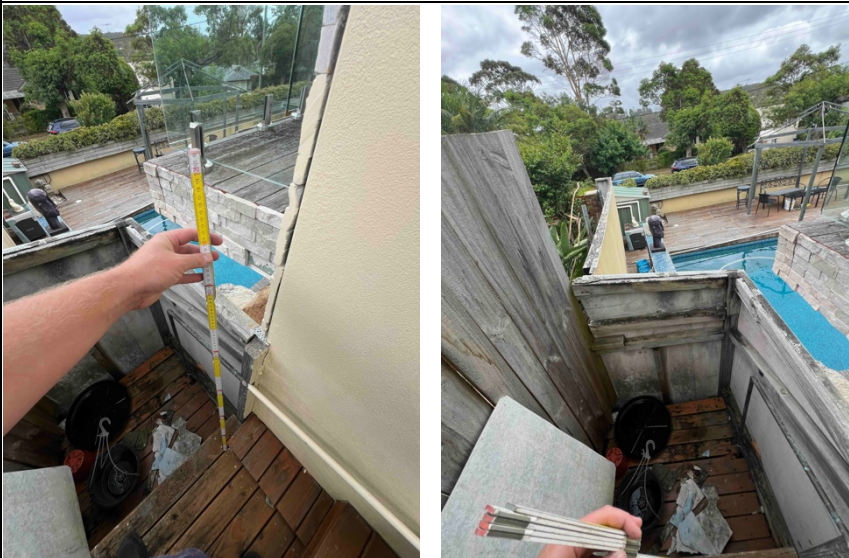
The effective height of the internal pool fence was not 1200 mm or more in height.

Increase the height of the fence so that the effective height is 1200 mm or more measured on the outside of the fence. The height of the fence is measured from the top of the fence to the ground level on the outside of the fence. Where there is an object within 500 mm of the pool fence, the 1200 mm height is measured to that object and not the ground. Alternatively, any object on the outside of the fence that is within 500 mm of the fence can be lowered or removed so the 1200 mm can be measured to the ground. If raising the fence is the option used, the gap under the fence must not exceed 100 mm. In most cases, the fence will need to be raised to a height that will create a gap greater than 100 mm under the fence. In such cases, it is more effective to raise the fence and then close the gap (that is created) by using permanent and secure construction under the pool fence panels rather than replacing the entire fence with higher fence panel.

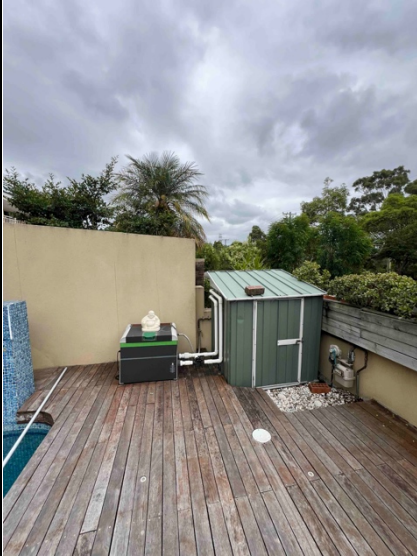
Objects were located on the inside of the boundary fence that could be used as a foothold for children to climb down into the pool enclosure. Any surface, indentation or projection

greater than 10mm is not permitted inside the boundary fence 900mm NCZ5.

Remove or shield the objects from within the 900 mm Non-Climb Zone (NCZ 5).

Alternatively, the boundary fence could be raised to achieve the required 900 mm Non-Climb Zone (NCZ 5) clearance from the object. The NCZ 5 is a 900 mm arc measured from the top of the fence and is quarter-circle in shape.

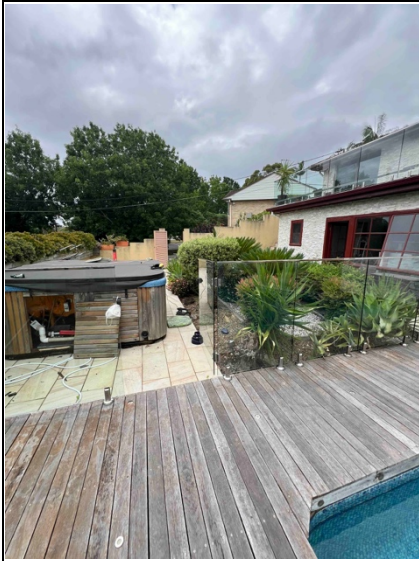
The pool gate did not self-close and self-latch because the gate hinges did not have enough tension to close the gate.

Adjust the hinges to increase the closing tension on the gate. The hinges have an internal spring that can be adjusted with an Allen key or screwdriver (by removing the top cap). The hinges must be adjusted so the gate self-closes and self-latches from any open position. Any open position includes when the gate strike is resting against the latching mechanism.

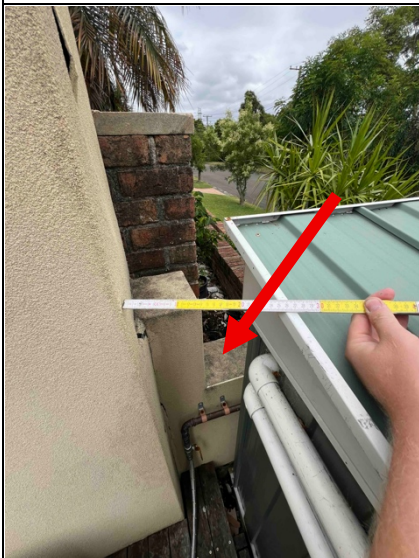
There was a gap in the boundary fence greater than 100 mm. Gaps greater than 100 mm are not permitted in or under the pool fence.

Reduce all gaps to less than 100 mm using permanent and structurally adequate construction.

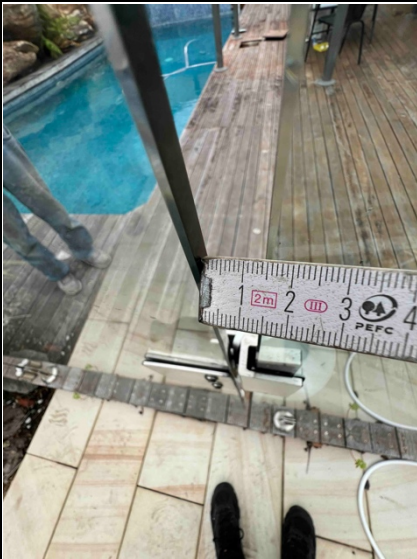
The glass gate had a gap greater than 10 mm wide where the gate adjoins the glass pool fence.

Modify the gate and/or fence panel so that the gap between the gate and adjoining fence panel is less than 10 mm so that that the latch cannot be accessed from the outside of the gate.

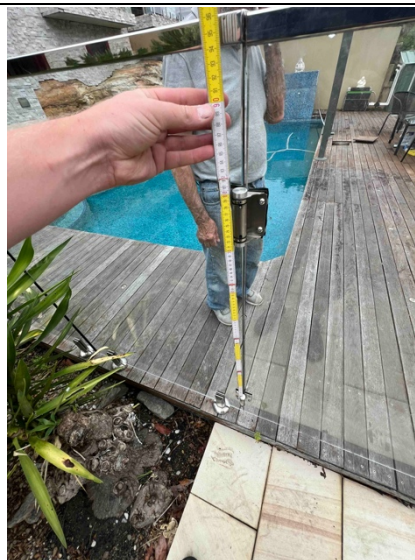
The hinges on the gate were too close together. The top surface of the top hinge must be 900 mm or more from the top surface of the bottom hinge.

Move the hinges further apart or alternatively, some modern hinges can be fitted with a 60° hinge cap that could be fitted onto one or both of the hinges.
