Property Inspection Report

Inspection Date: 2 Dec 2025

Property Address: 12 Sunjewel Boulevard Currimundi 4551

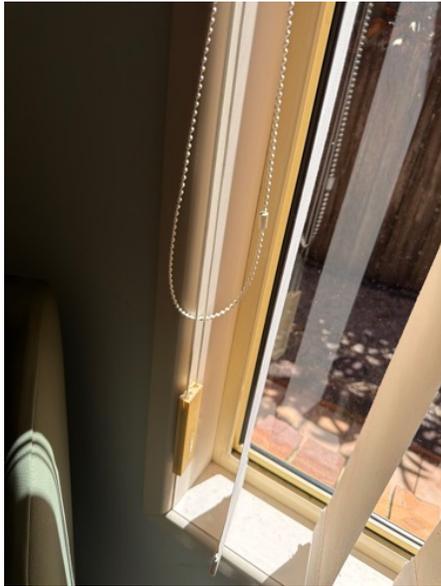
Safety Hazard 1.02

Location: All Internal Areas

Finding: Blind cords should be secured to window/door frames

To avoid creating a possible strangulation hazard for children, blind cords must be installed in such a way that a loose cord cannot form a loop 220 mm or longer at a height of less than 1600 mm above floor level. A cord guide may be installed lower than 1600 mm above floor level if the cord is sufficiently secured or tensioned to prevent a loop 220 mm or longer being formed.

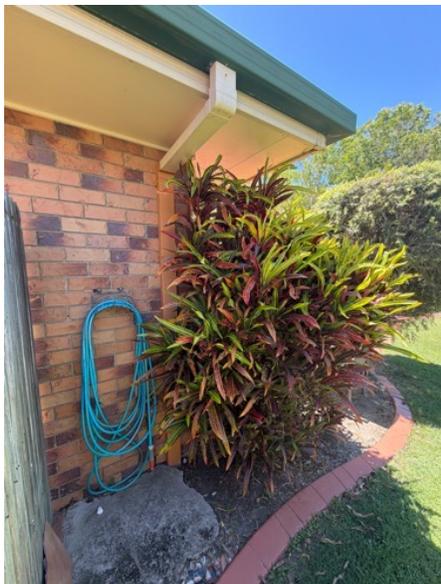
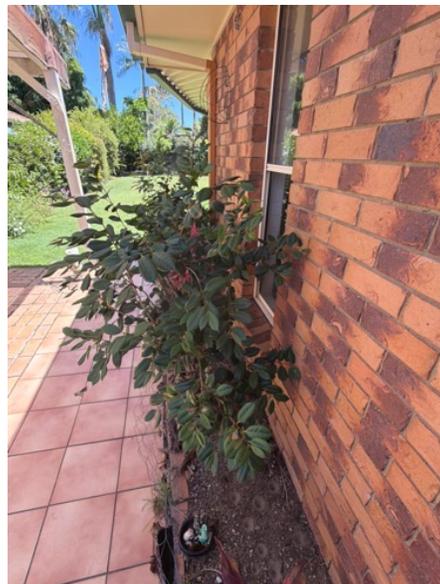
Minor Defect 2.01

Location: All External Areas

Finding: Vegetation growing against the building

Vegetation can encourage timber pests into the building, increase moisture around the foundations of the building and can also damage to the building elements. It can obstruct the visual inspection zone for termite management systems. It is recommended that all vegetation is removed from against the building.

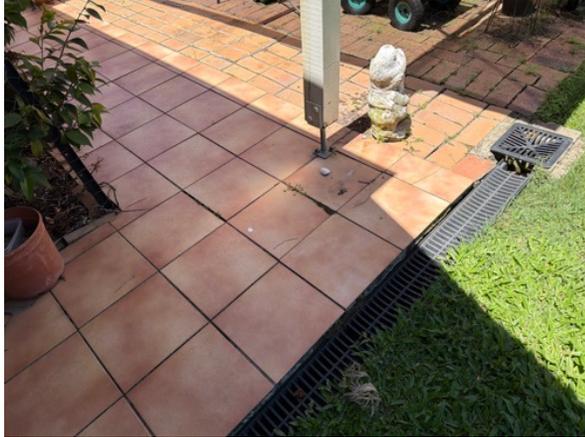
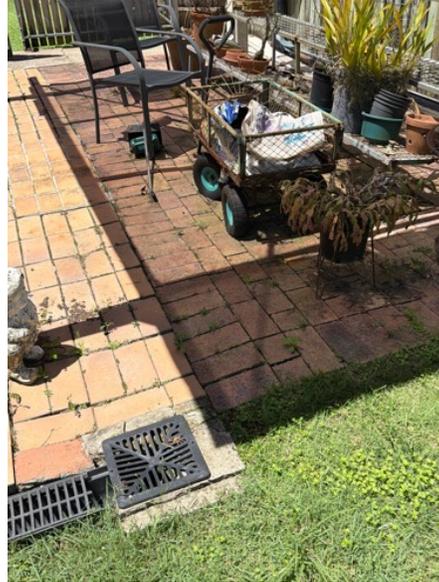
Minor Defect 2.02

Location: East Elevation

Finding: Paving and tiling

Paving and tiling around the property is undulating in places which detracts from the aesthetics of the area. (Some photo examples following) Movement such as this can be caused by a variety of issues including poor drainage, inadequate base preparation, excessive watering, plumbing issues, subsidence from trenches in the construction process etc. An investigation (by a competent person e.g. a landscaping contractor) is recommended to determine the cause of the movement and the method and extent of any remedial work required, and associated costs.

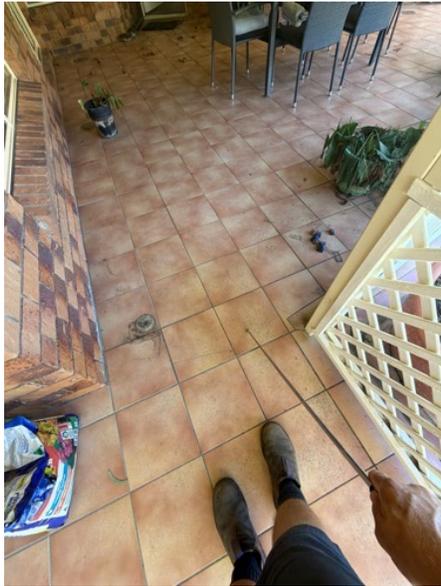
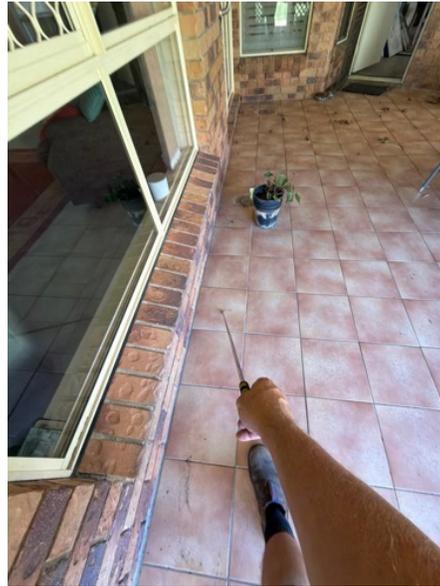
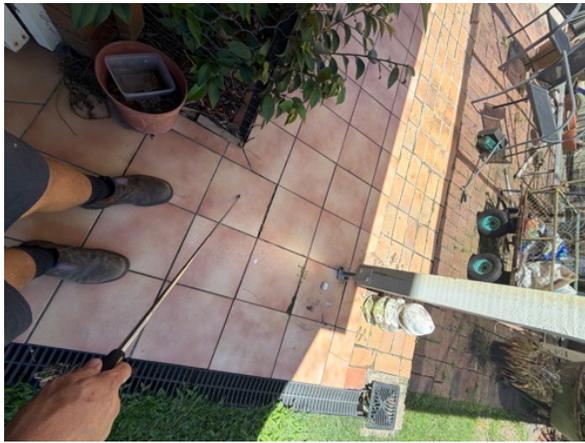
Minor Defect 2.03

Location: Rear Elevation

Finding: Floor tiles drummy and cracked

There were some drummy tiles detected. Some of the deficiencies which can result in drummy tiles are insufficient glue coverage, failure of the adhesive to bond, incorrect adhesive used etc. There were not any cracked or loose tiles observed. It would be prudent to monitor this issue and if there is further cause for concern, an investigation (by a competent person e.g. a floor & wall tiler) is recommended to determine the method and extent of any remedial work required, and associated costs.

Note: Drummy tiles have a hollow sound when tapped.

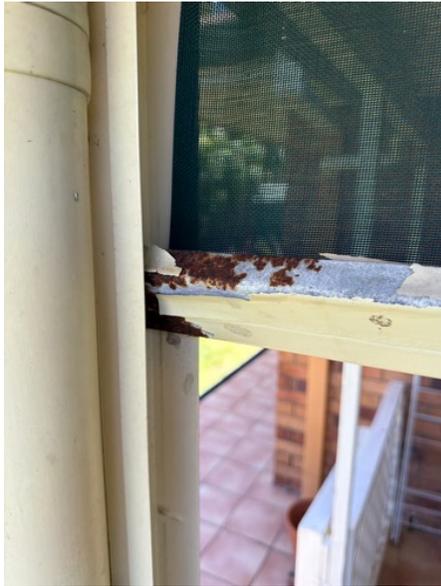
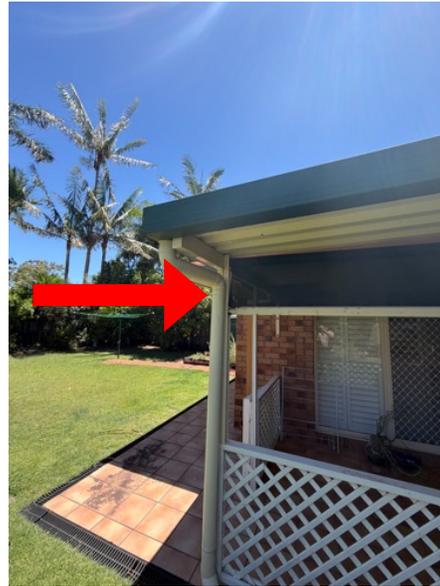
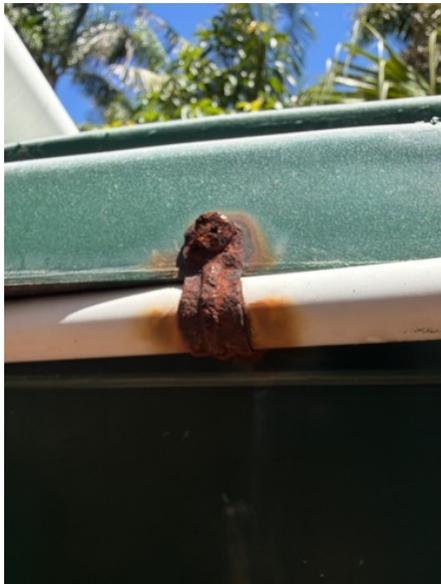
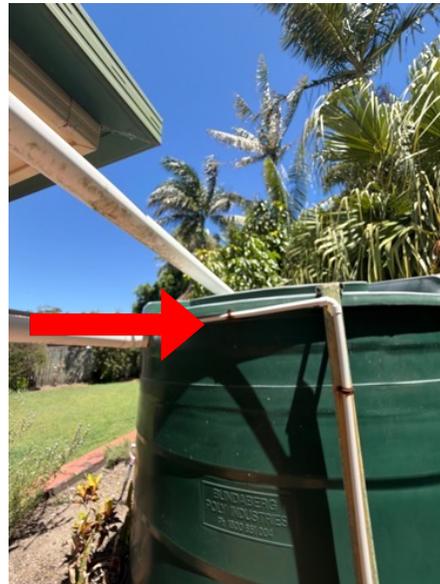
Minor Defect 2.04

Location: All External Areas

Finding: Corrosion to external metal elements

Metal is susceptible to corrosion particularly when used externally. Any rusted components should be treated or replaced to prevent further deterioration by approximately qualified contractors.

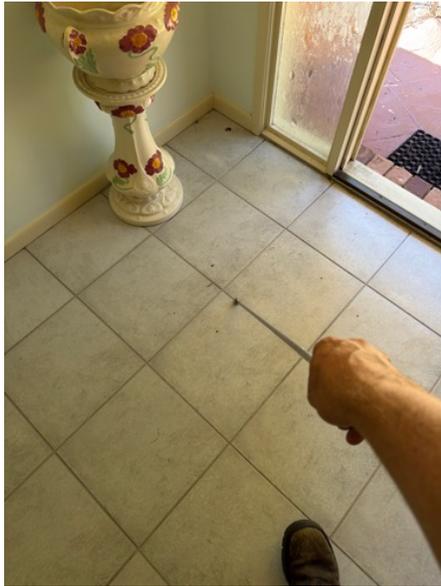
Minor Defect 2.05

Location: All Internal Areas

Finding: Floor tiles

There were some drummy tiles detected. Some of the deficiencies which can result in drummy tiles are insufficient glue coverage, failure of the adhesive to bond, incorrect adhesive used etc. There were not any cracked or loose tiles observed. It would be prudent to monitor this issue and if there is further cause for concern, an investigation (by a competent person e.g. a floor & wall tiler) is recommended to determine the method and extent of any remedial work required, and associated costs.

Note: Drummy tiles have a hollow sound when tapped.

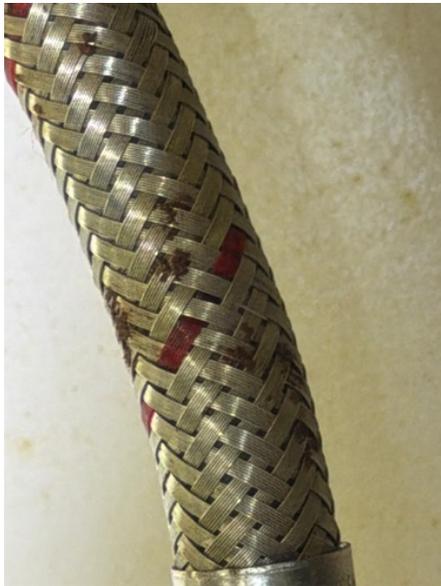
Minor Defect 2.06

Location: Kitchen

Finding: Flexible hoses

Some corrosion was observed to flexible water hoses which are used for connecting plumbing fixtures. Recommend getting all flexible hoses to be checked by a plumber and replaced where necessary. As they are under constant pressure, a burst hose can cause significant water damage.

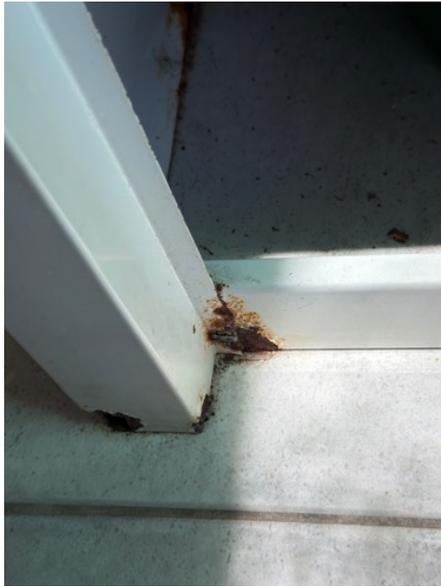
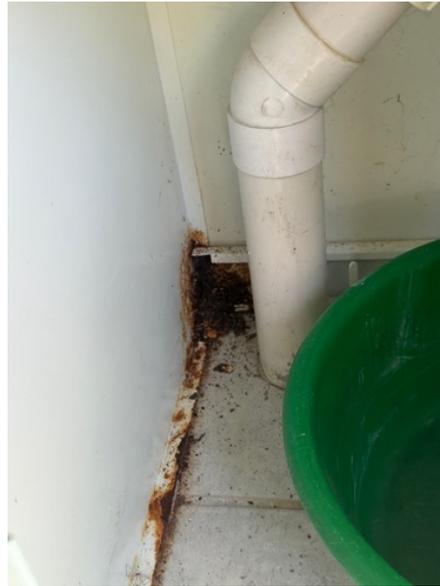
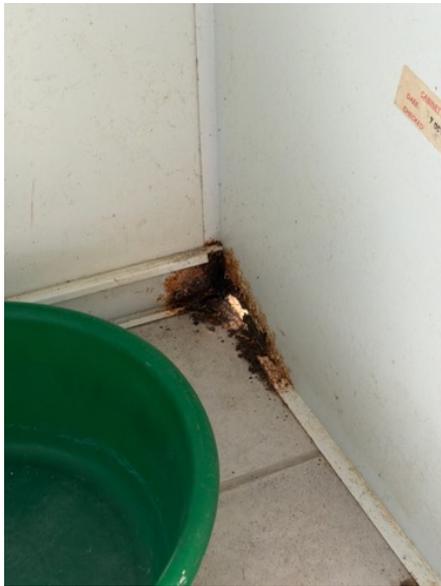
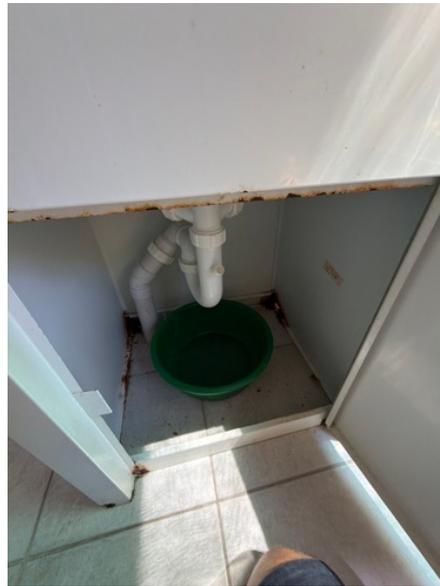
Minor Defect 2.07

Location: Laundry

Finding: Laundry tub is corroded at the base

A licensed plumber should be consulted to recommend repair or replacement as required.

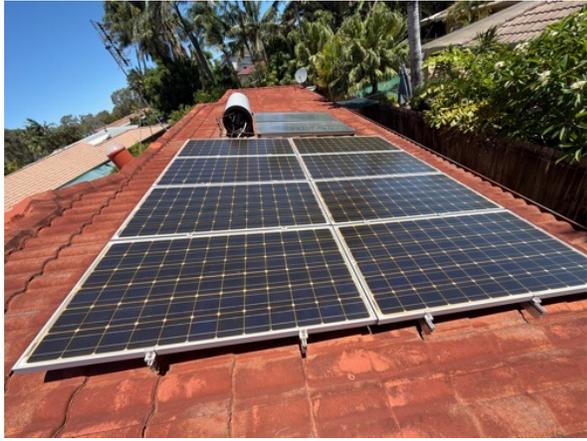
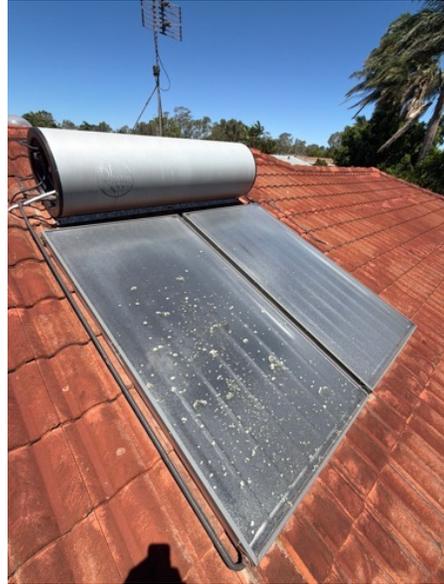
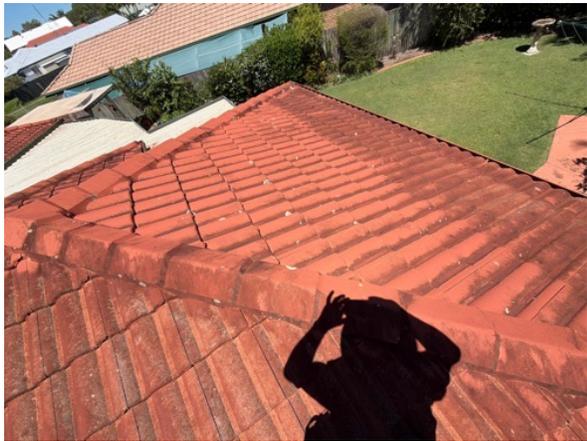
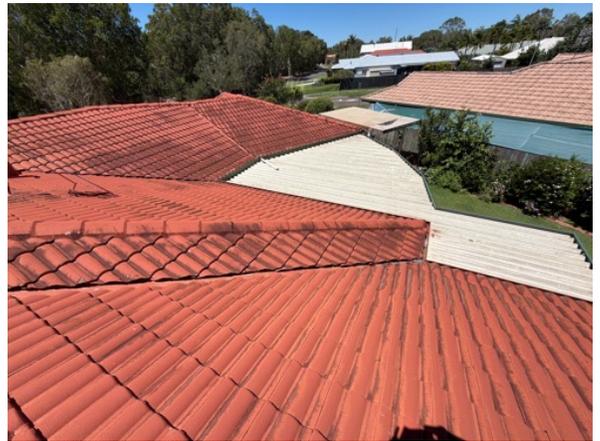
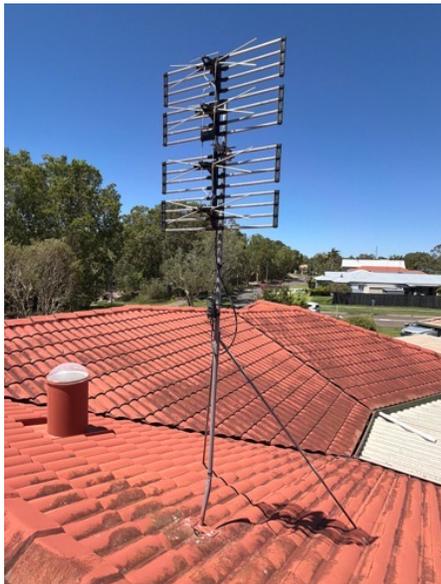
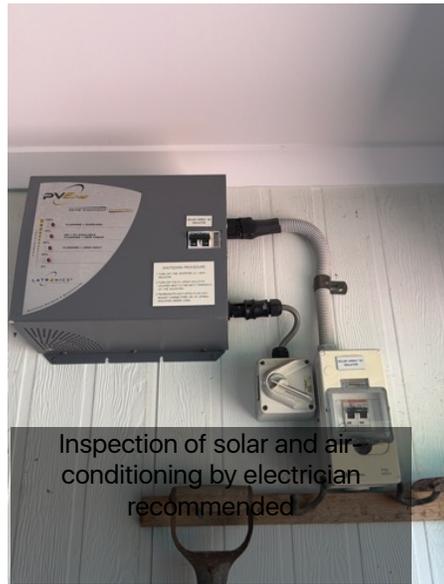
Inspection of solar and air conditioning by electrician recommended
