PRE-PURCHASE BUILDING INSPECTION REPORT

Property Address:
56 Drift Street, The Ponds NSW 2769

Inspection Report Ref:
Ai5136

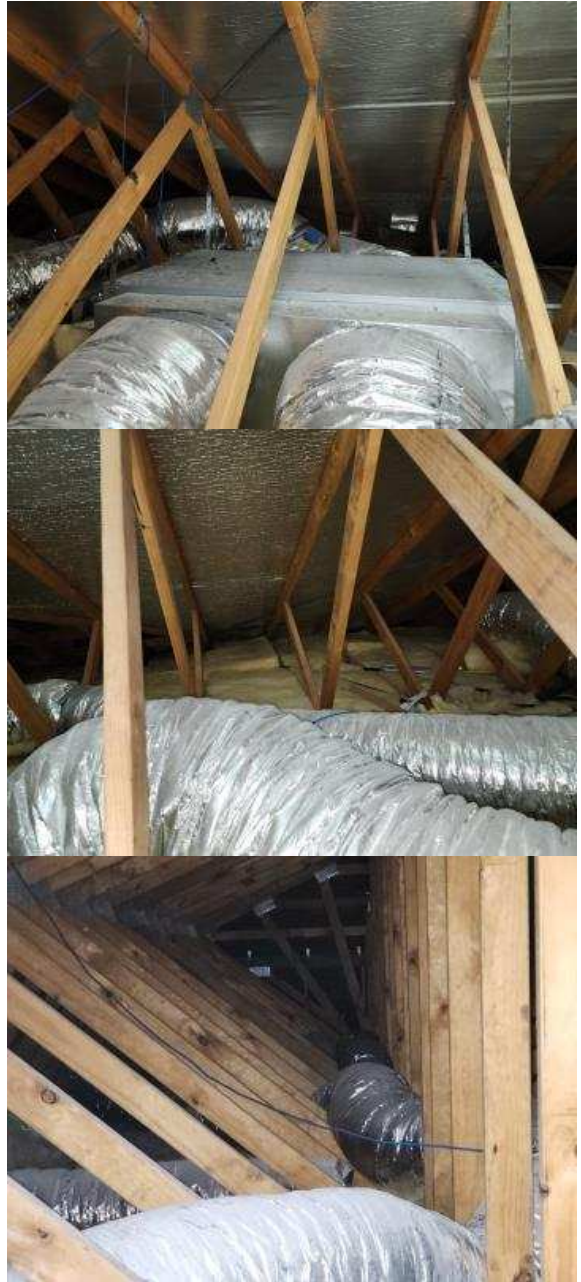
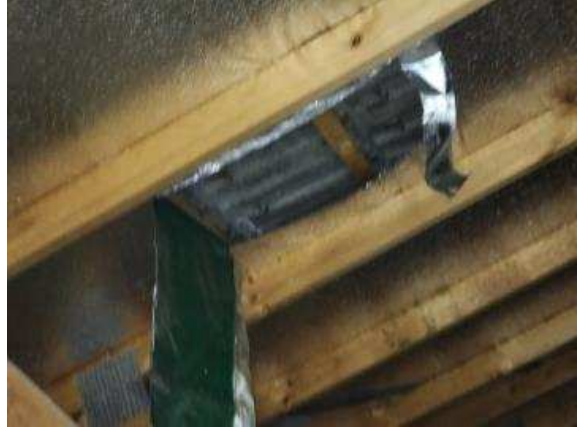
Sarking Status:

Sarking is present but is torn in some minor areas. This may affect the waterproofing ability of the sarking and this should be repaired.

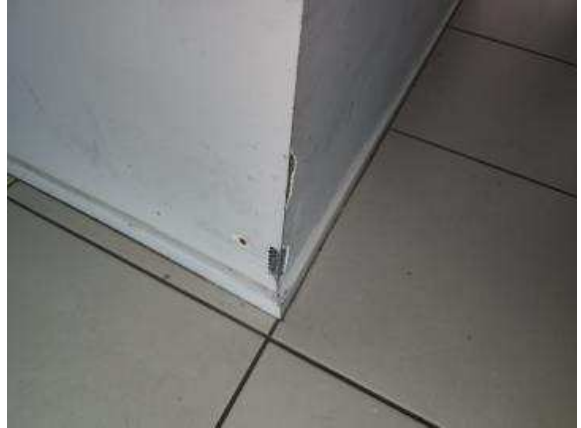
Internal Walls Condition:

The condition of the walls is generally fair. Minor defects or imperfections were noted on wall surfaces, maintenance or repairs are required for a satisfactory finish.

The following action is recommended:

A Licensed painter should be called to make a further evaluation and repairs or rectification as needed.

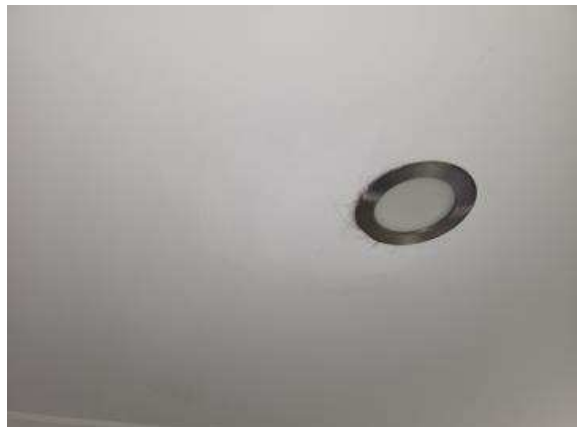
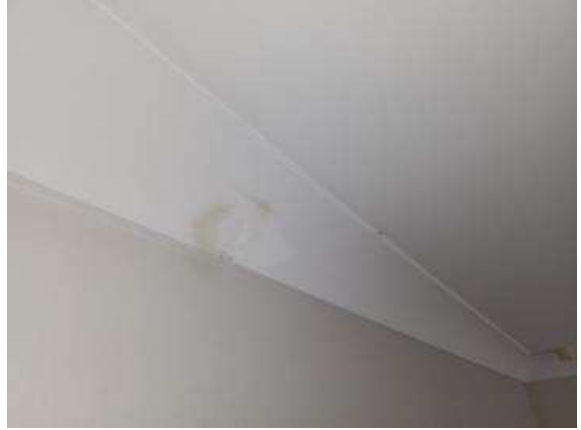
Ceiling Condition:

The condition of the ceilings is generally fair. Minor defects or imperfections were noted to the ceilings, maintenance or repairs are required for a satisfactory finish.

The following action is recommended:

A Licensed painter should be called to make a further evaluation and repairs or rectification as needed.

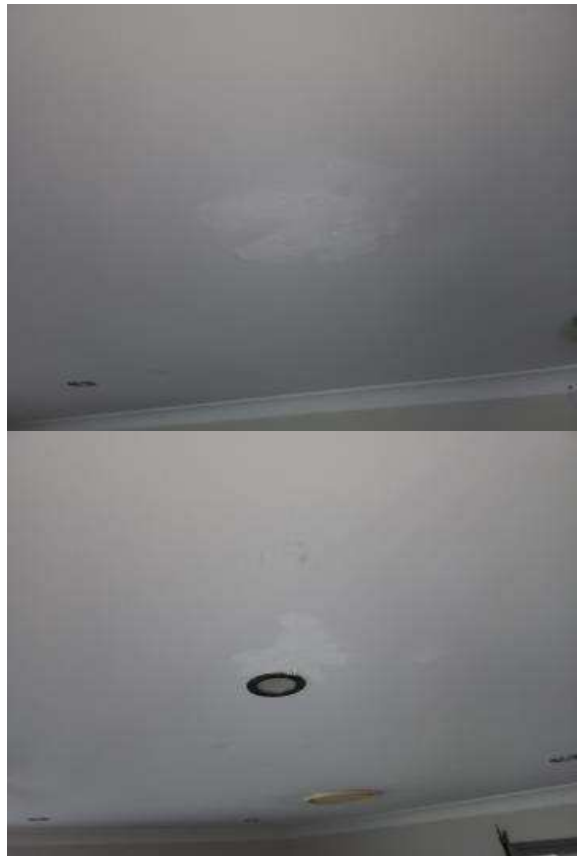
Ceiling Condition:

The condition of the ceilings is generally fair. Minor defects or imperfections were noted to the ceilings, maintenance or repairs are required for a satisfactory finish.

The following action is recommended:

A Licensed painter should be called to make a further evaluation and repairs or rectification as needed.

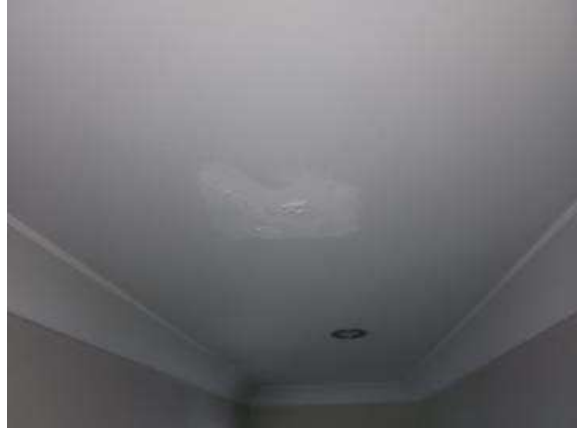
Ceiling Condition:

The condition of the ceilings is generally fair. Minor defects or imperfections were noted to the ceilings, maintenance or repairs are required for a satisfactory finish.

The following action is recommended:

A Licensed painter should be called to make a further evaluation and repairs or rectification as needed.

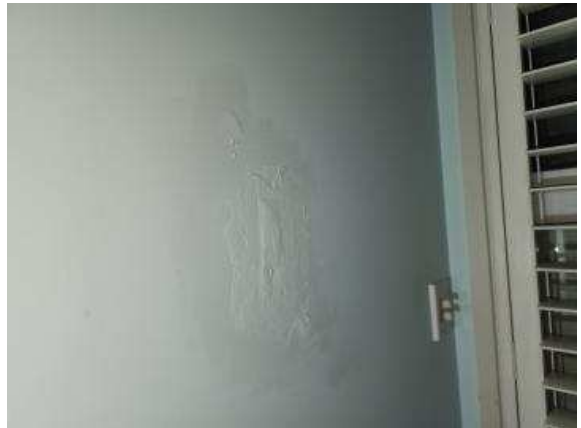
Internal Walls Condition:

Minor surface damages were noted to walls, repairs are required for a satisfactory finish.

The following action is recommended:

A plasterer should be called to make a further evaluation and repairs or rectification as needed.

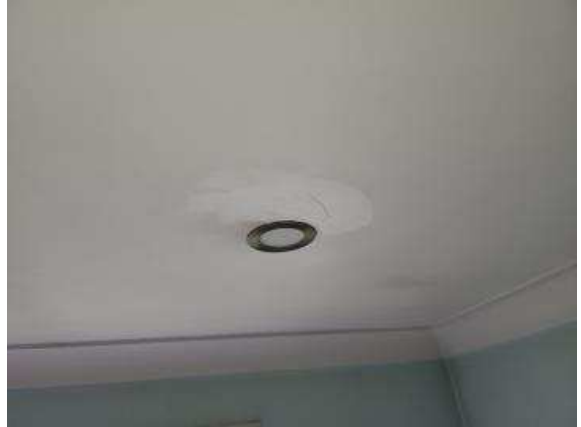
Ceiling Condition:

The condition of the ceilings is generally fair. Minor defects or imperfections were noted to the ceilings, maintenance or repairs are required for a satisfactory finish.

The following action is recommended:

A Licensed painter should be called to make a further evaluation and repairs or rectification as needed.

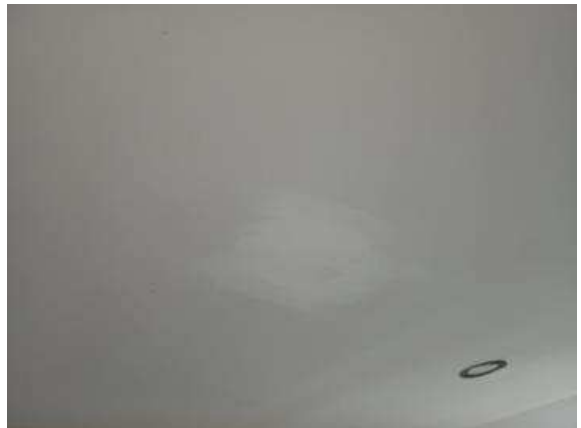
Ceiling Condition:

The condition of the ceilings is generally fair. Minor defects or imperfections were noted to the ceilings, maintenance or repairs are required for a satisfactory finish.

The following action is recommended:

A Licensed painter should be called to make a further evaluation and repairs or rectification as needed.

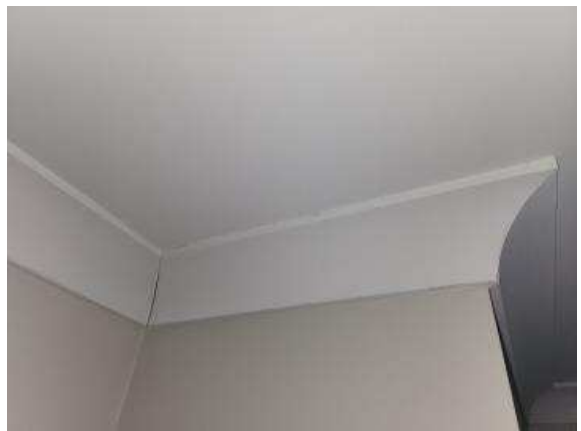
Minor cracking or gaps at joints are present to cornices.
This will require maintenance.

The following action is recommended:

A Licensed painter should be called to make a further evaluation and repairs or rectification as needed.

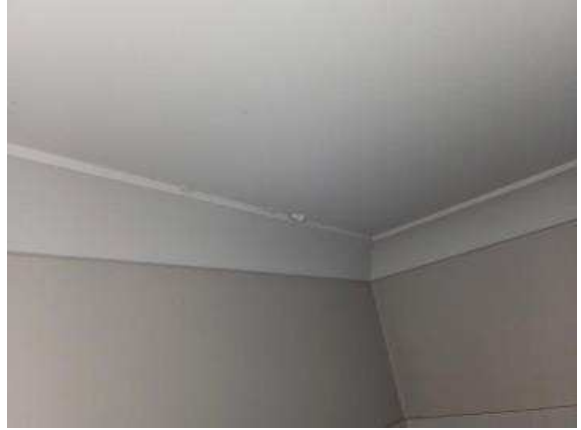
Minor peeling paint was noted to ceilings.

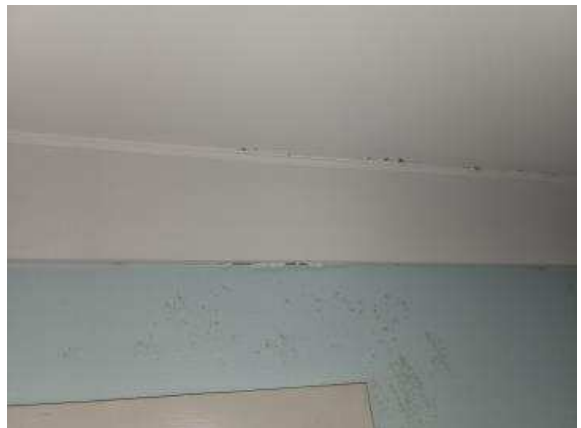
The condition of the ceilings is generally fair. Minor peeling paint was noted to ceilings.

The following action is recommended:

A Licensed painter should be called to make a further evaluation and repairs or rectification as needed.

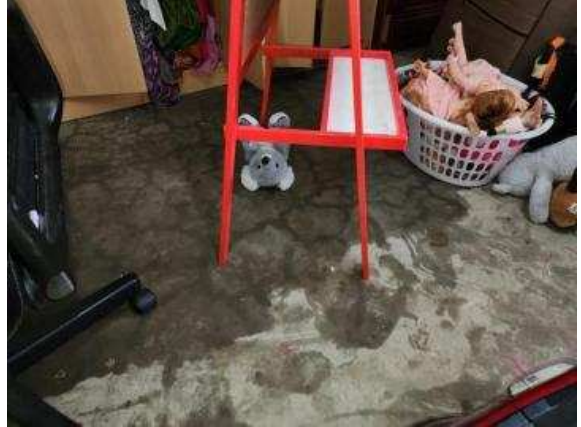
The concrete floor is generally in fair condition. Surface water entry as noted at the right side of the garage, this area should be monitored during rainfall to determine the cause and required rectification.

The following action is recommended:

A licensed builder should be called to make a further evaluation and repairs or rectification as needed.
