Pre-Purchase Building & Timber Pest Inspection Report

In accordance with Australian Standard AS 4349.1 - 2007 and AS 4349.3-2010

19 Arkose Rd Gables Sydney NSW AUSTRALIA

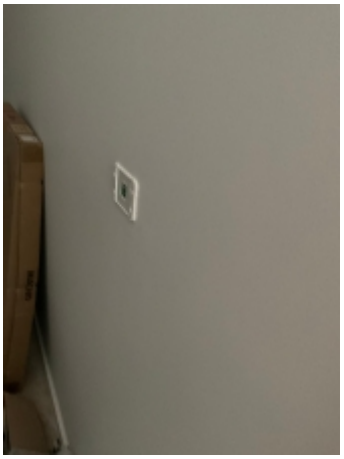
Garage

Defect Severity	Minor Defect
Defect Classicfication	F - Installations (including omissions)
Defective Item	Walls
Comment	Light Switch Cover is Missing

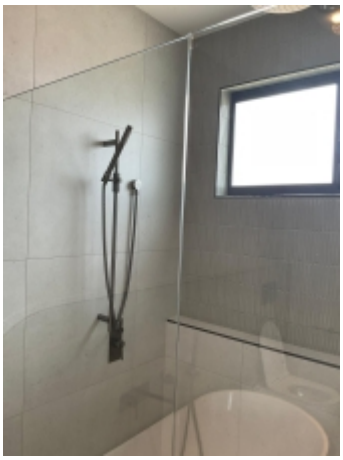
Bath 2

Defect Severity	Minor Defect
Comment	Need a door Stopper in front of the Toilet , Shower door Needs adjusting

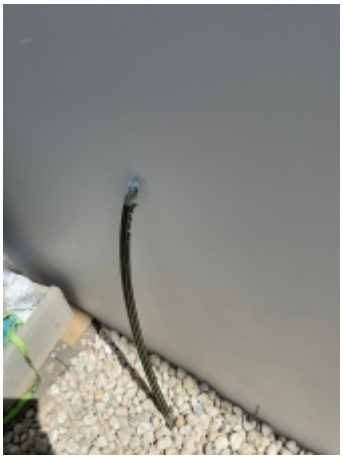
Left Side Elevation

Defect Severity	Minor Defect
Defect Classicfication	E - Operational
Comment	Side Gate Needs Adjusting , Condute sticking out from the ground

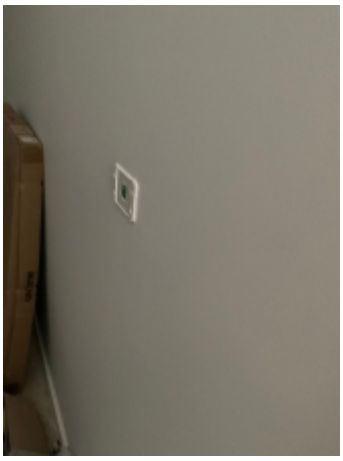
Site Area Defects

Defect Severity	Minor Defect
Comment	Power Switch = Cover Missing
