Pre-Purchase Inspection - Residential Building Report

Complies with Australian Standard AS 4349.1- 2007 Inspection of Buildings Part 1: Pre-Purchase inspections - Residential buildings

2 Rodway Parade Kotara

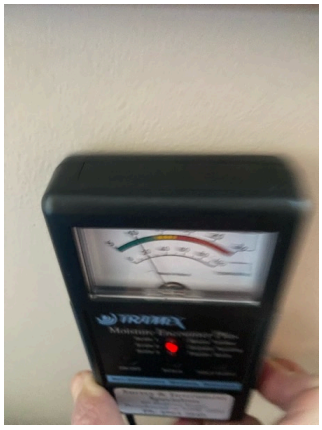
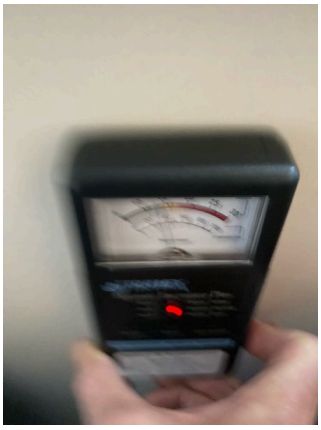
Observation 1

Area Location:	Internal walls
Description:	No higher than normal moisture readings were recorded in the internal walls.

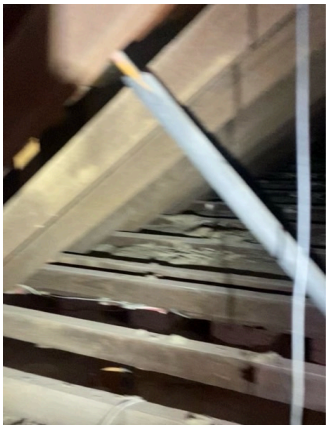
Observation 2

Area Location:	Roof void
Description:	Timber framing in the roof void is still in good condition. Sarking has only being installed under a small section of the roof tiles. There are also some minor signs of deterioration on the underside of the tiles, but it’s nothing major.

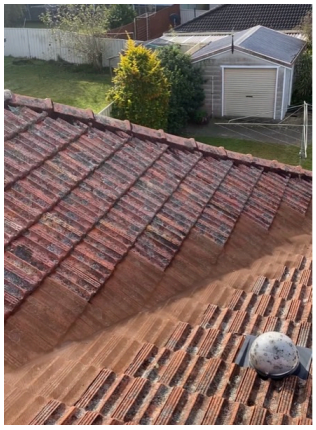
Observation 3

Area Location: Roof exterior

Description: The exterior of the roof is still in good condition.

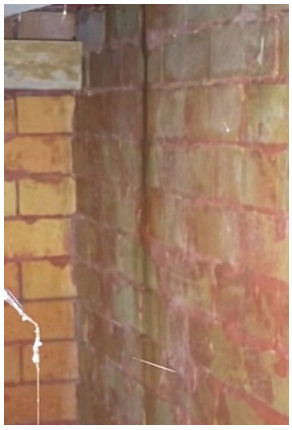
Observation 4

Area Location:	Sub floor
Description:	Piers and the majority of the timber framing underneath the house were still in good condition and besides the area near the leak the ground was dry.
