KINGFISHER
BUILDING & PEST INSPECTIONS
We see what's below the surface.

Property and Timber Pest Report

Inspection Date: 19 Jun 2026

Property Address: 50 Sedgwick Avenue Edgeworth 2285

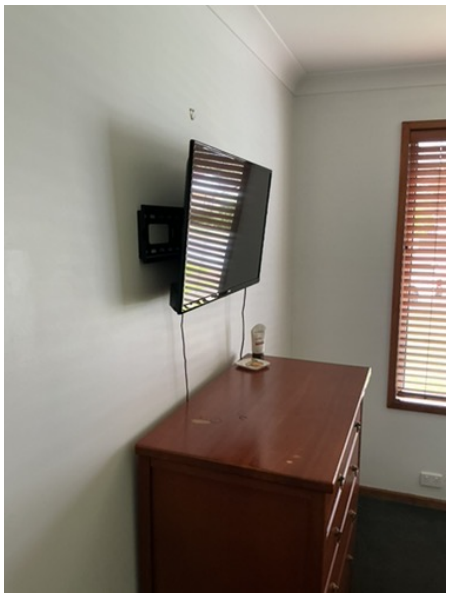
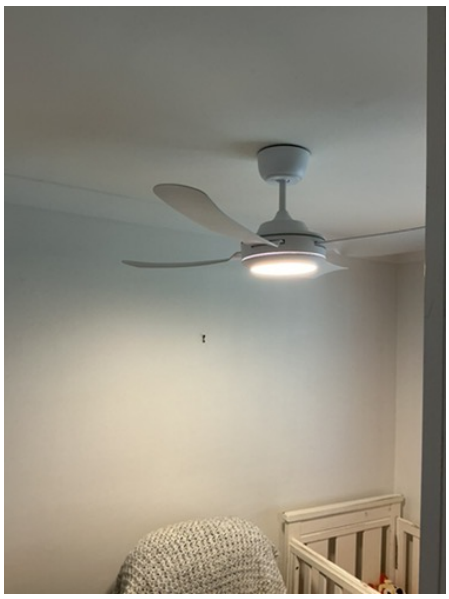
The bedrooms are in good general condition, with no notable issues identified. The spaces are well-maintained, featuring adequate storage with fitted closets that appear to be in robust condition. The aesthetics are largely intact, with no visible signs of damage or wear. Fixtures

such as ceiling fans and window coverings are present and seem to be functional. Overall, these rooms provide a sound environment, indicating regular upkeep and care.
