KINGFISHER
BUILDING & PEST INSPECTIONS
We see what's below the surface.

Property and Timber Pest Report

Inspection Date: 27 Aug 2026

Property Address: 8 Lindley Street Edgeworth 2285

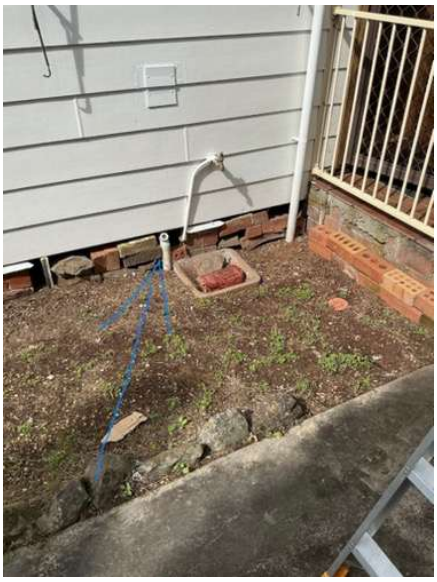
Minor Defect 1.01

Finding: Site draining from road

The site exhibits dampness under the house, potentially due to inadequate site drainage. Absence of curb and guttering on the street can result in water tracking down the driveway and seeping under the house. It is advisable to consult with relevant trades to explore the installation of a strip drain or stormwater pit to mitigate this issue.

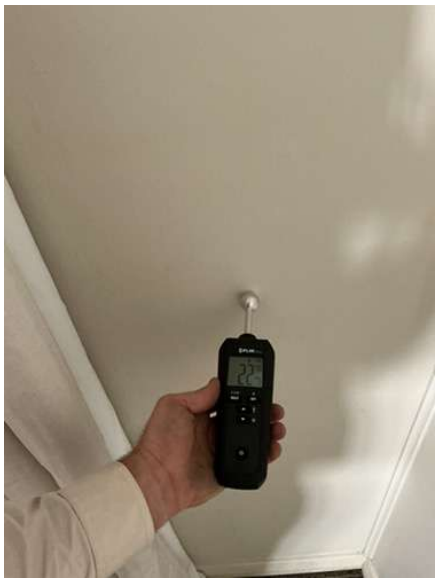
Minor Defect 1.02

Location: Bedroom 1

Finding: Old water damage on cornice

In Bedroom 1, the plaster cornice shows signs of damage with a rough repair observed. The tiles above this area appear misaligned, likely from a prior repair attempt. No moisture was detected at the time of inspection. It's recommended to seek professional advice for comprehensive repair to prevent further issues. Remedial action may involve restoring the cornice to a smooth finish and ensuring proper alignment and sealing of tiles to enhance durability and aesthetics.

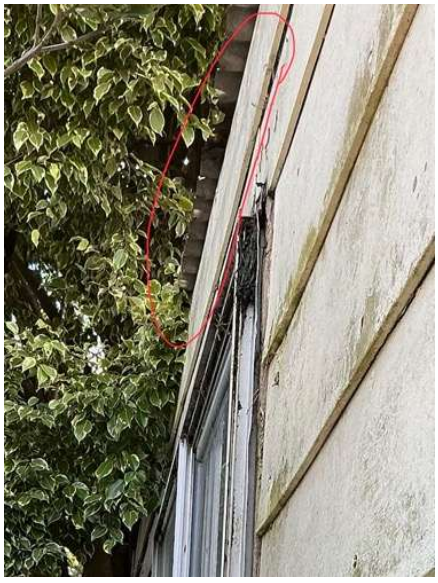
Finding: Roof and gutter

The garage roof has a significant build-up of debris from an overhanging tree, lacking a proper gutter and downpipe connection to stormwater drainage. Additionally, a window is not adequately sealed, and there are visible cracks in the cladding. It is recommended to clean the roof and consult a roofer to install a gutter system connected to stormwater for effective drainage. Sealing the damaged window and repairing the cladding are also advised to prevent further deterioration and water ingress.
