Visual Property Inspection Report

**9 King Street
Raymond Terrace, NSW 2324**

February 9, 2026

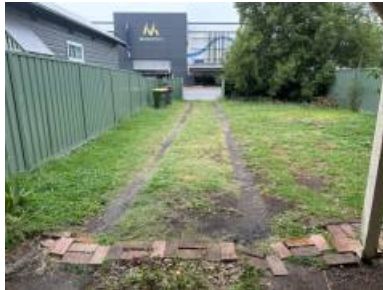
The fences are mainly constructed from timber and metal. The fences are generally in fair condition but some repairs or maintenance are required. Wet rot decay and defects were noted to the wooden fencing. Repairs and or replacement of damaged timber will be required.

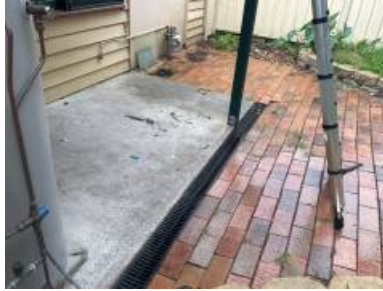
Site drainage appears to be acceptable. However, the site should be monitored during heavy rain to determine whether the existing drains can cope. If they cannot cope, then additional drains may be required.

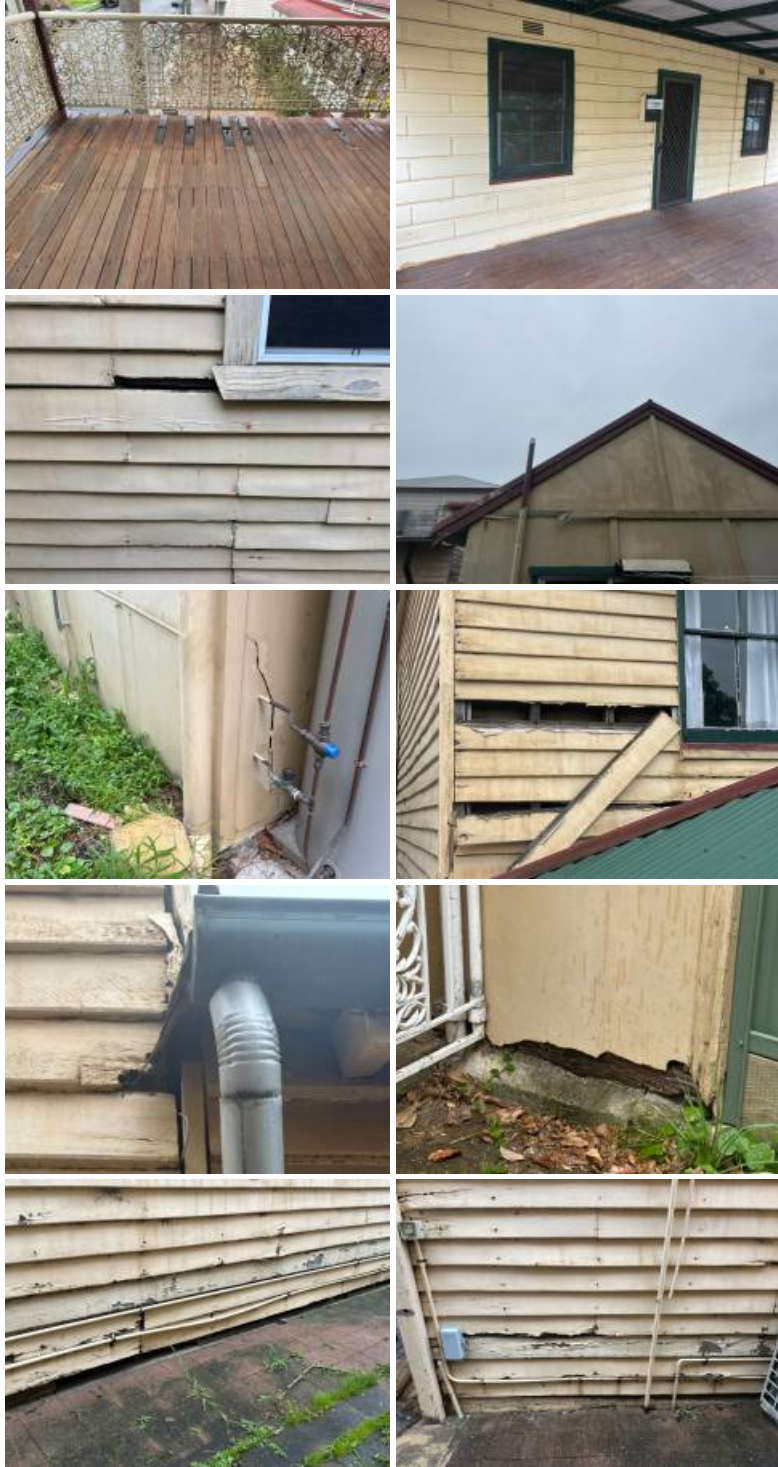
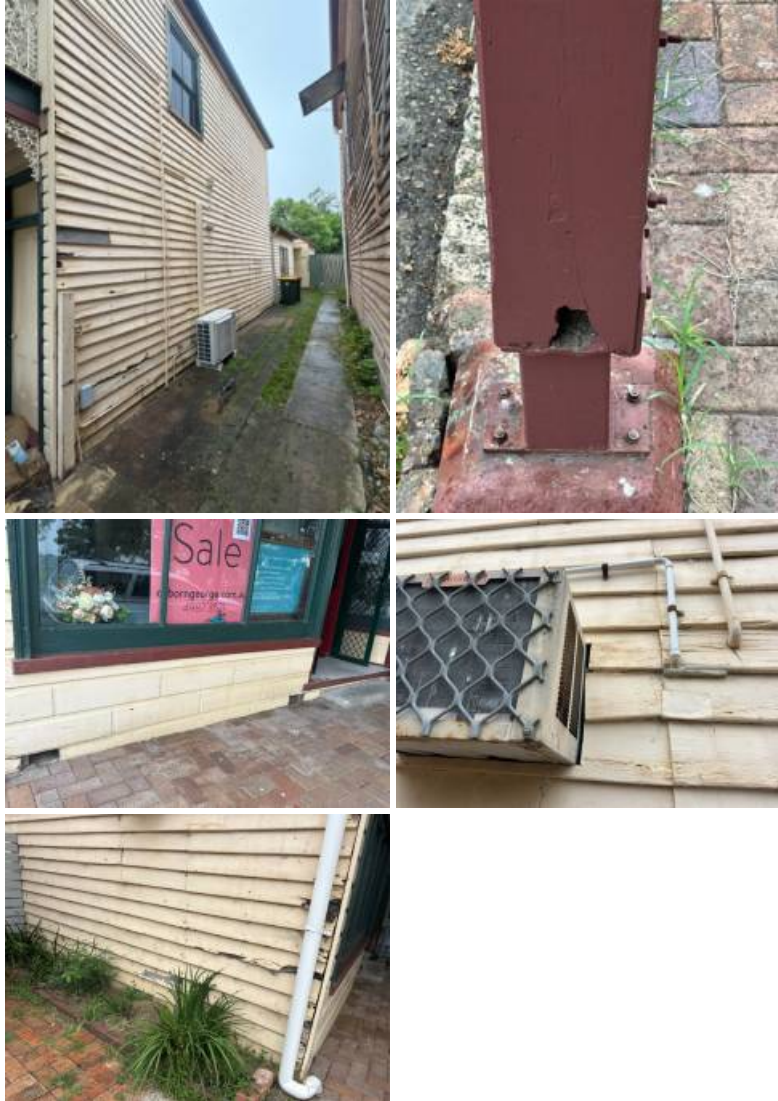
The external wall timbers show signs of age and weathering. Maintenance and or repairs will be required. Moderate wet rot decay is present to external walls. Recommend decayed timbers be replaced. Cladding is damaged and will require repairs and maintenance. External cladding is in contact with or close to soil areas. This practice is conducive to timber pest attack and we recommend modifications be made to prevent contact with soil.

Gap around AC unit should be filled. Bottom weatherboard is missing from western elevation. Minor repairs required to decking. Handrails require further fixings as are loose in areas.

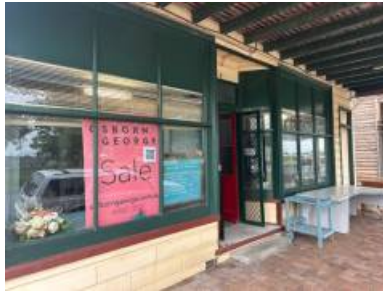
The condition of the exterior of the windows is generally fair. Insect screen/s have not been provided to all openings and should be installed. Some glazing beads to windows have deteriorated and require repair/replacement.

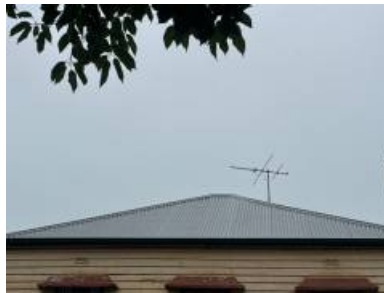
Level 1.

The overall condition of the roof coverings is fair. Paint to roofing has deteriorated.

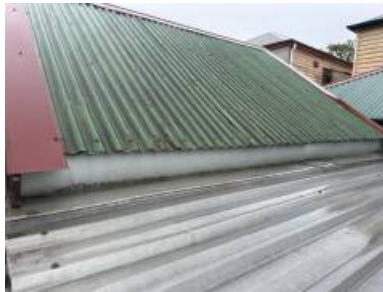
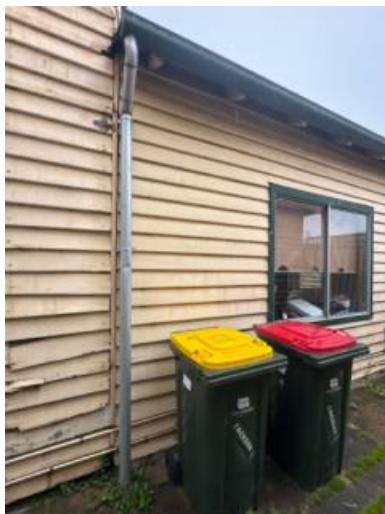
Appear to be in serviceable condition. Downpipes are damaged or rusting and should be repaired or replaced as necessary. Leaves and debris are present in gutters and the guttering should be cleared. Painting to downpipes require completion.

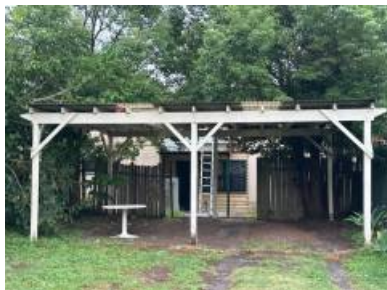
Carport.

The structure is generally in fair condition. Some repairs required. Wet rot is present to some parts of the structure. No gutters/downpipes have been installed.

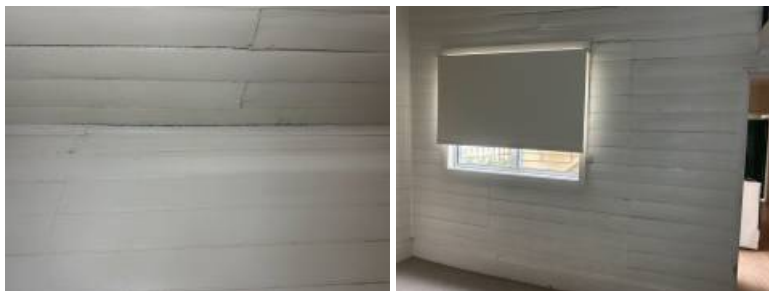
The condition of the windows is generally fair. Sash/s are sticking or fixed in the closed position and will require easing or repair to be operational. The windows show signs of age and weathering. Periodical maintenance will be required. The condition of the window hardware is generally fair. Some repairs or maintenance will be required. Insect screens require minor repairs/maintenance. Wet rot is present to some window frames.

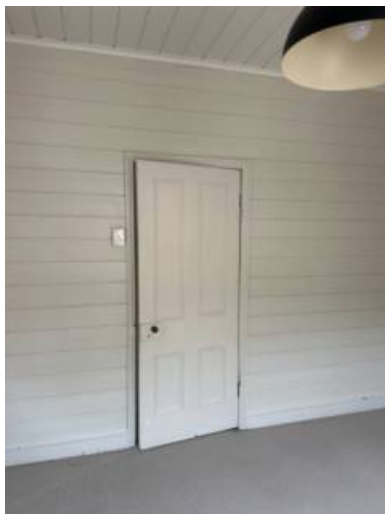
Flooring is uneven and squeaking flooring was noted. These areas should be leveled and secured to prevent movement. Trims to flooring are loose in areas.

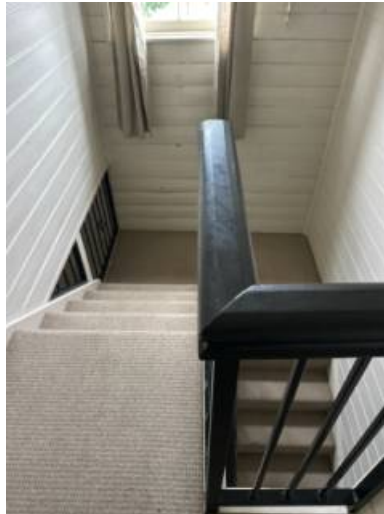
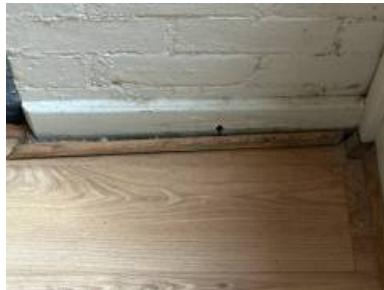
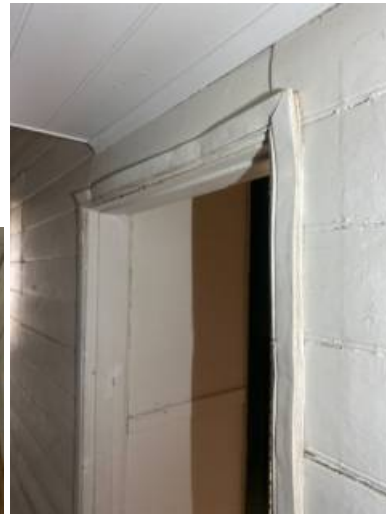
The condition of the woodwork is generally fair. Minor maintenance and or repairs required prior to next repainting. MDF or Medium Density Fibreboard has been installed at the property. It is made from wood fibres and resin. It is not water resistant and any exposure to moisture can cause swelling, warping and deterioration.

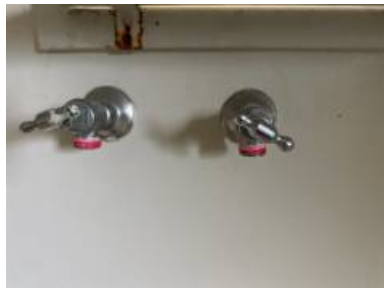
Tiles are not present to wet areas. Recommend tiles be installed to prevent water penetration. Recommend that the gap around tap spindles (behind the handle/tap fitting flanges) in the shower/bath areas be sealed with a flexible sealant to prevent water entering the wall area.

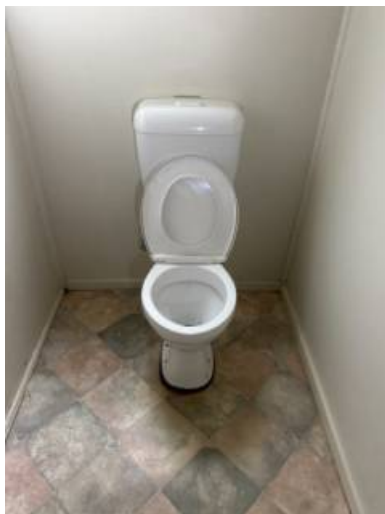
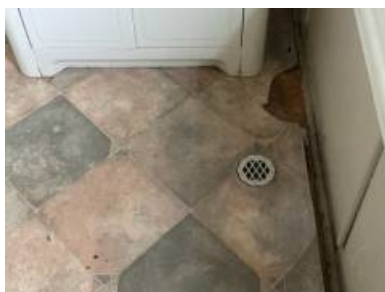
The floor waste point was not able to be tested during this visual inspection. Defects or blockage may be present and not detected. There is no visible floor waste and no way for any overflow of water to escape. In the case of an overflow water may enter areas adjacent and cause a safety hazard or damage. Recommend a floor waste be installed or a fall be provided to the external of the building.

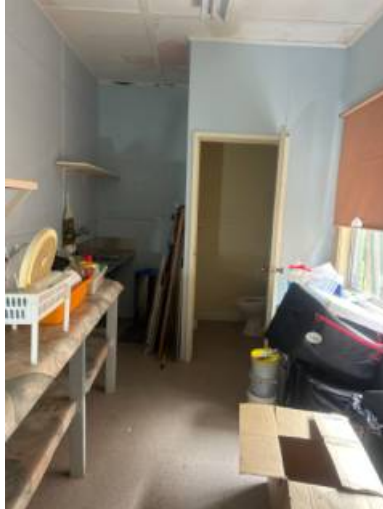
The toilet appears to be in working order. Toilet seat is loose and requires adjustment.

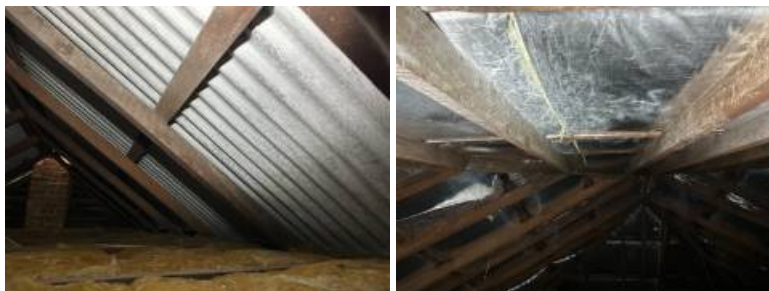
Roof sarking is not provided to all of the roof area.

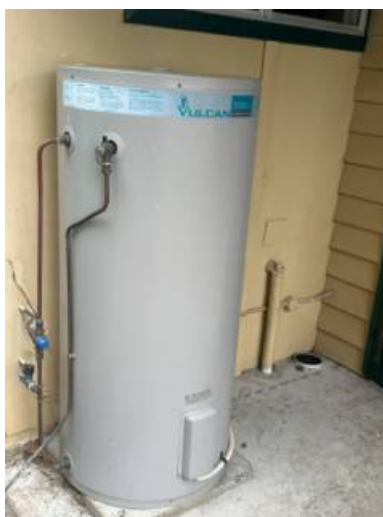
Hot Water Service Type/Condition: Mains electric hot water system: Mains pressure: Located externally: The hot water system appears to be in working condition. No specific tests other than running the hot water tap were carried out. No determination has been made as to the suitability or adequacy of the hot water system in relation to capacity or otherwise.

19/06/2017.

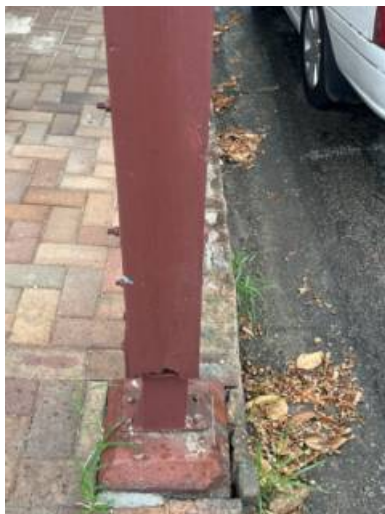
Visible timber damage appears minor to moderate. Please refer to the building report for details or if a building inspection was not commissioned we recommend a builder inspection and report on the property. Refer to the definitions section of this report - TERMS & LIMITATIONS - Timber Damage.

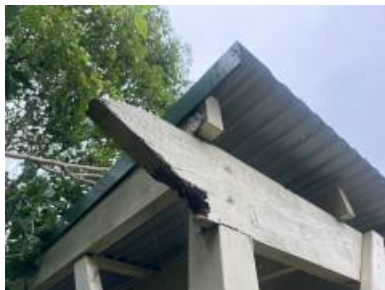
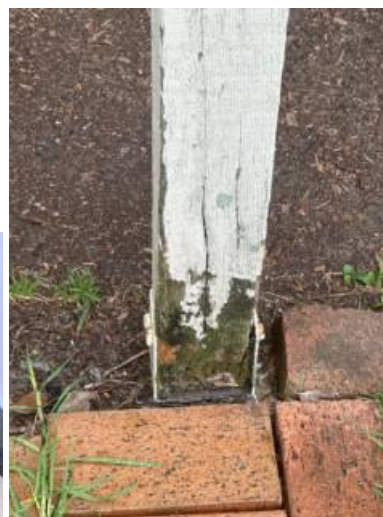
Affected Garage Timbers;

Timber posts, roofing beam.

Visible timber damage appears minor to moderate. Please refer to the building report for details or if a building inspection was not commissioned we recommend a builder inspection and report on the property. Refer to the definitions section of this report - TERMS & LIMITATIONS - Timber Damage.

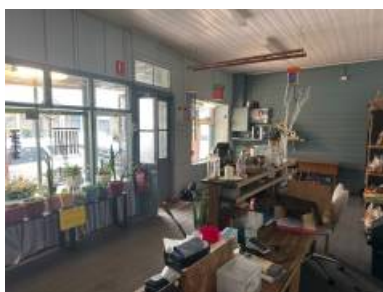
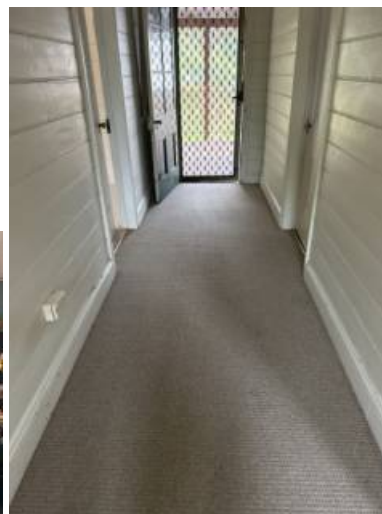
Floorcoverings were present and restricted inspection to the upperside of flooring. Both floorcoverings and furnishings were present and restricted inspection within this area. Inspection was limited in the following locations and or areas: All internal areas.

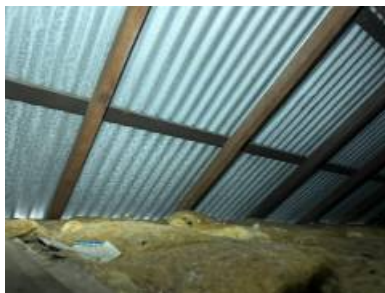
Inspection over the eaves and low areas to the perimeter of the building was restricted due to the low pitch and method of construction allowing only a limited visual inspection from a distance. Items such as top plates and ceiling and roof framing in these areas was not able to be fully inspected. Inspection was restricted above the following locations and or areas: All internal areas.

A comment is not made where access was unable to be gained. Active termites, other timber damaging pests or timber damage may be present and not detected in areas where inspection was limited, obstructed or access was not gained. Timbers above the areas nominated were not accessed and not able to be inspected. Recommend access be gained to allow a full inspection of inaccessible areas.
