Inspection Report

Nova Home Inspections

3 Horesham Place Chipping Norton 2170

Pest And Building Inspection

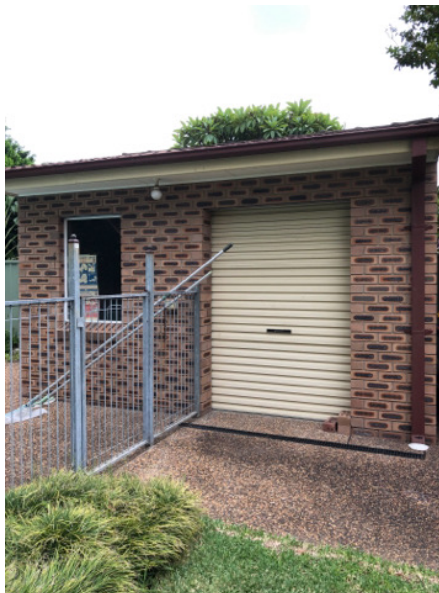
Shed Condition

The shed/s are in fair usable condition.

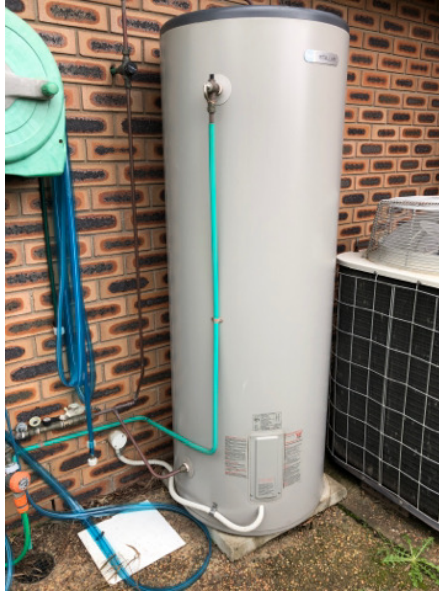
Hot Water Unit Findings

The hot water system appears to be in a serviceable condition. No specific tests other than running the hot water from a tap was carried out. No determination has been made as to the suitability or adequacy of the hot water system in relation to capacity or otherwise.

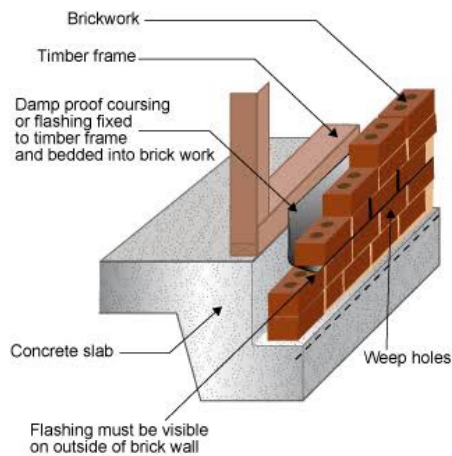
Damp Proof Course

A damp proof course (DPC) was noted.

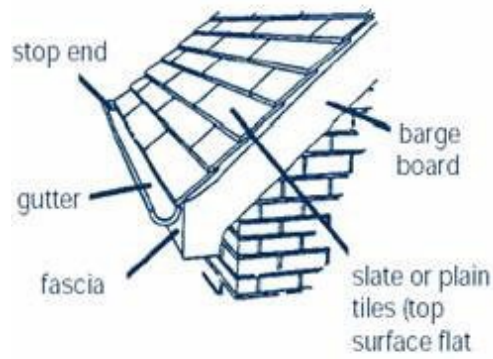
Condition

On visual inspection, the general condition of the fascia/barge boards is serviceable.

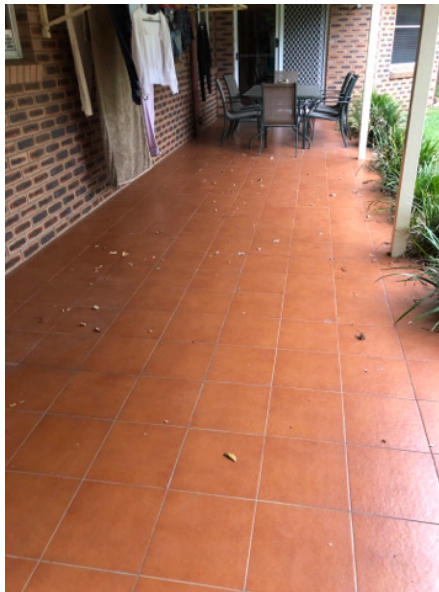
Alfresco Area

Visible sections of the Alfresco area are serviceable or in reasonable or condition for the age of this dwelling.

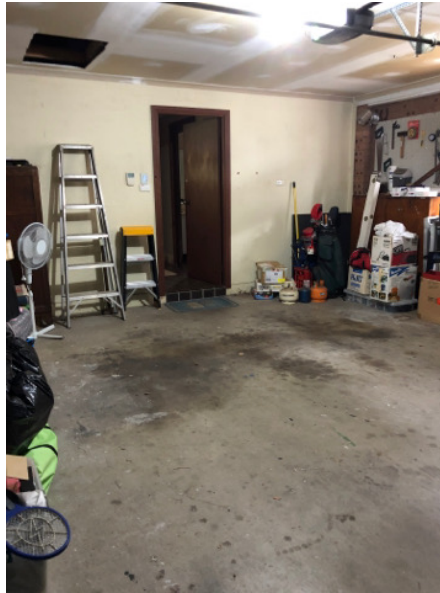
Type

Attached garage

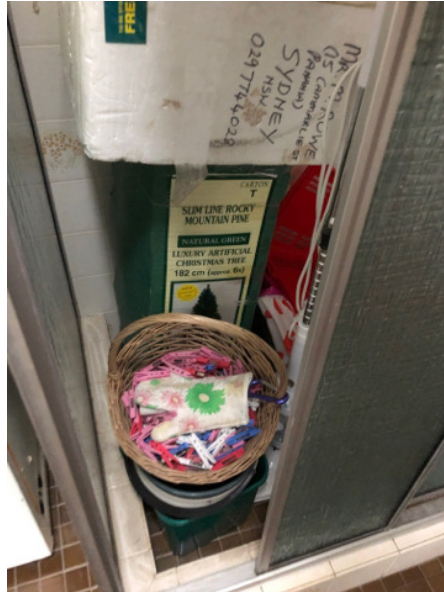
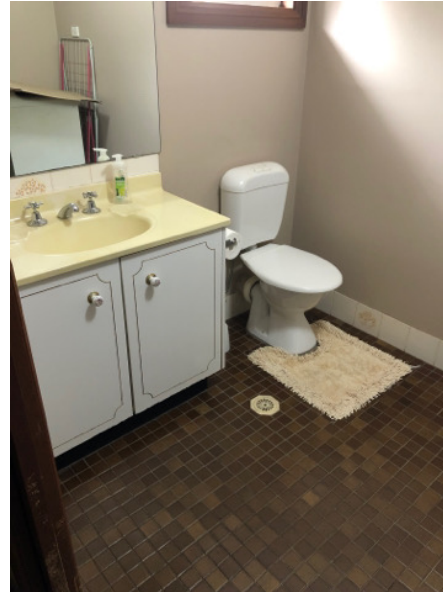
Laundry Bathroom

Of the visible areas, the general condition of this bathroom is serviceable or in reasonable condition for age of dwelling.

Stored items in the shower prohibited an inspection

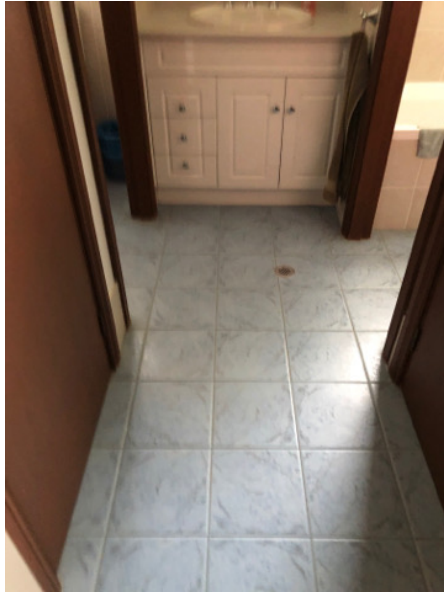
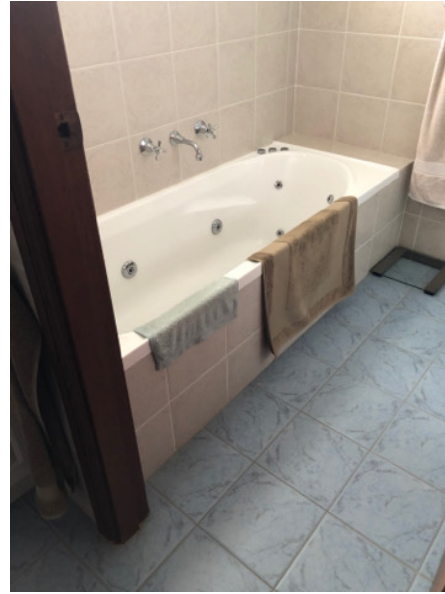
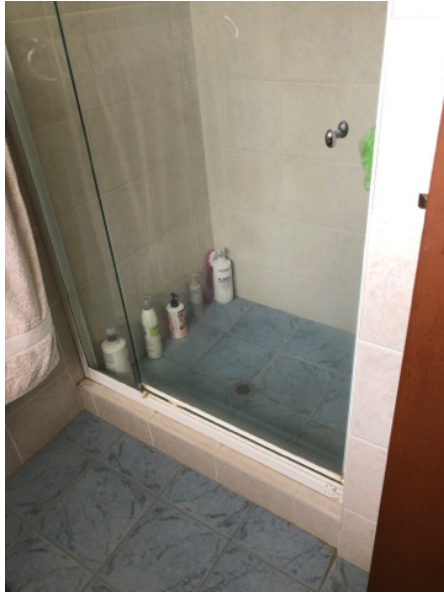
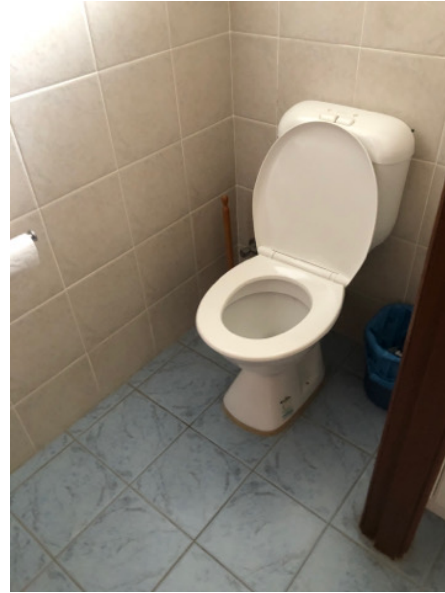
Bathroom 1

Of the visible areas, the general condition of this bathroom is serviceable or in reasonable condition for age of dwelling.

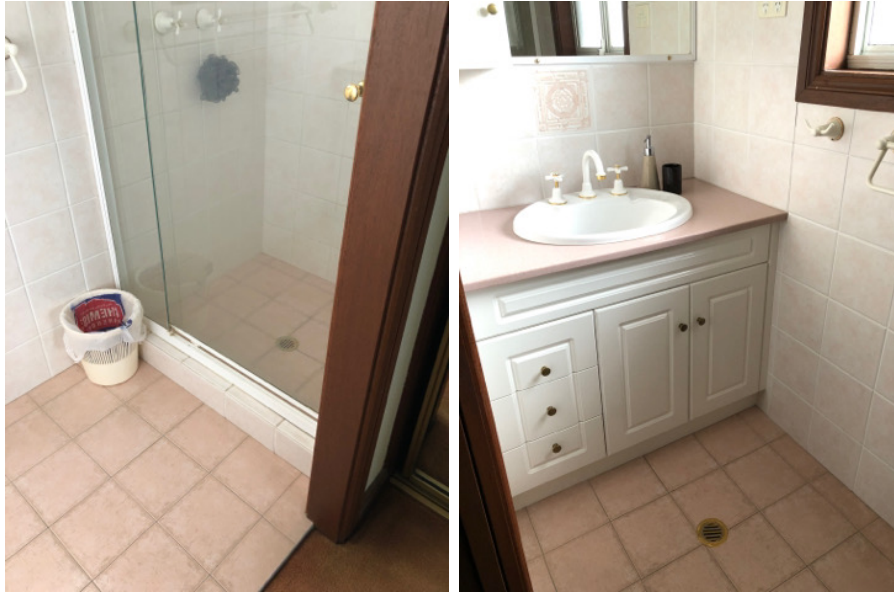
Master bedroom

Of the visible areas, the general condition of this bathroom is serviceable or in reasonable condition for age of dwelling.
