## **Visual Property Inspection Report**

Complies with Australian Standard AS 4349.1-2007 & 4349.3

**26 Fairchild Street  
Raymond Terrace, NSW 2324**

**June 18, 2026**

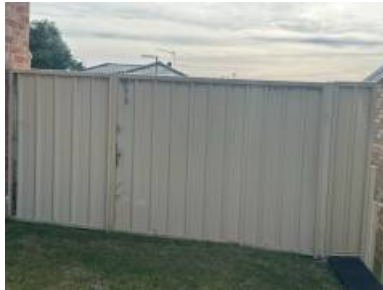
All boundaries.

The fences are mainly constructed from metal. The fences are generally in fair condition but some repairs or maintenance are required. Damage to the metal fencing/gate should be repaired.

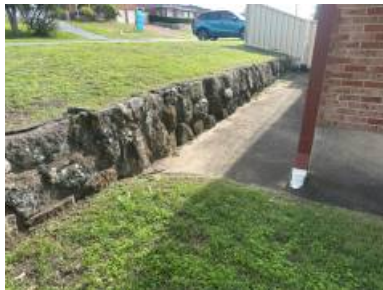
Southern elevation. Western elevation.

The masonry retaining walls show deterioration, cracks etc, and should be monitored for additional movement.

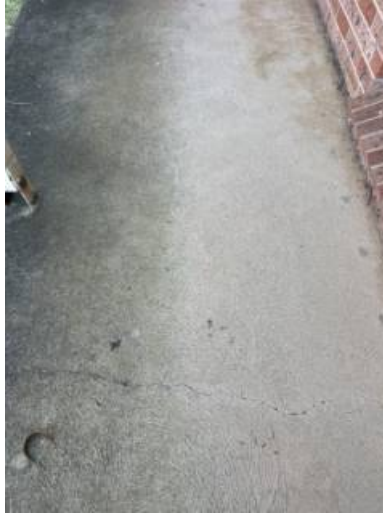
The paths/paved areas are in fair condition. The paths/paved areas have some visible cracking and damaged areas may require repair and or replacement.

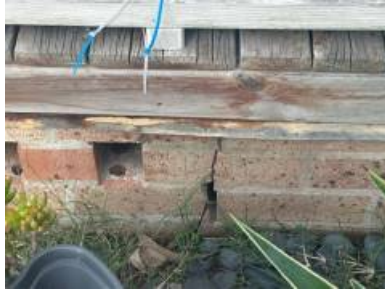
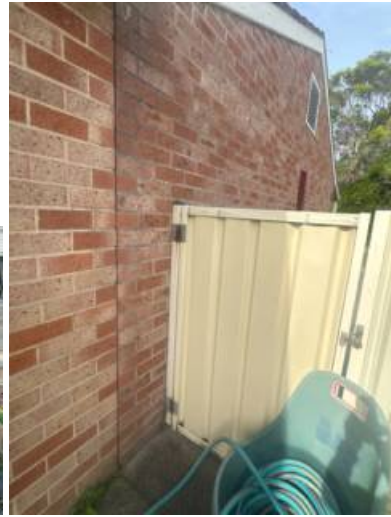
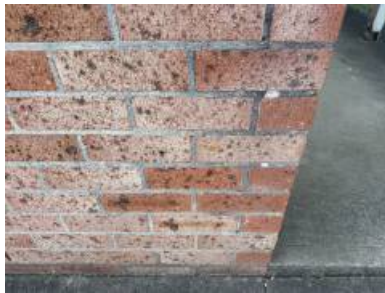
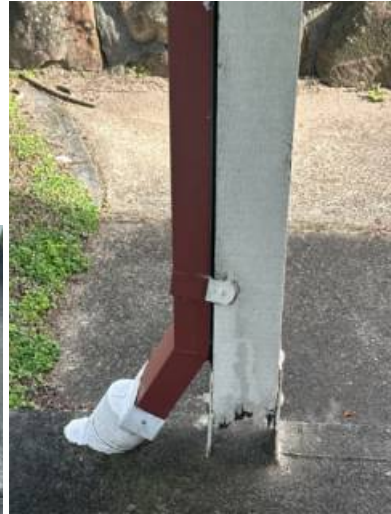
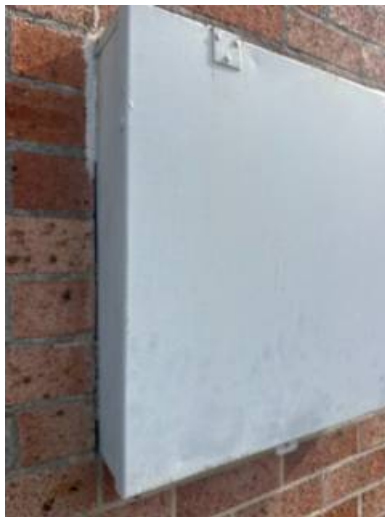
All elevations.

The condition of the walls is generally fair. Cracks are evident to masonry. Visible cracking appears minor. Periodic maintenance may be required. Please refer to section of this report - CRACKING OF BUILDING ELEMENTS for additional details. Expansion joints should be filled with sika flex to prevent moisture/vermin entering wall cavity. Gap around electrical meter box should be filled with trim/silicone to prevent moisture/vermin entering wall cavity. Paint to front timber posts has deteriorated. Wet rot is present to front posts.

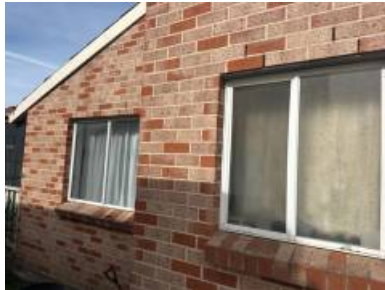
Rear elevation.

Lintel type/s noted: Mild steel: The condition of the lintels is generally fair.

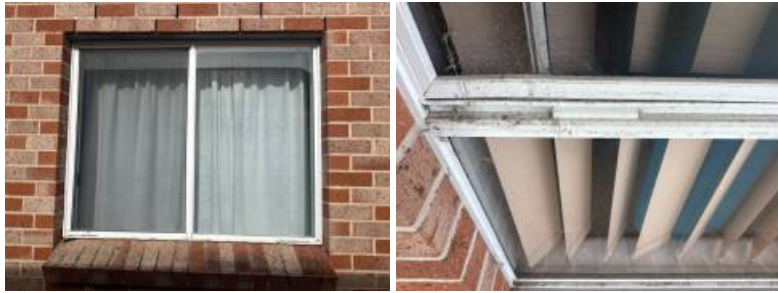
All elevations.

The condition of the exterior of the windows is generally fair. Insect screen/s are damaged and require repair or replacement.

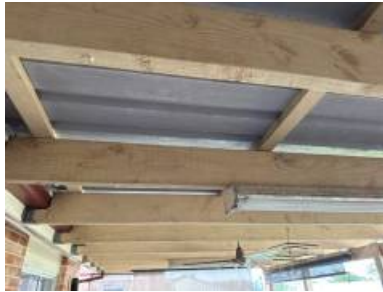
The overall condition of the roof coverings is fair. Roof area should be cleaned to remove, lichen and or moss buildup. Some repair & maintenance of the roofing material may be required following clean. A roofing expert should further evaluate the roof area.

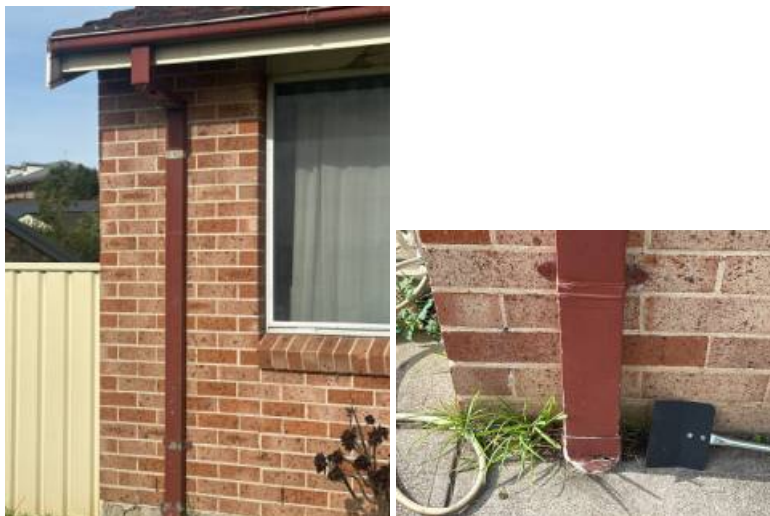
The eaves appear to be lined with fibre cement sheeting. The overall condition of the eaves lining is fair. Minor repairs/maintenance required prior to next repainting. Wet rot is present to front eave trim/beam.

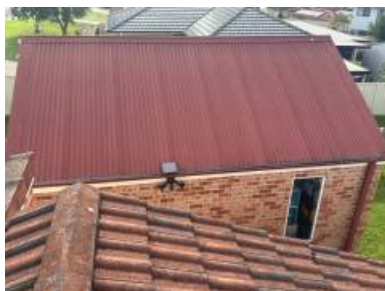
Appear to be in serviceable condition. Some down pipes require a fixing to gutter nozzles.

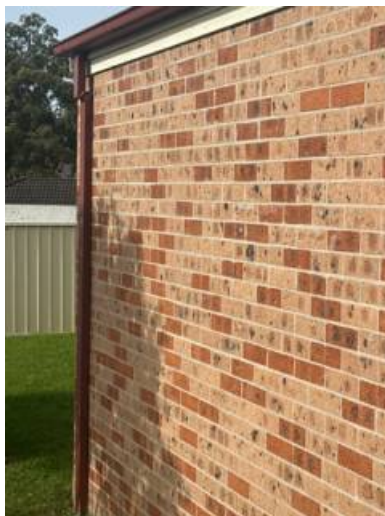
*Fascias & Bargeboards Condition:* The overall condition of the fascias/bargeboards is fair. Moderate wet rot decay is present to some sections of the timber fascias/bargeboards. Maintenance and or replacement of damaged timber will be required. The paint work is deteriorating; Consider maintenance as well as a cosmetic upgrade.

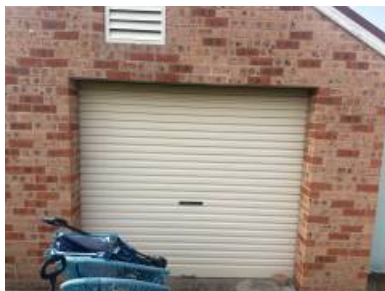
The concrete floor is generally in fair condition. The concrete floor shows signs of minor cracking. Please refer to section of this report - CRACKING OF BUILDING ELEMENTS for additional details.

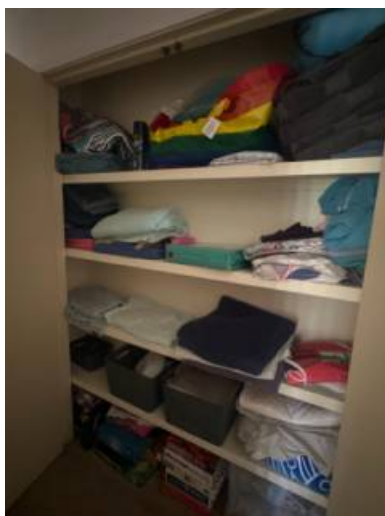
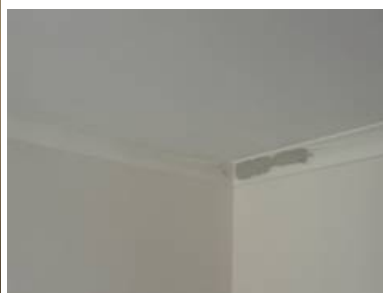
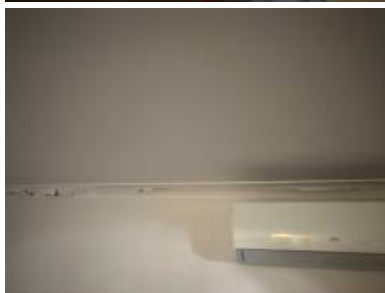
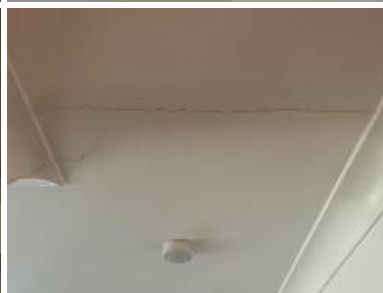
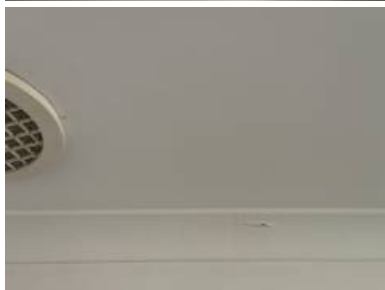
The condition of the ceiling area is generally acceptable, however, minor cracking is present to some of the cornices and these areas will require maintenance and or repair prior to next repainting. Minor settlement cracks were noted and these are typical of this type of material. Periodic maintenance may be required. Peeling paint was noted to ceilings.

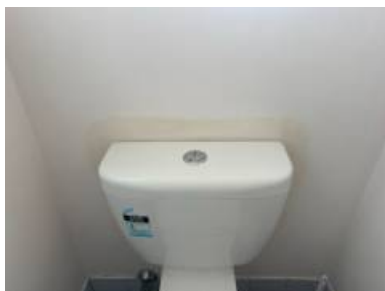
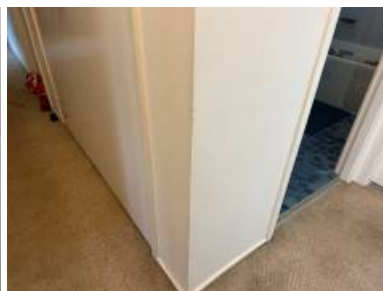
The condition of the walls is generally fair. Minor maintenance and or repairs required prior to next repainting.

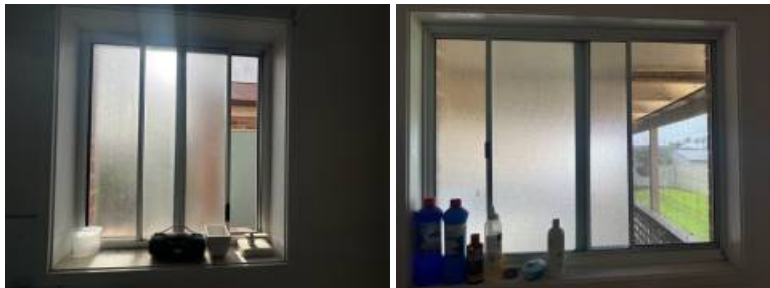
The condition of the windows is generally fair. The condition of the window hardware is generally fair. Some repairs or maintenance will be required.

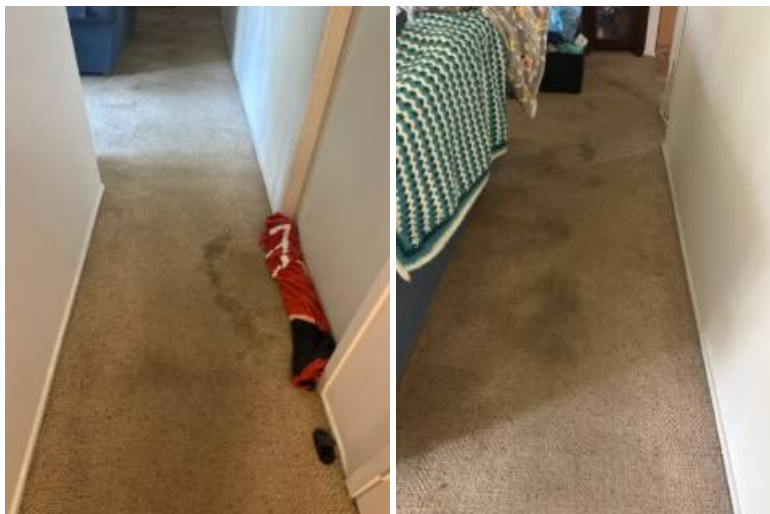
The condition of the floors is generally fair. Some of the carpeted edges have frayed, exposing barbed smooth edge and require repair and or replacement.

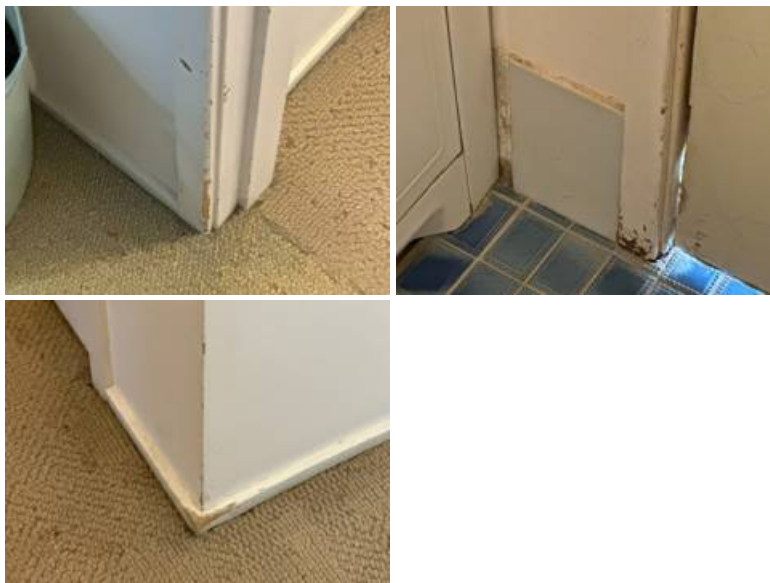
The condition of the woodwork is generally fair.

Minor maintenance and or repairs required prior to next repainting.

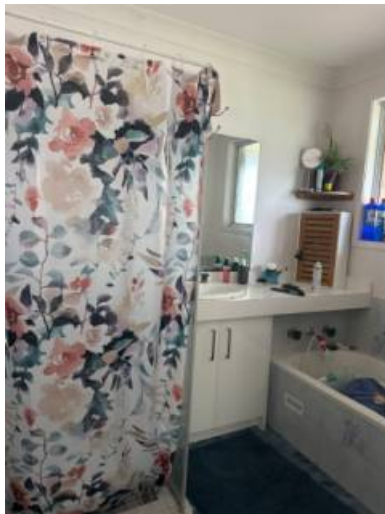
The shower recess was tested and there was no visible water penetration to surrounding areas. IMPORTANT NOTE: This test may not reveal water leaks until the shower is put into constant use and surrounding areas monitored over a period of time. Junction of wall finish and shower base should be resealed appropriately to prevent water entry to wall cavity. The bath appears to be in fair condition. The area will need to be kept well sealed to prevent water penetration to surrounding areas.

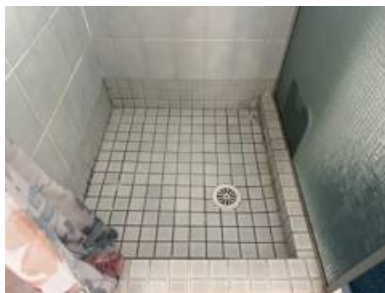
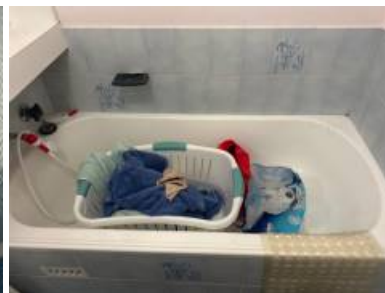
The condition of the tiles is generally fair. Some cracked tiles were noted in this area. Consider repair or replacement of damaged tiles.

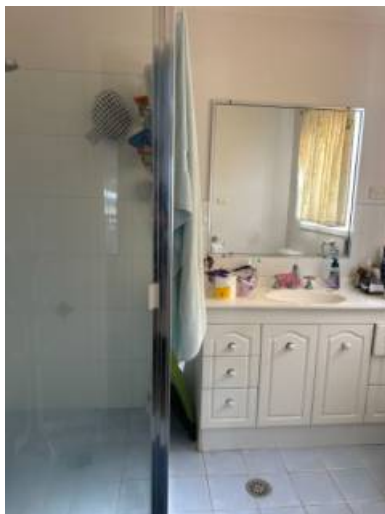
The shower recess was tested and there was no visible water penetration to surrounding areas. **IMPORTANT NOTE:** This test may not reveal water leaks until the shower is put into constant use and surrounding areas monitored over a period of time. Junction of wall finish and shower base should be resealed appropriately to prevent water entry to wall cavity.

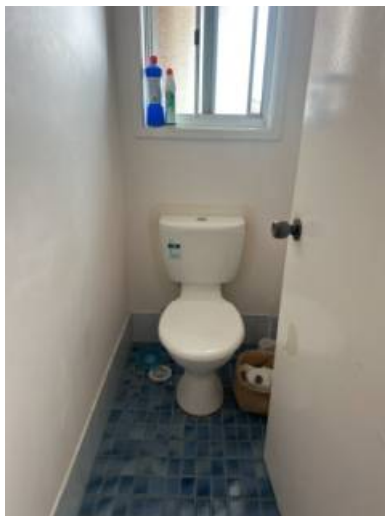
The toilet appears to be in working order. Toilet area is restrictive and the door swings inwards. In case of an emergency the door cannot be readily removed from the outside. Recommend liftoff hinges be installed to the door to comply with current Standards.

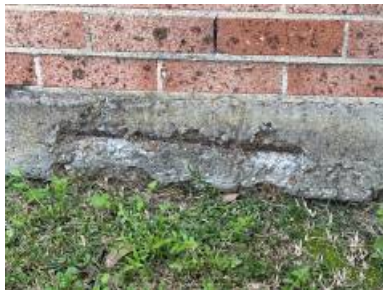
The building is constructed on a combination of strip footings and concrete slab footings. The footings appear to be generally sound. Rep is exposed to slab edge on eastern elevation. Minor repair required.

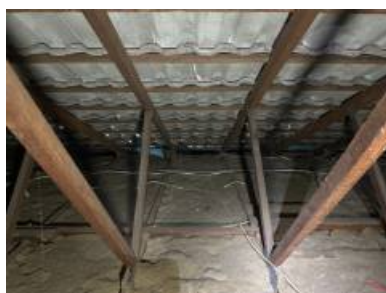
Sarking has not been provided to the roof area.

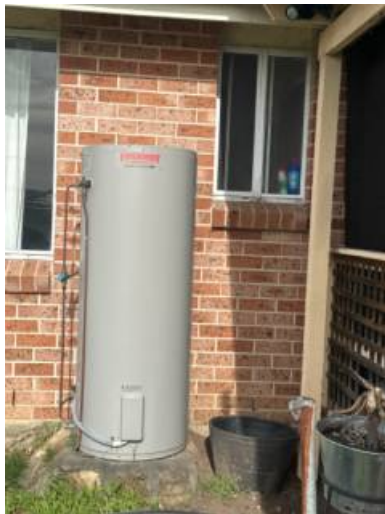
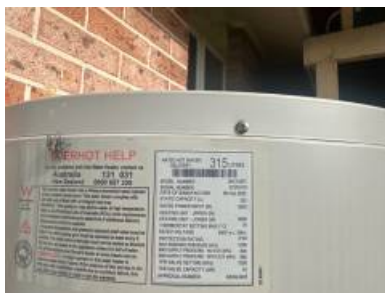
Age Of Unit:

*Hot Water Service Type/Condition:* Mains electric hot water system: Mains pressure: Located externally: The hot water system appears to be in working condition. No specific tests other than running the hot water tap were carried out. No determination has been made as to the suitability or adequacy of the hot water system in relation to capacity or otherwise.

**Important Note:** It would be prudent to have all services (visible and non-visible) including electrical wiring, plumbing and drainage etc checked by appropriately qualified contractors.

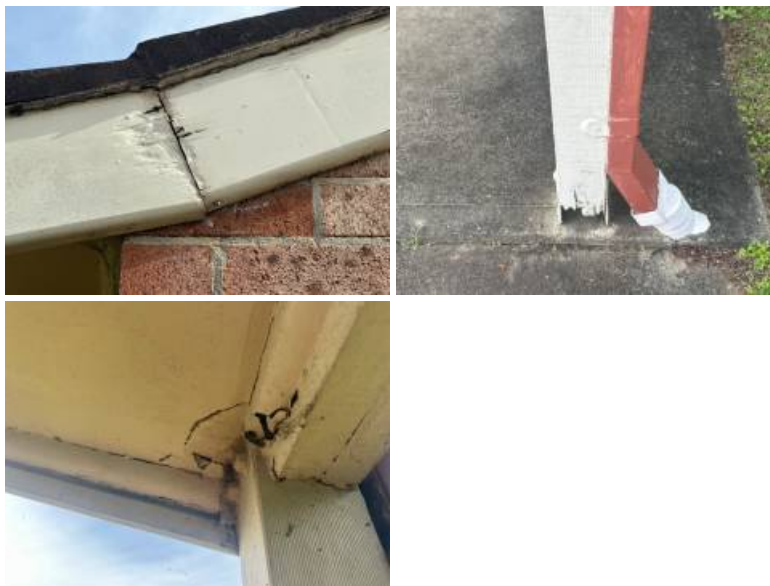
Visible timber damage appears minor to moderate. Please refer to the building report for details or if a building inspection was not commissioned we recommend a builder inspection and report on the property. Refer to the definitions section of this report - TERMS & LIMITATIONS - Timber Damage.

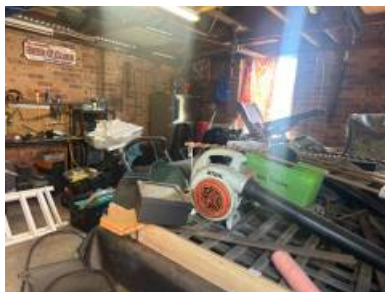
*Garaging*

Stored items restricted inspection to the interior. These goods must be removed to enable a more complete report to be submitted.

Active termites or other timber damaging pests may be present and not detected in areas where inspection was limited, obstructed or access was not gained. Recommend access be gained.

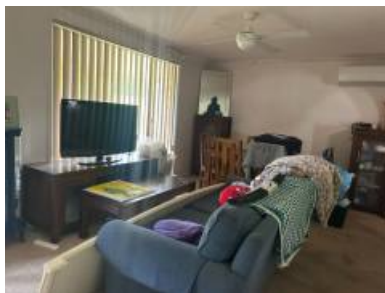
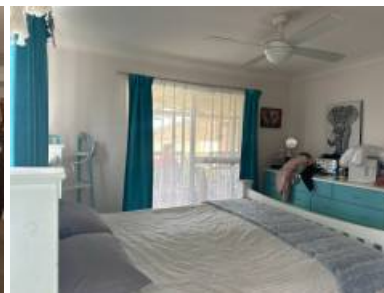
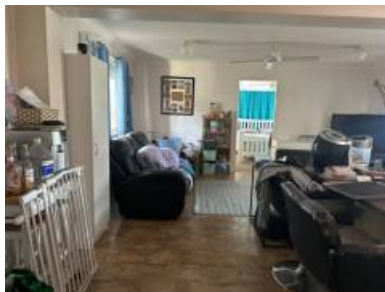
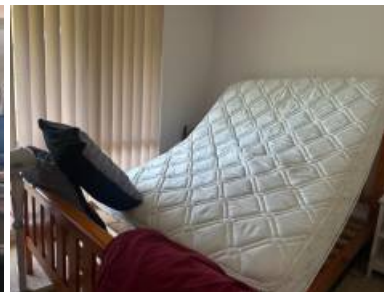
*Inspection Limitations*

Both floorcoverings and furnishings were present and restricted inspection within this area. Inspection was limited in the following locations and or areas: All internal areas.

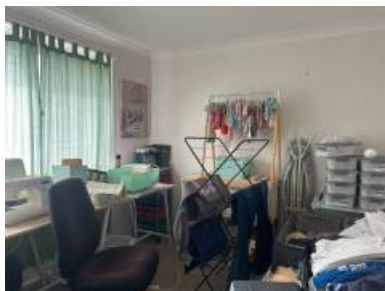
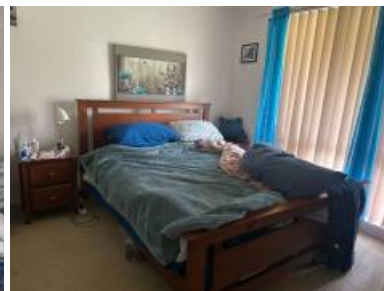
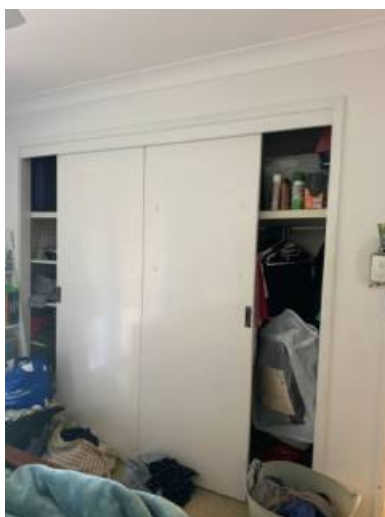
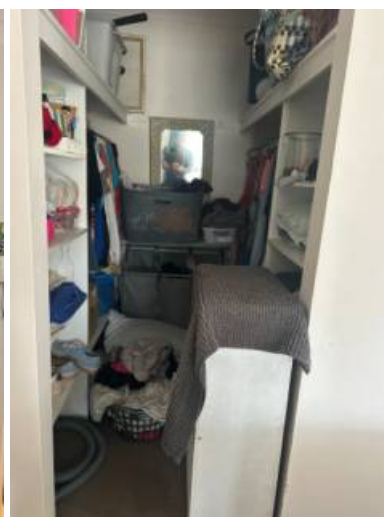
*Access Limitations*

A significant amount of stored goods were present to the area(s) listed below which restricted the inspection. Stored items should be removed to allow a more complete inspection to be carried out. Access was limited in the following locations and or areas: Wardrobes. Linen cupboard.

Active termites or other timber damaging pests may be present and not detected in areas where inspection was limited, obstructed or access was not gained.

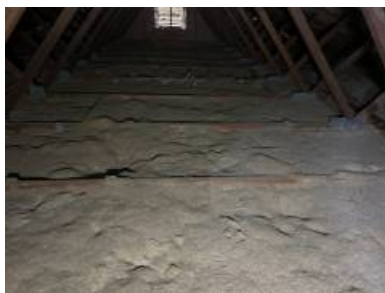
**RESTRICTIONS:***Inspection Limitations*

Insulation is present in the roof cavity. This restricted inspection to some roofing timbers. Removal of insulation is not within the scope of a standard visual inspection report. Inspection was restricted above the following locations and or areas: All internal areas.

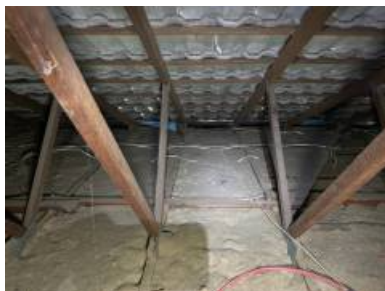
*Access Limitations*

Inspection over the eaves and low areas to the perimeter of the building was restricted due to the low pitch and method of construction allowing only a limited visual inspection from a distance. Items such as top plates and ceiling and roof framing in these areas was not able to be fully inspected. Inspection was restricted above the following locations and or areas: All internal areas.

A comment is not made where access was unable to be gained. Active termites, other timber damaging pests or timber damage may be present and not detected in areas where inspection was limited, obstructed or access was not gained. Timbers above the areas nominated were not accessed and not able to be inspected. Recommend access be gained to allow a full inspection of inaccessible areas.
