BUILDING AND TIMBER PEST REPORT

56 Centaurus Cres
Regents Park, QLD 4118

BYB
13/05/2025

Pre-Purchase Inspection - Residential Building Report

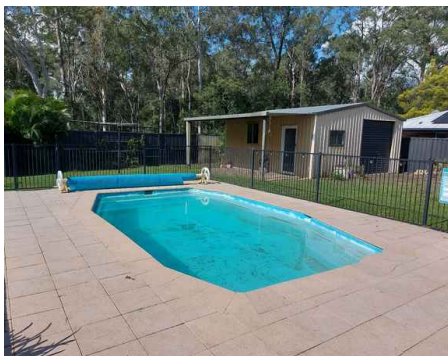
General: A swimming pool/spa is present.

This inspection specifically excludes any inspection of the pool, associated fencing, surrounds and safety elements. We recommend you obtain an inspection from a specialist pool inspector to determine the condition of the pool, pool equipment, safety barriers and surrounds.

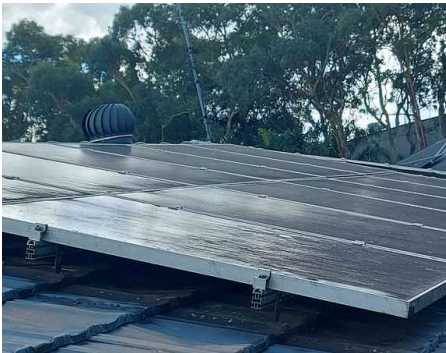
Restrictions And Limitations: Solar Panels / Fixtures

Solar panels or other fixtures obstructed some areas of the roof surfaces from being inspected.

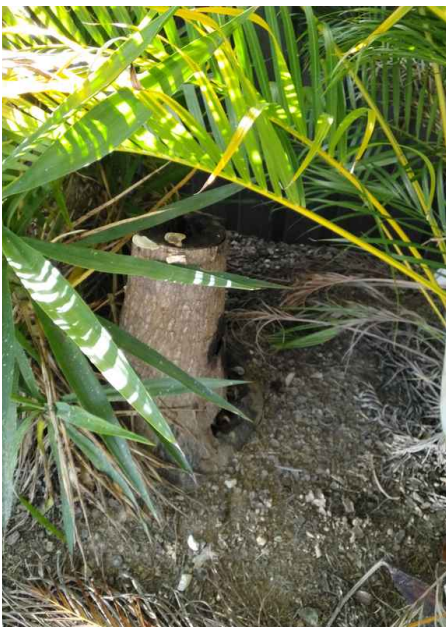
Site and Exterior: Trees & Stumps

Timber in direct contact with the ground and or soil produces are ready food source for termites. Susceptible Timbers used in a hazardous environment are prone to fungal decay. It is recommended that you remove this condition order to prevent timber pest activity.

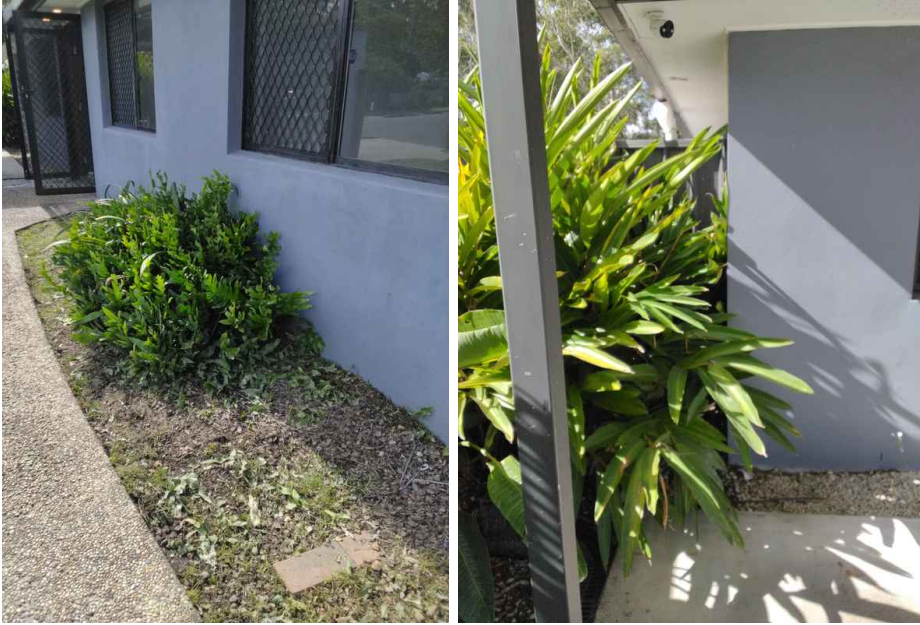
Site and Exterior: Gardens against / close vicinity to building

This condition can create conditions that encourage timber pest, and may allow hidden access for termites
