# Inspection Report

## Certified Building Inspection Services

**32 Angophora Dr, Pokolbin, NSW, 2335**

### Pest And Building Inspection

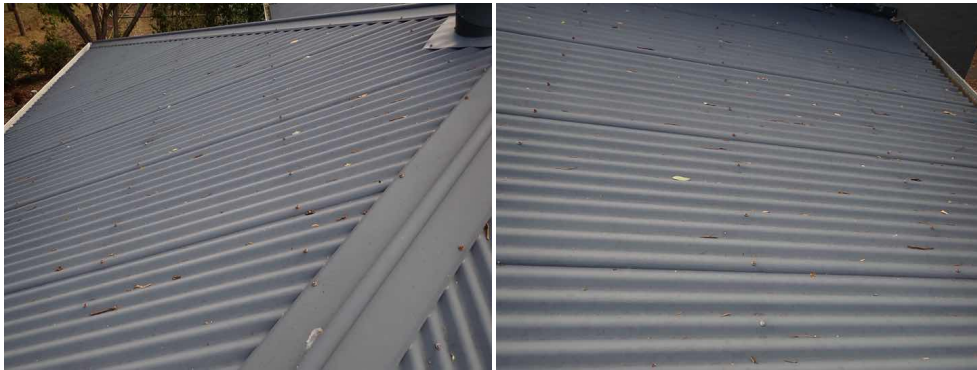
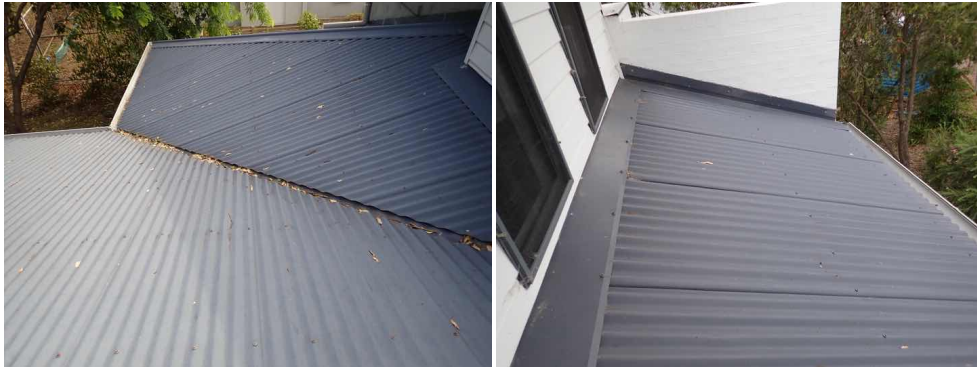
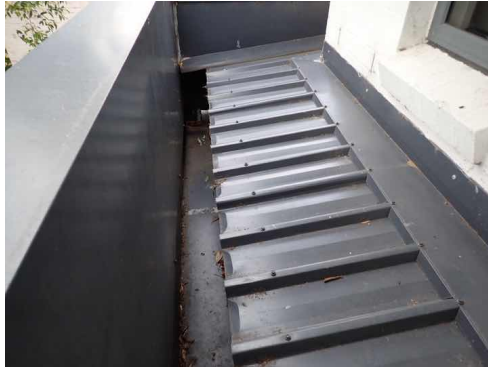
2nd storey roof Not inspected as too high to reach by ladder.

Sections of the roof not inspected due to access limitations. See terms and conditions

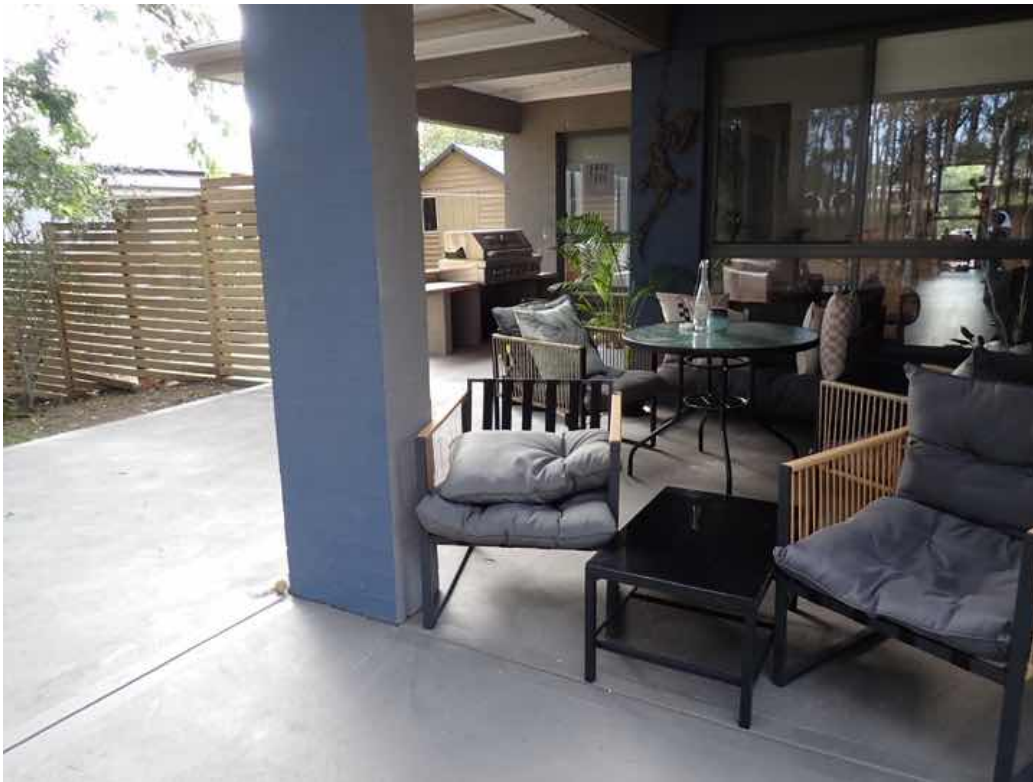
**Ceiling Lining Condition**

Minor sag noted to ceiling. Currently not causing any issues

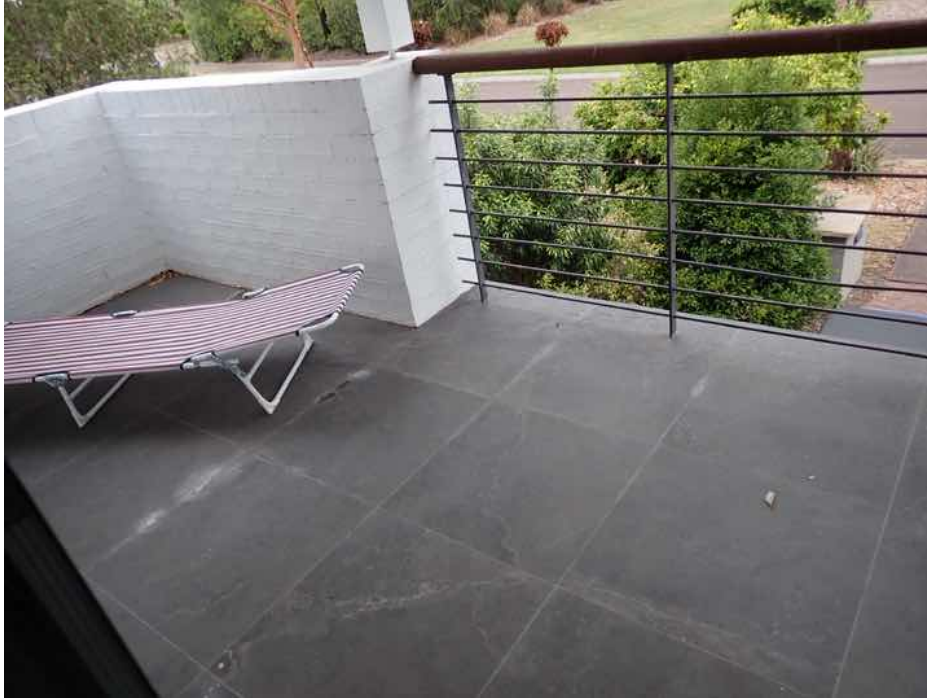
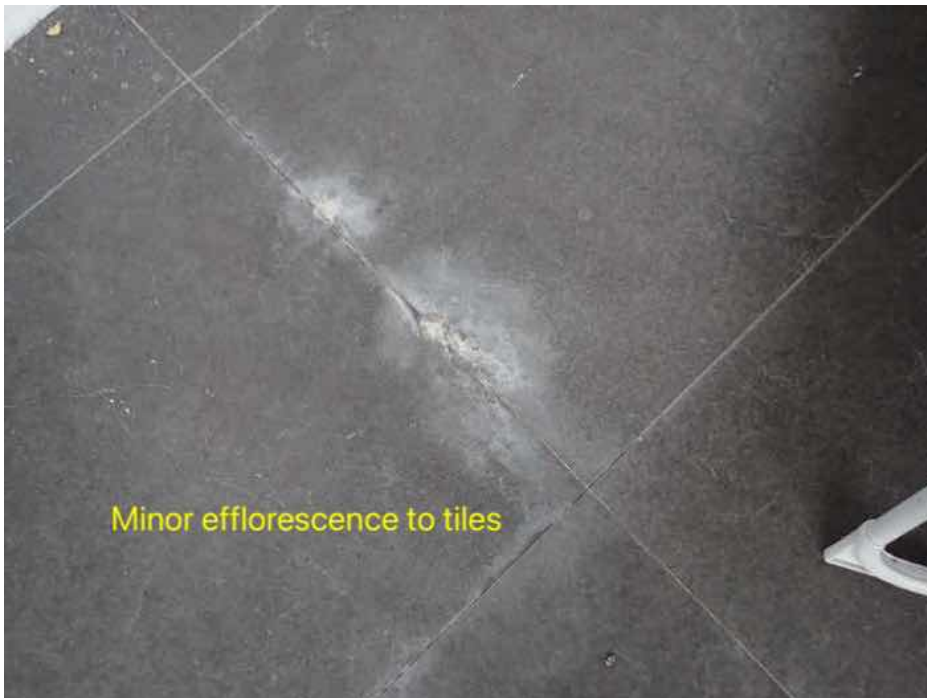
Though we are not structural engineers the balcony/s appear to be in a serviceable condition.

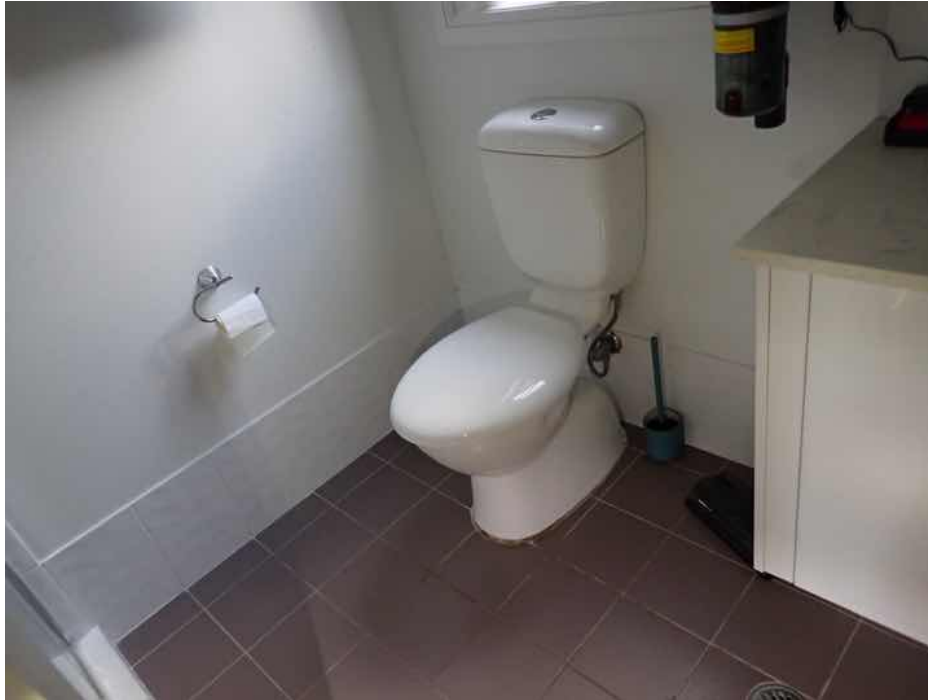
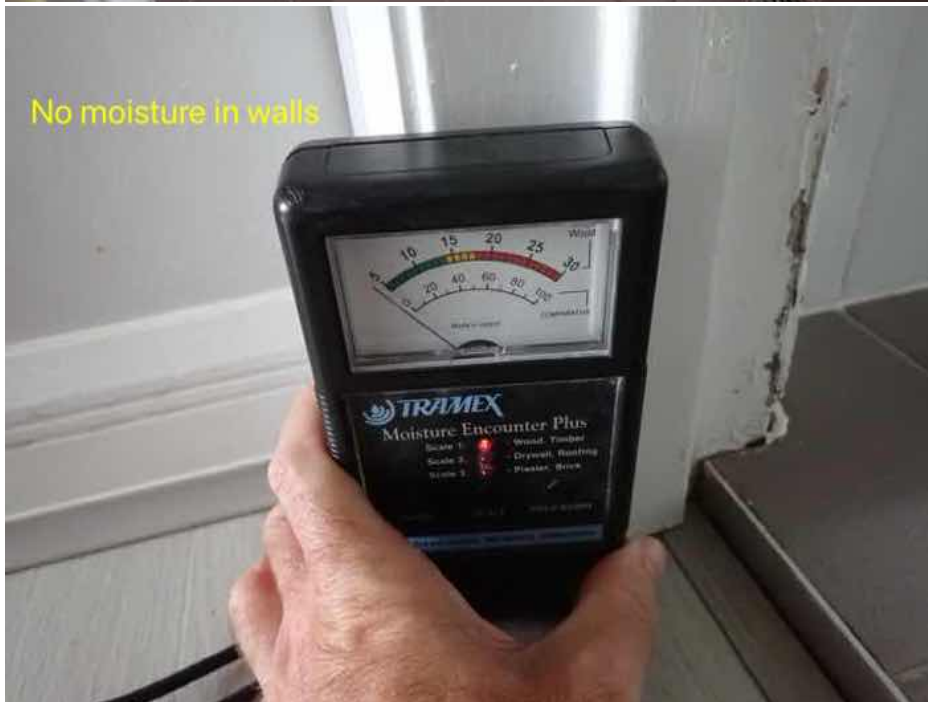
#### Door

Door / frame deterioration - General age/deterioration has occurred to door frame, face or components.

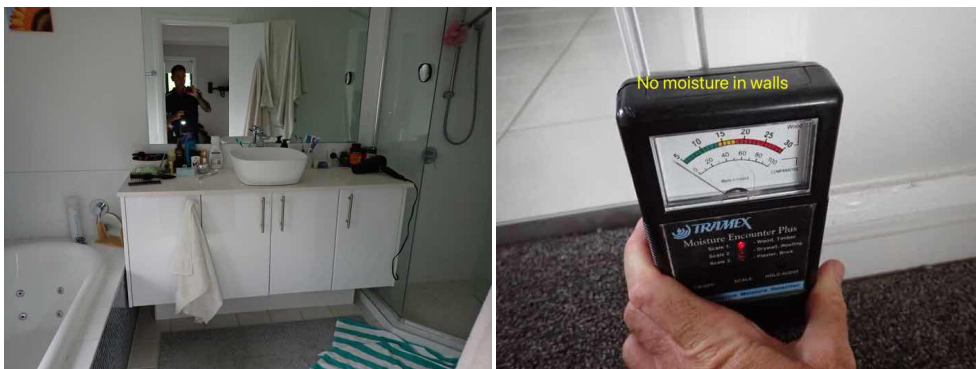
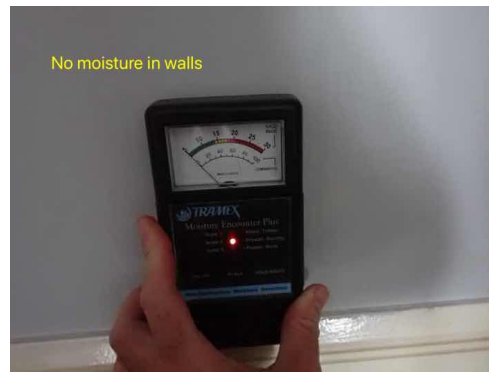
### Shower And Bath

Cracked tiles around bath. Currently not causing any leaks but this should be repaired at the earliest as this has the potential to lead to many related issues such as damp, water ingress to other areas. Contact a licensed tiler for repairs and recommendation

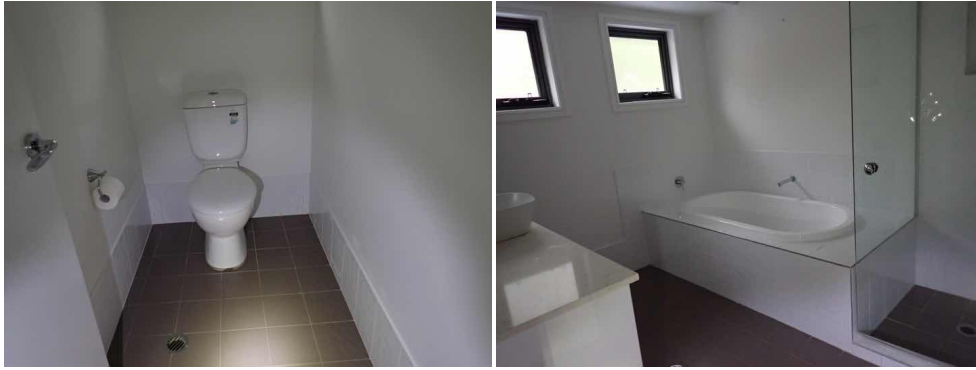
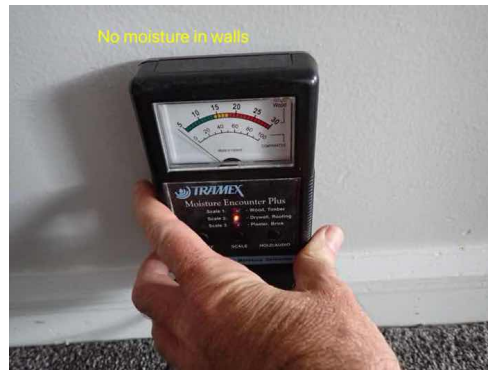
## Shower And Bath

Cracked tiles. Currently not causing any leaks but this should be repaired at the earliest as this has the potential to lead to many related issues such as damp, water ingress to other areas. Contact a licensed tiler for repairs and recommendation

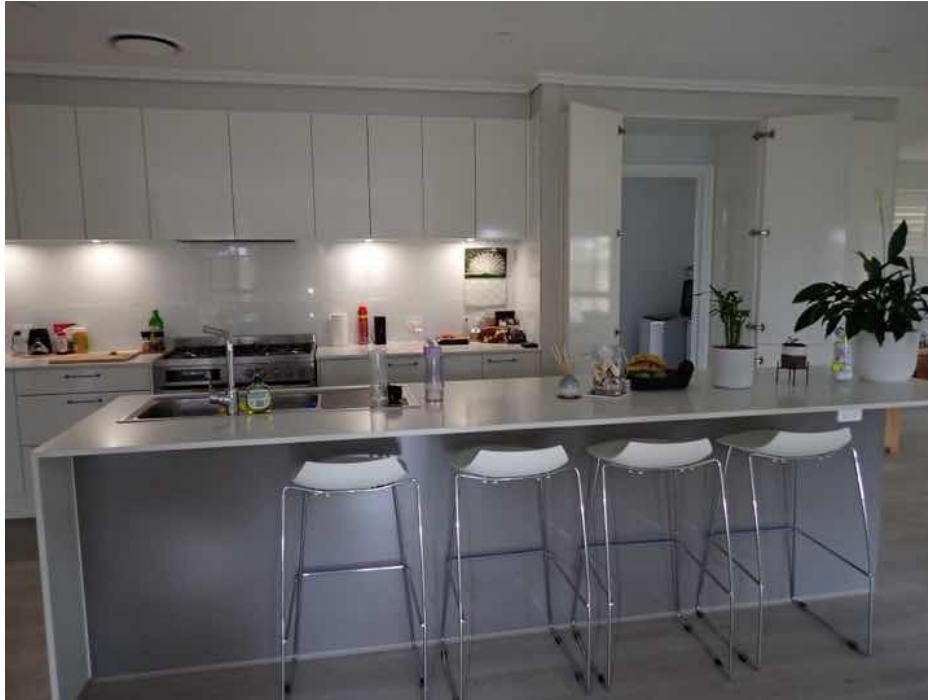
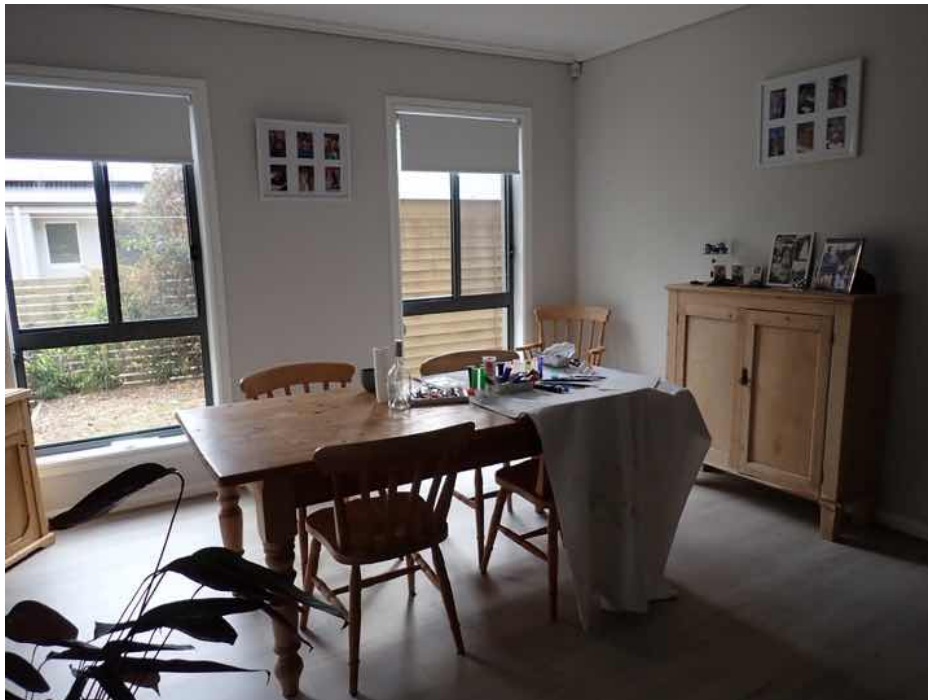
#### Ceiling

General ageing and deterioration and the like is evident on ceiling linings - Recommendations: A qualified painter should be engaged to assess and repair as required.

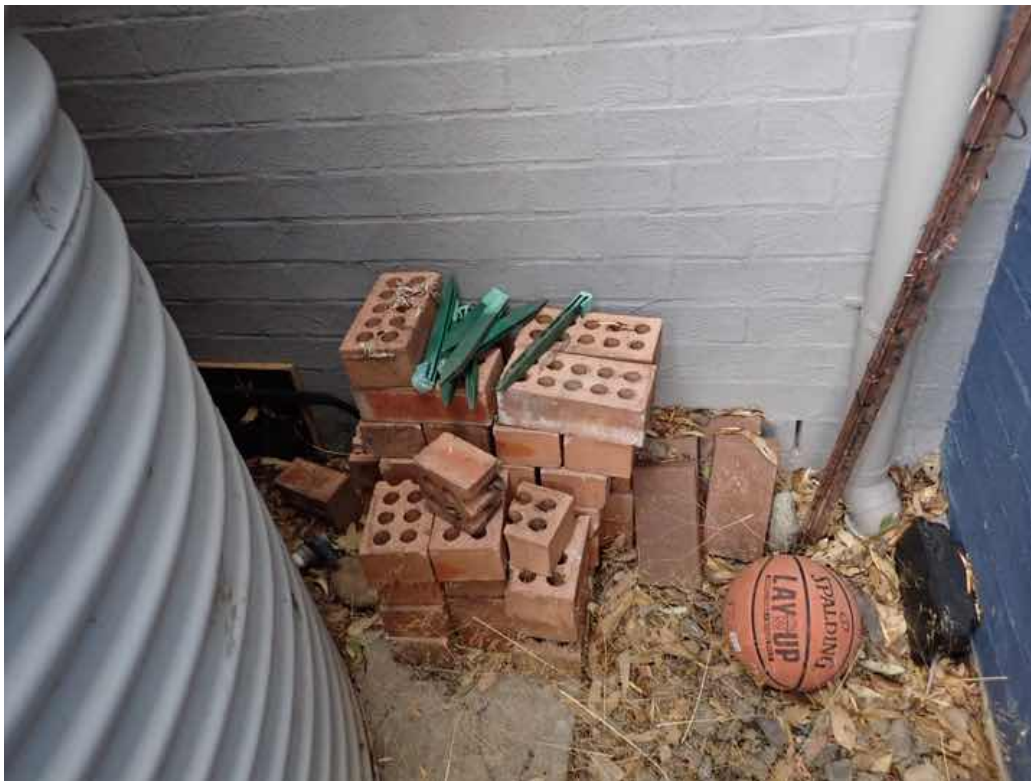
Items stored on external walls,

Stored item in garage obstructed visual inspection,

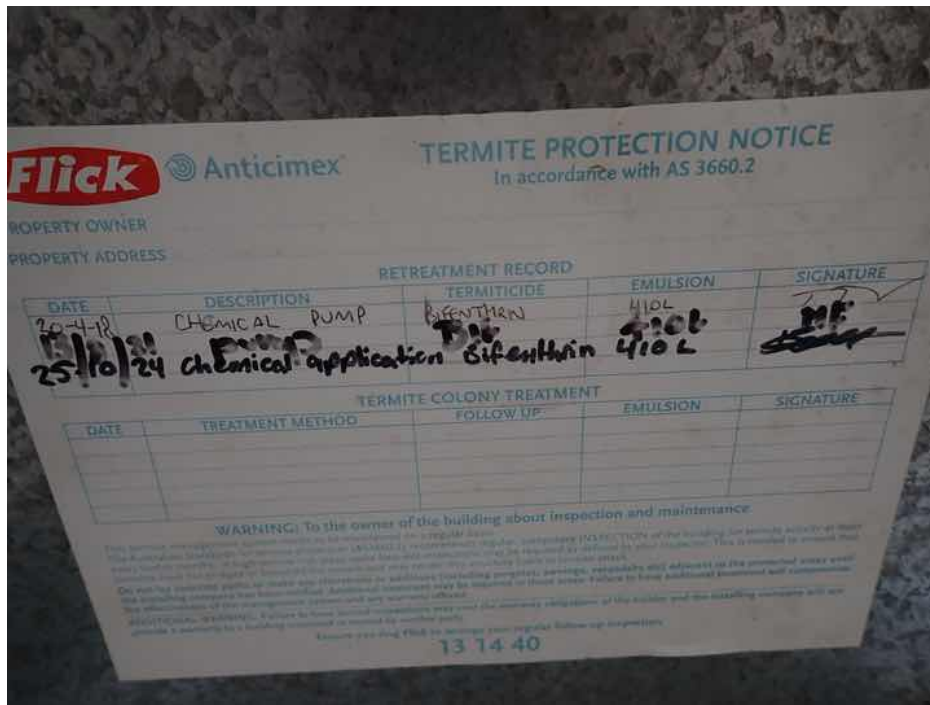
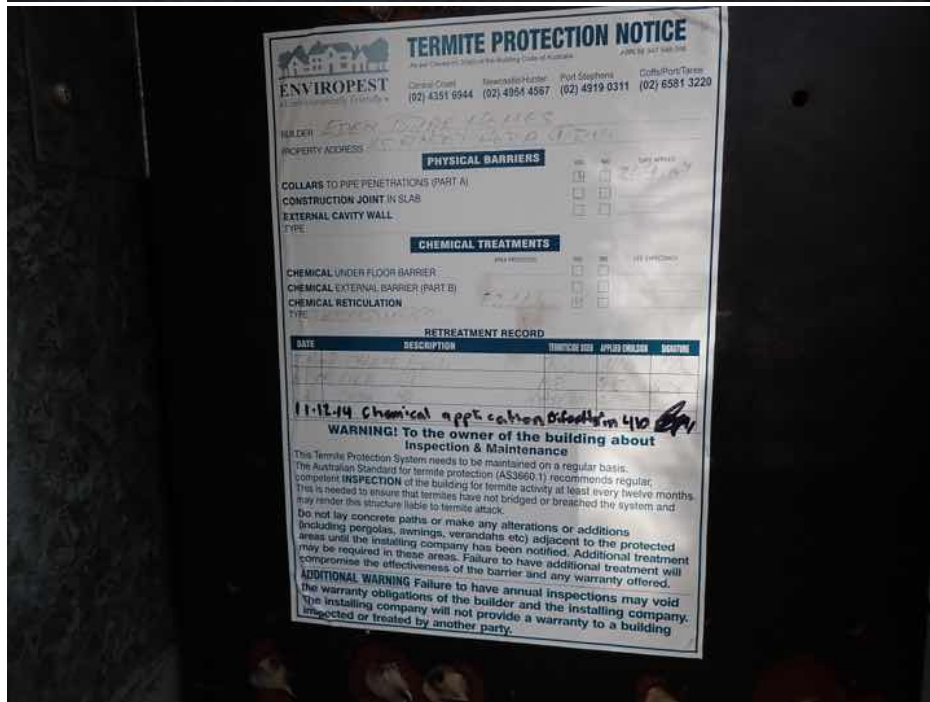
Yes, a durable notice was found during the inspection.

This firm can give no assurances with regard to work that may have been previously performed by other firms. You should obtain copies of all paperwork and make your own inquiries as to the quality of the treatment, when it was carried out and warranty information. In most cases you should arrange for a treatment in accord with "australian standard 3660" be carried out to reduce the risk of further attack.

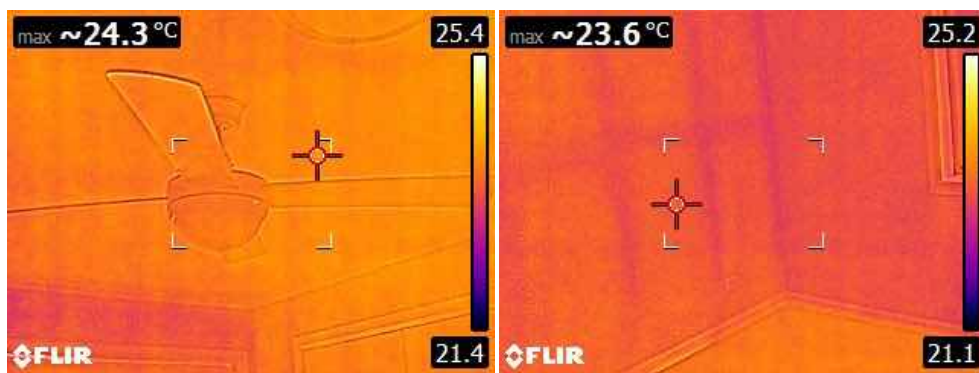
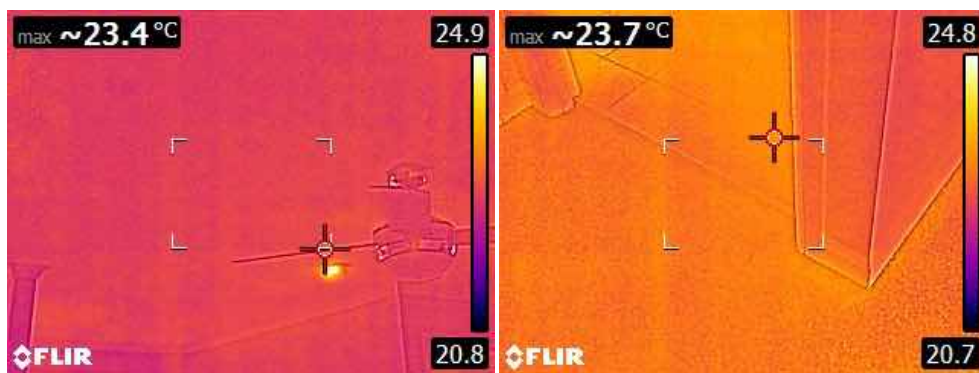
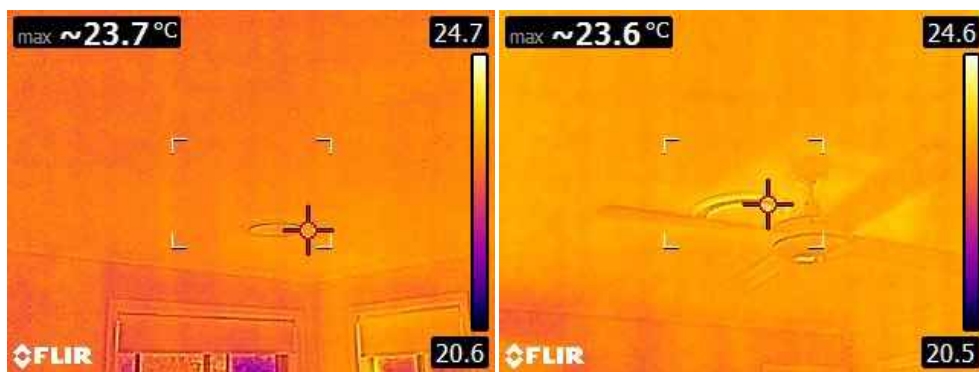
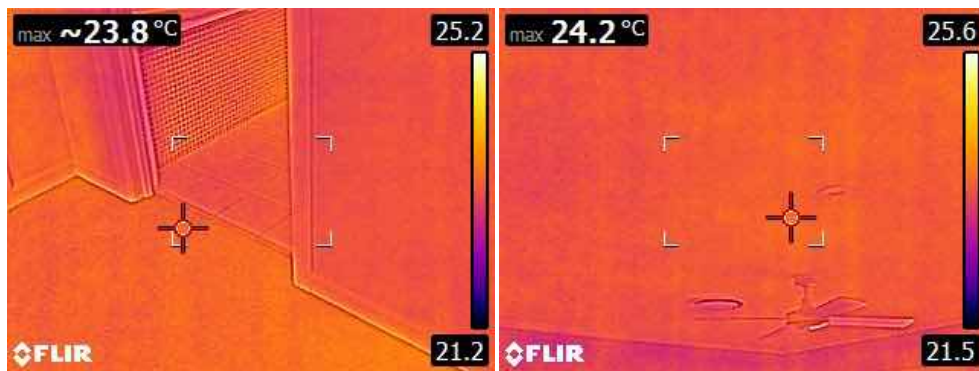
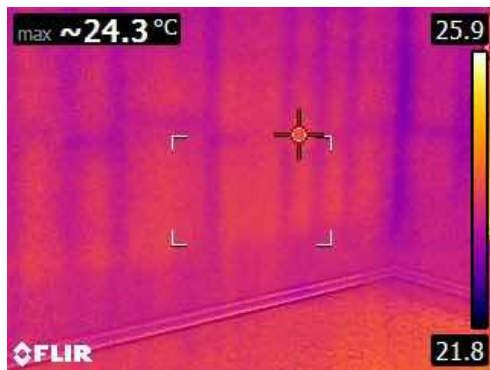
An infrared thermal imager was utilised during the inspection.

No thermal anomalies were detected during this inspection, however various factors must be taken into effect which may hamper or impede the reading obtainable by the imager. These factors include obstructions, ambient temperature, wall material and thickness etc. If any surface is restricted visually or otherwise, a proper thermal reading is not possible and is not within the scope of this inspection. Any findings or otherwise is reported on at the time of the inspection only.
