388-390 Murray rd Preston

Job- Investigate video footage of water bubbling out of front steps.

## RE: Site Investigation at 388 Murray Road, Preston

A site investigation was undertaken on 15 August 2025. The purpose of the investigation was to provide remedial recommendations for two external stairs.

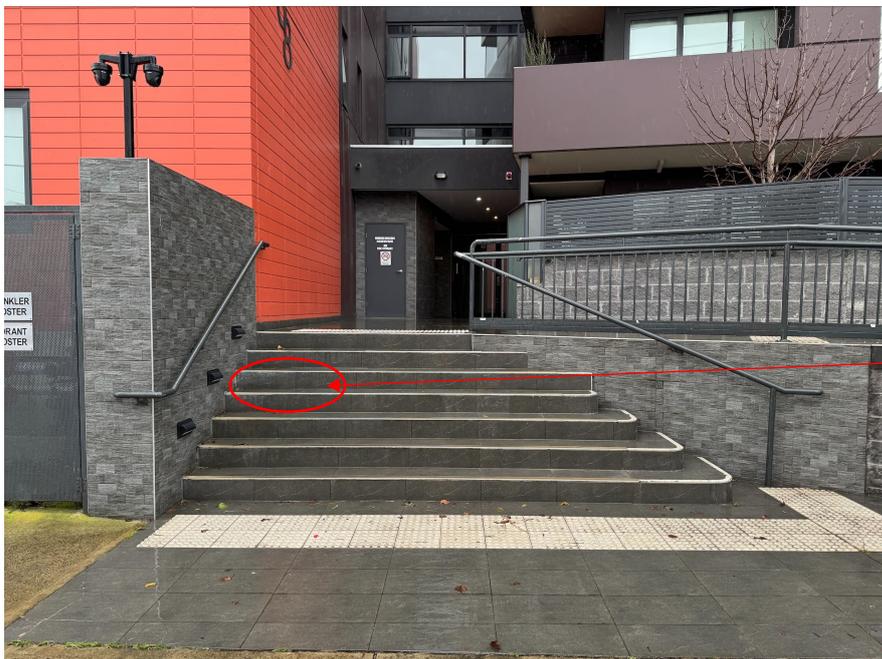
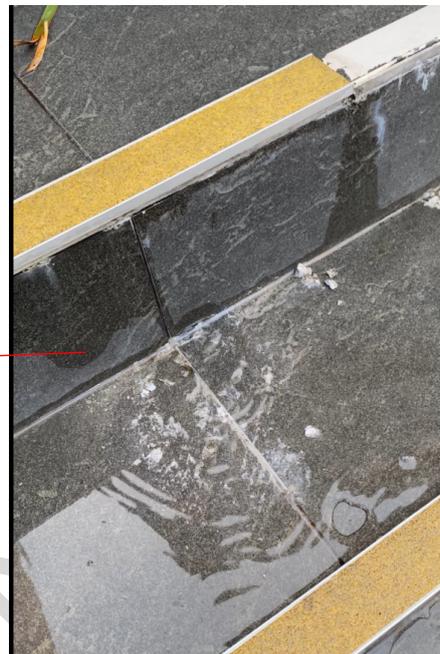
Caulking at the base of the tiles on the lefthand side approximately halfway up the steps was disturbed and water flowed out from behind the tile kicker.

Water was observed seeping into cracks in the tile grout and gaps where the steps have subsided.

We believe that rain water enters the tile bed through cracks and gaps and builds up behind the tile kickers on the stair treads. When the caulking at the bottom of one of the steps was disturbed the built up water was able to escape.

There are cracks and evidence of subsidence of the stairs.

We recommend a tiler inspect and provide comment on the installation and advice on appropriate repairs to prevent water lifting the tiles and creating slip hazards on the stairs.

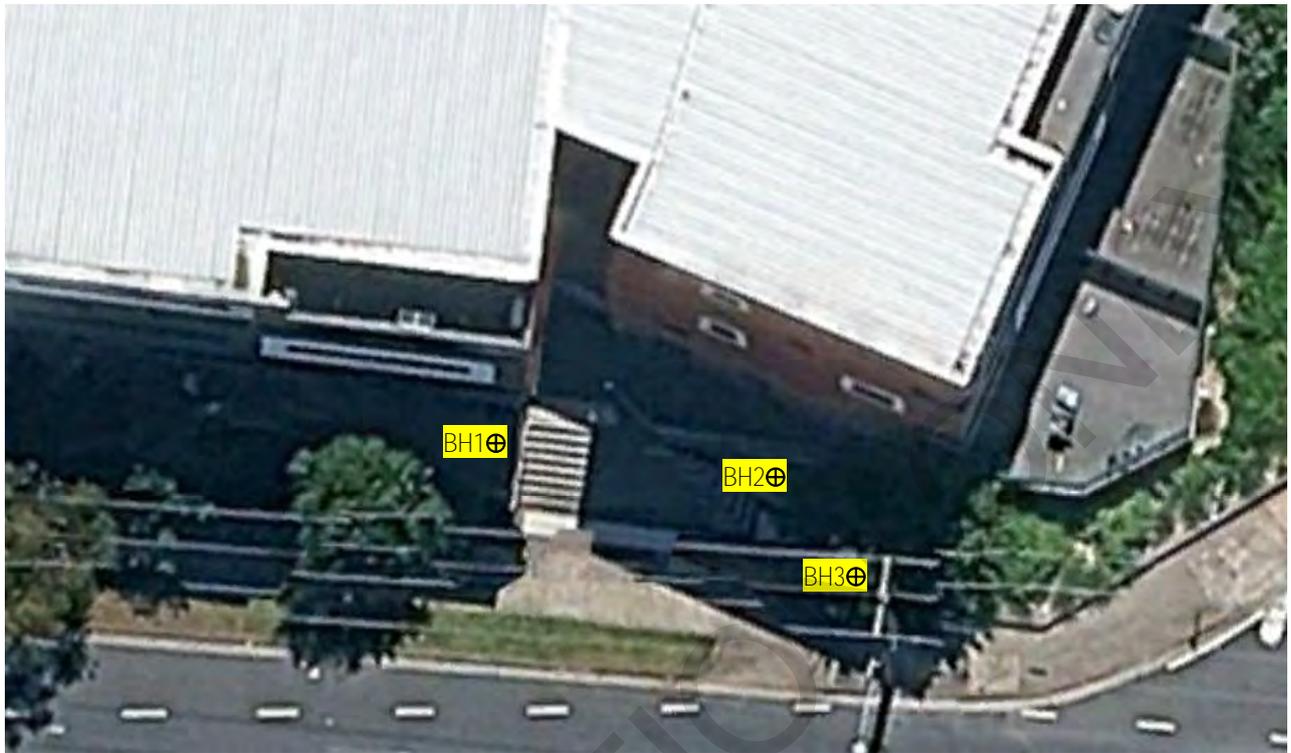
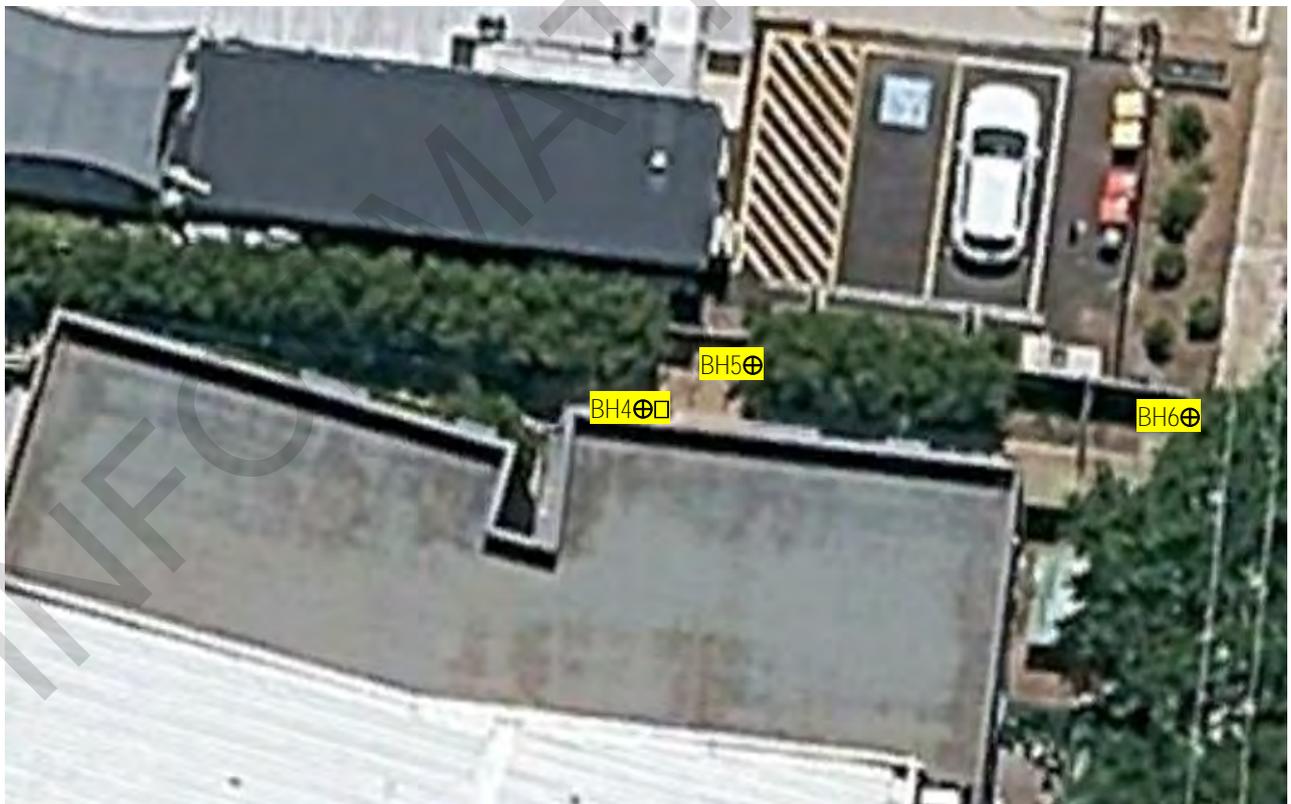
Figure 1

The existing northern stair footings were exposed at borehole 4 (see figure 1). Dimensions and founding material are shown below; depths are relative to the existing surface levels at the time of the investigation.

Location	Borehole 4
	Northern stair
Type	Concrete strip
Founding Depth	600mm
Depth of Footing	450mm
Projection	80-150mm (irregular)
Founding Material	FILL

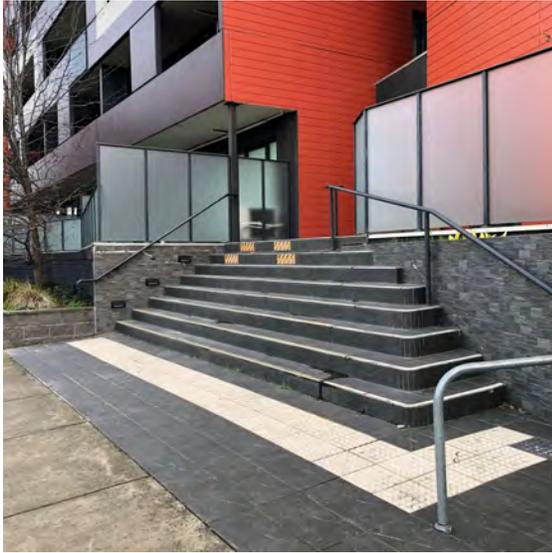
Fig 1. Entry steps on South side of building.

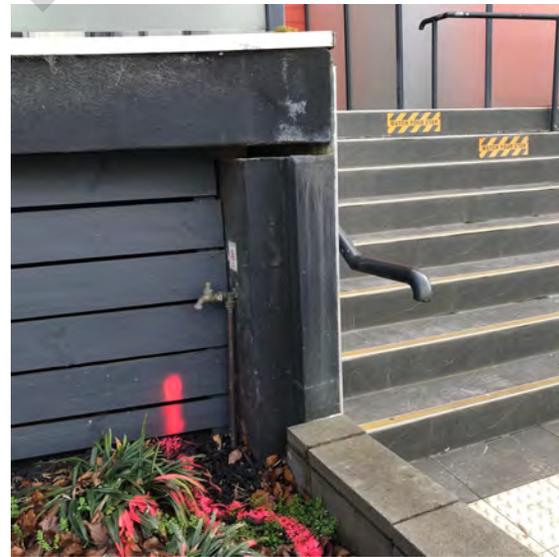
Fig 4. End view of west end wing wall indicates wall has settled whilst ground floor slab has not.

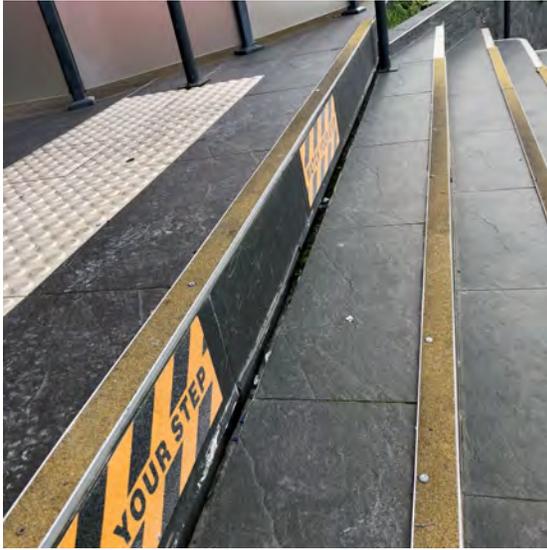
Fig 5. Gap indicates steps have rotated towards the south, away from the ground floor slab.

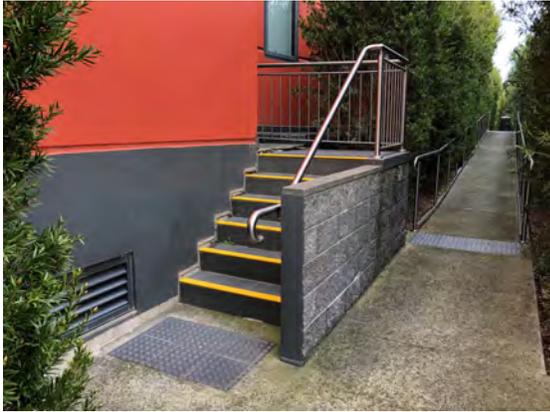
Fig 8. Steps & path on North side of building.

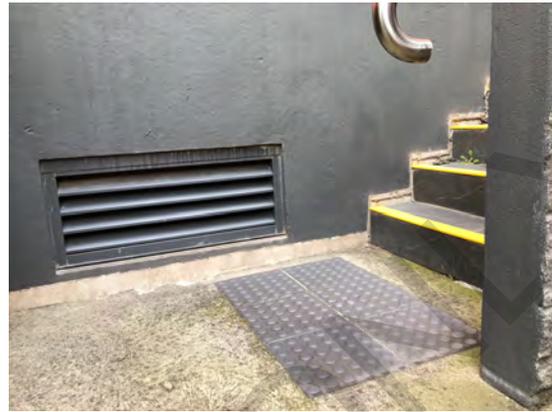
Fig 9. Gap indicates steps and path have settled downwards.

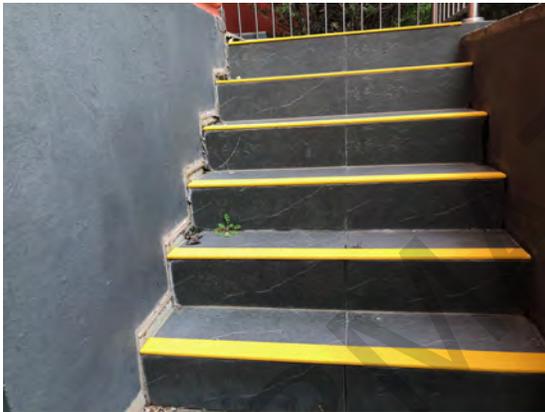
Fig 10. Front view of steps

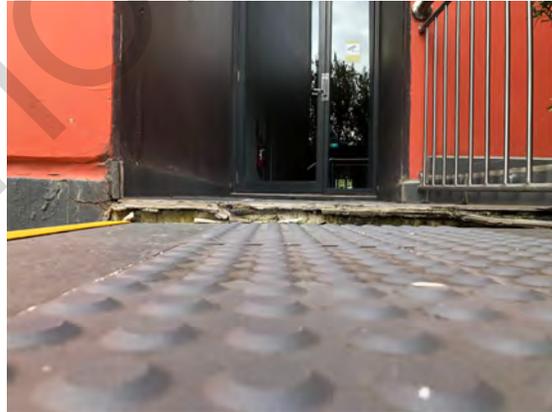
Fig 11. Step between stair landing and ground level slab due to stair settlement.

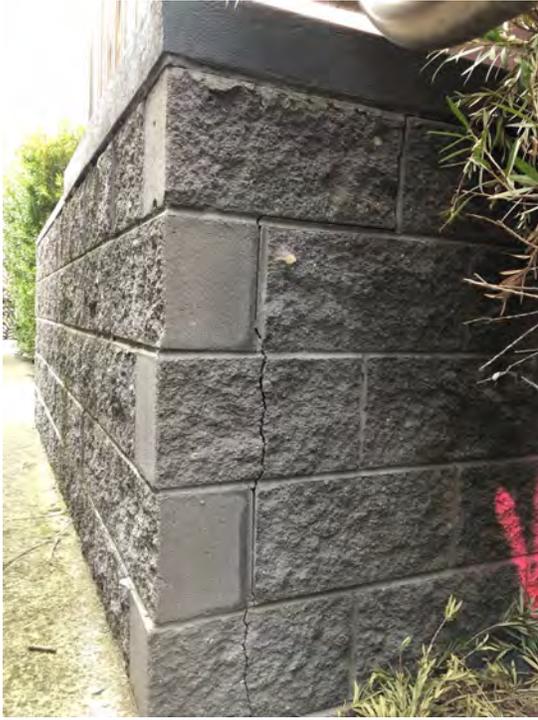
Fig 12. Blockwork supporting landing at top of steps.

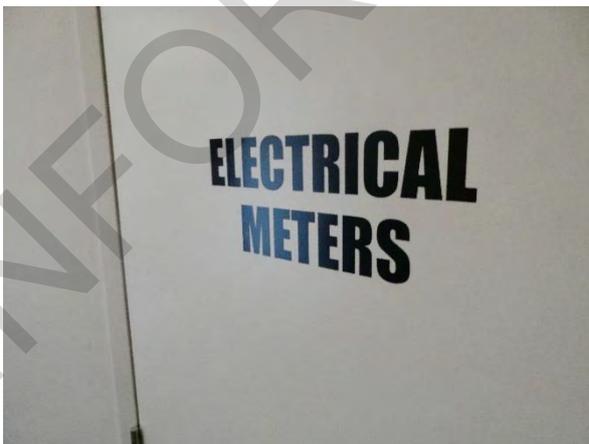
Photograph 1. Services cupboards were inspected on each floor of the building.

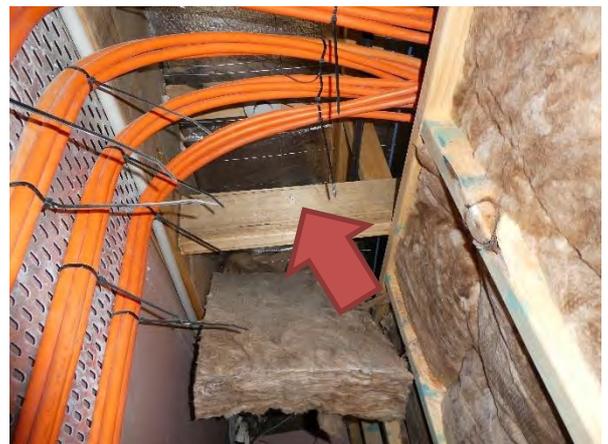
Photograph 2. Services cupboards on the top floor revealed no fire separation extending through to the underside of the roof cladding.

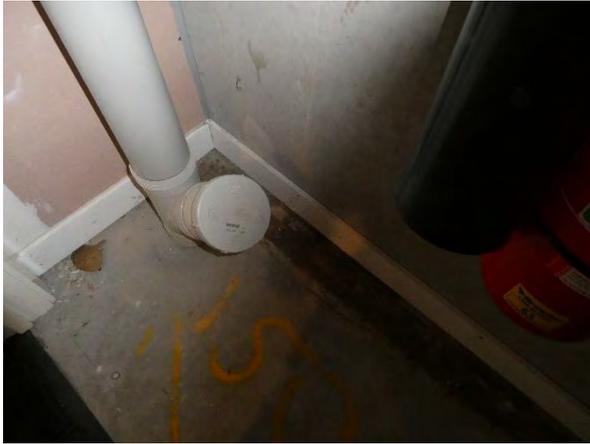
Photograph 3. Base of services cupboards generally found to be fire sealed. Wall plasterboard not fixed at compliant centers.

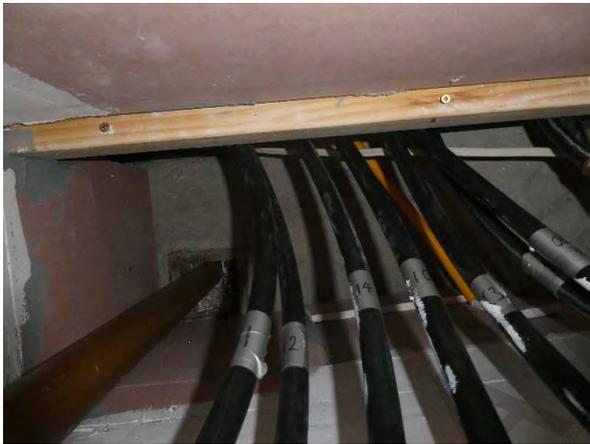
Photograph 5. Large opening in water meter cupboards where pipes branch to individual lots.

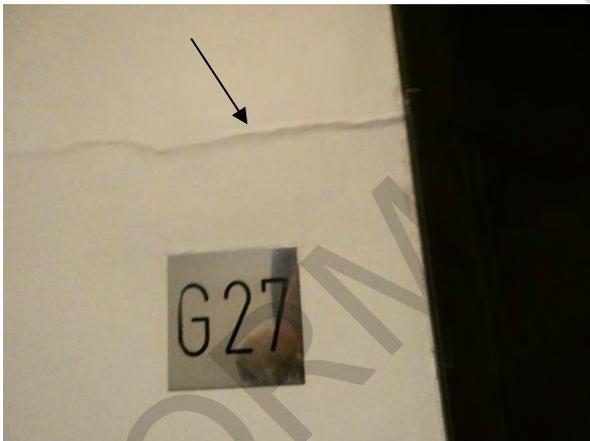
The damage at G27, West elevation of the building is adjacent to the carpark. This building movement extends through all levels of the building, in the same location.

Photograph 7. Building movement has compressed the hallway plasterboard in the location of G27.

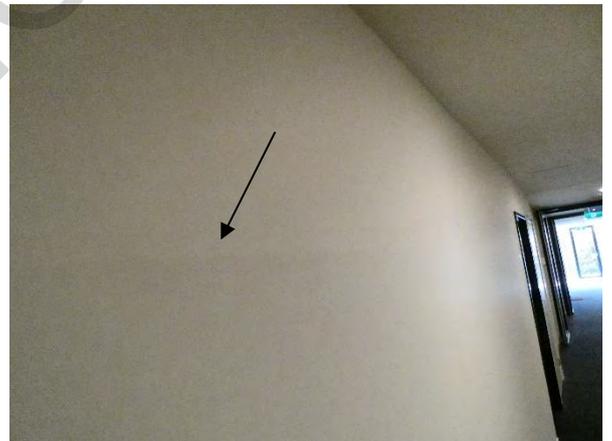
Photograph 8. The plasterboard can be seen with a deflection along the sheet join from compression or building movement. This can be seen from a normal viewing position.

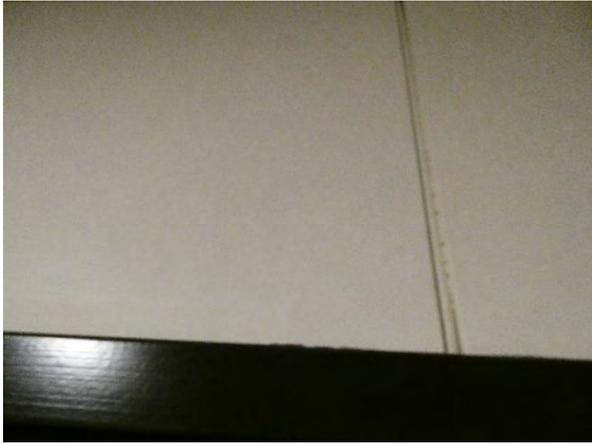
Photograph 9. In the location of G17, there has been retrospective works to install movement control joints.

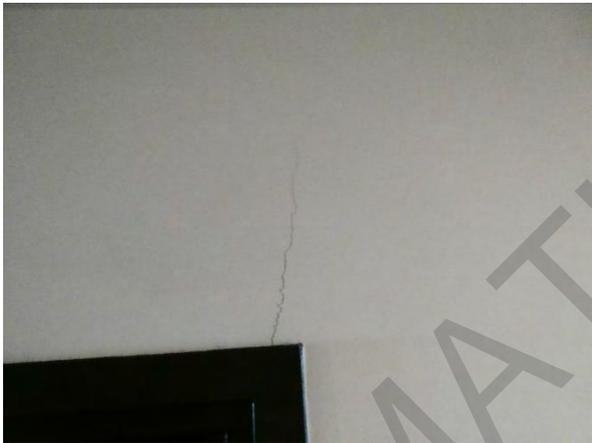
Photograph 11. In the location of 3.23 building movement has caused cracking of the plasterboard at the door entry.

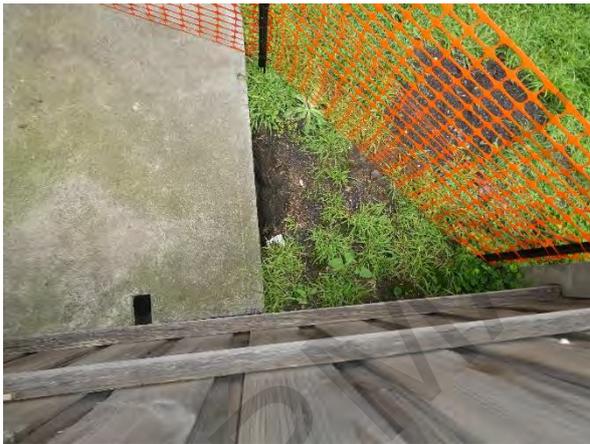
Inspection of the neighbouring property revealed the sink hole is about 400mm deep and extends under the existing concrete path which has likely been in place for more than 60 years.

Photograph 13. Sink hole as viewed from the carpark ramp.

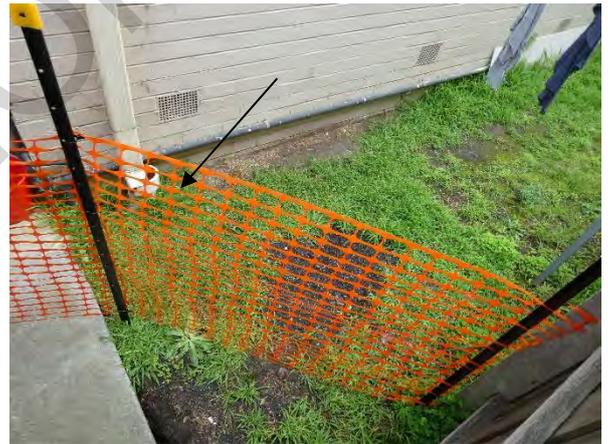
Photograph 14. Stormwater downpipe and drain in the vicinity of the sink hole.

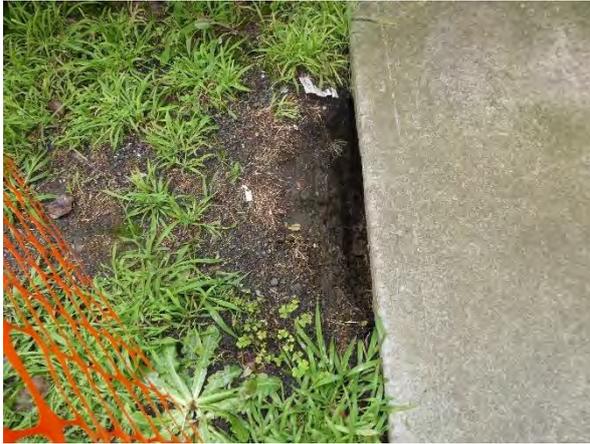
Photograph 15. Sink hole extends under the old existing concrete footpath which remains intact.

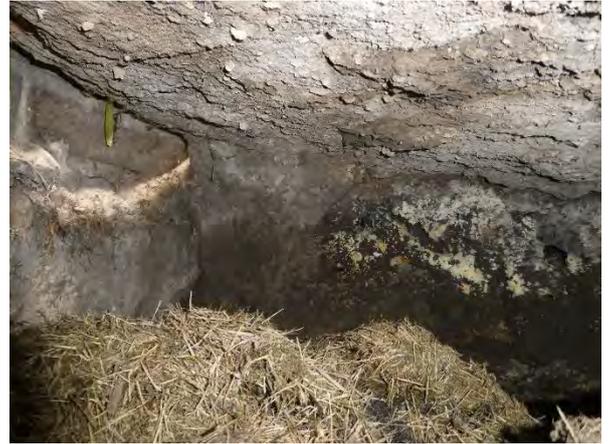
Photograph 16. Sink hole is approximately 400mm deep.

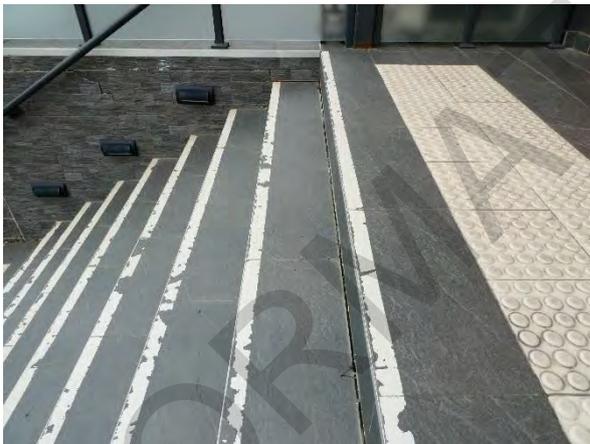
Photograph 19. General view of the external steps at the entry of the building.

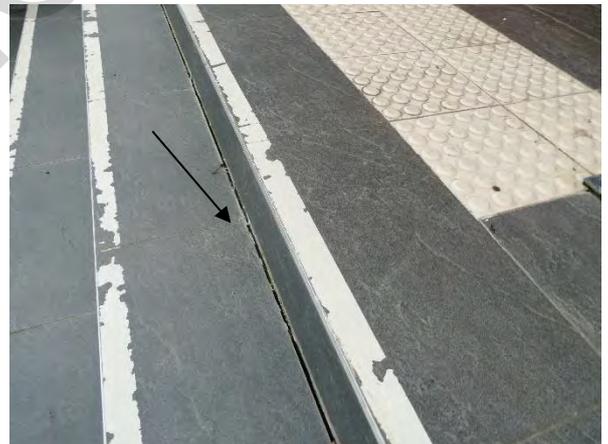
Photograph 20. The steps and the footings supporting them appear to have settled.

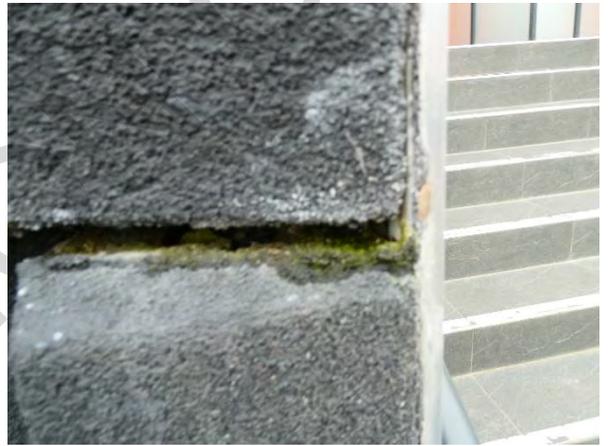
Photograph 24. Footing has separated from terrace slab.

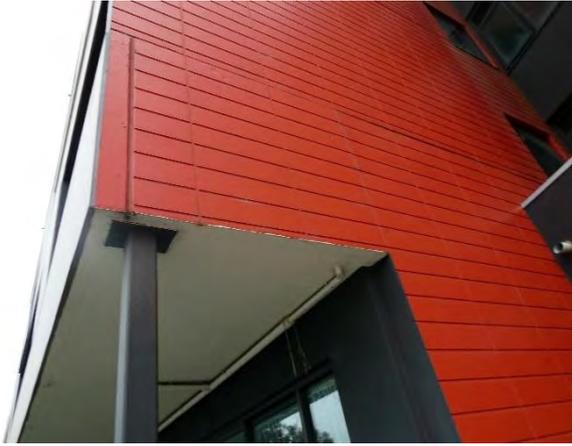
There is a steel post at the top of the stairs which is supporting several floors of the building, the post has surface corrosion at the base.

Photograph 25. Steel post supporting several floors of the building.

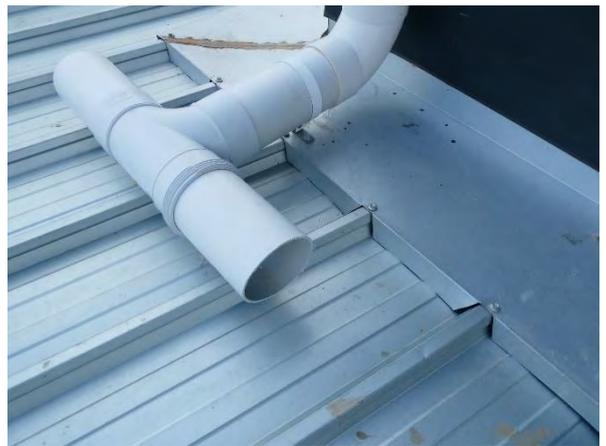
Photograph 28. Downpipe spreader does not comply with HB39.

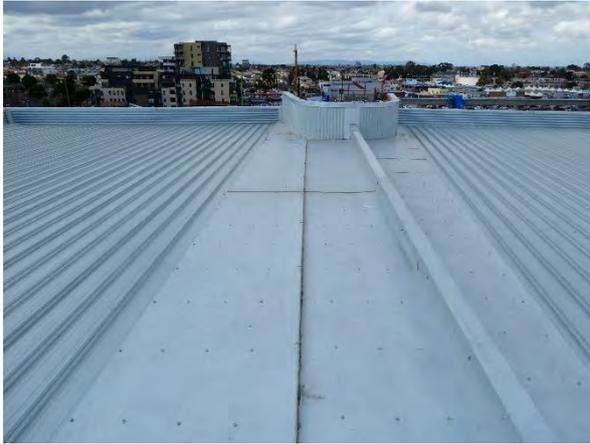
Photograph 29. Oversized and joined apron flashing.

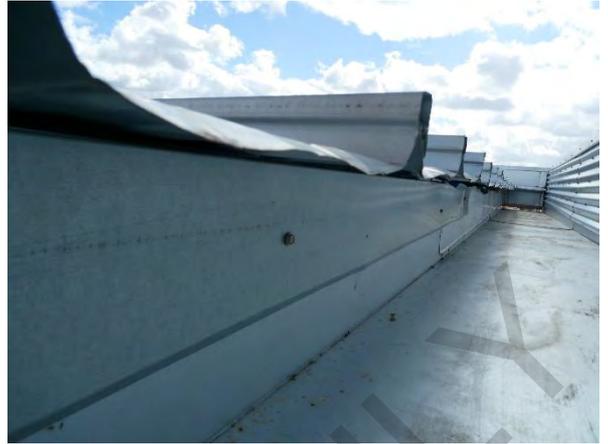
Photograph 30. Lack of turn down angle on the roof sheets in some locations.

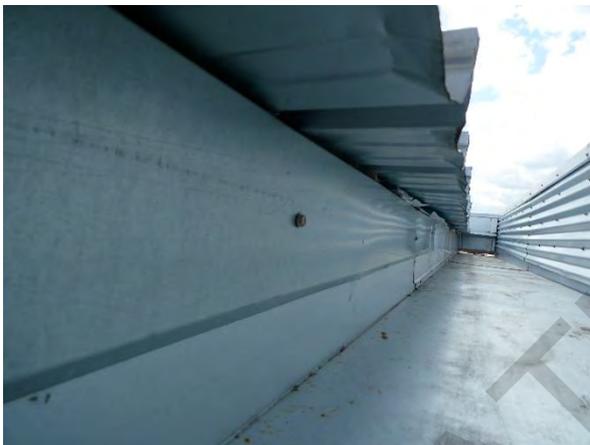
Photograph 31. Appears there has been a retrospective flashing installed to cover the roof framing.

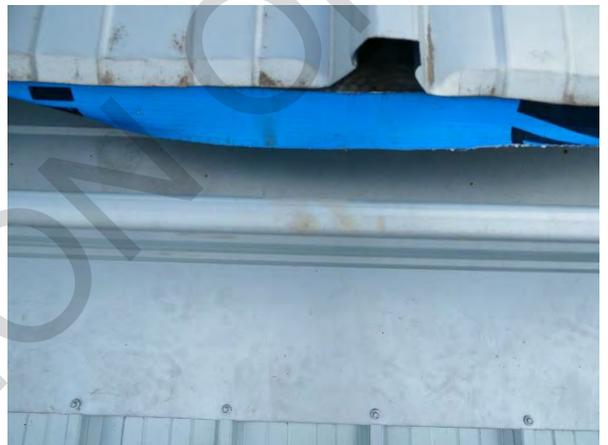
Photograph 32. Roof sarking extends into gutter. Whilst the sarking should emanate from under the roof sheets, it should not extend into the gutter as it allows water into the building via capillary action.

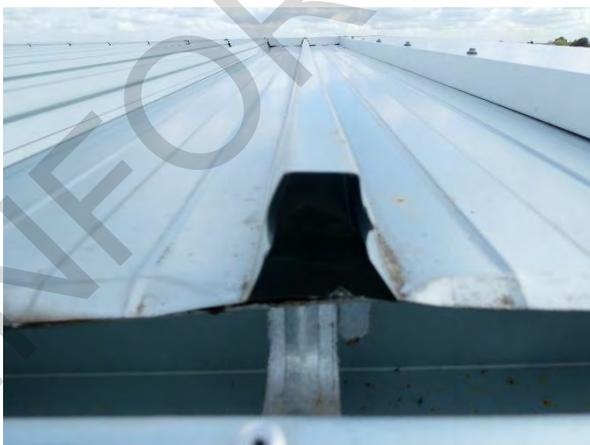
Photograph 33. Flat smaller roofs allow stormwater into the building via the rib ends.

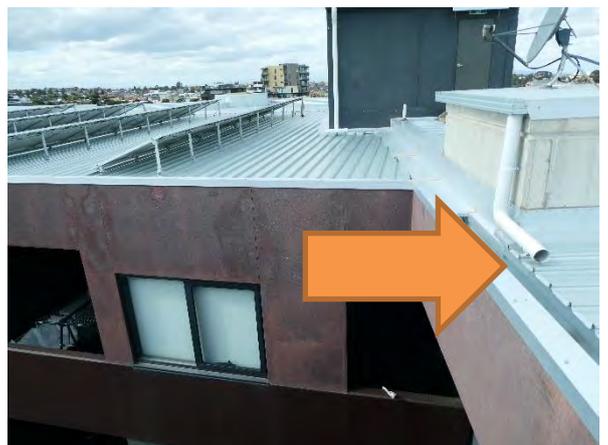
Photograph 34. Downpipe spreader discharges stormwater directly into the ribs of the roof.

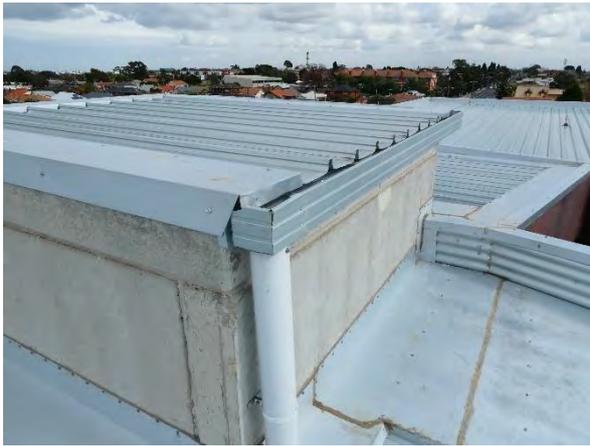
Photograph 35. Small roof constructed with little to no fall.

The roof cladding and stormwater system, whilst reasonable, has not been constructed in accordance with AS/NZS 3500.3, HB-39 – 1997 or good building practice and has allowed moisture to enter the building.

I recommend the committee consider the engagement of a plumbing consultant that could provide a report for submission to the Victorian Building Authority Plumbing Industry Commission to enable them to investigate the identified issues.

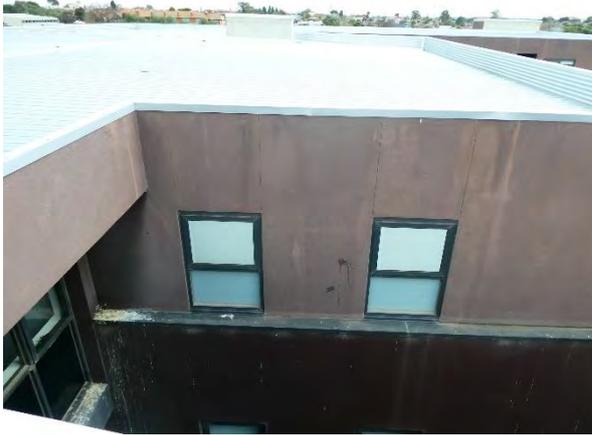
Photograph 37. General view of the lightweight cement sheet external cladding.

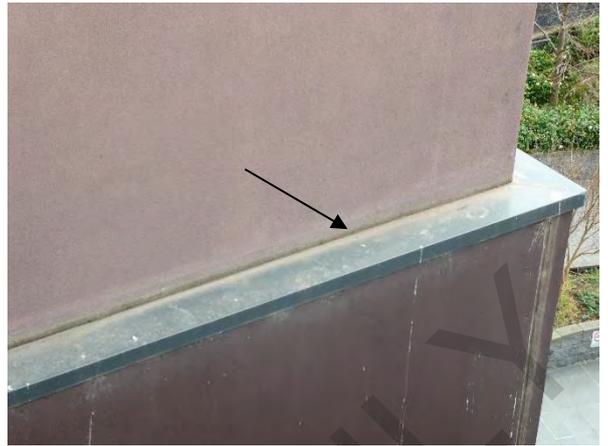
Photograph 38. All the lightweight cement sheet has been sealed at the base.

Sealing the cladding at the base of the walls and to the heads of window and sliding door frames prevents any moisture within the wall cavity from discharging away from the building, instead water is directed back into the building which is causing water damage to perishable building elements within the building.

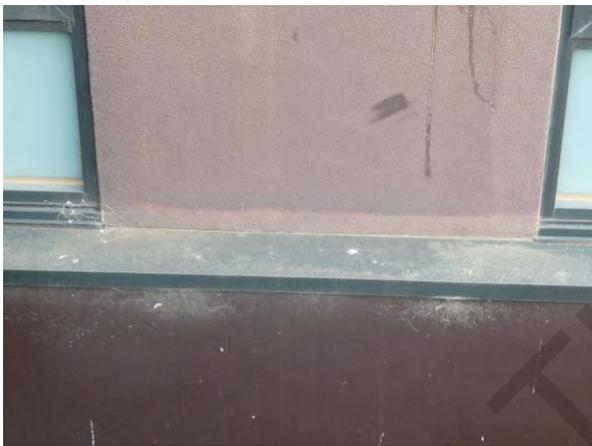
Photograph 39. Further view of the cement sheet sealed at the base.

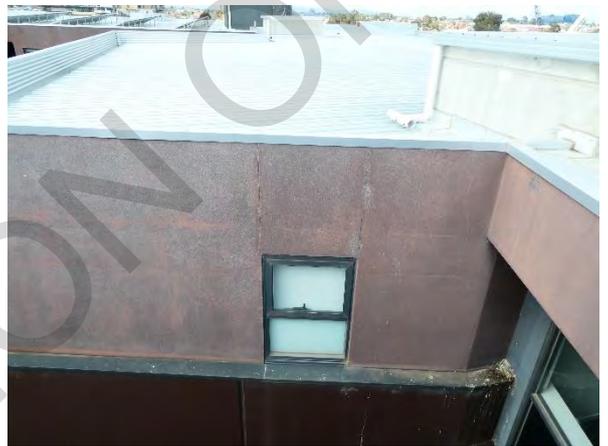
Photograph 40. Joints in the sheet can be seen through the thin render coat and the sheets have been installed horizontally.

Installing sheets horizontally is not recommended by the manufacturer as these joints can open up and allow moisture directly into the wall cavity.

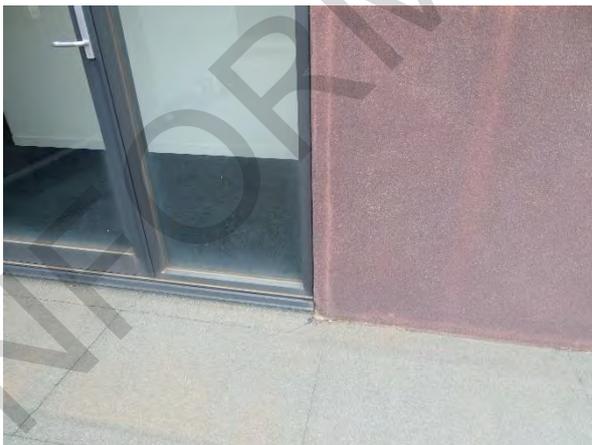
Photograph 41. Cement sheet cladding has been sealed at the base of terraces and balconies.

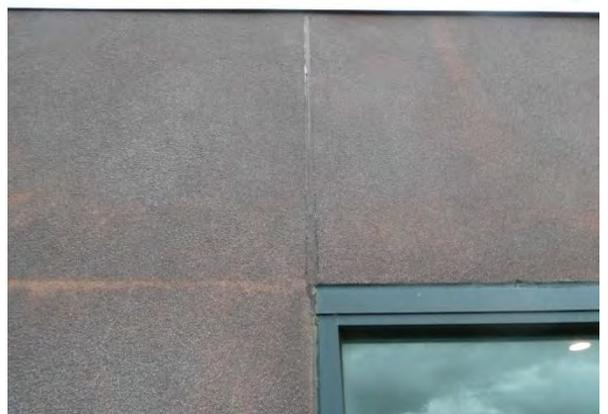
Photograph 42. Articulation joint has split open allowing moisture into the wall cavity which has been sealed at the base. Horizontal joint in the sheet also visible.

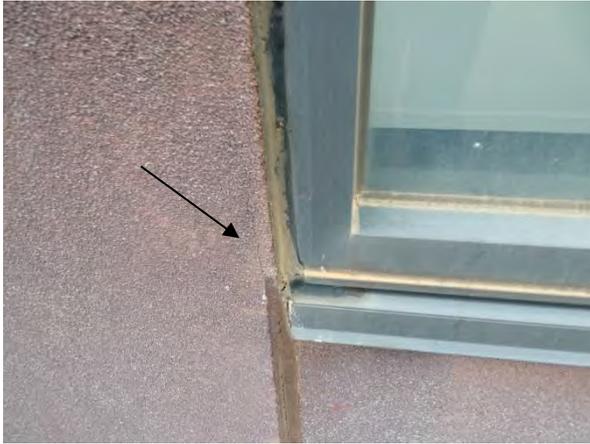
Photograph 43. Articulation joint has split open, and cracks have developed in the render coat. This allows moisture into the wall cavity where it is sealed at the base.

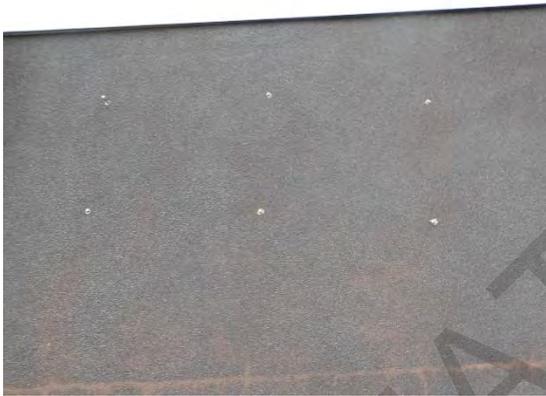
Photograph 45. Poorly installed fixings are delaminating from the material which may evidence a lack of fire rating behind the cladding.

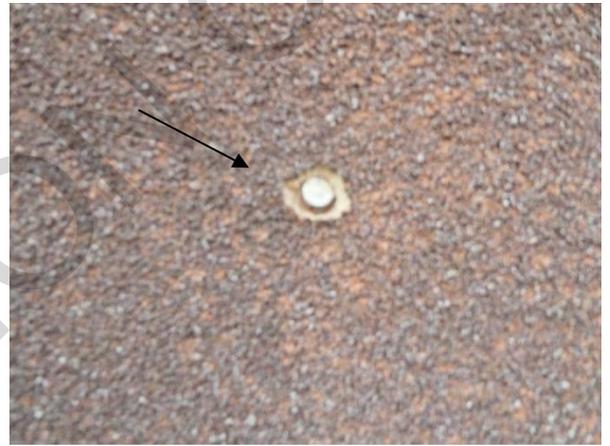
Photograph 46. Fixing has popped from the cladding taking the thin render coat with it.

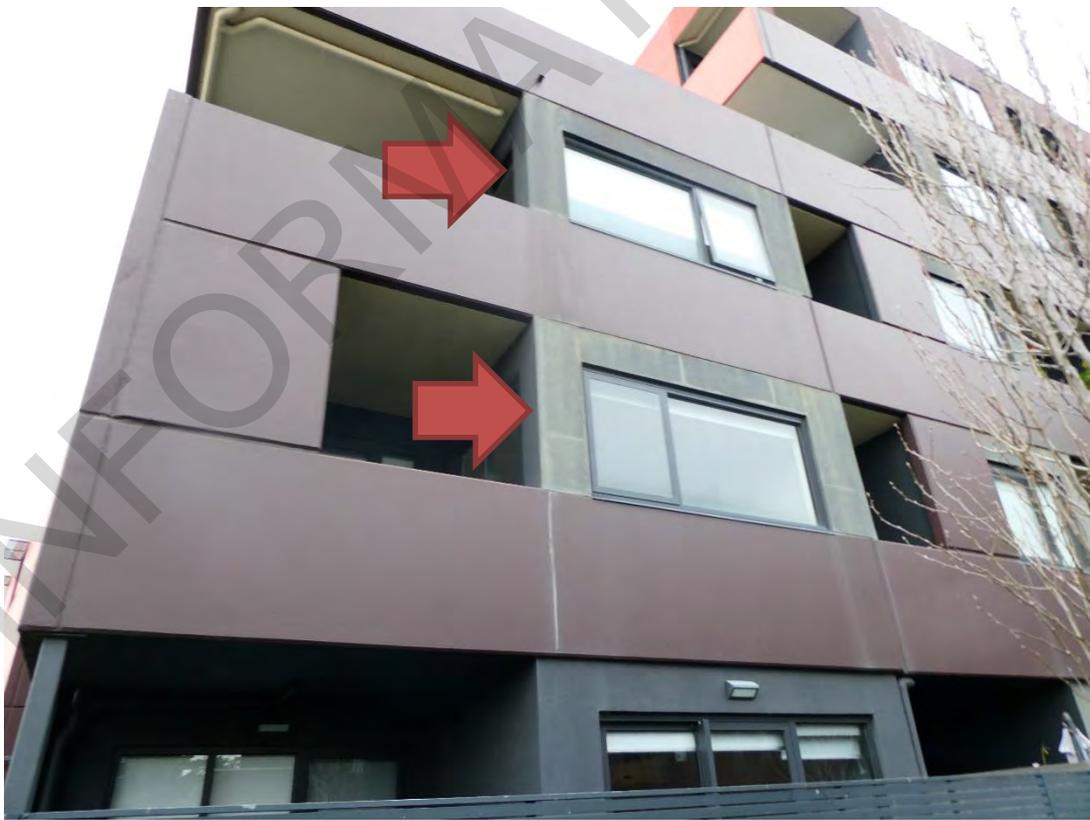
There is an unknown cladding on the building as highlighted below. The plans appear to illustrate this was to be a metal cladding, but a rendered board has been instead. This could be combustible foam cladding.

This cladding should be investigated for compliance with the approved plans and to ensure it is non-combustible. A fire safety engineer may be required for investigation.

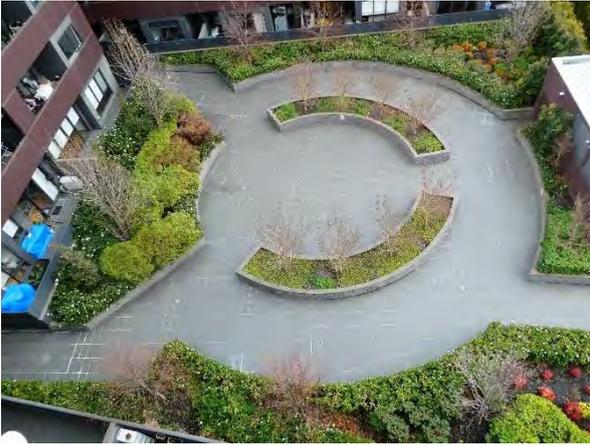
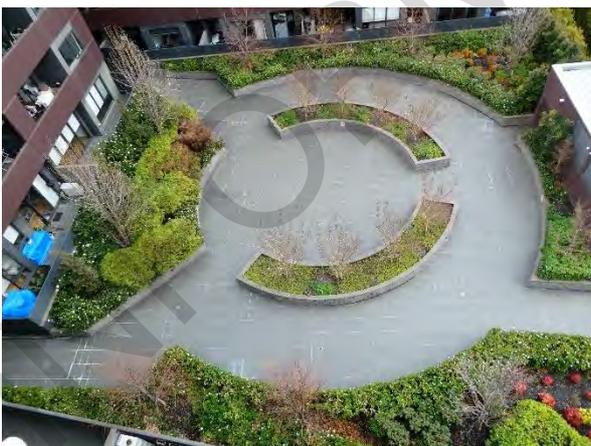
Photograph 47. General view of the common property terrace.

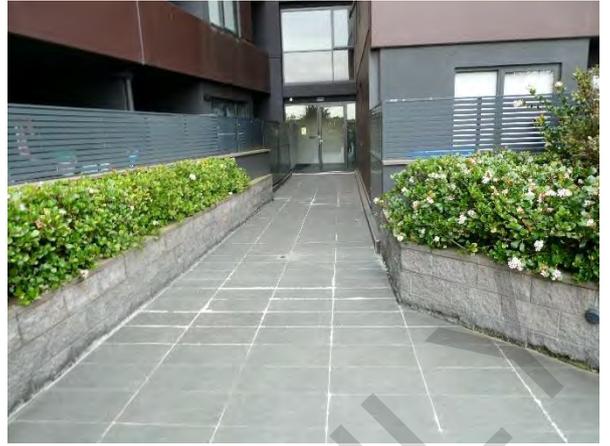
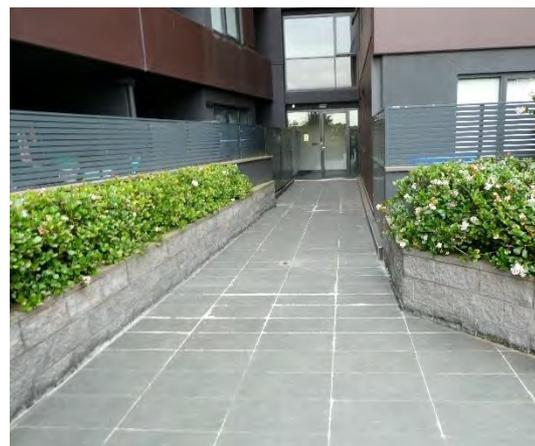
The large expansive terrace and concrete slab substrate under does not have enough fall to the outlets. The drains are also significantly undersized which causes stormwater to pond on the surface of the tiling eventually saturating the grout, screed, and adhesive of the tiling system. Whilst I was unable to inspect the privately owned terrace at the Southeast corner of the building, it is likely the conditions are identical.

Photograph 48. The terrace is a large expanse of floor tiles which has very small drain outlets.

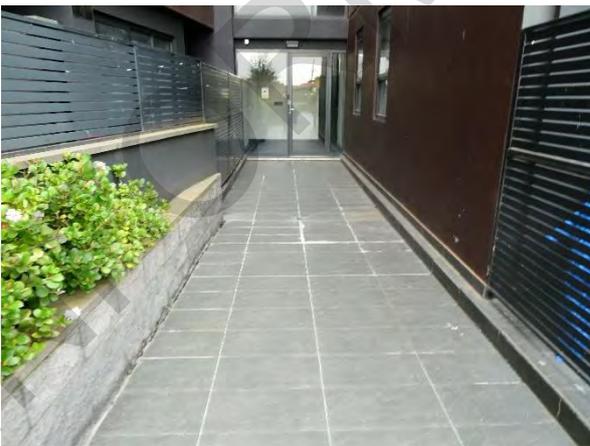
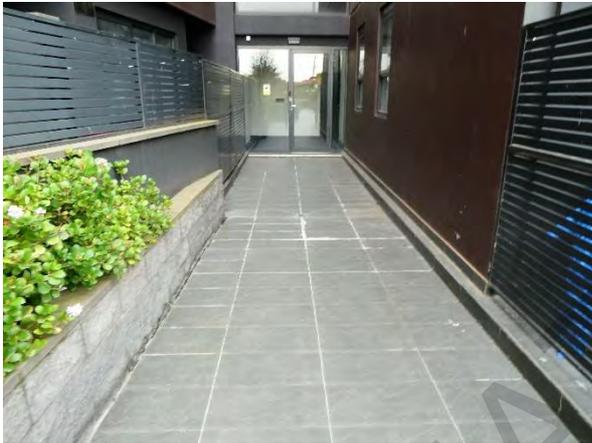
Photograph 51. There is a lack of fall to the outlets, which are undersized.

The terrace has not been constructed in accordance with the BCA or its referenced standard AS4654.2 - 2012 which requires all external terraces and decks to have a minimum 1 in 100 fall or gradient away from the building to appropriately sized drains. The expansive terrace in the middle of the property allows ponding of surface stormwater around undersized drains. This causes saturation of the screed/adhesive via the porous grout.

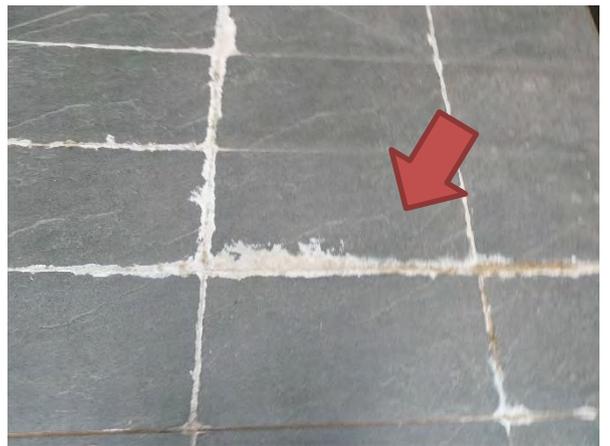
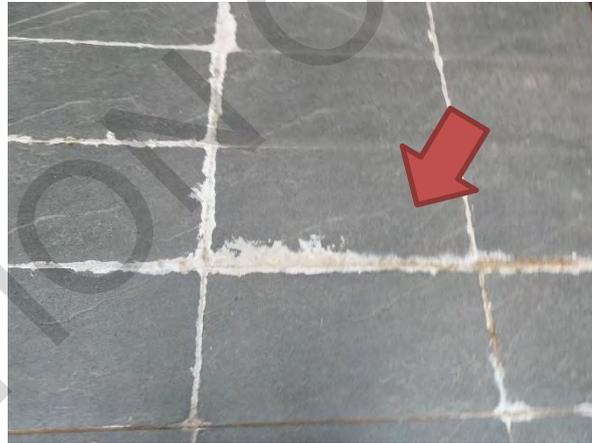
The saturation of the terrace substrate is causing excessive efflorescence to form in the grout lines across the terrace. Whilst a waterproof membrane is in place, the termination around the drains and drains within the planter boxes have failed causing salt laden moisture to leech into the basement carpark.

Photograph 52. Further view of the efflorescence emanating from the grout lines.

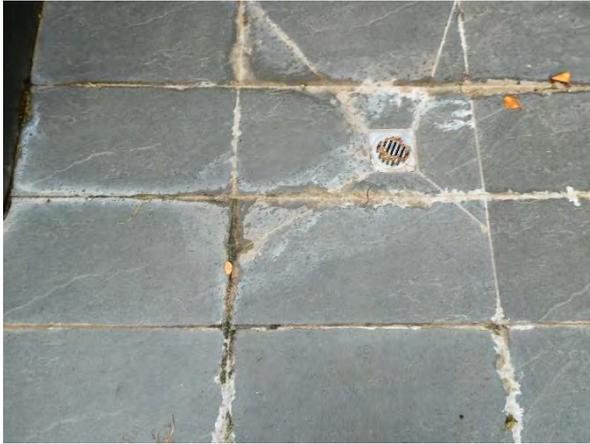
Photograph 53. There is efflorescence around drain penetrations, the drains are undersized, and the saturation of the screed and adhesive continues to keep the upper efflorescence wet.

The terraces and balconies are constructed almost flat with little to no fall to the undersized drains.

The drains do not have a waterproof membrane extending into the throat of drain to protect the penetration through the slab.

Failure to construct a compliant fall allows moisture to pond under the tiling for prolonged periods as evidenced by the efflorescence in grout lines. The prolonged exposure to moisture has likely emulsified the waterproof membrane at the drain termination, allowing moisture to enter the basement below through the penetration in the slab.

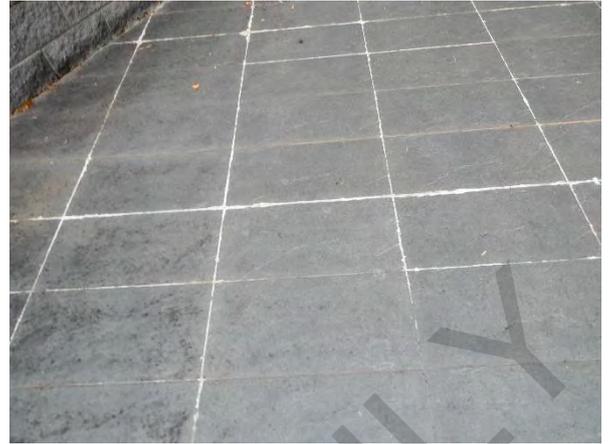
Photograph 54. There are expansion joints in the tiling, however these exceed 4.5m in each direction.

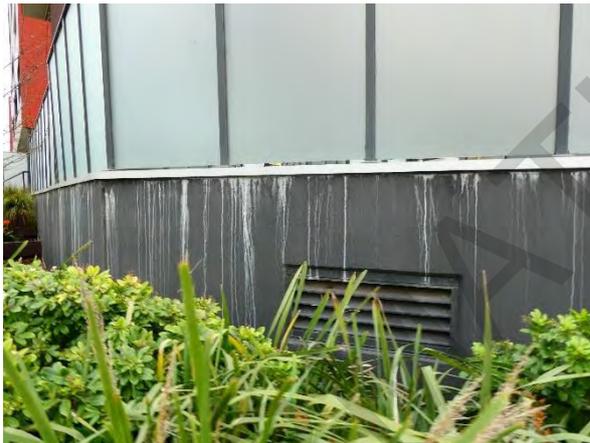
Photograph 55. Private lot terrace at the Southeast corner of the building, the terrace is leeching efflorescence down the façade of the building and into the basement below.

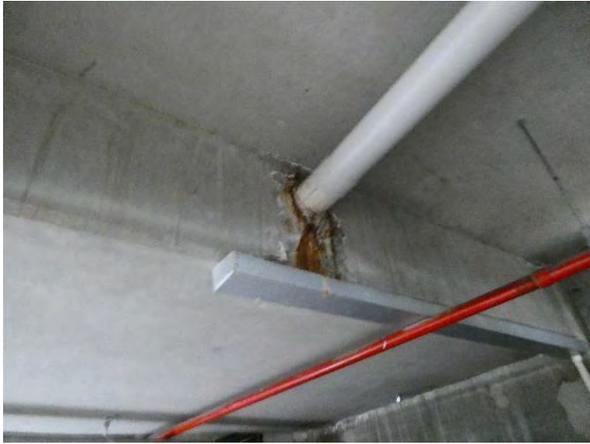
The water leeching into the basement has not been halted and there has been attempts to control the damage to surfaces under these locations with the placement of stainless-steel trays, these trays do not provide a long-term solution to the failed membranes on the terrace and within planter boxes.

Photograph 57. Stainless steel drip trays installed to capture salt laden moisture entering the basement.

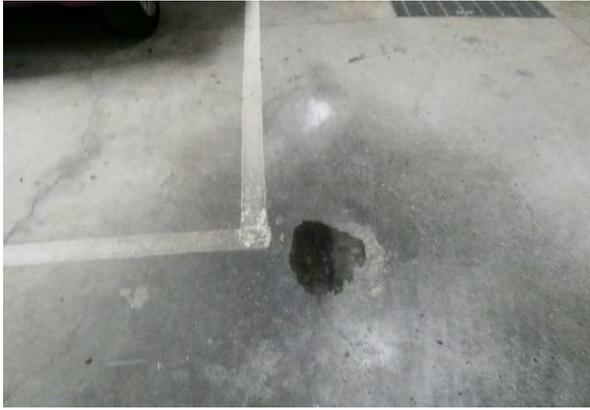
Efflorescence stains surfaces including permanently damaging the paint surface of vehicles.

Photograph 61. Salt laden deposits on the floor of the basement. The salts stain surfaces permanently including vehicle paint.

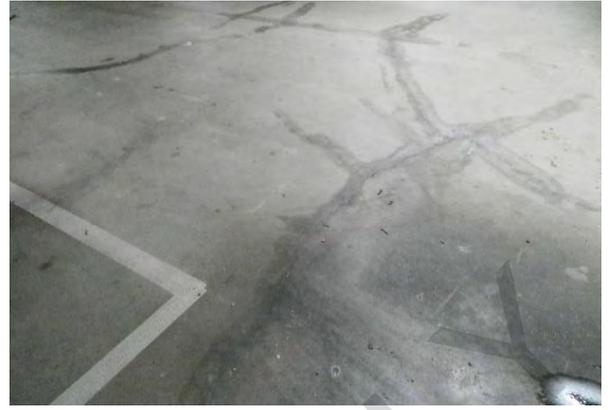
Photograph 62. Cracks in the concrete infill slab have been filled with an epoxy sealant, these are most likely usual shrinkage cracks, but should be commented on by a structural engineer.

An opinion from a structural engineer is required in relation to the long-term damage to steel reinforcement within the concrete from prolonged exposure to moisture.

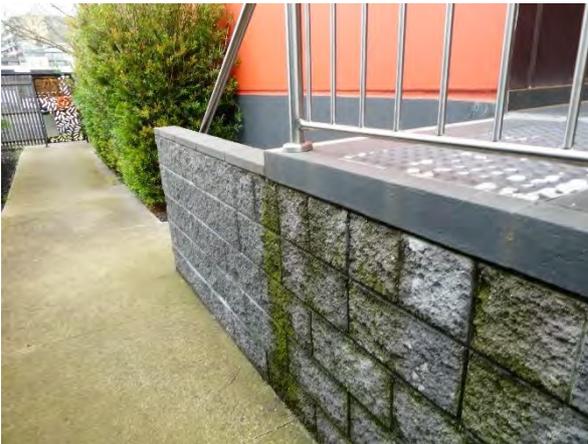
- The footing supporting the stair and entry appears to be ‘sinking’ or settling.
- The terrace has been constructed flat with no fall away from the building. This allows water to pond on the floor tiles causing efflorescence.
- The failure to construct a compliant hob/freeboard is allowing stormwater to enter the building.

Photograph 63. North entry stairs to the building. There is water emanating from under the tiling and leeching down the wall.

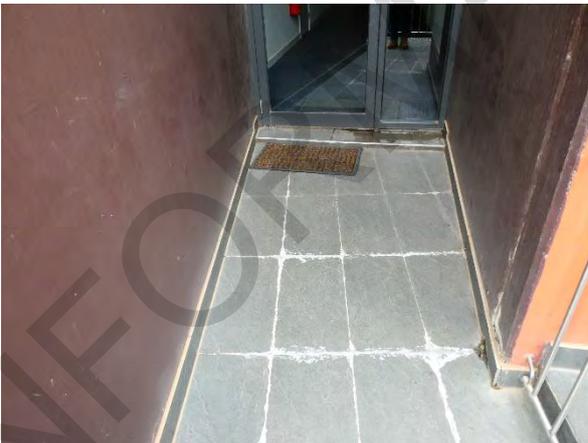
Photograph 65. Entry to the building, there is no fall on the tiling away from the building and prolonged exposure to moisture has caused efflorescence to form in the grout joints.

There is no fall on the landing, therefore stormwater is permitted to pond on the surface causing the grout, adhesive, and screed to be saturated with stormwater. The prolonged exposure to moisture has caused efflorescence to form in the grout lines and water can be seen leeching down the face of the bluestone wall forming the stairs.

Water entry into the building was observed. Efflorescence, which is a building defect as detailed in the Victorian Building Authority's Guide to Standards and Tolerances, is evident throughout the entry floor tiling.

The floor tiles are to be removed and replaced, a compliant hob/freeboard to be constructed and an appropriate waterproof membrane installed.

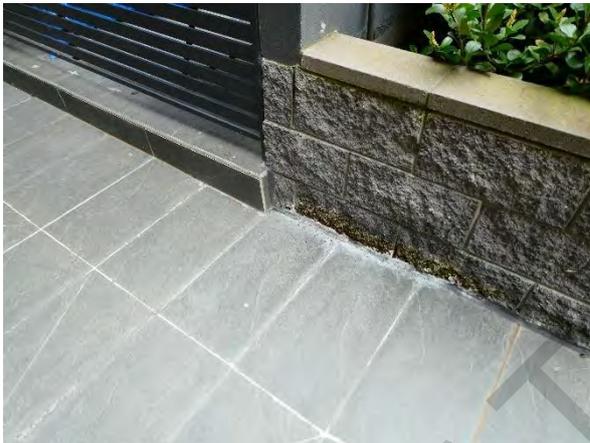
The same poor detail is evidenced in other locations around the building with water able to leech from planter boxes and the base of external walls.

Photograph 67. Damp blockwork from prolonged exposure to moisture.

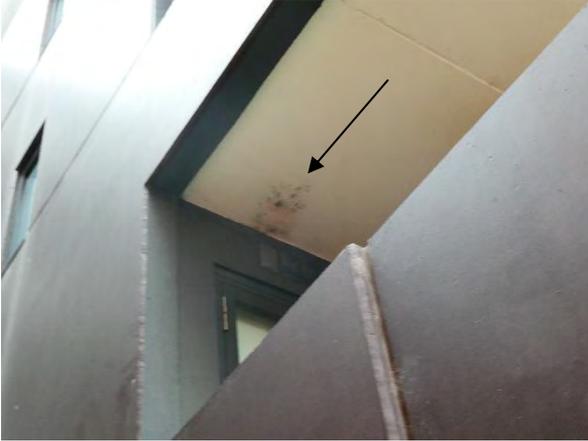
I noted what appears to be evidence of mould and water staining of a soffit under an external balcony.

Photograph 69. Staining evident on the soffit under a balcony.
