388-390 Murray rd Preston

Job- Investigate video footage of water bubbling out of front steps.

## RE: Site Investigation at 388 Murray Road, Preston

A site investigation was undertaken on 15 August 2025. The purpose of the investigation was to provide remedial recommendations for two external stairs.

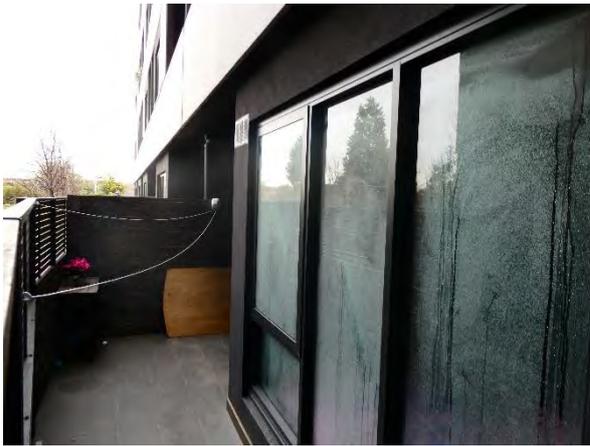
There is condensation evident at the building.

Photograph 70. General example of condensation noted on windows/sliding doors.

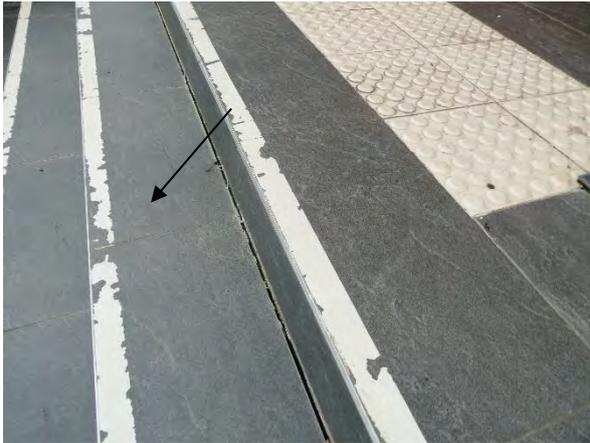
Whilst technically a maintenance item, the tactile markers on all stairs and ramps have delaminated in part and require replacement.

I highlight this as it is a health and safety issue for occupants and visitors to the building and this could impact the OC insurance for the building.

Photograph 72. Tactile indicators required replacement.

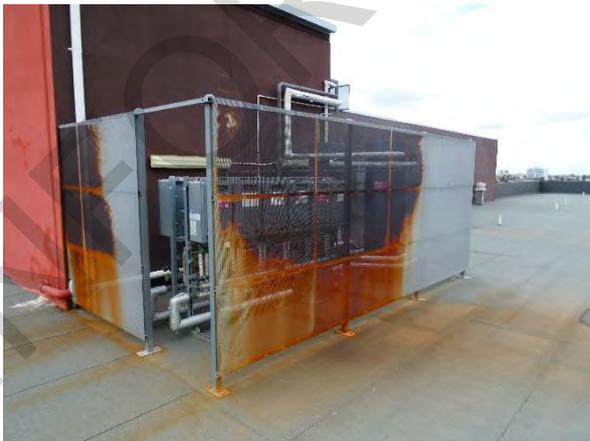
The screens protecting the hot water services have been damaged by the heat emitted from the units. The screens are corroding and staining adjacent surfaces, I do not consider these to be fit for purpose and should be replaced.

Photograph 73. Heat damaged screens.

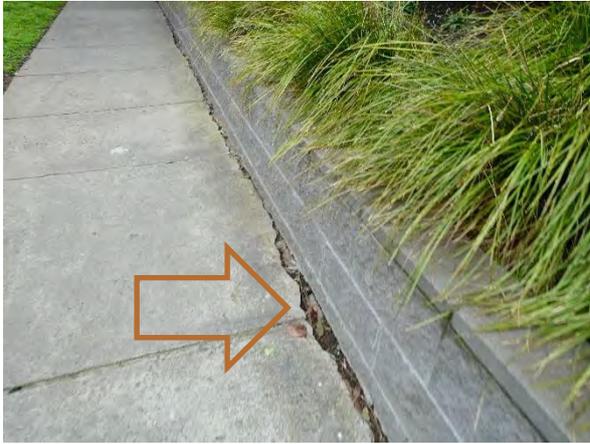
Post construction, the footpath was not reinstated in a proper and workmanlike manner.

In my opinion, the builder was obligated to return Council property back to the condition it was in prior to construction.

Photograph 74. Damaged concrete footpath remains post construction.

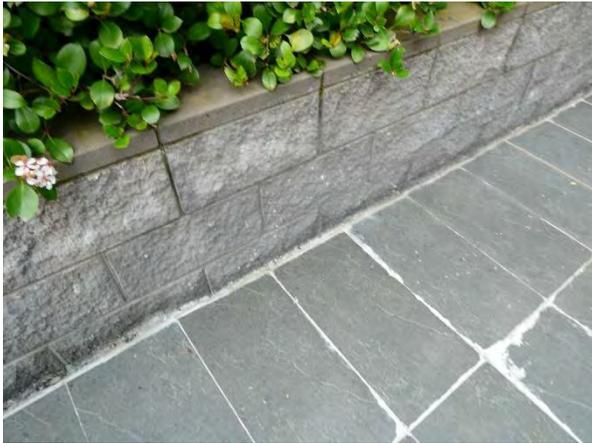
Planter boxes allow moisture to egress at the base of the blockwork walls indicating the membrane is either not compliant or has failed. Consideration to a thicker more robust water proofing system needed to be considered by the builder due to the aggressive tree root systems planted at the property.

*Photograph 49. The planter boxes have been poorly constructed allowing moisture to exit at the base of the wall.*

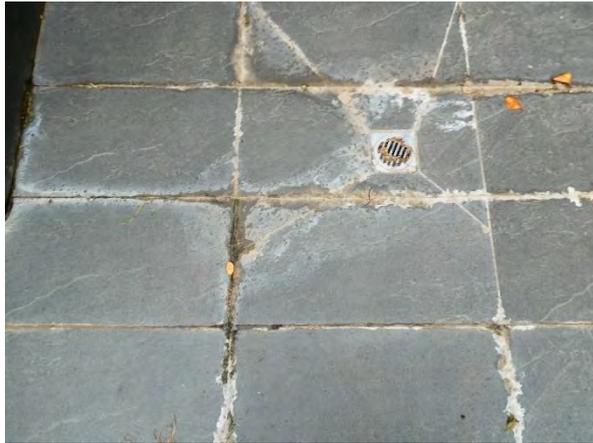
*Photograph 53. There is efflorescence around drain penetrations, the drains are undersized, and the saturation of the screed and adhesive continues to keep the upper efflorescence wet.*

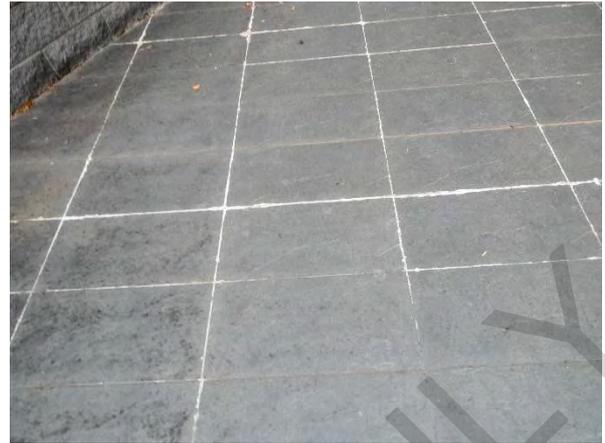
*Photograph 54. There are expansion joints in the tiling, however these exceed 4.5m in each direction.*

*The terraces and balconies are constructed almost flat with little to no fall to the undersized drains.*

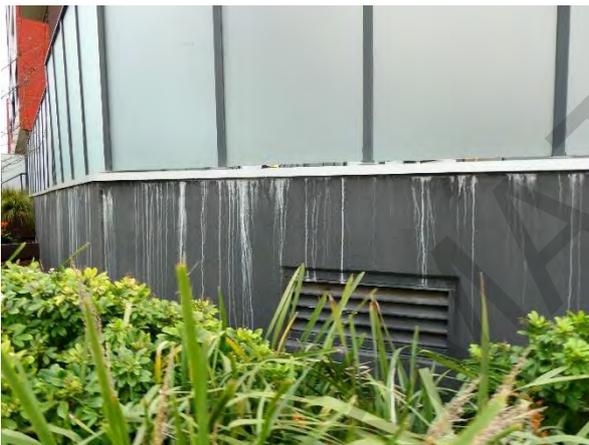
*Photograph 55. Private lot terrace at the Southeast corner of the building, the terrace is leeching efflorescence down the façade of the building and into the basement below.*

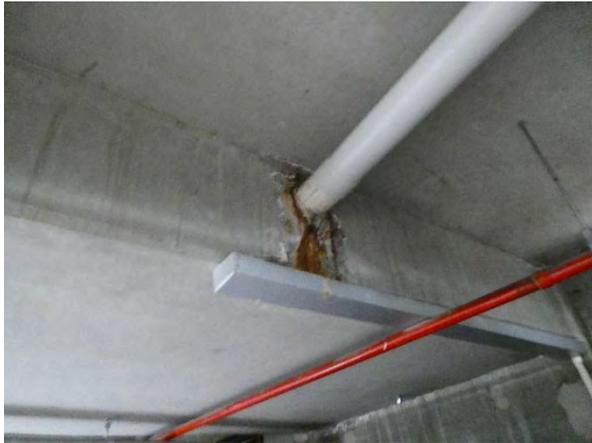
The water leeching into the basement has not been halted and there has been attempts to control the damage to surfaces under these locations with the placement of stainless-steel trays, these trays do not provide a long-term solution to the failed membranes on the terrace and within planter boxes.

Photograph 57. Stainless steel drip trays installed to capture salt laden moisture entering the basement.

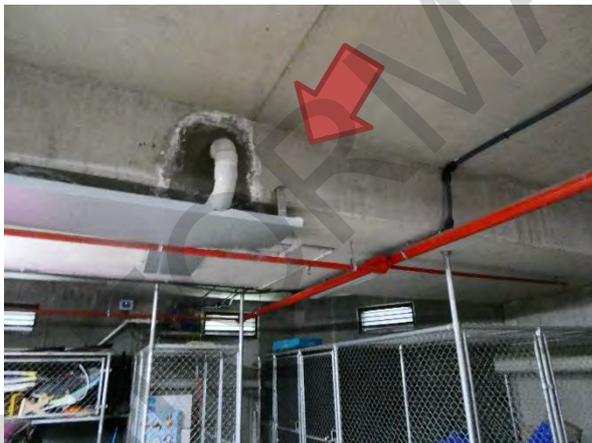
Photograph 59. Active water leak into the basement. These salt laden salt stain surfaces.

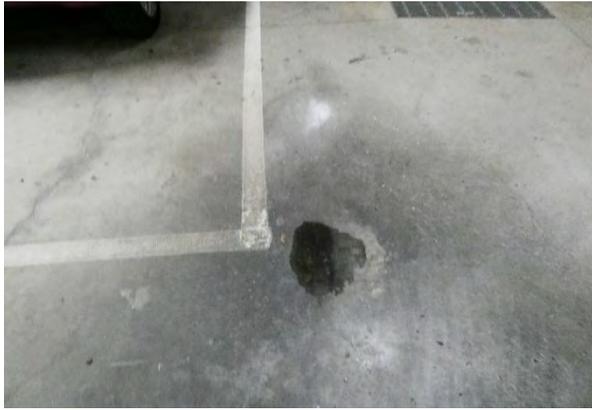
*Photograph 61. Salt laden deposits on the floor of the basement. The salts stain surfaces permanently including vehicle paint.*

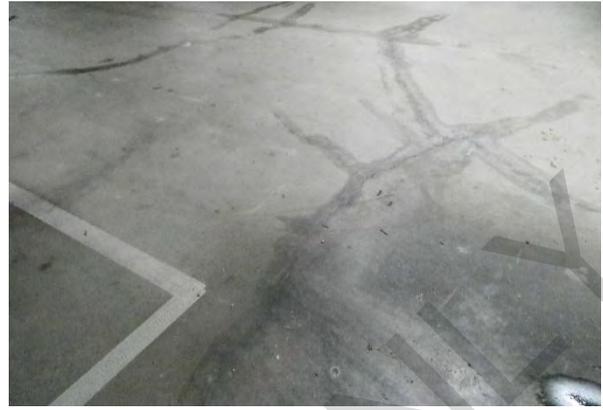
*Photograph 62. Cracks in the concrete infill slab have been filled with an epoxy sealant, these are most likely usual shrinkage cracks but should be commented on by a structural engineer.*

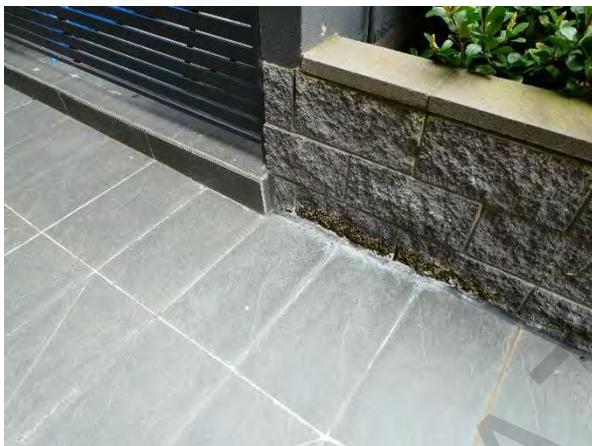
*The base of blockwork has no flashing installed and/or a rebate that prevent lateral transfer of water into wall cavities or does not prevent moisture egressing the planter boxes.*

*Photograph 67. Damp blockwork from prolonged exposure to moisture.*

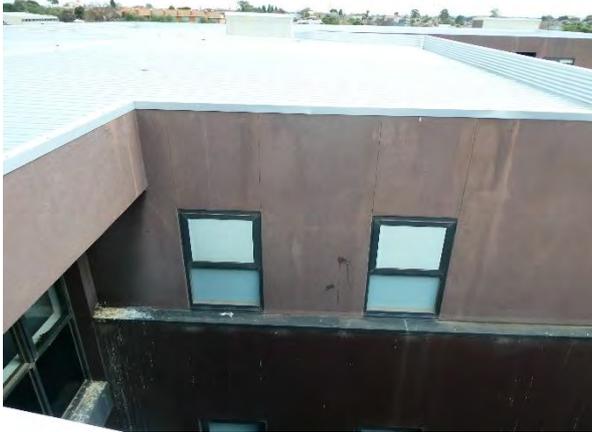
Photograph 37. General view of the lightweight cement sheet external cladding.

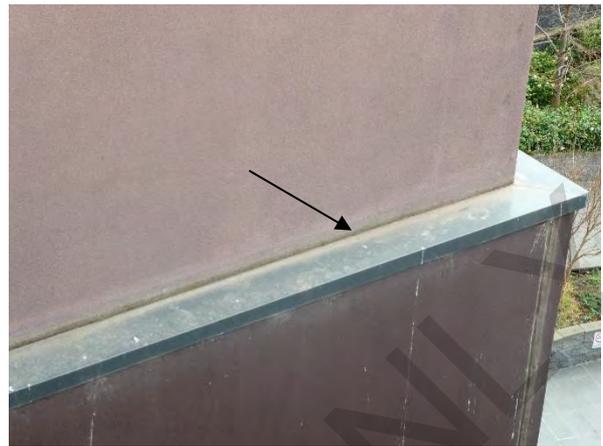
Photograph 38. All the lightweight cement sheet has been sealed at the base.

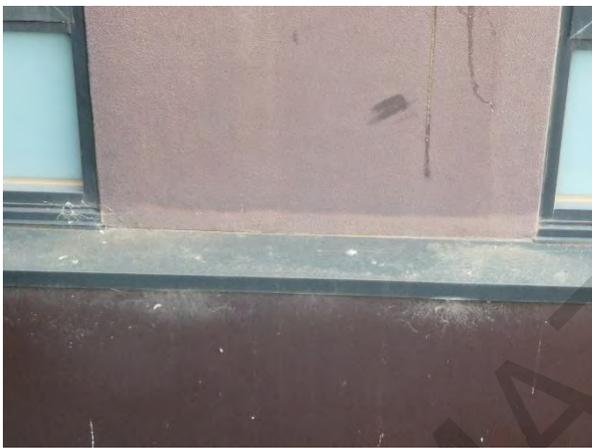
Photograph 39. Further view of the cement sheet sealed at the base.

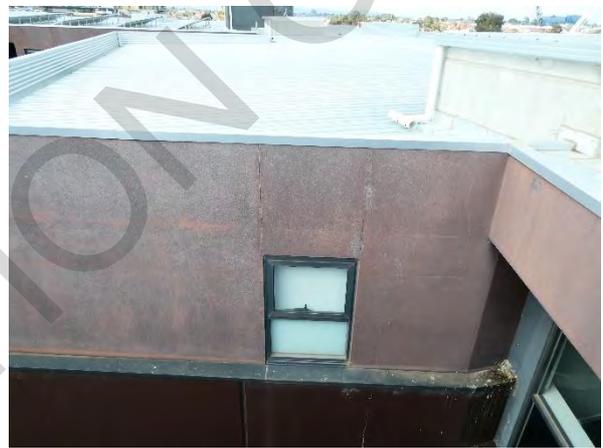
Photograph 40. Joints in the sheet can be seen through the thin render coat and the sheets have been installed horizontally.

*Horizontally installing sheets is not recommended by the manufacturer as these joins can open up and allow moisture directly into the wall cavity.*

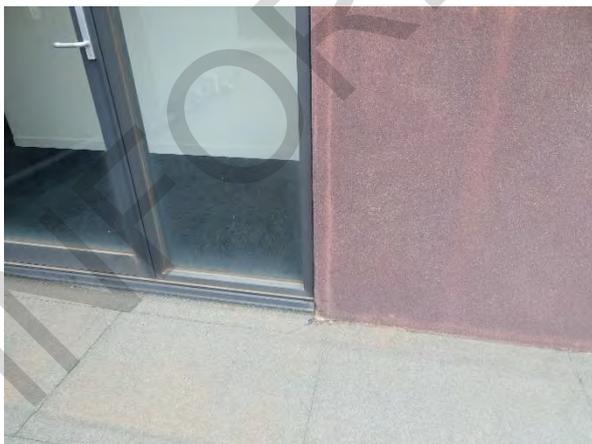
Photograph 41. Cement sheet cladding has been sealed at the base of terraces and balconies.

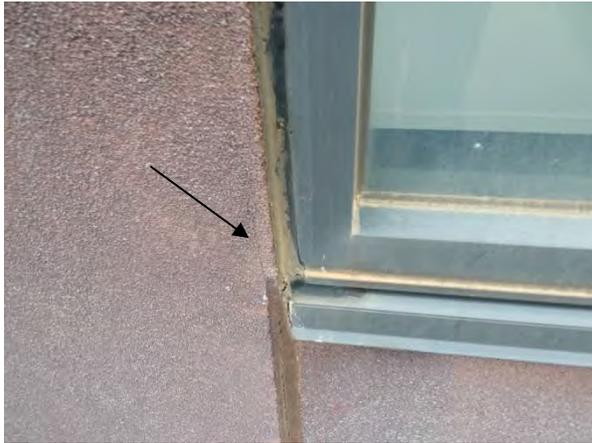
Photograph 43. Articulation joint has split open, and cracks have developed in the render coat. This allows moisture into the wall cavity where it is sealed at the base.

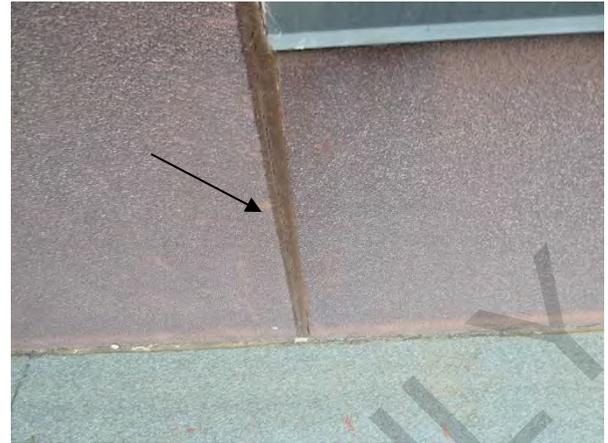
Photograph 44. Closer view, sealant split open, material sealed at the base.

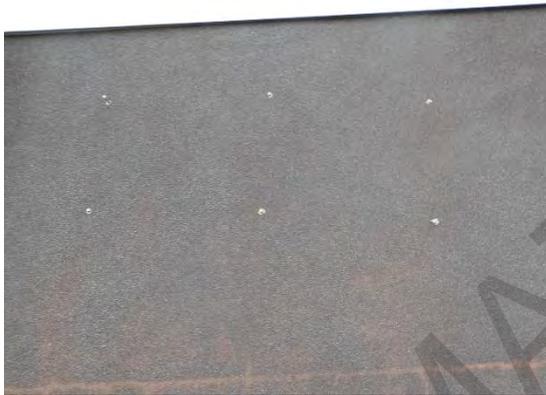
Photograph 45. Poorly installed fixings are delaminating from the material which may evidence a lack of fire rating behind the cladding.

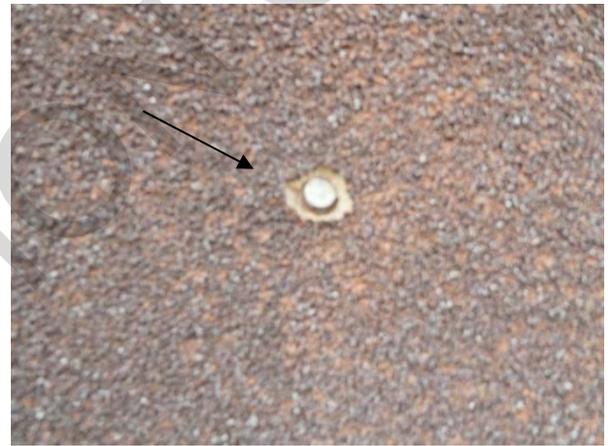
Photograph 46. Fixing has popped from the cladding taking the thin render coat with it.

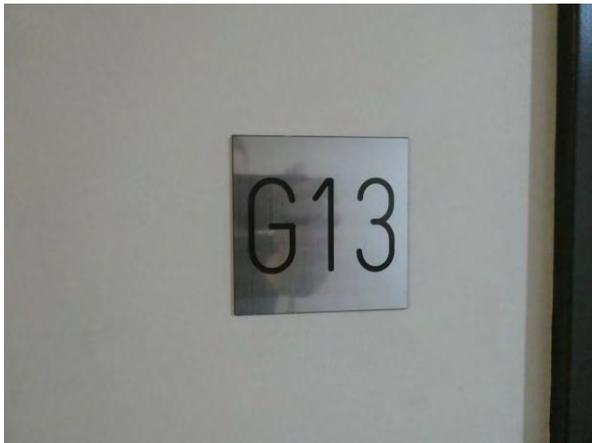
Photograph 1. Apartment G13. The occupant reported previous water ingress.

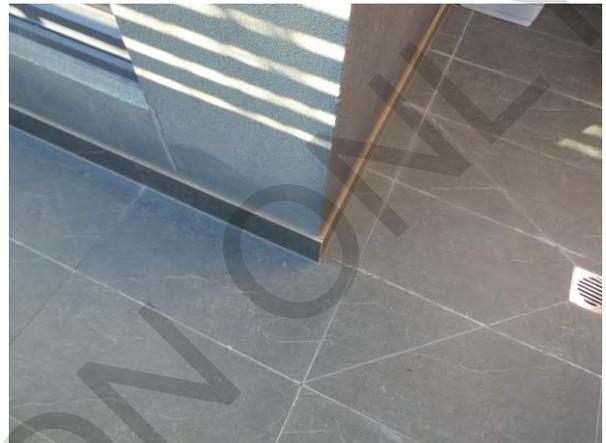
Photograph 2. The EPS foam cladding is sealed at the base.

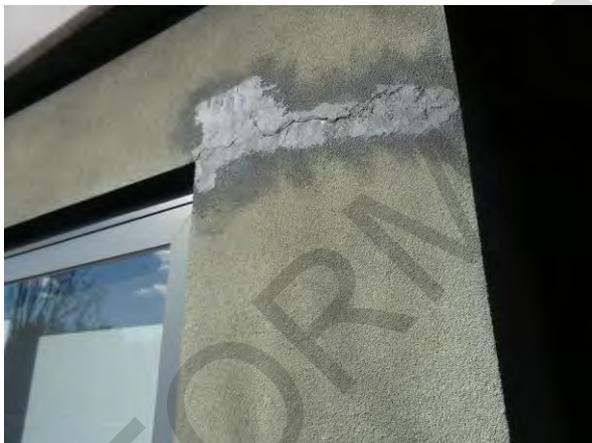
Photograph 3. I understand from the occupant a representative of the builder attended the property and 'patched' the cracks in the render applied to the EPS foam cladding.

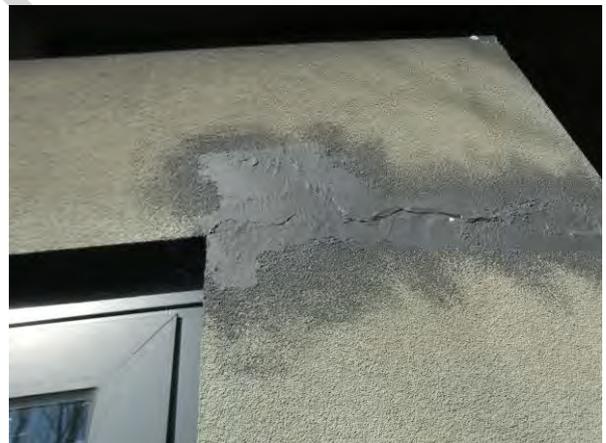
Photograph 4. The rectification appears to be temporary as it is a poor finish and does not match the render color.

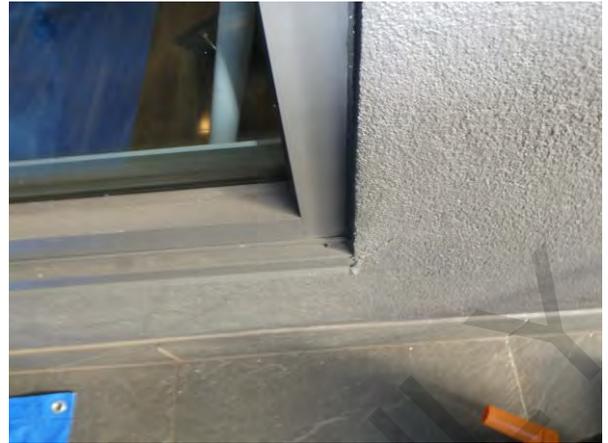
Photograph 6. The EPS foam cladding is sealed at the base.

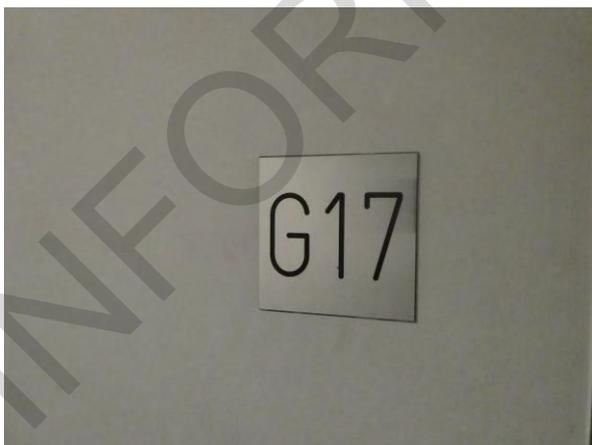
Photograph 9. I inspected apartment G17. The occupant had previously reported waster ingress at the base of North facing external walls.

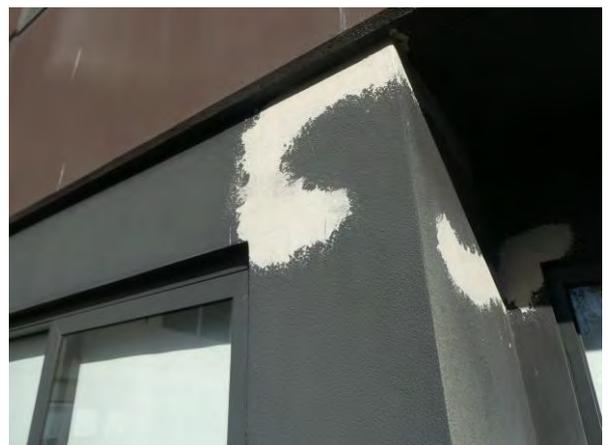
Photograph 10. Poorly patched external cladding.

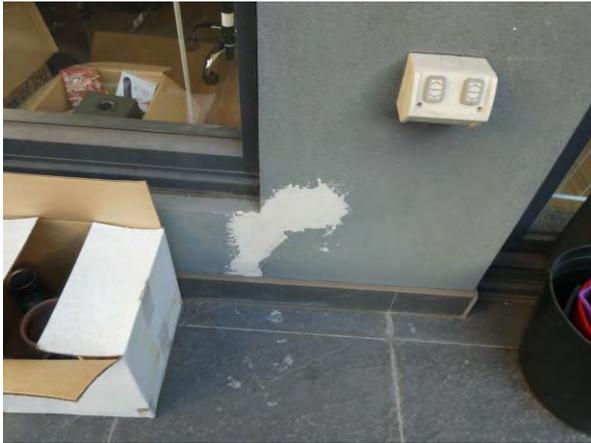
Photograph 11. Poorly patched external cladding under the window.

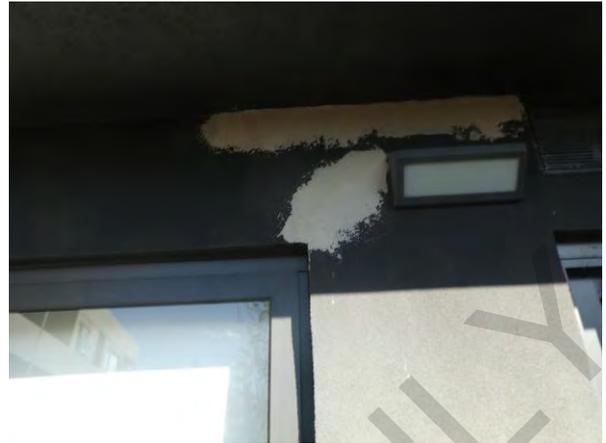
Photograph 12. Poorly patched external cladding above the sliding doors.

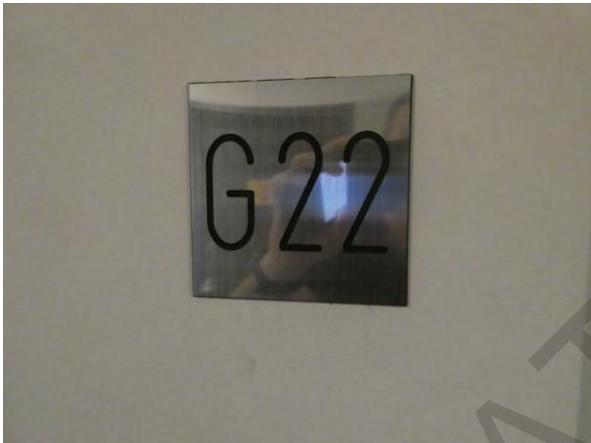
Photograph 13. Apartment G22. The occupant had previously reported waster ingress at the base of East facing external walls.

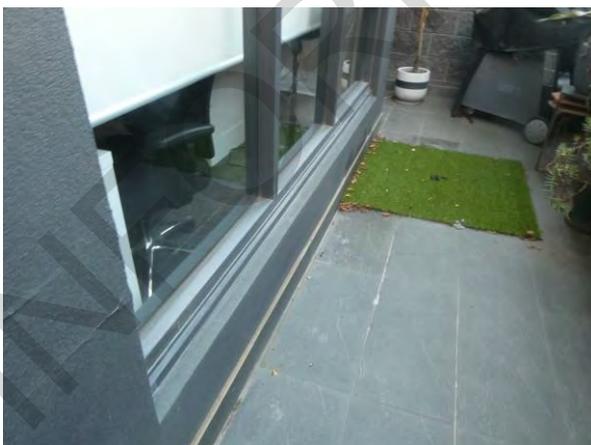
Photograph 15. I understand from the owner of the property that a representative of the builder returned and replaced floor tiles.

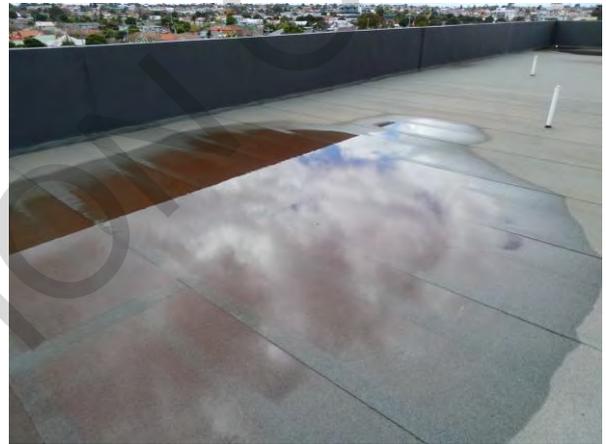
Photograph 18. Further view.

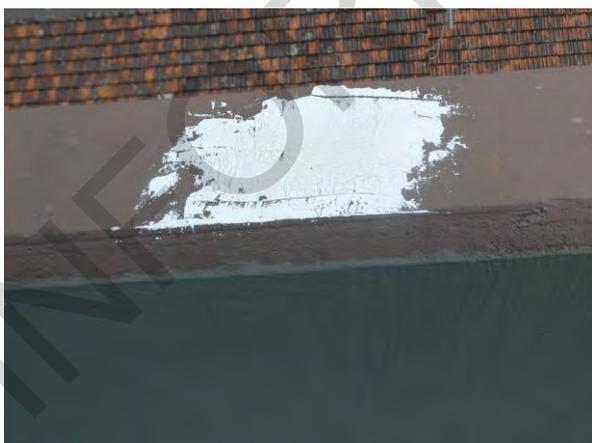
Photograph 19. The cracks in the precast concrete panel have been filled with an unknown material.

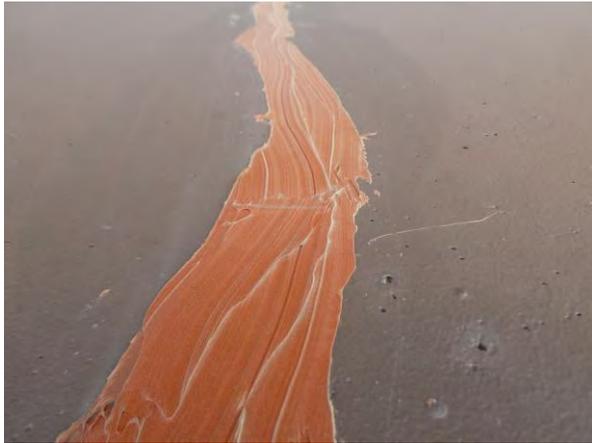
Photograph 21. Closer view.

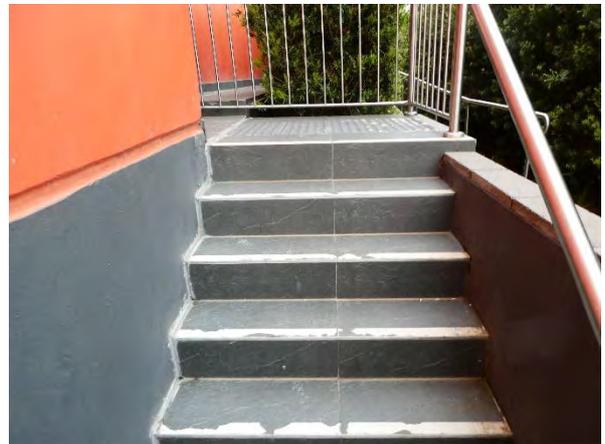
*Photograph 64. Entry stairs, tactile markers require replacement.*

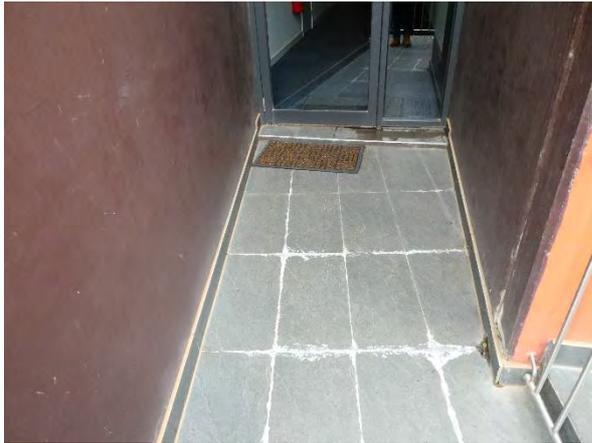
Photograph 65. Entry to the building, there is no fall on the tiling away from the building and prolonged exposure to moisture has caused efflorescence to form in the grout joints.

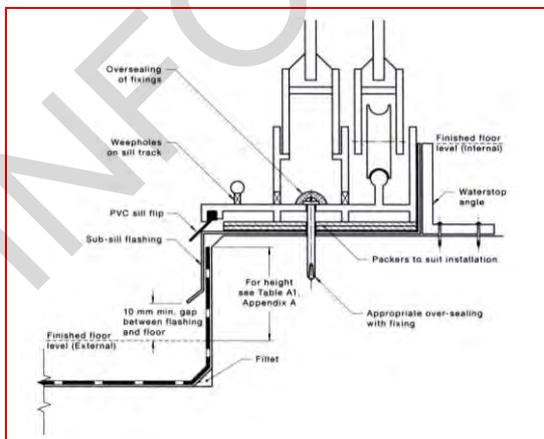
Photograph 66. Stormwater ponds at the entry door due to a lack of fall in the floor tiling. The water was observed entering the building under the door. There is an insufficient hob or freeboard under the entry door.

*There is no fall on the landing, therefore stormwater is permitted to pond on the surface causing the grout, adhesive, and screed to be saturated with stormwater. The prolonged exposure to moisture has caused efflorescence to form in the grout lines and water can be seen leeching down the face of the bluestone wall forming the stairs.*

*A compliant hob/freeboard has not been formed under the door entry to prevent stormwater entering the building. A diagram of a compliant door hob/freeboard from AS4654.2 has been provided below.*

*Water entry into the building was observed. Efflorescence, which is a building defect as detailed in the Victorian Building Authority's Guide to Standards and Tolerances, is evident throughout the entry floor tiling.*

*The floor tiles are to be removed and replaced, a compliant hob/freeboard to be constructed and an appropriate waterproof membrane installed.*

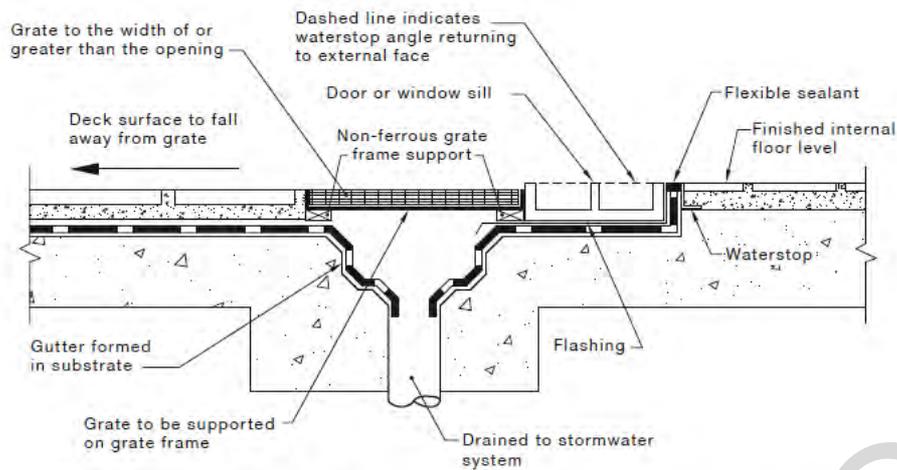
FIGURE 2.9 TYPICAL DETAILS OF MEMBRANE TERMINATION AT WALL OPENINGS WHERE THE INTERNAL AND EXTERNAL FINISHED FLOOR LEVELS DO NOT ALLOW FOR AN UPTURN

There is no fall or gradient on the landing, therefore stormwater is permitted to pond on the surface causing the grout, adhesive, and screed to be saturated with stormwater. The prolonged exposure to moisture has caused efflorescence to form in the grout lines and water can be seen leeching down the face of the stone wall forming the stairs.

A compliant hob/freeboard has not been formed under the door entry to prevent stormwater entering the building. A diagram of a compliant door hob/freeboard from AS4654.2 has been provided below.

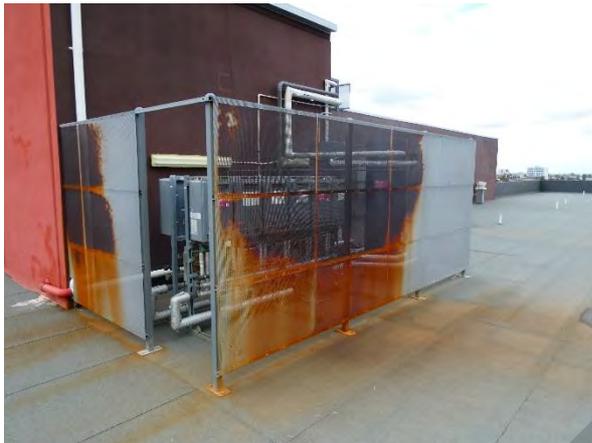
The screens protecting the hot water services have been damaged by the heat emitted from the units. The screens are corroding and staining adjacent surfaces, I do not consider these to be fit for purpose and should be replaced.

Photograph 73. Heat damaged screens.

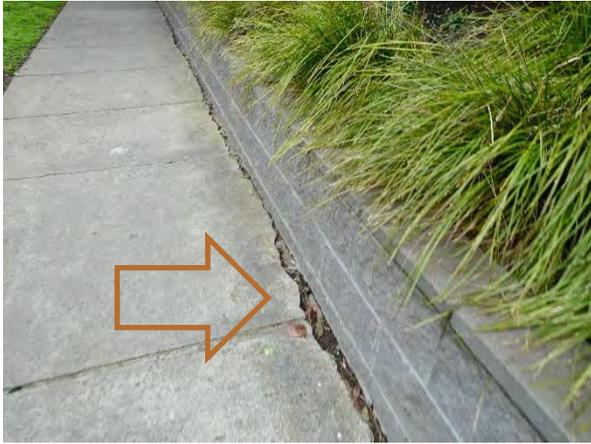
Post construction, the footpath was not reinstated in a proper and workmanlike manner.

In my opinion, the builder was obligated to return Council property back to the condition it was in prior to construction.

Photograph 74. Damaged concrete footpath remains post construction.

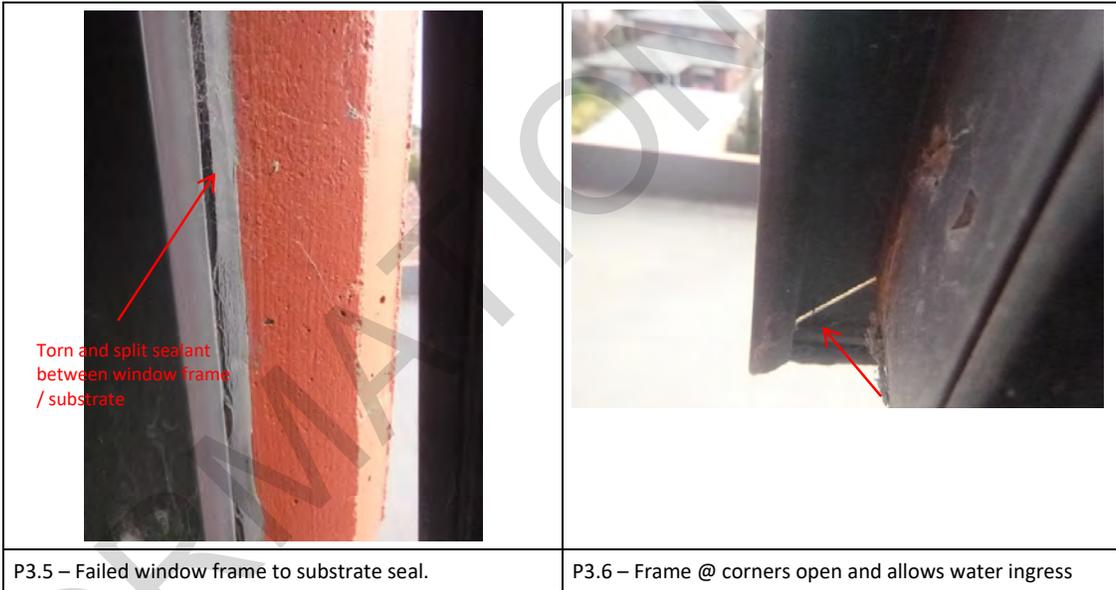
Upon inspection, the seals between the awning window frame and the surrounding substrate were found to be significantly deteriorated and torn, likely due to building movement. Additionally, the mitred corners of the awning frame were not flush, leaving gaps that were inadequately sealed, allowing water to penetrate even when the window is closed. Refer to P3.5 & P3.6.

To remediate this window, the joints need to be properly prepared and the sealant reapplied. At the frame corners, a bead of silicone can be applied on the inside to act as a backing, and once cured, an external sealant should be applied along each mitred connection to ensure a continuous weatherproof seal.

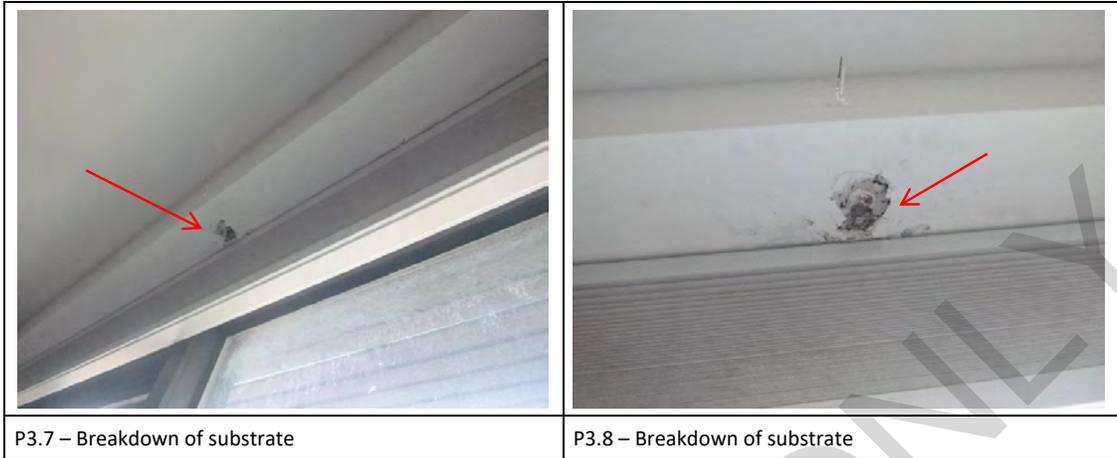
During the inspection, it was observed that the water ingress affecting the west-facing strip window does not originate from the window itself, but from the structure and roof above. Evidence of concrete deterioration and material degradation was noted above the window head in the main structural element. Refer to Photos P3.7 and P3.8.

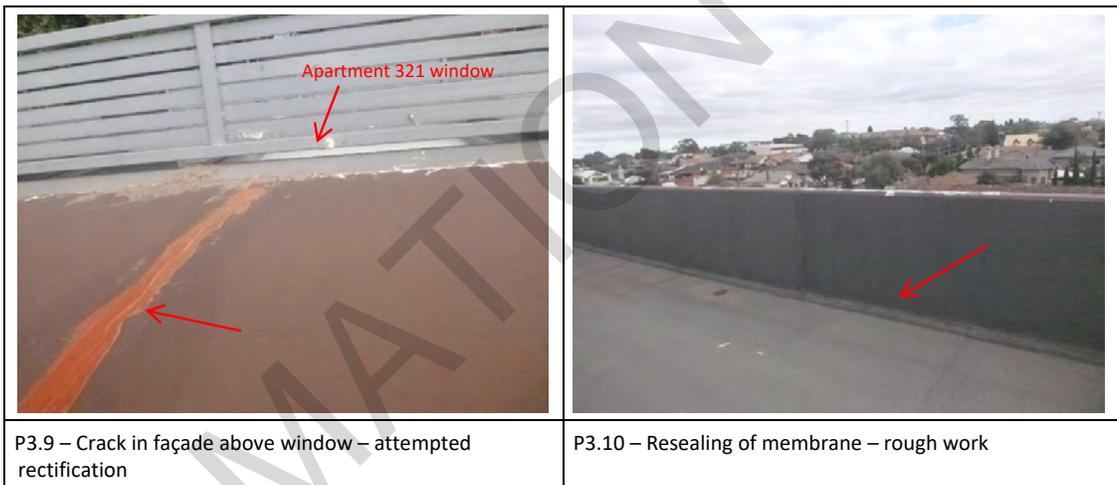
Further investigation determined that the water ingress is not related to the window itself but rather to cracking at the façade and roof/parapet interface. Inspection of the roof area above the window revealed signs of attempted rectification, including rough sealing and patching of both the façade and waterproofing membrane. Refer to P3.9 & P3.10.

Based on my assessment, this issue is associated with building movement. Once the underlying structural movement is addressed, the façade cracks can be effectively sealed, and the resulting water ingress mitigated. As water is penetrating through the structural element, it is recommended that a structural engineer evaluate the condition of the concrete in this area to determine any necessary remedial works.

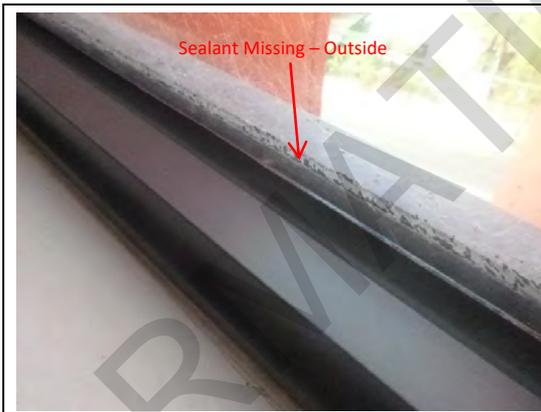
On Level 4, the window installed in the south-facing corridor (refer to Figure 3.2 for location) was found to have degraded sealant between the glass and frame. It appeared that the sealant had been forcibly removed from the joint, and given its location on the exterior, it is likely the damage was caused by birds or other vermin. Refer to P3.11 & P3.12.

P3.11 – Sealant missing from joint

This issue can be addressed by effectively preparing the joint and resealing.

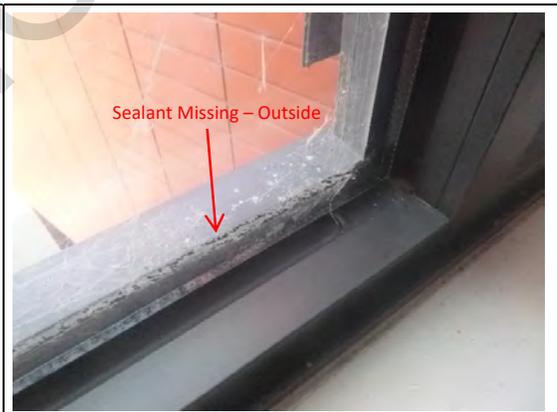
P3.12 – Sealant missing from joint

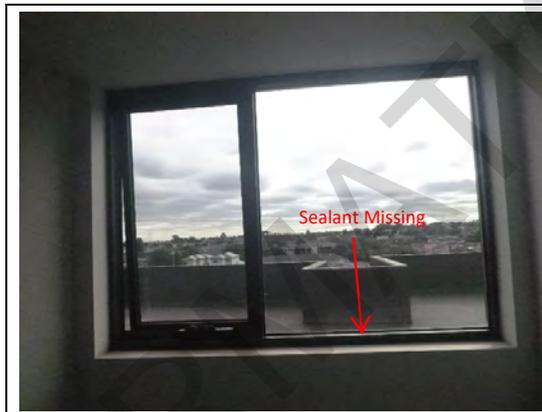
On Level 3, the window installed in the north-facing corridor (refer to Figure 3.3 for location) was found to have no sealant installed between the glass and the frame, suggesting the glass panel had either been removed to access the level 3 roof or it has been replaced and the seal was never reapplied. Refer to P3.13 & P3.14.

P3.13 – Sealant missing from joint

This issue can be addressed by effectively preparing the joint and resealing.

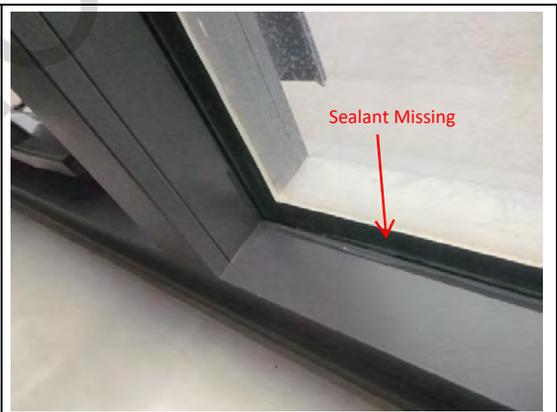
P3.14 – Sealant missing from joint

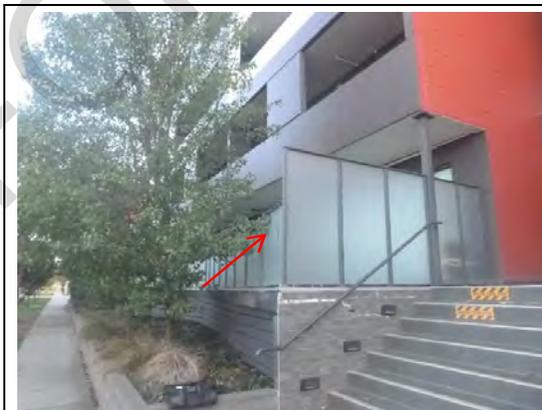
It was noted in one area that the gasket has dislodged from the handrail and should be reinserted. Refer to P4.8 & P4.9.

P4.8 – B1 – Semi-Frameless Balustrade – dislodged gasket

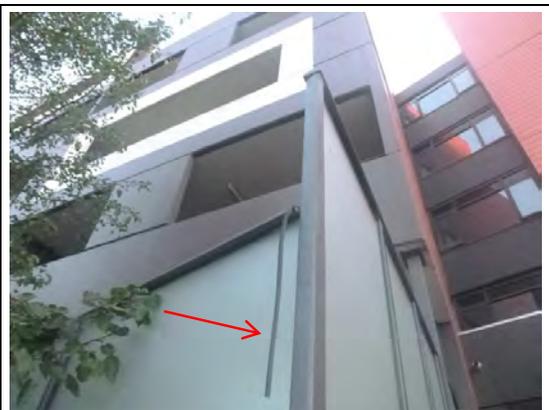
P4.9 – B1 – Semi-Frameless Balustrade – dislodged gasket

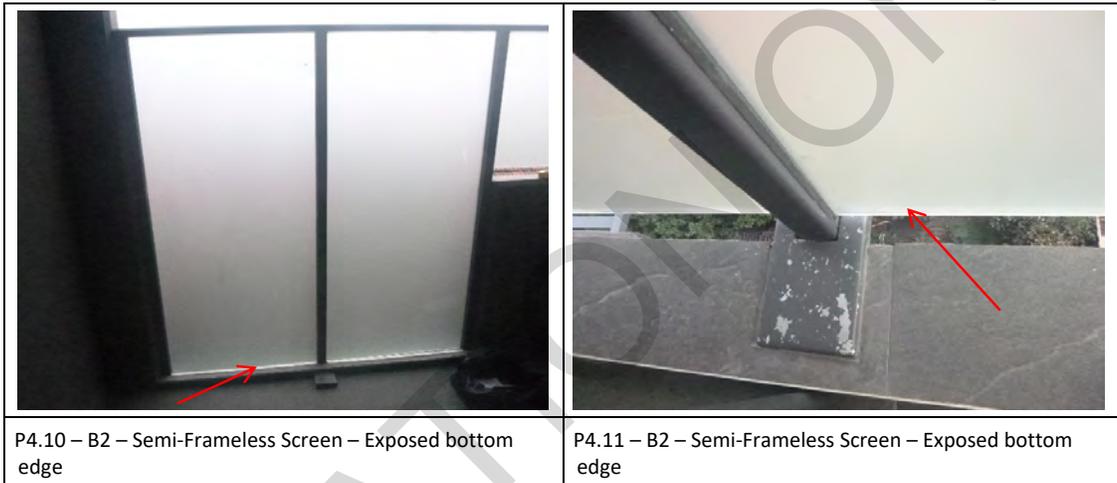
In my assessment, the use of privacy screens as the primary balustrade for the apartments along the West Elevation represents a suboptimal design approach and does not correspond to good design practices. These screens serve as the main fall-protection barrier for the balcony areas; however, the installation method introduces significant safety risks and potential for failure.

1. The use of unframed 6 mm toughened glass.
2. Exposed glass edges at floor level, increasing the risk of chipping or breakage occurring from incidental contact.
3. The absence of a handrail at the standard balustrade height, reducing lateral support and user safety.

The glass is supported along 3 sides with the bottom edge unsupported (semi-frameless) and as the bottom edge is located at floor level there is a high risk that incidental impact may occur and cause the glass to shatter, which if it was human impact as there is no handrail may result in the person falling through the opening to the ground below. Refer to P4.10 & P4.11.

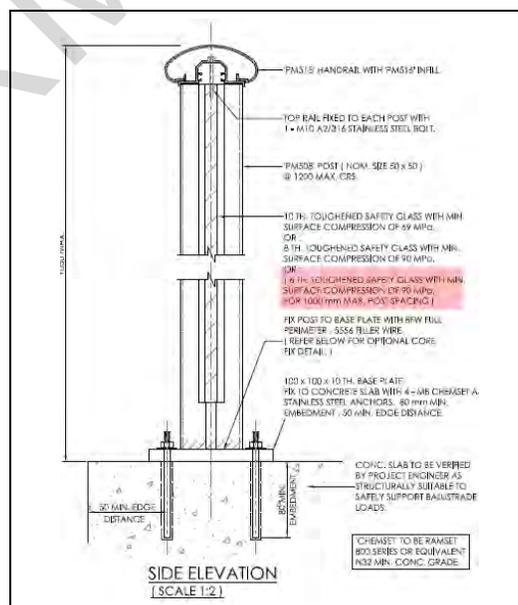
FIGURE 5.4 – EXTRACT FROM 18474-S01

- Document 18474-S01 Rev A indicates when incorporating 6mm thick toughened glass the maximum post spacing allowed is 1000mm, however at ground floor there are a number of the panels that were measured to have posts installed at >1100mm wide. Refer to figure 5.4 – extract from drawing 18474-S01.

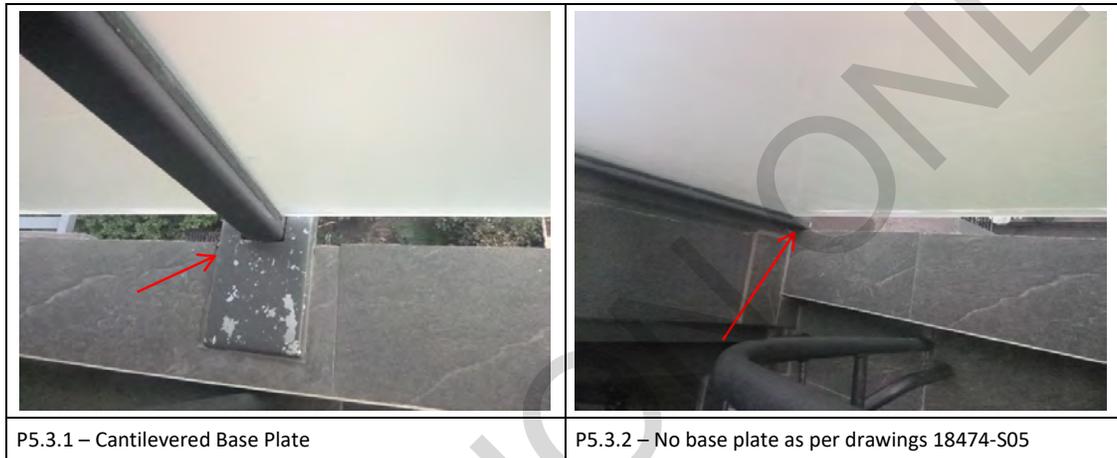
- The screen design outlined in 18474-S05 Rev A indicates a handrail at approximately 1050mm from the finished floor. These handrails have not been installed.
- The base plate securing the screen stanchion has been designed to be sitting on the slab and the specific site conditions to be verified by the project engineer, however at 388 Plenty Road the base plate was found to be cantilevering over the edge of the slab and not fully supported which is not in accordance to the certified design. It was also noted that the end stanchions have been fixed to a cantilevered plate and not to the base plates as per the requirements outlined in the design documents. Refer to P5.3.1 and P5.3.2 and Figure 5.5.

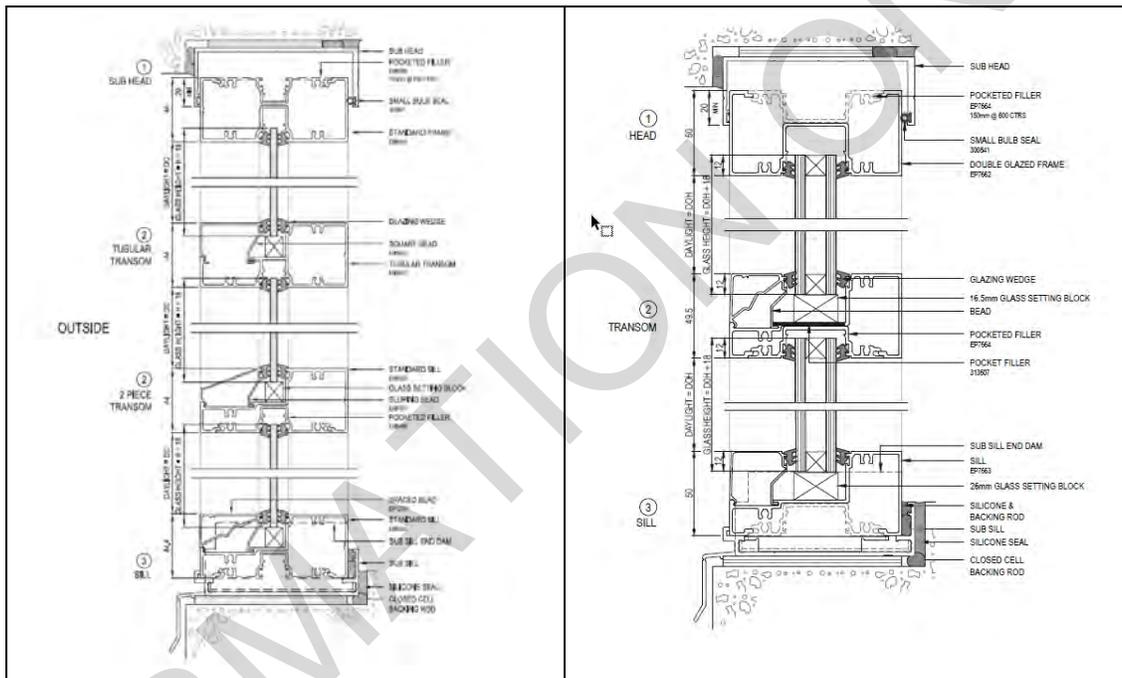
FIGURE 5.5 – CAPRAL 400 SERIES – SINGLE GLAZING

The architectural drawings, specifically A7.01, A7.02, and A7.03, specify the window systems as Capral 400 series. Site inspection confirmed that the installed windows are consistent with the specified series in overall size and style. The Capral 400 series is characterised by a 101.6mm x 44 mm frame for single-glass units and a 101.6mm x 50 mm frame for double-glass units. Verification measurements and visual examination indicate that the installed frames conform to these dimensions. Figures 5.5 and 5.6 illustrate the Capral 400 series frame profiles for reference.
