# Inspection Report

## Nova Home Inspections

**32 Guise Ave Casula**

Report/Agreement #           06121902007870  
 Inspection Date:               06 Dec 2019  
 Inspection Time:               01:30 pm

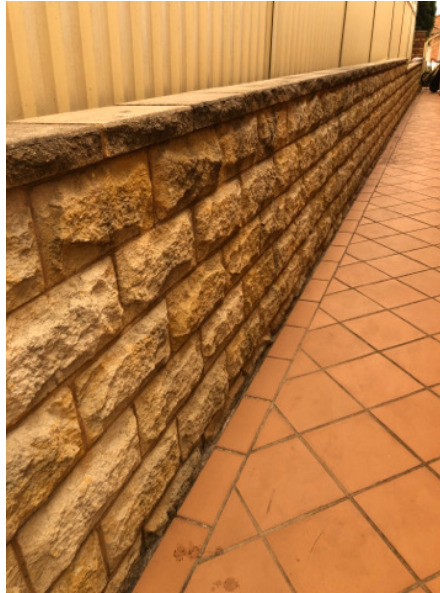
Keystone blocks

Of the visible areas, the general condition is serviceable or in reasonable condition for age of dwelling.

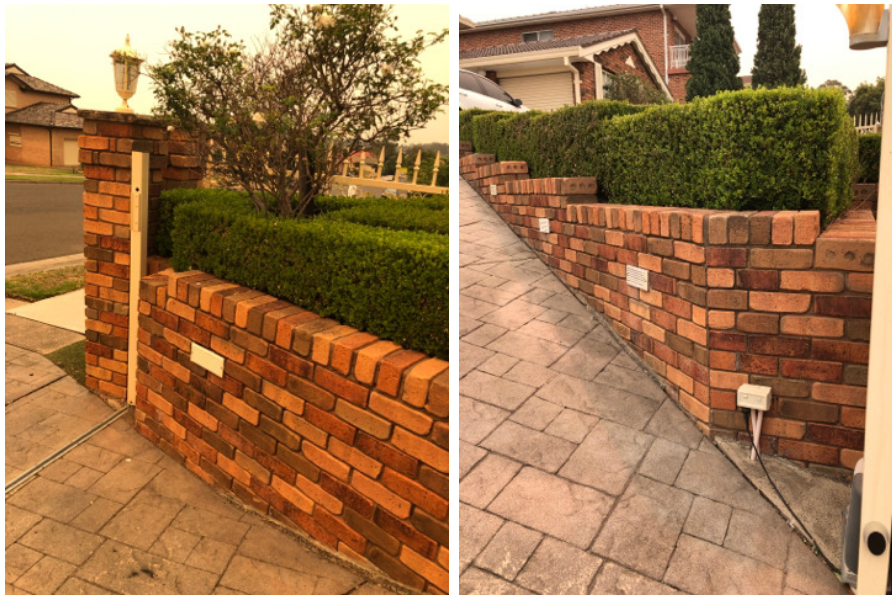
The retaining wall material is brick.

Of the visible areas, the general condition is serviceable or in reasonable condition for age of dwelling.

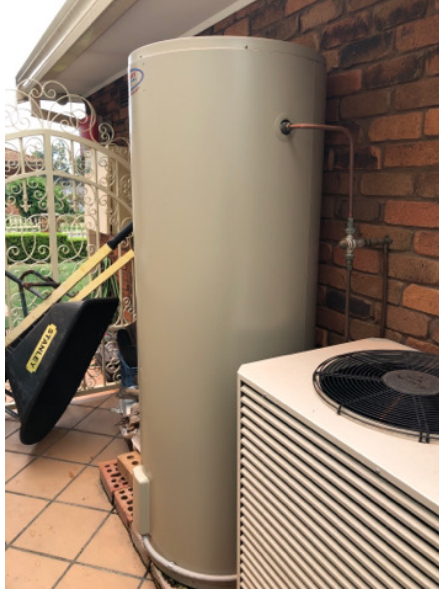
The hot water system appears to be in a serviceable condition. No specific tests other than running the hot water from a tap was carried out. No determination has been made as to the suitability or adequacy of the hot water system in relation to capacity or otherwise.

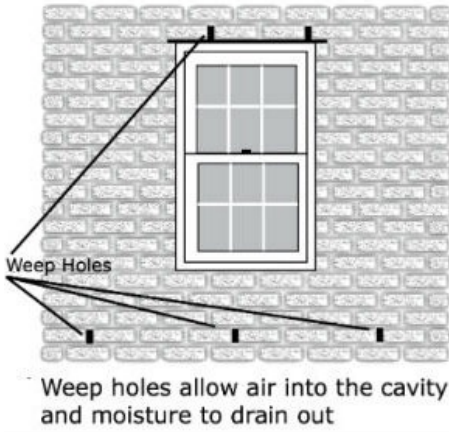
The weep holes are unobstructed .

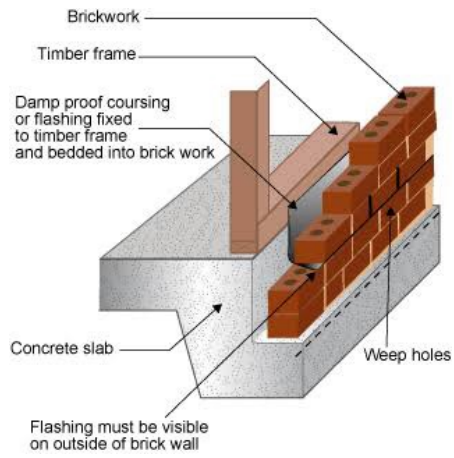
A damp proof course (DPC) was noted.

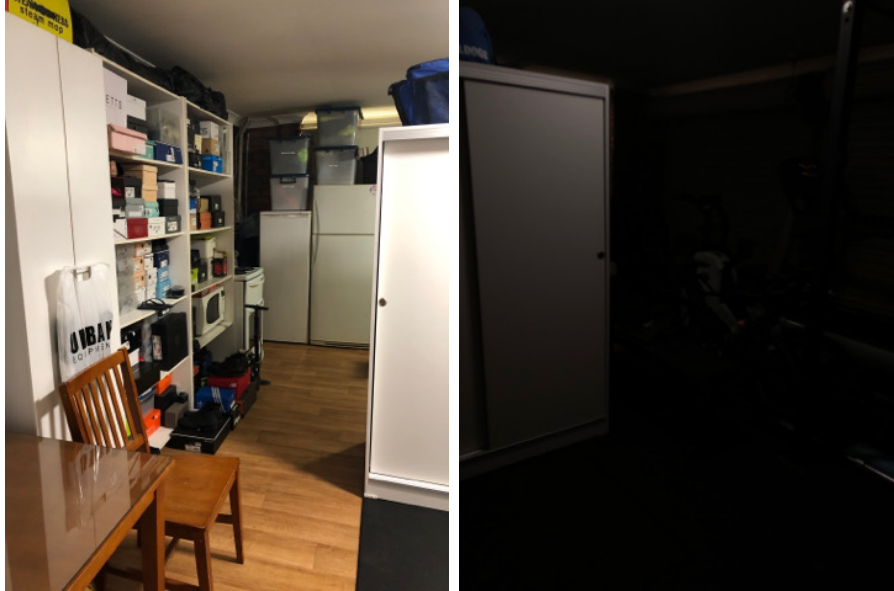
Attached garage

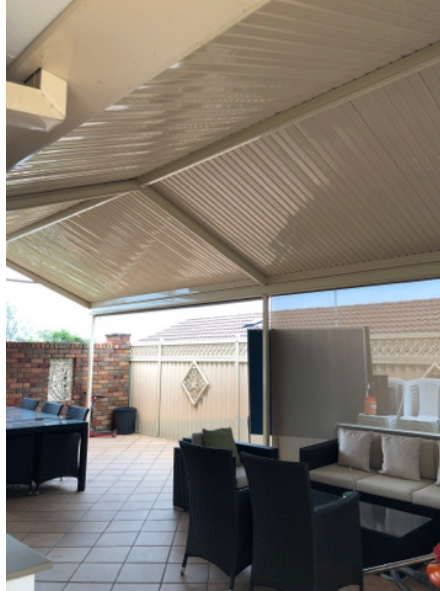
The Pergola is in a serviceable condition with no notable defects sighted.

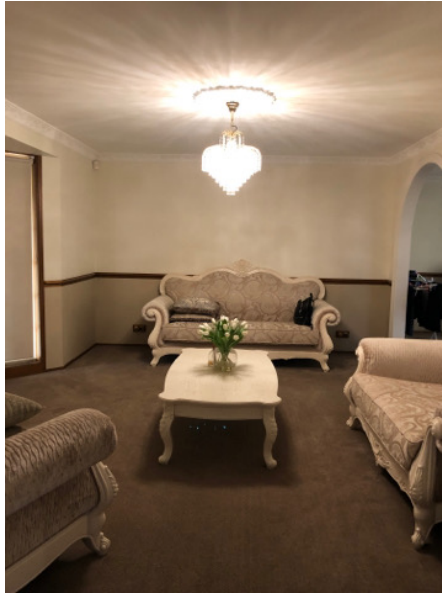
From the visible and accessible areas, the lounge room appears to be in a serviceable condition for the age of the property with no notable structural defects sighted.

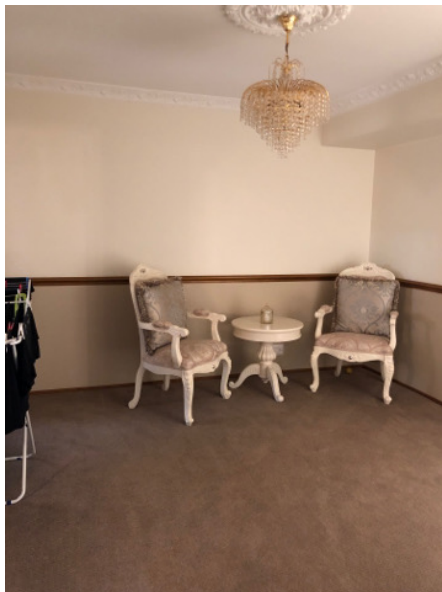
From the visible and accessible areas, the dining room appears to be in a serviceable condition for the age of the property with no notable structural defects sighted.

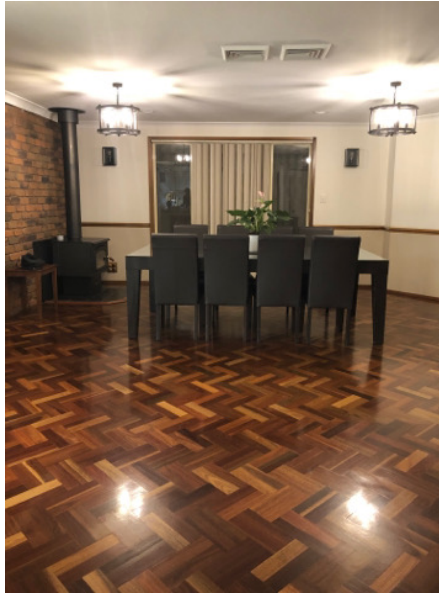
From the visible and accessible areas, the family room appears to be in a serviceable condition for the age of the property with no notable structural defects sighted.

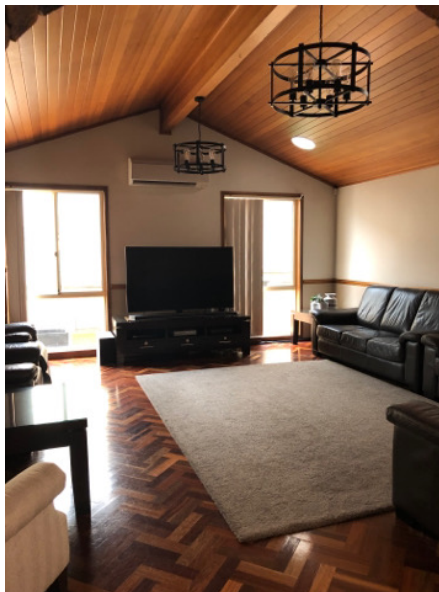
From the visible and accessible areas, the rumpus room appears to be in a serviceable condition for the age of the property with no notable structural defects sighted.

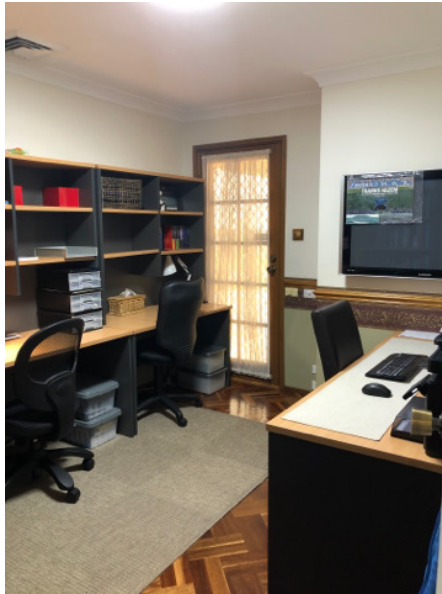
From the visible and accessible areas, the study/office appears to be in a serviceable condition for the age of the property with no notable structural defects sighted.

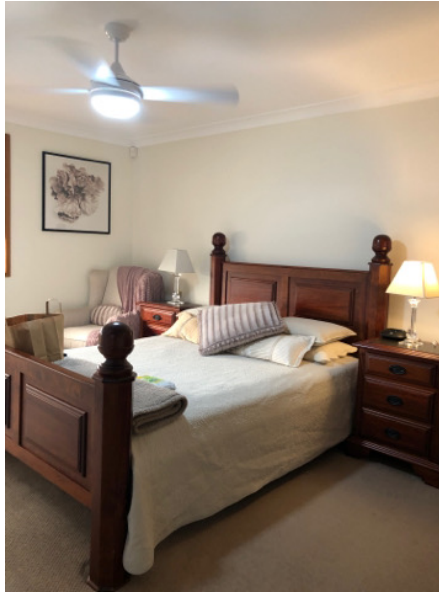
This bedroom is in serviceable condition for the age with no notable structural defects sighted.

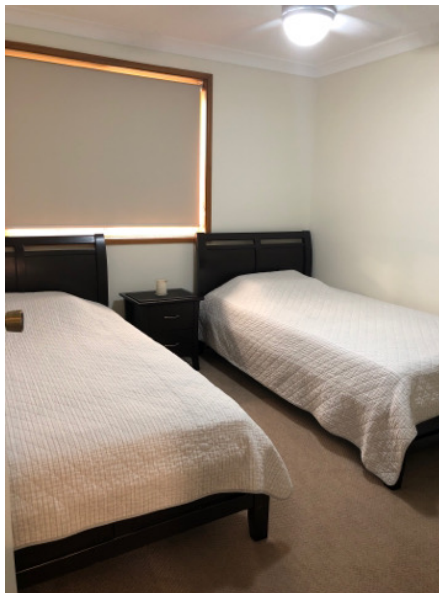
From the visible and accessible areas, this bedroom appears to be in a serviceable condition for the age of the property with no notable structural defects sighted.

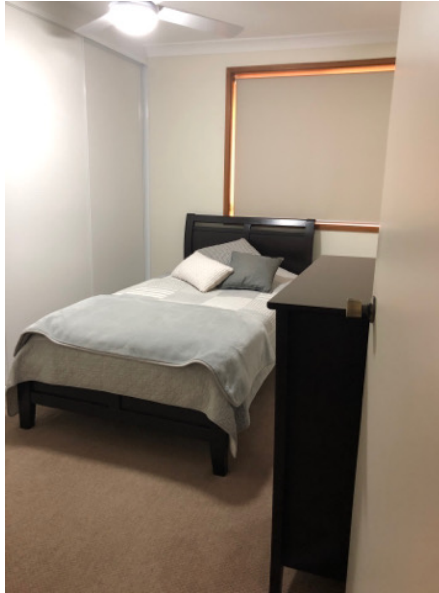
From the visible and accessible areas, this bedroom appears to be in a serviceable condition for the age of the property with no notable structural defects sighted.

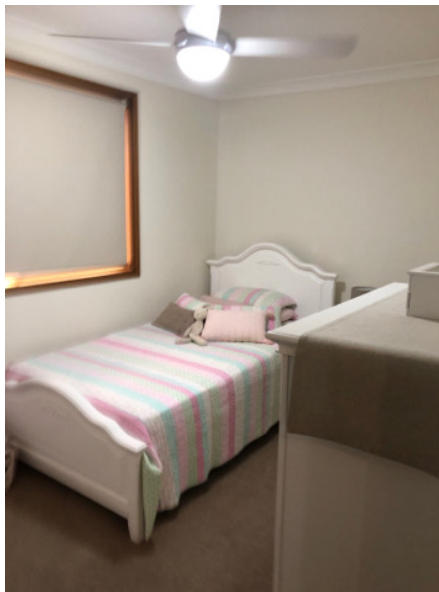
From the visible and accessible areas, this bedroom appears to be in a serviceable condition for the age of the property with no notable structural defects sighted.

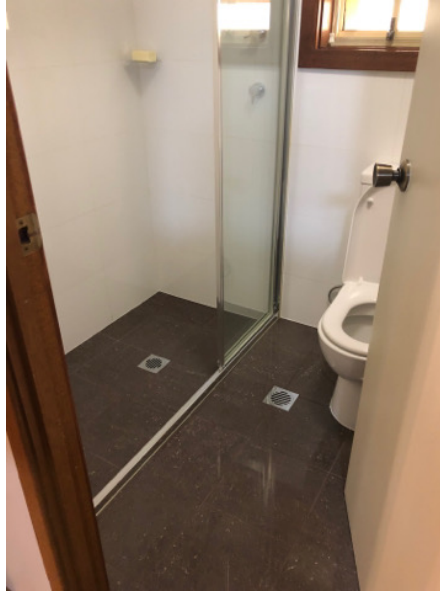
Downstairs

Of the visible areas, the general condition of this bathroom is serviceable or in reasonable condition for age of dwelling.

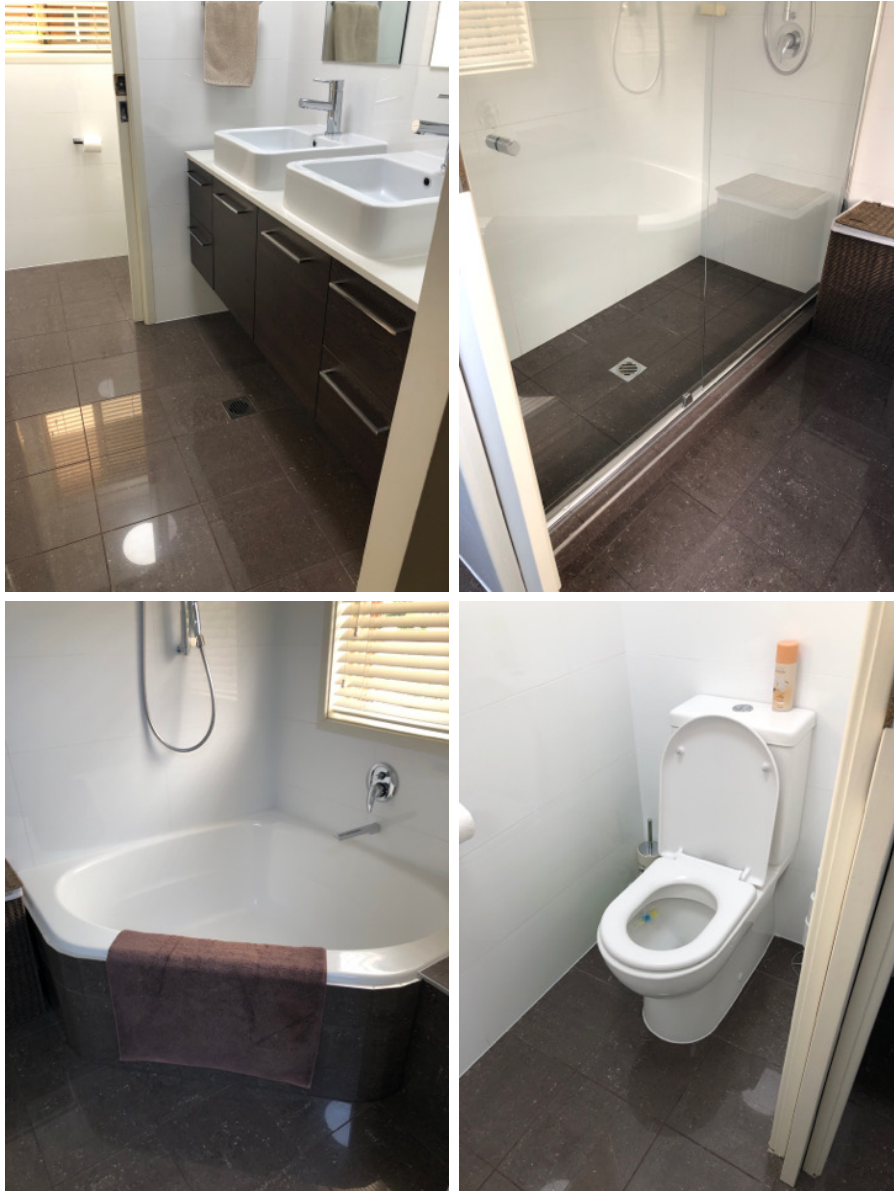
**Location**  
Upstairs

Of the visible areas, the general condition of this bathroom is serviceable or in reasonable condition for age of dwelling.

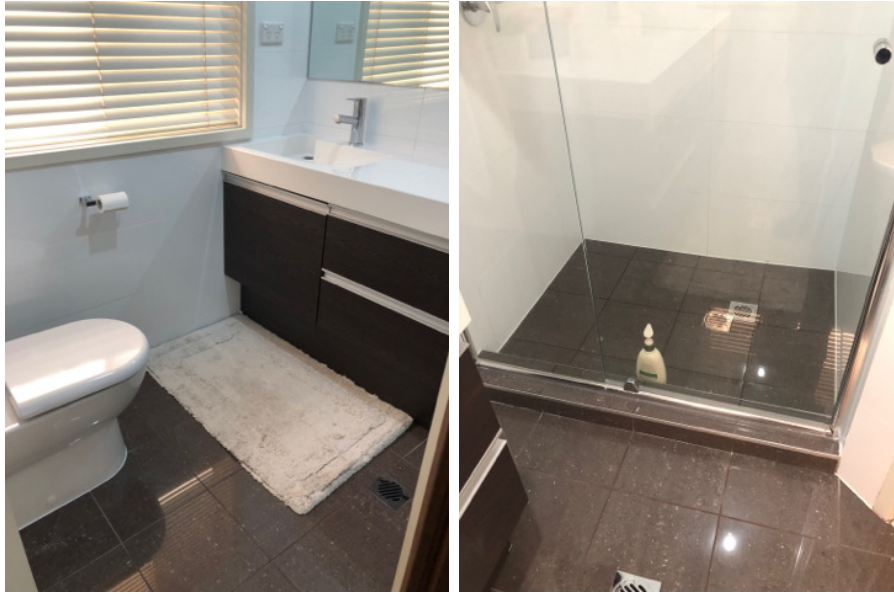
Master bedroom

Of the visible areas, the general condition of this bathroom is serviceable or in reasonable condition for age of dwelling.

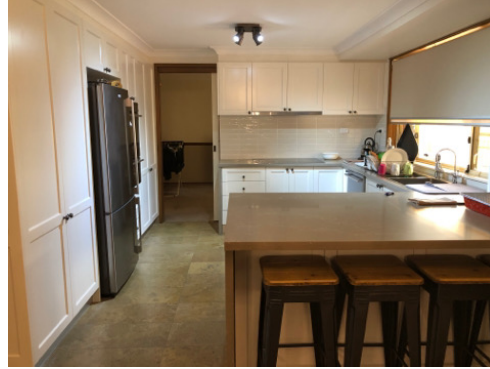
Of the visible areas, the general condition of the kitchen is serviceable or in reasonable condition for age of dwelling.

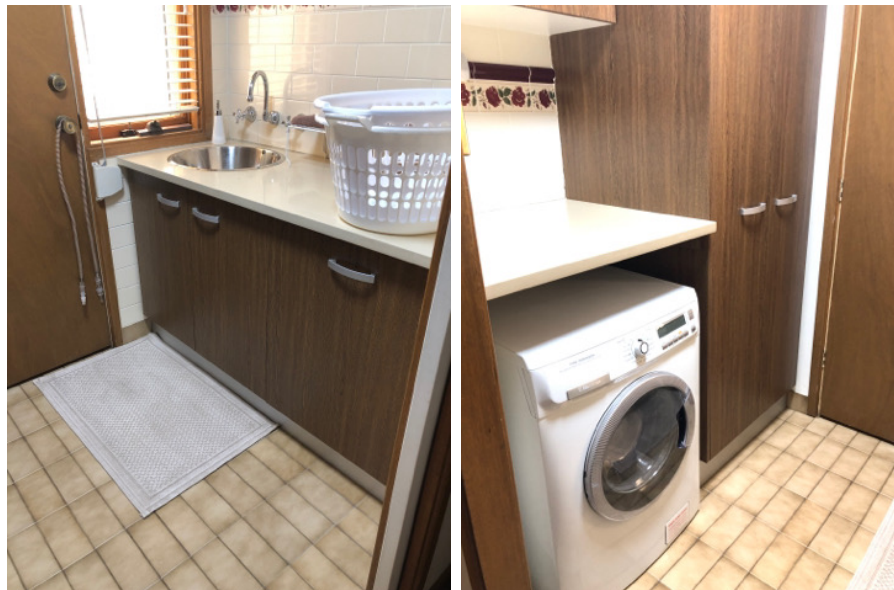
Of the visible areas, the general condition of the laundry is serviceable.

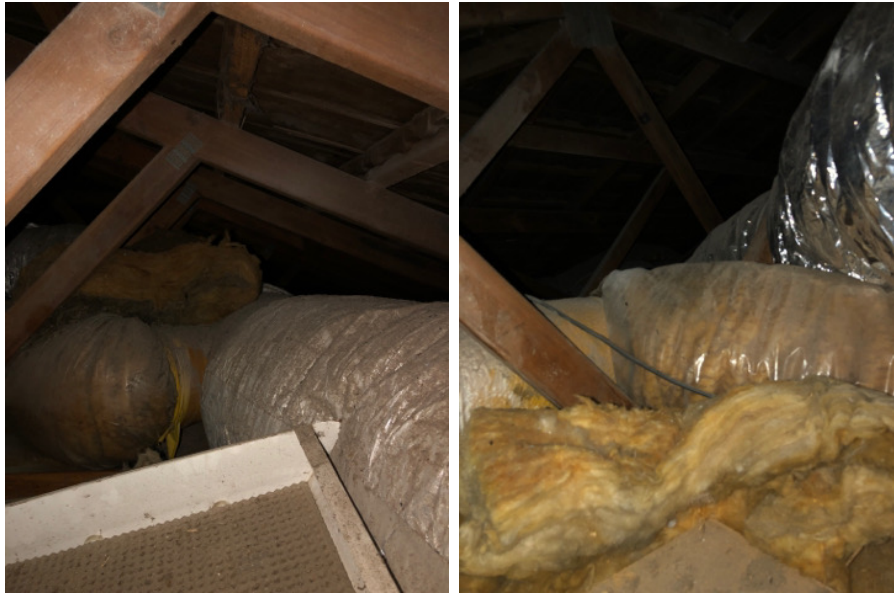
Truss Webbing

There is insulation present in the roof space/void. This is preventing a full inspection of ceiling joists from being undertaken. It is strongly recommended that full access be gained as it could be harbouring timber pest activity, damage or defects.

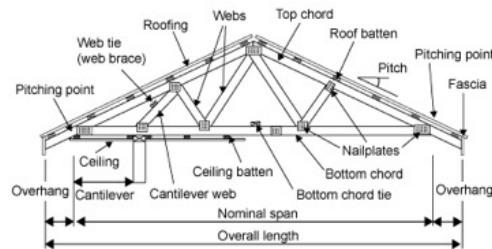
The roof frame is a truss timber frame.
